# Building To Resist The Effect Of Wind

NBS BUILDING SCIENCE SERIES 100-3

## VOLUME 3: A Guide for Improved Masonry and Timber Connections in Buildings

S. George Fattal

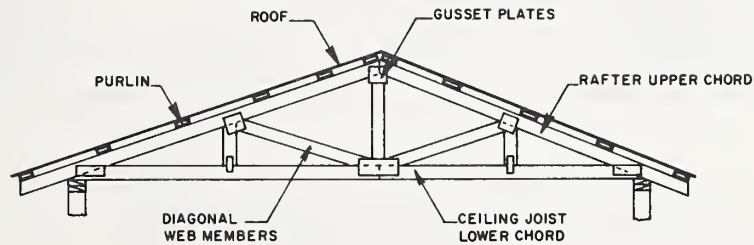
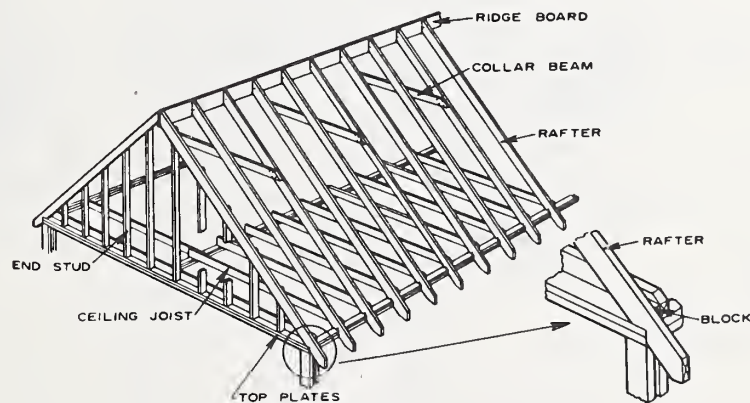
FIGURE 1 COMMON ROOF SYSTEMS FOR LOW-RISE BUILDINGS.

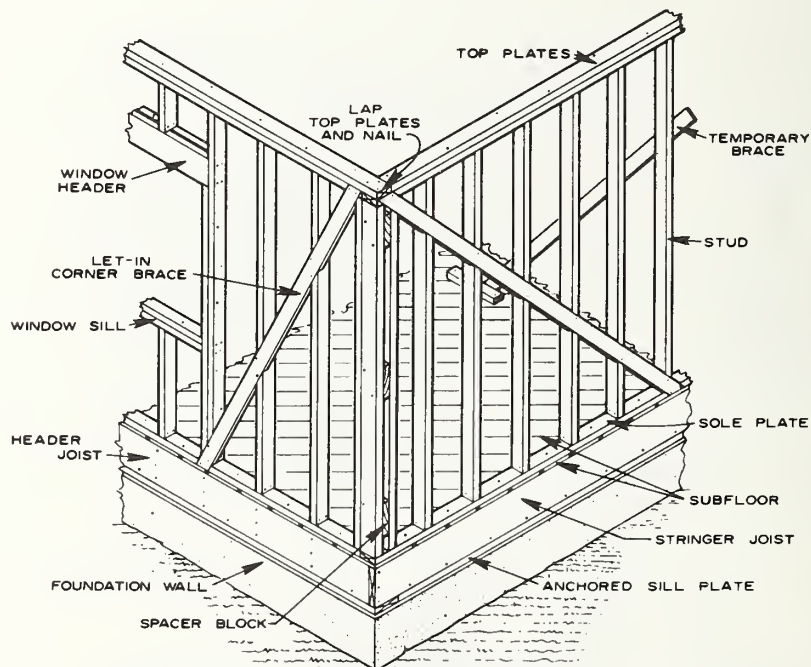
FIGURE 5 TIMBER WALL CONSTRUCTION.

Figure 5 shows a partial view of a timber "stud" wall system. The studs or "verticals" transmit gravity loads and the vertical component of wind-induced loads which may be reversible (bearing or uplift). In addition, the studs provide flexural resistance against direct horizontal wind pressure or suction. The diagonals stiffen the walls in their own planes and increase the capability of the system to resist lateral loads. The specific fastener details for the stud wall system are discussed in section 3.

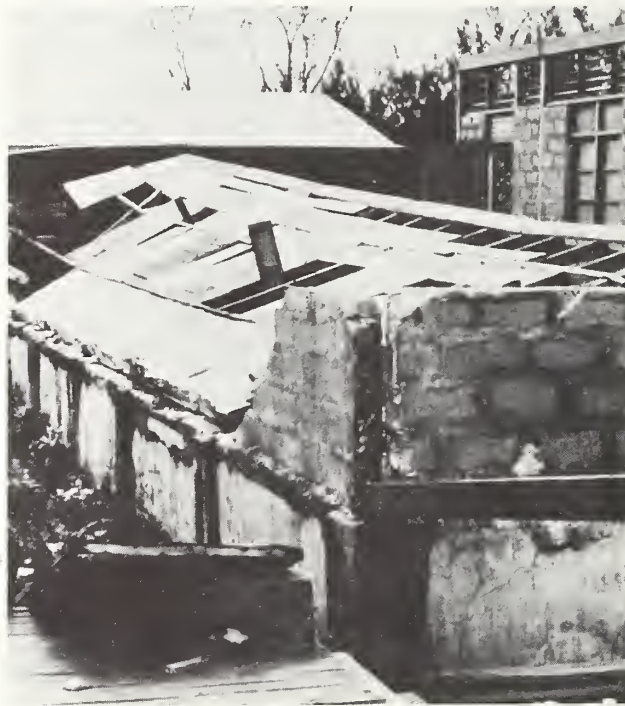
FIGURE 8 COLLAPSE OF ONE-STORY BUILDING  
CAUSED BY THE NOVEMBER 1974  
TYPHOON IN THE PHILIPPINES.

Figures 8 to 17 exhibit buildings damaged or destroyed by recent hurricanes and typhoons. The buildings shown in figures 8 to 10 belong to a group of one-story structures in Northern Luzon, the Philippines, which either sustained severe damage or collapsed as a result of the November 1974 typhoon. These structures consisted of masonry walls and wood posts, a pitched roof system of wood trusses, purlins and corrugated iron cover, and a continuous foundation wall of cast concrete.

Figure 10 exhibits a typical failure of the fasteners connecting the purlins to the top chords of the trusses. Most of the roofing was "peeled off" in this manner. Portions of the corrugated iron roofing found on the ground contained the purlins with their metal wire attachments still in place (fig. 50). Instability of the trusses, few of which were still standing, was attributed to the loss of purlins and the absence of other longitudinal bracing between the trusses. The collapse of the masonry walls as shown in figure 8 was likewise attributed to the loss of lateral support at the roof level. However, the extent and severity of wall damage is also attributed to the absence of connections between abutting walls and the ineffectiveness of the vertical anchorage at the base. As indicated in figure 9, the only anchorage consisted of steel plates bolted to the wood posts. Close inspection revealed severe corrosion of these plates, especially at the ruptured section through the bolt-holes (fig. 9). The masonry walls in these buildings were nonload-bearing as they were stopped short of the roof to provide openings at the top (fig. 8). Thus the wood posts were the only vertical load-bearing elements and with the loss of the roof many of the corner posts were tipped over (fig. 8).

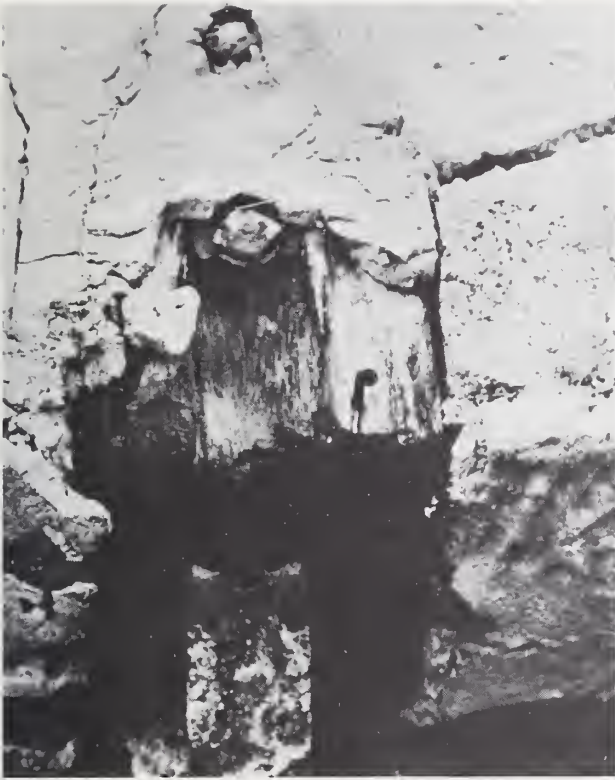
**FIGURE 9** FAILURE OF METAL ANCHOR  
PLATE IN BUILDING  
DESTROYED BY NOVEMBER  
1974 TYPHOON IN THE  
PHILIPPINES.

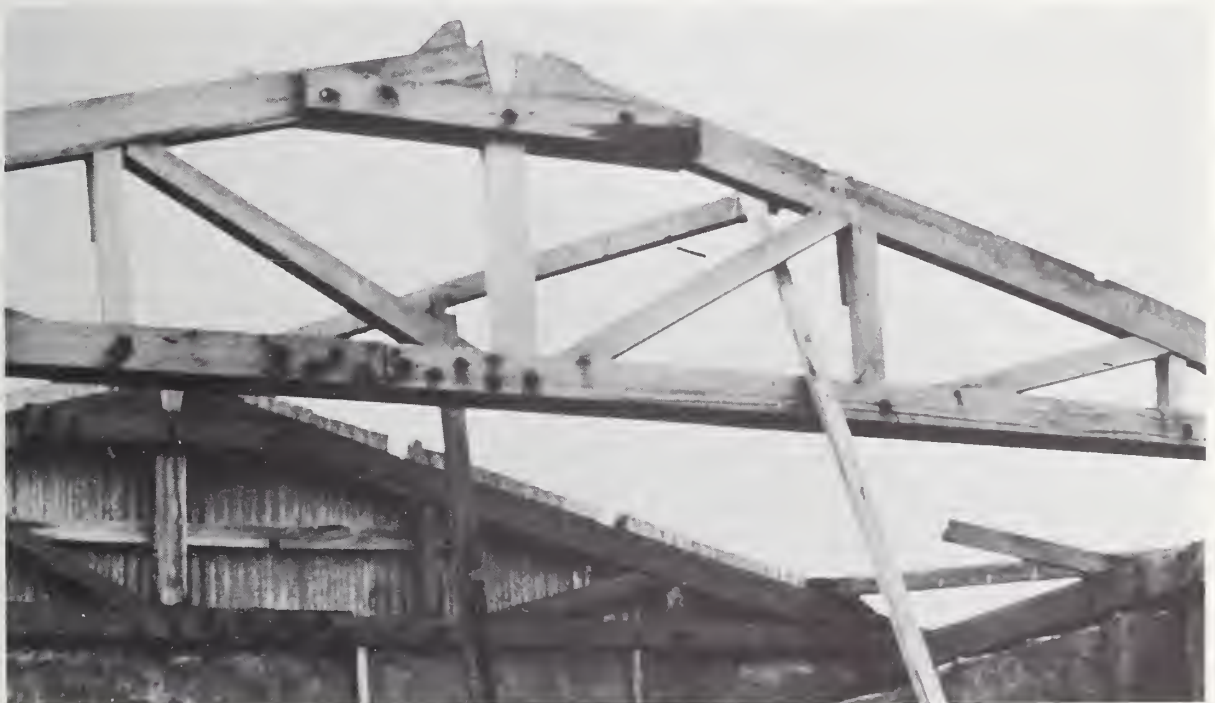
**FIGURE 10** ROOF FAILURE IN BUILDING CAUSED BY NOVEMBER 1974 TYPHOON IN  
THE PHILIPPINES.

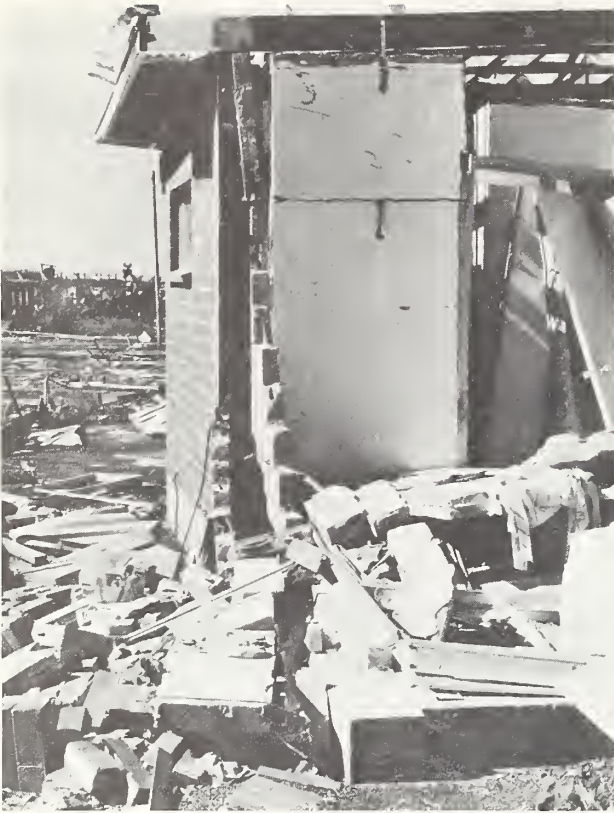
**FIGURE 15 BUILDING OF CAVITY WALL CONSTRUCTION IN DARWIN, AUSTRALIA, PARTIALLY DESTROYED BY THE DECEMBER 1974 CYCLONE.**

A damage study of the Darwin structures reveals some features worthy of note. In figure 15, it appears that failure occurred at the fourth bed joint from the top, in the inner concrete masonry wythe of the double-wythe cavity wall. Since the inner wythe is the loadbearing component, its failure was probably caused by an outward thrust of the roof under the action of wind. The tilted position of the inner wythe with its top leaning against the brick facing indicates the absence of ties between the wythes near the roof level. The masonry wall in figure 14 consists of two concrete block wythes with a cavity in between. The condition of the reinforcement demonstrates the ineffectiveness of the light-gage ties in assisting the integral functioning of the two wythes in out-of-plane flexure.

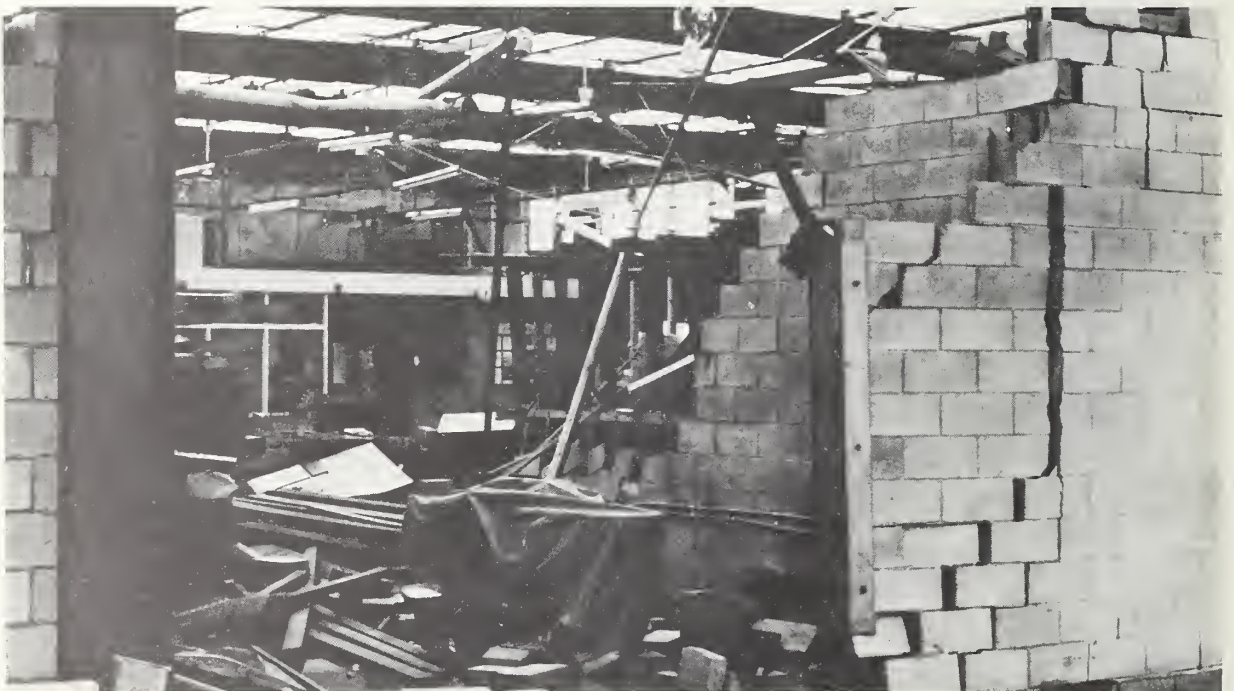
**FIGURE 16 BUILDING IN DARWIN, AUSTRALIA SHOWING PARTIAL COLLAPSE OF ROOF AND MASONRY INFILL WALLS CAUSED BY THE DECEMBER 1974 CYCLONE.**

Figure 16 shows an infill wall construction with a steel frame and concrete masonry filler walls. There is no visual evidence of any reinforcement having been used in the filler walls. Note the severity of vertical cracking through the wall on the right and also the separation between the steel column and the wall at the left. It is not possible to establish by examination of the figure whether there were any connectors between the steel columns and the filler walls. Figure 17 shows the portion of a concrete masonry wall under the sill of a large window opening that has failed. Note that the top course was connected to the window frame with anchor straps embedded into the grouted cores. It is likely that failure was caused by the movement of the window frame, prying the top course loose from the rest of the wall.

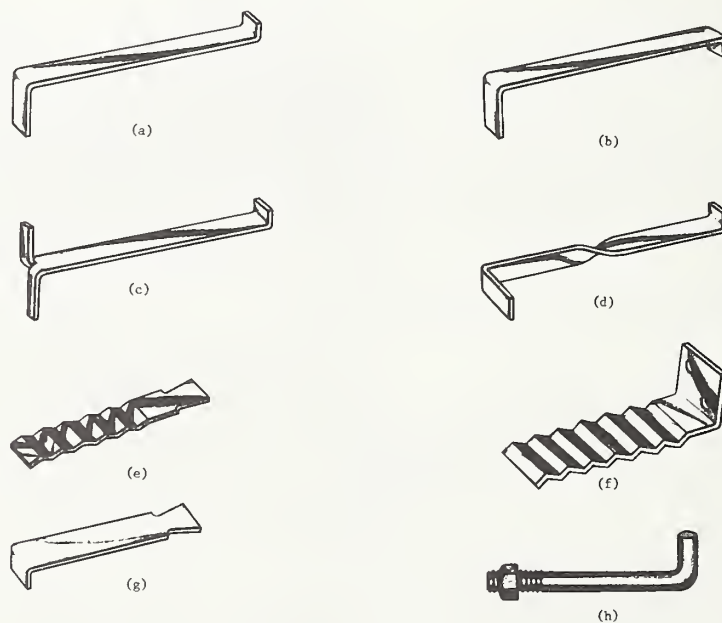
**FIGURE 28 VARIOUS METAL ANCHORS: (a), (b) TIEBARS WITH END HOOKS; (c) TIEBAR WITH HOOK AND SPLIT HOOK; (d) TIE BAR WITH 90° TWIST; (e) CORRUGATED DOVETAIL TIE; (f) CORRUGATED TIE; (g) DOVETAIL TIE WITH HOOK; (h) ANCHOR BOLT.**

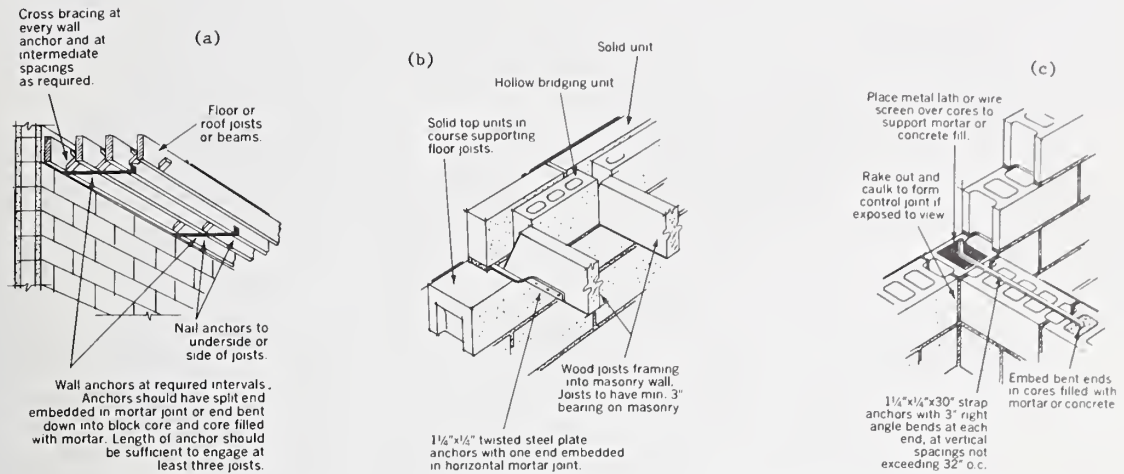
**FIGURE 29 APPLICATION OF METAL ANCHORS IN MASONRY CONSTRUCTION: (a) TIEBAR ANCHOR TO WOOD JOISTS; (b) TWISTED ANCHOR CONNECTING WOOD JOIST TO CONCRETE MASONRY BEARING WALL; (c) TIEBAR ANCHOR CONNECTING CONCRETE MASONRY INTERSECTING WALLS.**

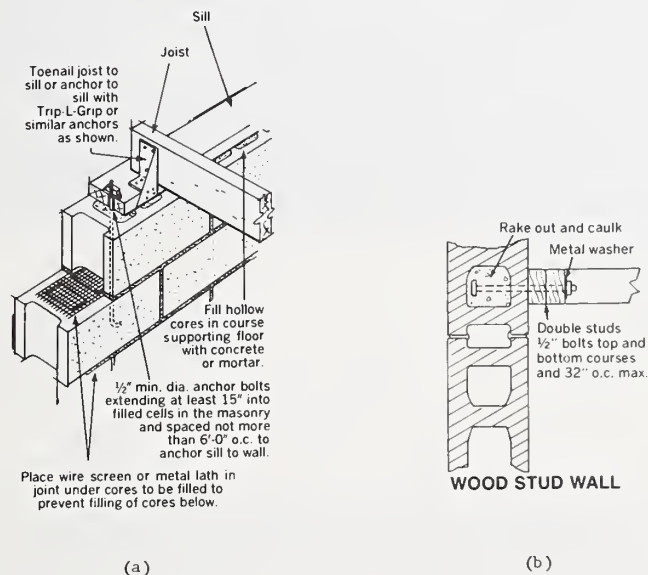
**FIGURE 30 APPLICATION OF ANCHOR BOLT FOR MASONRY CONNECTION: (a) CONNECTION OF SILL PLATE TO CONCRETE MASONRY BEARING WALL; (b) CONNECTION OF CONCRETE MASONRY WALL TO WOOD STUD WALL.**

two anchor bolt applications: (a) anchorage of sill to masonry wall and (b) anchorage of stud wall to masonry wall. Also consult figures 55 and 56 which illustrate the use of anchor bolts to connect a stud wall system to cast concrete slab footings and concrete masonry foundation walls.

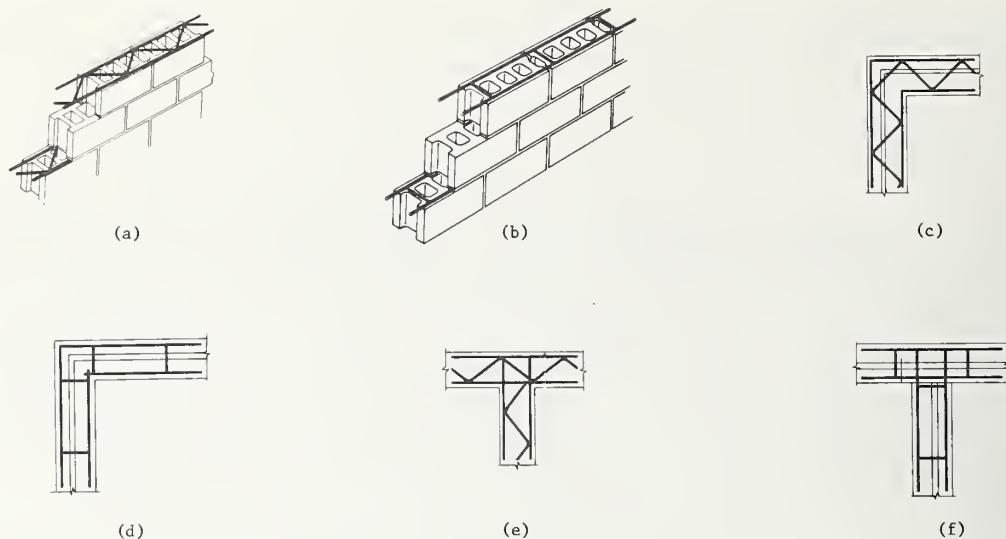
**FIGURE 31 JOINT REINFORCEMENT IN MASONRY WALLS: (a) TRUSS; (b) LADDER; (c) AND (d) PREFABRICATED CORNER SECTION; (e) AND (f) PREFABRICATED TEE SECTION.**

Figure 31 shows reinforcement designed for placement in the horizontal joints of masonry walls. The two common shapes are the truss and the ladder shown in (a) and (b), respectively. This reinforcement is fabricated from light-gage, cold-drawn steel and consists of two longitudinal rods welded together by cross rods. Joint reinforcement is used as a means to prevent or control cracking in masonry walls and to improve their tensile strength in horizontal flexure.

The use of joint reinforcement is strongly recommended in walls of stacked bond construction which are prone to develop cracking in service along the vertically aligned mortar joints. A good practice is to use them in alternate courses in stacked bond construction and in every third course in running bond construction. Special prefabricated units are also available for continuous reinforcement around corners as in figure 31(c) and (d), and for tying abutting walls and partitions as in figures 31(e) and (f).

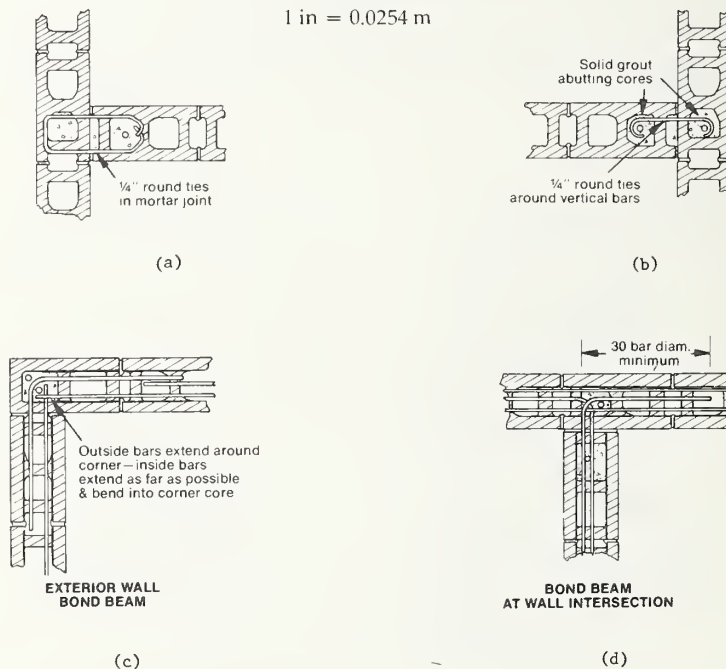
**FIGURE 32 HORIZONTAL REINFORCEMENT BETWEEN INTERSECTING MASONRY WALLS: (a) AND (b) WITHOUT BOND BEAMS; (c) AND (d) WITH BOND BEAM**

To provide anchorage between intersecting walls, reinforcing bars formed into a loop or hooked at both ends may be placed in bed mortar for construction without using bond beams as indicated in figures 32(a) and (b). Where bond beams are utilized, a more substantial anchorage may be effected by bending and extending the bars into the neighboring walls as indicated in figures 32(c) and (d). Likewise, walls may be connected to the foundation by dowels embedded in the footing (bent dowels are preferable) and extending into the grouted core of the wall and lapping with the vertical reinforcement.

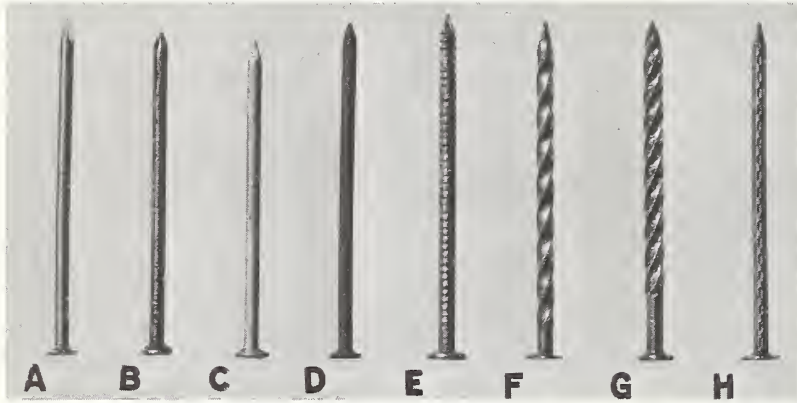
**FIGURE 33 VARIOUS TYPES OF NAILS: (a) BRIGHT, SMOOTH WIRE NAIL; (b) CEMENT-COATED; (c) ZINC-COATED; (d) CHEMICALLY ETCHED; (e) ANNULARLY THREADED; (f) HELICALLY TREADED; (g) HELICALLY THREADED AND BARBED; AND (h) BARBED.**

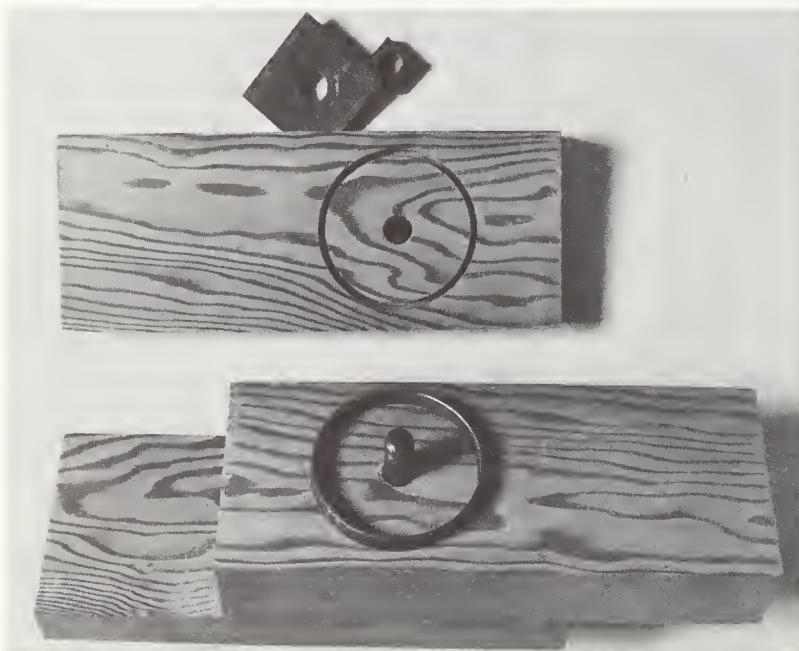
**FIGURE 34 JOINT WITH SPLIT-RING CONNECTOR SHOWING CONNECTOR, PRECUT GROOVE, BOLT, WASHER, AND NUT.**

Split rings and toothed rings are used for wood-to-wood joints, and shear plates are used for wood-to-steel joints, and sometimes for wood-to-wood joints. Proper joint design procedures and loads can be found in ref. [47].

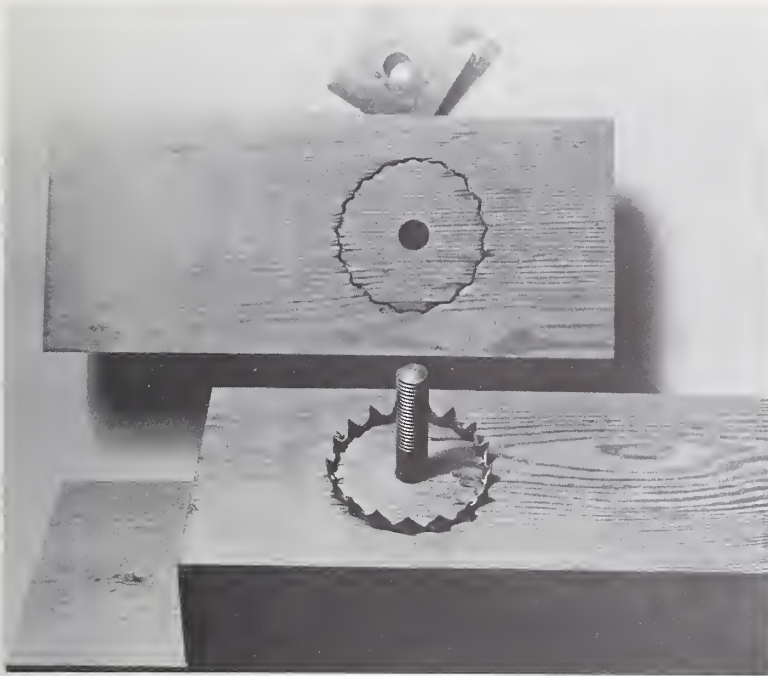
FIGURE 36 JOINTS WITH SHEAR-PLATE  
CONNECTORS WITH (a)  
WOOD SIDE PLATES; AND  
(b) STEEL SIDE PLATES.

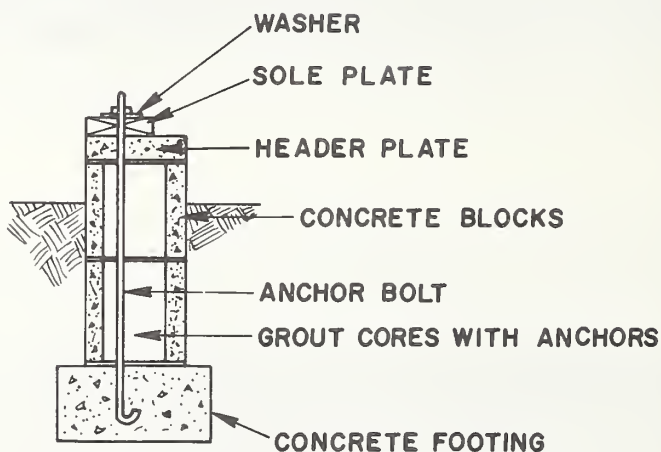
FIGURE 55 ANCHOR BOLT IN CONCRETE A MINIMUM OF 0.2 m (8 in); WASHER TO SPREAD LOAD.

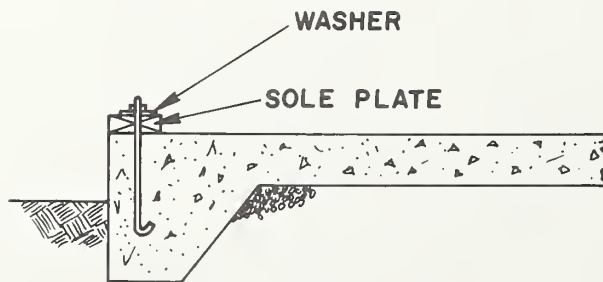
FIGURE 56 ANCHOR BOLT THROUGH CONCRETE BLOCK FOUNDATION INTO FOOTING.

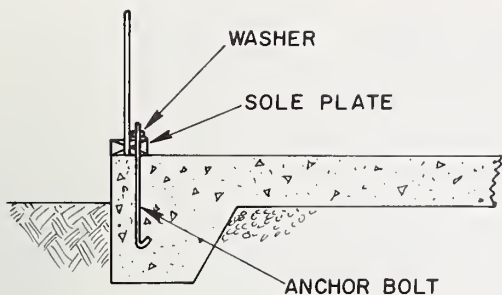
**FIGURE 57** ANCHOR BOLT INSTALLED ON PROTECTED SIDE OF WALL.

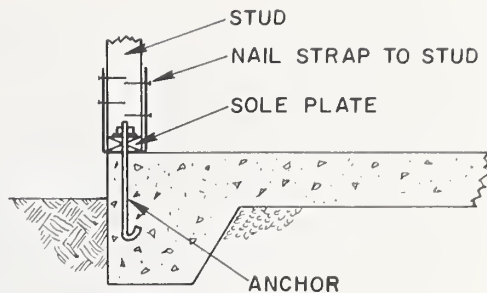
**FIGURE 58** SHEET METAL STRAP TYING STUD TO BOTTOM PLATE.

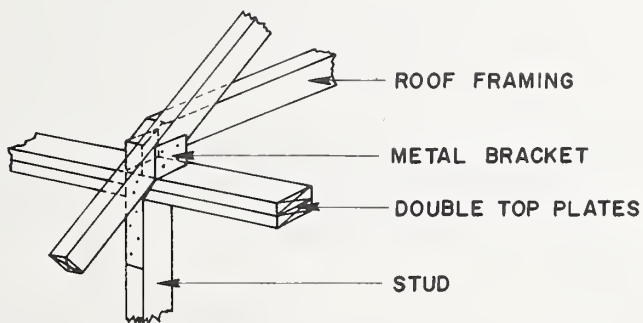
**FIGURE 59** SHEET METAL BRACKET FOR TYING ROOF FRAMING TO WALLS.

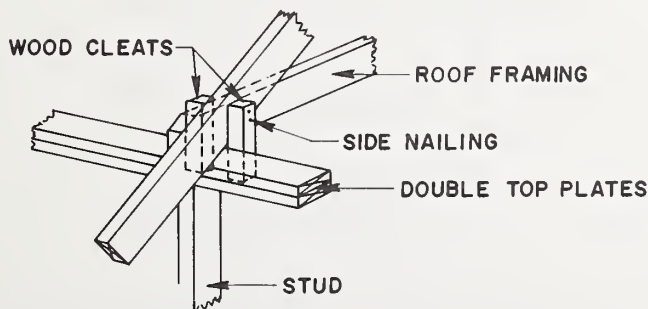
**FIGURE 60** WOOD CLEATS NAILED TO EACH SIDE OF ROOF FRAMING AND TO TOP PLATES.

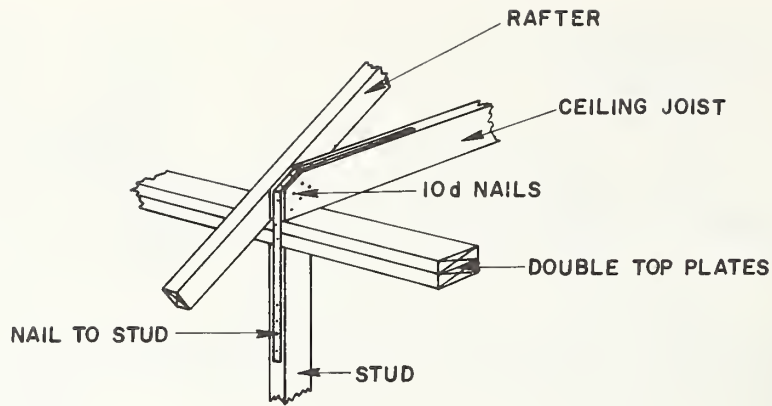
FIGURE 61 SHEET METAL STRAP NAILED TO CEILING JOIST AND STUD TO ANCHOR ROOF FRAMING TO WALL.

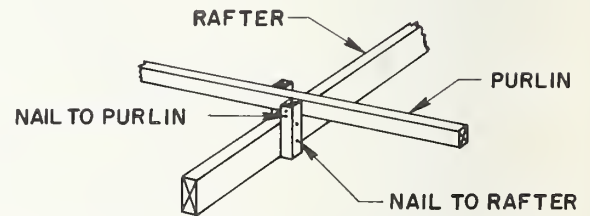
FIGURE 63 PURLINS TIED TO RAFTERS BY WOOD CLEATS.

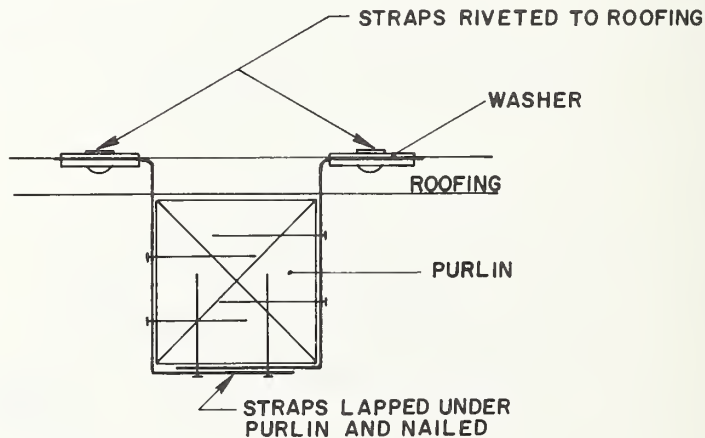
FIGURE 64 TWO METAL STRAPS RIVETED TO CORRUGATED ROOFING, LAPPED UNDER PURLIN AND NAILED TO PURLIN.

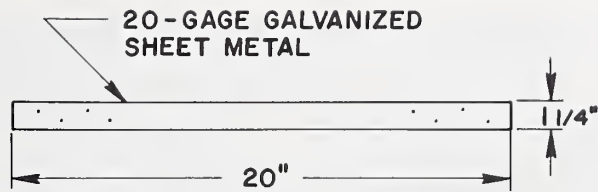
FIGURE 65 MULTI-PURPOSE STRAP; LENGTH AND WIDTH CAN BE VARIED FOR SPECIFIC APPLICATIONS.

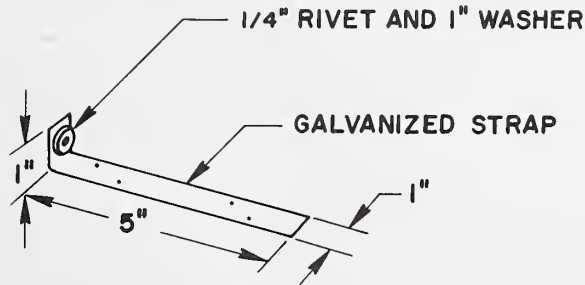
FIGURE 66 GALVANIZED SHEET METAL STRAP WITH RIVET AND WASHER FOR TYING DOWN CORRUGATED ROOFING.

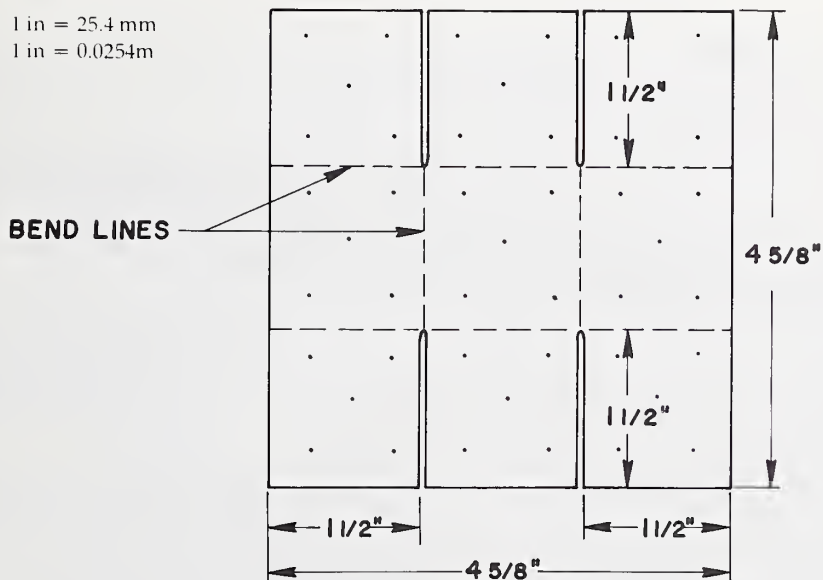
FIGURE 67 MULTI-PURPOSE BRACKET FABRICATED FROM 20-GAGE GALVANIZED STEEL; BEND EITHER DIRECTION AT BEND LINES TO FORM DESIRED BRACKET.
