BS BUILDING SCIENCE SERIES 108

Safety on Stairs

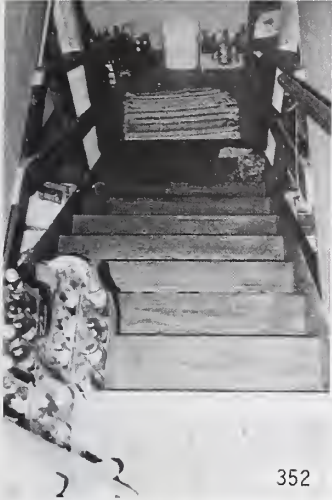
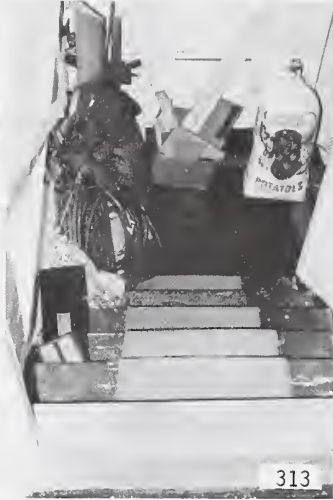
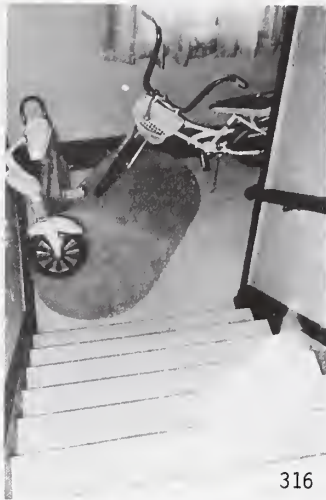
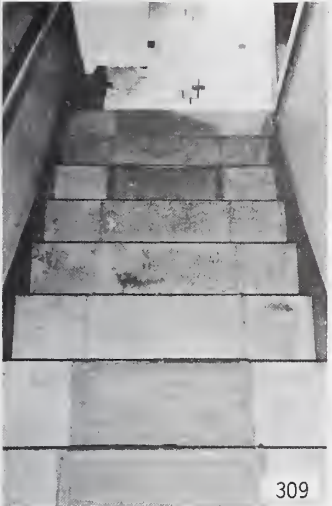
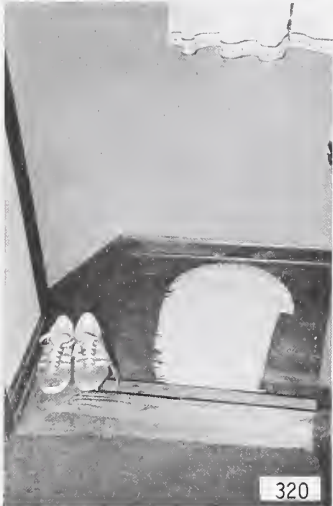
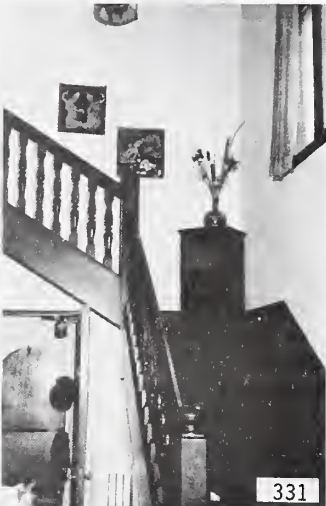
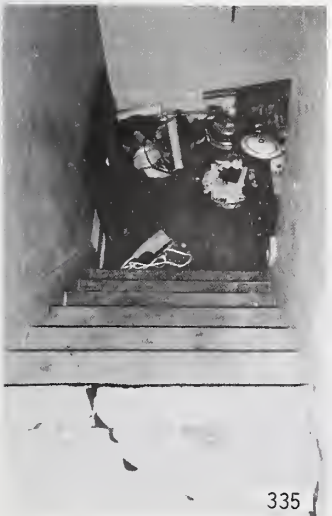
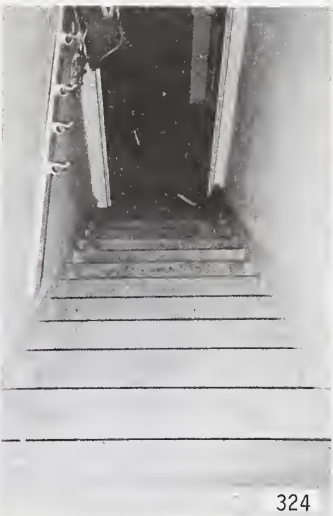
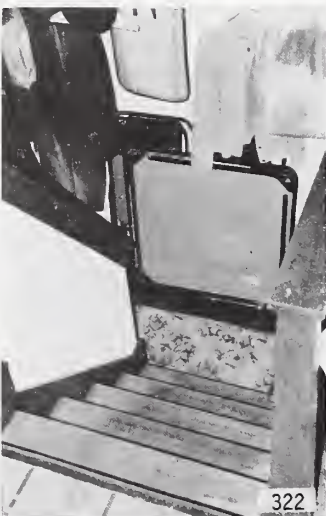
FIGURE 3. CAPTIONS FOR PHOTOS OF STAIRWAYS WITH ACCIDENT EVENTS*

These stairways have been selected primarily to show the range of objects that are stored on steps more or less permanently and not merely to be picked up and carried up or down for redistribution. However, they are typical of all the stairways with objects in the sample (61%). Features other than objects that are noted are not unique to these stairways, being present in more than one additional case.
