# **Study of the Local Resistance of Conventional Plywood Subflooring to Concentrated Load**

Felix Y. Yokel

March 26, 1973

Final Report

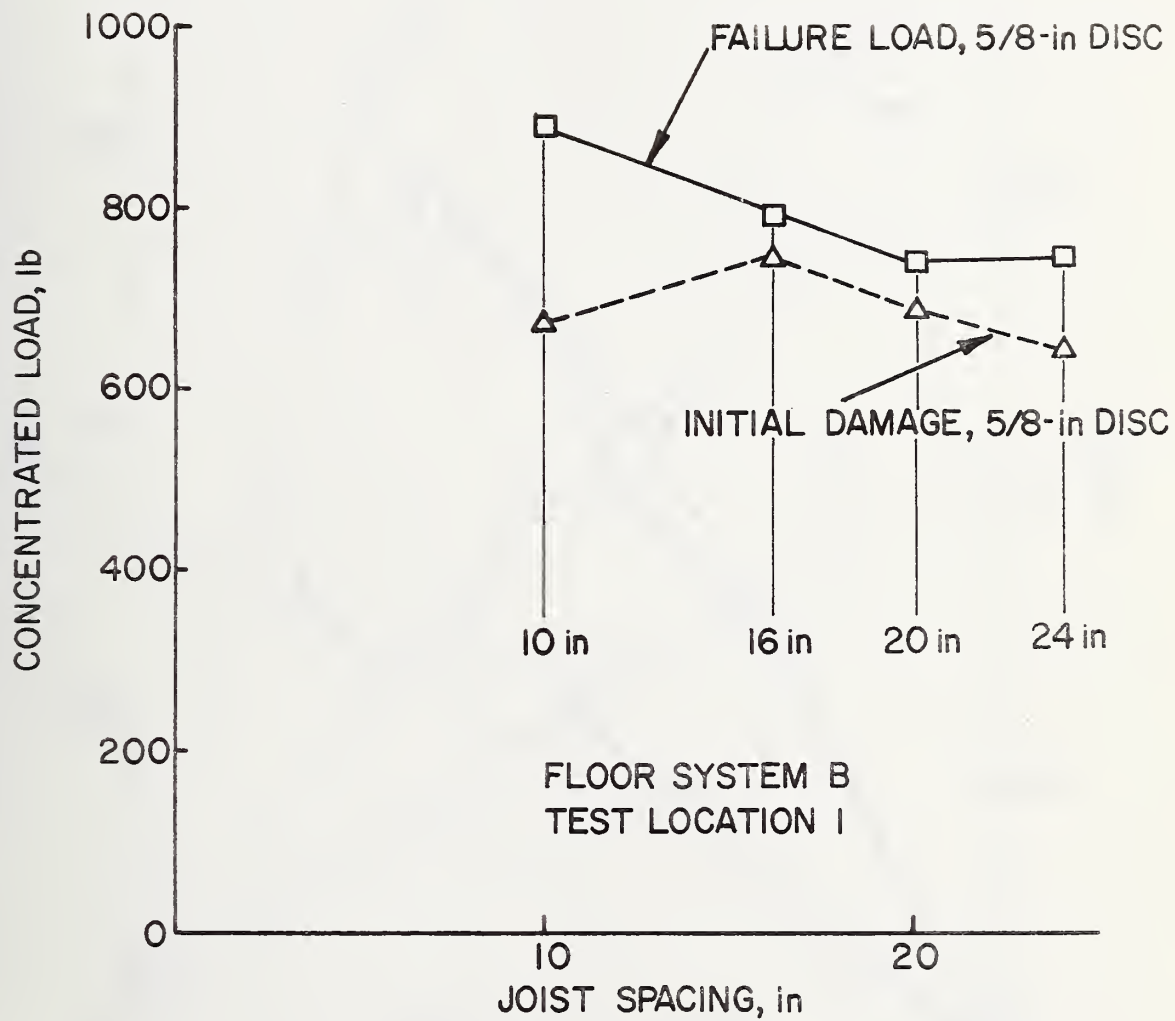
FIGURE 6.11 RELATIONSHIP BETWEEN JOIST SPACING AND STRENGTH

Figure 6.11 shows the relationship between load capacity and joist spacing for floor system B, loaded over a 5/8-in diameter area. In this case capacity only slightly decreased with joist spacing. The dominant failure mode for these specimens was probably local shear. Tests on specimens with other than 16-in joist spacing were only performed for floor systems A and B.

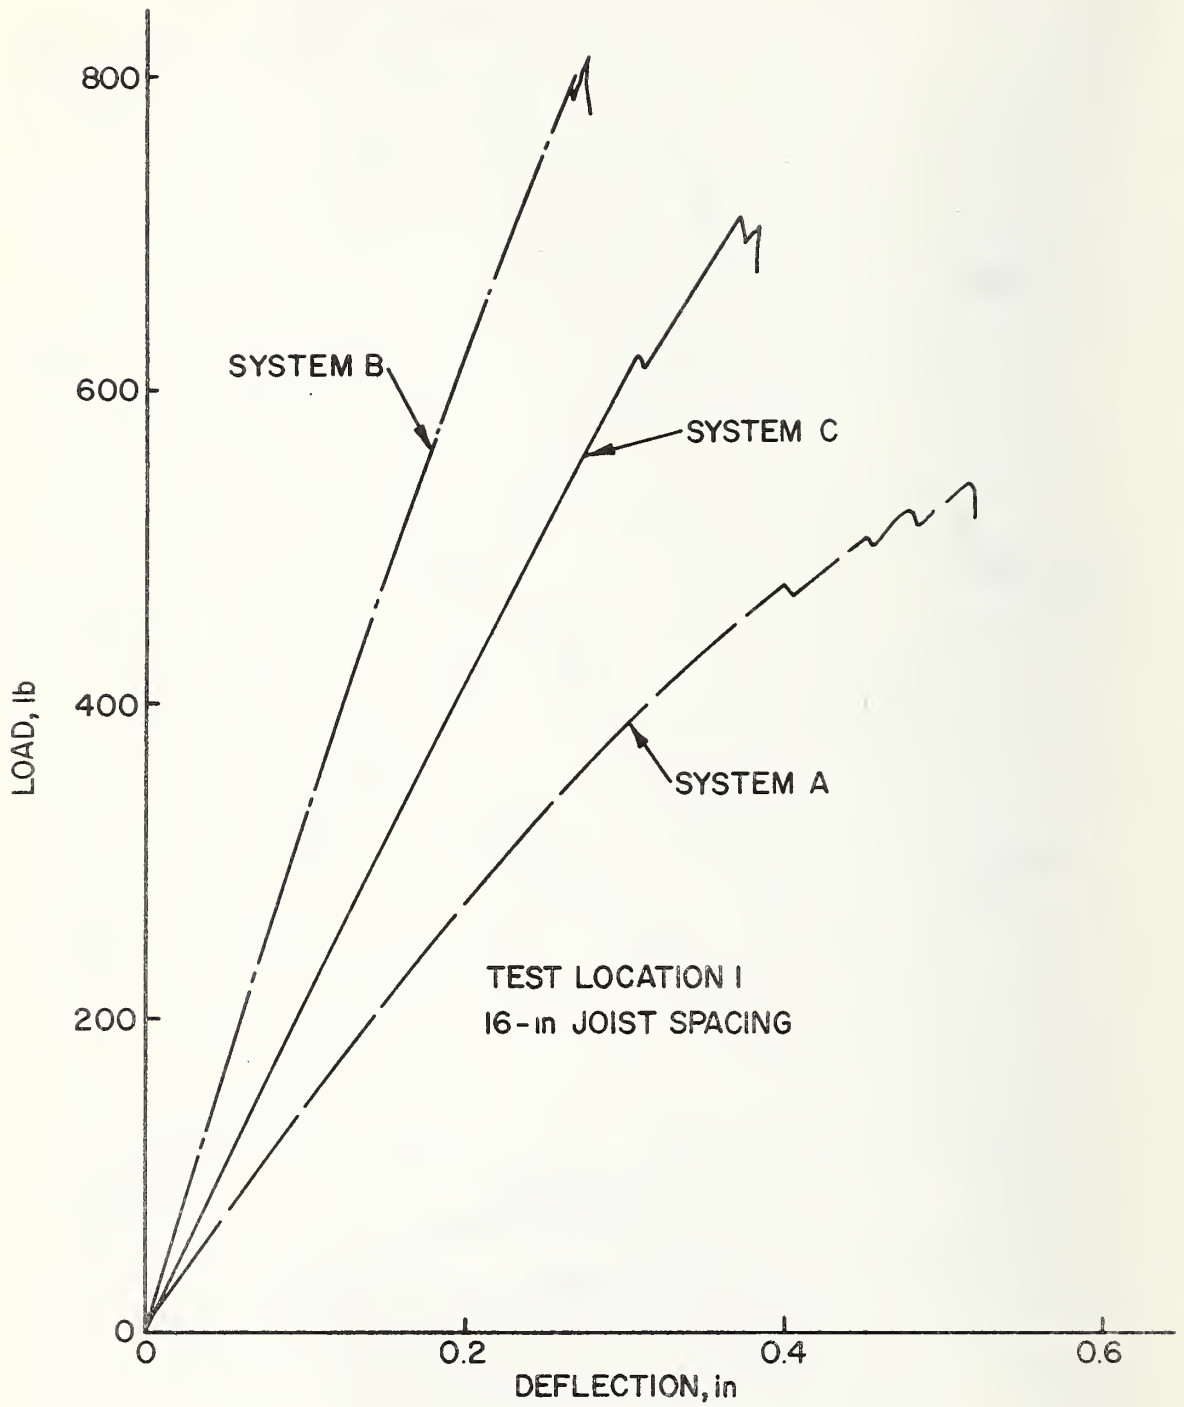
FIGURE 6.14 RELATIVE STIFFNESS OF FLOOR SYSTEMS WITHOUT UNDERLAYMENT

The load-deflection curves of the floor systems without underlayment, loaded at location 1, are compared in figure 6.14. The ratio between applied load and measured deflection at location 1 can be taken as a measure of stiffness. System A was the least stiff. This system also had the least strength. It should be noted, that system A does not meet the requirements set by "FHA Minimum Property Standards" since the thickness of the plywood was reduced by 1/32 of an inch by the sanding of one surface.
