# HIGH RELIABILITY SHEATHED, BERYLLIA INSULATED, TUNGSTEN-RHENIUM ALLOY THERMOCOUPLE ASSEMBLIES— THEIR FABRICATION AND EMF STABILITY

G. W. Burns, W. S. Hurst and M. G. Scroger

1. Report No. NASA CR-134549	2. Government Accession No.	3. Recipient's Catalog No.	
4. Title and Subtitle HIGH RELIABILITY SHEATHED, BERYLLIA INSULATED, TUNGSTEN-RHENIUM ALLOY THERMOCOUPLE ASSEMBLIES - THEIR FABRICATION AND EMF STABILITY		5. Report Date June, 1974	6. Performing Organization Code

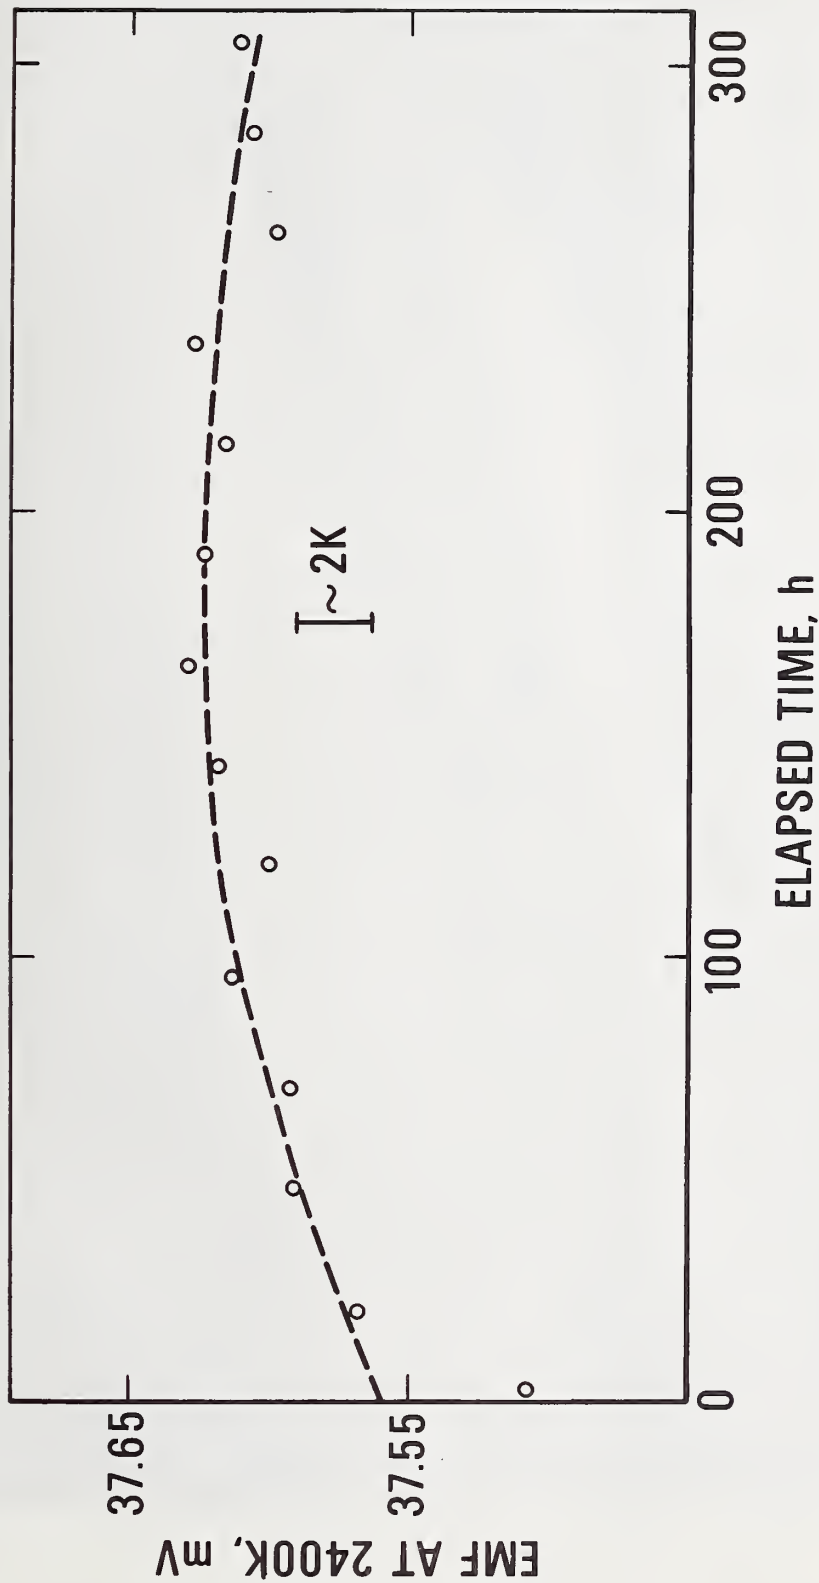
Figure 12. Drift in the thermal emf of an unsheathed, BeO-insulated, W-3% Re/W-25% Re thermocouple during exposure in argon for 307 hours at 2400 K. The thermocouple was installed in a tantalum black-body enclosure that was heated in a high temperature furnace and the temperature was measured with an automatic photoelectric optical pyrometer. The reference junctions of the thermocouple were maintained at 273.15 K. The curve through the data points is a quadratic equation fit to the data by the method of least squares.

The value of the thermal emf at 2400 K as a function of time was typically that illustrated in Fig. 12. Again, the data illustrated were obtained with the photoelectric pyrometer as a reference. Because of a gradual sagging of the Ta blackbody enclosure (about 6 mm in 307 hours), the test was terminated at 307 hours rather than risk failure of the enclosure and damage to the furnace. The results for four of the thermocouples in the test are summarized in Table IV. The values of the drift were obtained from curves (either linear or quadratic) that were fit to the experimental data by the method of least squares. The drift in the four thermocouples varied from about +3 K to about +11 K at 2400 K after 307 hours of exposure. A fifth thermocouple in the test behaved erratically after approximately 100 hours of exposure, and the results are not included in the summary. Post-test examination revealed a region of gross erosion of the BeO insulators that bared the thermoelements (as described in more detail in the next section). It is likely that electrical shorting of the thermoelements occurred, thus accounting for the erratic behavior of the fifth thermocouple.

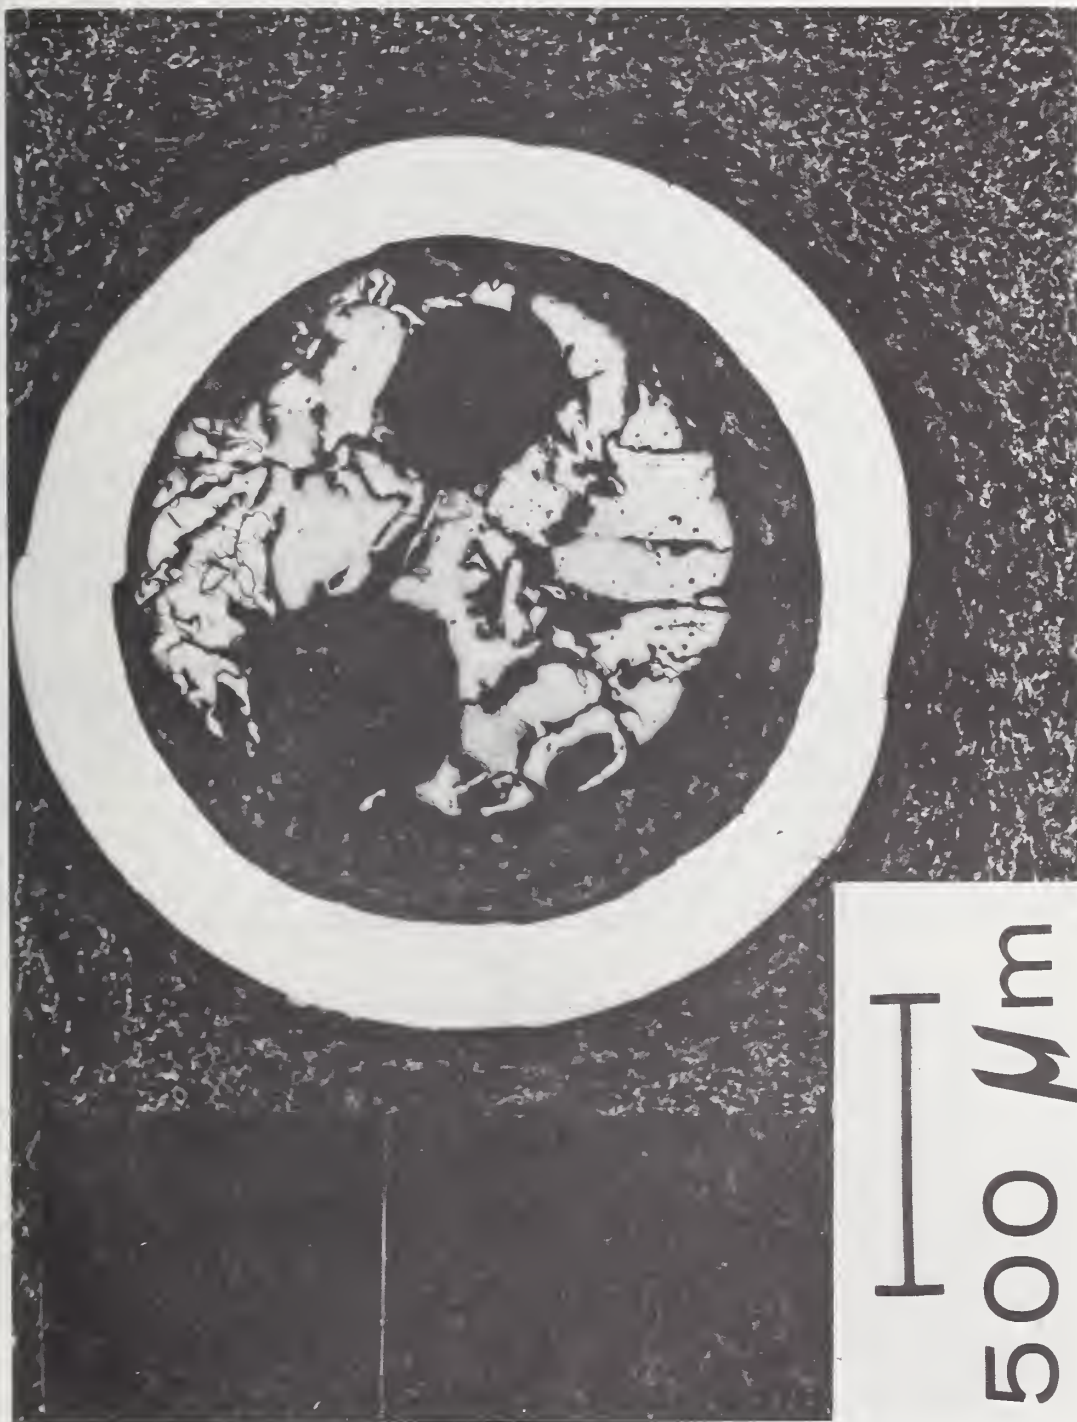
Figure 18. Photomicrograph showing a transverse cross-section of a BeO-Ta sheath assembly after exposure for 50 hours at 2400 K in argon. The cross-section was taken at about 4 cm below the open end of the sheath.
