MATERIALS RESEARCH FOR CLEAN UTILIZATION OF COAL

QUARTERLY PROGRESS REPORT
July 1976

Institute for Materials Research
National Bureau of Standards
Washington, D. C. 20234

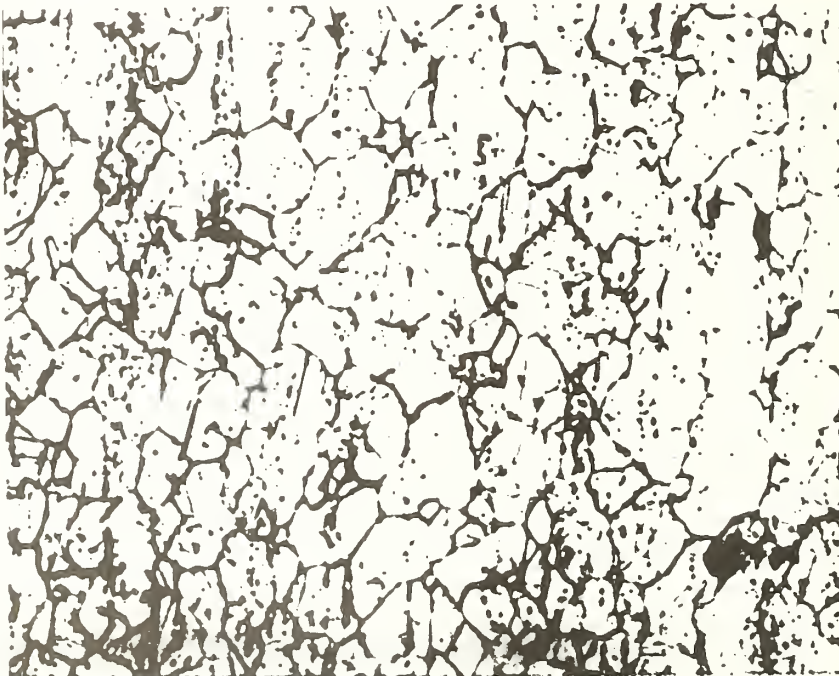
Fig. 9A. Photomicrograph of 310 SS as received. Etched for 5 seconds at 5 volts in 10% oxalic acid. 500 X

Fig. 9B. Photomicrograph of 310 SS after testing at 1000°F at a constant strain rate of $8.43 \cdot 10^{-7} \text{ S}^{-1}$. Etched for 5 seconds at 5 volts in 10% oxalic acid. 500 X

Other evidence that sensitization is occurring at the 1000°F test temperature and not at 700°F is shown in Figs. 9 and 10. Figs. 9A and B are photomicrographs of a 310 SS specimen as received and after testing at 1000°F at the slow strain rate of $8.43 \cdot 10^{-7} \text{ S}^{-1}$ (brittle fracture), respectively. Fig. 9A shows the grain boundaries to be partially etched indicating some sensitization or carbide precipitation. Fig. 9B shows that the grain boundaries are completely etched indicating that further sensitization has occurred during testing. Figs. 10A and B are photomicrographs of a 310 SS specimen as received and after testing at 700°F at the slow strain rate of $8.43 \cdot 10^{-7} \text{ S}^{-1}$ (ductile fracture), respectively. Fig. 10A shows the grain boundaries to be partially etched indicating some sensitization or carbide precipitation. Fig. 10B shows that the grain boundaries are not more deeply etched than in Fig. 10A indicating little or no further sensitization or precipitation occurred while testing at 700°F. (The same etching time was used for all specimens).

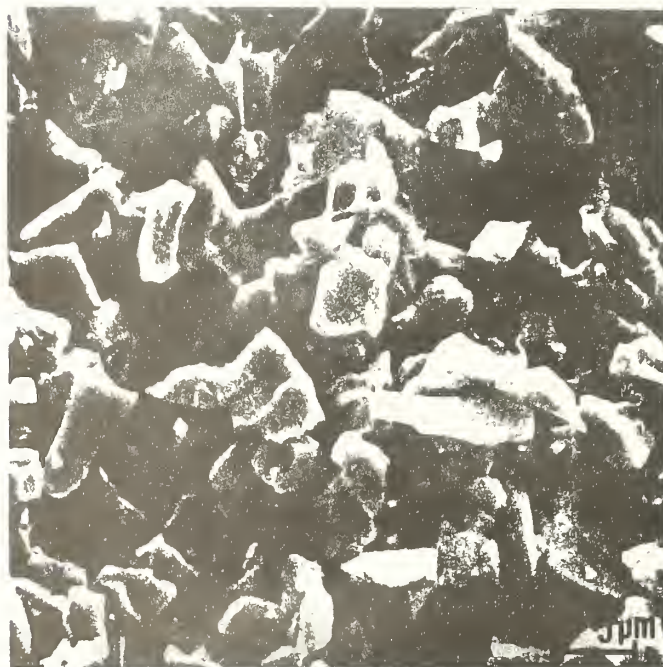
Fig. 2 Examples of 5 μm sized Al_2O_3 abrasive particles.

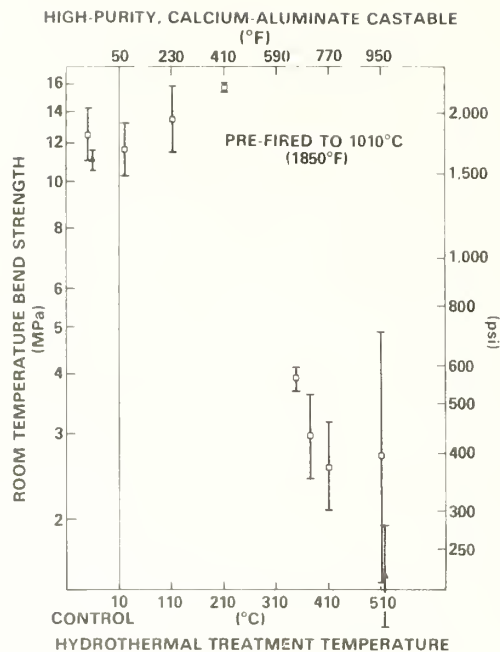
Figure 1. Room Temperature Bend Strength versus Hydrothermal Treatment Temperature for a High-Purity, Calcium-Aluminate Castable

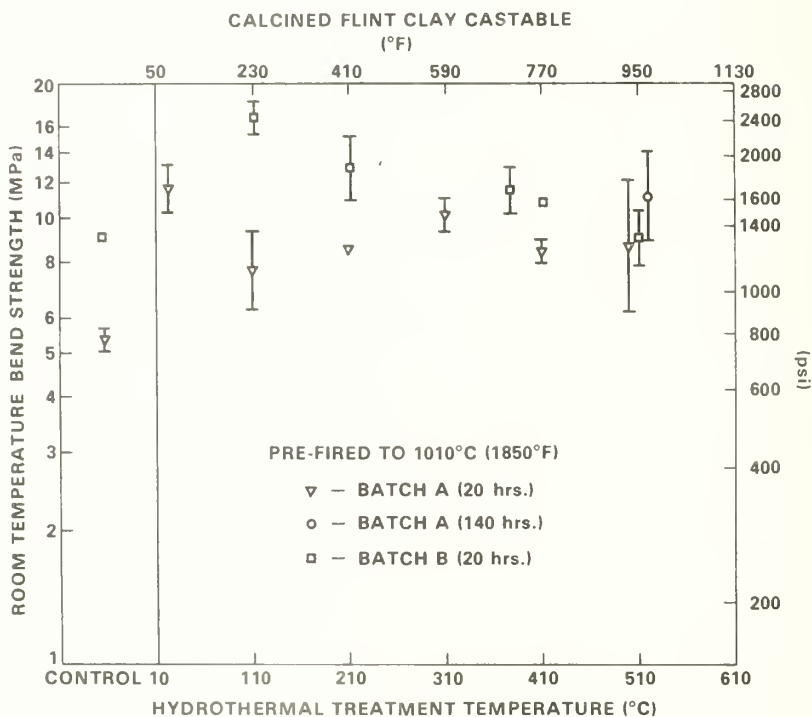
Figure 2. Room Temperature Bend Strength versus Hydrothermal Treatment Temperature for a Calcined Flint Clay Castable.

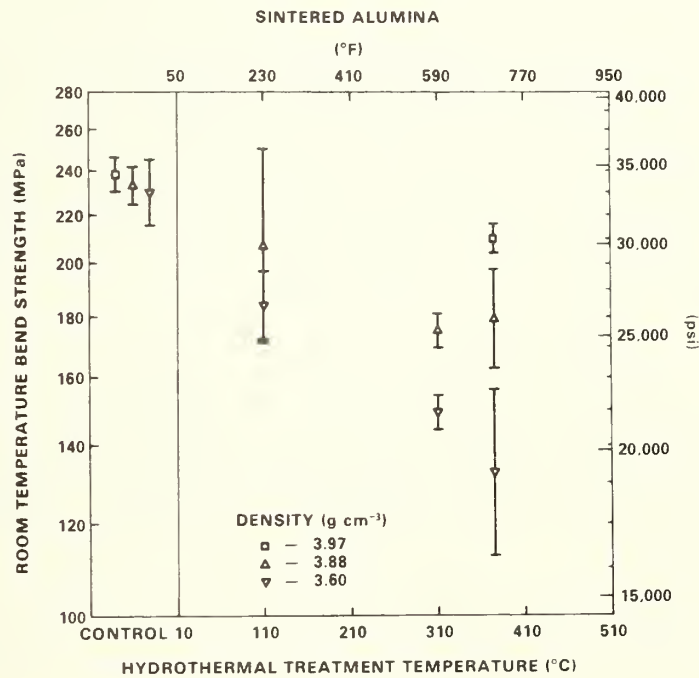
Figure 4. Room Temperature Bend Strength versus Hydrothermal Treatment Temperature for Three Densities of Sintered Alumina.

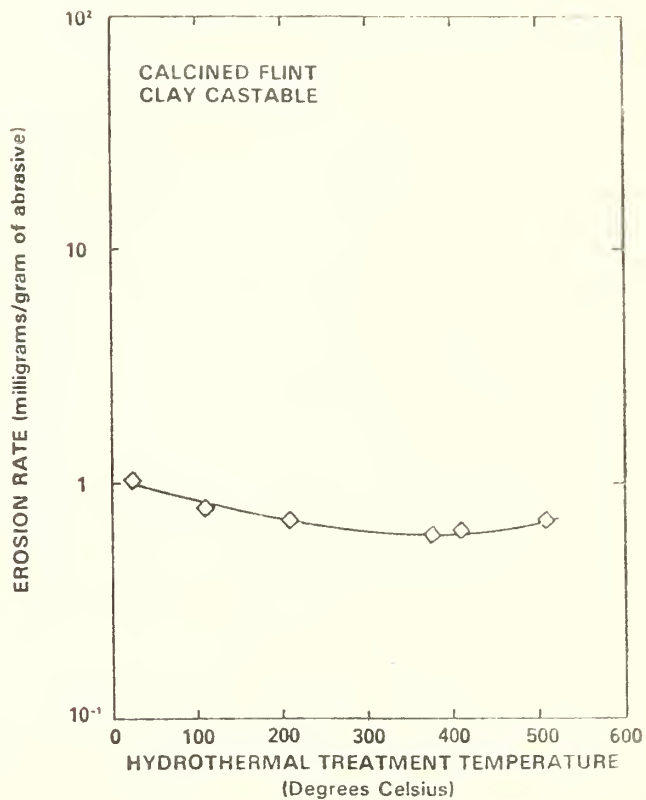
Figure 2. Effect of hydrothermal treatment on the erosive wear of castable refractories. Tests conducted at room temperature after hydrothermal treatment.

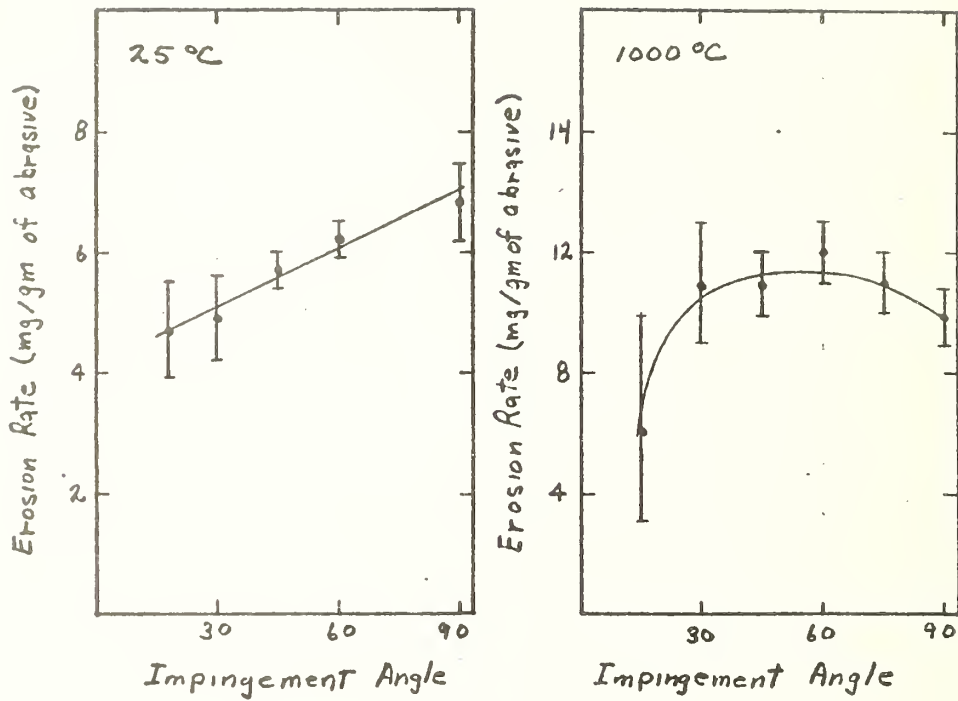
Figure 5. Erosion Rate as a function of impingement angle. Long term erosion with full channel development. High purity aluminum oxide castable refractory bonded with calcium aluminate. The error bars represent one standard deviation from the mean.
