NBSIR 81-2289

Preliminary Guidelines for Condition Assessment of Buildings Being Considered for Solar Retrofit

**PRELIMINARY GUIDELINES FOR CONDITION
ASSESSMENT OF BUILDINGS BEING
CONSIDERED FOR SOLAR RETROFIT**

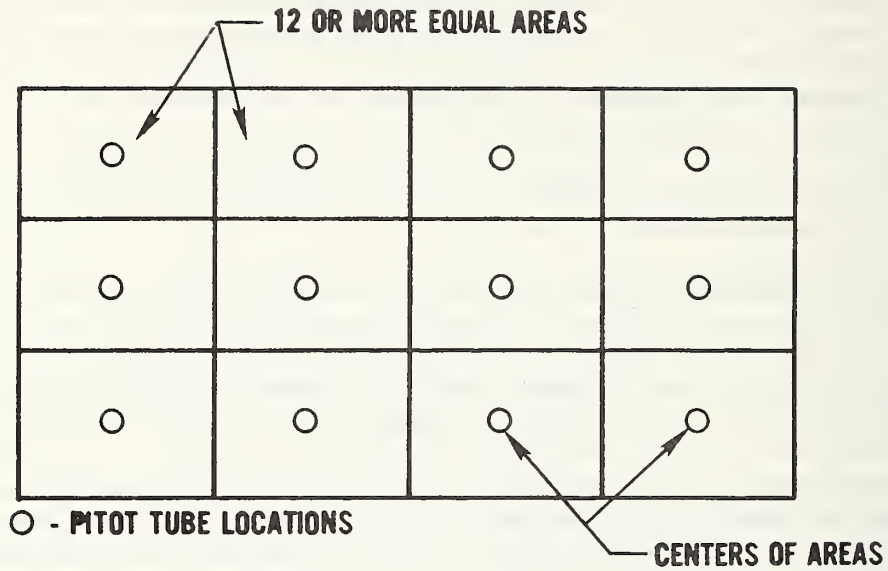
FIGURE 5 [7]

**PITOT TUBE MEASUREMENT LOCATIONS FOR
RECTANGULAR AND LARGE ROUND DUCTS**

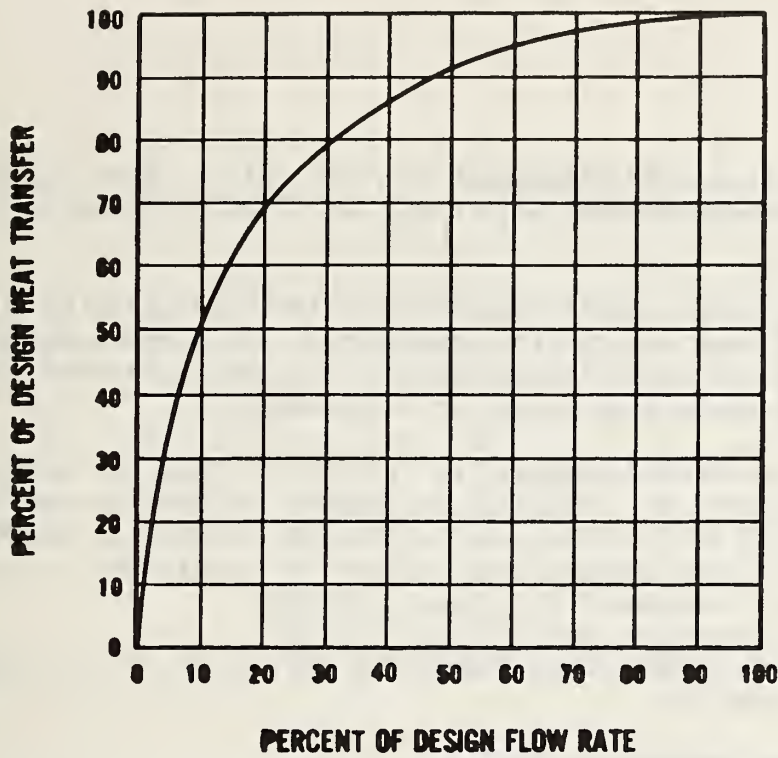
FIGURE 8 [7]

EFFECTS OF WATER FLOW RATE ON COIL HEAT TRANSFER FOR 20°F WATER TEMPERATURE DROP AT 200°F WATER SUPPLY TEMPERATURE

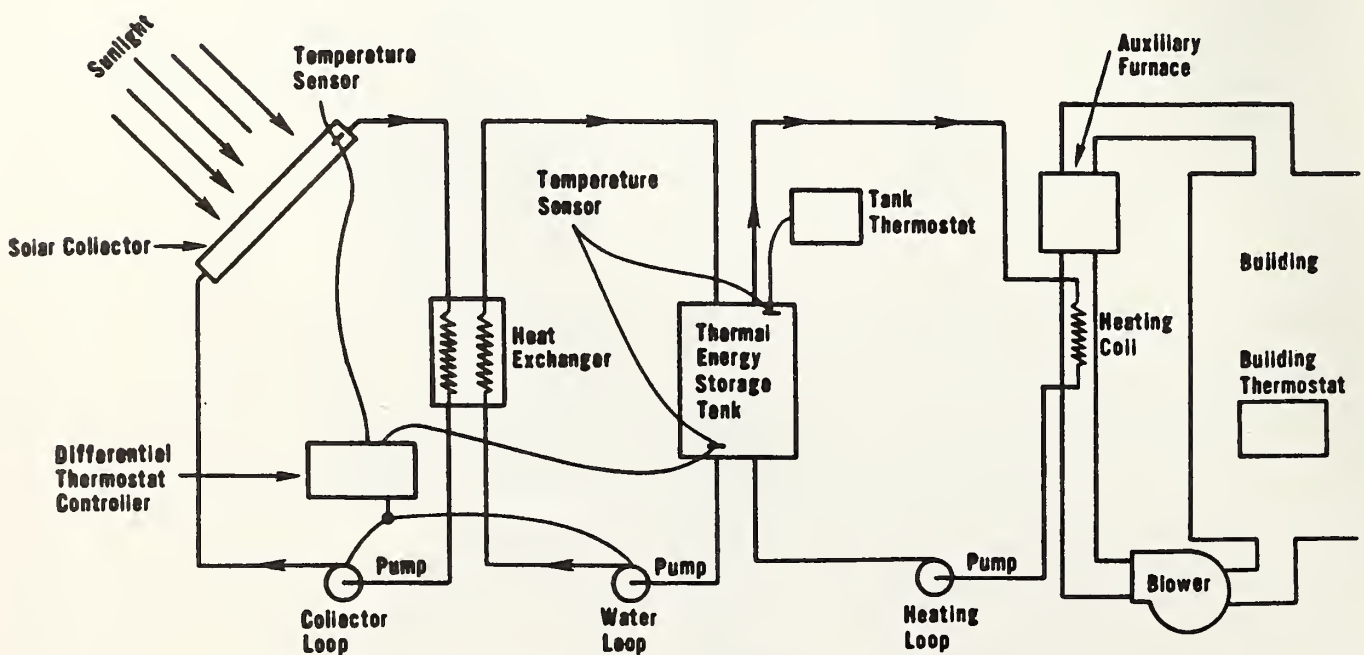
FIGURE 12 [7]

WATER-BASED SYSTEM WITH TANK STORAGE

The following figures no. 11-15 identify the kinds of equipment needed for only a few of the possible solar heat configurations which are in general use. Included is a schematic drawing of the operating modes for one type of heat collector system. Before deciding what specific space is needed for solar heating, it is important to consult with a competent solar system designer. The kinds and configuration of equipment chosen will vary between designers, and will be strongly influenced by the existing system and its components, the character of load, location of building, and other factors.

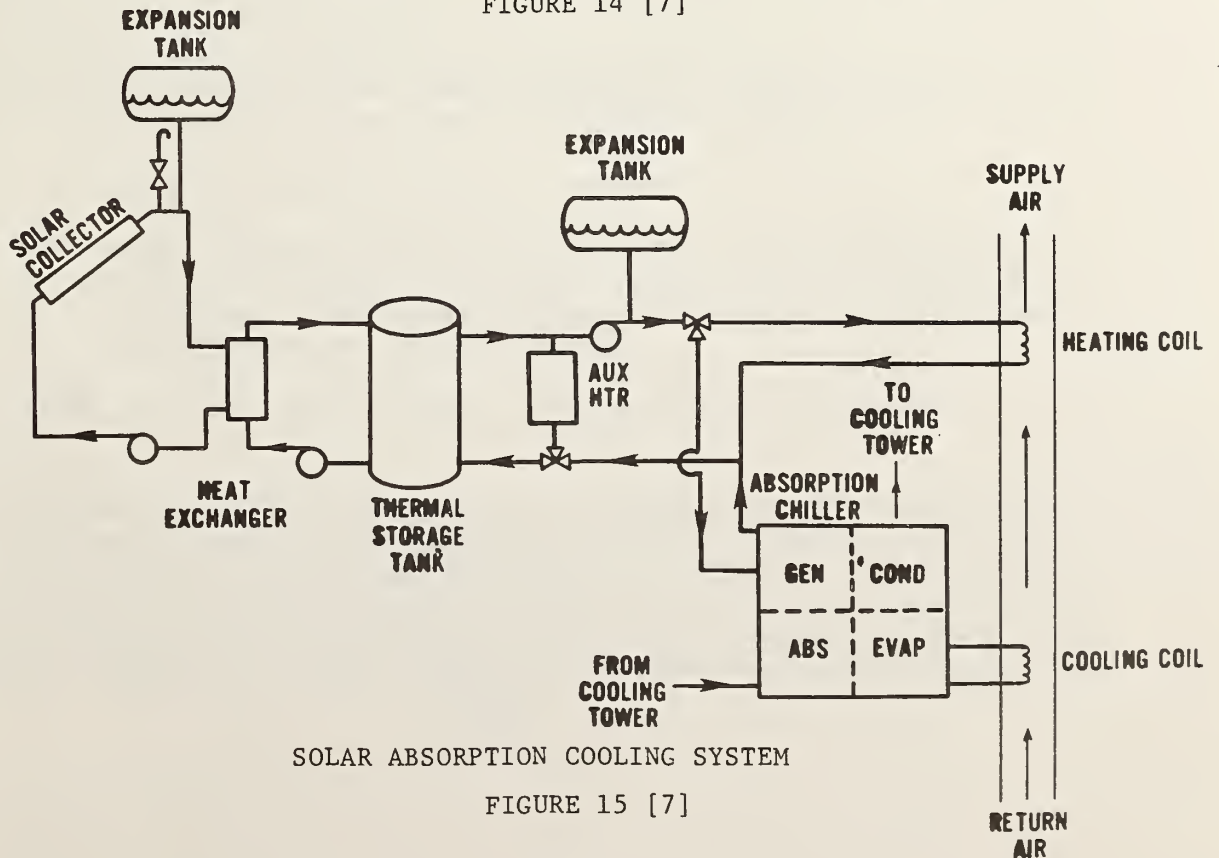
FIGURE 15 [7]

SOLAR ABSORPTION COOLING SYSTEM
