Solar Industrial Process Heat Systems -- An Assessment of Standards for Materials and Components

September 1981

NBSIR 81-2381

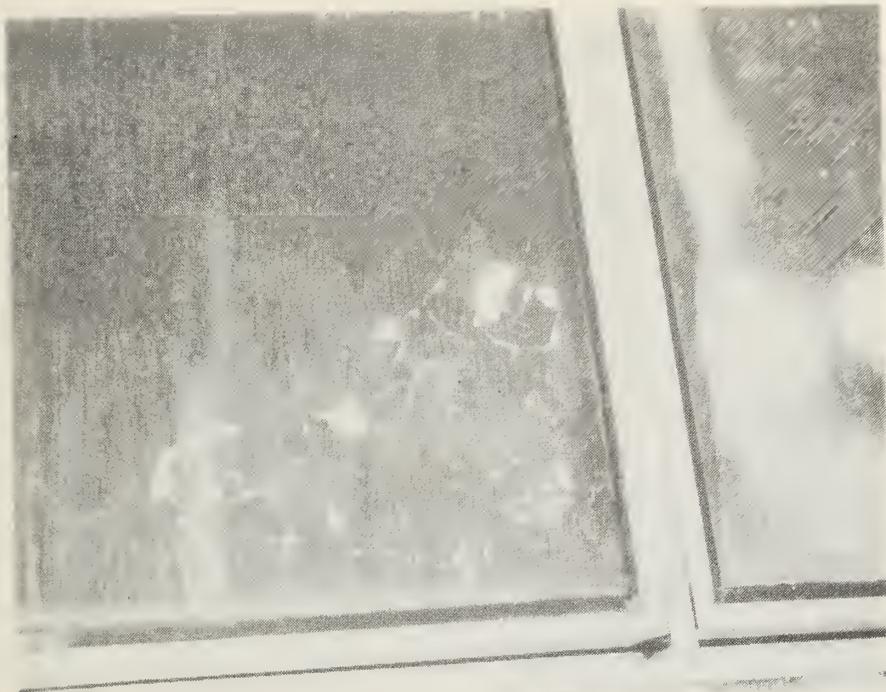
- o In one flat-plate system, the black velvet, nonselective absorptive coating was peeling from a number of the aluminum absorber plates. A representative of a collector manufacturer indicated that the poor adhesion of the coating may have been due to improper cleaning and preparation of the aluminum surface combined with the use of a brittle coating. Moisture had penetrated into some of the collector enclosures. Condensation was present on the underside of some of the cover plates when observed during mid-morning (figure 2.1). It was not determined whether there was a relationship between the peeling of the coating and the moisture.

Figure 2.1. Peeling and cracking of absorptive coating and moisture on the underside of the cover plate

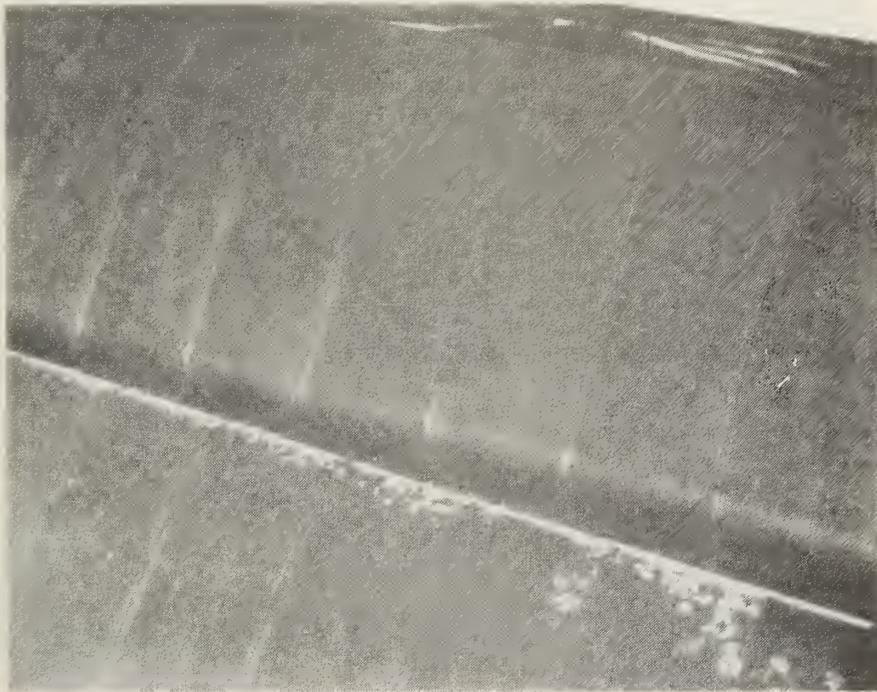
Figure 2.5. White deposits on upper section of the absorber ducts of an air system

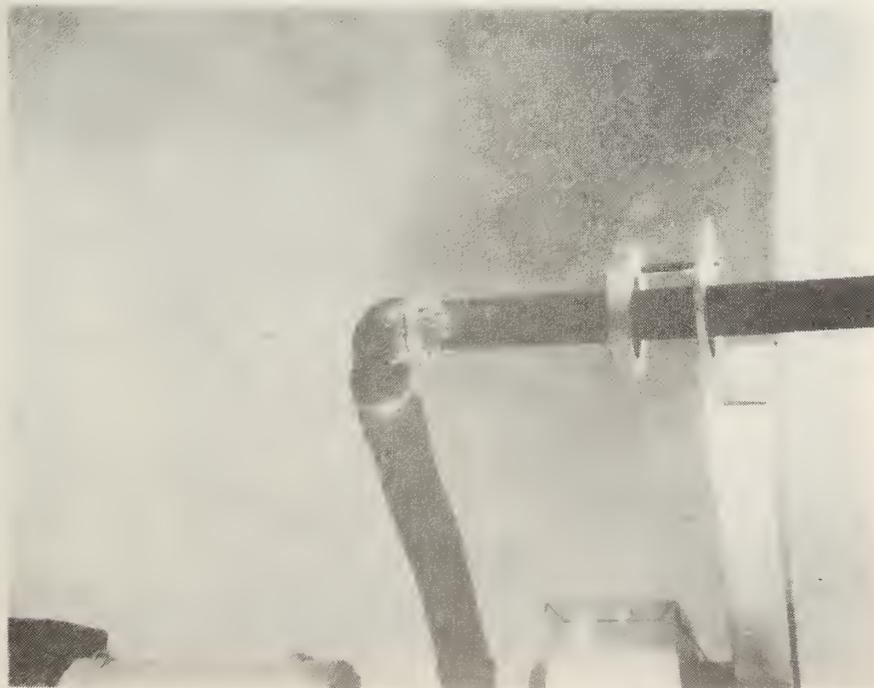
- Observations concerning the external appearance of containment materials indicated few problems. Observations were not made concerning the internal appearance of the containment materials, since the systems were generally operational and taking test cuts was beyond the project scope. Corrosion was observed on some brass elbow fittings connecting copper receiver tubes and copper flex hoses at one line-focus installation (figure 2.6). Some of the corroded elbow fittings were leaking. A representative for the collector manufacturer indicated that the corrosion may have been due to galvanic corrosion in addition to inadequate selection of the alloy composition. The fluid in the system was filtered well water. The corroded elbows were connected to the top of the flex hoses. Similar elbow fittings at the bottom of the flex hoses were not leaking.

Figure 2.6. Corrosion of an elbow fitting connecting a metal flex hose and a receiver tube

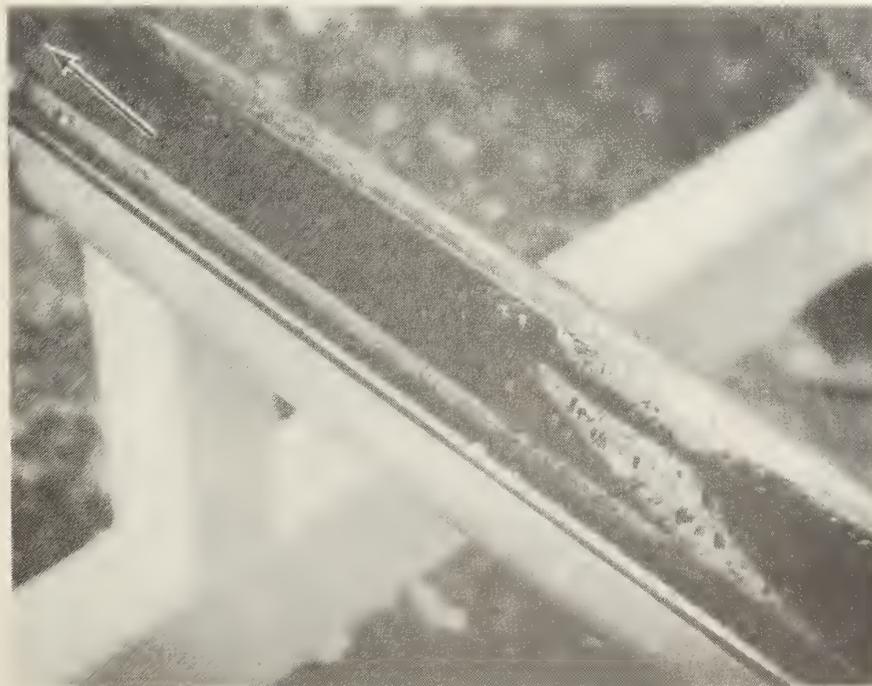
- o With one exception, the receiver tubes of the six line-focus collector systems had circular glass jackets (figures 2.3, 2.9, and 2.10) or flat covers (figure 2.11). In the case of the exception, there was no jacket on the receiver tube as designed and constructed. Some breakage of the glass had occurred at four sites. At one site, breakage had been attributed to inadequate allowance for thermal expansion. Redesign and replacement of the jacket supports to allow for expansion had corrected the breakage problem, although not all the broken jackets had been replaced. At another site, breakage of glass jackets was attributed by site personnel to the use of a metallic spacer ring around the midpoint of the absorber tube (figure 2.9). The spacer ring was intended as a support for the glass jacket. Upon thermal expansion, the rings scratched the glass, which subsequently broke. Removal of the spacer rings corrected the glass breakage problem. At a third site, semicircular glass jackets were held on insulated receiver tubes using spring clips (figure 2.10). Moisture was present within some sections of the receiver tubes. One small length of a glass jacket, which apparently had no spring clips holding it in place, broke when it fell from the receiver tube during focusing of the collector. The flat glass covers were used in an insulated receiver tube assembly (figure 2.11). In addition to some sections of broken glass, moisture was present on the underside of many of the flat glass covers.

- Receiver tubes on three line-focus systems were insulated on the backside (figure 2.10). In two of the cases, the insulation was fibrous glass; the type was not determined in the third case. Since the insulations could not be observed because of encapsulation, their condition could not be evaluated. Concern was expressed as to the thermal stability of the insulations in contact with receiver tubes.

Figure 2.10. Spring clip holding jacket on a receiver tube and moisture on the underside of the jacket

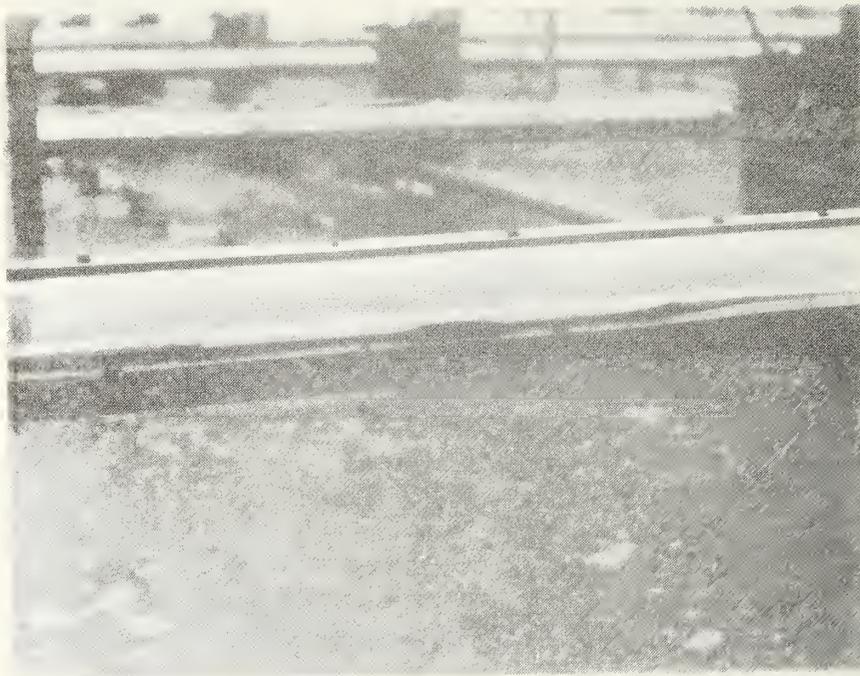
Figure 2.11. Insulated receiver tube assembly having a flat glass cover plate

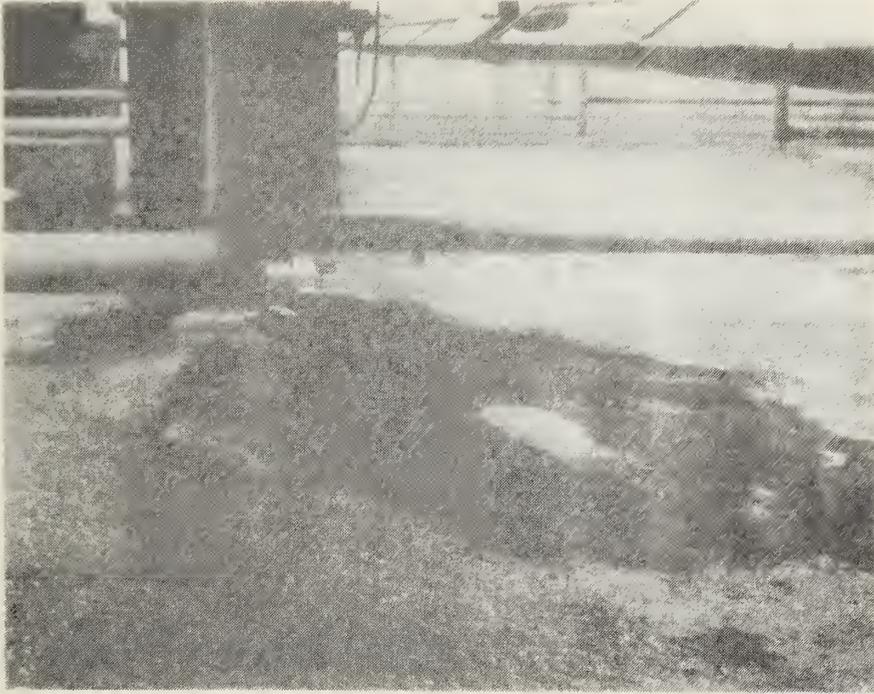
- o The performance of the drive systems of the six line-focus collectors was variable. For three of the six installations, the drive systems were functioning without any reported problems (figure 2.12). Conversely, in the worst case, all gear boxes of one system were frozen and the collectors could not be turned from the stow position. Reasons for the failure of the gear boxes were not reported, although they apparently leaked fluid. Oil deposits were observed on the roof under the gear boxes (figure 2.13). Excessive movement of the collectors due to faulty tracking may have also

Figure 2.13. Oil deposit on the building roof under the collector gear box

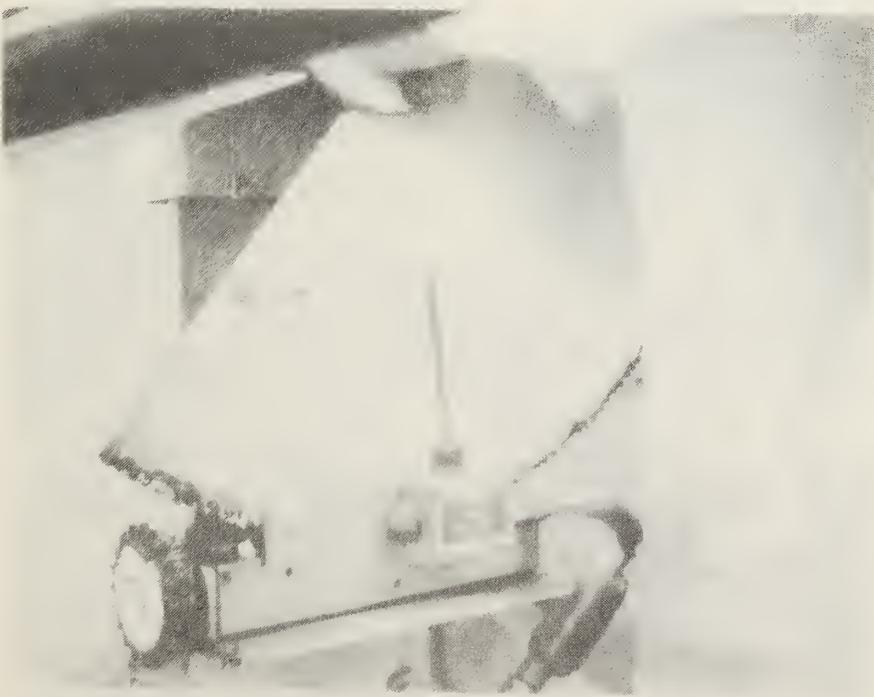
contributed to the failure (section 2.14). At another location, problems occurred with drive systems having undersized motors which operated intermittently. These motors are being replaced with those of proper size which operate continuously. At a third site, one gear box was frozen, while motors on some other gear boxes were described by site personnel as continually blowing fuses. At this site, the gear drive was exposed to the weather (figure 2.14). Site personnel indicated that future installations of this system were planned to have a housing around the gear drive.

Figure 2.14. Exposed gear mechanism

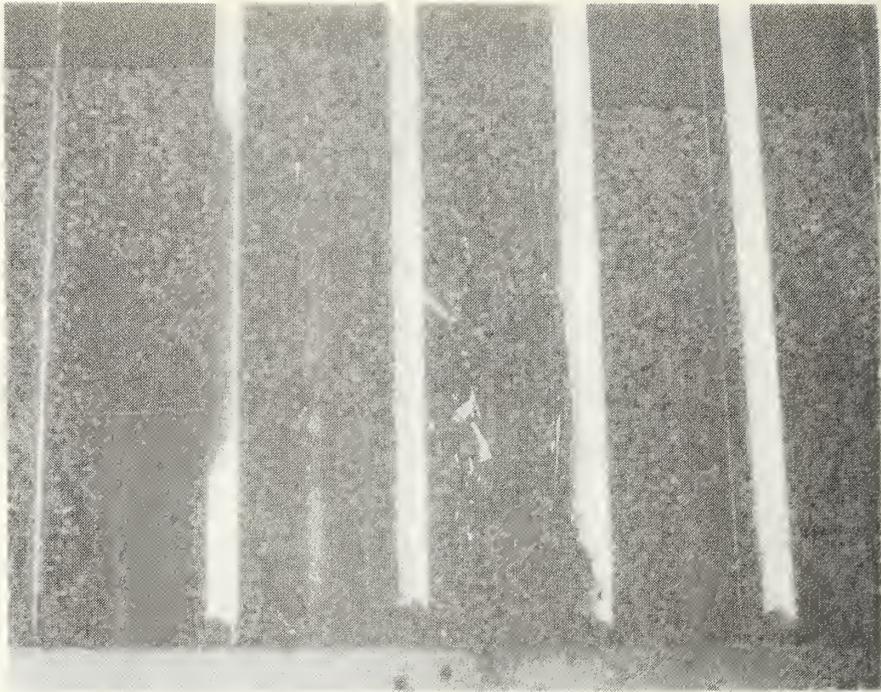
- Three of the sites visited had evacuated-tube collector systems. At two of the sites, breakage of the glass evacuated tubes was considered extensive; while at the third site, it was minor (figure 2.15). At this latter site, it was indicated during conversations that about 1 percent of the tubes broke during system start-up and were replaced by the manufacturer. Site personnel attributed breakage to factors such as thermal shock and scratching of the tubes during installation. In one case, site personnel reported that tube breakage occurred when the system became operational after brief interruptions of service for repairs. Vandalism was also a significant cause of tube breakage at one site.

Figure 2.15. Breakage of evacuated tubes

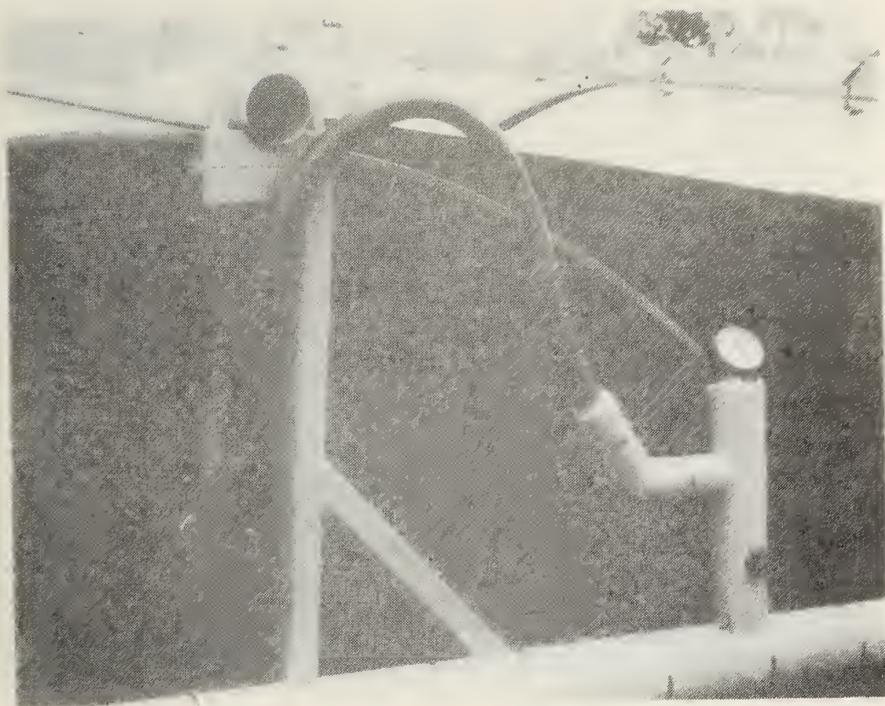
- Flex hoses (figure 2.17) in the six line-focus systems inspected were operating without problems. At one site, a single flex hose had failed and been replaced prior to the visit. Reasons for the failure of this flex hose were not given.
- One system which was not operational at the time of the visit contained swivel joints (figure 2.18). Some of the swivel joints were reported by site personnel to have leaked during system start-up, but the cause of the leakage was not given.

Figure 2.17. Flex hose of a line-focus system

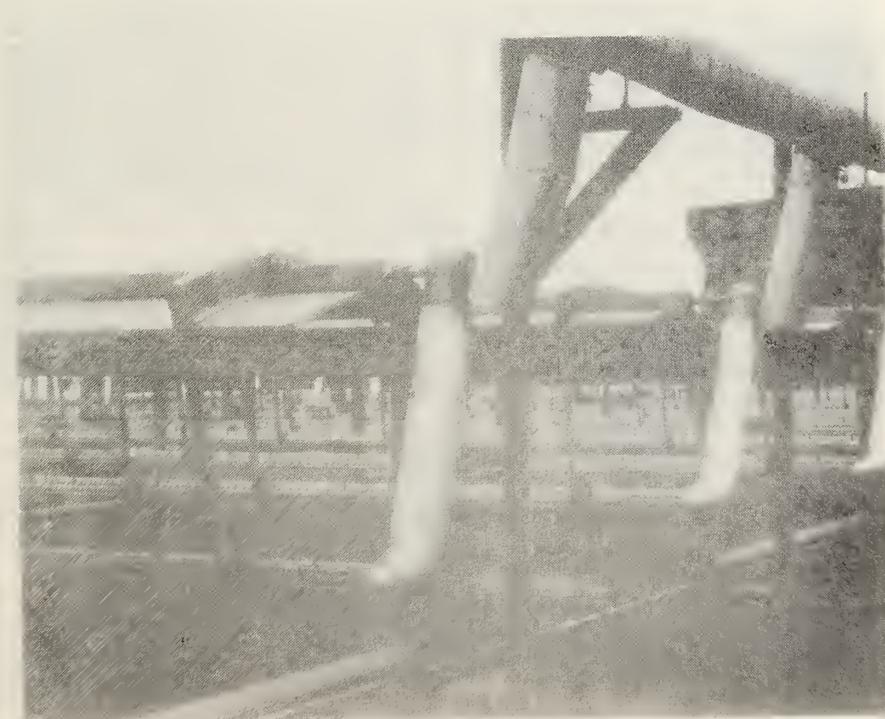
Figure 2.18. Swivel joint of a line-focus system

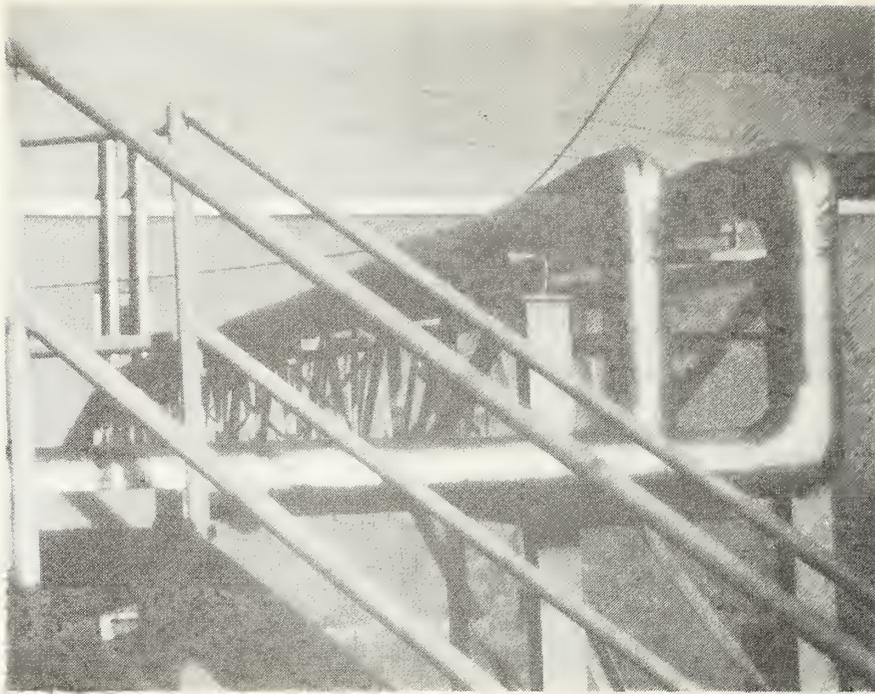
Figure 2.19. Insulated piping transporting heat transfer fluid to and from the collector field

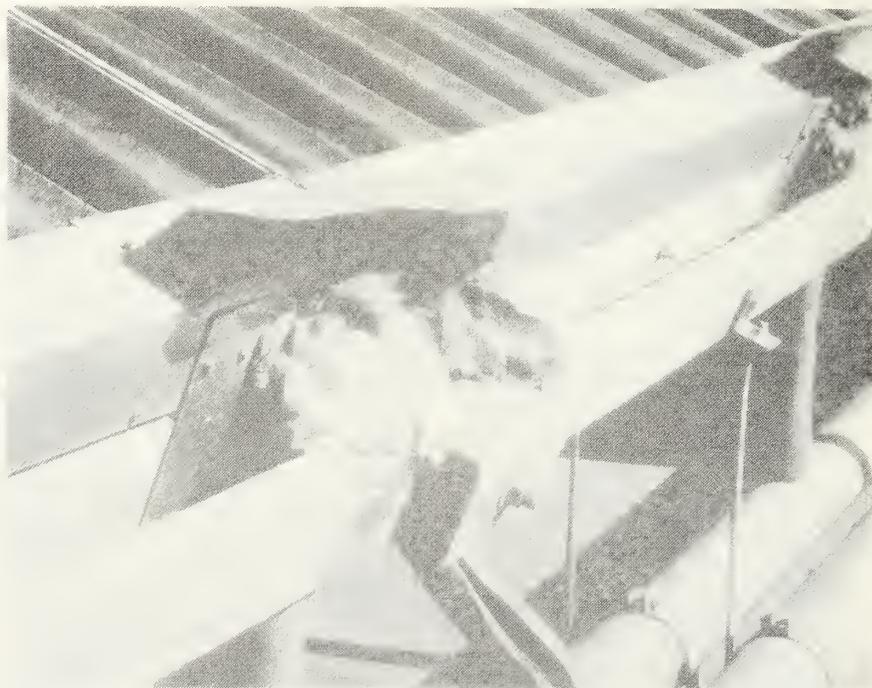
Figure 2.20. Exposed fibrous glass insulation

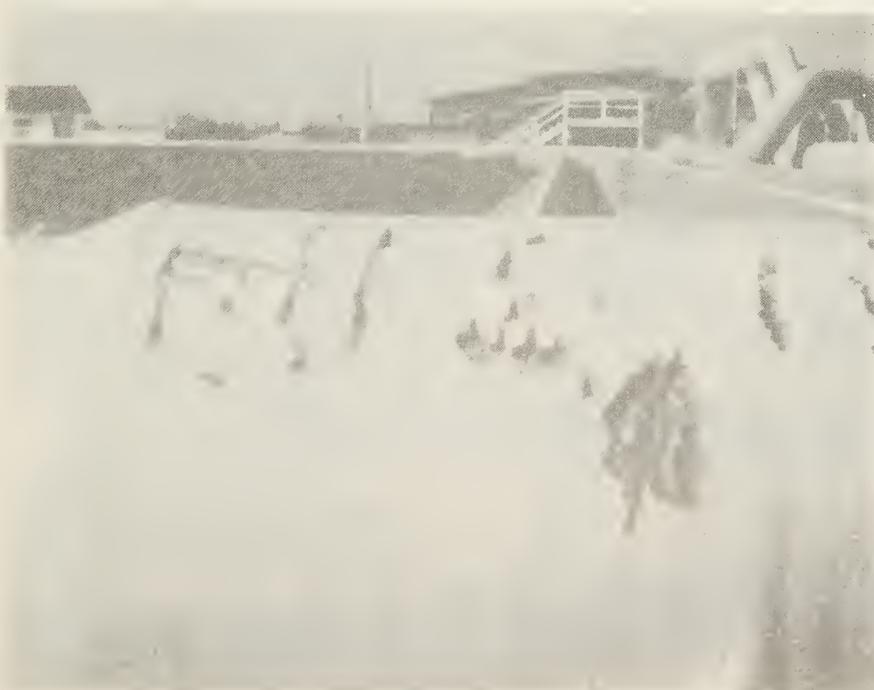
- The one air system in the field inspection had spray-in-place polyurethane foam insulation on the exposed air ducts. With the exception of vandalism, the coating on the foam appeared through visual inspection to be satisfactory after three years exposure. Vandalism had caused many punctures and splits in the coating and insulation (figure 2.22). Another site had pre-formed foam insulation with a liquid applied coating on manifold pipes. This insulation was not properly protected from the weather, as indicated by its cracked and crazed surface.

Figure 2.22. Punctures in spray-applied polyurethane foam and its protective coating due to vandalism

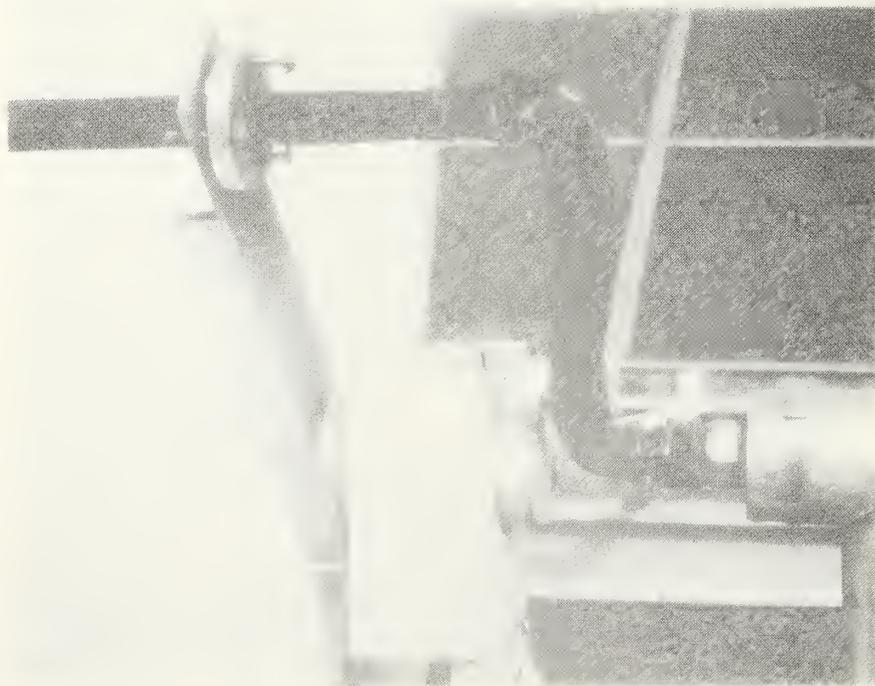
- At one line-focus installation, site personnel indicated that bending of some of the metallic receiver tubes had occurred when the receivers were in focus with low flow rates of the heat transfer fluid. This condition resulted in excessive receiver temperatures (figure 2.23). The bent receiver tubes were being replaced at the time of the visit.
- At one site the ends of the receivers were not sealed between the absorber pipe and glass jackets. Some dirt had blown into the receivers at these locations.
- At another site, receivers of an inoperable line-focus system contained some split copper pipes and broken glass covers. A cause of split pipes may have been freezing of water which was not drained from the non-operating receivers.
- Receiver tubes at some installations had short uninsulated sections extending beyond the glass jacket in the vicinity of the supports (figure 2.24).

Figure 2.24. Short section of uninsulated receiver tube

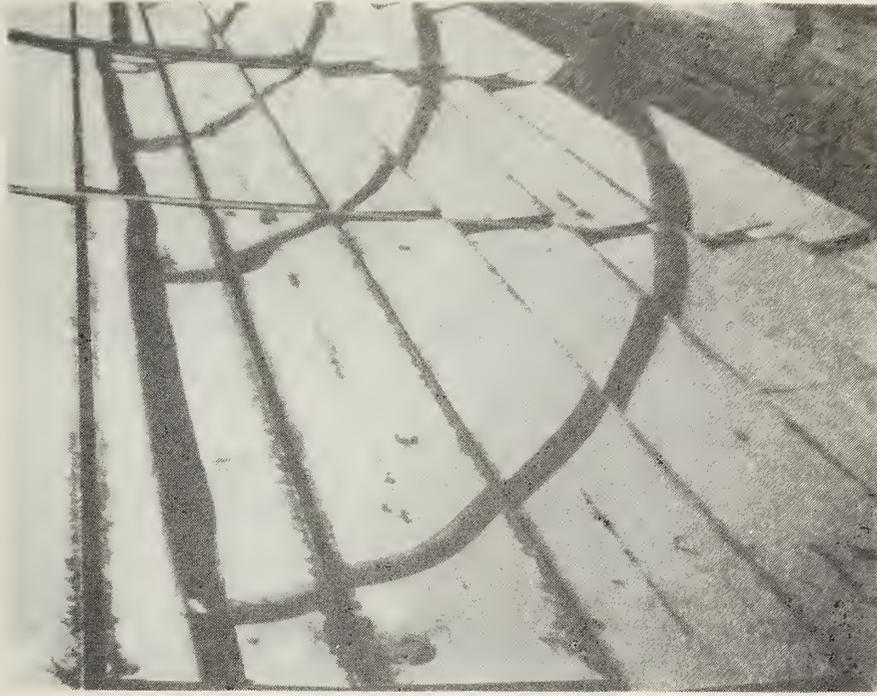
- Three types of reflective surfaces were used at the six line-focus installations: two systems had second surface glass mirrors, two had polished aluminum, and two had metallized plastic film. Two evacuated-tube systems used polished aluminum, and the third evacuated-tube system had a metallized plastic film. At one site with glass mirrors, desilvering had occurred and was particularly extensive along the mirror edges (figure 2.25), perhaps due to moisture penetration at those locations. Breakage of the mirrors was also evident at this site (figure 2.25). Site personnel indicated that the glass mirrors were to be upgraded with a metallized plastic film because of the extent of desilvering and breakage. Mirrors at the other site appeared in good condition.

Figure 2.25. Desilvering of exposed glass mirrors

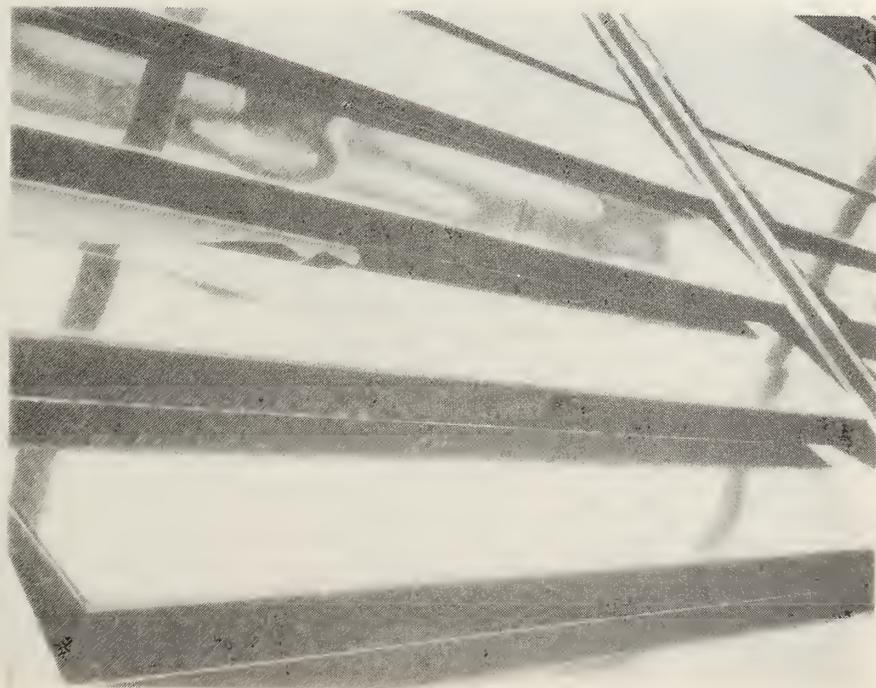
Figure 2.26. Broken glass mirror

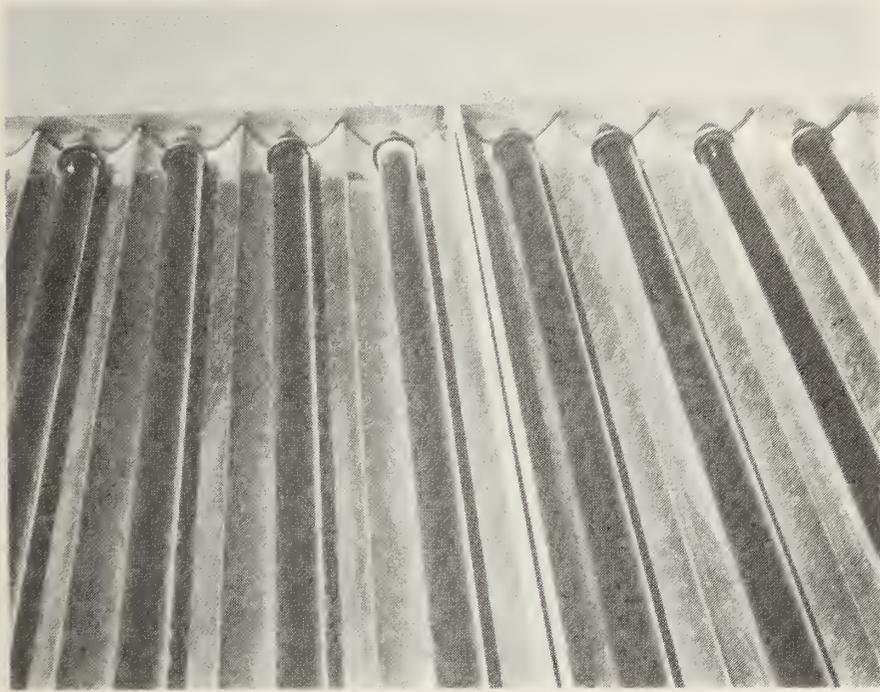
Figure 2.29. Dust and dirt on the surface of an evacuated-tube collector

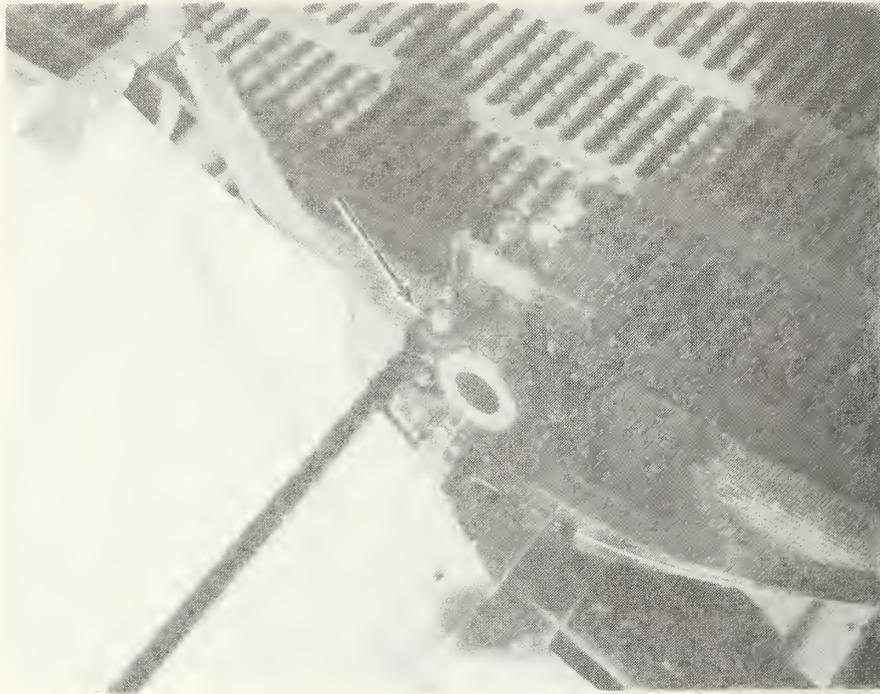
- o Rubber seals* were not used to any extent in the systems visited. At one site, rubber o-ring seals were originally installed at the ends of the receivers between the absorber tubes and glass jackets to protect against dirt and moisture entry (figure 2.31). According to site personnel, the temperature of the o-rings exceeded the design limits due to concentration of the solar radiation on the seals when the collectors were in focus. The excessive temperature reportedly resulted in deterioration of the seals. An expedient temporary correction of the problem was accomplished by installing reflective tape on the receiver jacket at the o-rings to prevent absorption of the concentrated solar radiation by the seals and excessive temperatures at those locations. Site personnel indicated that a metal seal was being designed to replace the o-rings as a permanent correction of the problem.

Figure 2.31. O-ring seal at the end of an absorber tube

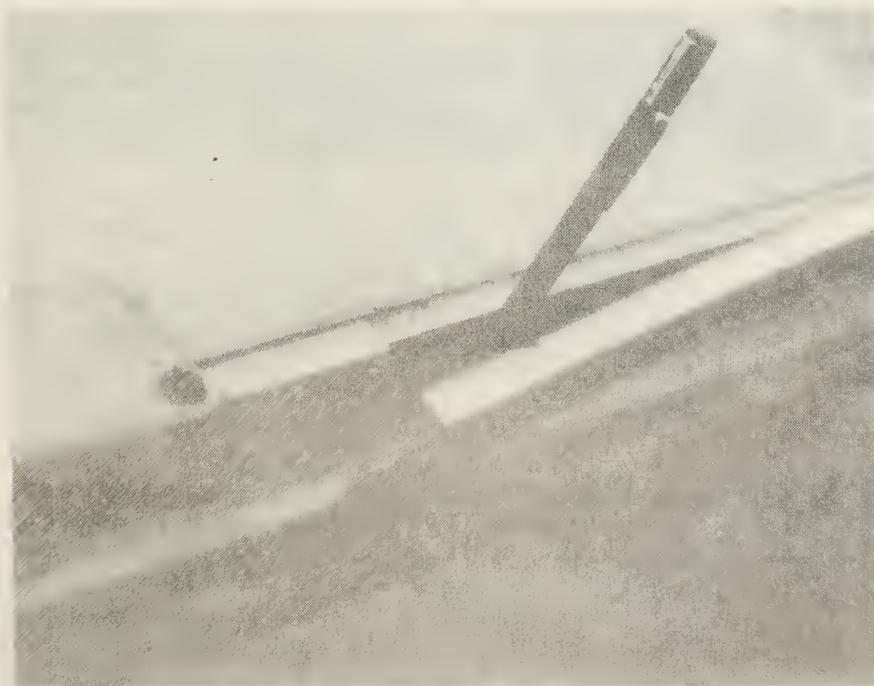
- o In the case of one line-focus collector having parabolic troughs, plastic strips used as molding to seal the edges of the troughs (aluminum honeycomb sandwiches) were delaminating (figure 2.34). These molding strips were brittle. The delamination of the edge moldings exposed the interior of the troughs to moisture.
- o At one site, the back surface of one collector trough was not protected from hot sparks and solder from welding operations during system construction. The trough had pitted areas where the sparks landed on the rear surface.

Figure 2.34. Delaminated plastic strip at the edge of a trough
