**NBSIR 85-3193**

# **Preliminary Recommendations for Maintenance of Factory Coated Metal Siding and Roofing**

June 1985

**Air Force Engineering and Services Center  
Tyndall Air Force Base, Florida 32403**

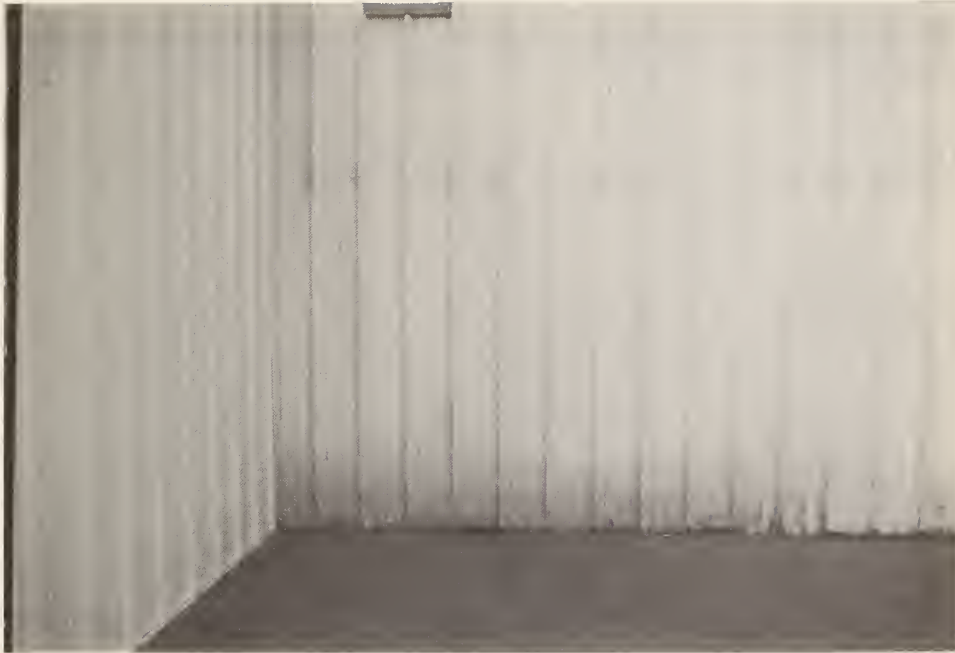
Figure 2. Illustration of loss of metal at bottom edges of panels

Metal loss due to corrosion was observed mostly at the following locations: at the bottom edges of the panels near the ground, just under the eaves, or at laps and seams (figures 2, 3, and 4). On one roof, corrosion of the metal was not visible from the top, however, severe loss of metal at most laps could be seen from the inside of the building.

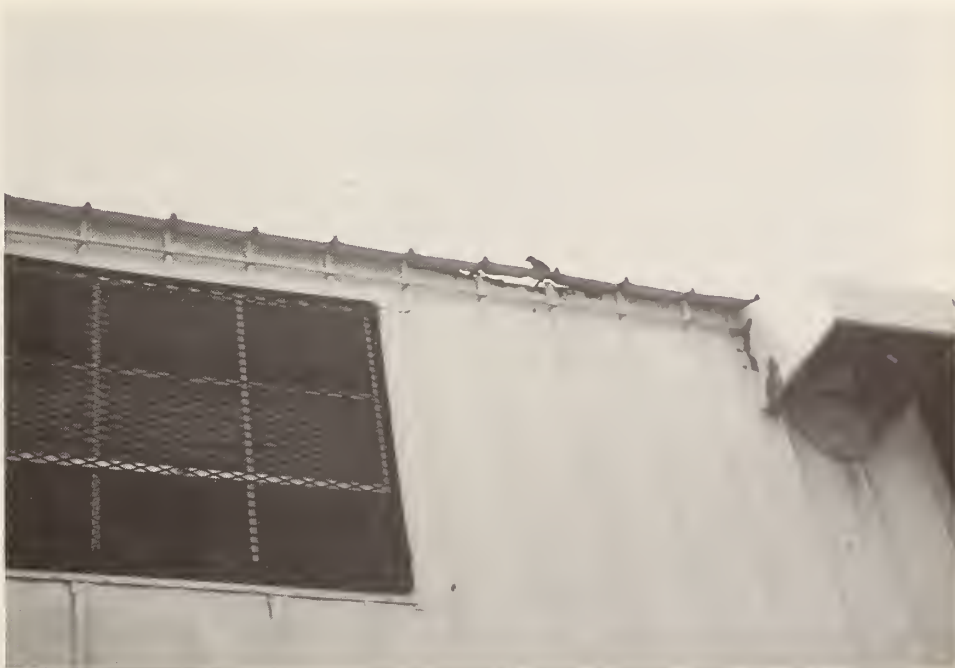
Figure 3. Illustration of loss of metal at top edges of panels under the eave

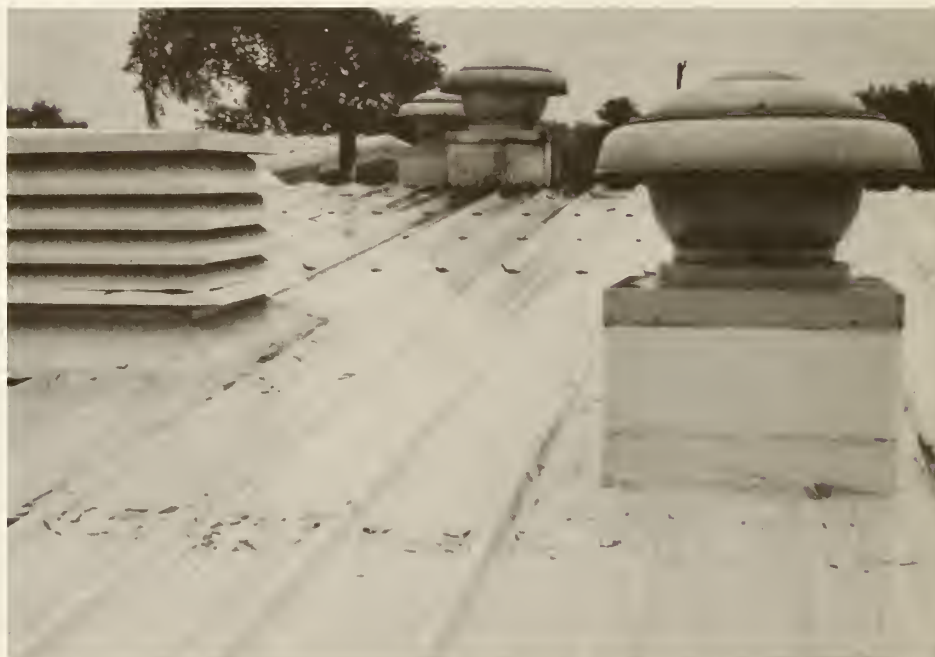
Figure 5. Bituminous mastic material used on roof to cover fasteners

In many instances, roof repairs were observed. One type of repair frequently observed, particularly on roofs with relatively little slope, was the use of bituminous mastic material to cover fasteners (figure 5). It was reported by base personnel that leaking often occurred at these fastener locations. Another type of repair was the use of thick bituminous coatings at the junction between two different types of roofing systems such as encountered with building modifications, additions, or repairs (figure 6).

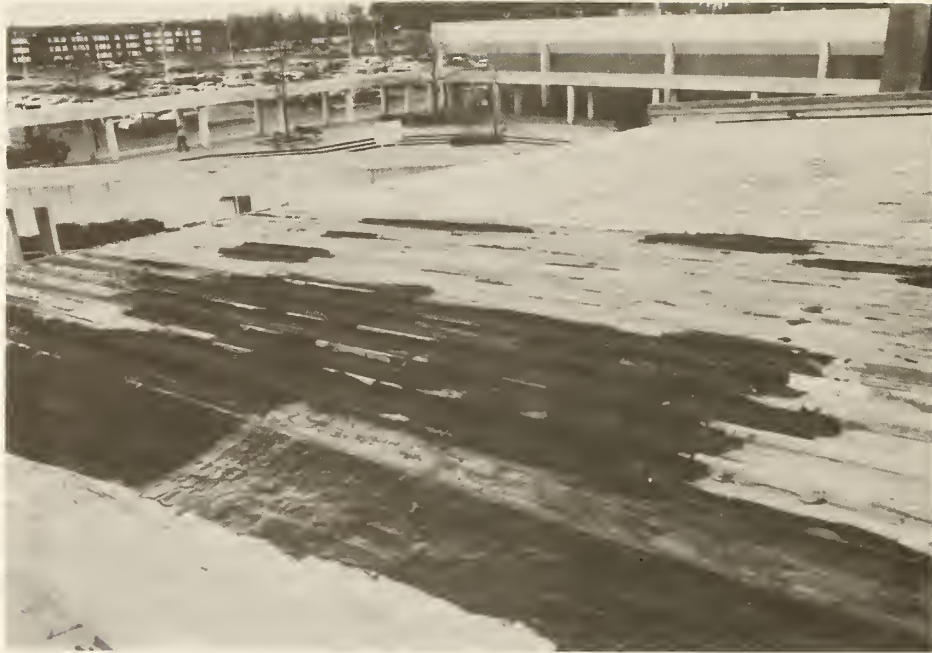
Figure 6. Thick fibrated bituminous roof coatings

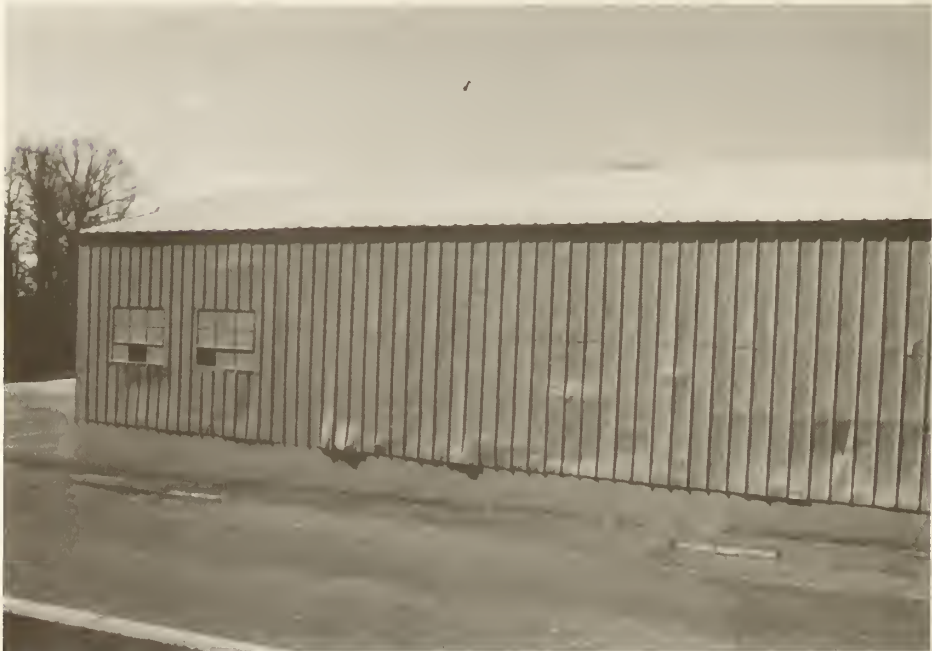
Figure 7. Impact damage of metal panels

Dents or severe localized bending of sheet metal was often observed (figure 7). This damage was attributed primarily to vehicles bumping into the buildings.

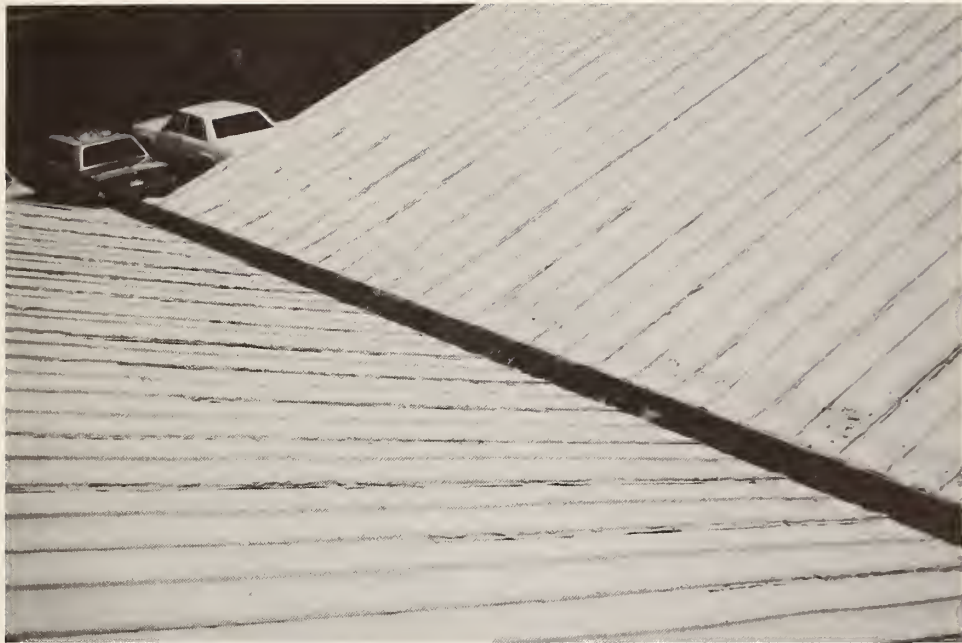
Figure 8. Deterioration of drainage system

Many problems with gutters or other parts of drainage systems were observed. These problems included deterioration of valleys, gutters, and downspouts (figure 8), and corroded gutter hangers (figure 9).

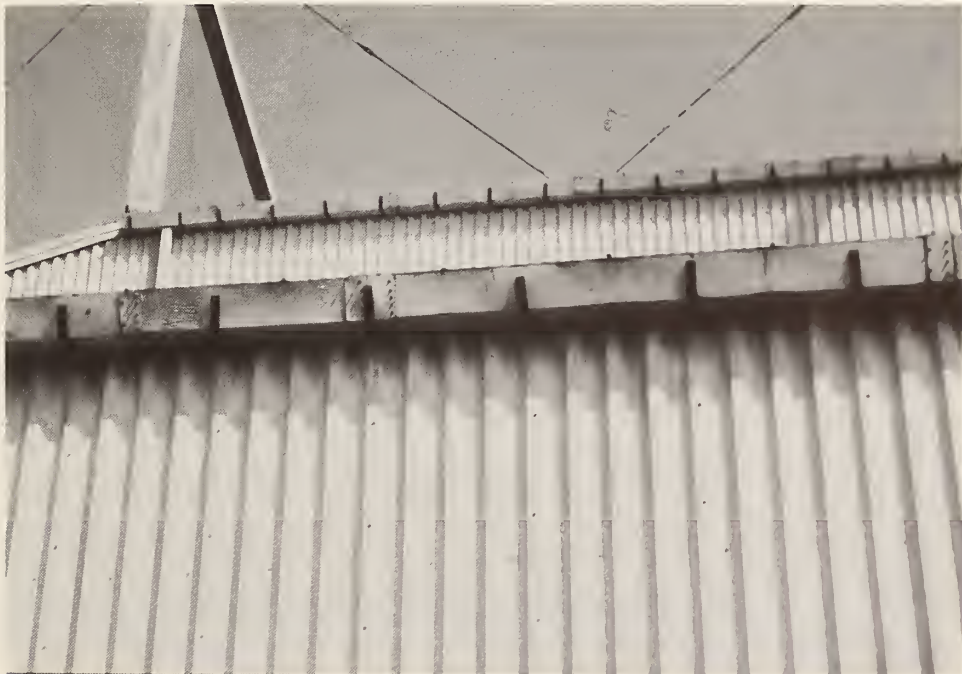
Figure 9. Corroded gutter hangers

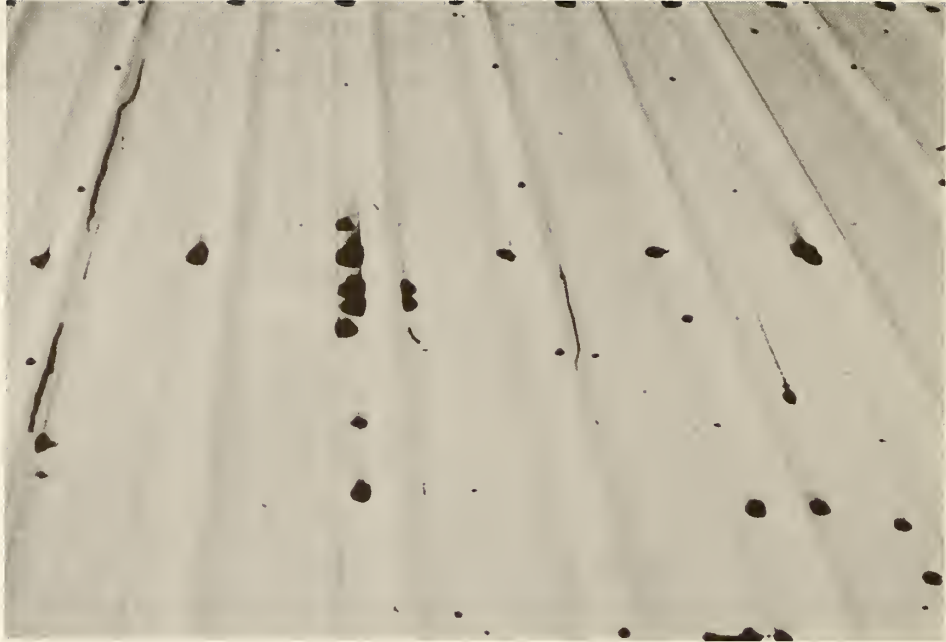
Figure 10. Corroded fasteners with associated corrosion of the metal panels

The extent of fastener corrosion ranged from slight to severe. In some cases where fasteners were badly corroded, the sheet steel adjacent to the fasteners was also corroded (figure 10). Some fasteners had pulled out of the panels (figure 11), and others were loose or missing. It appeared that in some instances the loose fasteners were never securely attached to the panels or support structures.

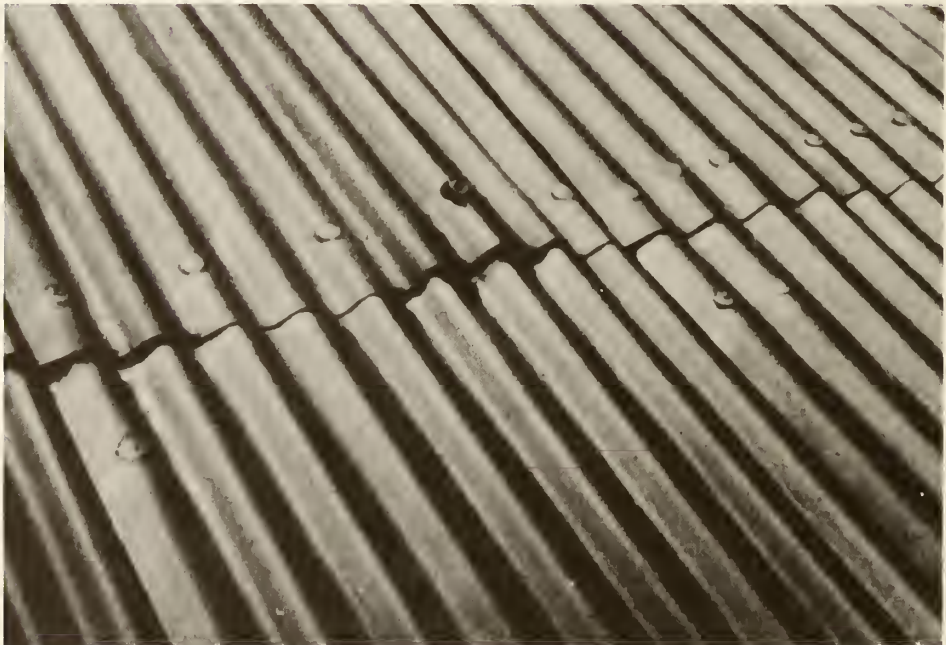
Figure 11. Loose fasteners

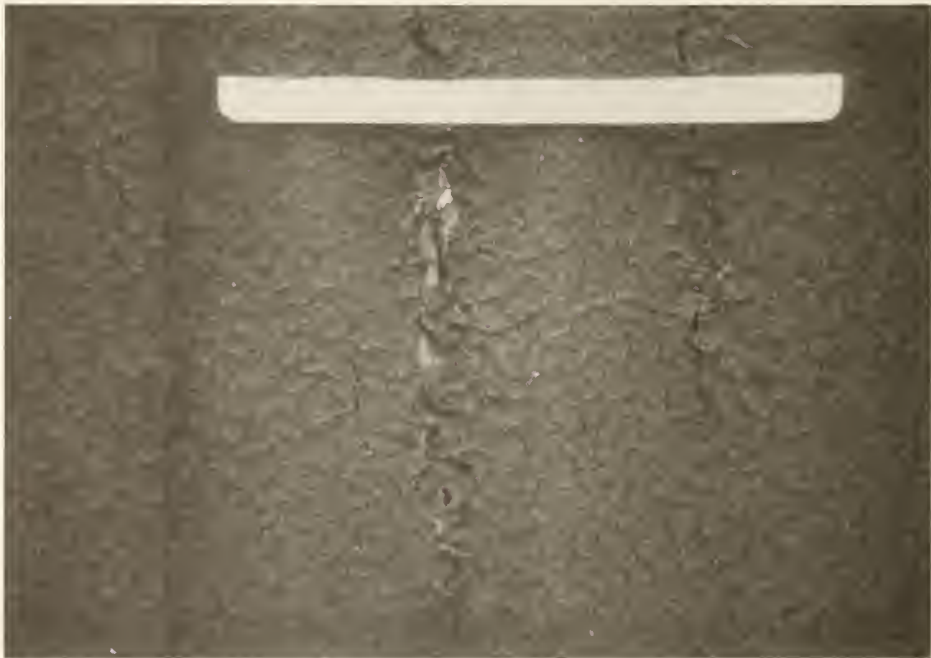
Figure 13. Cracking of bituminous coating

Bituminous coatings both with and without fibers and with and without factory applied topcoats were observed. All of the panels with bituminous coatings were more than 15 years old. These types of coating systems generally exhibited cracking. In cases where the bituminous coating was not topcoated, the cracks or breaks in the coating tended to extend to the metal substrate (figure 13). When the bituminous coating was topcoated, the cracks or breaks tended to be found only in the topcoat (figure 14). The topcoats were sometimes chalked and faded. The appearance of some buildings, without a topcoat, that were about 25 years old had an overall whitish cast. This was due to loss of the bituminous coating, and subsequent exposure of the white fibers in the reinforcing fabric which was in the coating (figure 15).

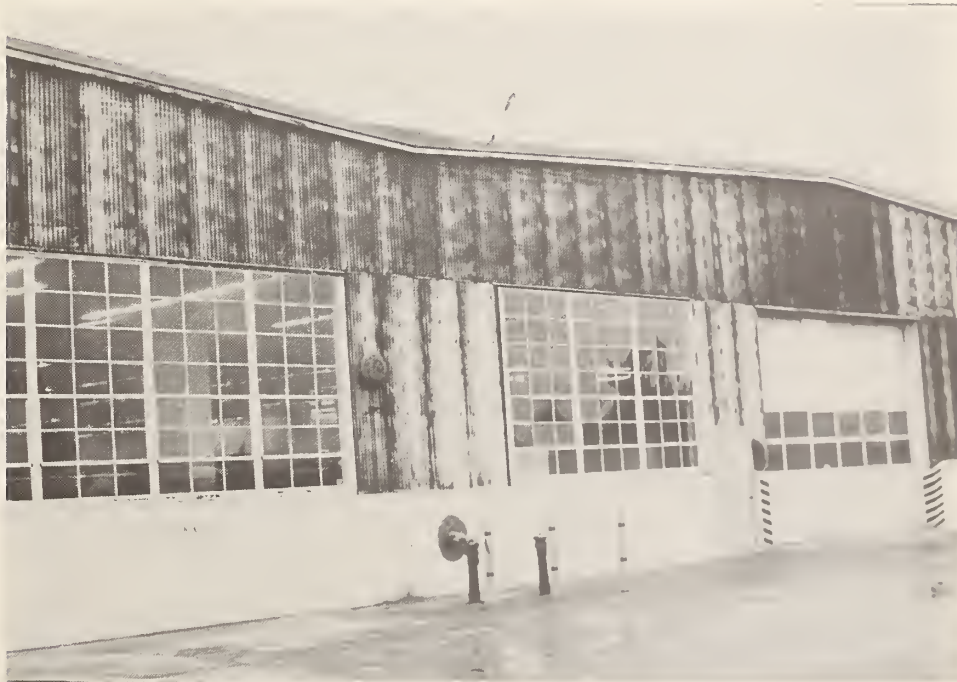
Figure 15. Fibers of reinforcing fabric showing on surface of deteriorated bituminous coating

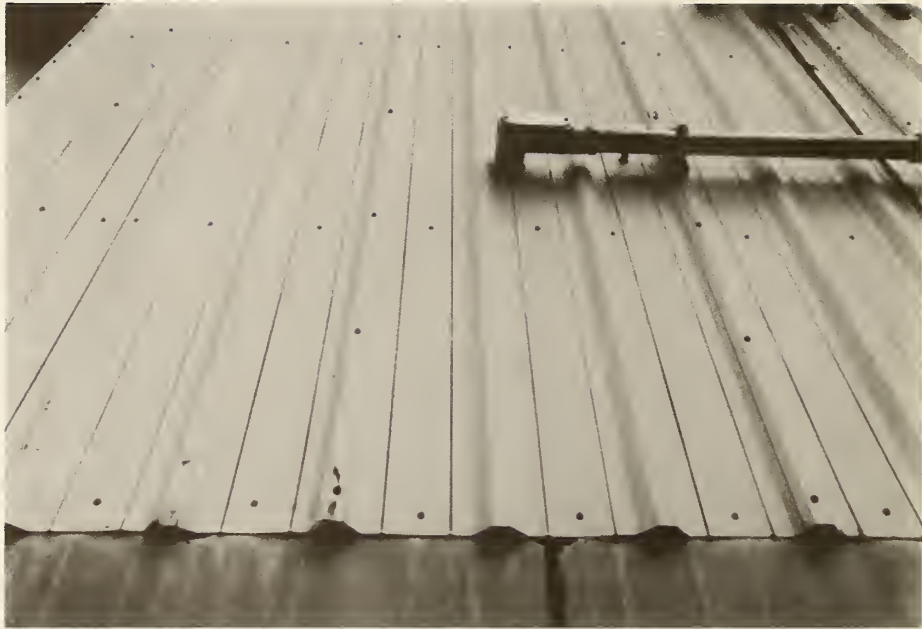
Figure 16. Corrosion along factory formed bends of steel panels protected by a thin organic coating

Most of the buildings constructed with metal panels having thin organic coatings, about 1 mil or 0.001 in. (0.025 mm), that were observed were less than 10 years old. The metal panels of these buildings were in general in excellent condition. However, deterioration was noted in some cases at the factory formed bends (figure 16) and at the edges of the siding and roofing panels (figure 17). Red rusting was detected at these locations. The deterioration for these noted cases was in some instances severe enough that recoating was needed. In a few cases, pin point rusting over flat surfaces was observed. Pin point rusting is characterized by tiny holes in the coating with rust staining extending from the holes. Fading, chalking, and mildew were also observed. The fading and chalking tended to be found together and was observed on the older buildings, those more than 10 years old.

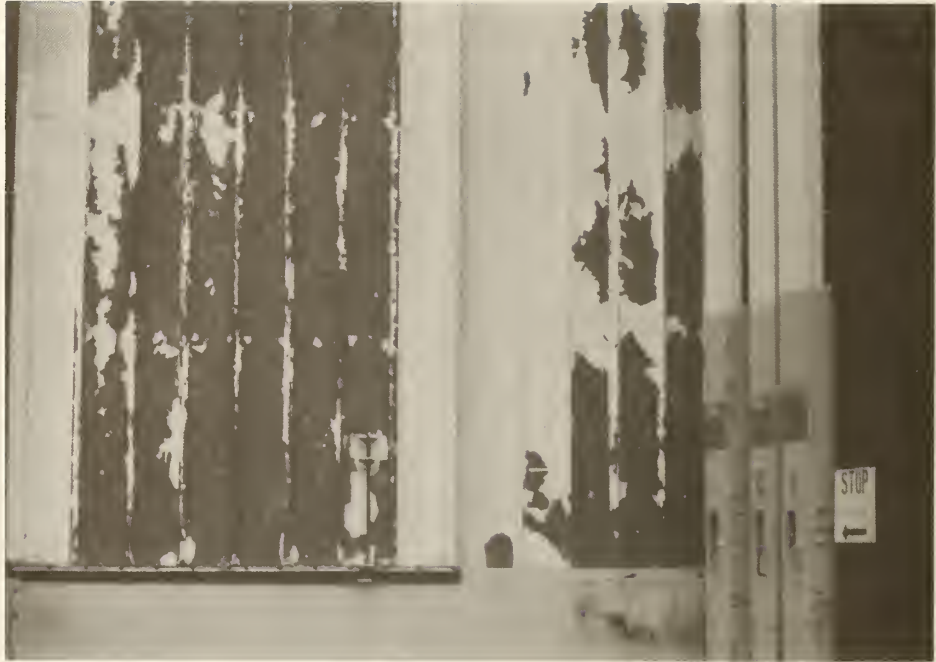
Figure 18. Peeling of alkyd coating from galvanized steel panels

The types of maintenance coatings that were observed on galvanized steel included zinc pigmented alkyd primers (e.g., TT-P-641)\* with an alkyd topcoat, red lead pigmented alkyd primers with either alkyd or acrylic topcoats, vinyl wash primer (e.g., MIL-P-15328)\*\* with alkyd or other topcoats, and acrylic or bituminous coatings with and without aluminum pigment. The condition of the maintenance coatings varied. It was often noted that alkyd systems either experienced peeling (figure 18) or they could be easily removed with tape after making an X-cut in the coating with a knife.

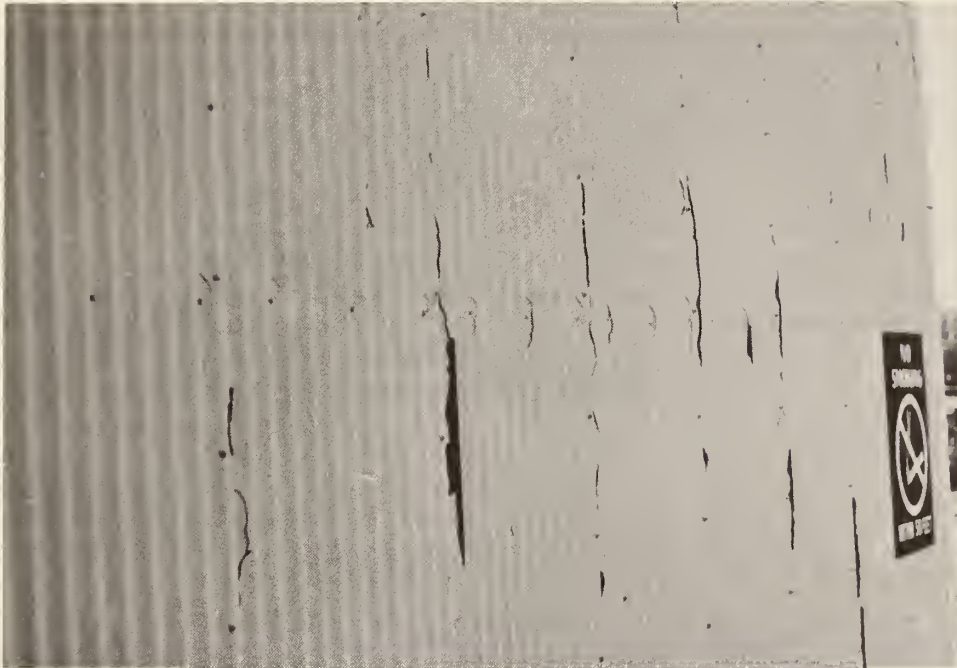
Figure 22. Peeling of bituminous factory coating system recoated with a mineral spirit solvent paint

On one large metal building, a paint containing mineral spirits had been applied to a bituminous factory coating with a polyester type of topcoat. During inspection of this building it was observed that the bituminous coating had

peeled extensively from the metal siding (figure 22). The solvent in the maintenance coating had likely weakened the bond between the bituminous coating and the metal.

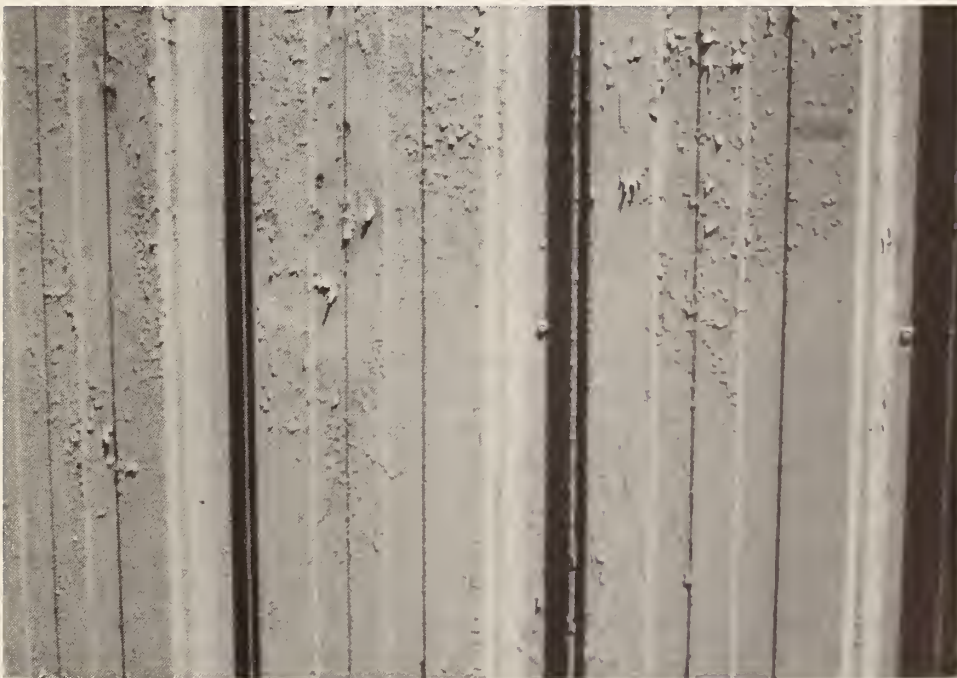
Figure 23. Adhesion failure of maintenance coating to a thin organic factory coating

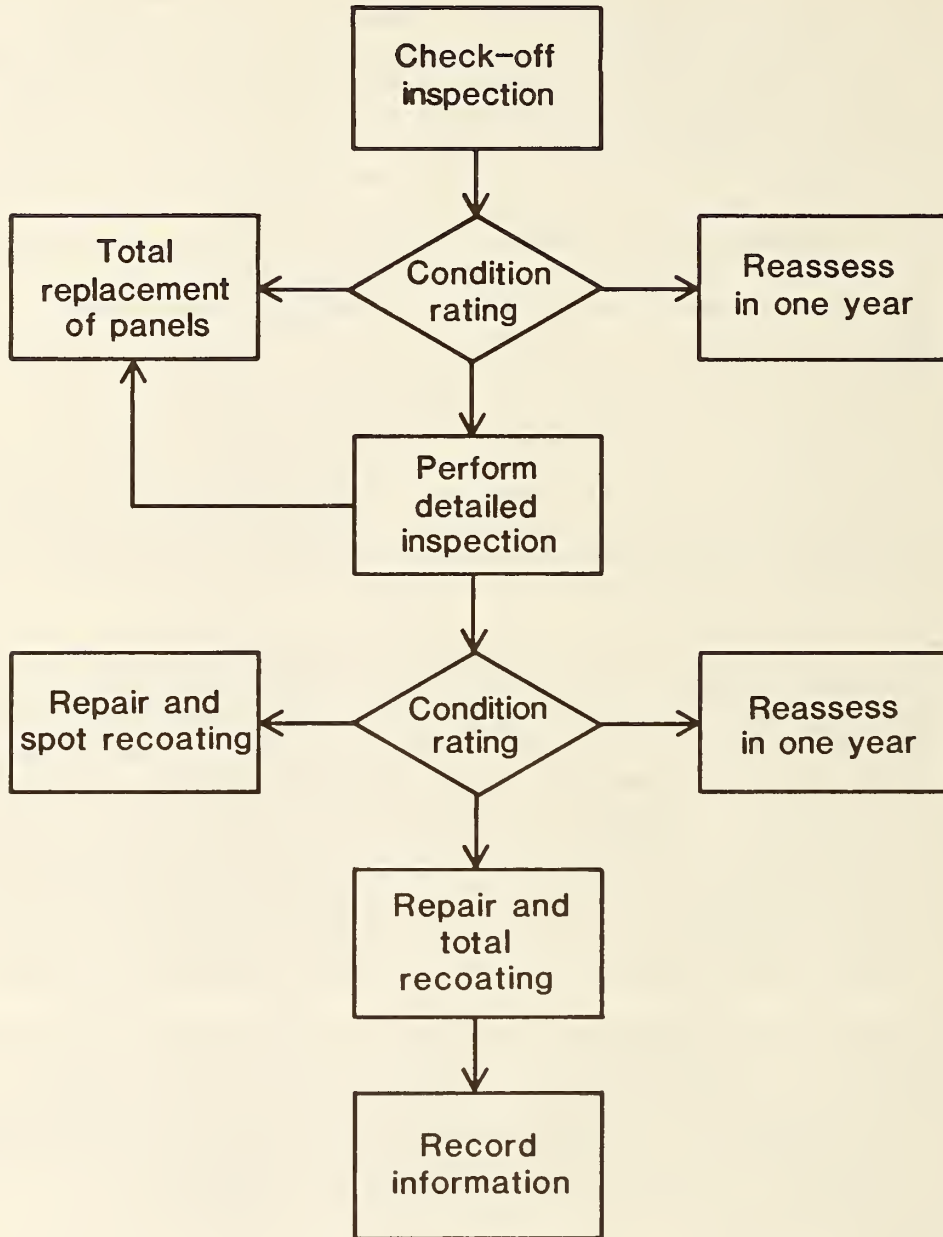
Figure 24. Condition assessment procedure

The initial check-off inspection is a relatively quick look at the building. The objective of this inspection is to determine the general condition of the metal siding, roofing, fasteners, and drainage systems. As a result of this inspection, it should be known whether the building components have essentially no deterioration, some deterioration, or severe deterioration.

Inspection Form 1 (table 4) is used in carrying out this initial inspection. The terms listed in the left-hand column are defined in the glossary in Appendix A. Many of the conditions listed in Inspection Form 1 (table 4) are illustrated in chapter 3. In the initial check-off inspection, the only type of deterioration for which a quantitative estimate is required is panel perforation. This requirement is made so that further inspection will not be necessary when panels are badly perforated.

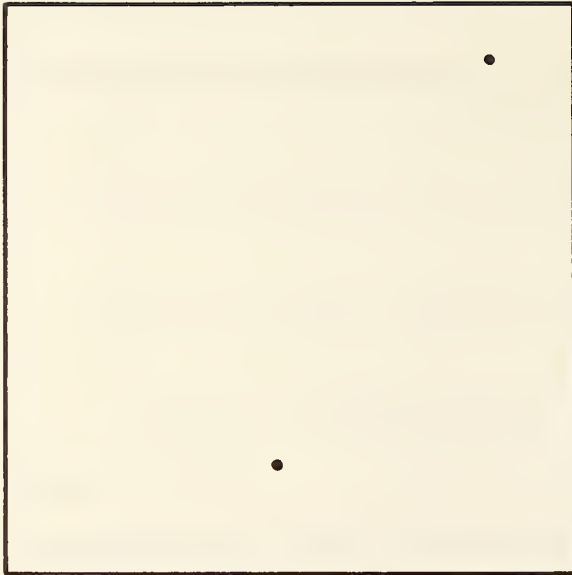
Level 8, (0.03% of area)

Level 5, (0.3% of area)

Level 2, (3% of area)

Level 5, photograph

Figure B.1. Visual standards for flat surface corrosion  
(sketches actual scale)

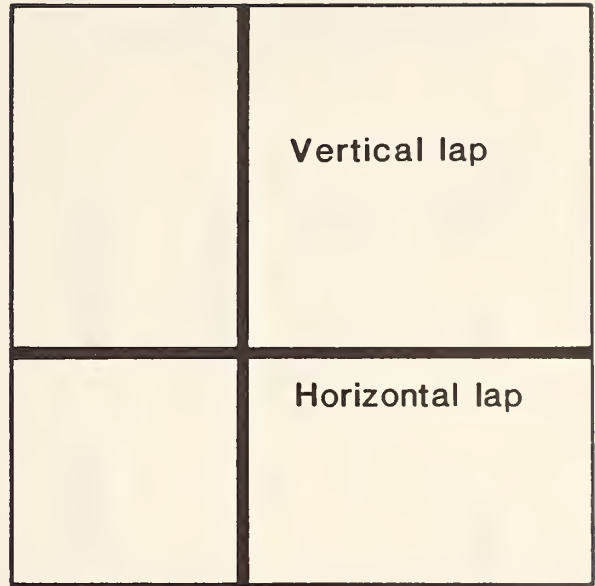
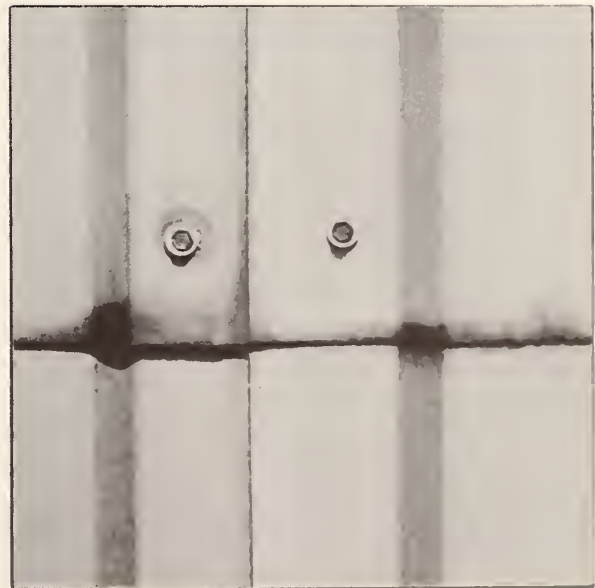
Level 8, discontinuous corrosion  
1/16 in. or less in width

Level 5, continuous corrosion  
1/16 in. or less in width

Level 2, continuous corrosion  
1/16 in. or more in width

Level 5, photograph

Figure B.2. Visual standards for edge corrosion at vertical and horizontal laps and at the top and bottom of metal panels (sketches actual size)

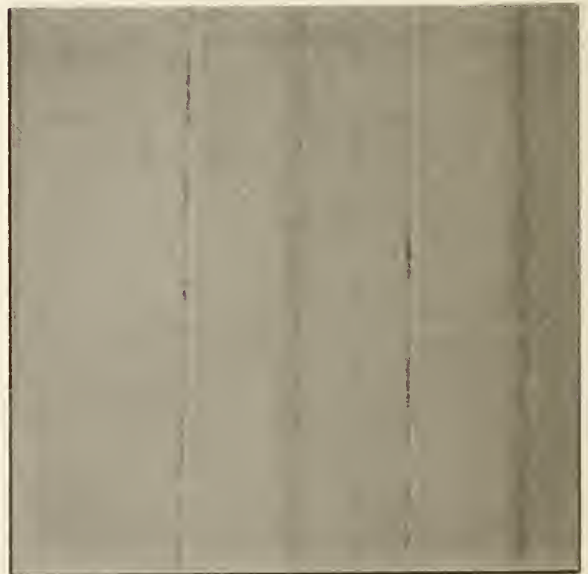
Level 8, discontinuous corrosion  
1/16 in. or less in width on 25%  
of bends

Level 5, discontinuous corrosion  
1/16 to 1/8 in. width on 50% of  
bends

Level 2, continuous corrosion  
1/8 in. or more in width on 50%  
of bends

Level 5, photograph

Figure B.3. Visual standards for bend corrosion (not to scale)

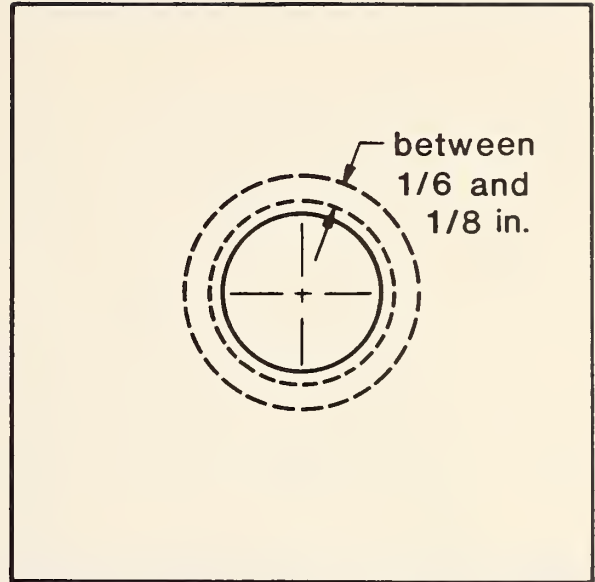
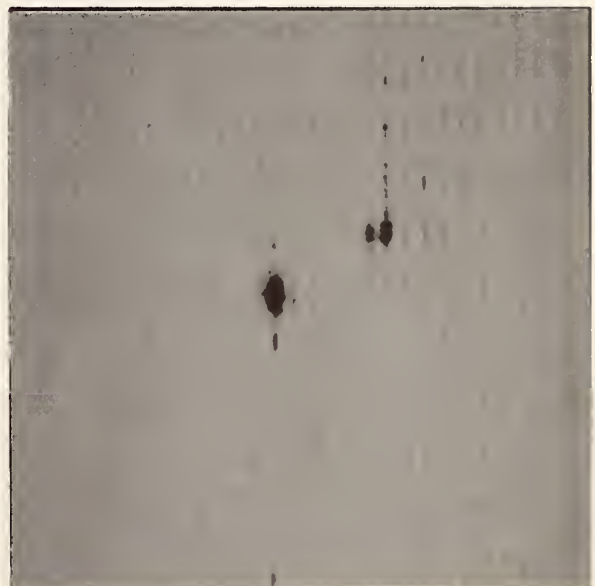
Level 8, paint film can be removed  
1/16 in. from defect

Level 5, paint film can be removed  
from between 1/16 and 1/8 in.  
from defect

Level 2, paint film can be removed  
1/8 in. from defect

Level 5, photograph

Figure B.4. Visual standards for undercutting. In the evaluation of the condition of metal panels, undercutting may affect the level of deterioration of the types of deterioration shown in the other visual standards, figures B.1, B.2, B.3, B.5 and B.6.

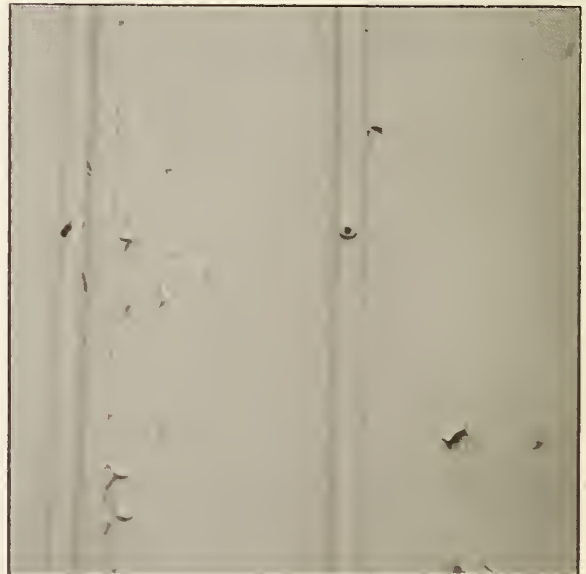
Level 8, (0.05% of area)

Level 5, (0.5% of area)

Level 2, (5% of area)

Level 5, photograph

Figure B.5. Visual standards for peeling/blistering (sketches actual scale)

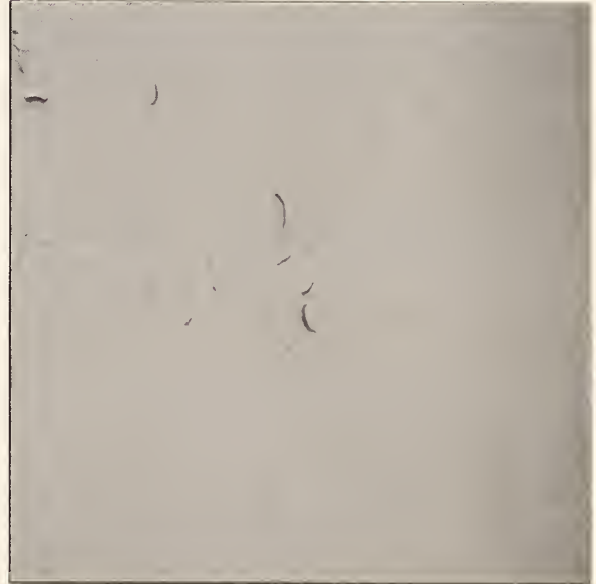
Level 8, (0.05% of area)

Level 5, (0.5% of area)

Level 2, (5% of area)

Level 5, photograph

Figure B.6. Visual standards for cracking (sketchs actual scale)

10	no cracking of paint film visible to naked eye
8	slight cracking of paint film, cracks do not extend to substrate and cover 0.05% of the area
5	moderate cracking of paint film, cracks do not extend to the substrate and cover 0.5% of the area
2	severe cracking of paint film, cracks extend to the substrate and cover 5% of the area
