NBSIR 86-3375

**TENSILE PROPERTIES OF PLEATED
SYNTHETIC ROPE**

S. G. Fattal

U.S. DEPARTMENT OF COMMERCE
National Bureau of Standards
Center for Building Technology
Structures Division
Gaithersburg, MD 20899

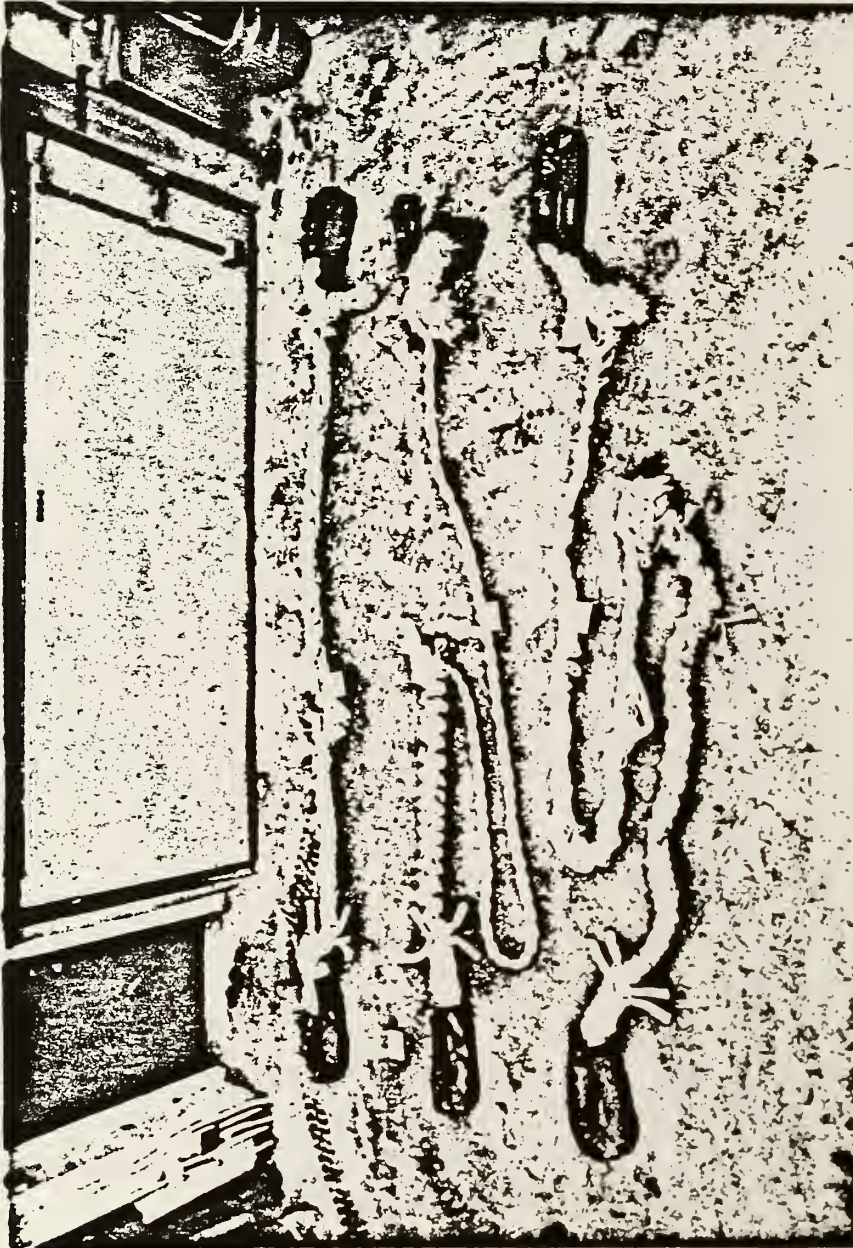
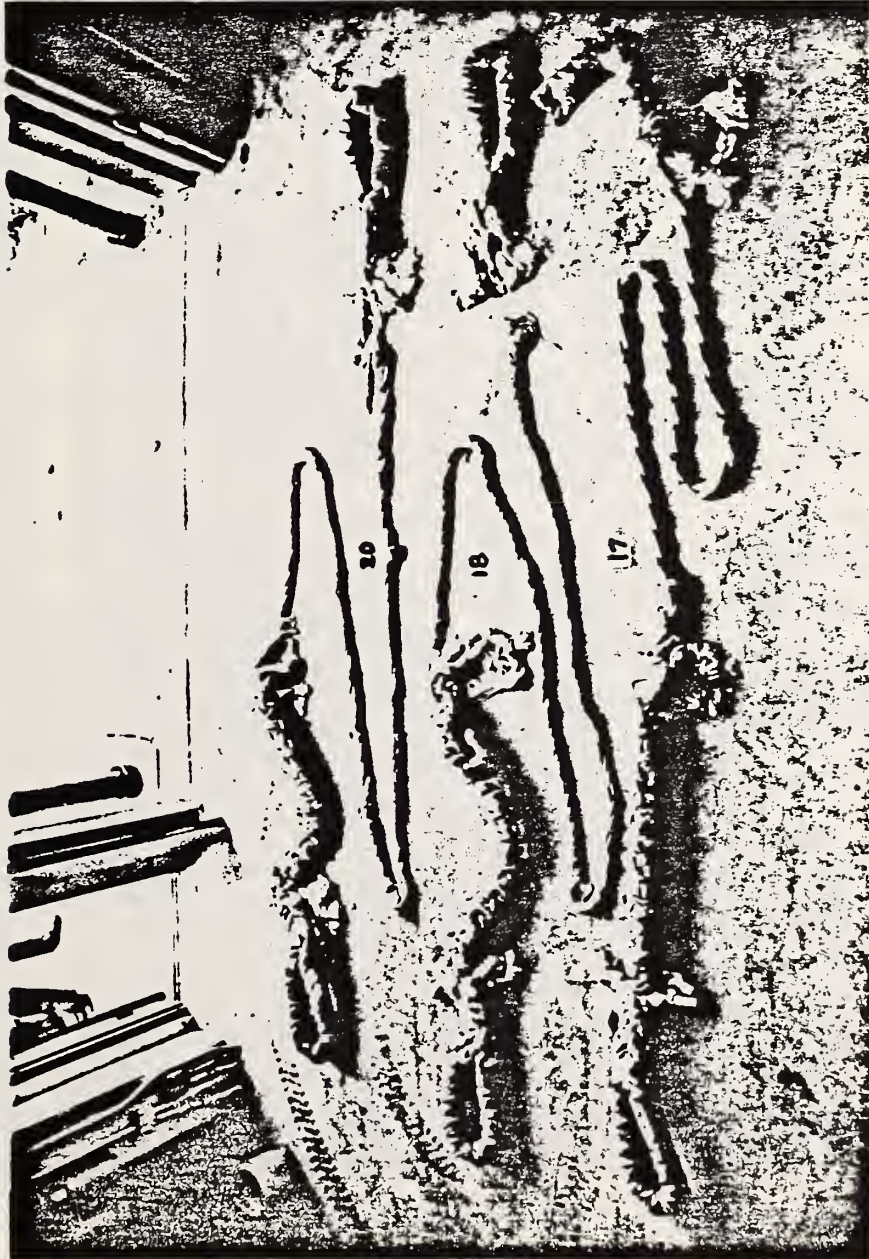
Figure 3.7 Failure of 64-mm untreated ropes.

Figure 3.8 Failure of 80-mm untreated ropes.

Figure 3.9 Failure of 64-mm heat-treated ropes.

Figure 3.10 Failure of 80-mm heat-treated ropes.

Figure 3.11 Failure of 64-mm cooled ropes.

Figure 3.12 Failure of 80-mm cooled ropes.

Figures 3.7-3.12 show the specimens after failure. Replicate specimens are shown in the same figure and are identified by their numbers. The top ends of the specimens (as installed in the test machine) are shown on the left side. Figure 3.13 is a general view of the testing facility with a specimen ready for testing. The movable work platform is at the center of the figure. Figures 3.14-3.17 show, respectively, specimen 17 being removed from the cooling box, being installed in the clevis, under load, and after rupture.

All the specimens broke suddenly and explosively, releasing fiber debris at the point of rupture. Popping of (intentionally-placed) black yarns within the ropes with increasing frequency provided an indication of approaching failure. In all cases rupture occurred in the rope. In some cases the point of rupture was away from the eyes (nos. 1,4,9,11,19). More frequently, rupture occurred close to or right beyond the eye splice. No ruptures occurred within the eye. Some of the specimens broke completely (nos. 1-4,6,7,9,11,19). In the others, a single or double-twisted strand remained unbroken.

All the specimens exhibited frictional heat damage to varying degrees, as evidenced by the coloring of the yarns from tan to dark brown and by their brittle texture. In specimen 1, smoke was detected near the point of rupture before it occurred. In most cases scorching was confined to the superficial yarns of the strands, which had maximum exposure to frictional heat. Upon rupture, the two segments of rope tended to compress axially

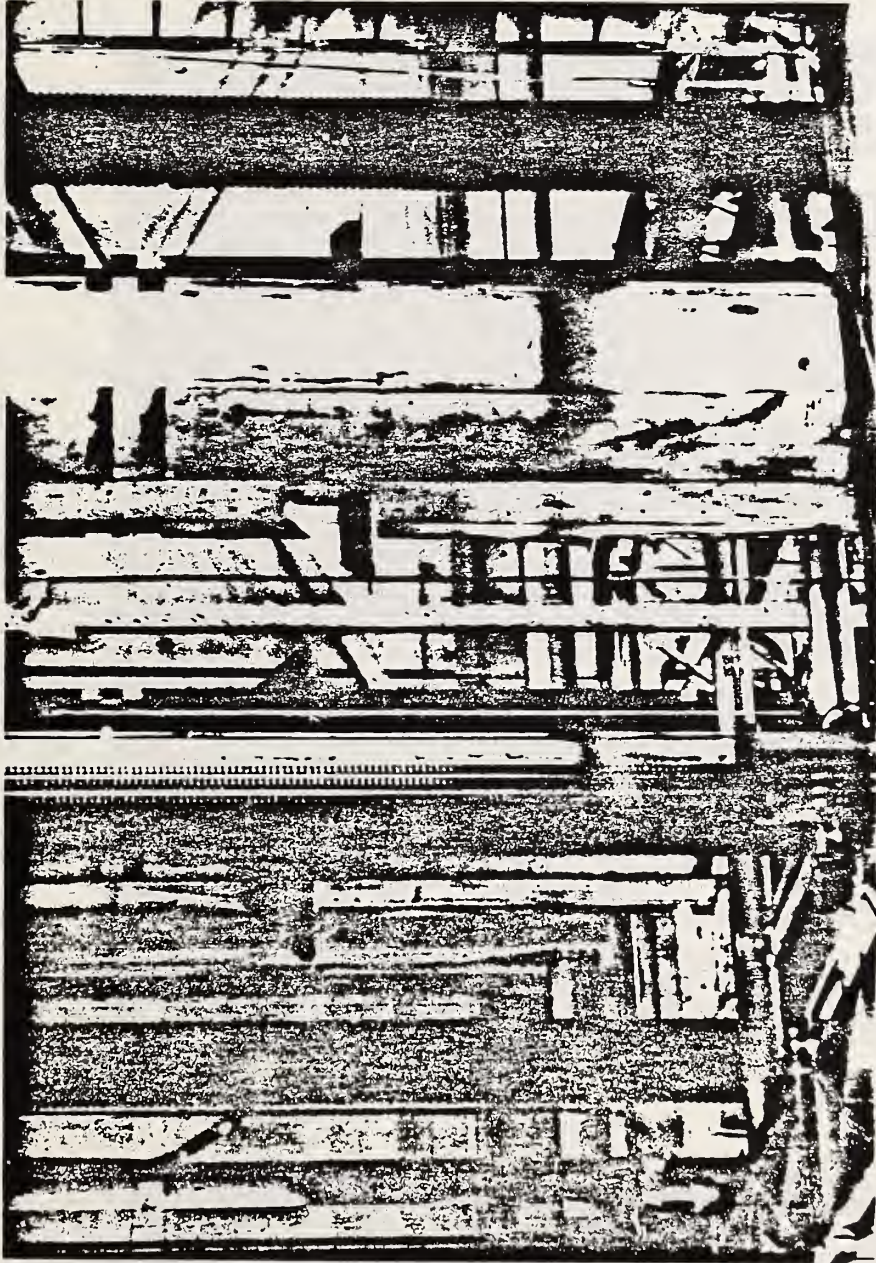
Figure 3.16 Specimen #17 under load.
