**NISTIR 89-4126**

# **VENTILATION AND AIR QUALITY INVESTIGATION OF THE U.S. GEOLOGICAL SURVEY BUILDING**

**July 1989**

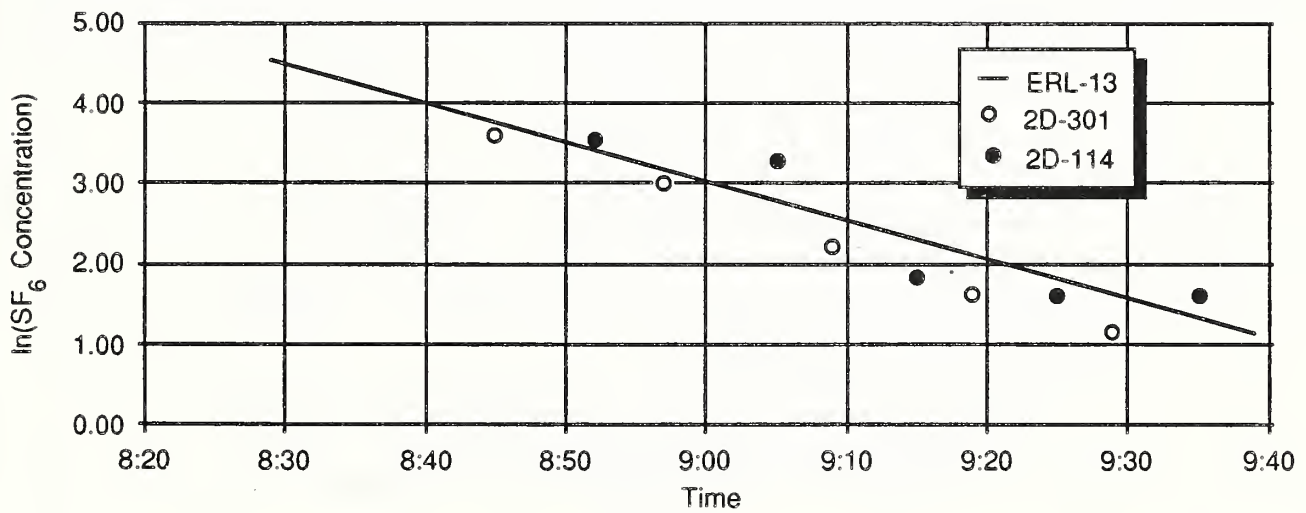
Figure 6: Local Tracer Gas Decay Results

Figure 6 shows three examples of the results of local decay tests. In each plot the logarithm of the tracer gas concentration at one or more of the test sites is plotted against time. The data in each plot corresponds to a specific room (or rooms) within the building (the distinct symbols in the graph) and the return fan serving the room(s) being tested (the solid line). In all of these plots, the concentration decay data for the individual rooms corresponds quite closely to the data for the return fan, indicating that the ventilation rate in these individual rooms is very close to that of the entire zone served by the corresponding return fan. While this information is qualitative, it does indicate good air distribution within the building. Table 2 shows the results of all of the local decay tests that were conducted in the building. A total of five tests are listed, and in each case the measured tracer gas decay rate is given for the test room and the return fan that serves that room. In almost all cases these two decay rates agree within the experimental uncertainty of about 20%. A few exceptions do exist, Room 4A108 in Test #2 and Room 2C310J in Test #4, in which the room decay rate is significantly higher than the return fan decay rate. The reason for this difference is not clear, but the fact that the room decay rate is larger, as opposed to smaller, than the return fan decay rate does not necessarily indicate poor air distribution in this room. A similar effect is seen in all of the rooms in Test #3.

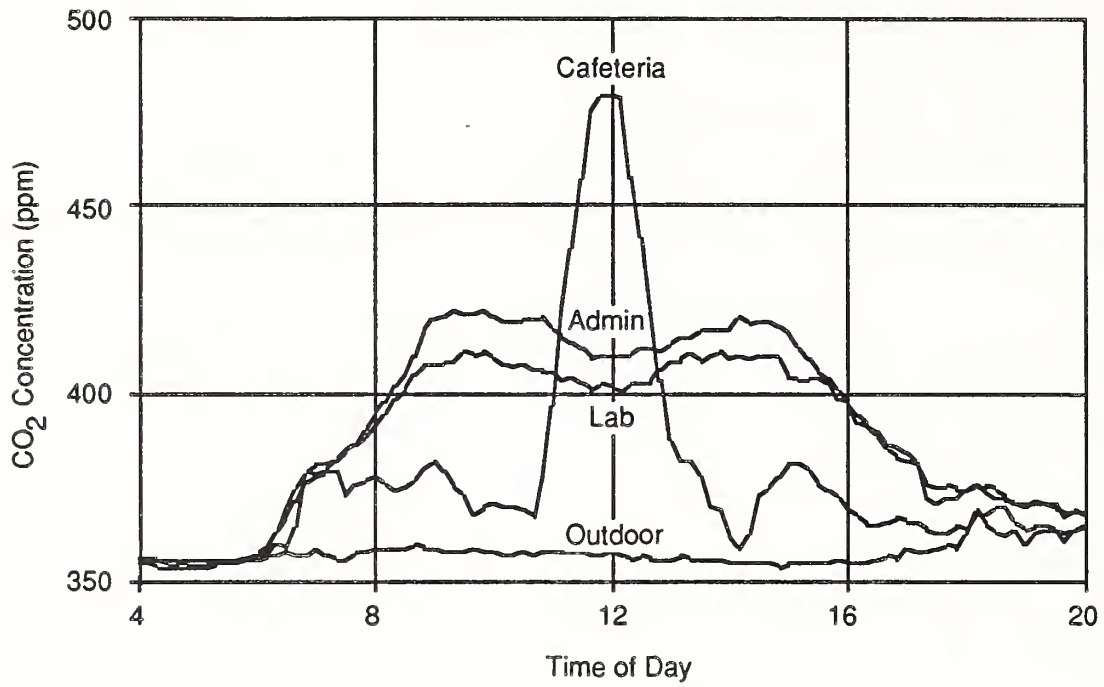
Figure 7: CO<sub>2</sub> Concentration During One Day

Indoor levels of carbon dioxide were measured in the building return air ducts during the first four months of 1988. During all of these CO<sub>2</sub> measurements, tracer gas decay measurements of whole building air exchange rates were being made. The results of these measurements indicate relatively low levels of CO<sub>2</sub> in the building, consistent with the high air exchange rates that were measured. Figure 7 is an example of the CO<sub>2</sub> concentration profile for a day in the building, showing the concentrations in the administration and laboratory sections, the cafeteria and the outdoors for a single day with an air exchange rate of about 2 ach. In the administration and laboratory sections of the building, the CO<sub>2</sub> concentrations start at the outdoor level in the early morning and reach a maximum by about 10 a.m. The maximum in the administration section is higher than in the laboratory, typical for this building. A slight decrease in concentration occurs in the administration section corresponding to the lunch break, with a lesser decrease in the laboratory section. The cafeteria concentration reaches its peak during lunch, as expected, with smaller peaks during morning and afternoon breaks. The maximum CO<sub>2</sub> concentration on this day is about 425 ppm in the administration section, 410 ppm in the laboratory section, and about 475 ppm in the cafeteria. These levels are typical for this building, indicative of a sufficient amount of ventilation relative to the building occupancy levels. Figure 8 is a plot of the CO<sub>2</sub> concentration over several days, showing the repetitive nature of the pattern seen in Figure 7. The gradual, though slight, increase in concentration over the three days is due to a combination of an increase in the outdoor CO<sub>2</sub> concentration and a small drift in the calibration of the CO<sub>2</sub> monitor. Measurements of local CO<sub>2</sub> concentrations were also made with portable equipment on several occasions at the locations listed in Table 1, and the measurements were always consistent with the low levels found in the building return ducts.

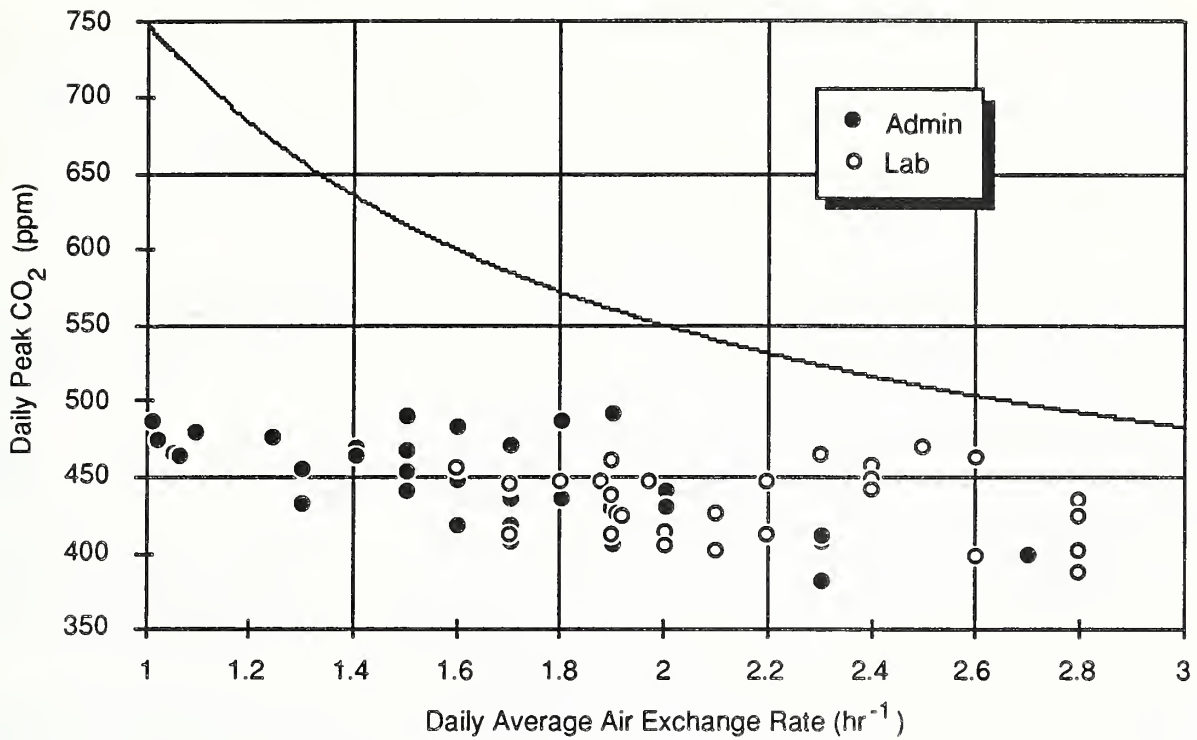
Figure 9: Daily Peak CO<sub>2</sub> Concentrations versus Daily Average Air Exchange Rates

The concentrations of CO<sub>2</sub> in this, or any other building, are determined by the CO<sub>2</sub> generation rate and the building ventilation rate. The generation rate in this building is essentially a function of the building occupancy level, since there is no indoor garage, indoor combustion, or other indoor sources of CO<sub>2</sub>. Assuming the occupancy patterns are the same during most working days, the CO<sub>2</sub> concentration is determined primarily by the ventilation rate. Figure 9 is a plot of daily peaks of average CO<sub>2</sub> concentration in the

administration and laboratory sections of the building versus the daily average air exchange rate for the corresponding portion of the building. Each dot corresponds to a single day. The solid line represents the predicted maximum assuming an occupancy level of 7 people per 100 m<sup>2</sup> (1000 ft<sup>2</sup>) and a constant CO<sub>2</sub> generation rate of 0.0053 L/s (0.011 cfm) per person. The predicted values are also based on the assumption that the CO<sub>2</sub> concentration is at equilibrium, i.e. the occupancy has been constant for a long enough period of time that the CO<sub>2</sub> concentration has built-up to its maximum level. The measured data agree with the predictions within expected experimental variations for air exchange rates above about 2 air changes per hour. At lower air exchange rates the measured maximum concentrations are below the predicted levels, with larger deviations at lower air exchange rates. This trend in the differences between measured and predicted maximum CO<sub>2</sub> concentrations is expected because at lower air exchange rates it takes longer for the CO<sub>2</sub> concentrations to attain equilibrium. For example, at 1 air change per hour, it takes more than three hours for the CO<sub>2</sub> concentration to attain its maximum value, and the lower the air exchange rate the longer it takes for the CO<sub>2</sub> concentration to reach equilibrium. In most office buildings, the occupancy levels are not constant for long enough periods of time for equilibrium concentrations to be achieved. Therefore, the lower the air exchange rate the greater the difference between the actual maximum CO<sub>2</sub> concentration and the predicted maximum value.

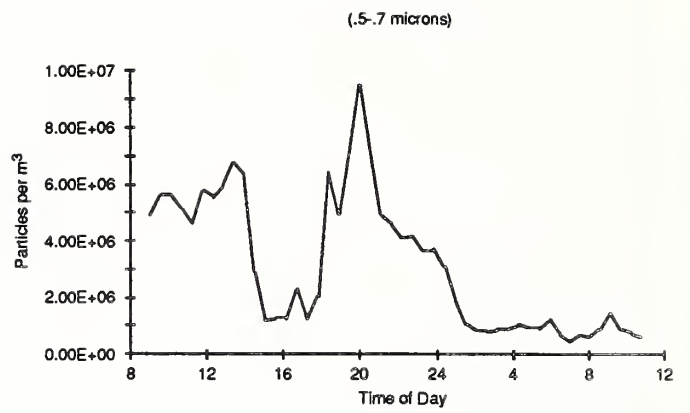
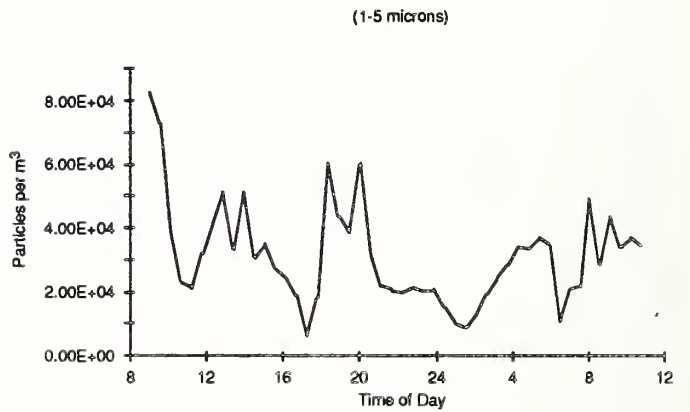
Figure 10: Example of Particulate Measurements

Particulate levels were measured at 10 locations in the building with a light-scattering particle counter that determines particulate concentrations in 6 different ranges of particle size. Figure 10 shows a sample of the measured data, from a conference area in Room BC115, taken over approximately 24 hours. The six plots in the figure show particulate concentrations in units of particles per cubic meter in six size ranges: >10, 5-10, 1-5, 0.7-1, 0.5-0.7, and 0.3-0.5  $\mu\text{m}$  in diameter. The horizontal axes in these plots is the time of day in hours, with the plot extending from approximately 9 a.m. on the first day to 9 a.m. the next day. The data are similar to those seen in other buildings in that the concentration variation in the larger particles (>5  $\mu\text{m}$  in diameter) is greater than the variation in the smaller particles. The concentrations of these larger particles decreased to almost zero after the building occupants left, while the concentrations of the smaller particles decreased to a lesser extent after occupancy.

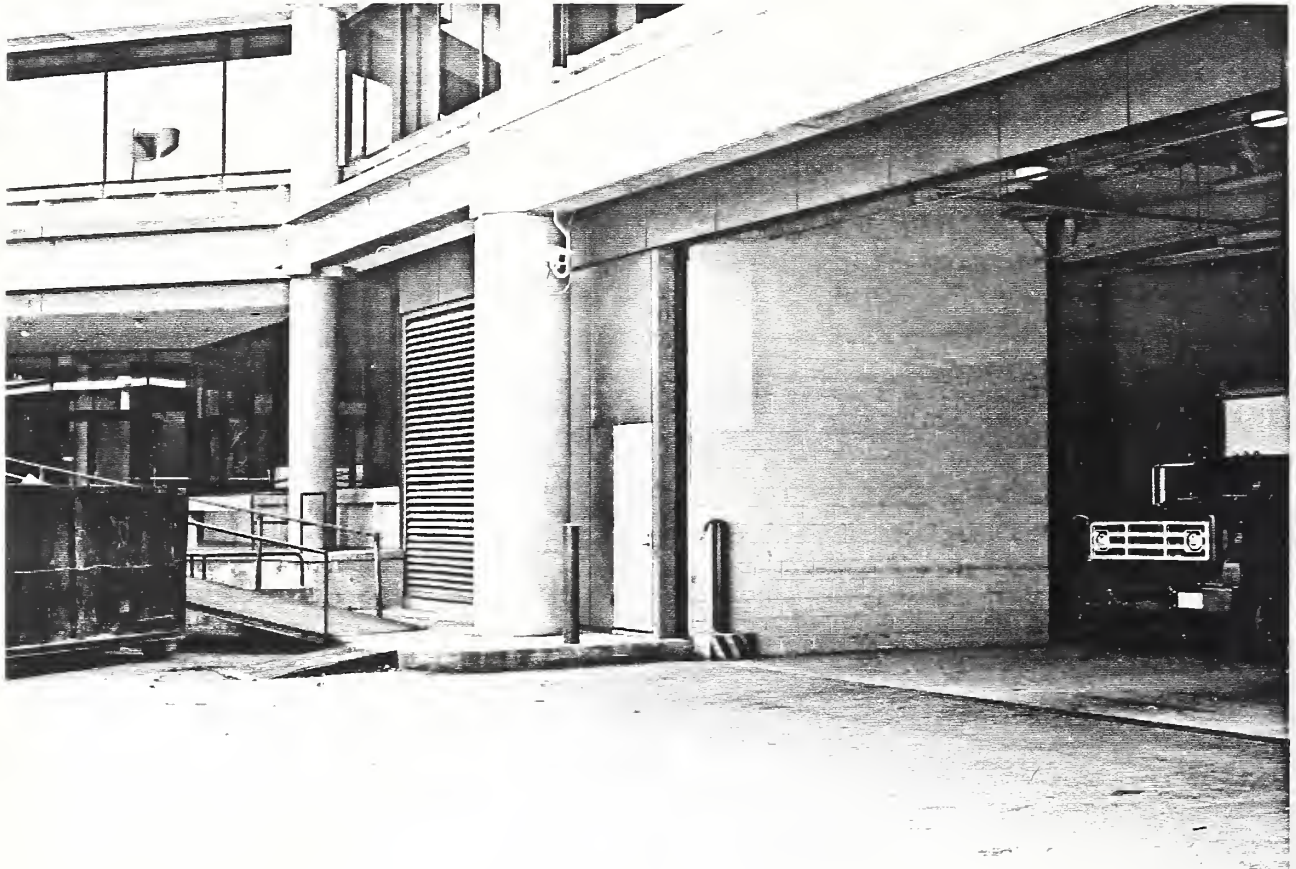
Figure 12: Photograph of Loading Dock, Exhaust Grille and Trash Dumpsters

zero. The highest levels of the large particulates were measured in the freight elevator lobby on the fourth floor. This could be an indication of air movement up the freight elevator into the occupied space of the building. This air movement could carry contaminants from the loading dock, such as motor vehicle exhaust, or from the trash bins outside of the loading dock.

In addition, the numerous building exhausts are also located at ground level, creating the potential for the entrainment of building exhaust air into the ventilation system's air intakes. The situation is further complicated by the fact that the building sits in a low lying area in comparison to the immediate terrain. Under appropriate wind and temperature conditions, pollutants generated by the various sources associated with the complex may

Solutions to the intake air quality problems in this building must deal with the fact that the air intakes are located at ground level and address the sources of the pollutant. The entrainment of some of these contaminants by the air intakes could be reduced by modifications which essentially raise the level from which the intake air is provided. Barriers could be constructed around the intakes such that contaminants from ground level sources are not as readily entrained. These barriers would need to be on the order of at least one-story in height. Another option would be the installation of ductwork from the air intakes to a higher level that would also serve to reduce the intake of outdoor contaminants from ground level. An engineering and cost study should be conducted to investigate the merit of these approaches.
