NIST NCSTAR 1-2B

**Federal Building and Fire Safety Investigation of the
World Trade Center Disaster**

**Analysis of Aircraft Impacts into the
World Trade Center Towers
Chapters 1, 2, 3, 4, 5, 6, 7 & 8**

September 2005

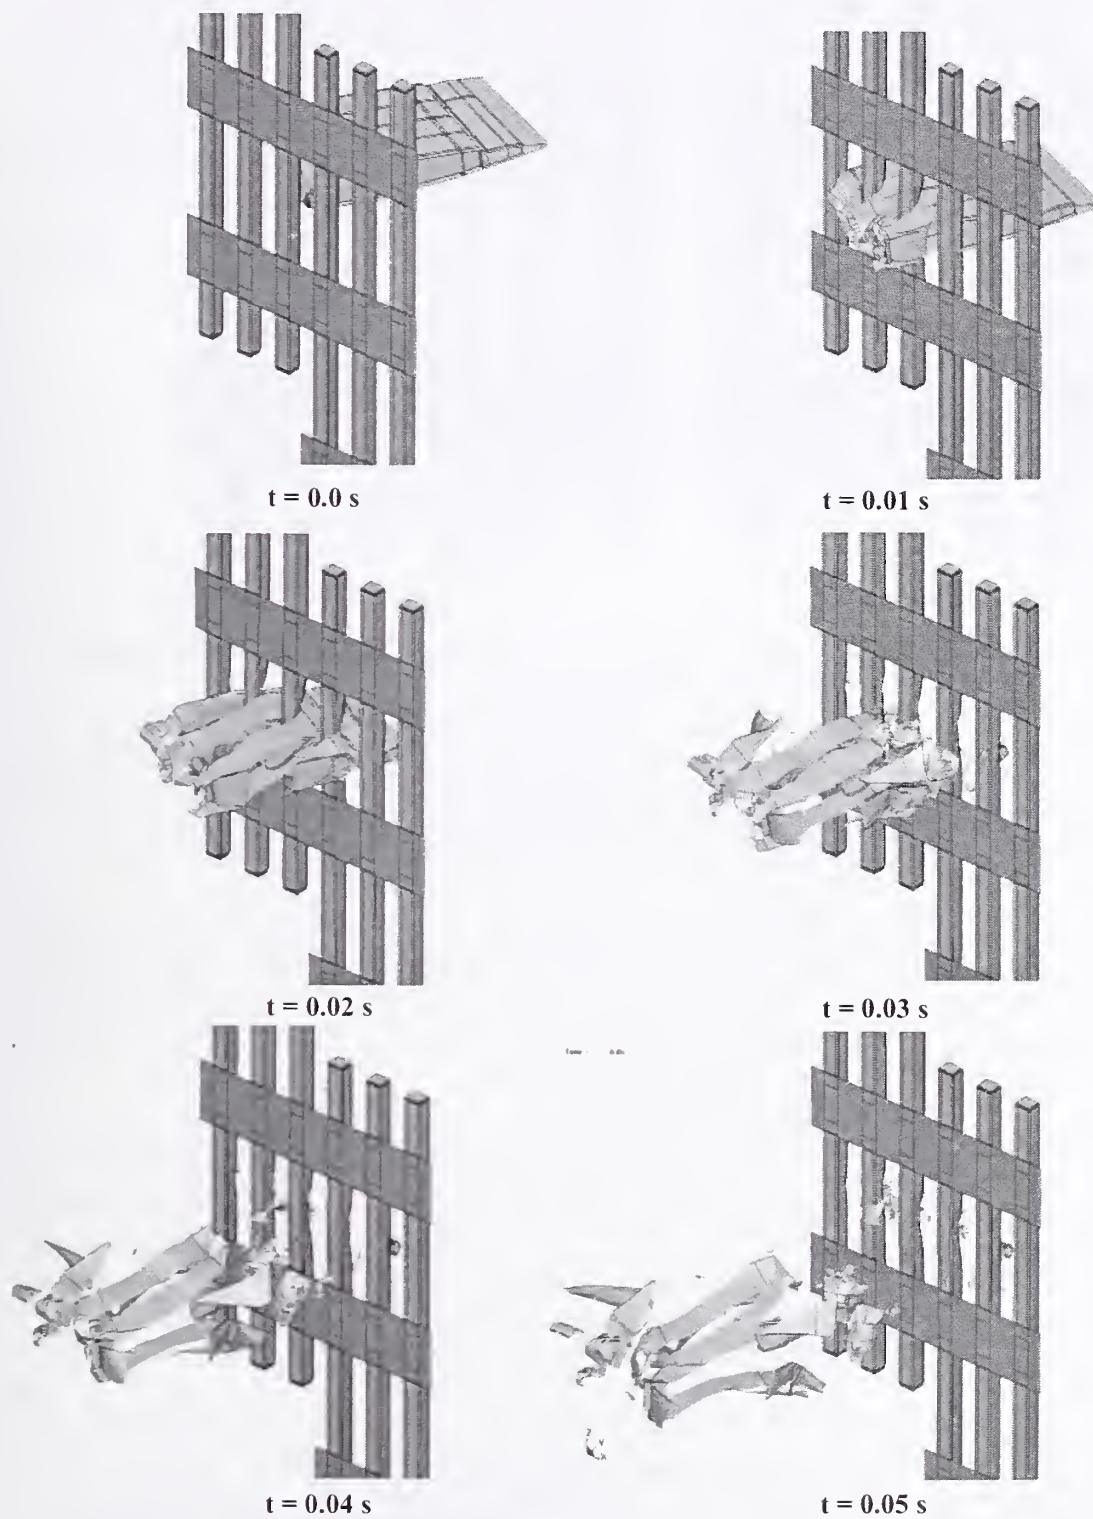
Figure 5–31. Calculated impact of a fine-mesh empty wing section with two exterior panels at 442 mph.

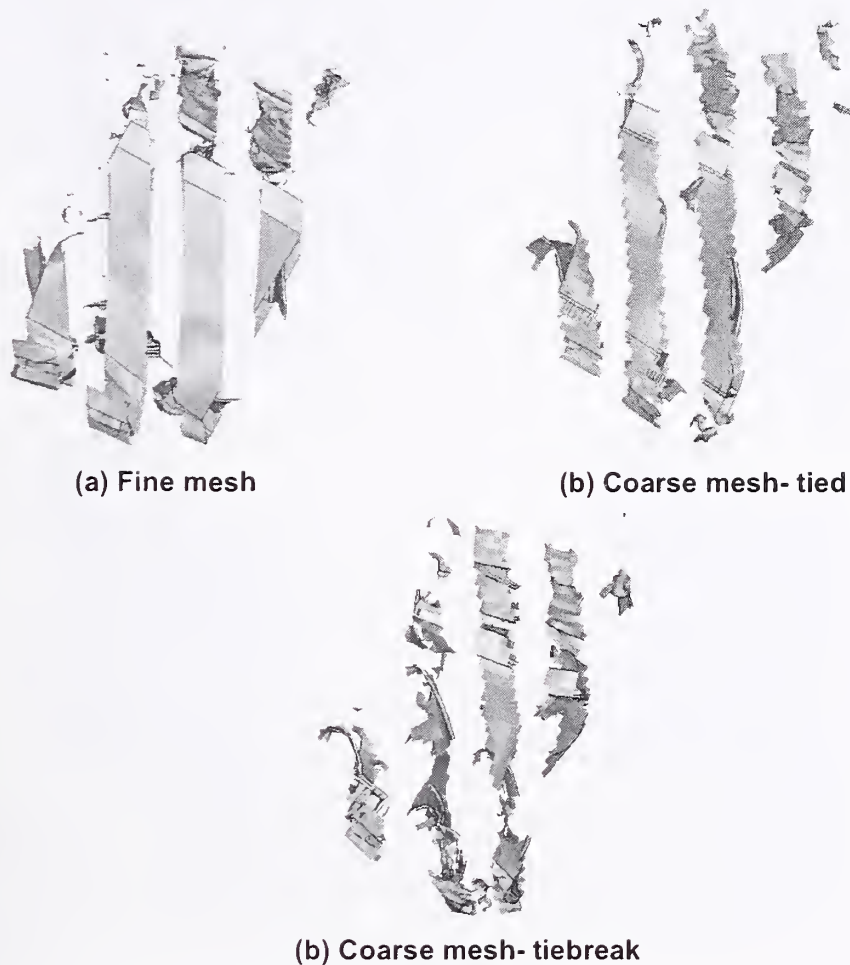
Figure 5–35. Fine and coarse mesh fragmentation.

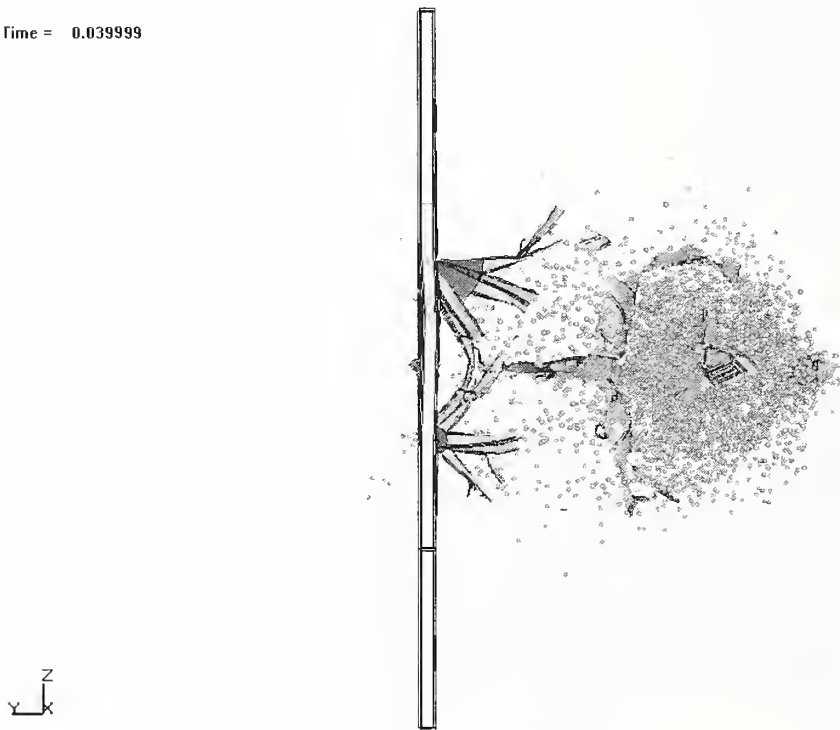
Figure 5–47. SPH analysis of structural damage and fuel dispersion (side view).
