NATIONAL BUREAU OF STANDARDS REPORT

CORROSION RESEARCH

Progress Report
January 1, 1969 - March 31, 1969
OSW No. 14-01-0001-1091

H. C. Burnett
Project Coordinator
Metallurgy Division

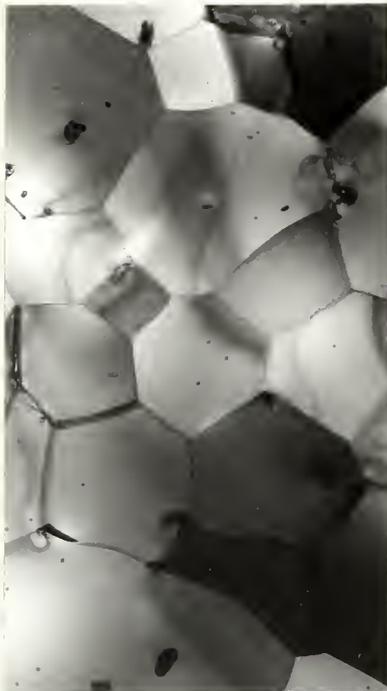
Fig. 1 X4,000
Ti-0.15Pd - uncorroded

Figures 1 through 12 show the progress of corrosion on the Ti-0.15Pd alloy as it is taken from the uncorroded state through several testing conditions. Figure 1 is a low magnification electron micrograph showing the grain structure of uncorroded Ti-0.15Pd. Figure 2 shows the same alloy at higher magnification. Figure 3 is a diffraction pattern from this uncorroded alloy. Additional (small) diffraction spots result from a hydride particle in the diffraction area. The absence of any diffraction rings indicates that surface film formation is not advanced. Figure 4 shows the microstructure after corroding for 1 hr. at 100°C and Figures 5 and 6 show the alloy surface after corroding at 150°C and 175°C respectively. Figure 7 is an electron diffraction pattern taken with perhaps some crystalline TiO₂ (anatase) present. Figure 8 is taken from a specimen corroded for 1 hr. at 200°C and Figure 9 shows the microstructure after corroding for 2 hrs. at 200°C. It is apparent that the first film (TiO) is disappearing and that the final film and oxide surface particles are TiO₂ (anatase) which give the crystallite diffraction pattern of Figure 10.

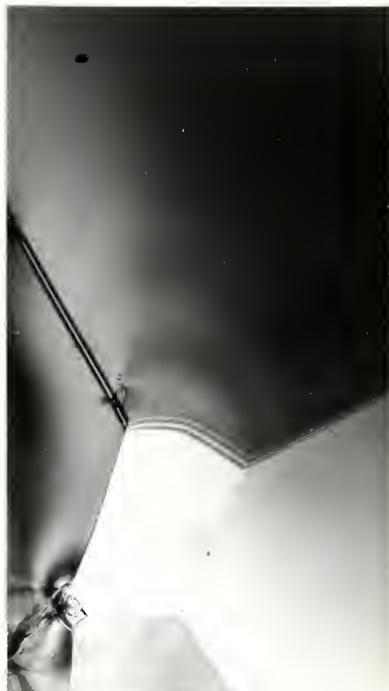
Fig. 2 X18,000
Ti-0.15Pd - uncorroded

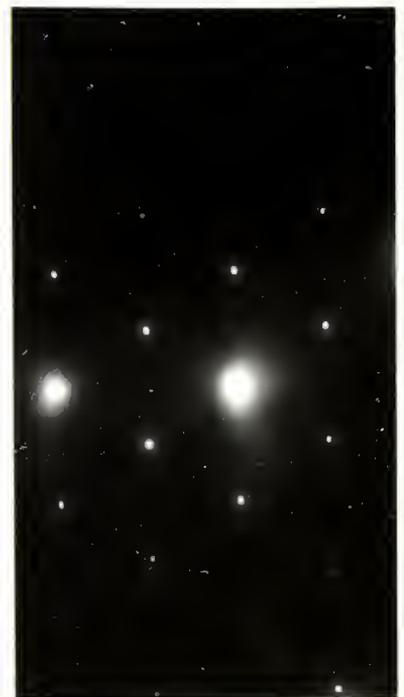
Fig. 3 Diffraction
pattern uncorroded
Ti-0.15Pd and TiH_2

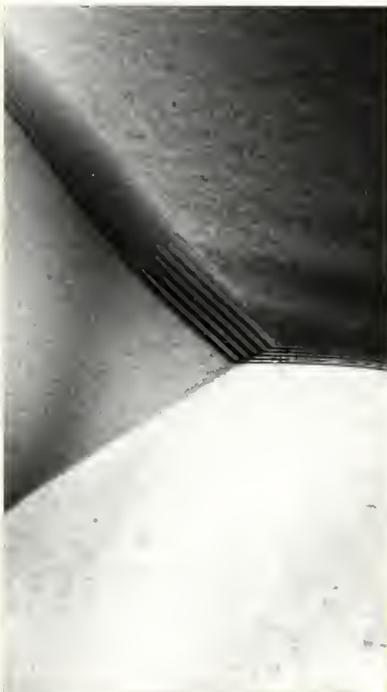
Fig. 4 X32,000
Ti-0.15Pd - corroded
1 hr. at 100°C

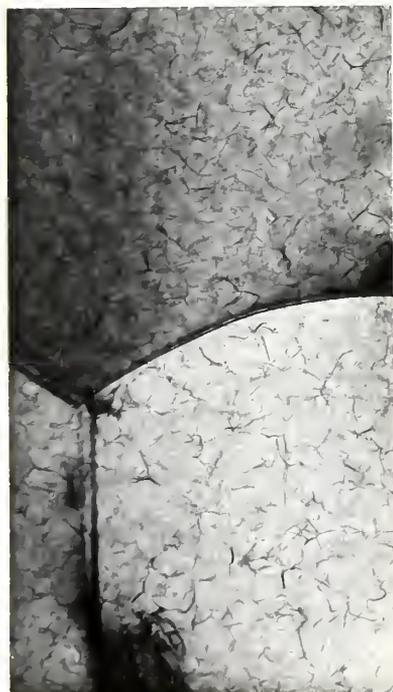
Fig. 5 X32,000
Ti-0.15Pd - corroded
1 hr. at 150°C

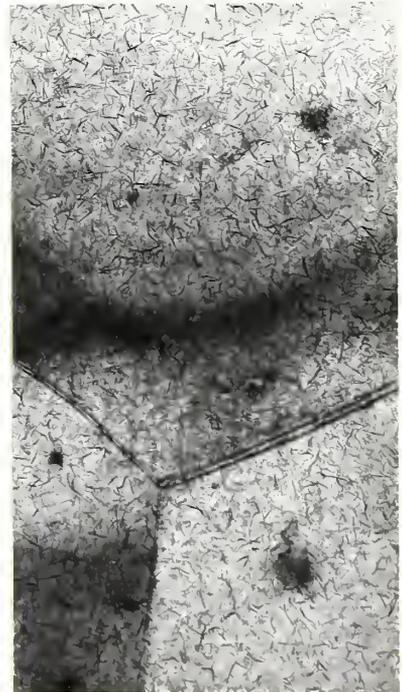
Fig. 6 X32,000
Ti-0.15 Pd - corroded 1 hr.
at 175°C.

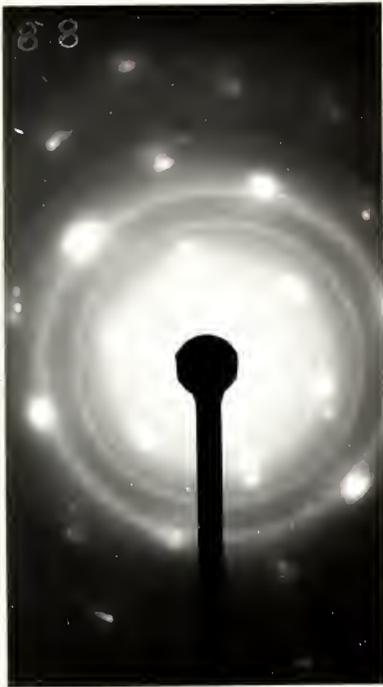
Fig. 7 Diffraction pattern Ti-0.15Pd and TiO surface oxide of Figs. 5 and 6

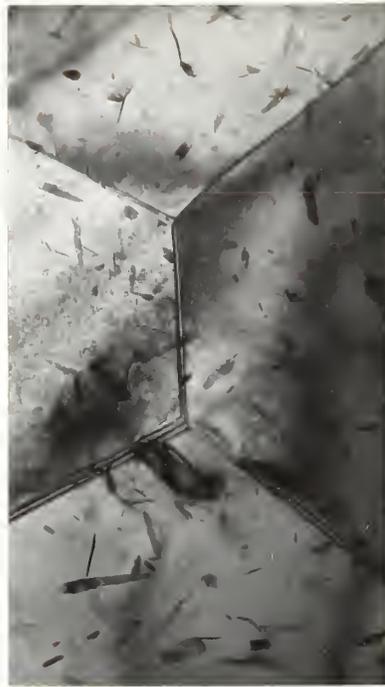
Fig. 8 X32,000 Ti-0.15Pd - corroded 1 hr. at 200°C

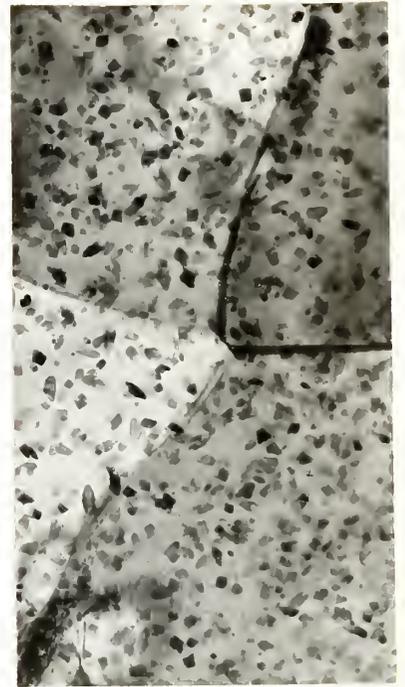
Fig. 9 X32,000 Ti-0.15Pd - corroded 2 hrs. at 200°C

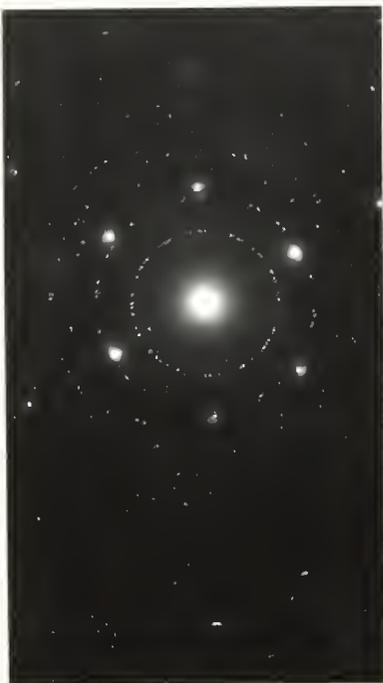
Fig. 10 Diffraction pattern Ti-0.15Pd and TiO₂(anatase) - corroded 2 hrs. at 200°C

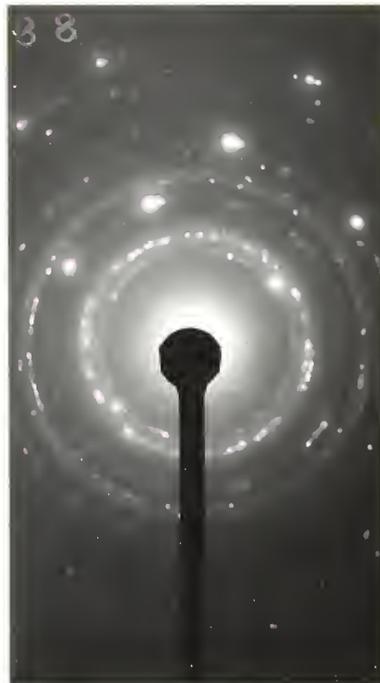
Fig. 11 Diffraction Ti-0.15Pd and Ti₃O₅ deposit - corroded 1 hr. at 175°C

Figure 11 is an electron diffraction pattern showing the presence of Ti_3O_5 and Figure 12 shows the morphology of this phase and the manner in which it is deposited.

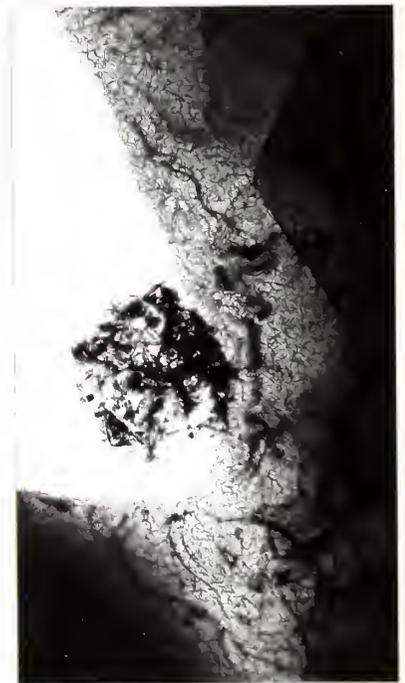
Fig. 12 X12,000 Ti-0.15Pd with deposited Ti₃O₅-corroded 1 hr. at 175°C

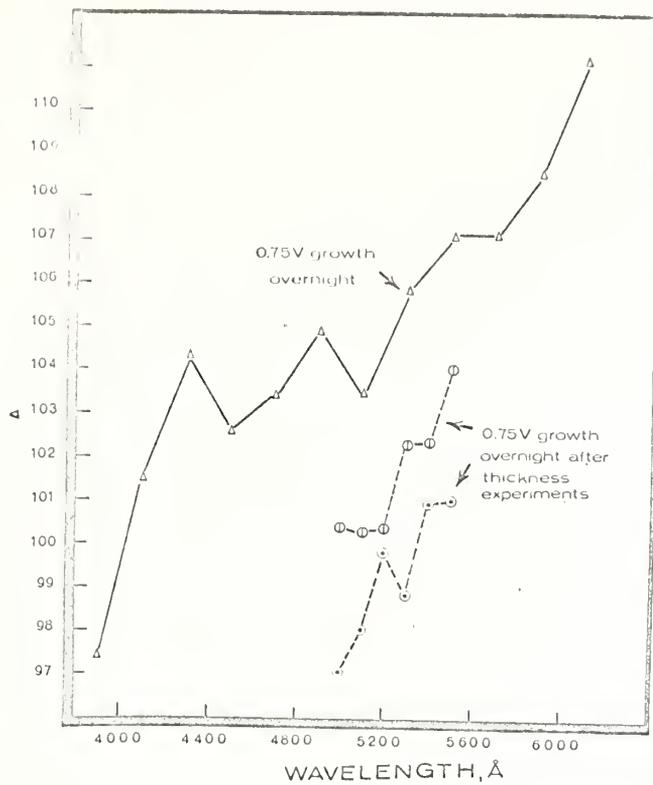
Fig. 1
Comparison of spectra of passive films grown overnight on surfaces which have undergone thickness experiments with a surface that has just undergone reduction once.

The latest approach to this problem has concerned itself with thickness experiments, as described in the last report. Films are grown at various potentials producing oxide films of increasing thickness as the potential is increased. It is hoped that the various thickness films would have only one set of refractive indices in common, thus eliminating the other multiple values associated with each λ . A number of such experiments have been attempted so far. Growth at potentials 0 volts, +0.3V, +0.6V and +0.75V produced films of from 5Å to 50Å. The spectra for these experiments, however, did not coincide as closely as would be desirable. The reason for this behavior has not been established as yet, but may lie in the treatment given the surface during the thickness experiments. An oxide film is grown for 1 hr. at a set potential, readings are taken, then the film is reduced back to the substrate values and another film is grown, etc. It was found that the specimen so treated did not produce the same kind of overnight passive spectrum (at +0.75v) as did a specimen that was just reduced to a clean substrate once and then passivated overnight. Figure 1 illustrates this situation using plots of the relative phase retardation, Δ . Thus, it may be possible that the growth and reduction cycles are producing some change on the surface. It will be necessary to produce a surface that does not change before thickness experiments can be successfully utilized to combat the multiple value problem. Since thickness experiments can only be carried out reasonably for short growth times, it is important to determine whether a film grown for 1 hr. (or x hours) at a certain potential would be the same as a film grown for a longer period of time under the same conditions. In Figure 2 a spectrum of the relative phase retardation, Δ for a film grown for 1 hr. at +0.3v is compared with that for a film grown overnight at +0.3V. The

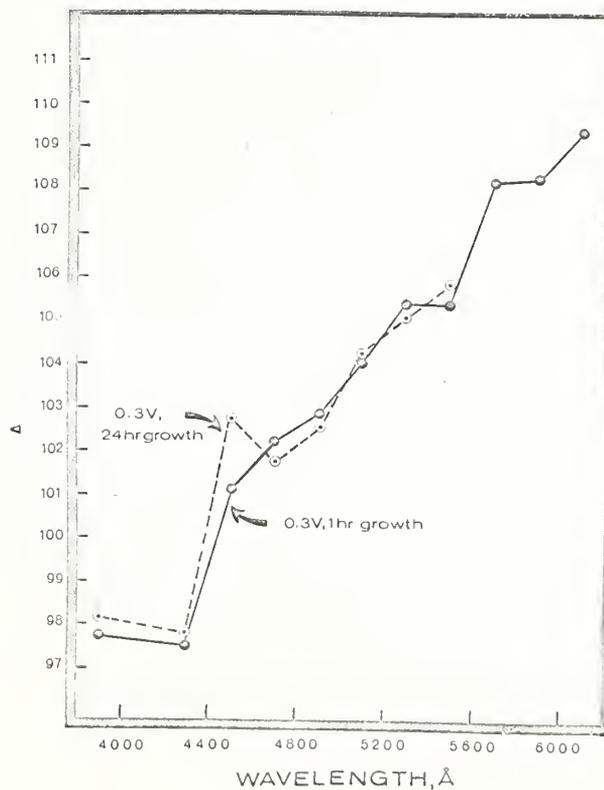
Fig. 2
Spectrum for a film grown just 1 hr. at +0.3V in borate solution compared with a film grown 24 hrs. under the same conditions.

correlation is quite good and indicates that data taken for 1 hr. growth experiments would reasonably be applied to spectra for films grown for >20 hrs.

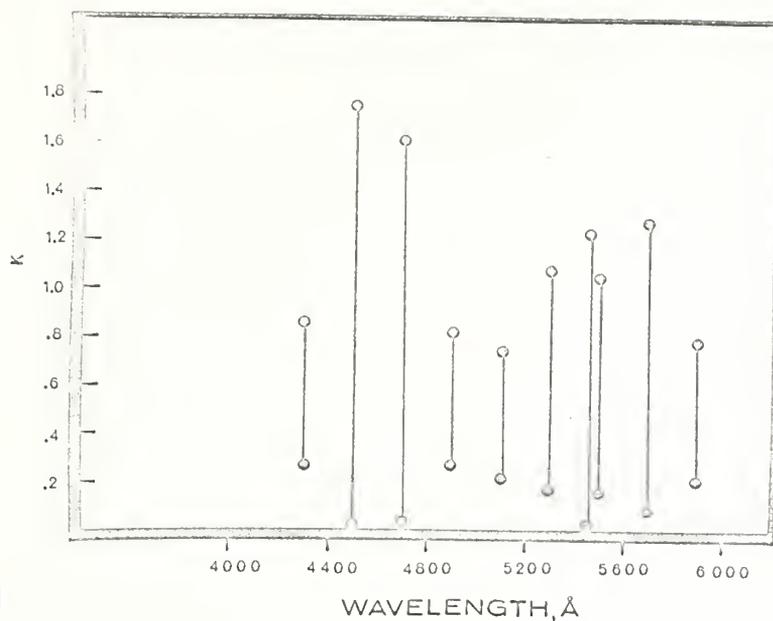
Fig. 3
The absorption coefficient, K , spectrum for a film grown in the transpassive region at +1.25V.

In another experiment attempting to classify one of the possible oxides of the passive film ($\gamma\text{-Fe}_2\text{O}_3$ and Fe_3O_4), a specimen was held at +1.25V in the transpassive region for 1 hr. According to previous electron diffraction data the film formed under these conditions would probably be Fe_3O_4 . Difficulty with gas evolution from the surface prevented readings below 4300\AA and above 5900\AA where the reflections are least intense. Figure 3 shows the absorption coefficient spectrum for the transpassive film, for $d = 68\text{\AA}$. Multiple values for single λ 's are connected vertically. This spectrum does not duplicate the spectrum for bulk Fe_3O_4 reported previously. This fact may indicate that the films grown in solution are actually not comparable to bulk oxide spectra. Further investigations will be needed, however, to determine whether this is the case.

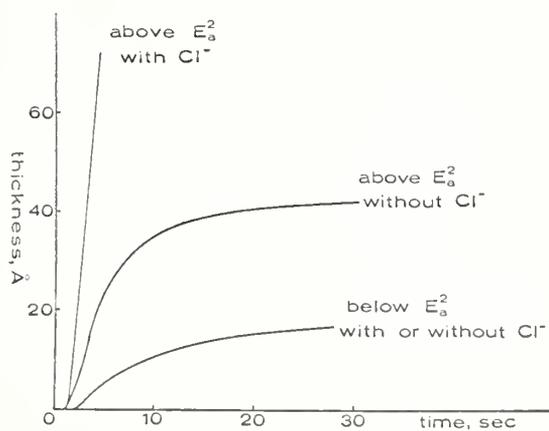
Fig. 4
The effect of potential above E_a^2 (+0.8V SCE) and below E_a^2 (-0.35V SCE) on film growth in the absence and presence of chloride ion ($10^{-3}M$) in boric acid - sodium tetraborate buffer solution (pH = 8.4). Film thickness was measured by ellipsometry.

Figure 4 shows that the growth process of the passive film was the same regardless of whether or not chloride ions were present as long as growth occurred at potentials below the potential called E_a^2 . This is the potential observed for the passivation of iron below which ferrous ions were observed in solution while above it no appreciable ferrous ion concentration was observed. Figure 4 also shows that when a film was grown above this potential, there was a marked difference in the growth process as compared to that of a film formed in the presence of chloride. The film continued to grow to much greater thicknesses than the limiting thickness observed when chloride was absent. The chloride produces a different film, which has been shown in the past to contain γFeOOH as well as a cubic oxide. Moreover, it looks as if with chloride present the deposition of ferrous ions is taking place continuously with the production of thick films ($>100\text{\AA}$).

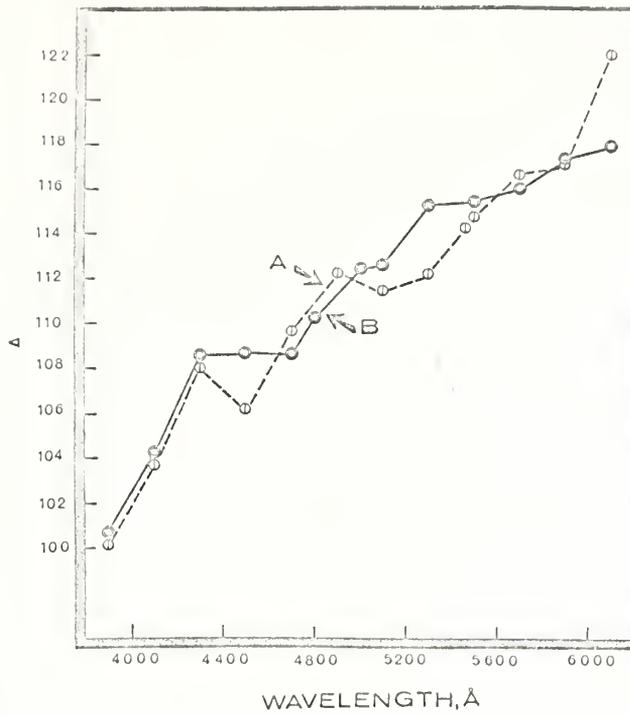
Fig. 5
 The spectrum for 1 hr. growth at $-0.35V$ (near E^2) is shown in curve A to be almost the same as a spectrum for a decayed passive film, decayed to $-0.3V$, curve B.

An experiment was carried out to characterize the behavior of films grown below the potential E_a^2 , i.e. around -0.35V. (vs. SCE) First a film was grown at this potential in the borate solution. A spectrum of Δ is shown for this growth of 1 hr. in Figure 5, curve A. Curve B in the figure indicates a passive film decayed to -0.3V in a previous experiment. The correspondence between the two cases is good. Figure 6, curve C, indicates the effect of a concentration of (.005N) chloride ion present during the 1 hr. growth period, at -0.35V. The only significant change occurs at 5900Å as shown. For comparison, curve A again shows the growth without chloride present.

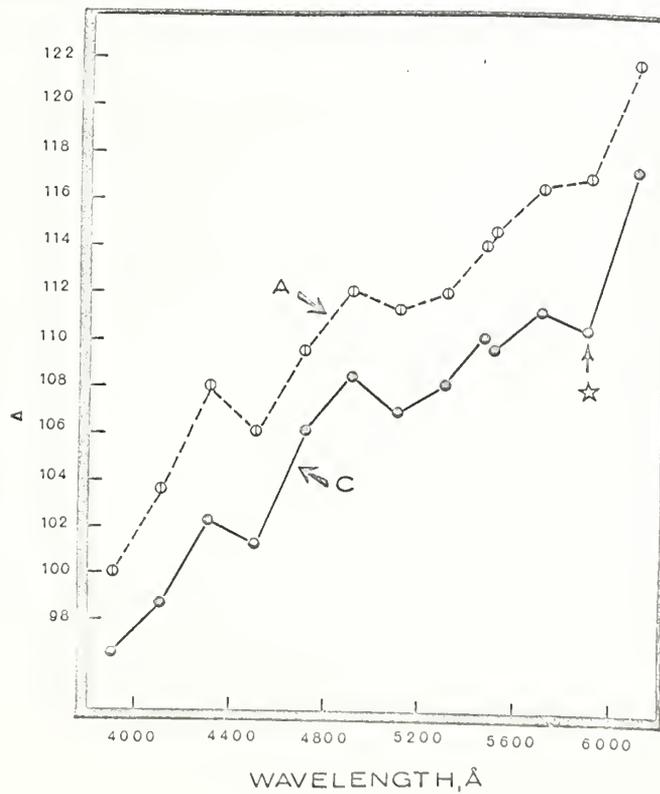
Fig. 6
 The spectrum for 1 hr. growth at $-0.35V$, curve A, in borate is shown in comparison with a 1 hr. growth spectrum for the same potential, with $0.005N$ chloride ion present in the solution.

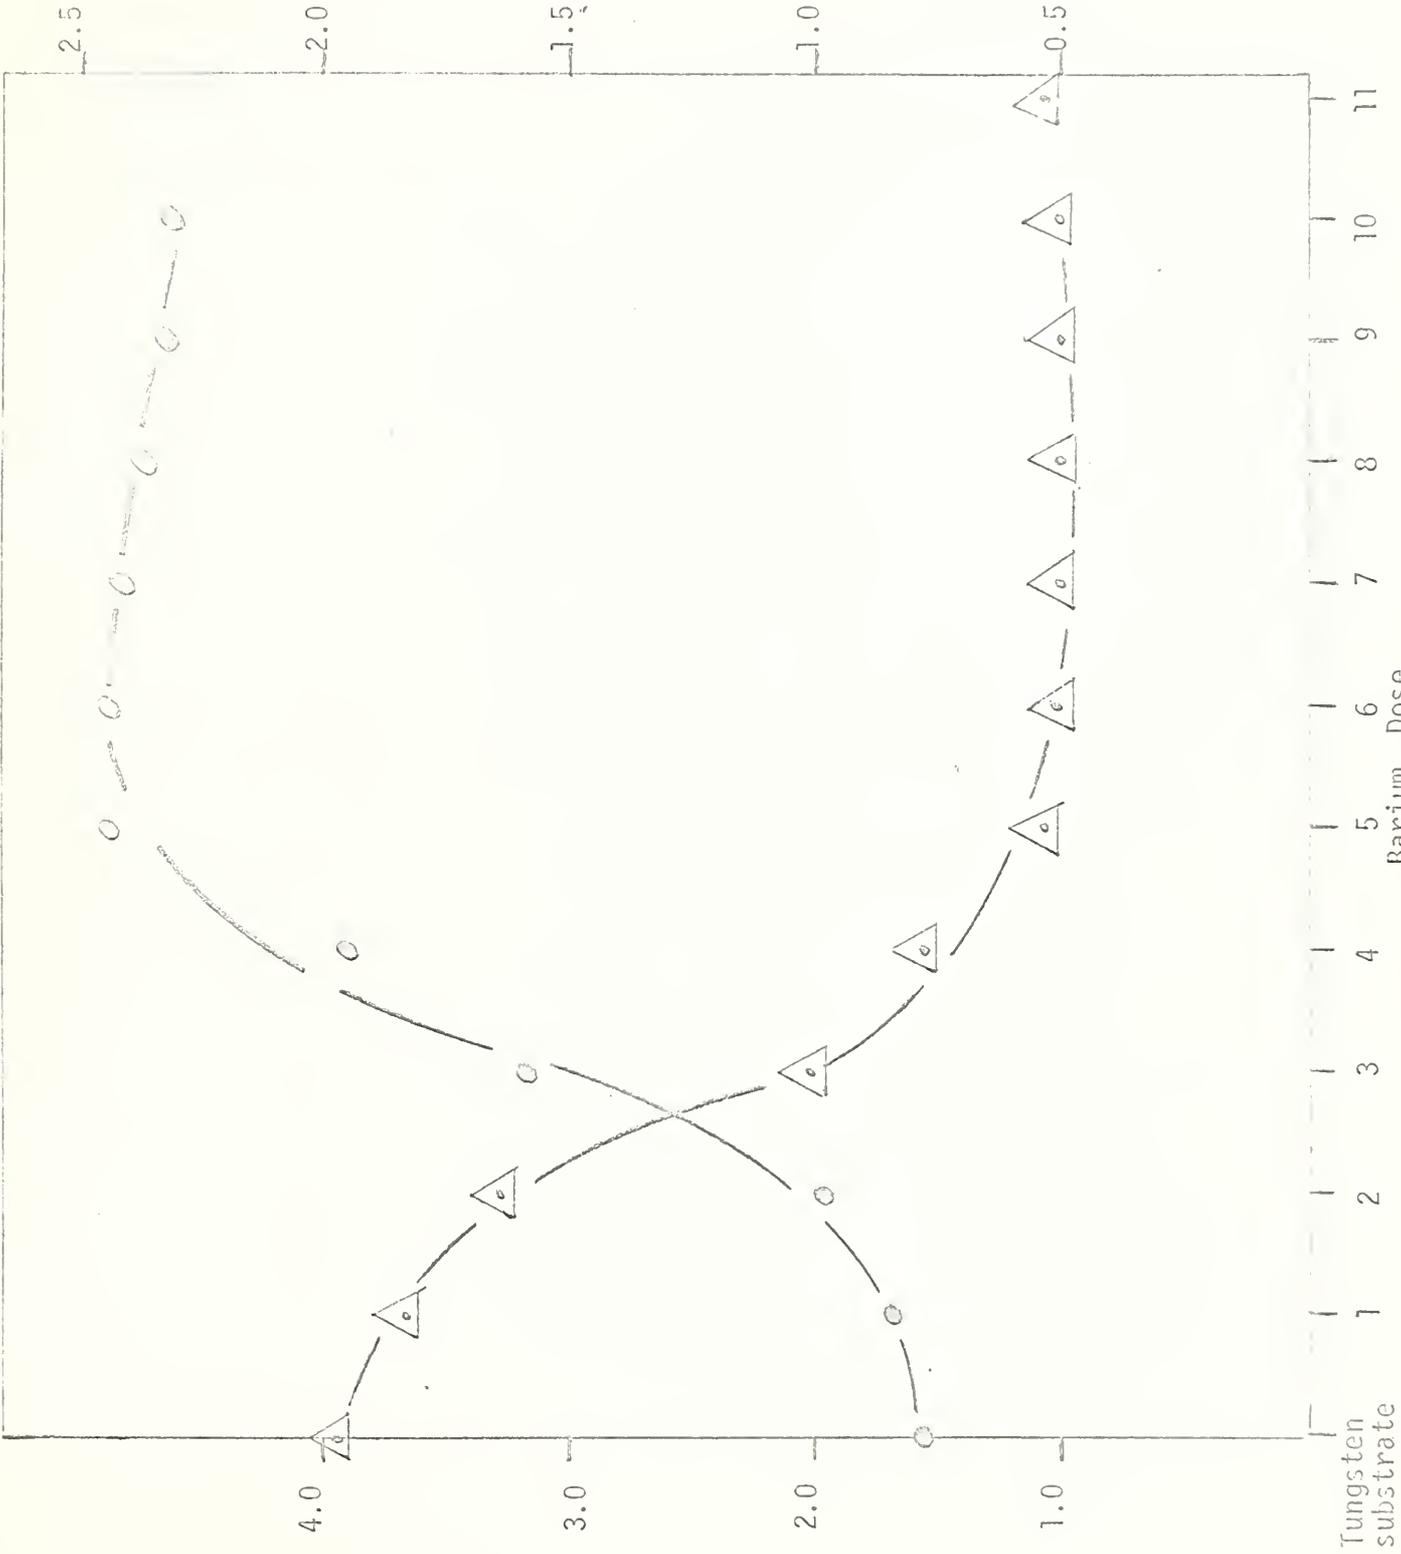
Tungsten substrate
Barium Dose
Figure 1

Index of Refraction, n (Δ)
 $\lambda = 5461 \text{ \AA}$

Absorption Coefficient, k (\circ)
 $\lambda = 5461 \text{ \AA}$

Progress: The ELF vacuum system is now functioning properly. We have completed a prototype experiment using an evaporated metal film on a (011) - orientated single-crystal tungsten substrate. The tungsten specimen had some carbon contamination as determined by LEED pattern observations. However, n and κ substrate values remained reproducible after repeated high temperature heat treatments of the specimen. The metal was barium; for which optical constants data of evaporated films are available in the technical literature. Our results are shown in Figures 1 and 2. Starting with the tungsten substrate heated to above 2000K in ultra-high vacuum, barium was deposited by evaporation of successive doses from a heated iron clad barium wire source, and ellipsometric measurements were made after each dose. Figure 1 shows n and κ , the effective optical constants of the Ba film plus tungsten substrate, as a function of the number of Ba doses (which were not equal doses). Figure 2 shows the optical constants as a function of computed film thickness, assuming that the film optical constants are equal to the limiting values found in Figure 1. It can be seen that the optical constants of the film-substrate combination become approximately constant for film thickness greater than about 400Å, in agreement with the range of thickness values found for other metal films by previous workers. Effective optical constants obtained at high barium film thicknesses appear in good agreement with O'Bryan's work.
