# NATIONAL BUREAU OF STANDARDS REPORT

10 409

## STRUCTURAL EVALUATION OF STEEL FACED SANDWICH PANELS

Prepared for the  
Office of Research and Technology  
Department of Housing and Urban Development

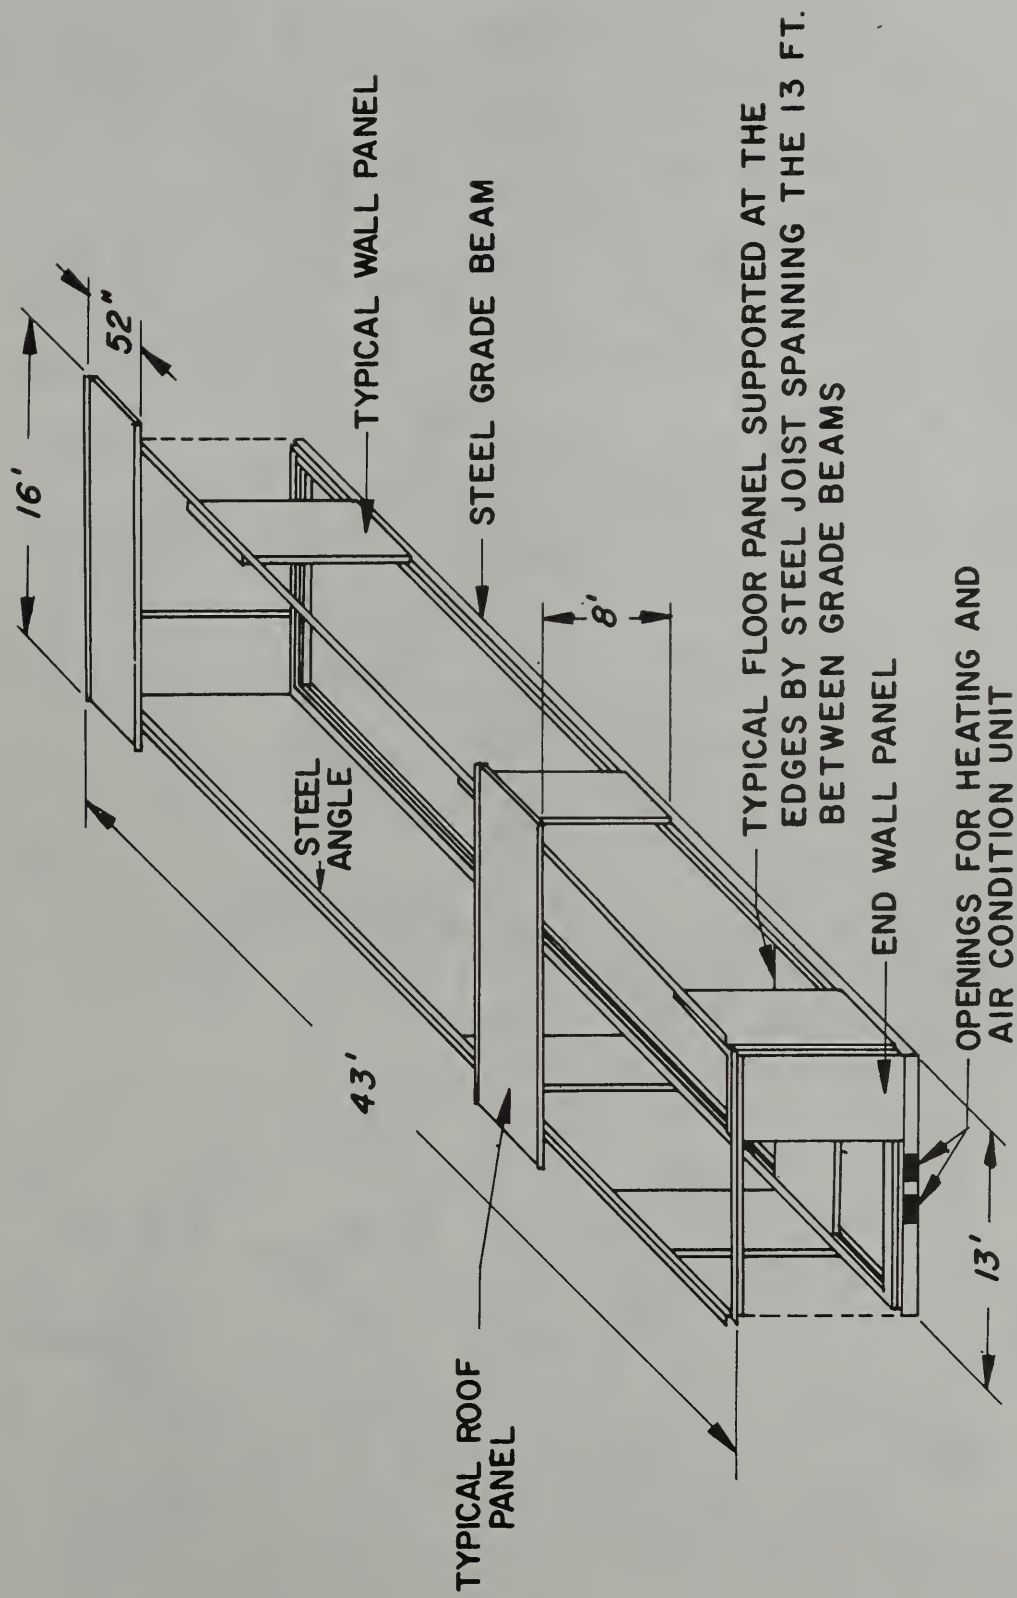
Fig. 2. Structural Isometric of Housing Systems

1.1 Description of System. A housing system (figure 1) proposed for the "Operation BREAKTHROUGH" program of the Department of Housing and Urban Development (sponsor) utilizes factory-produced sandwich panels for roof, floor and wall members. The wall and floor panels are attached to a steel grade-beam system as shown in figure 2. The floor panels are supported along the edges by the grade beams and cold-formed steel joists spanning between the grade beams. All panels are 3-inches thick; the roof and wall panels consist of a 26-gage (.0179 in.) steel sheet bonded to each side of a resin-impregnated paper honeycomb core as shown in figure 3. The floor panels are similar except that the upper surface is 3/8 in. plywood. Urethane foam is pressed into the honeycomb prior to final assembly to improve thermal properties. Wood edge members are fastened around the perimeter of the panels.

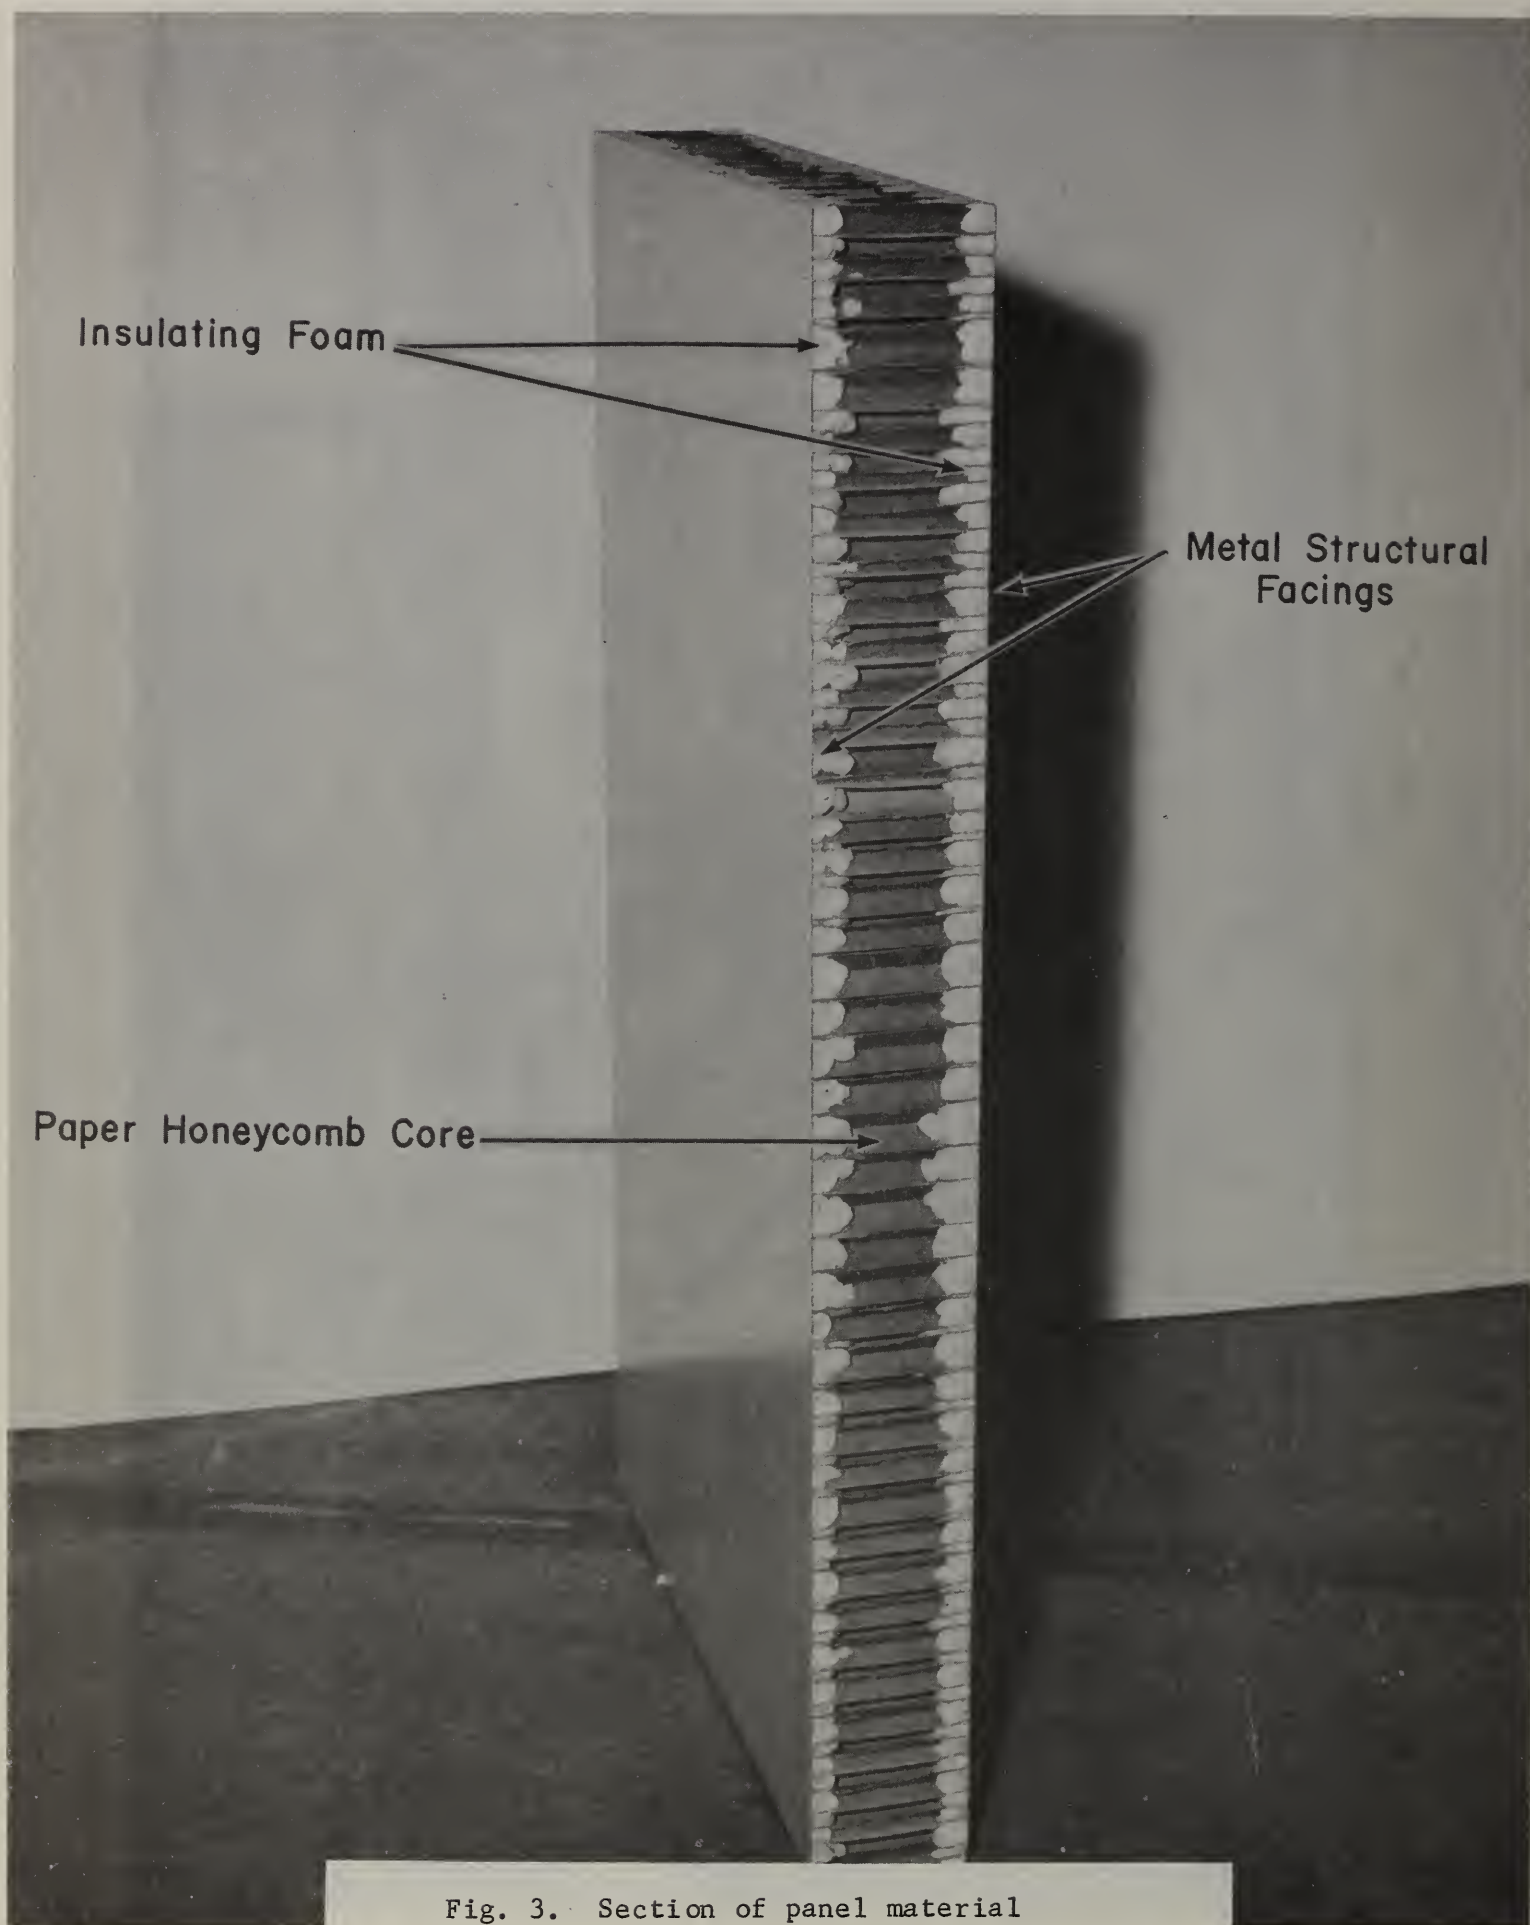
Fig. 3. Section of panel material

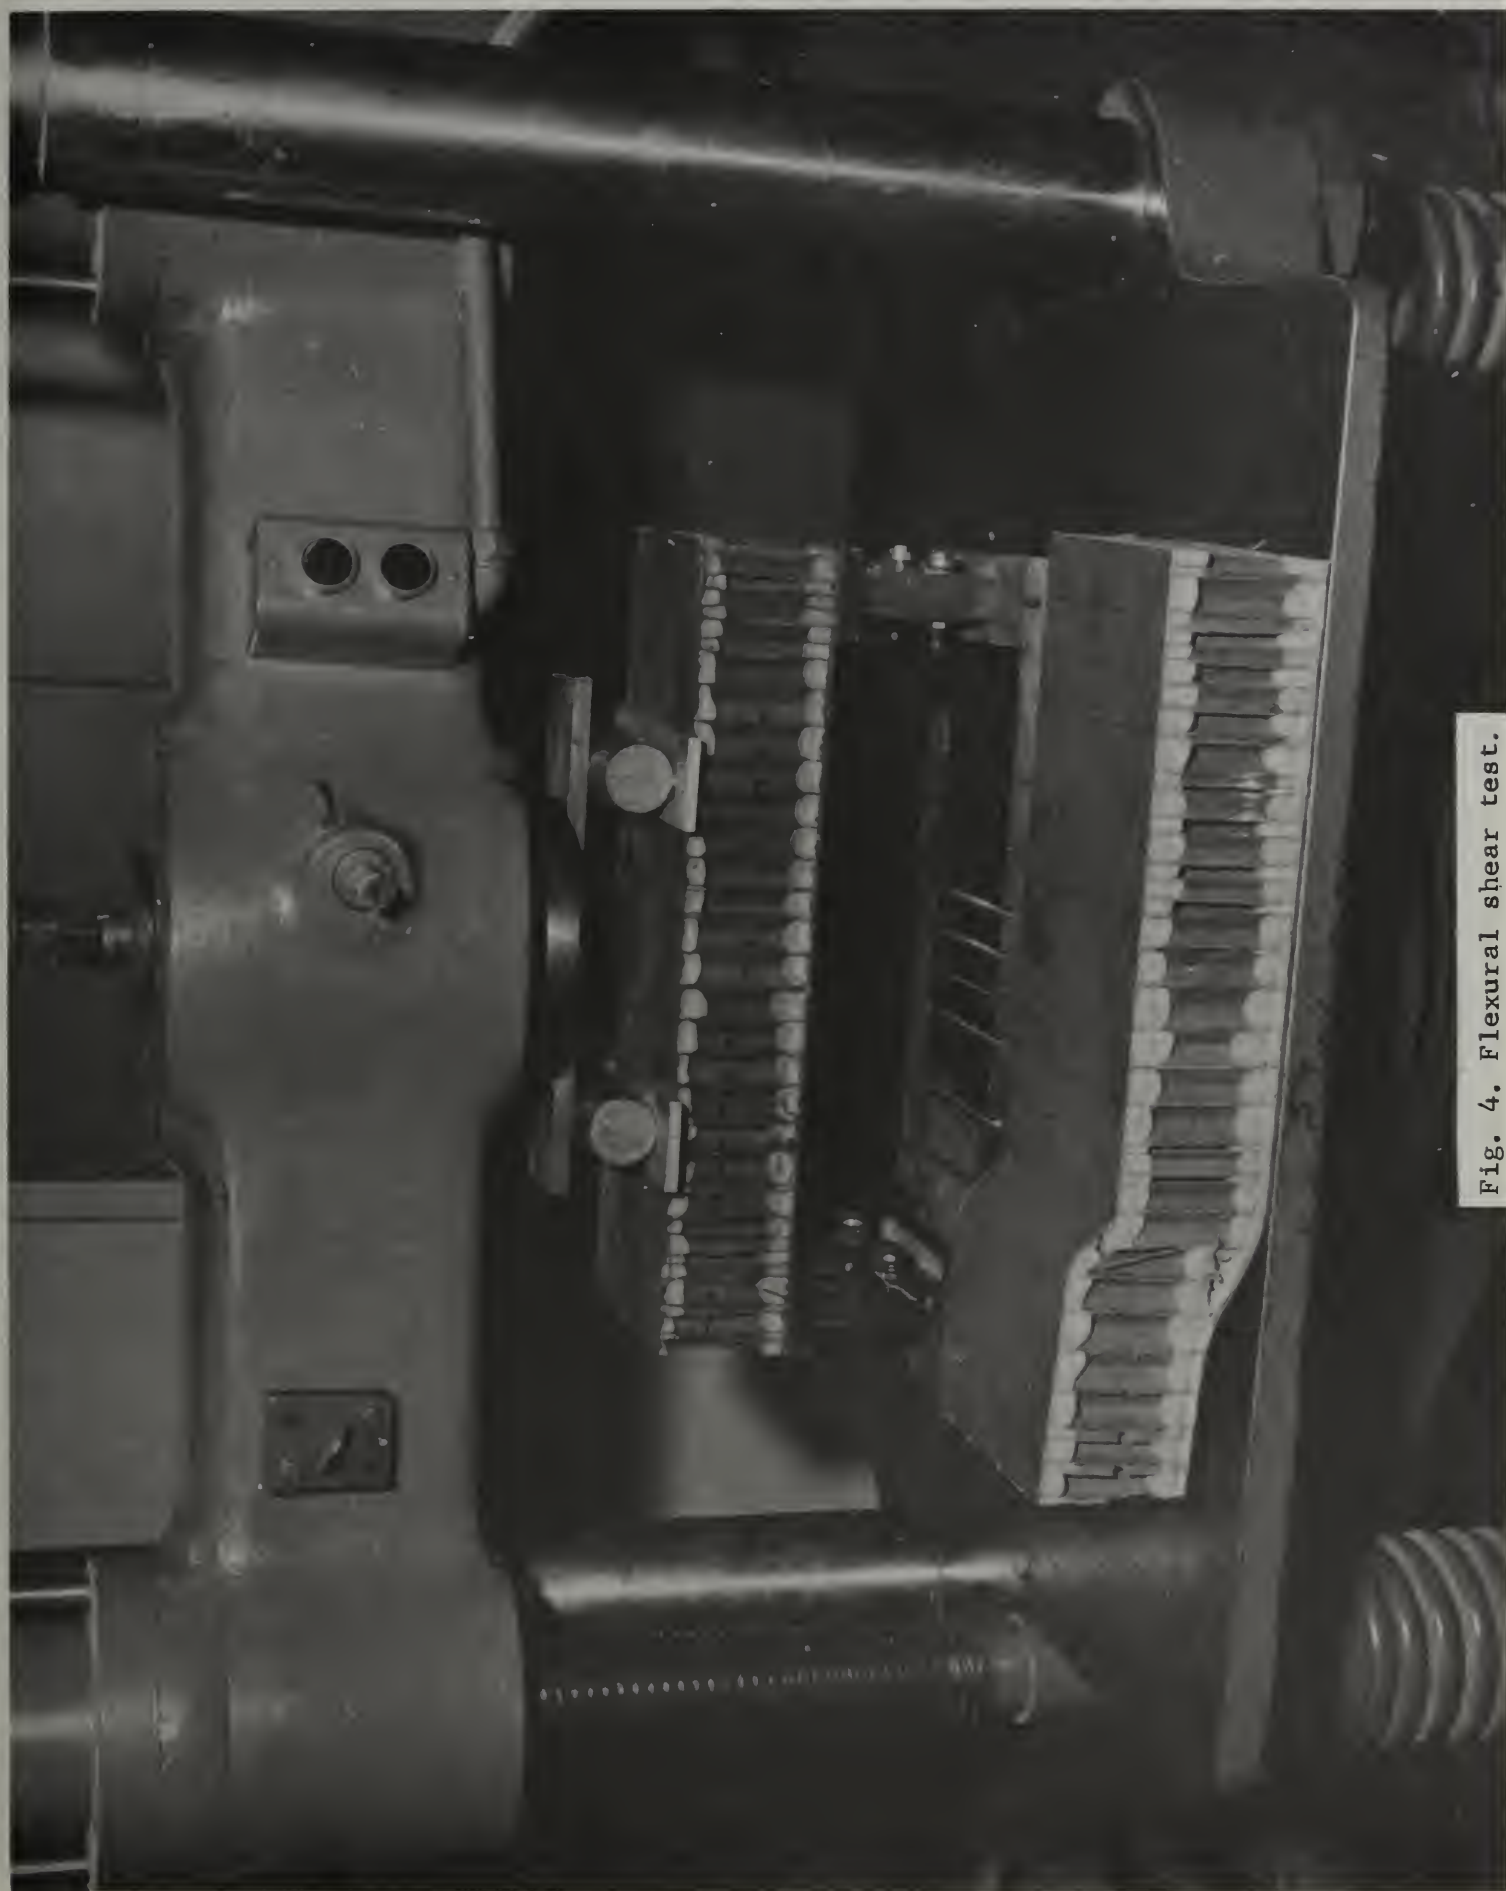
Fig. 4. Flexural shear test.

2.2.1 Flexural Shear Test. The shear strength of the honeycomb cores was determined by ASTM C 393-62 [2] using quarter point loading. The specimens were 6 in wide x 23 in long. The test span (18 in) was chosen so that failure would be either by shear buckling of the core or by shear along the core-facing interface. Figure 4 shows the test setup and a specimen following the test. The rate of loading was approximately one-third the expected maximum load per minute.

All the flexural shear specimens failed by shear buckling of the core indicating that the strength of the adhesive bond was sufficient to develop the shear capacity of the core. (See figure 4)

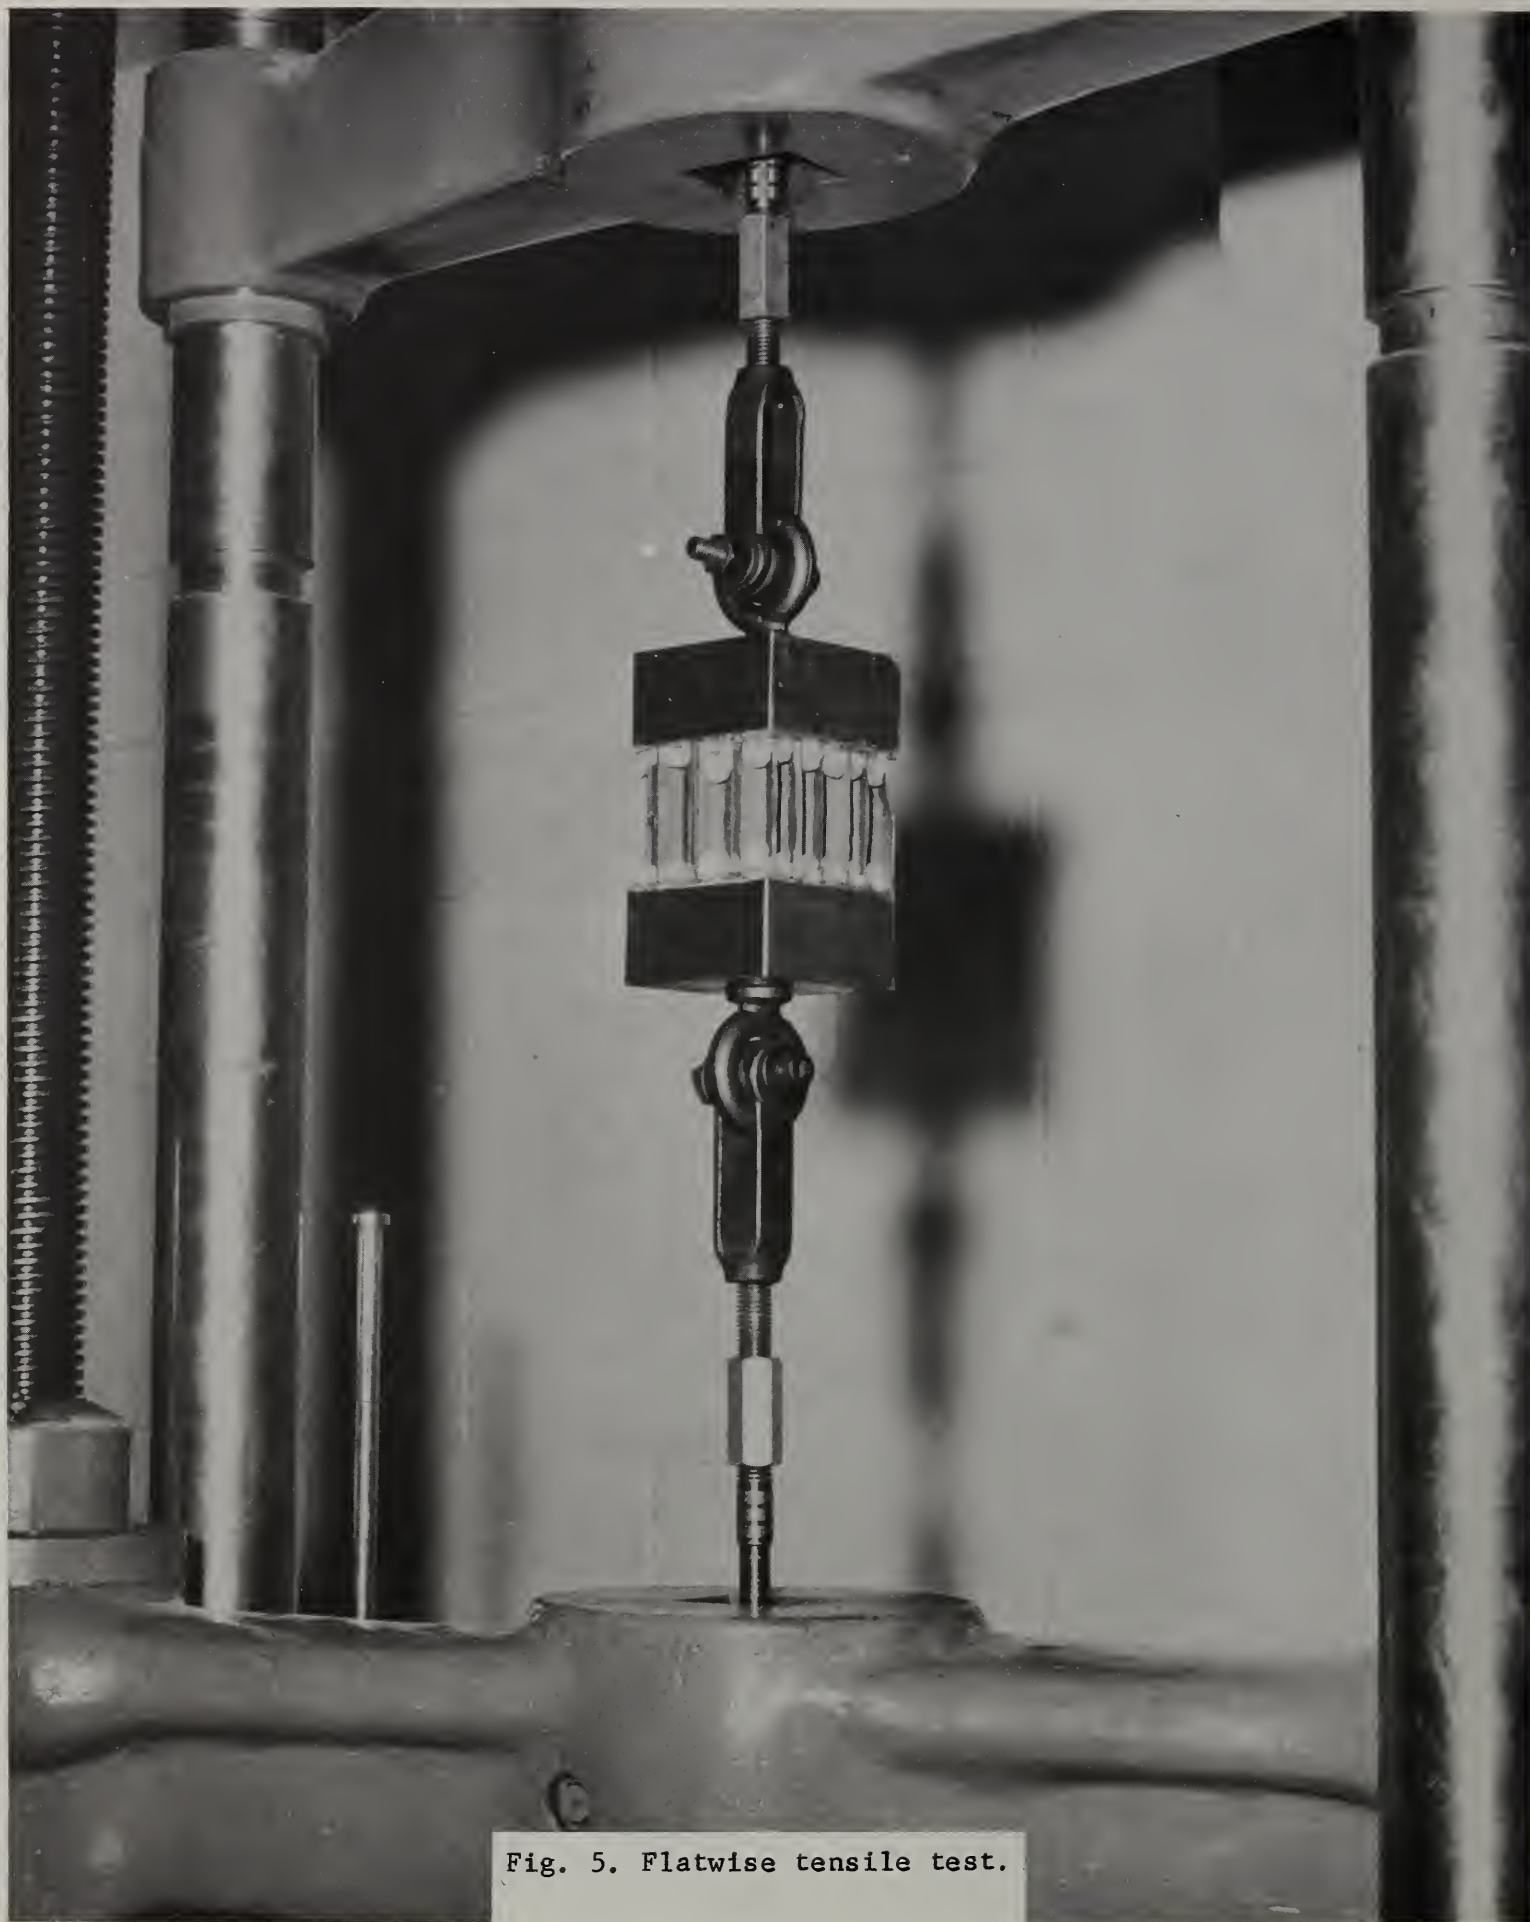
Fig. 5. Flatwise tensile test.

The purpose of this test is to determine the tensile strength of the weakest link in the sandwich. Thus, the core will fail if the tensile strength of the core is less than the tensile strength of the adhesive bond.

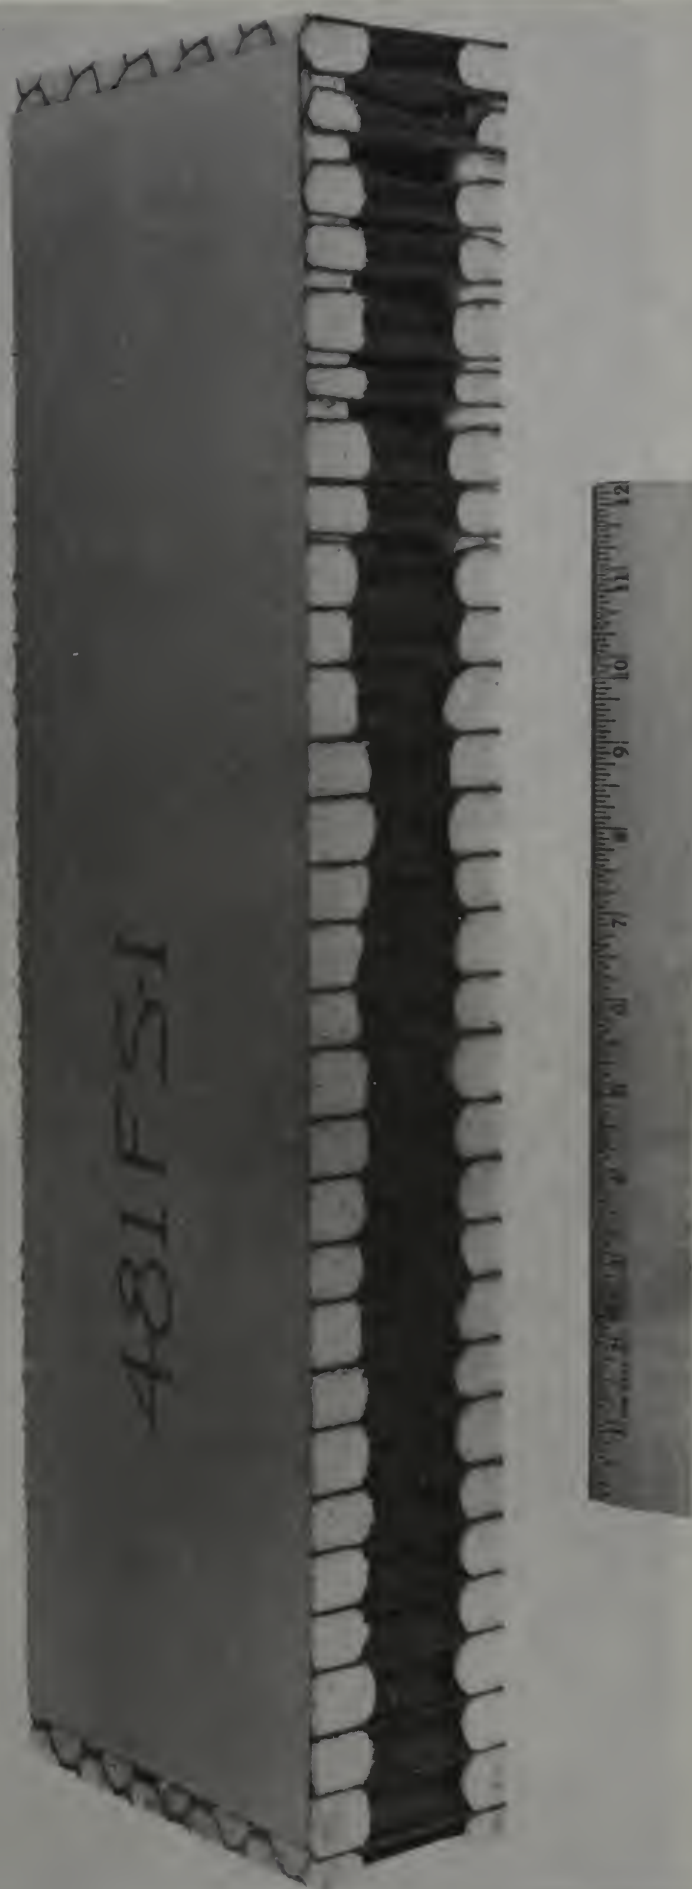
Fig. 6. Sample A specimen following 1-hour  
soak in 120°F water.

2.3.1.1 Sample A. The first step of the aging procedure was to immerse the specimens in warm water (120°F) for one hour. At the end of this step all specimens from Sample A were showing signs of delamination. Most specimens had at least one facing completely delaminated from the core. Figure 6 is a picture of a flexural-shear specimen (6 in x 23 in) after water soaking. The stresses set up in the core from the moisture expansion were sufficient to completely separate the facings from the core. Note, in this photograph, that the core had expanded until it was about 1 in longer than the facing. Sample A material was rejected and testing terminated because the adhesive was water soluble.

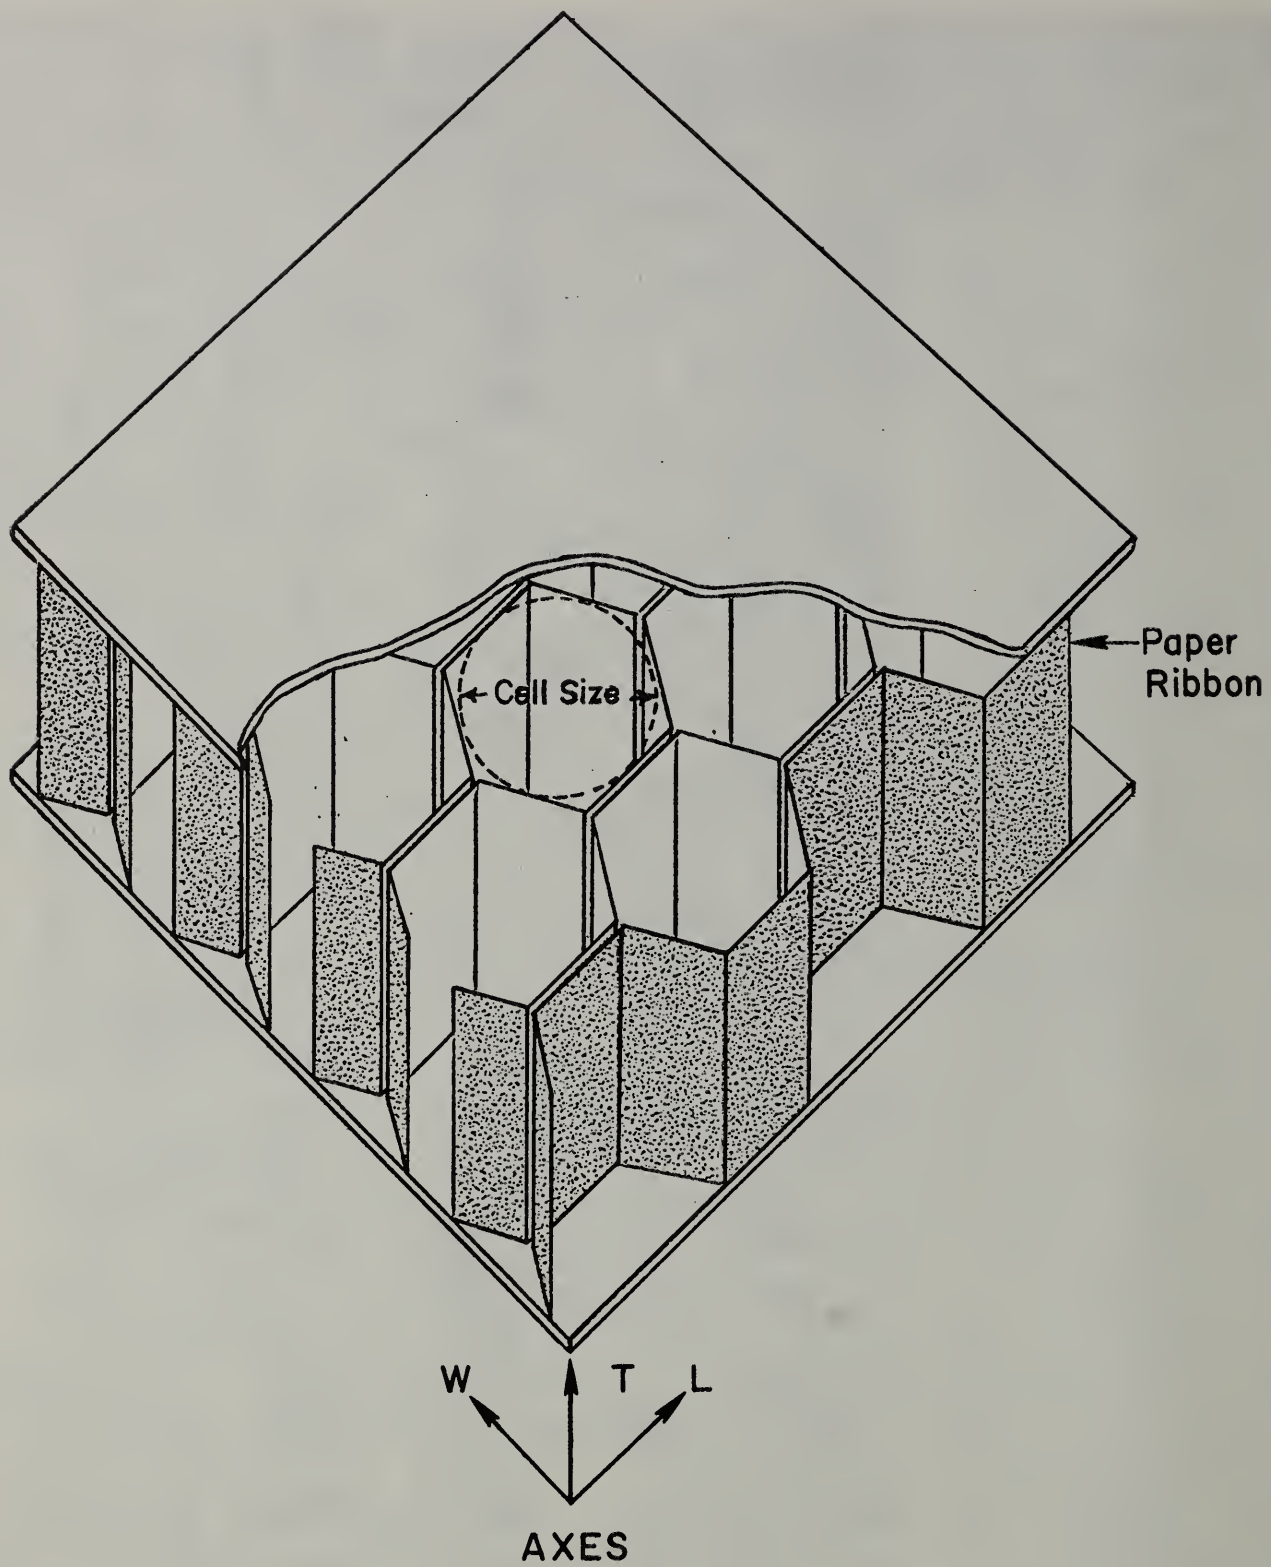
Fig. 7. Hexagonal Honeycomb Orientation

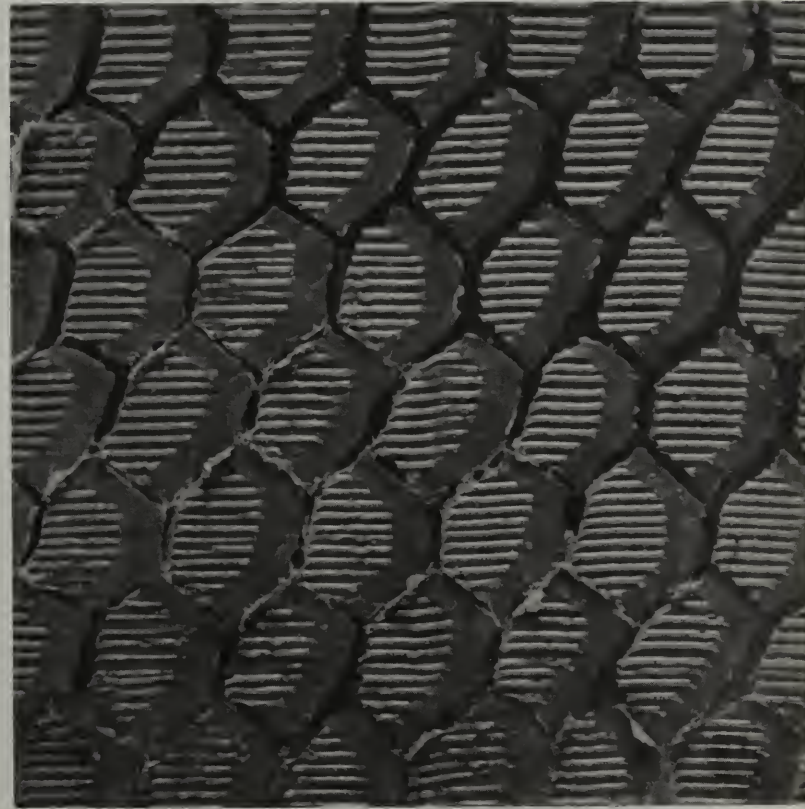
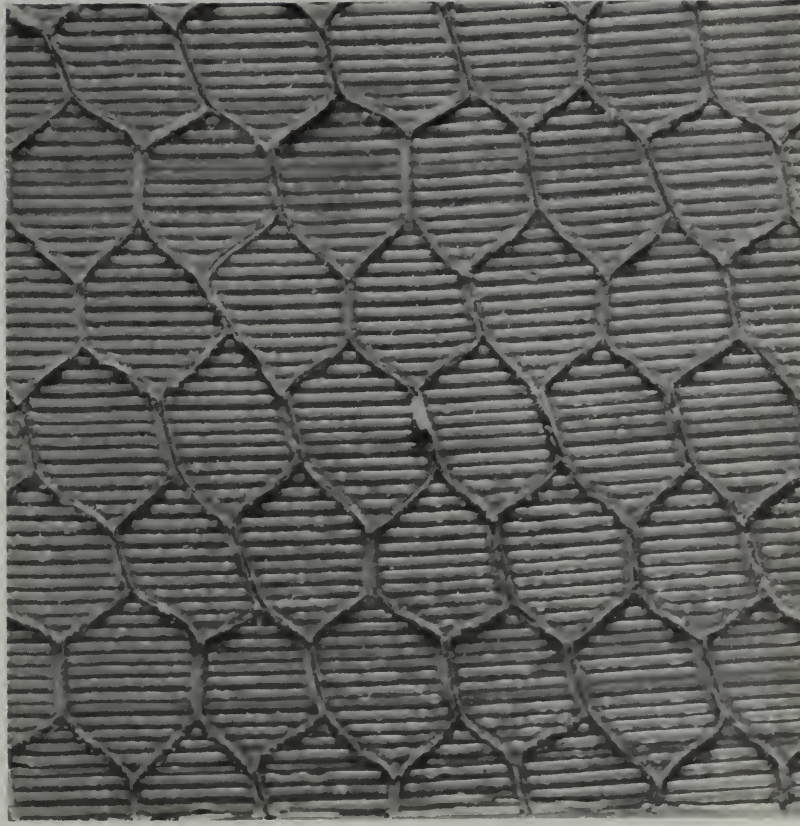
**Aged by ASTM C-481**  
**Mostly Bond Failure**

**Aged in Laboratory Air**  
**Mostly Core Failure**

Fig. 8. Facings from Sample C specimens following tensile test.

Most bond failures for Samples C and D occurred at the interface of the steel facing and a primer which had been applied prior to application of the adhesive. Since significant bond failures occurred only on the aged specimens it seems reasonable to assume that the durability of the primer bond to the steel is the weak link in the system and not the adhesive. However, it would appear from the low results for the "squeegeed" aged

<sup>3</sup> Specimen was cut from an area of the panel where there had been relative movement between the core and one facing during fabrication. This movement had "squeegeed" the adhesive so that certain areas were starved for adhesive. (See Fig. 8)

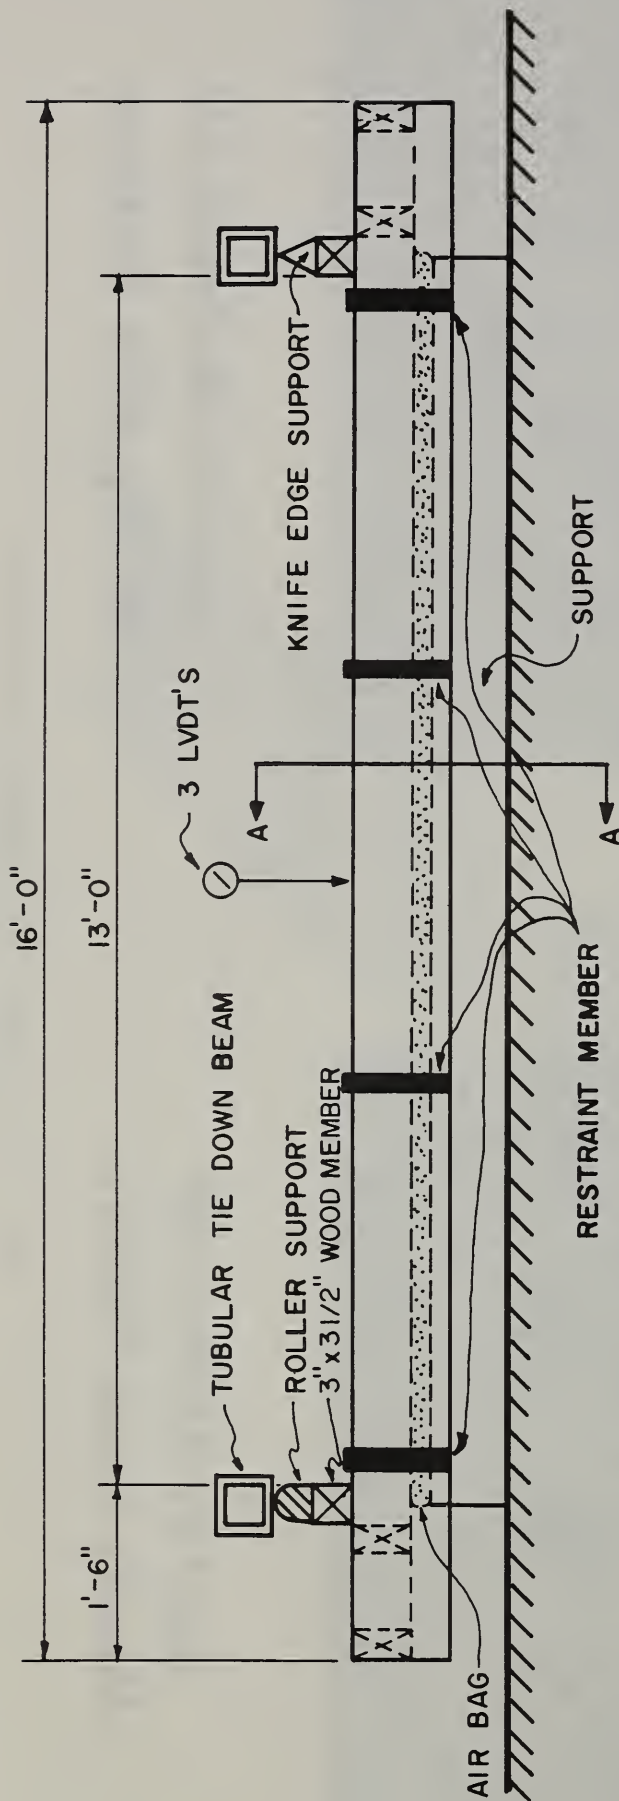
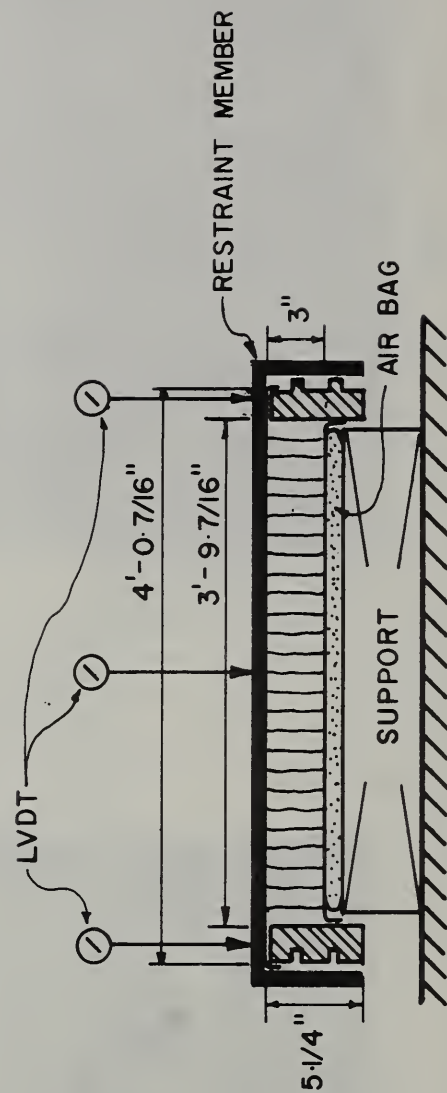
Fig. 9. Schematic of test setup for short-term flexural tests on full-size roof panels.

3.2.1 Short-Term Flexural Test. The roof panel was tested in the horizontal inverted<sup>2/</sup> position with an air bag sandwiched between it and a wood support placed on the laboratory floor as shown in figures 9 and 10. The support members were 3 in x 3 1/2 in wood blocks to simulate the actual wall support condition. The overall panel length was 16 ft 0 in and inside-to-inside dimension of the supports was 13 ft 0 in. The specimen supports were square tubular tie down beams with a roller at one end and a knife edge at the other. Four steel bracing members were placed between supports in an attempt to simulate lateral restraint provided by adjacent panels to the edge members in a completed roof structure.

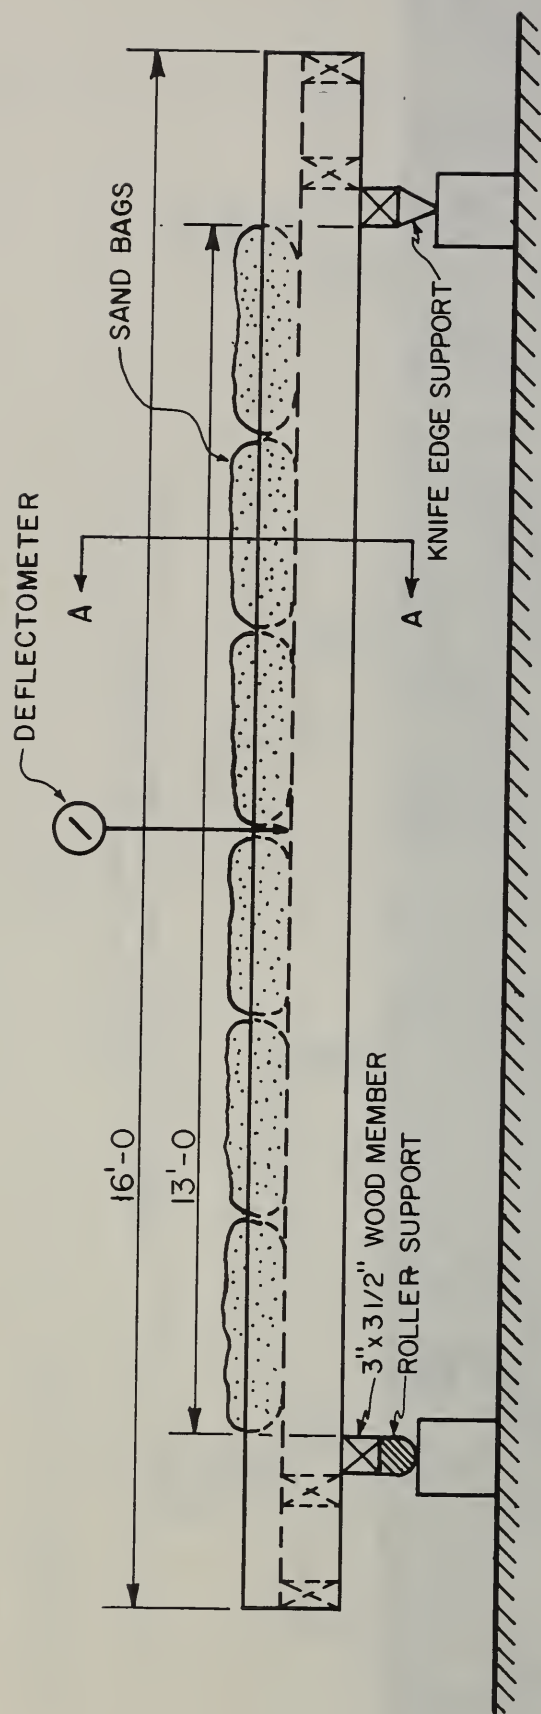
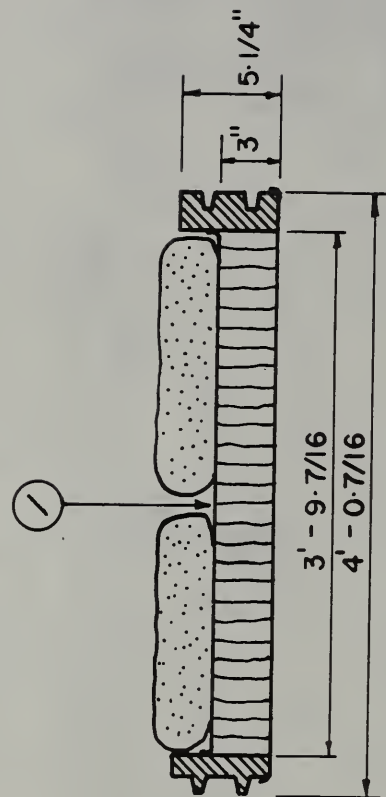
Fig. 11. Schematic of sustained-load test on full-size roof panel.

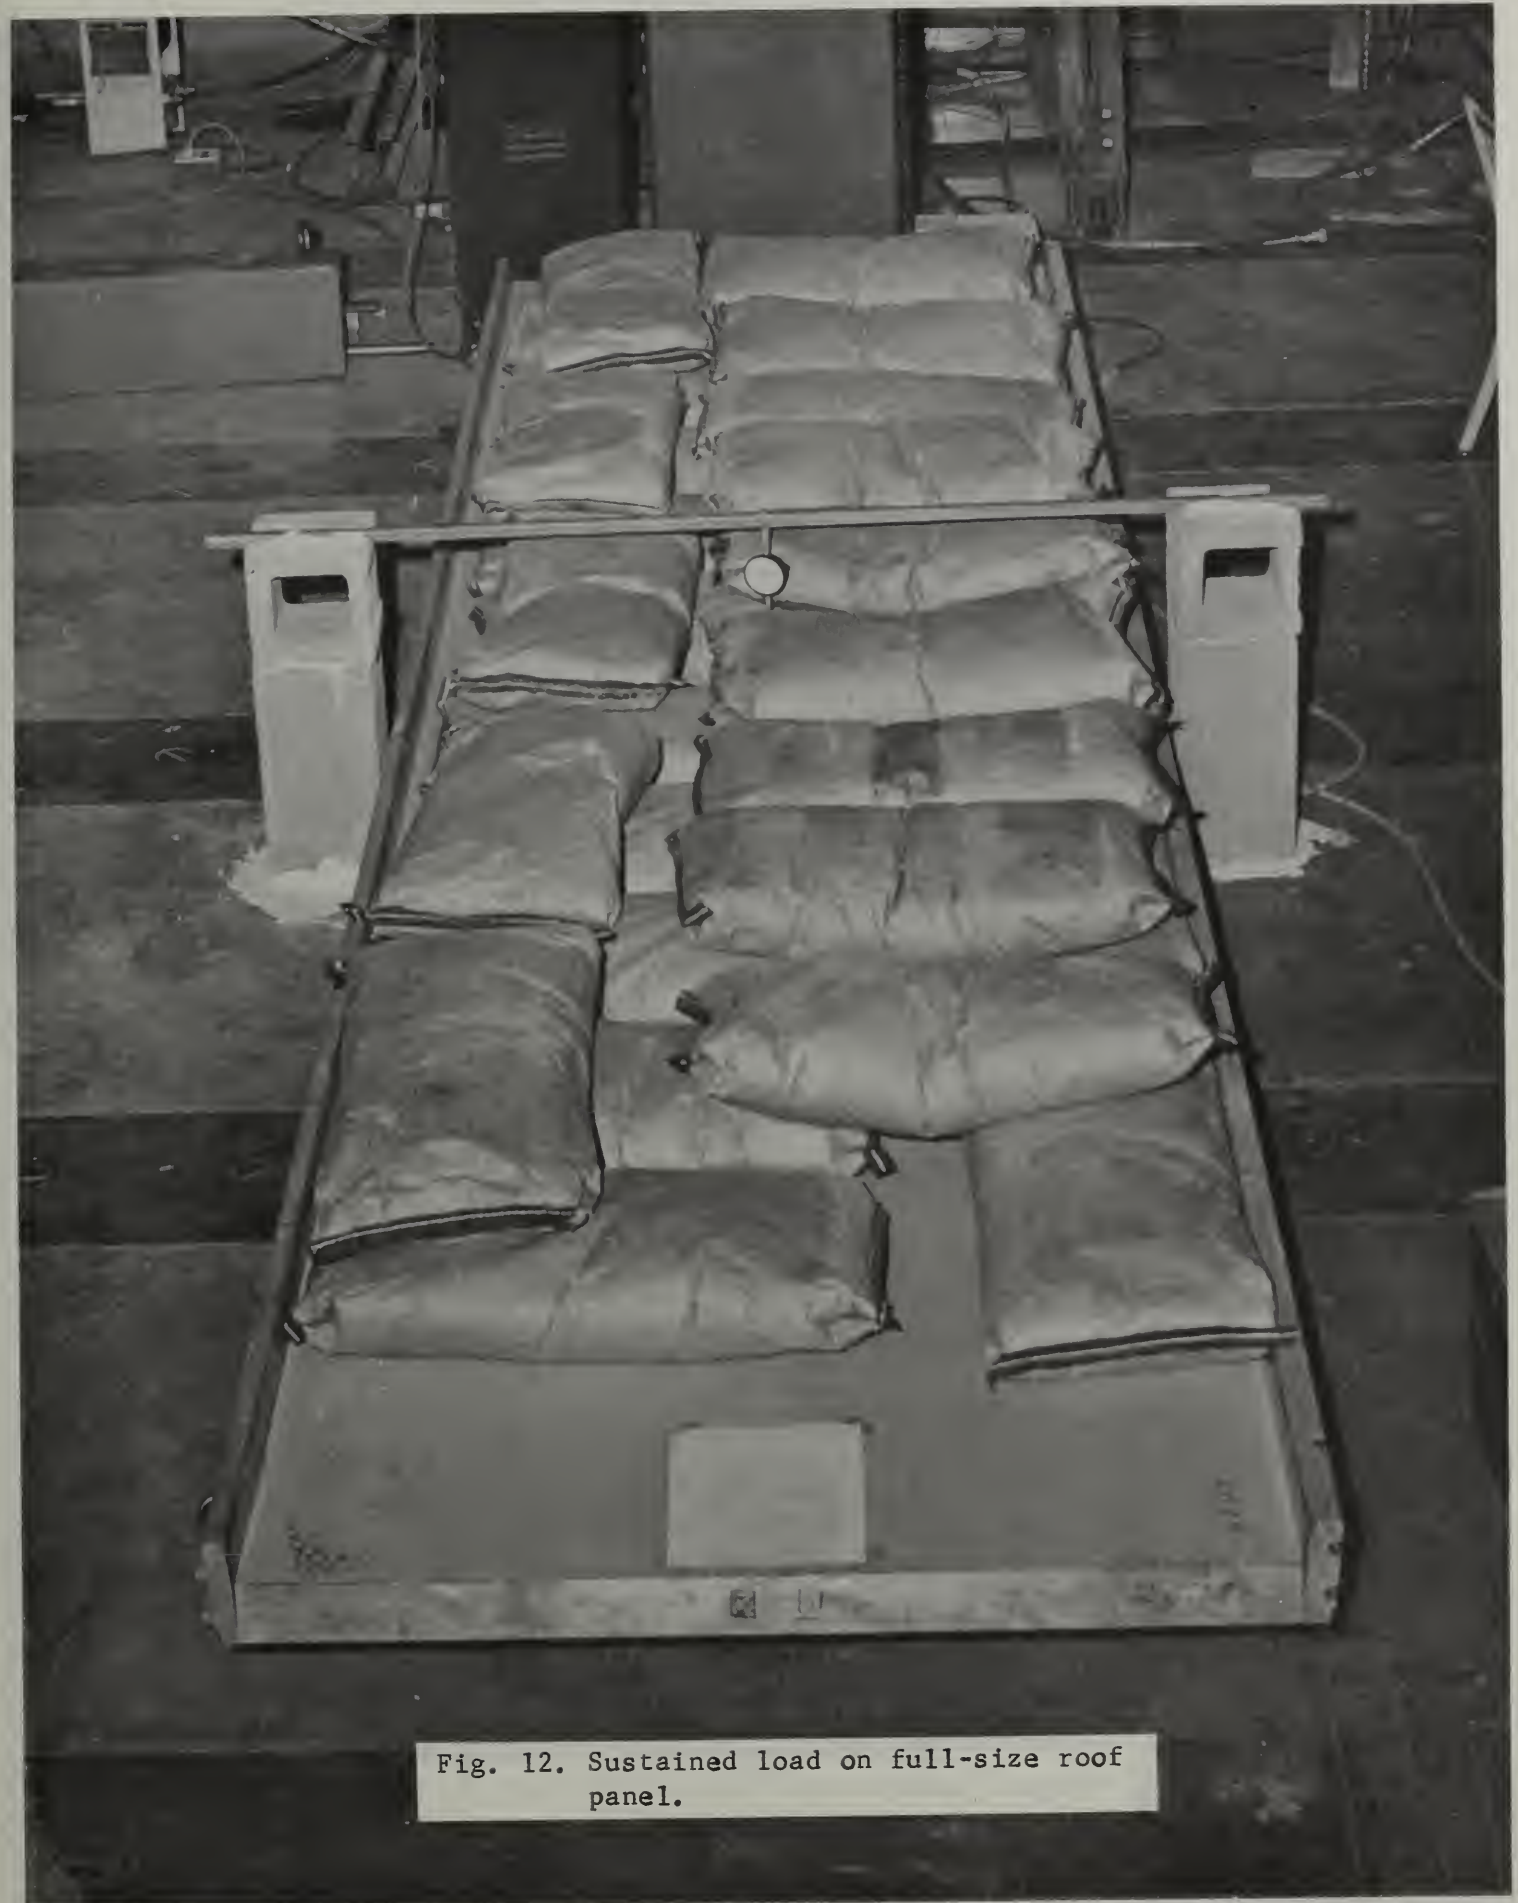
Fig. 12. Sustained load on full-size roof panel.
