# NATIONAL BUREAU OF STANDARDS REPORT

10 409

## STRUCTURAL EVALUATION OF STEEL FACED SANDWICH PANELS

Prepared for the  
Office of Research and Technology  
Department of Housing and Urban Development

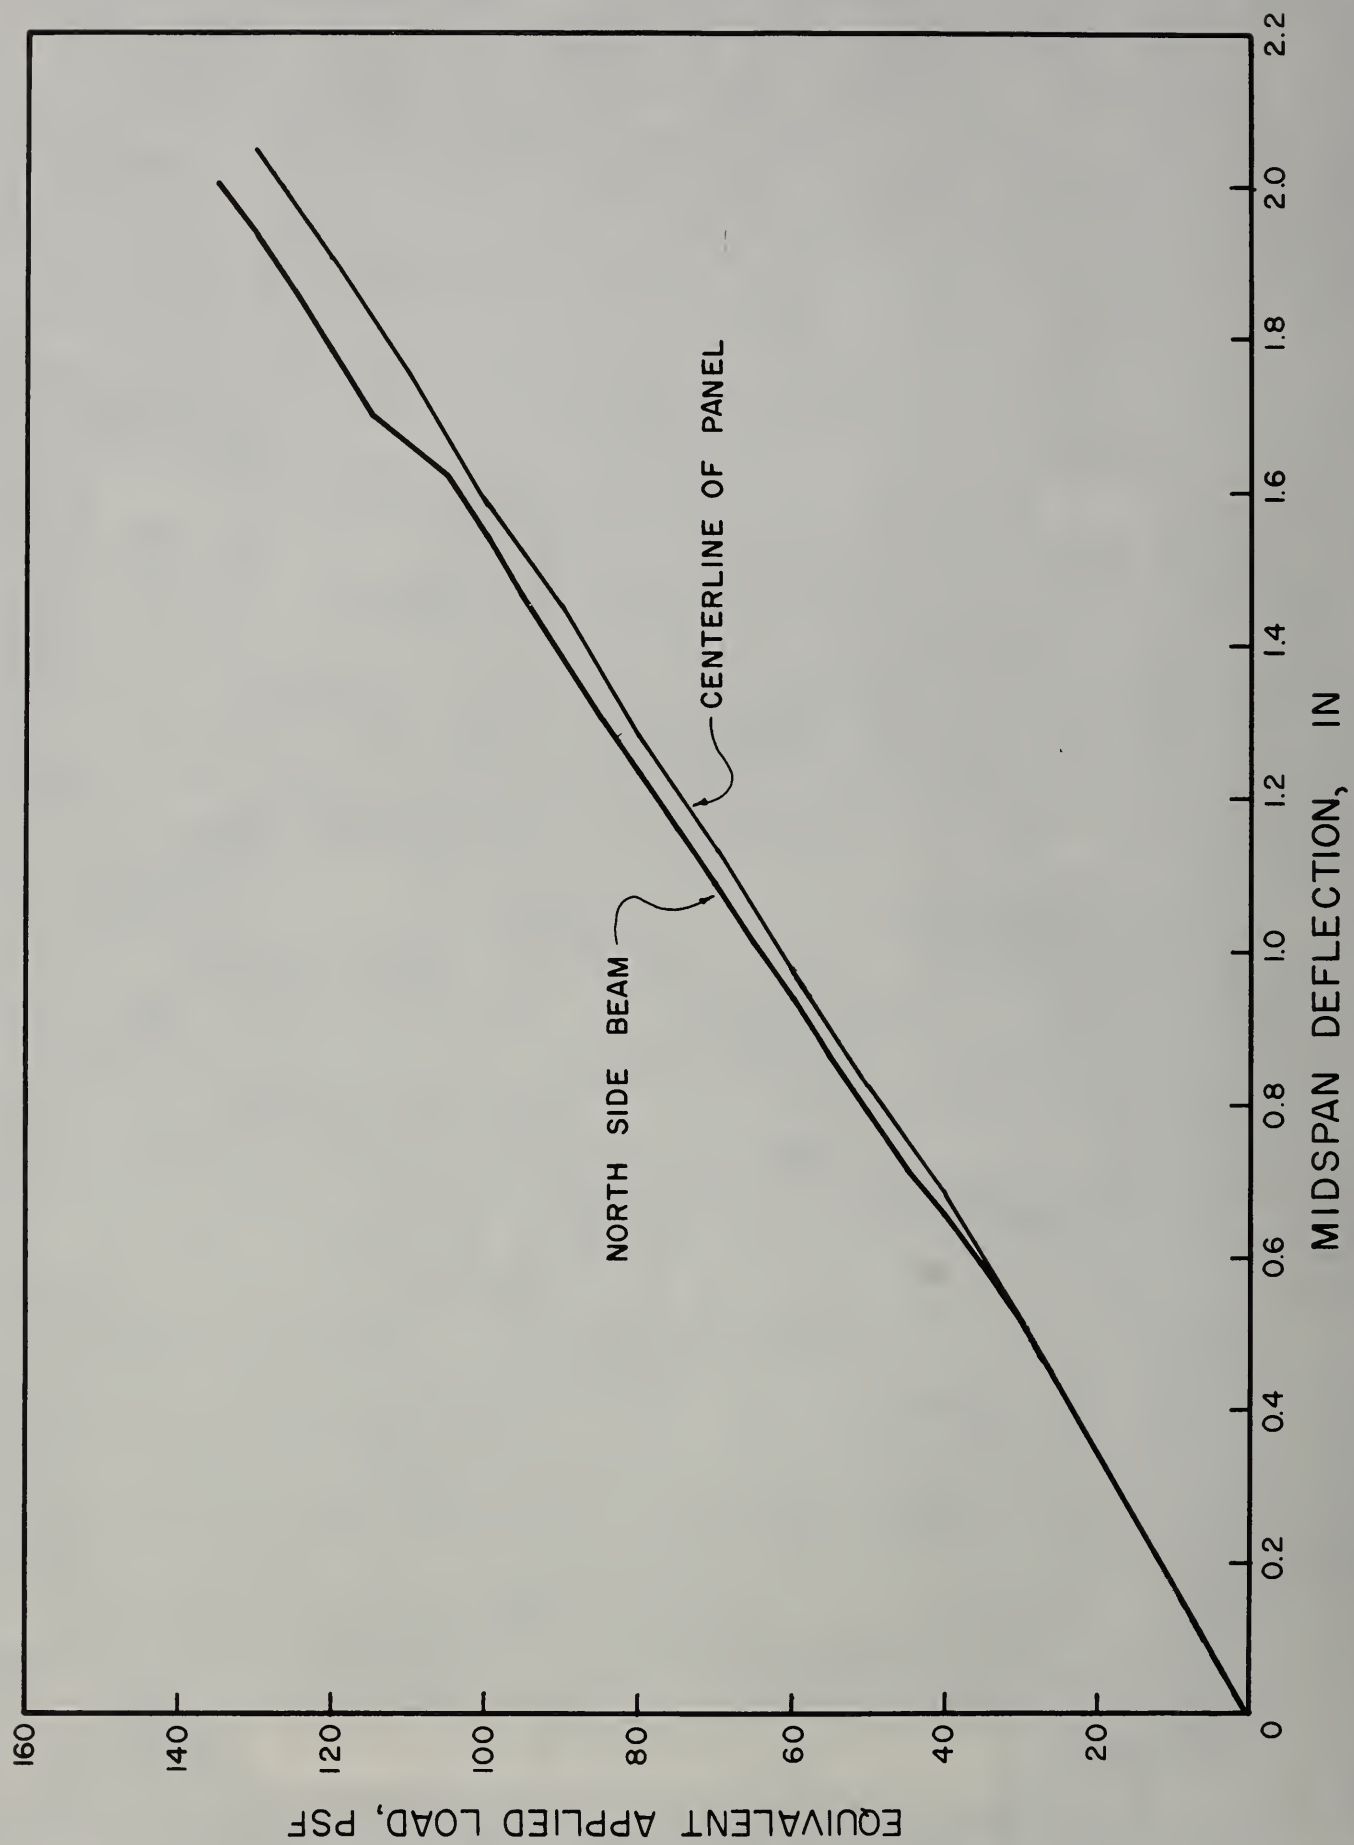
Fig. 13. Short-term flexural results on specimen conditioned by Procedure 1.

3.4.1 Panel Conditioned by Procedure 1. This panel failed at an equivalent applied load of 135 psf with elastic load-deflection behavior up to failure. The specimen was then unable to sustain any significant load. Figure 13 shows the load-deflection history of the midspan LVDT's located at a side beam and at the centerline. Failure occurred by local buckling (wrinkling) of the compressive facing in a straight line transversely across the panel approximately six inches from, and parallel to, a splice in the honeycomb core (see figure 14).

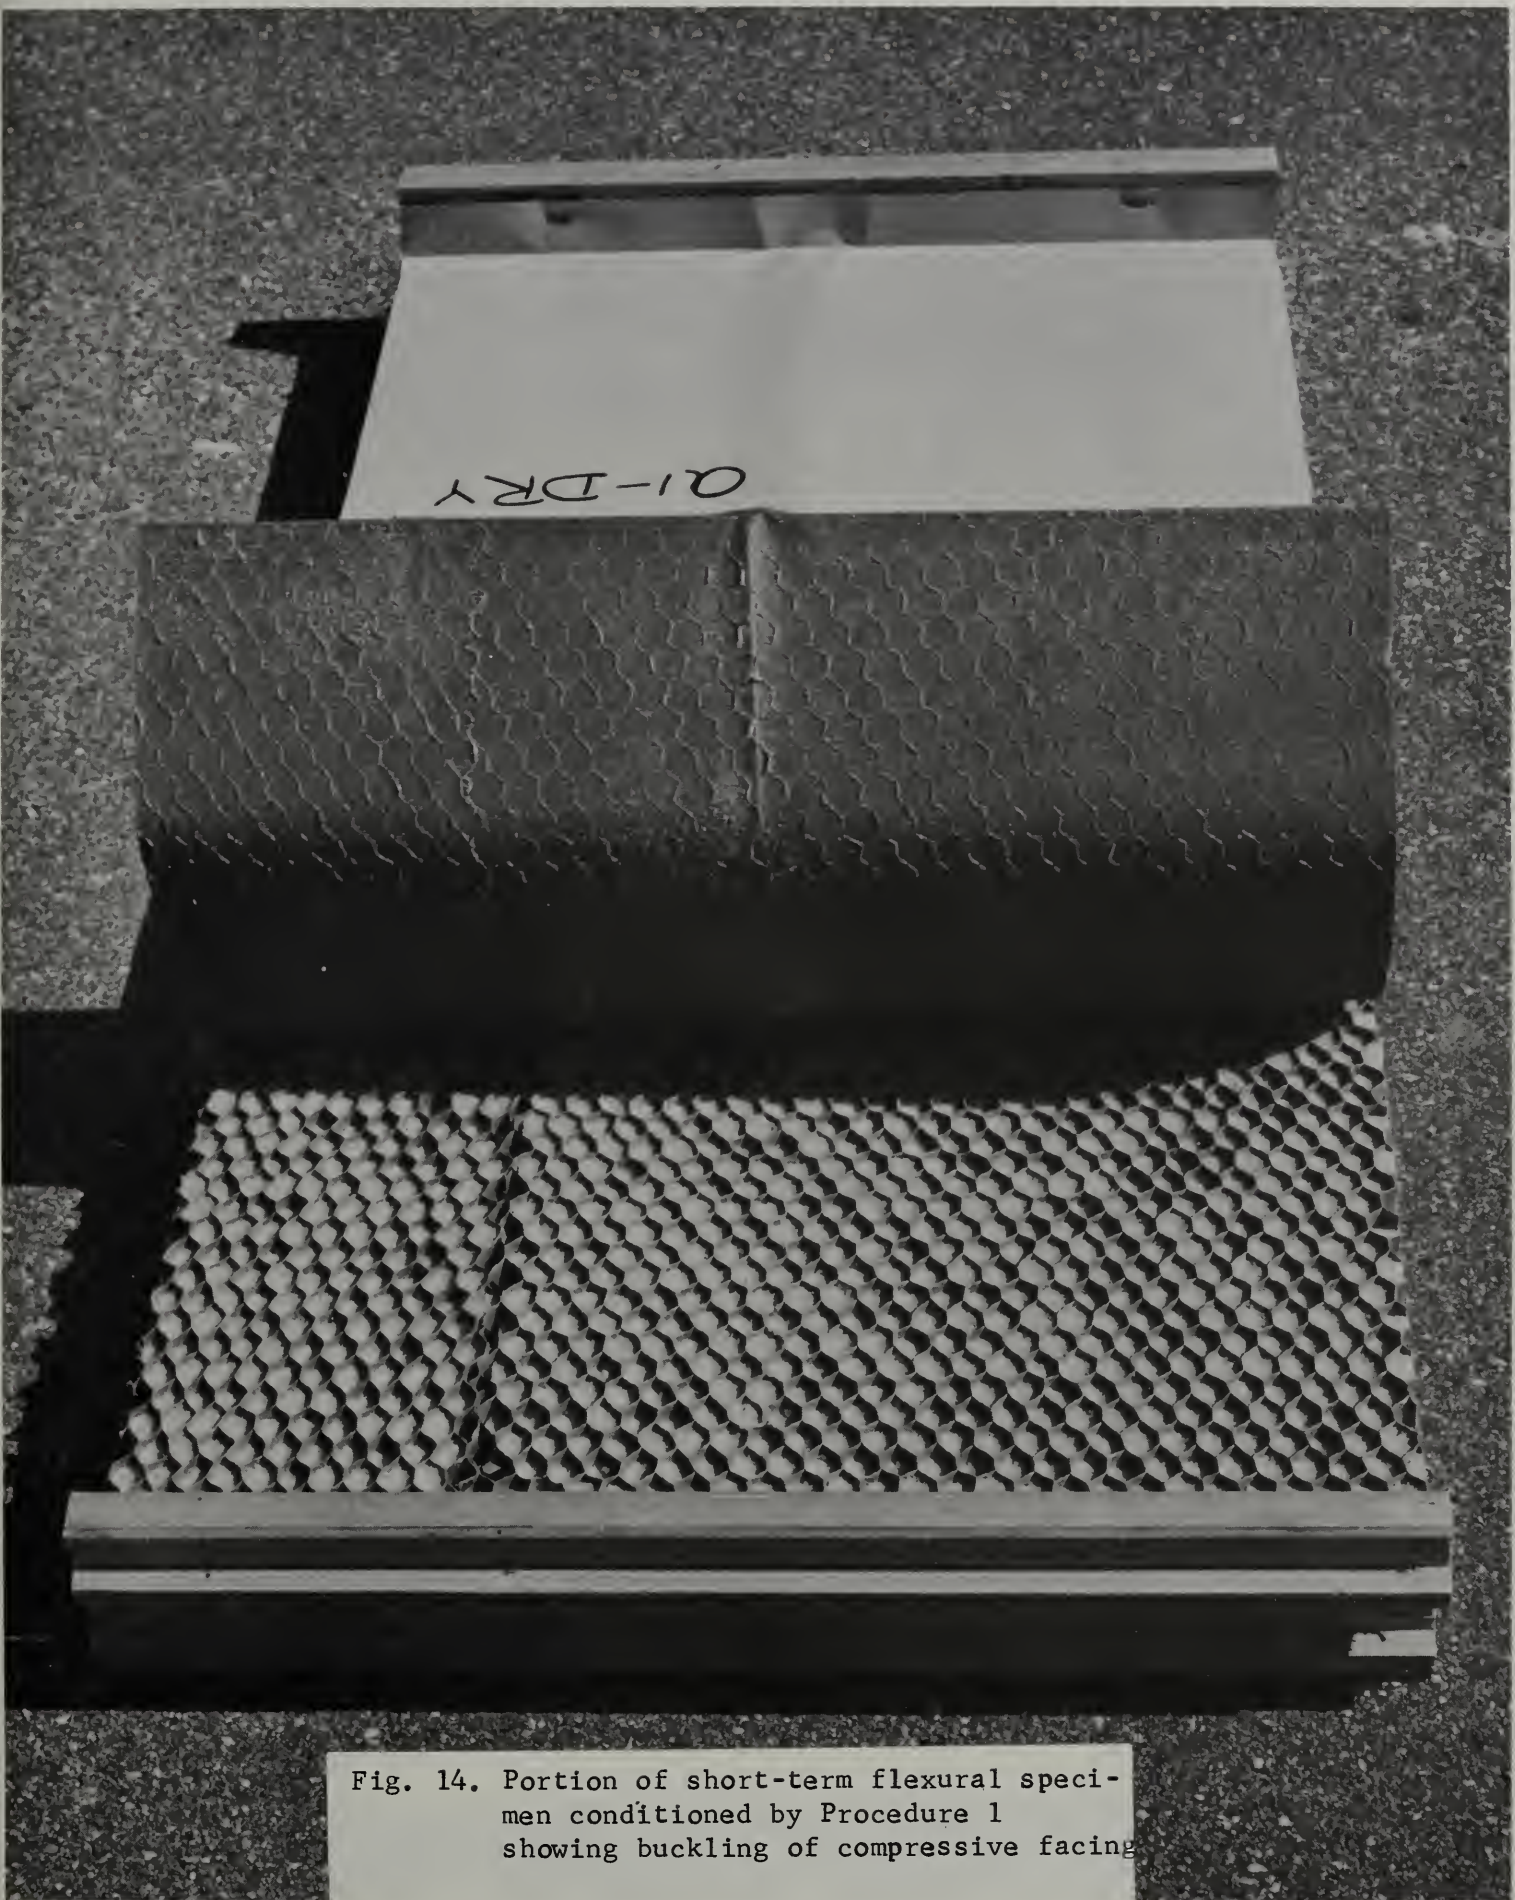
Fig. 14. Portion of short-term flexural specimen conditioned by Procedure 1 showing buckling of compressive facing

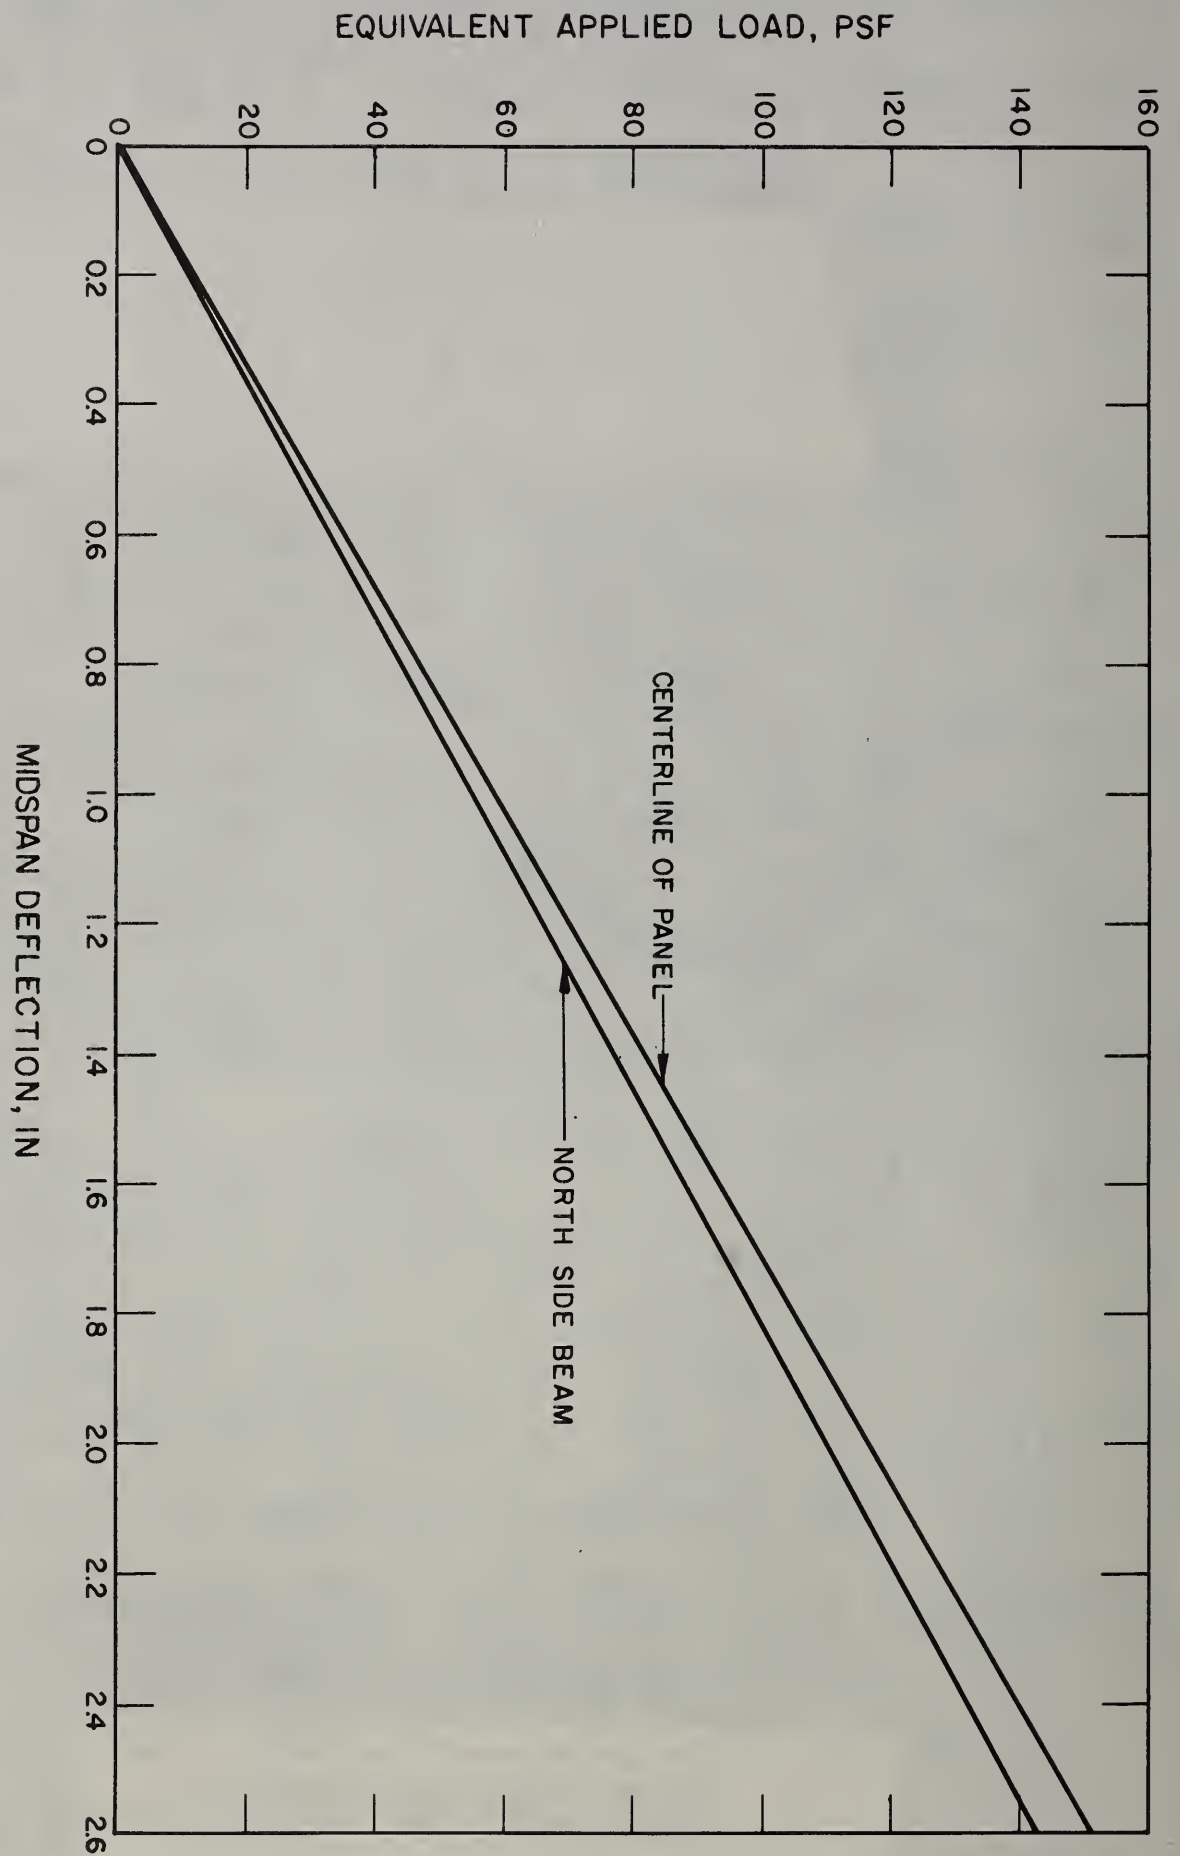
Fig. 15. Short-term flexural test results on specimens conditioned by Procedure 2.

3.4.2 Panel Conditioned by Procedure 2. This panel failed at an equivalent applied load of 155 psf with elastic load-deflection behavior up to failure. The specimen was then unable to sustain any significant load. Figure 15 shows the load-deflection history of the midspan LVDT's located at the side beam and at the centerline. Failure occurred by local buckling of the compressive facing in a straight line transversely across

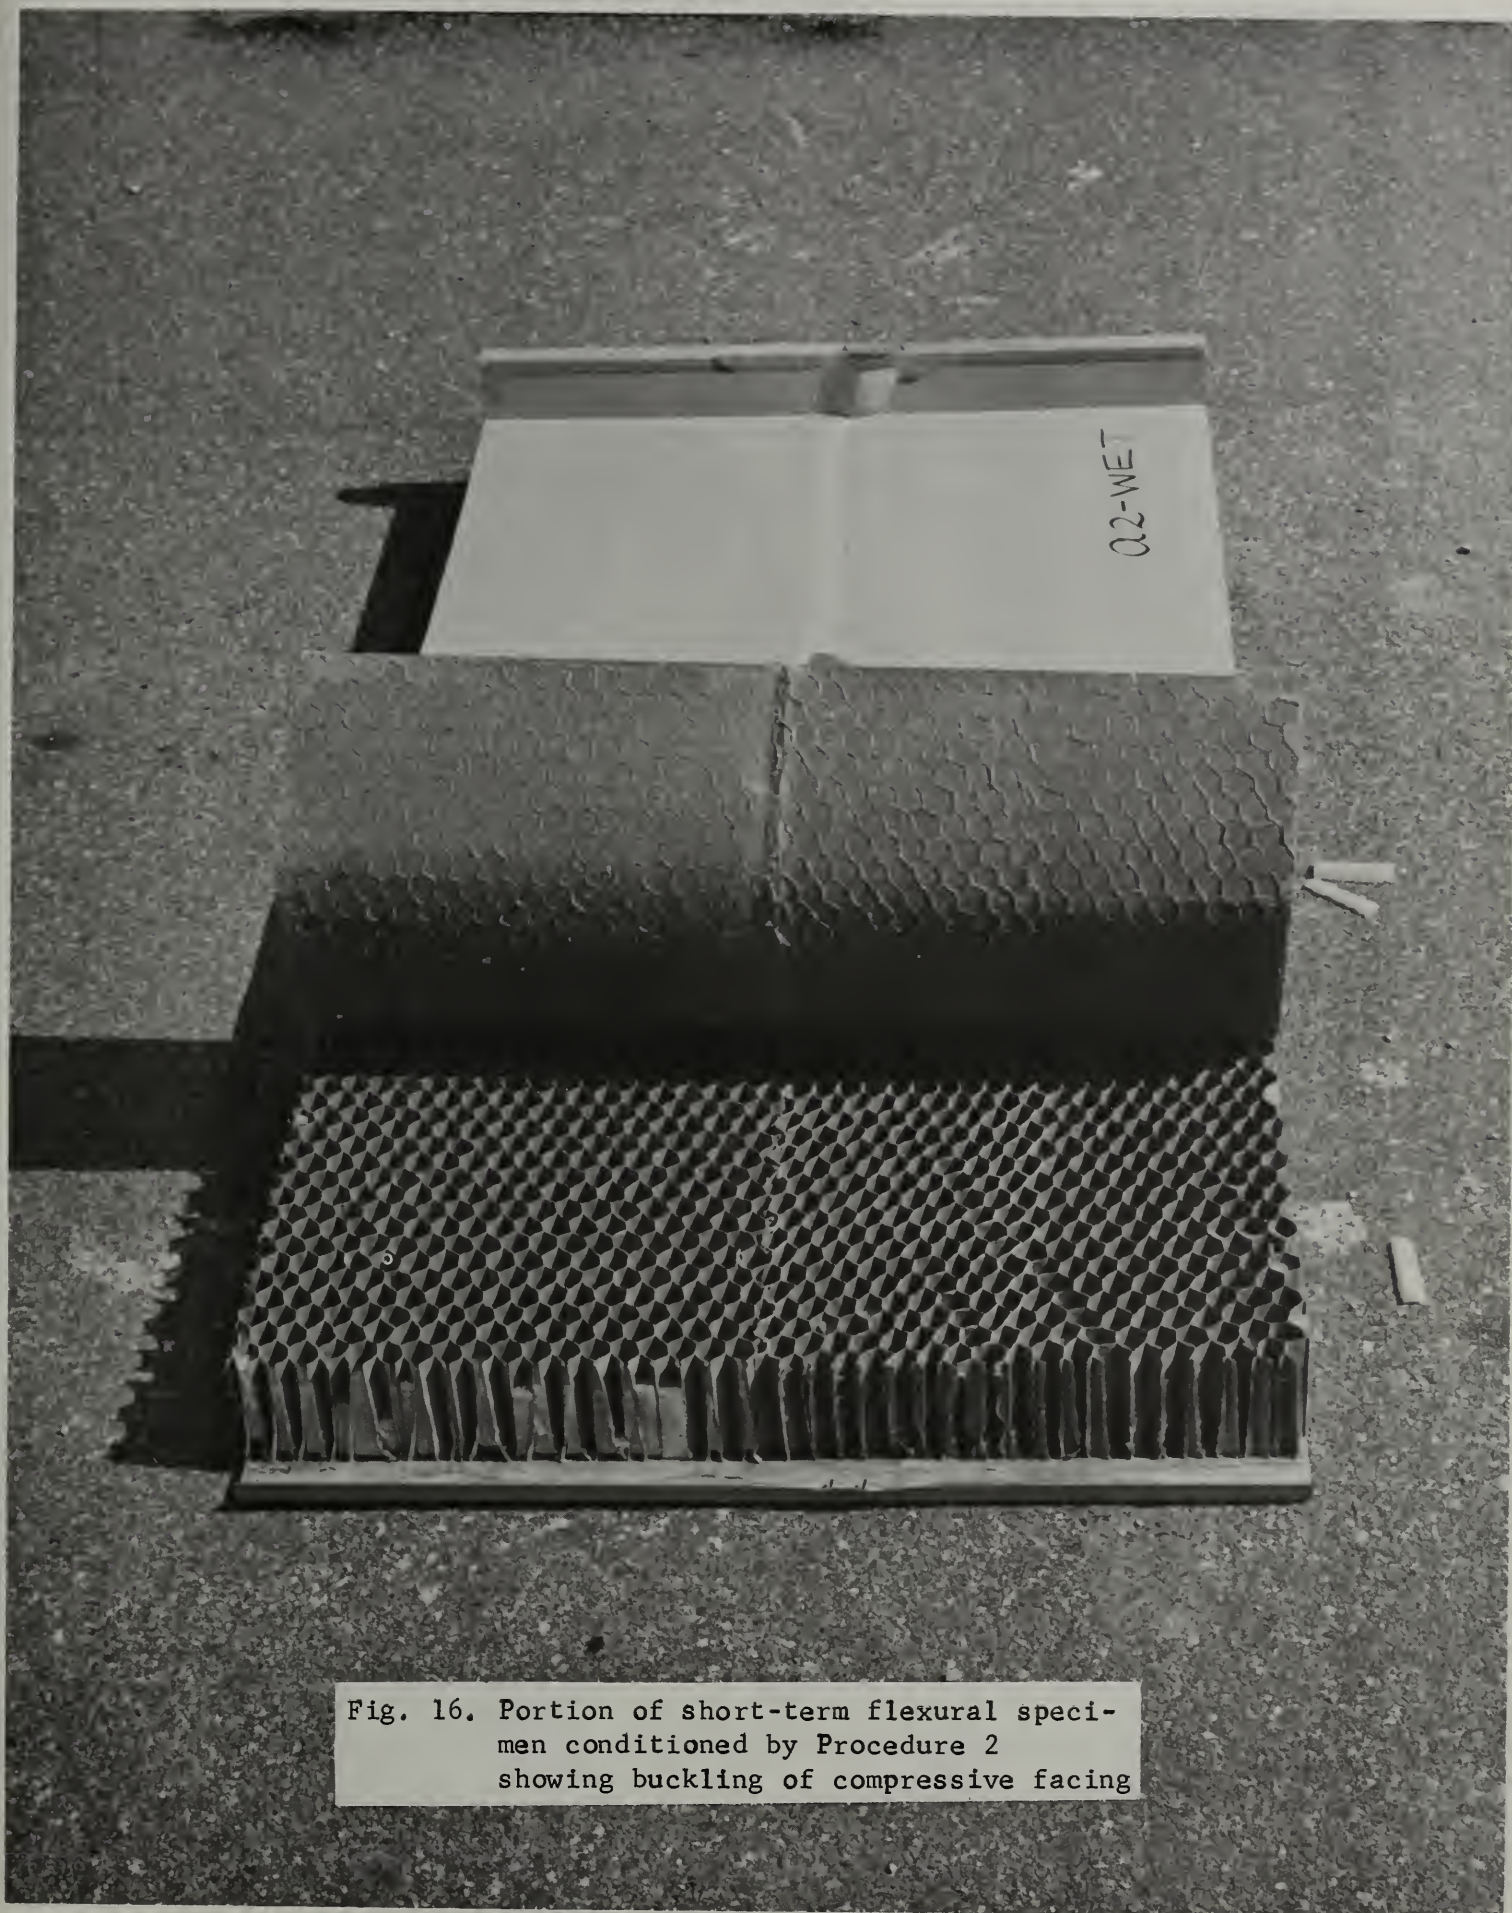
Fig. 16. Portion of short-term flexural specimen conditioned by Procedure 2 showing buckling of compressive facing

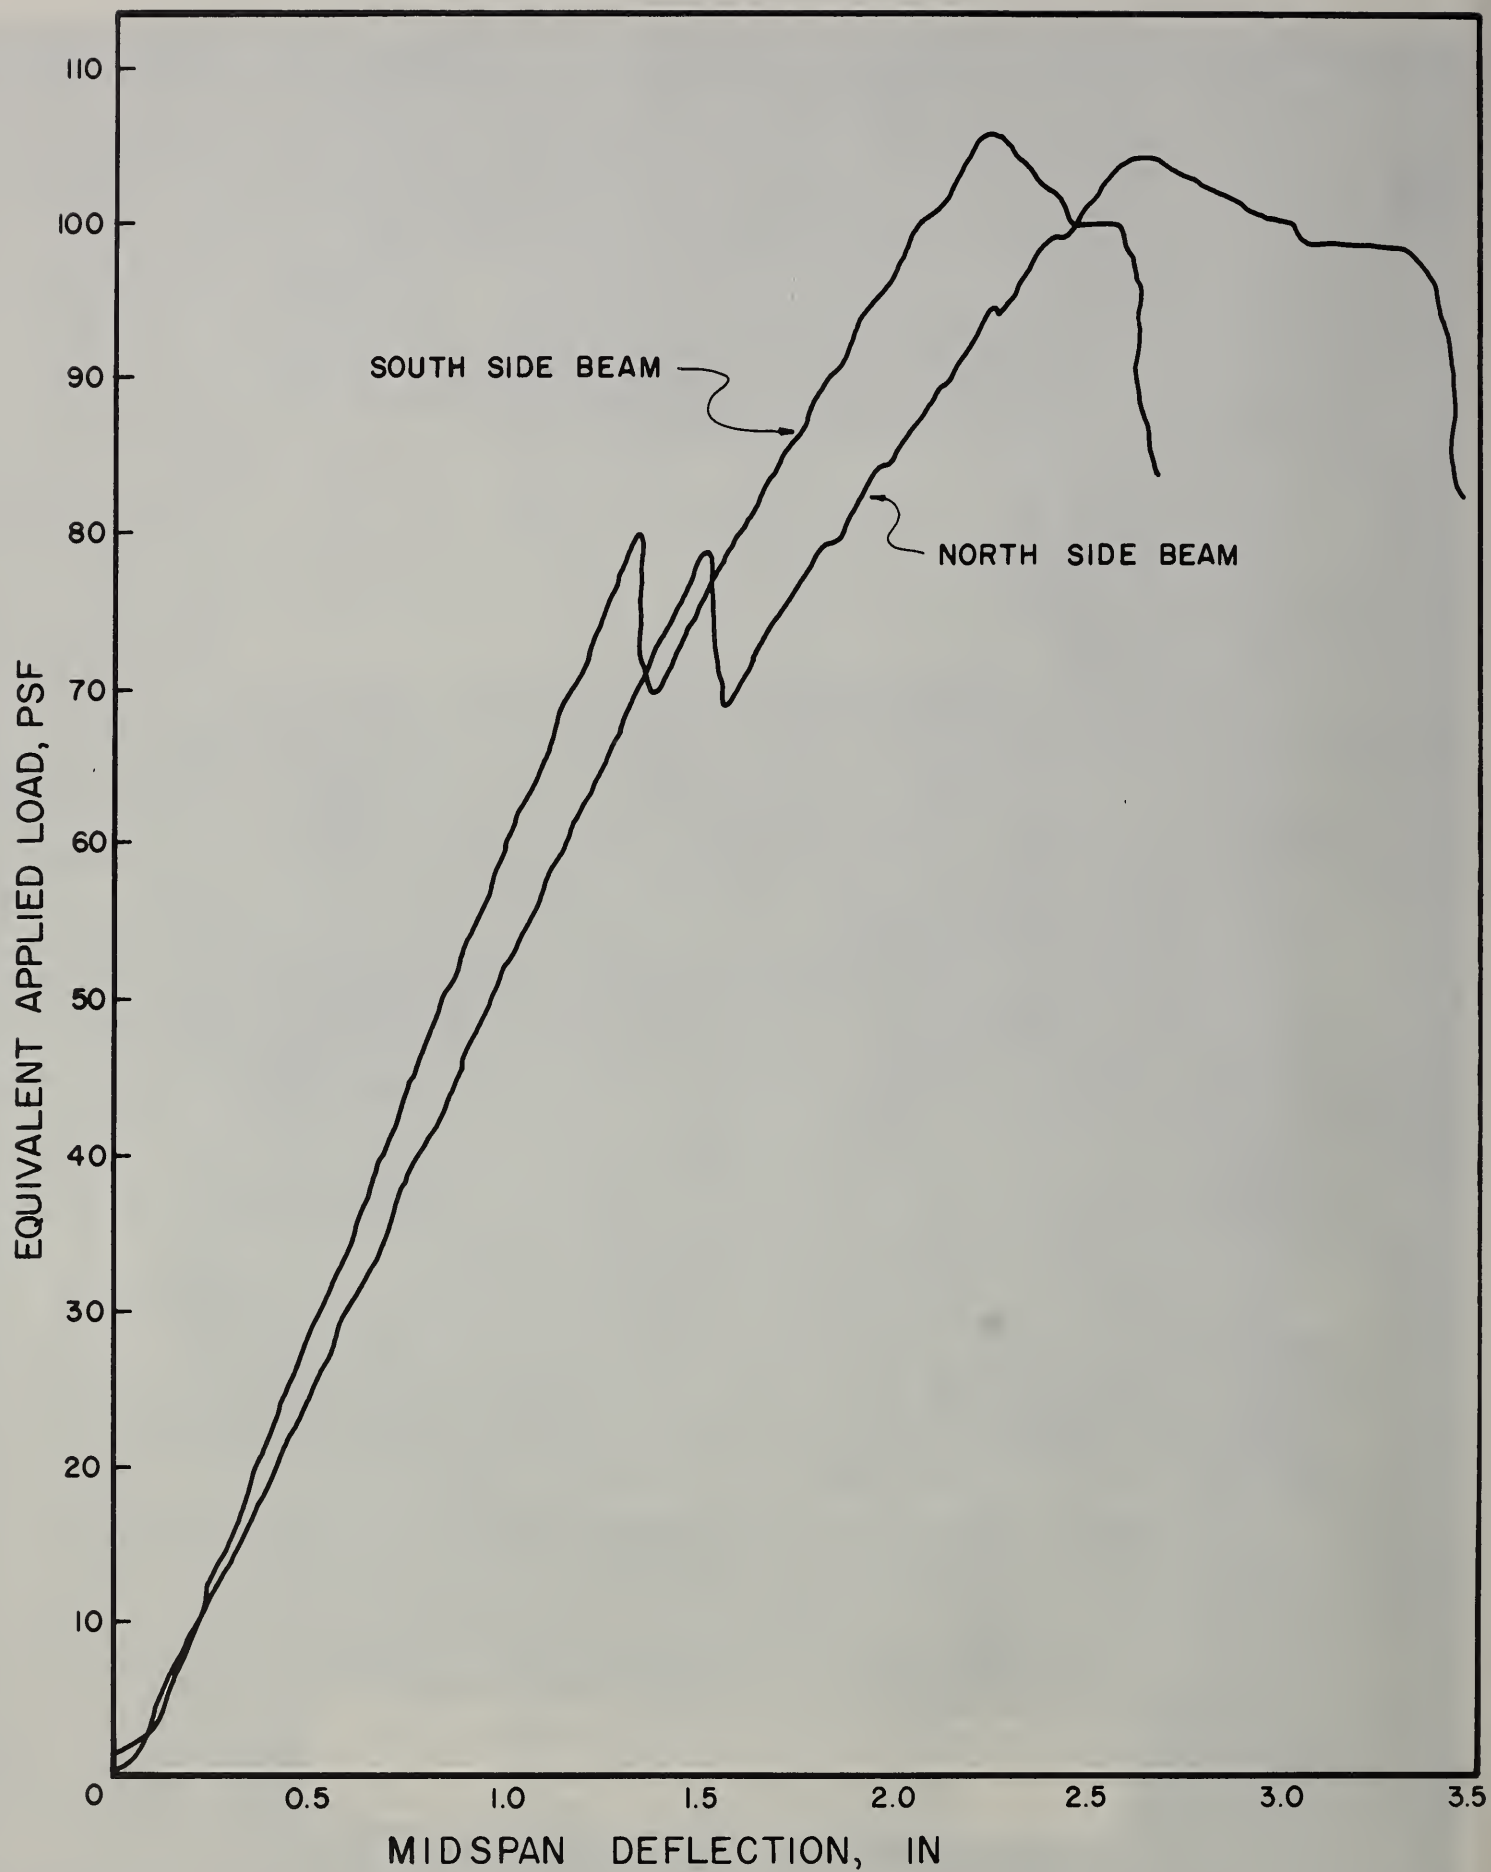
Fig. 17. Short-term flexural test results on specimen conditioned by Procedure 3.

3.4.3 Panel Conditioned by Procedure 3 (Soaked). The panel behaved elastically up to an equivalent applied load of 80 psf when a sudden drop in load occurred (see figure 17). This was believed to be caused by readjustment of the air bag with the increase in bag volume resulting in a decrease in pressure. The panel was again able to take load linearly with respect to deflection.

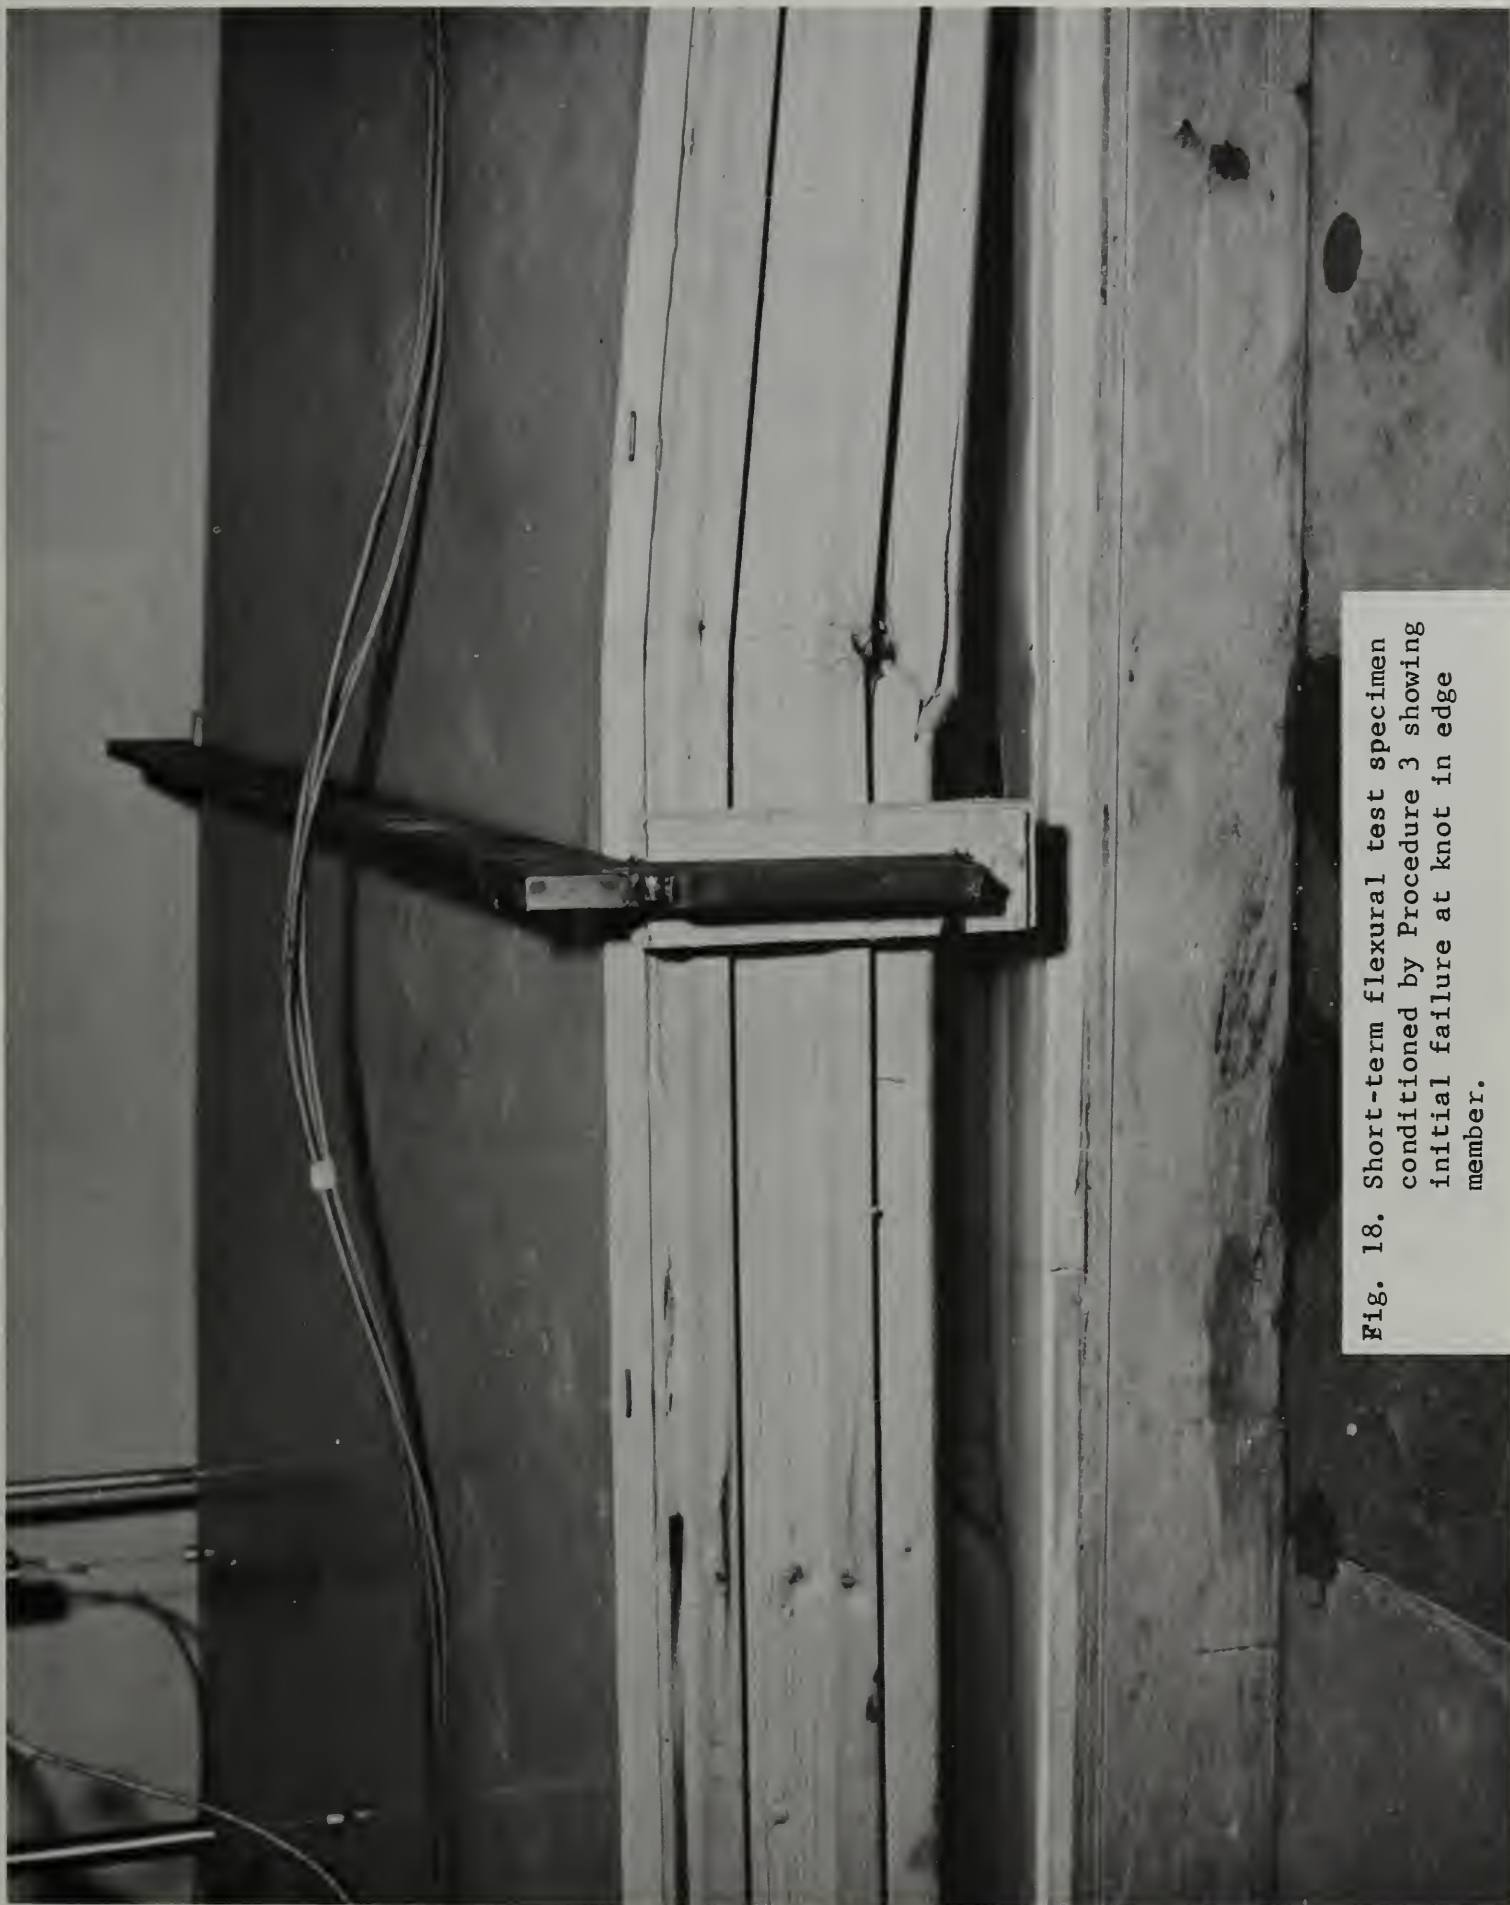
Fig. 18. Short-term flexural test specimen conditioned by Procedure 3 showing initial failure at knot in edge member.

Failure occurred at an equivalent applied load of 104 psf and was apparently initiated by fracture at a knot in the edge member as is shown in figure 18. This was followed almost immediately by a local buckling of the compressive facing and a complete loss of load carrying capability. The buckling occurred in a straight line transversely across the panel at, and parallel to, a splice in the honeycomb core as shown in figure 19.

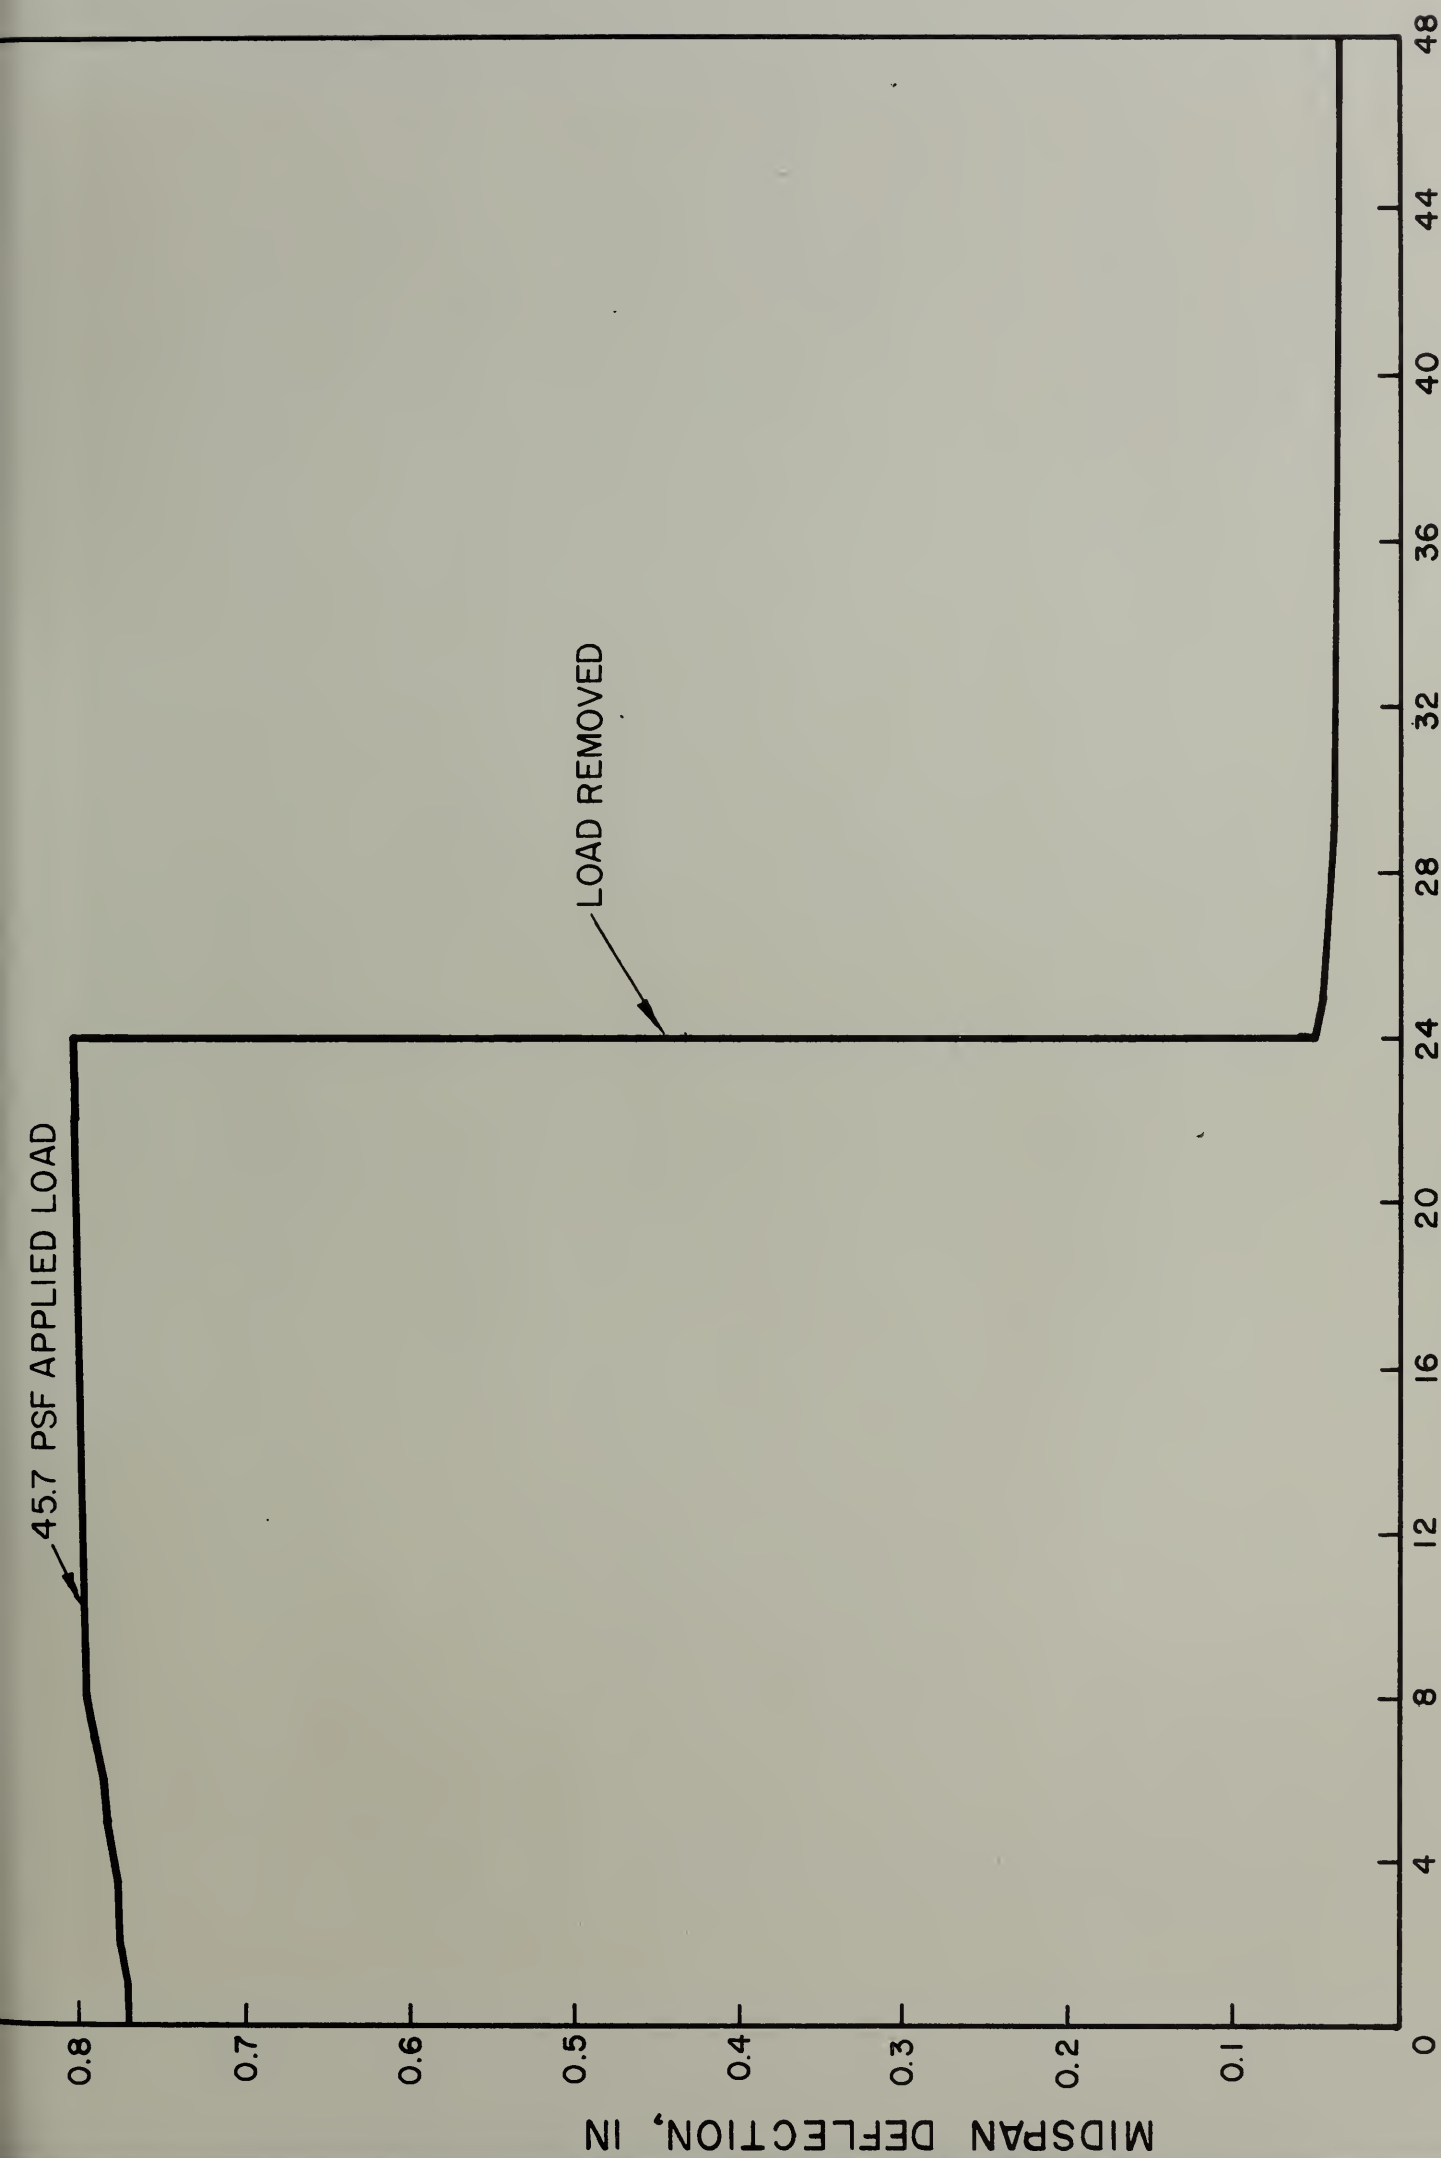
TIME AFTER INITIAL LOAD APPLICATION, HR

Fig. 20. Sustained-load test results on specimen conditioned by Procedure 1
