# NATIONAL BUREAU OF STANDARDS REPORT

## Investigation of Performance Characteristics for Sanitary Plumbing Fixtures

Building Research Division  
Institute for Applied Technology

September 21, 1965

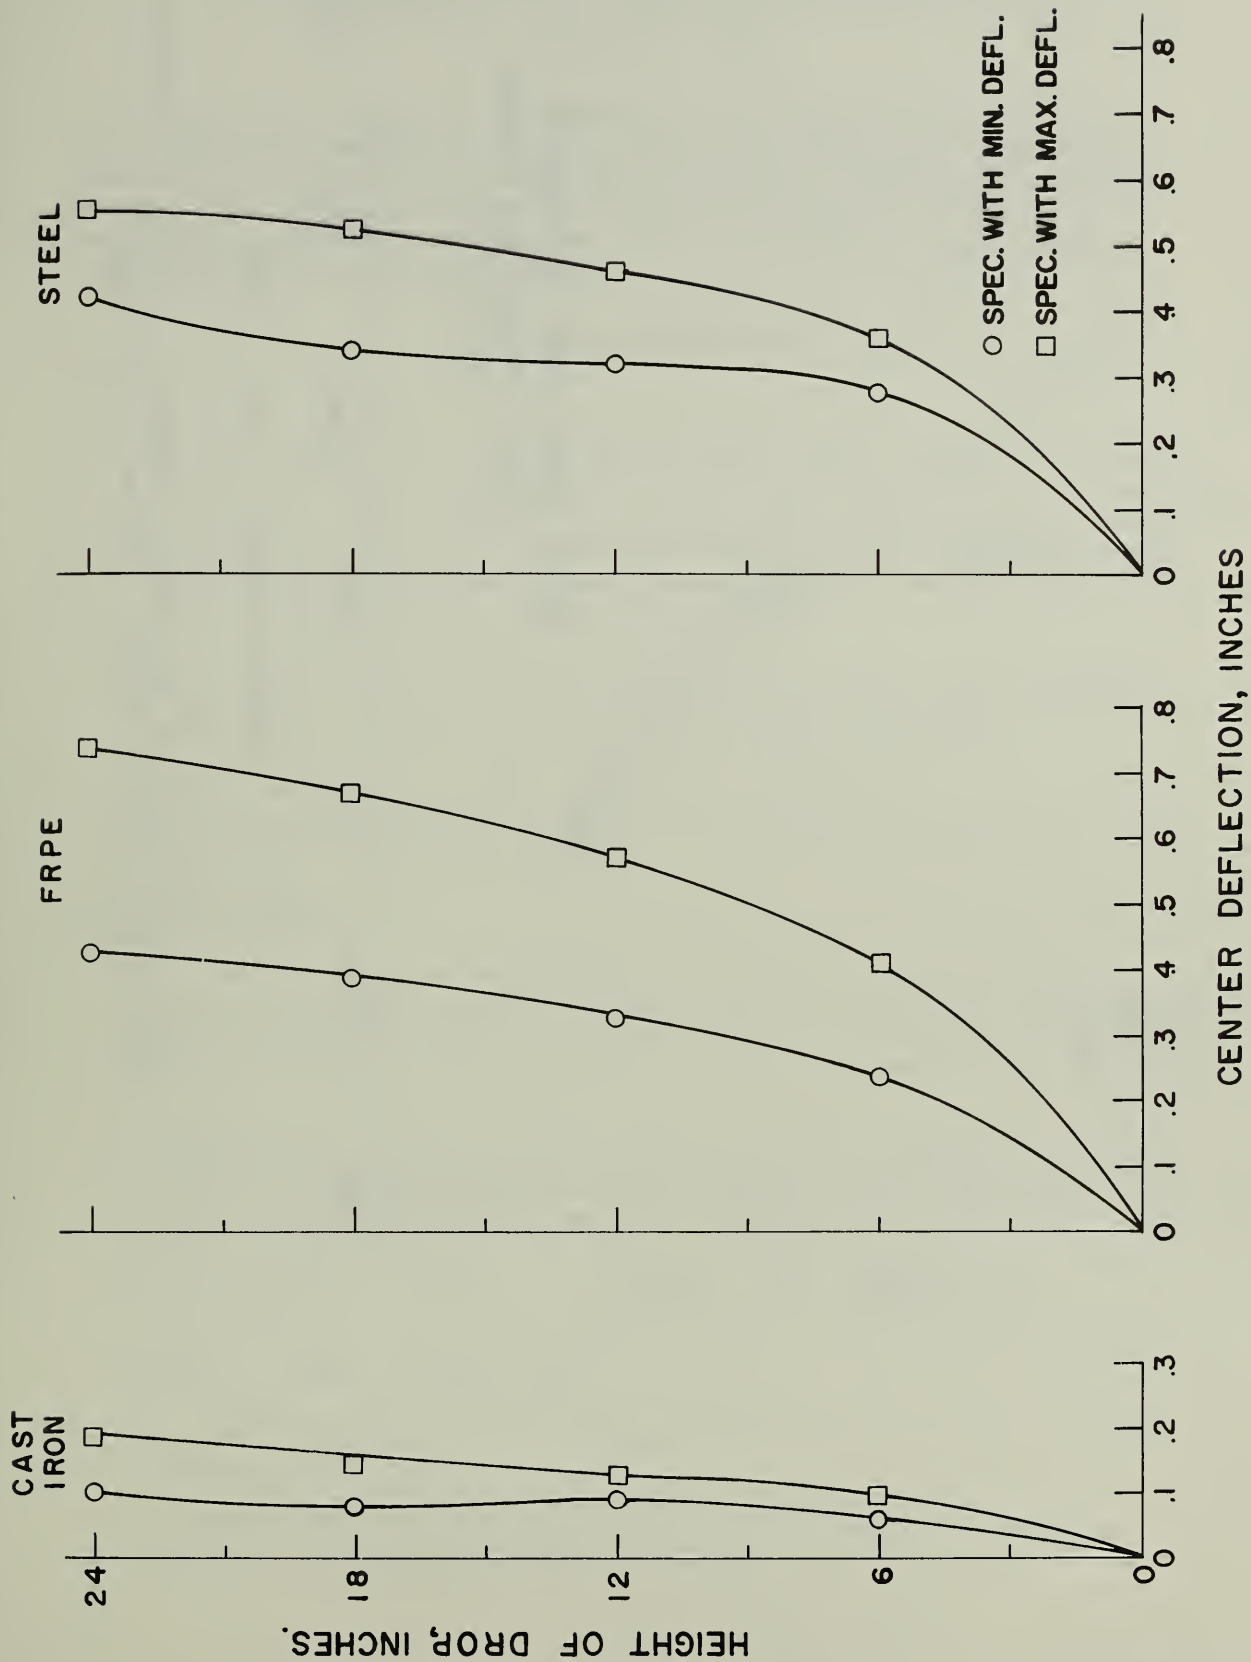
FIG. 2.4-1 CONCENTRATED LOAD TEST (DYNAMIC) 150 LB. LEATHER BAG.

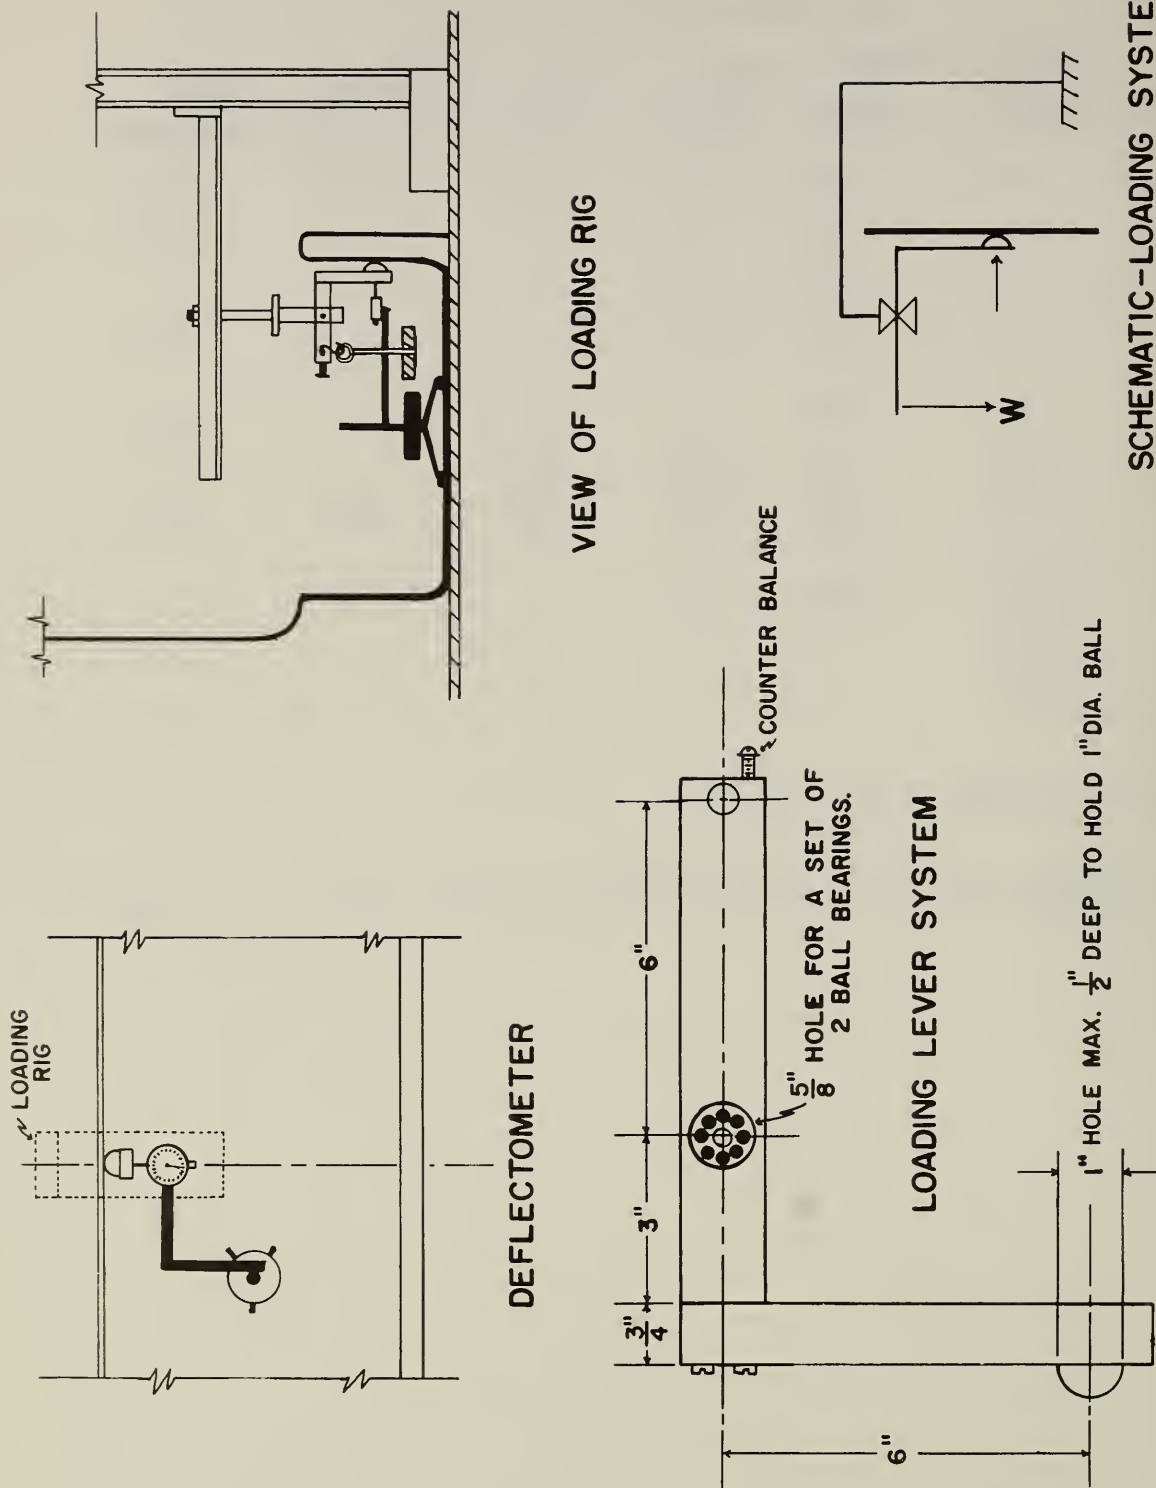
FIG. 2.5-1 DEFLECTION TEST FOR UNSUPPORTED AREA

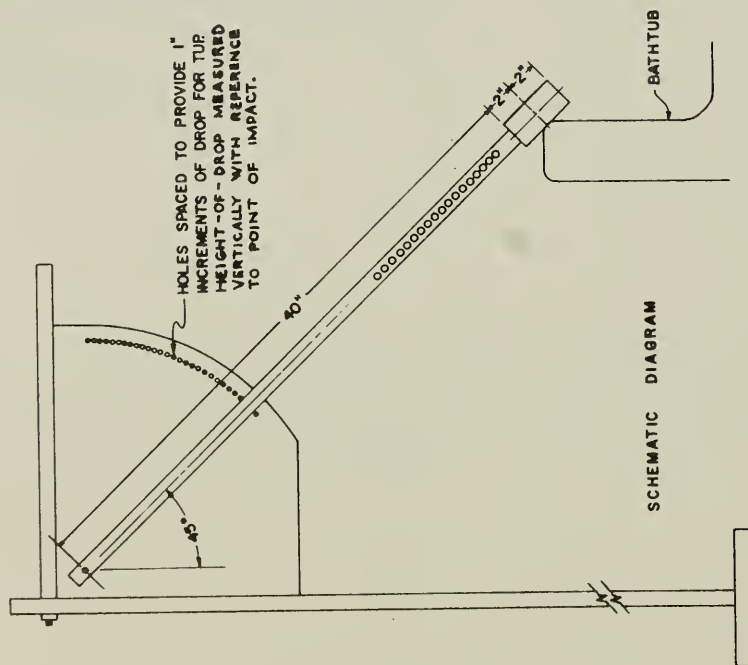
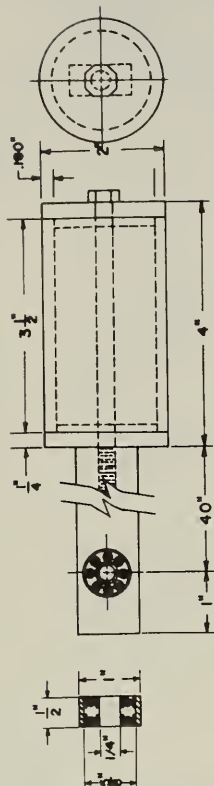
TUP 2" ROUND 6061-T6 ALUMINUM TUBING WITH .180" WALL THICKNESS.  
END PLATES MACHINED FROM 3/8" THICK ALUMINUM PLATES FOR  
SNUG FIT IN TUBING.

ARM 1" X 1/2" ALUMINUM BAR 41" LONG WITH 18 - 7/16" HOLES @ 5/8"  
O.C. STARTING 1" FROM TUP END OF ARM DRILLED AND  
TAPPED FOR 1/4" ASSEMBLY BOLT.

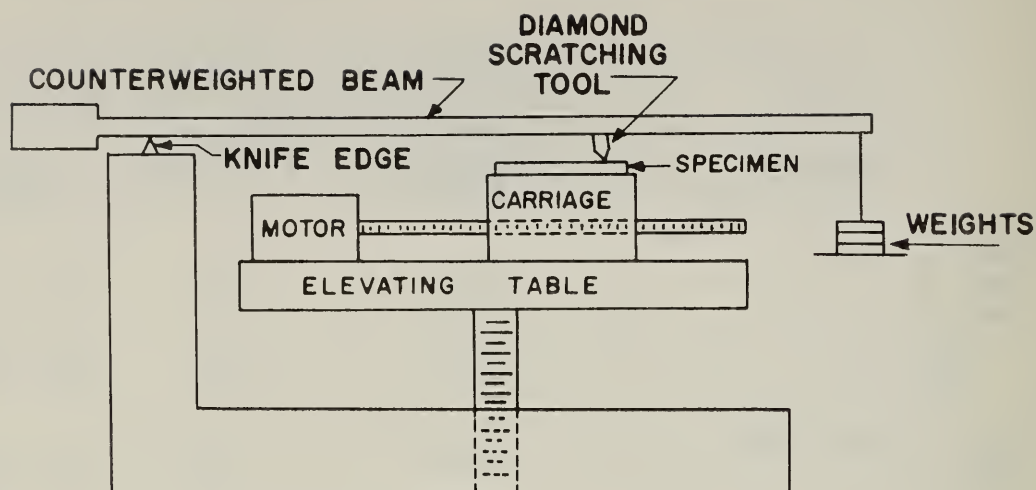
FIG. 2.16 -1. SCRATCH TEST APPARATUS

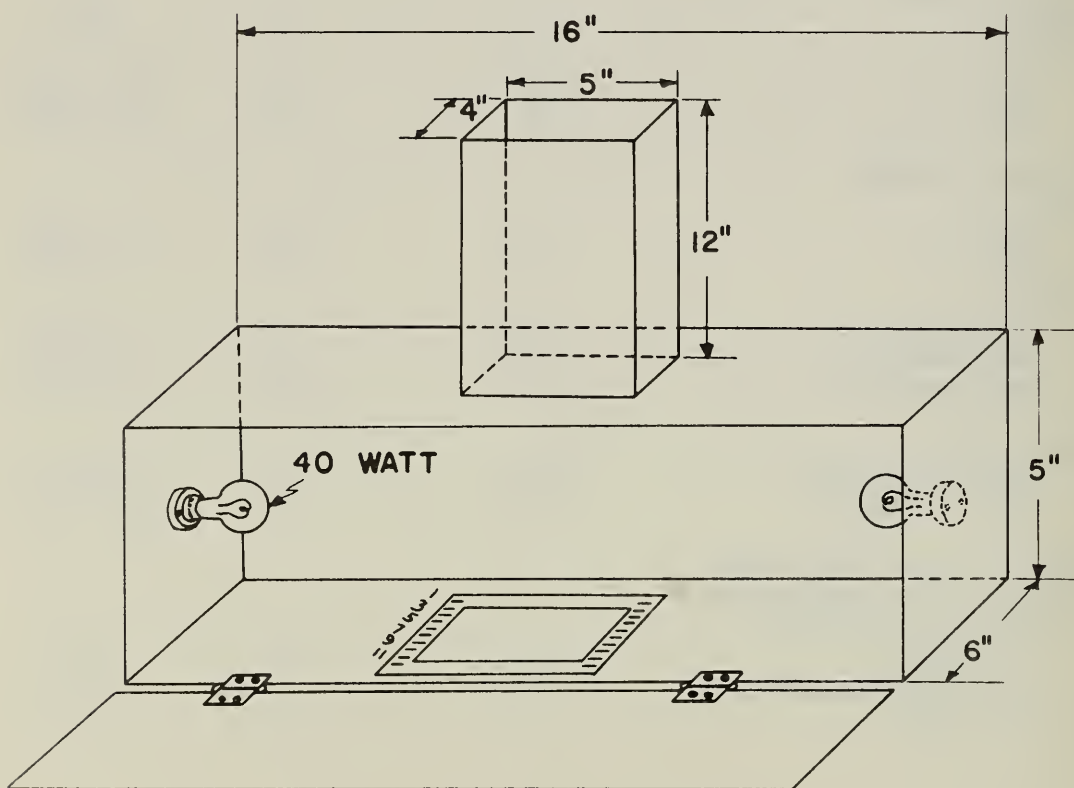
FIG. 2.16 -2. SPECIMEN VIEWING BOX

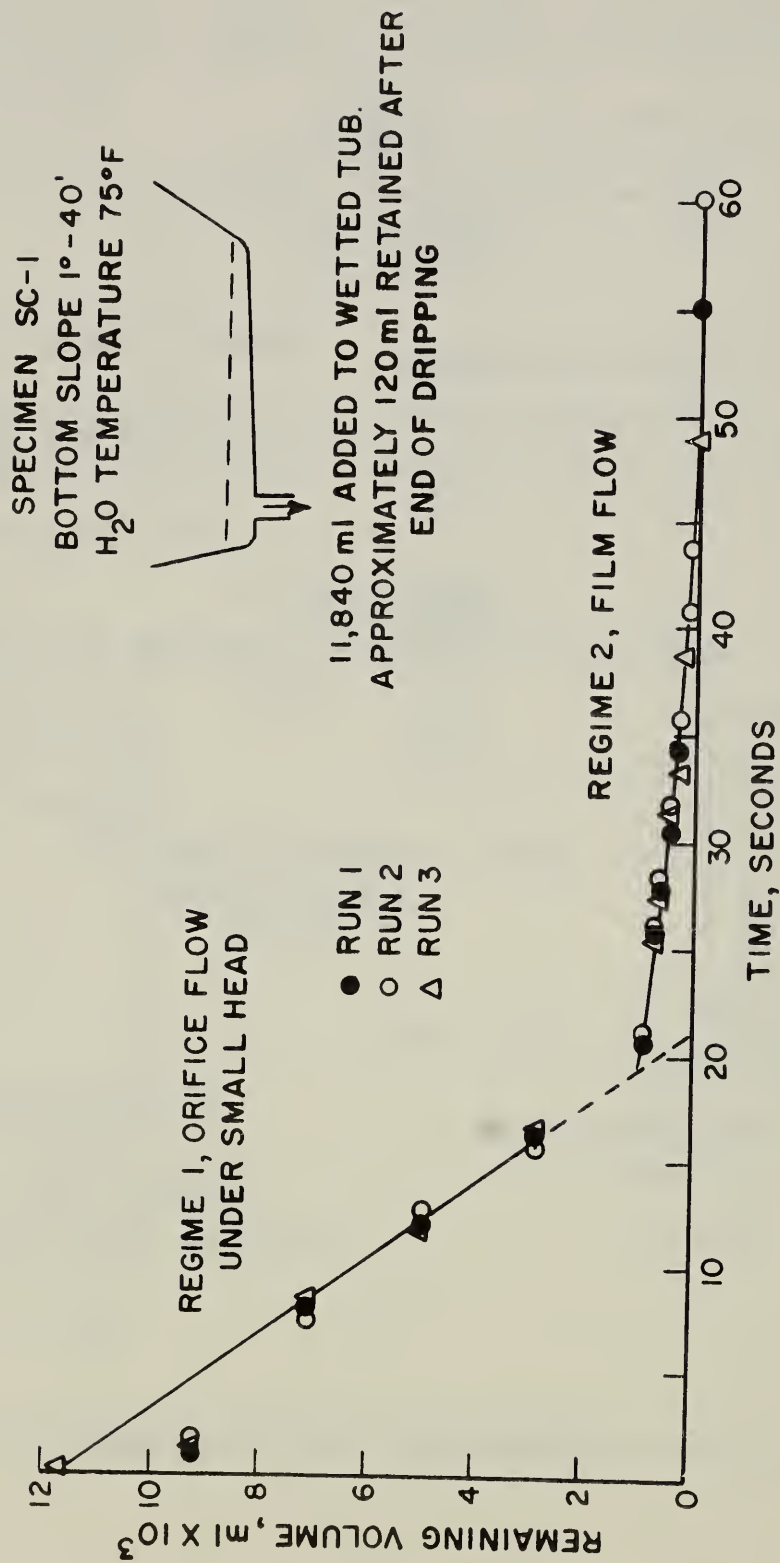
FIG.2.17-2 —DISCHARGE PATTERN FOR BATHTUB

SPECIMEN SC-1  
 11,840 ml ADDED TO WETTED TUB  
 H<sub>2</sub>O TEMPERATURE 76°F

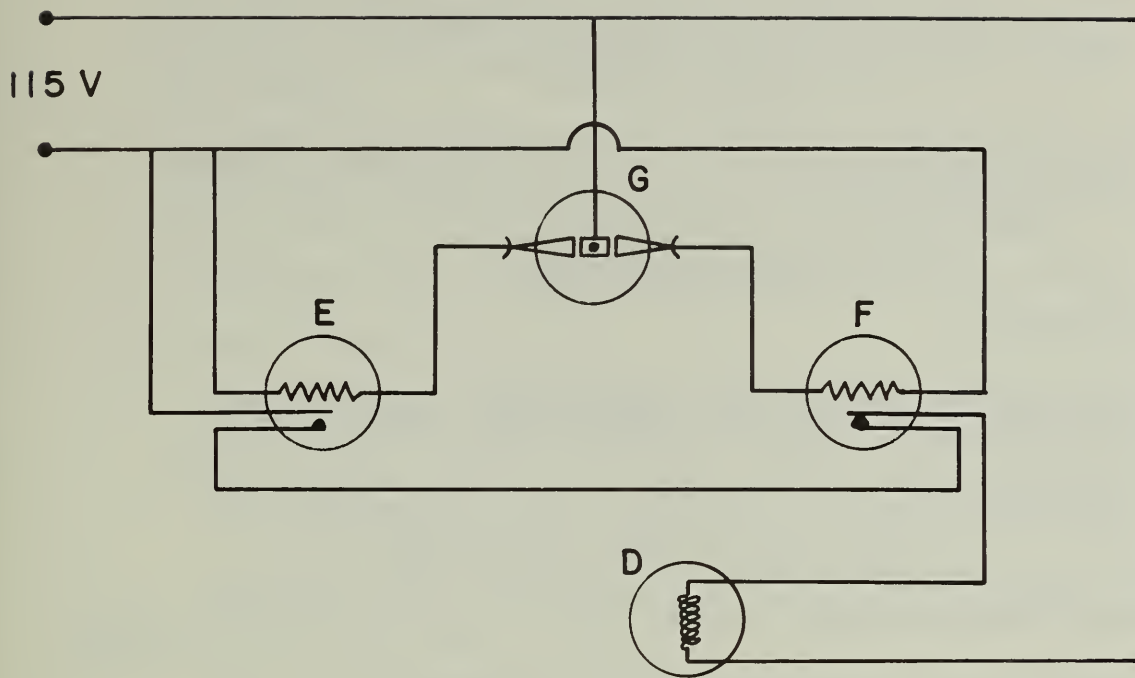
#### PLACEMENT AND DIMENSIONS OF HEATING ELEMENT IN TEST TUB

MATERIAL: Type L Copper Water Tube

- A. Steam Trap Safe for Use at Line Pressure --Opens to Discharge Condensate into Test Tub
- B. Thermostat and Recorder Sensor Location Approx, Mid-depth and Mid-length, 2" to 4" from Wall
- C. Riser, 3/4" Copper or Brass Pipe
- D. Solenoid Operated Steam Valve, Nominal 3/4" Dia.
- H. Pump Capable of Circulating 10 gpm through Suction and Discharge Lines.

FIG. 2.18-1 APPARATUS FOR HOT WATER RESISTANCE TEST.

D - SOLENOID OPERATED STEAM VALVE, NOMINAL 1" DIA.

E - 45 SEC. TIME DELAY RELAY, CONTACTS N.O.

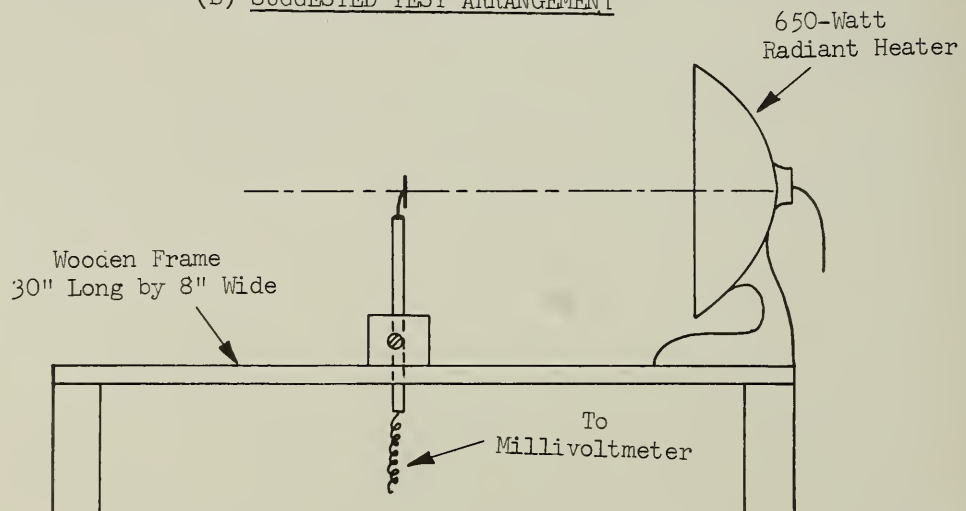
(A) BLACK-PANEL RADIOMETER

Note: Black paint to be sprayed to a thickness of 0.002". Abrade surface prior to spraying with 400C silicon carbide paper.

(B) SUGGESTED TEST ARRANGEMENT

Figure 10-1. Black-panel radiometer probe and suggested arrangement for calibration of radiant heater.

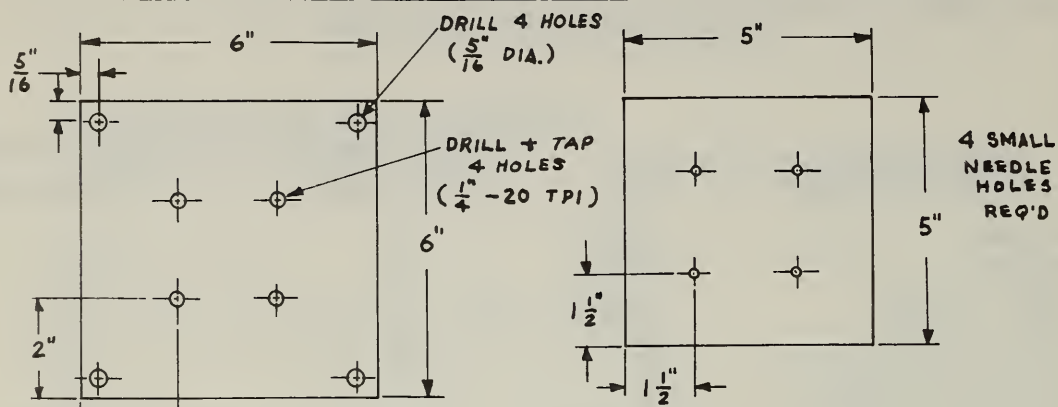
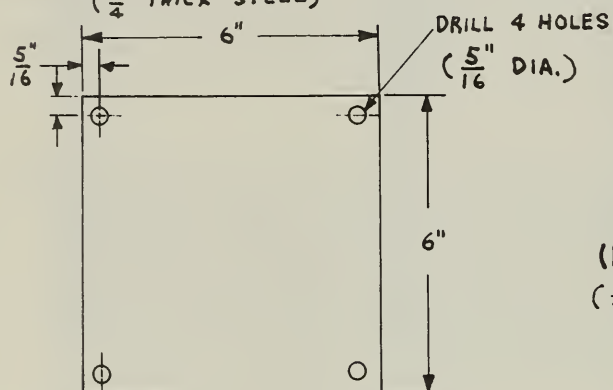
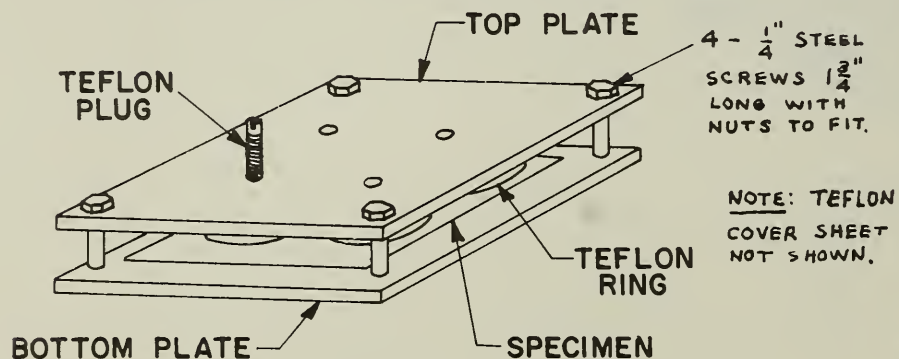
2.22-1

(A) TOP PLATE  
( $\frac{1}{4}$ " THICK STEEL)

(C) TEFLON COVER SHEET ( $\frac{1}{16}$ " THICK TEFLON)

(B) BOTTOM PLATE  
( $\frac{1}{4}$ " THICK STEEL)

(E) TEFLON PLUG  
( $\frac{1}{4}$ " DIA., 20 TPI, 1" LONG, 4 REQ'D)

(F) ASSEMBLY

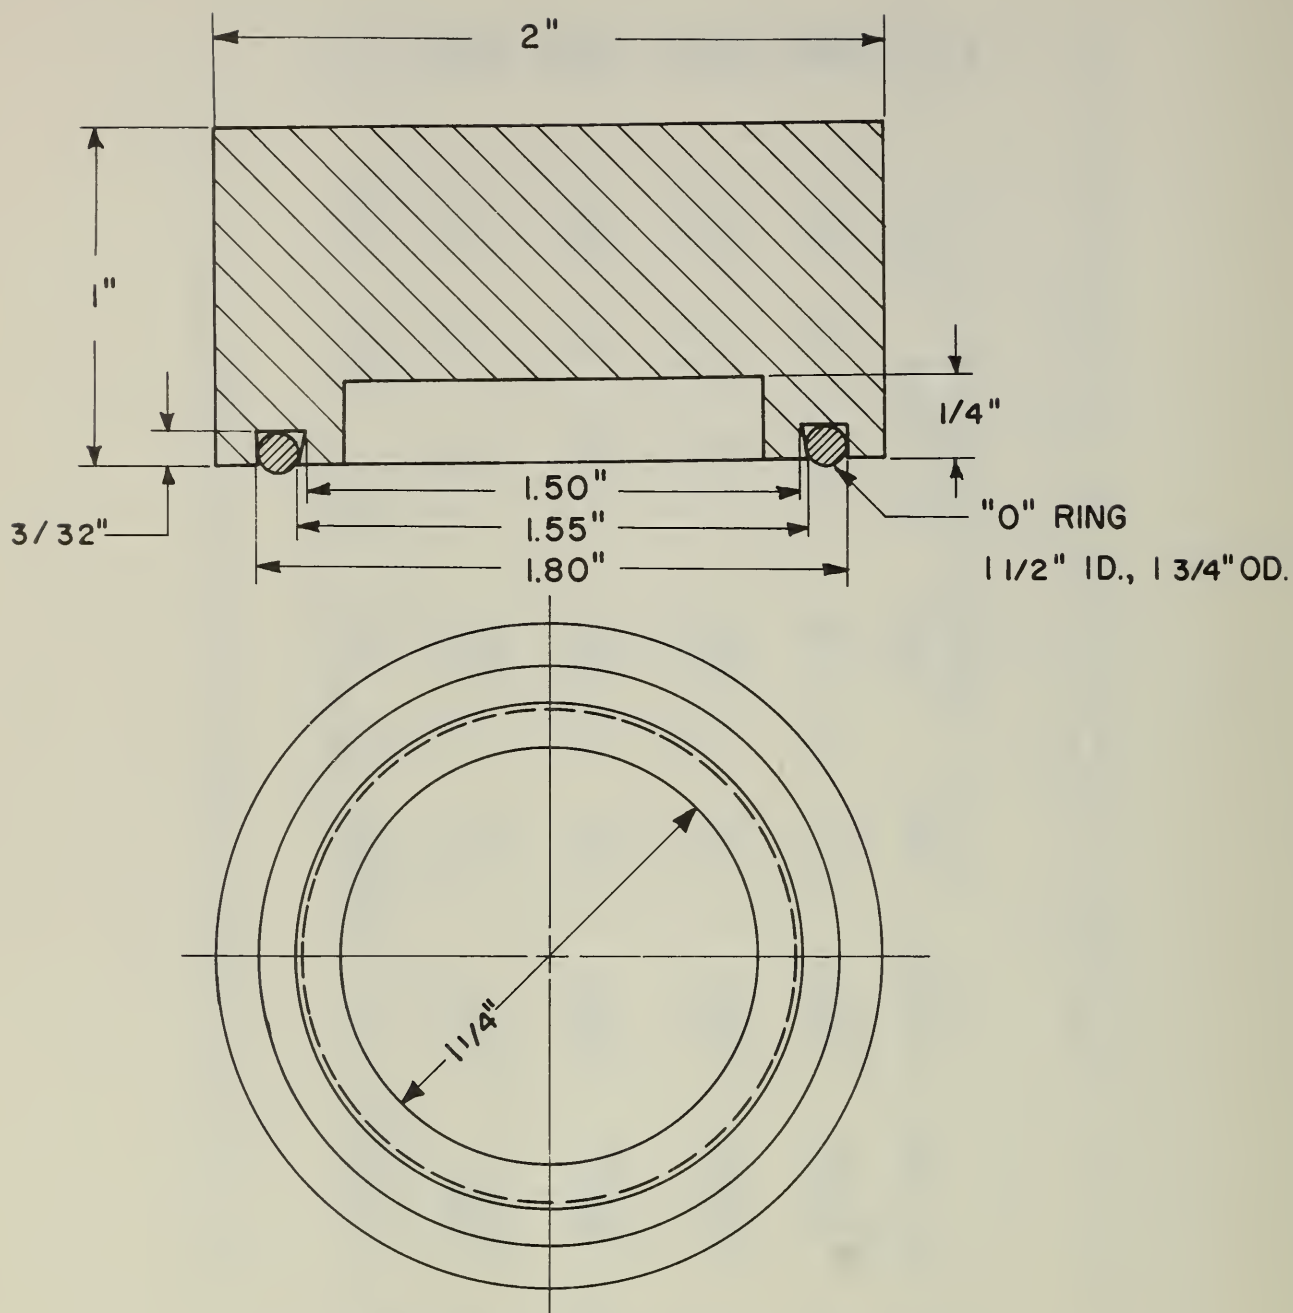
Fig. 2.23-1 Brass cover block for stain testing
