# NATIONAL BUREAU OF STANDARDS REPORT

A Stub Approach Beacon

February 1966

Bureau of Naval Weapons

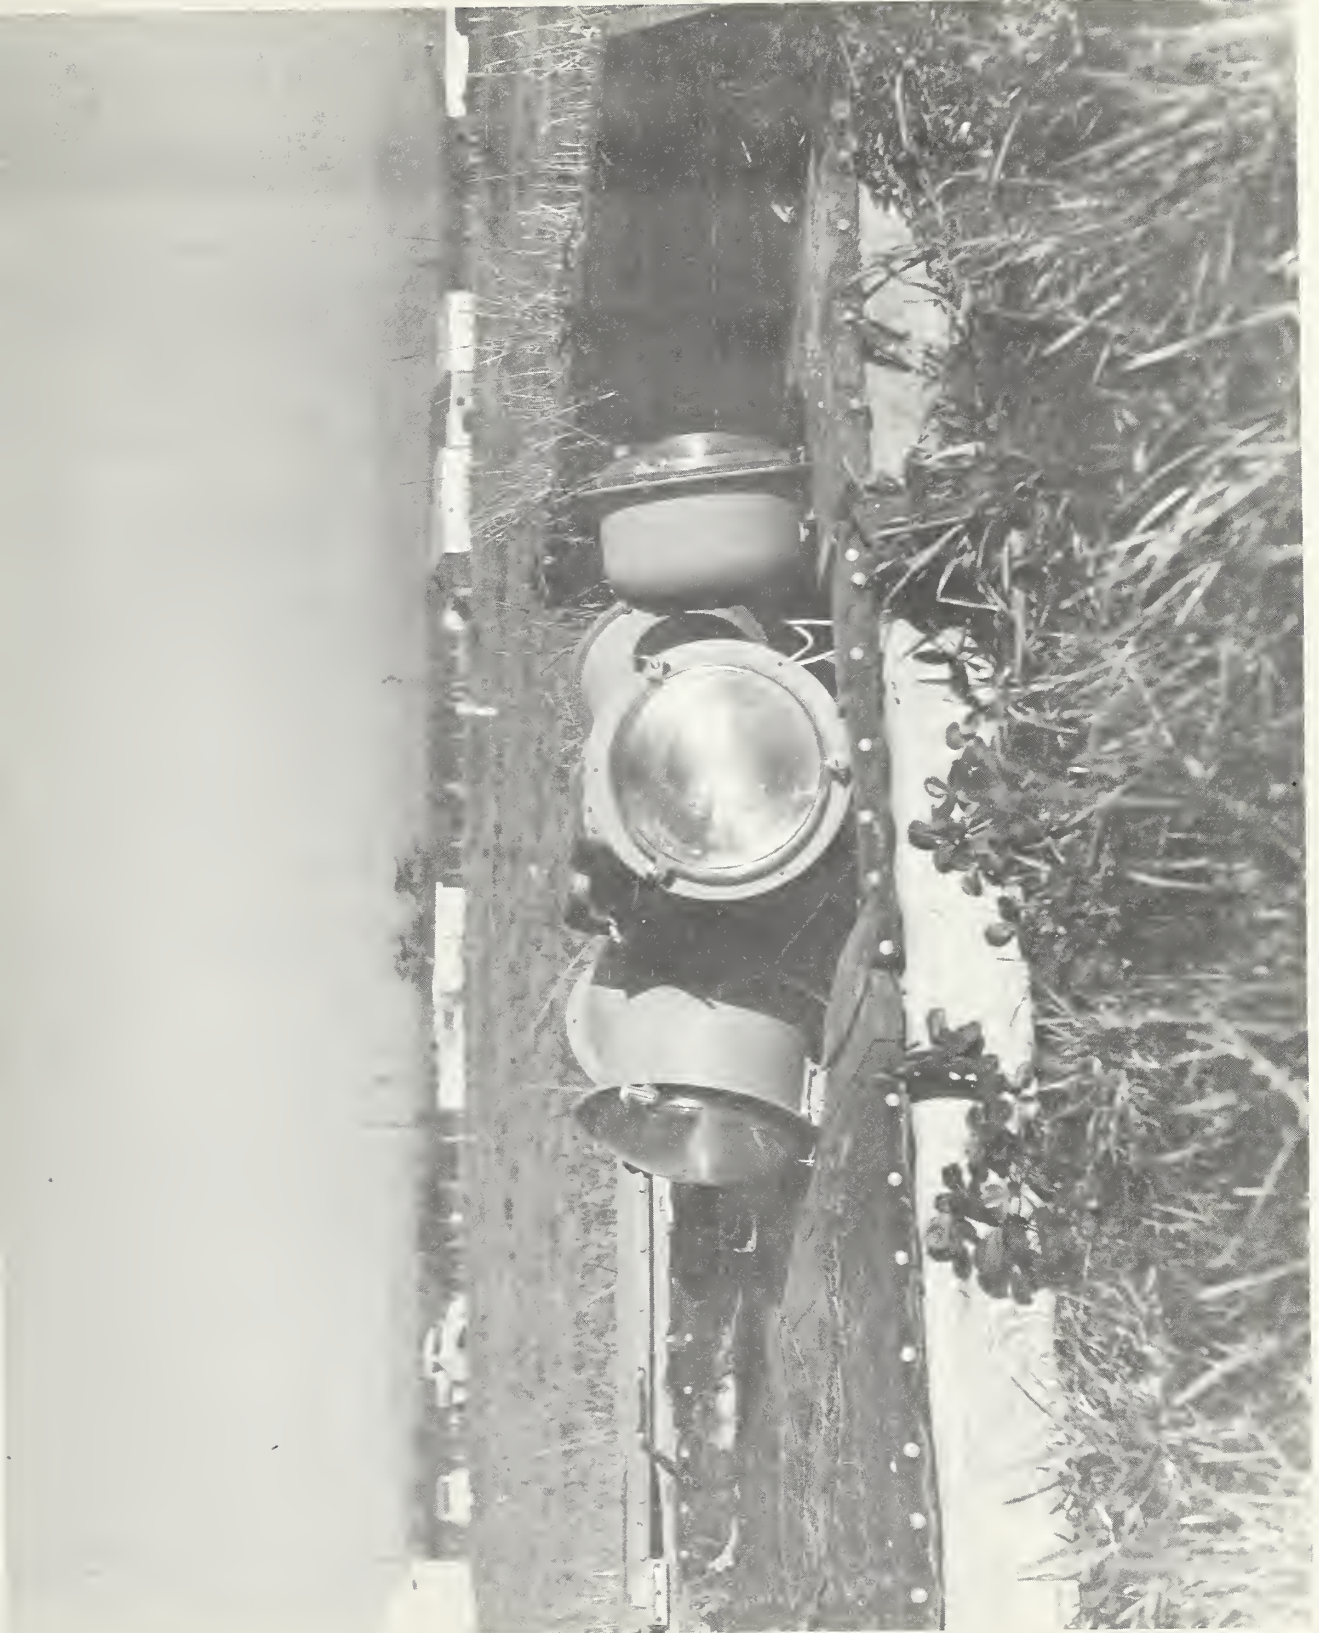
Preferably the stub approach beacon should be placed in the approach zone on the extended runway centerline at a sufficient distance from the threshold so that the light will not be an obstruction and so that it will not cause distortion of the localizer beam of the instrument landing system (ILS) if the antenna of such a system is located in the area. This was not possible at the end of runway 13 at Arcata because of a bluff some 400 feet from the threshold. Therefore, an underground installation with only the lamps extending above the ground surface was required. Fortunately there was a conveniently prepared site on the approach to runway 13 on the extended runway centerline 380 feet from the threshold at the entrance to the underground vault beneath the concrete slab for the old dismantled localizer antenna shelter. The beacon base was suspended in this entrance by hangers prepared from strap steel, at a height such that the lamps and lampholders were the only parts of the beacon above the surface of the concrete slab, as shown in figure 1. The beacon was only 75 feet beyond the ILS localizer antennas.

With the approach beacon located so close to the localizer antennas, there was a possibility that it might affect the localizer signal, not so much from the exposed mass of the beacon as from the reflectors of the lamps if the turntable should be stopped in certain positions. To eliminate the possibility of interference, a simple shield was installed. The shield consisted of a 1-inch by 12-inch board five feet long, wrapped in fine-mesh chicken wire. The shield was placed very near the beacon on the runway side. The top was tilted back toward the beacon approximately 20 degrees. Then earth was smoothly mounded up against the shield on the localizer side. The length of this shield was selected to screen the outer antennas of the localizer from any exposed part of the beacon. The shield, in addition to protecting from localizer interference, served as a glare shield for the runway and taxiway. The length of the shield was kept to the minimum

Figure 1. The stub approach beacon and shield.

needed to prevent glare and ILS interference in order to provide the maximum feasible horizontal coverage.

The light from the beacon should be visible throughout all permissible horizontal angles. A light shield may be required on the back side toward the runway and nearby taxiways to prevent objectionable glare. The size of the shield should be the minimum required. An electromagnetic shield may be required for some installations to prevent interference with electronic signals such as the ILS localizer. This may require installing the beacon below ground, with only the light sources above the surface, and placing a shield between the beacon and the electronic signal source. The shield should be the minimum size required to prevent interference.
