# NATIONAL BUREAU OF STANDARDS REPORT

9895

## THE PERFORMANCE CONCEPT

### Its Application to Hospital Floor Coverings

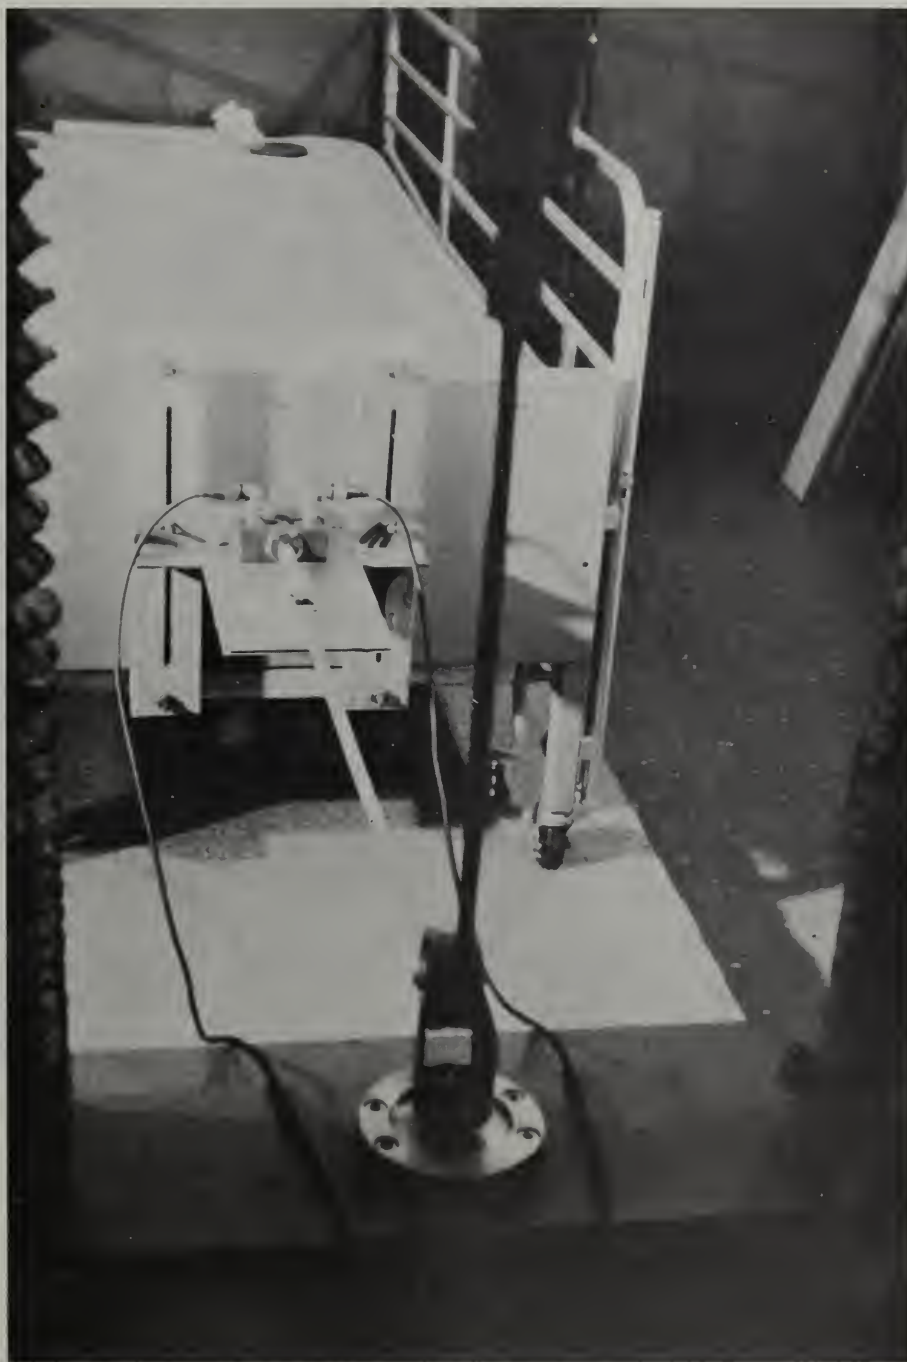
Figure 1. Equipment for testing resistance to wheeled equipment. Platform with carpet; hospital bed and connections to load cell, pulley, crosshead of load-strain testing machine.

Because of its availability it was decided to use a manual type bed for laboratory studies of rolling friction. Measurements were made with the empty bed and with 300 pounds weight. Casters used in the study were new, 5 inches in diameter, 1-inch tread. Two sets of casters (four in each set) were used, one being made of hard rubber (recommended for carpet) and the other set made of soft rubber (recommended for smooth floor coverings). Tests were performed using a load-strain testing machine. A load cell was connected to the foot of the bed and attached to the crosshead by means of a pulley and cable arrangement. Tests were performed at a crosshead speed of 50 cm. per minute, with the casters or wheels aligned in the direction of pull. Floor coverings were cemented on plywood, with the exception of stretched carpet, and the plywood leveled by means of wooden shims. The equipment and alignment of the casters are illustrated in Figures 1-4.

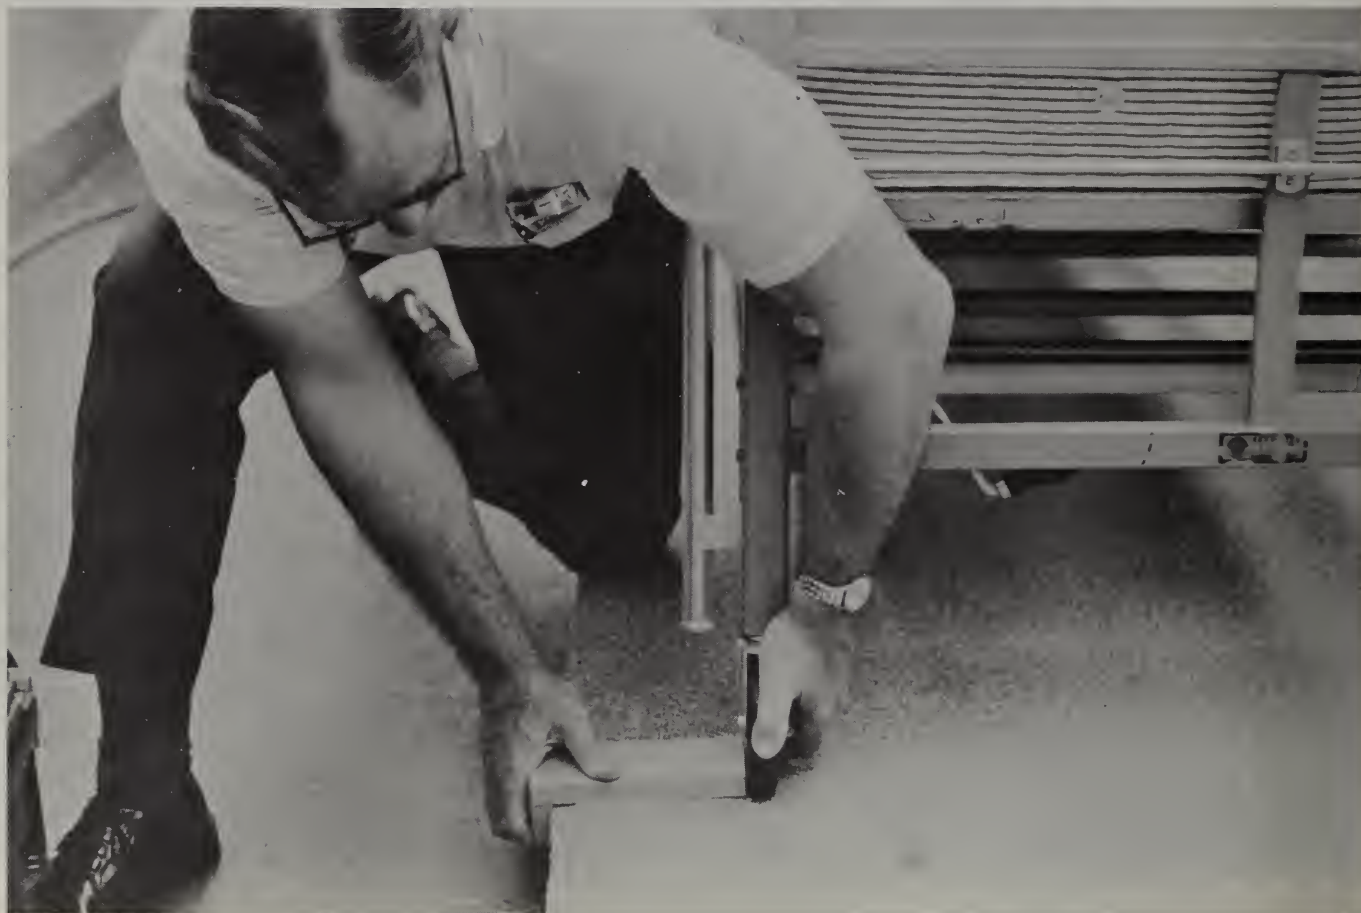
Figure 4. Alignment of casters

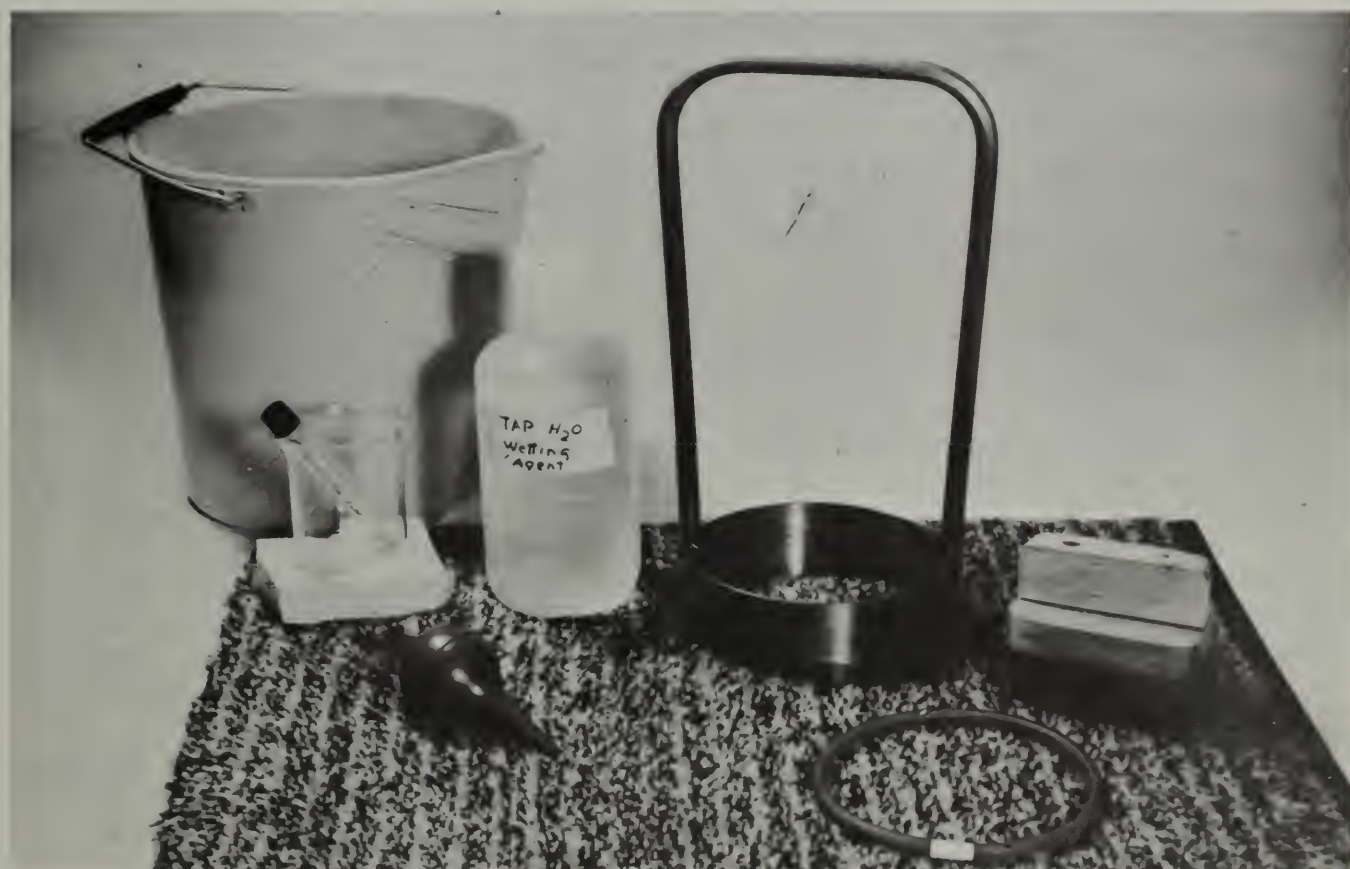
Figure 7. Device for sampling floor dirt
