NBS SPECIAL PUBLICATION **658**

Wind and Seismic Effects

Proceedings of the
Eleventh Joint UJNR
Panel Conference

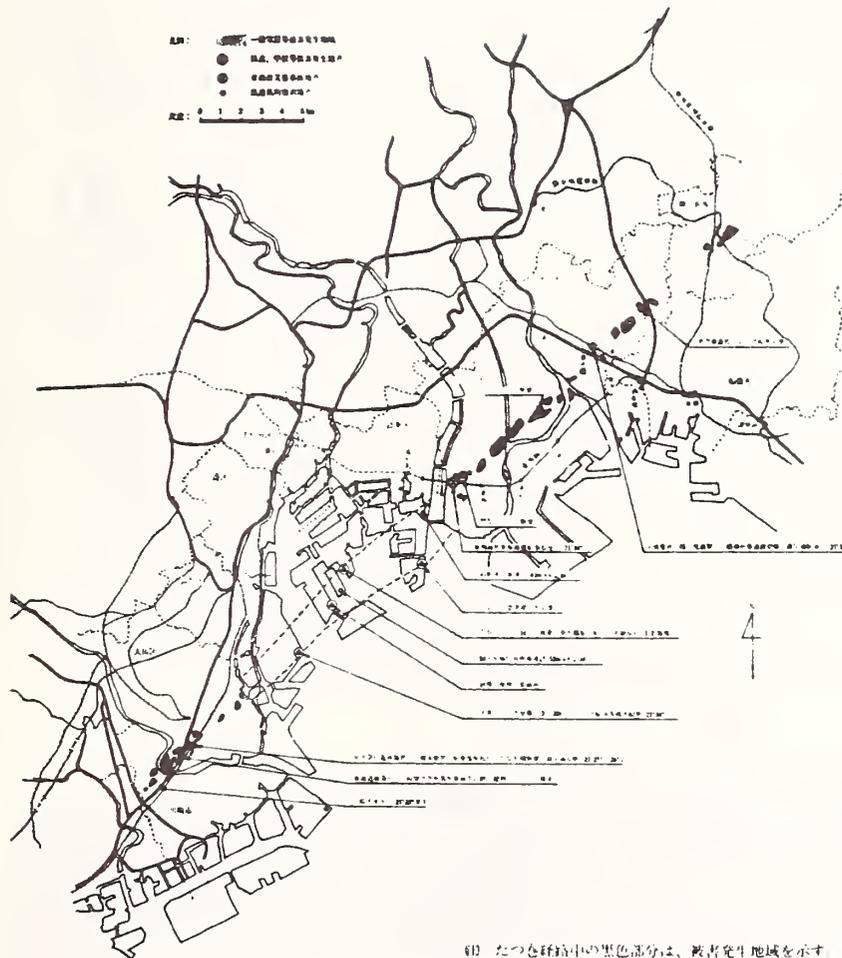
Fig. 3 A schematic sketch of damage distribution caused by a tornado on Feb. 28, 1978. Black spot areas show severe damage areas¹⁾.

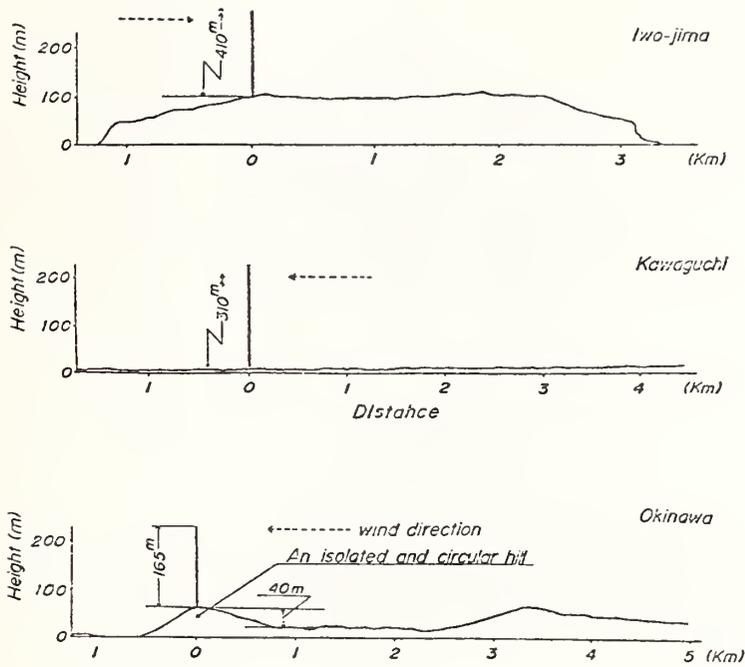
Fig.3 Topographical conditions and observed wind directions around the towers.

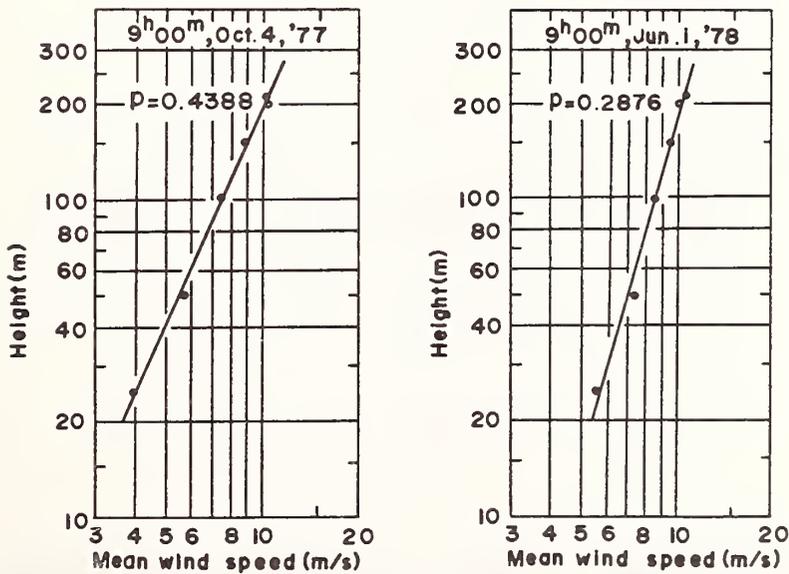
Fig.4 Examples of the vertical profile of the mean wind speed larger than 10m/s at the tower top in Tsukuba Science City.

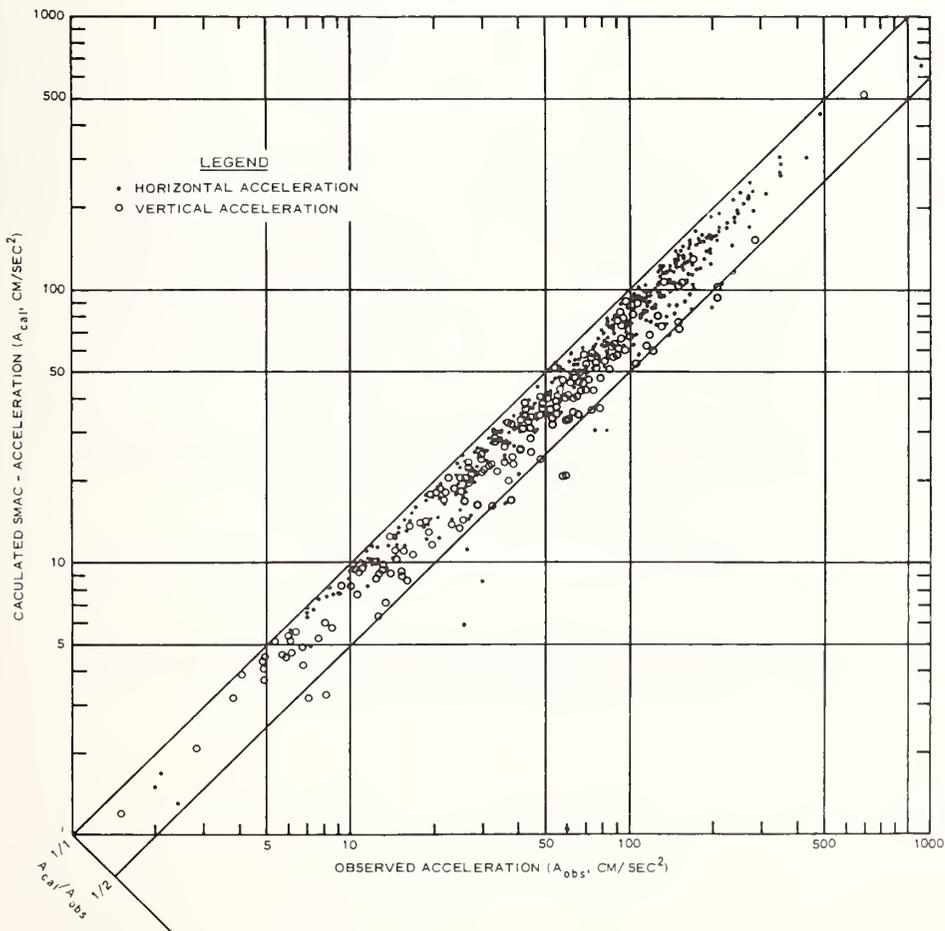
Figure 10. Calculated SMAC Acceleration Versus Observed Acceleration

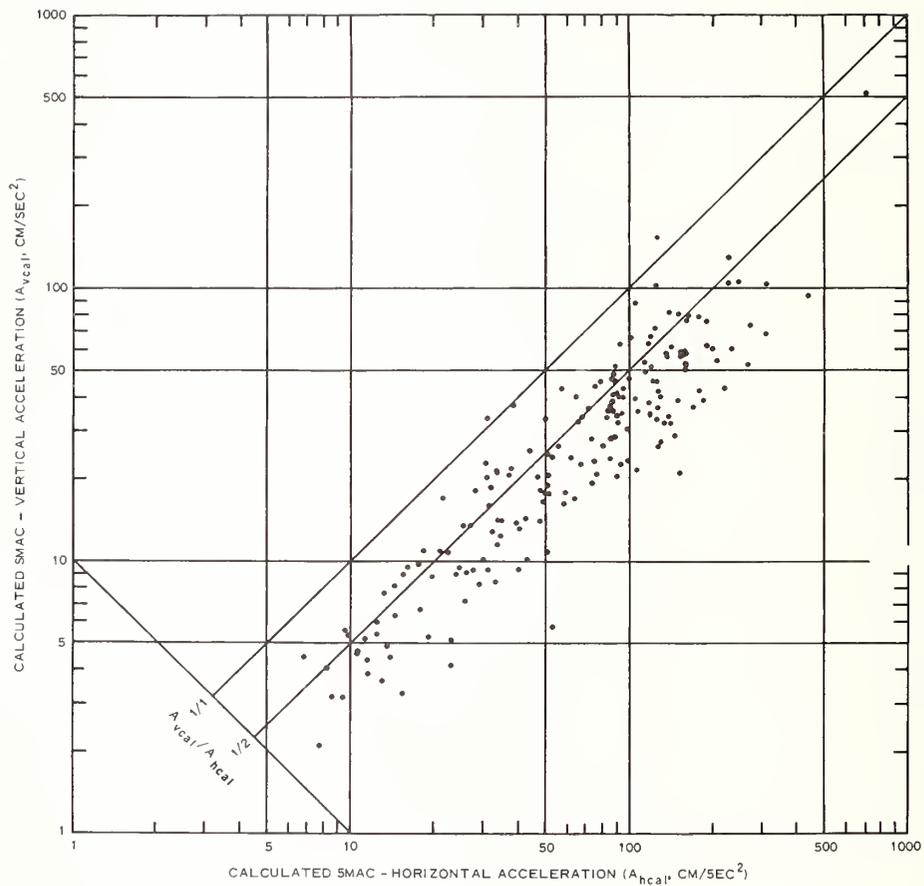
Figure 11. Calculated SMAC Vertical Acceleration Versus Calculated SMAC Horizontal Acceleration

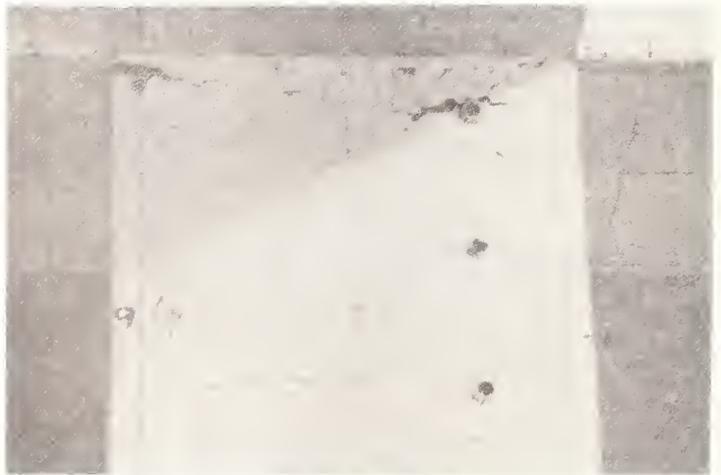
Photo. 3 Damage of the top of column (2nd Frame)

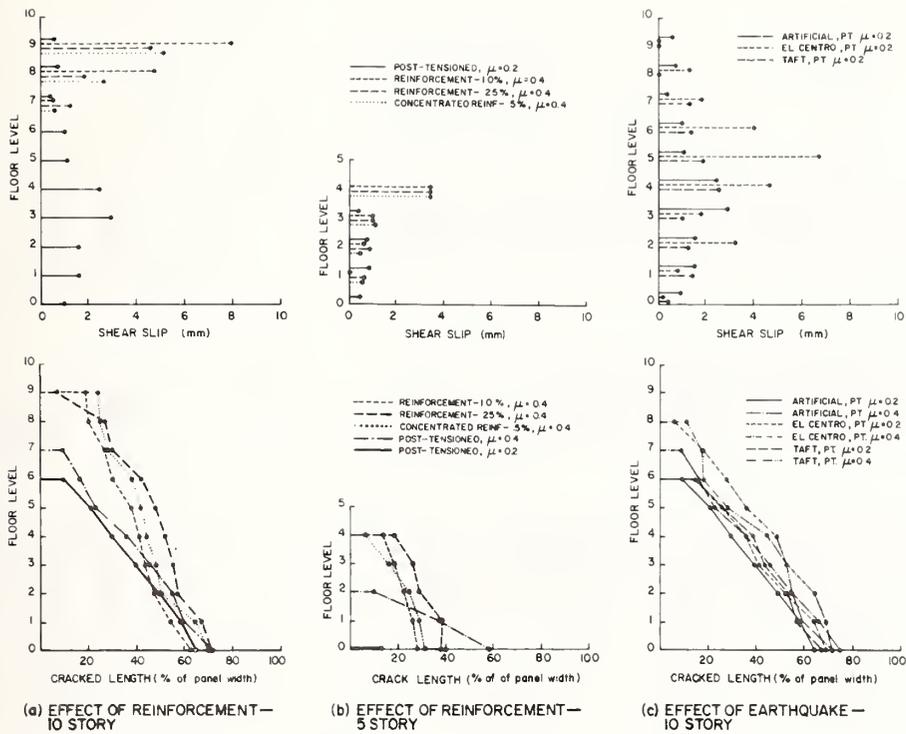
FIGURE 16 EFFECT OF REINFORCEMENT AND EARTHQUAKE ON SHEAR SLIP AND CRACK LENGTH

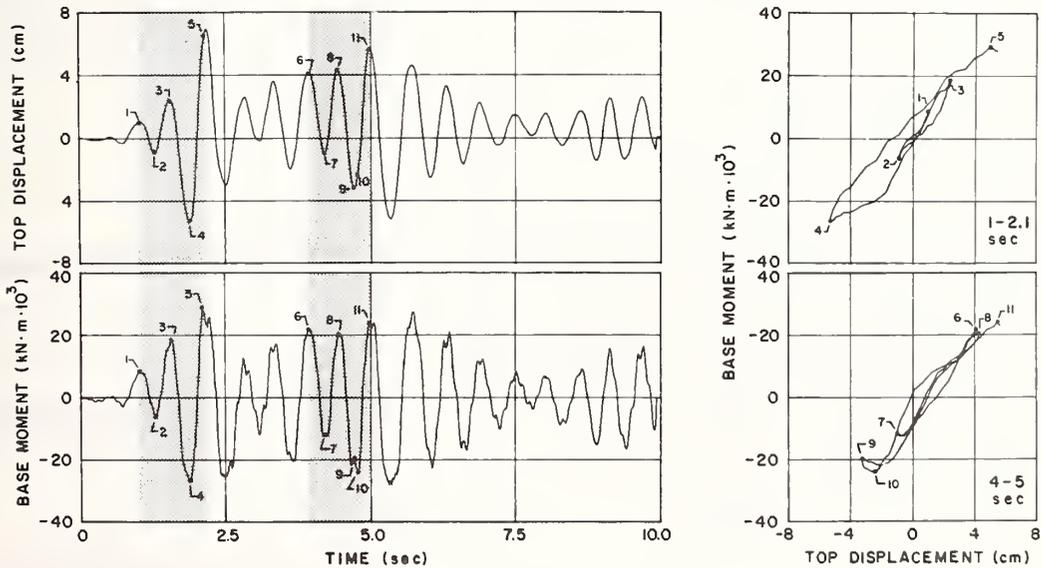
FIGURE 17 BASE MOMENT-TOP DISPLACEMENT RELATIONSHIP, 10 STORY, P.T. $\mu = 0.2$, ARTIFICIAL 0.25g

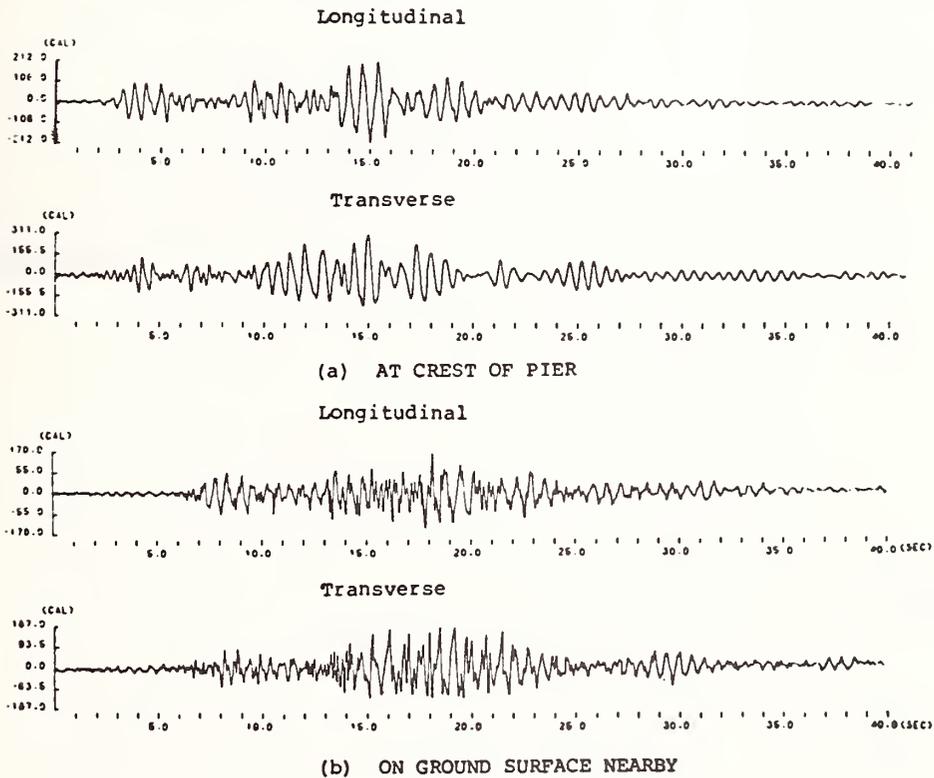
Fig. 4 Acceleration Records At the Itajima Bridge During the Hyuganada Earthquake of April 1, 1968 (A-Earthquake)

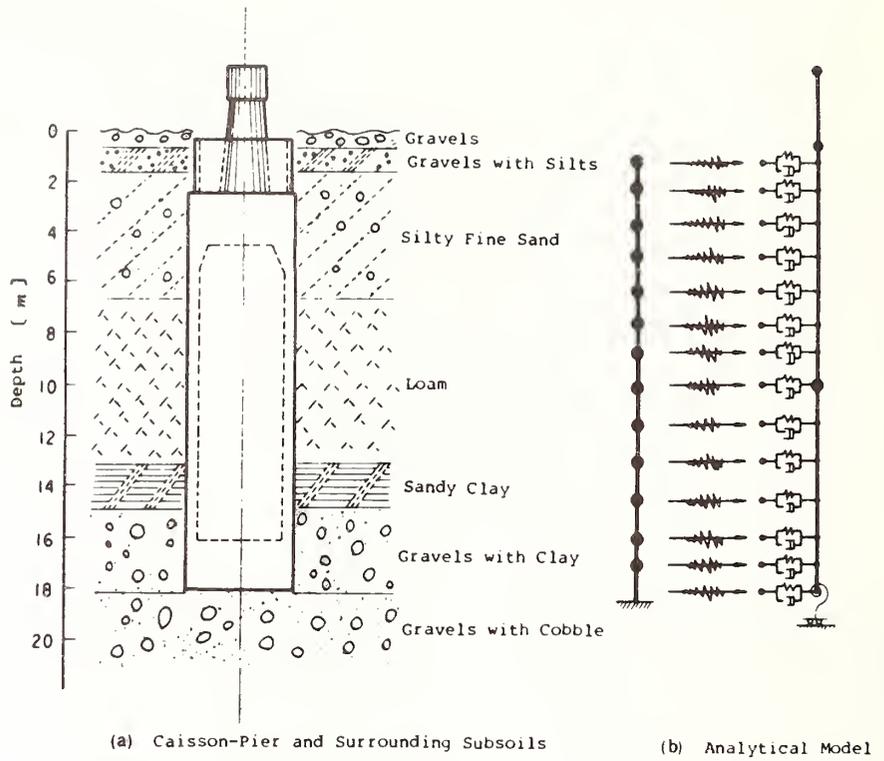
Fig. 13 Analytical Model of Subsoils and Foundation

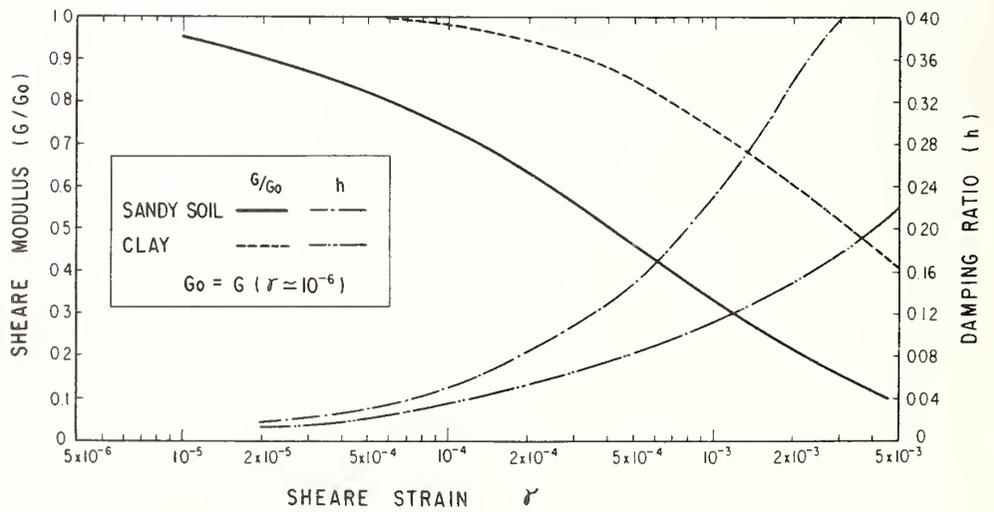
Fig. 14 Shear Strain Dependence of Shear Modulus and Hysteretic Damping Ratio Assumed in Seismic Analyses

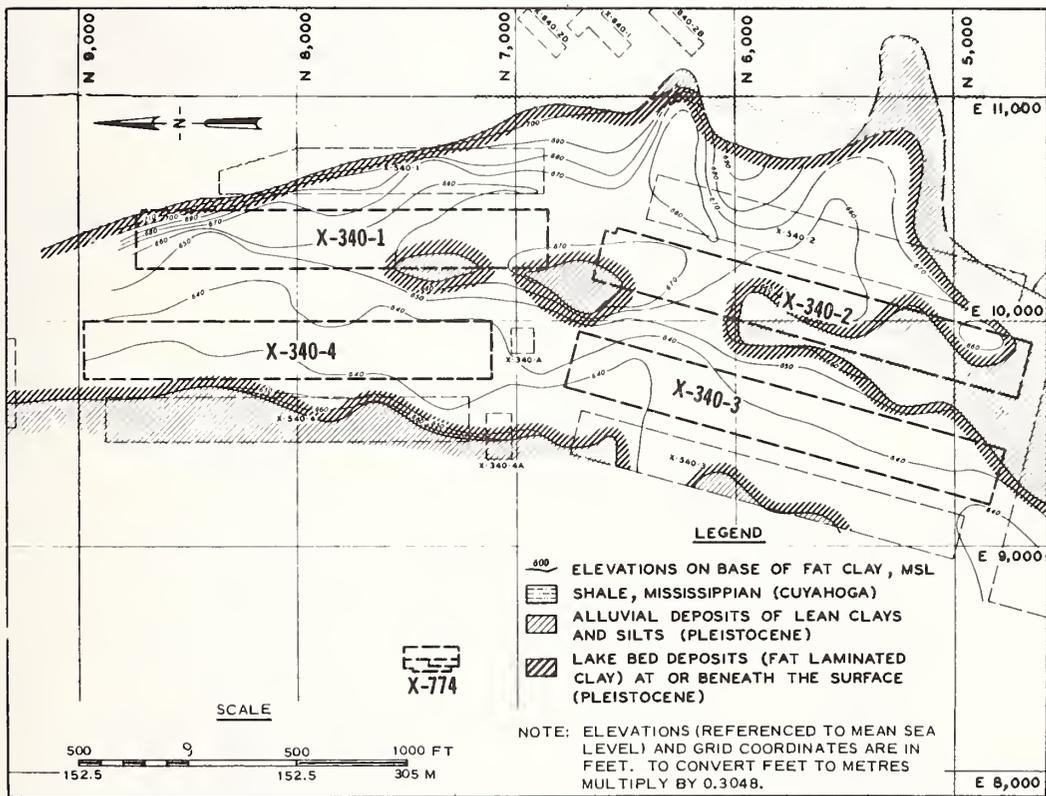
Fig. 2 In Situ Seismic Test Layout, Proposed Building X-340-4 Location

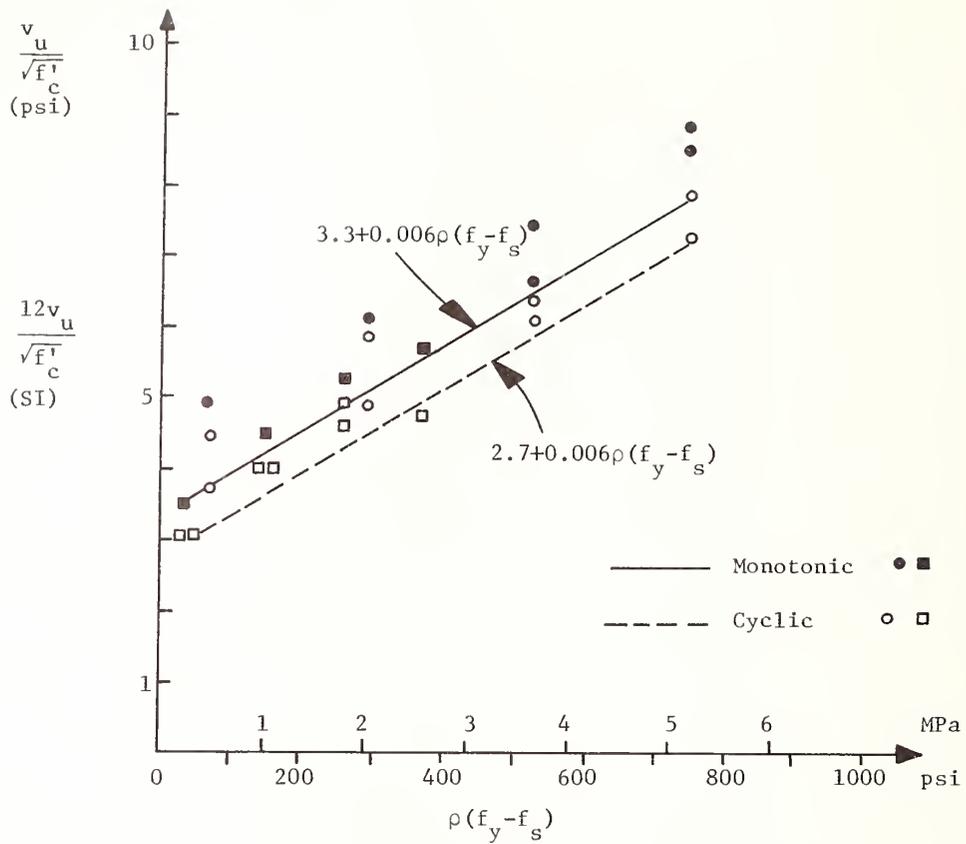
Fig. 3 Diagonal tension strength of biaxially tensioned small scale specimens.

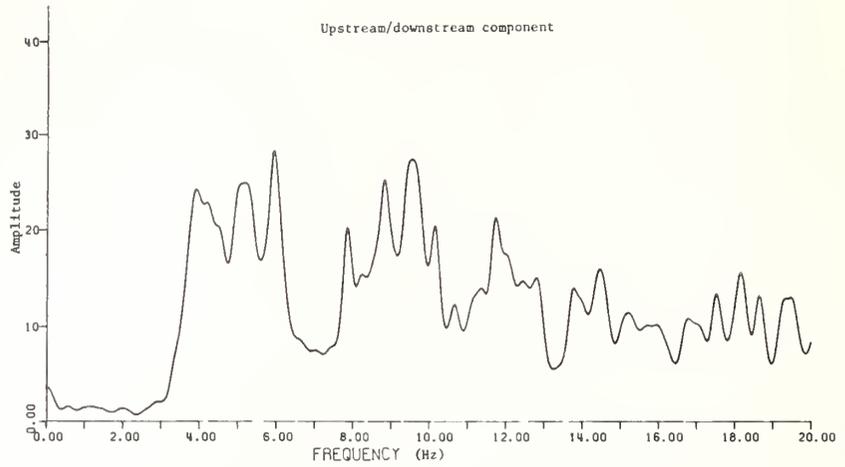
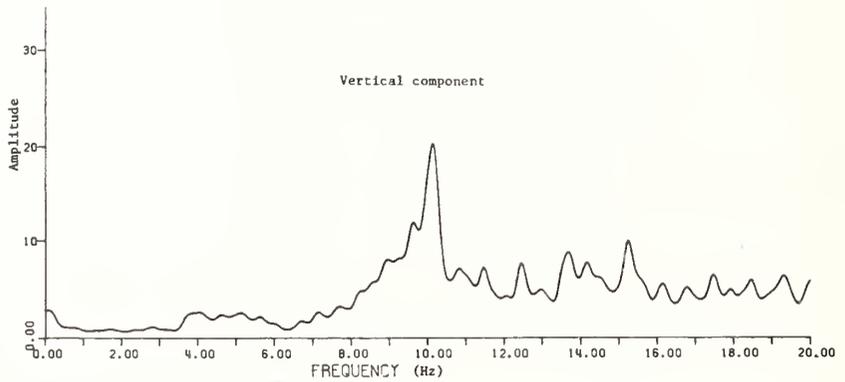
Fig. 18 Frequency response functions for dam crest obtained from recorded accelerograms of the 1978 earthquake

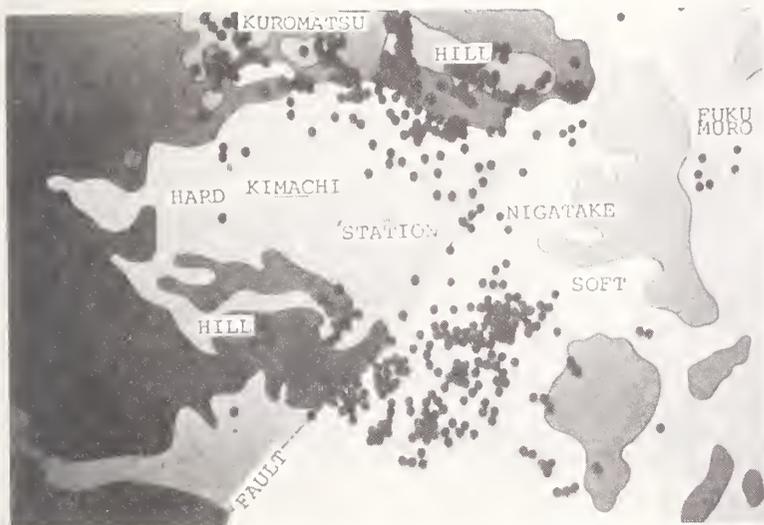
Fig. 11 Damage Distribution of overturned concrete block fences, in Sendai

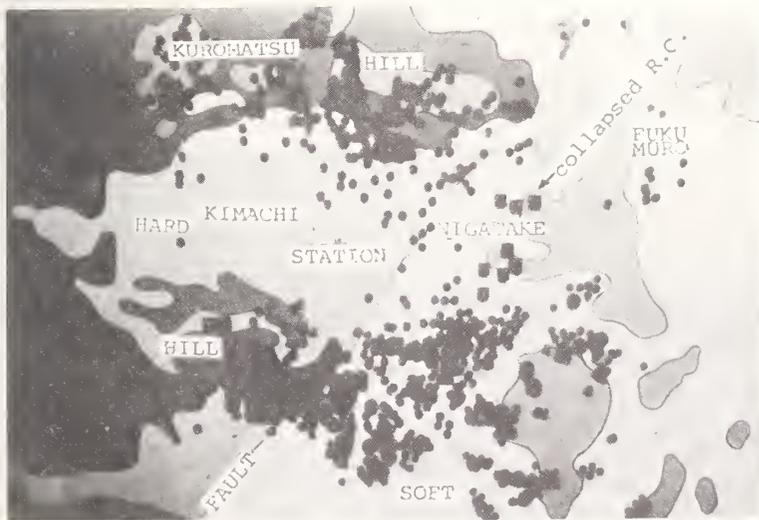
Fig. 12 Damage Distribution of wooden house and collapsed R.C. buildings plus Fig.-11.

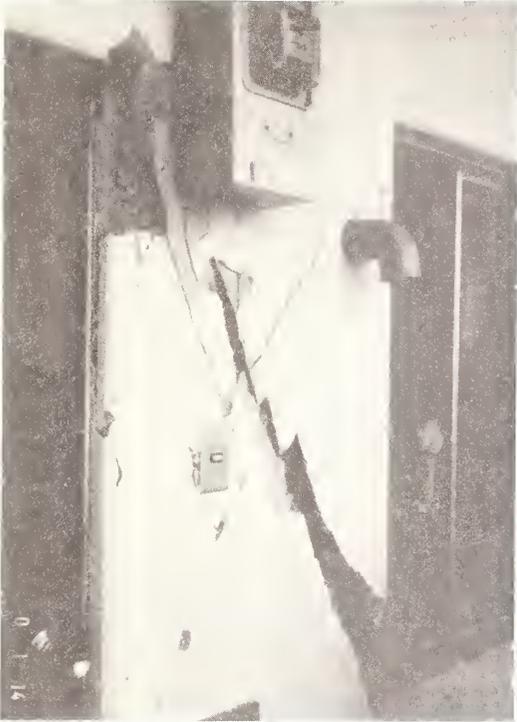
Photo. 1
Damage of Non-structural
Walls in R.C.&Steel Compo
site Apartment Build.

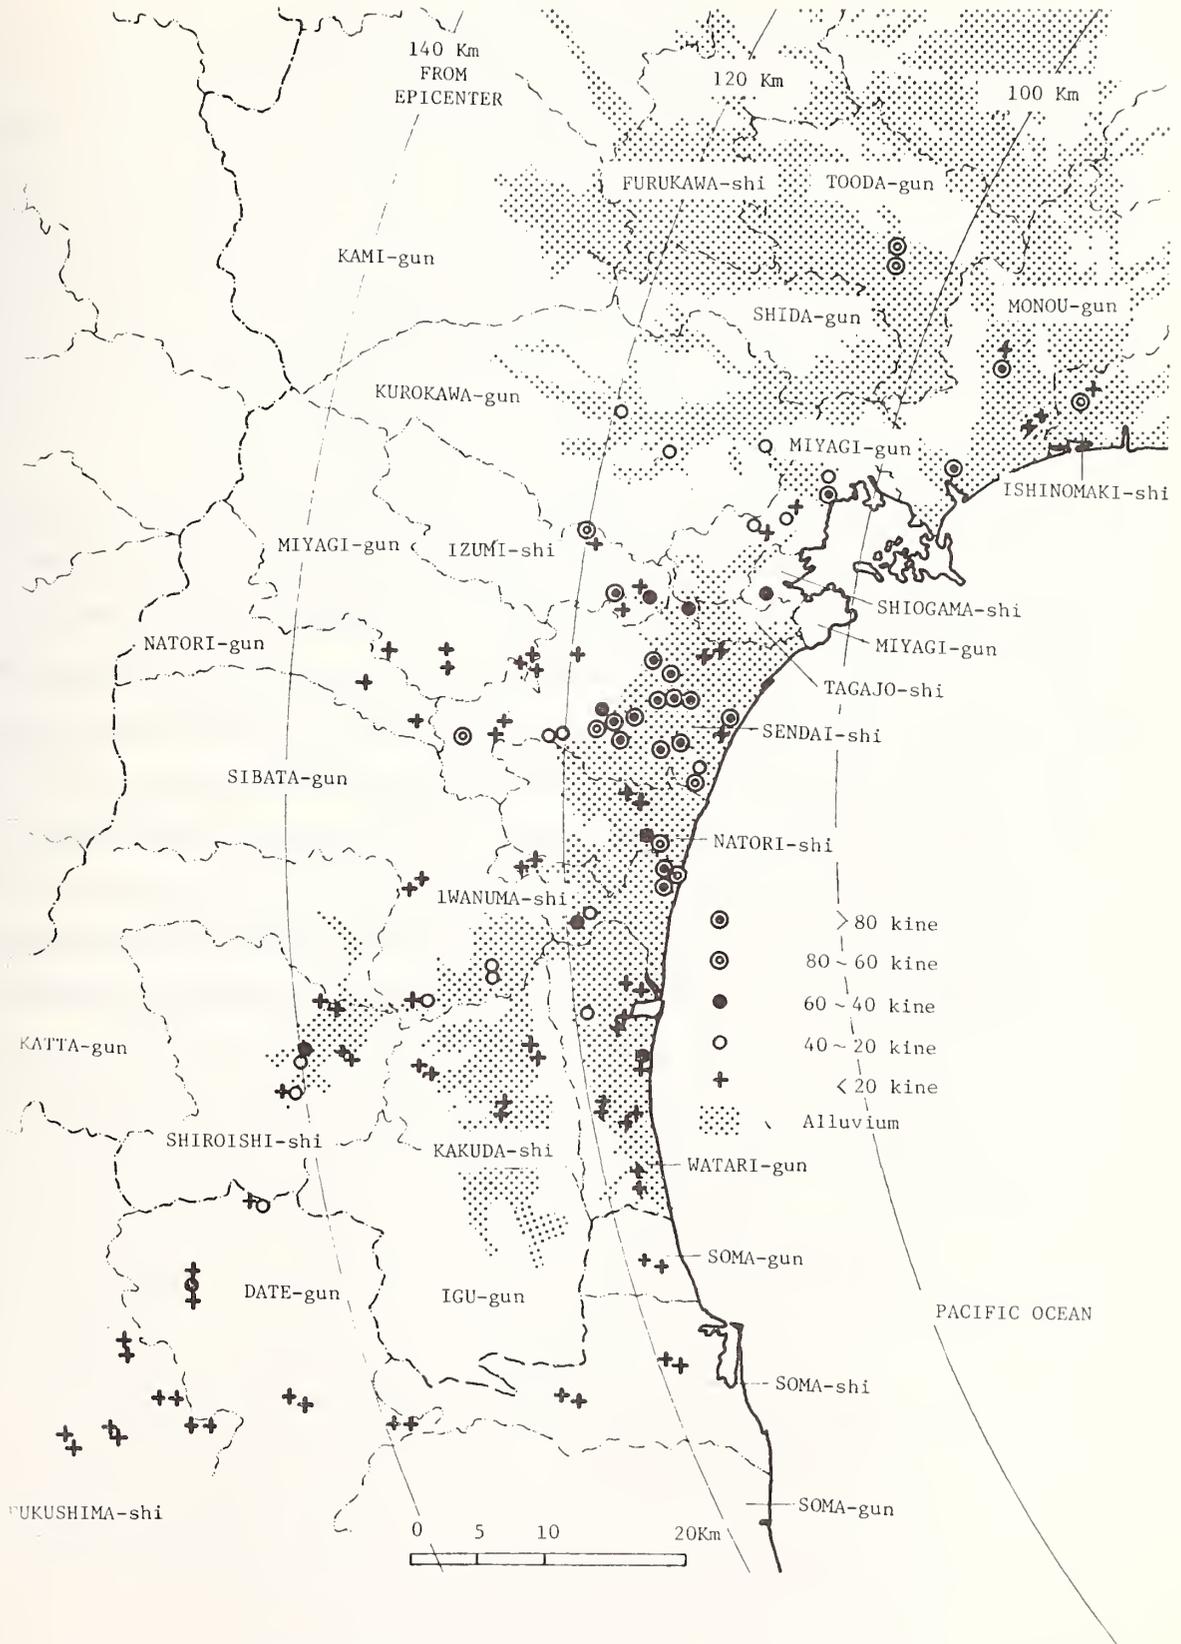
Fig. 19 Velocity Distribution Estimated by Overturning of Furniture
 in THE 1978 MIYAGI-KEN-OKI EARTHQUAKE
 VII-21

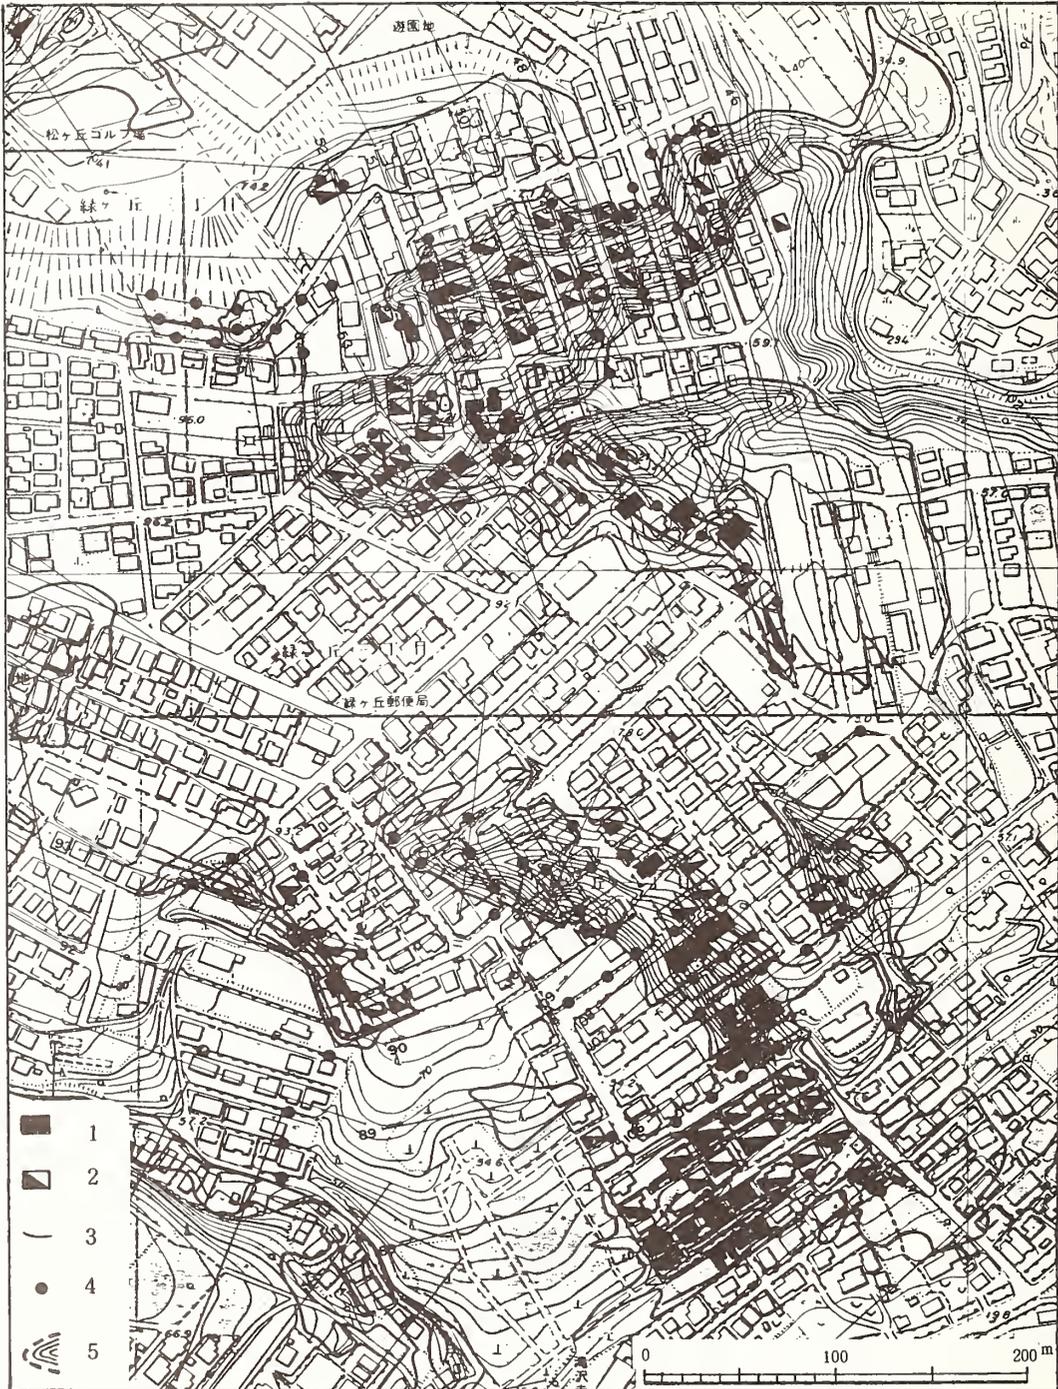
Fig.6 Isopleth map of thickness of artificial fill and the disastrous ground failure (Main Part of Midorigaoka district)

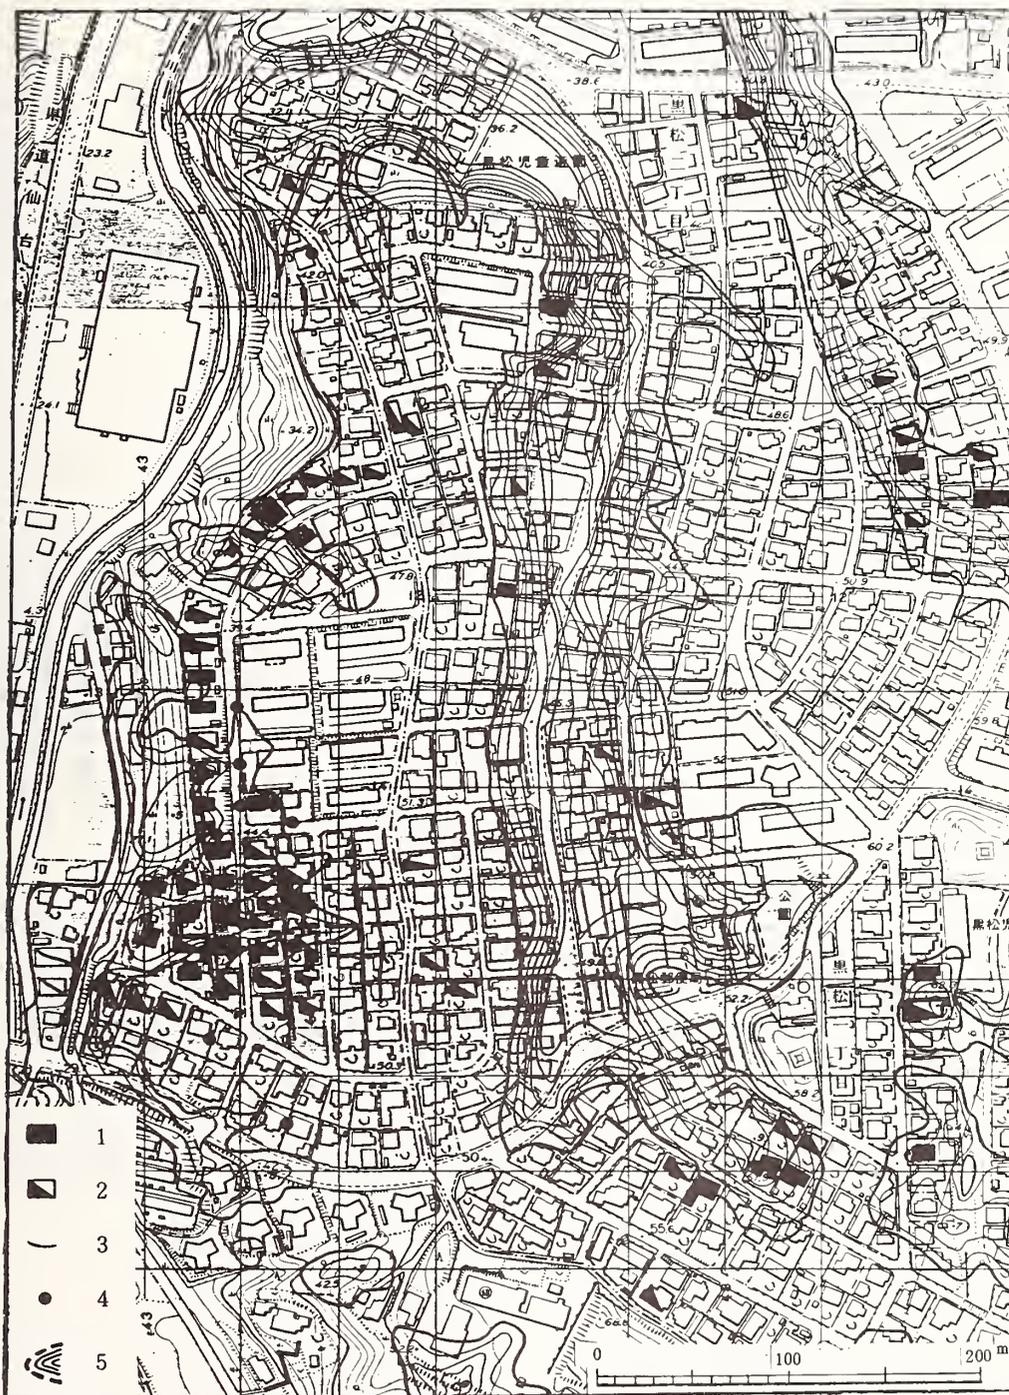
Fig.7 Isopleth map of thickness of artificial fill and the disastrous ground failure (A part of Kuromatsu district)

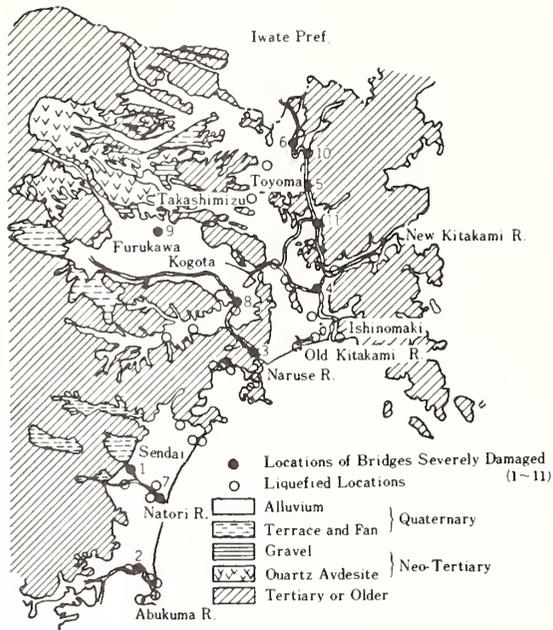
Fig.11 Geological Features and Locations of Major Bridge Damages and Liquefaction Sites

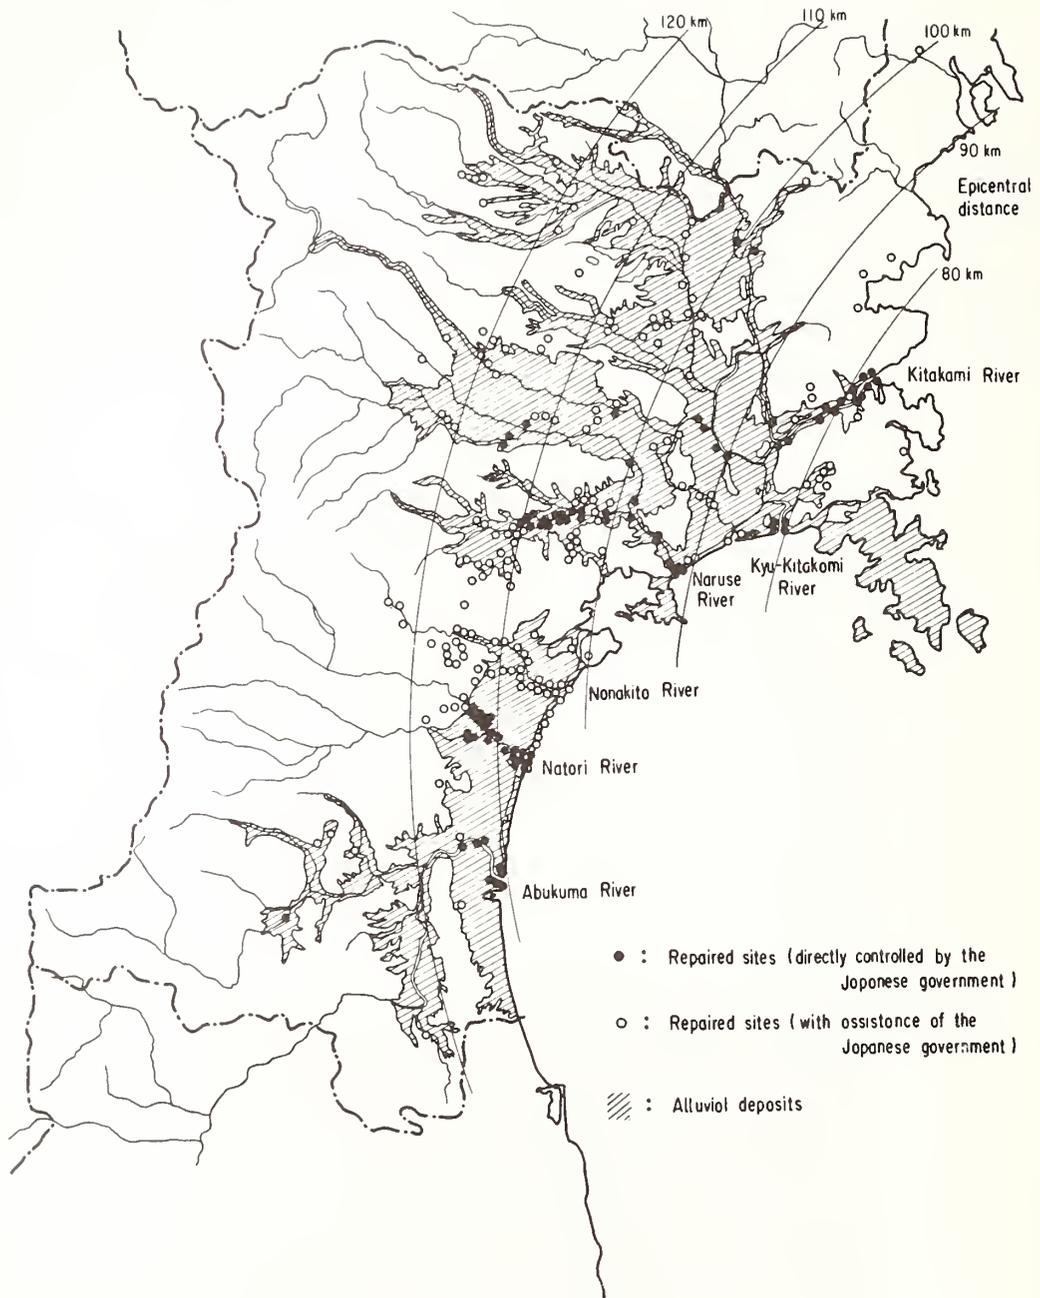
Fig. 1 Damaged sites of river dykes by the Miyagi-Ken-Oki earthquake

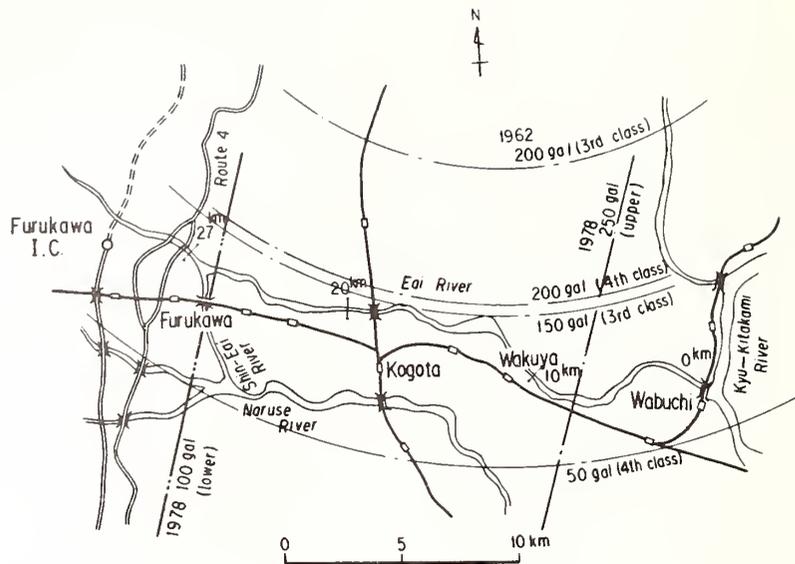
Fig. 3 Estimated acceleration at the ground surface near Eai River by two earthquakes in 1962 and 1978

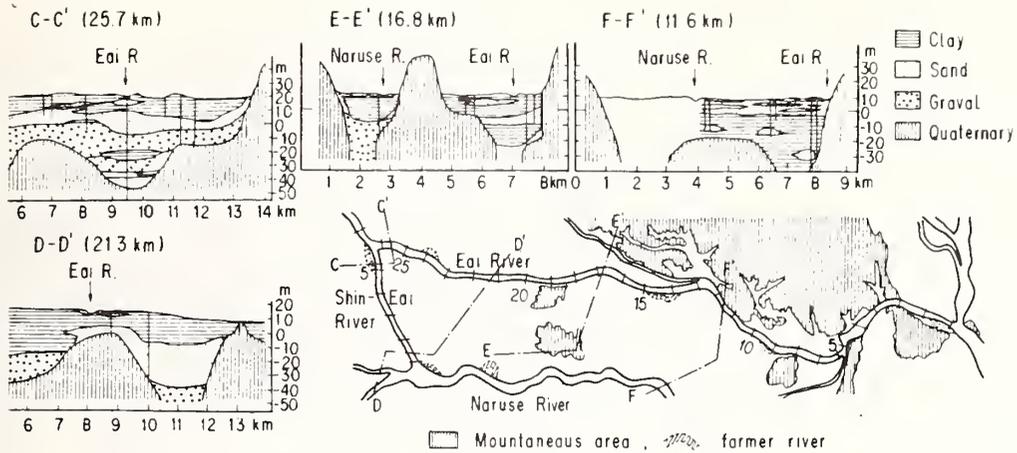
Fig. 4 Geological Profiles Near Eai River

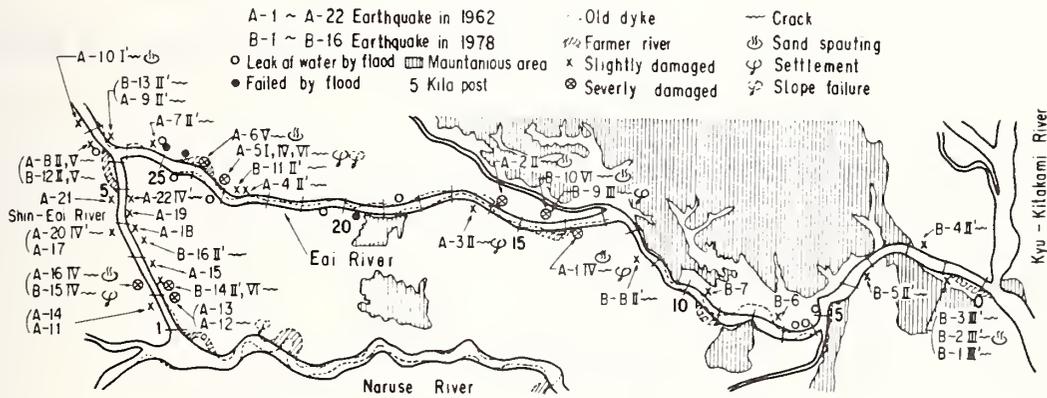
Fig. 5 Damaged Points by the Two Earthquakes in 1962 and 1978

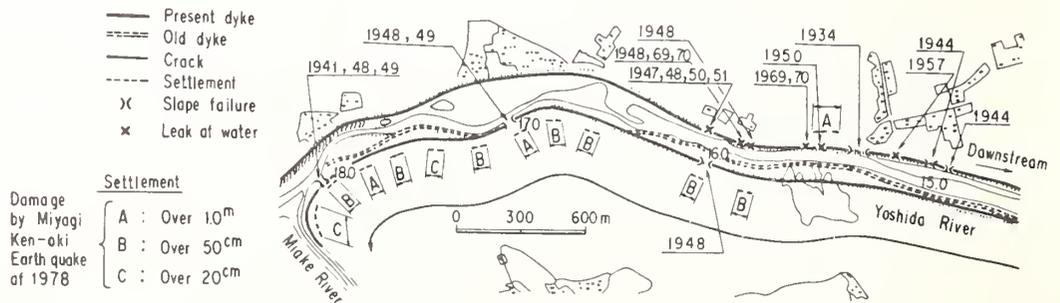
Fig. 8 Distribution of Earthquake Disaster along Yoshida River and Historical View of Slope Failure and Leak of Water by Flood

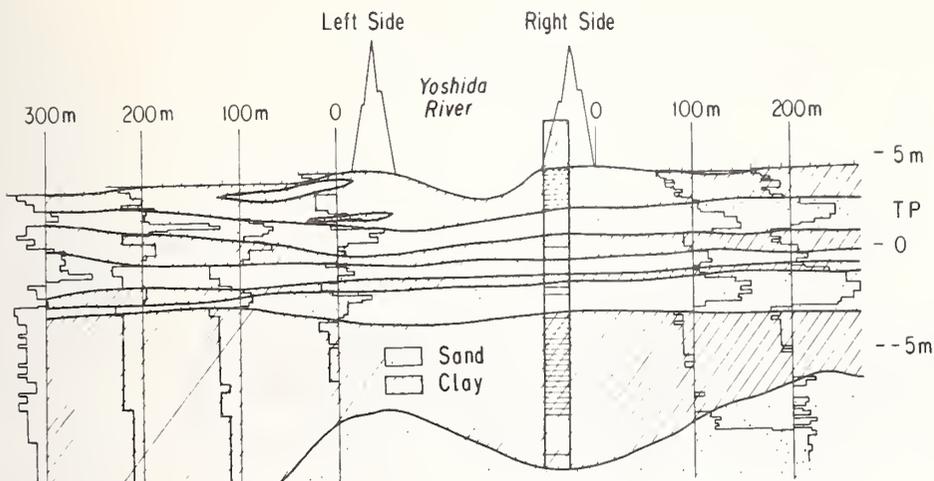
Fig. 9 Cross section of the ground
(Yoshida River)

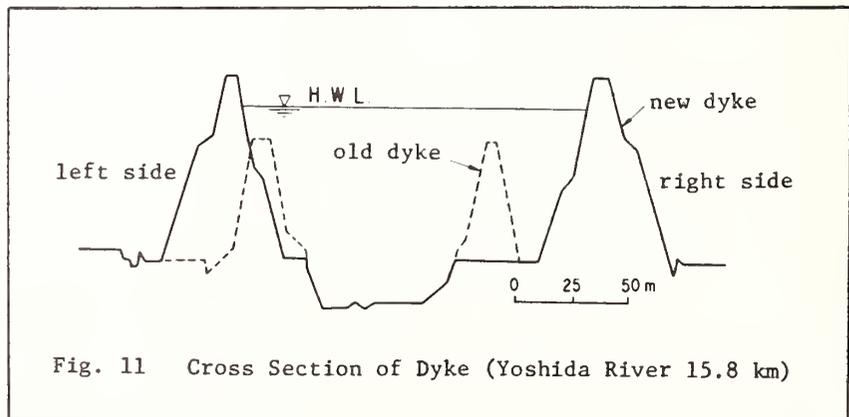
Fig. 11 Cross Section of Dyke (Yoshida River 15.8 km)

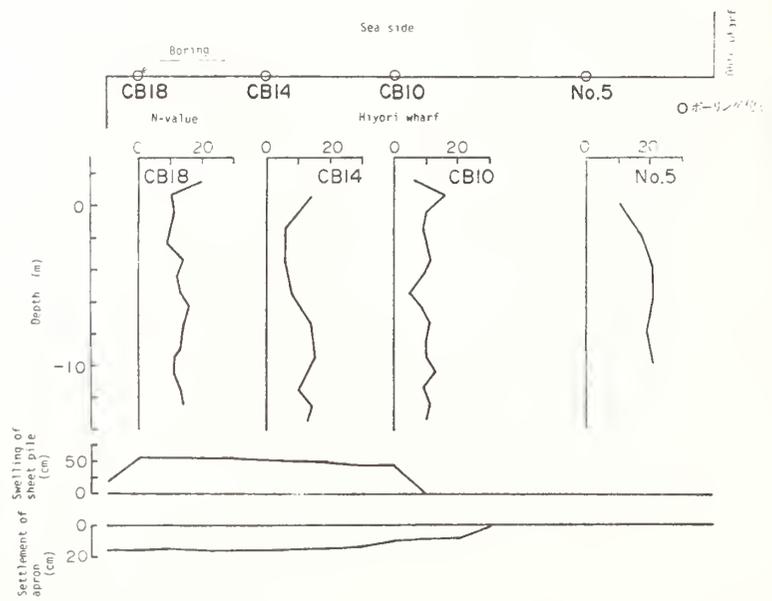
Fig. 21 N-values and Damage (Hiyori Wharf)

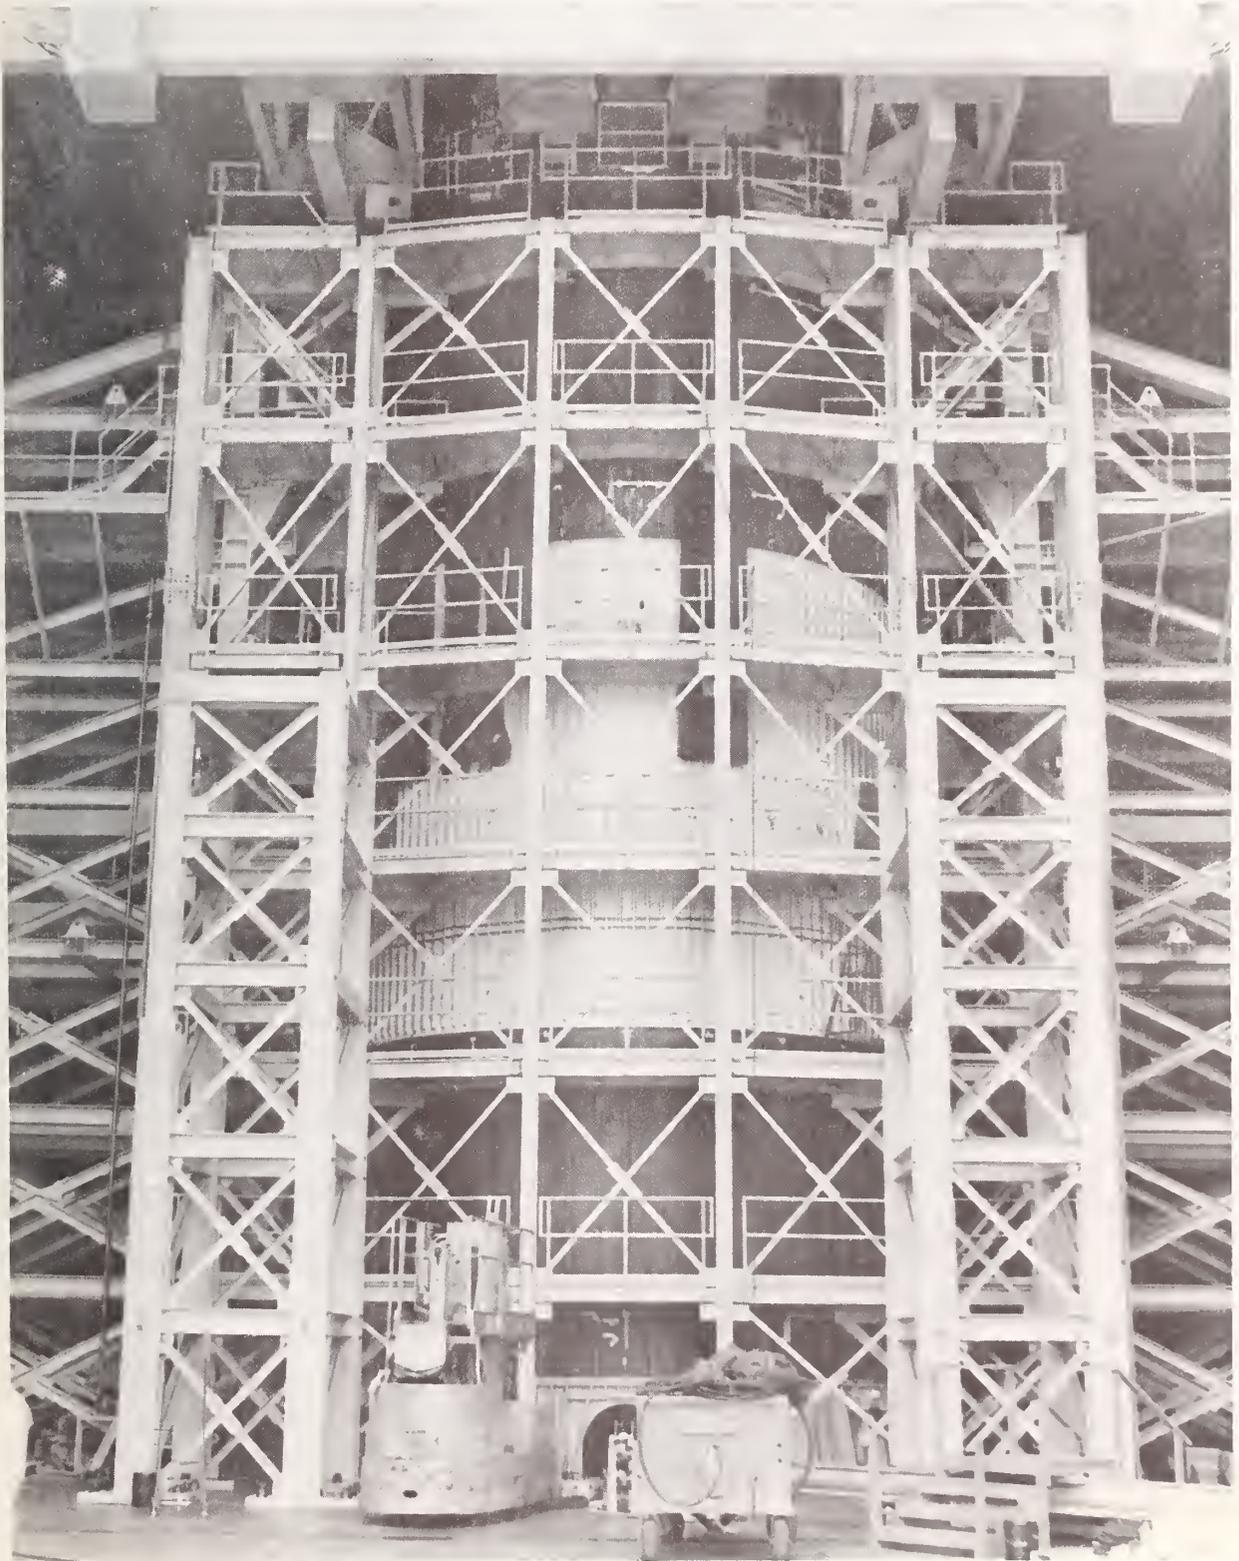
FIGURE 2
STRUCTURAL TEST TOWER WITH TEST SPECIMEN
AND LOAD REACTION TEST FIXTURE
