NBS SPECIAL PUBLICATION **658**

Wind and Seismic Effects

Proceedings of the
Eleventh Joint UJNR
Panel Conference

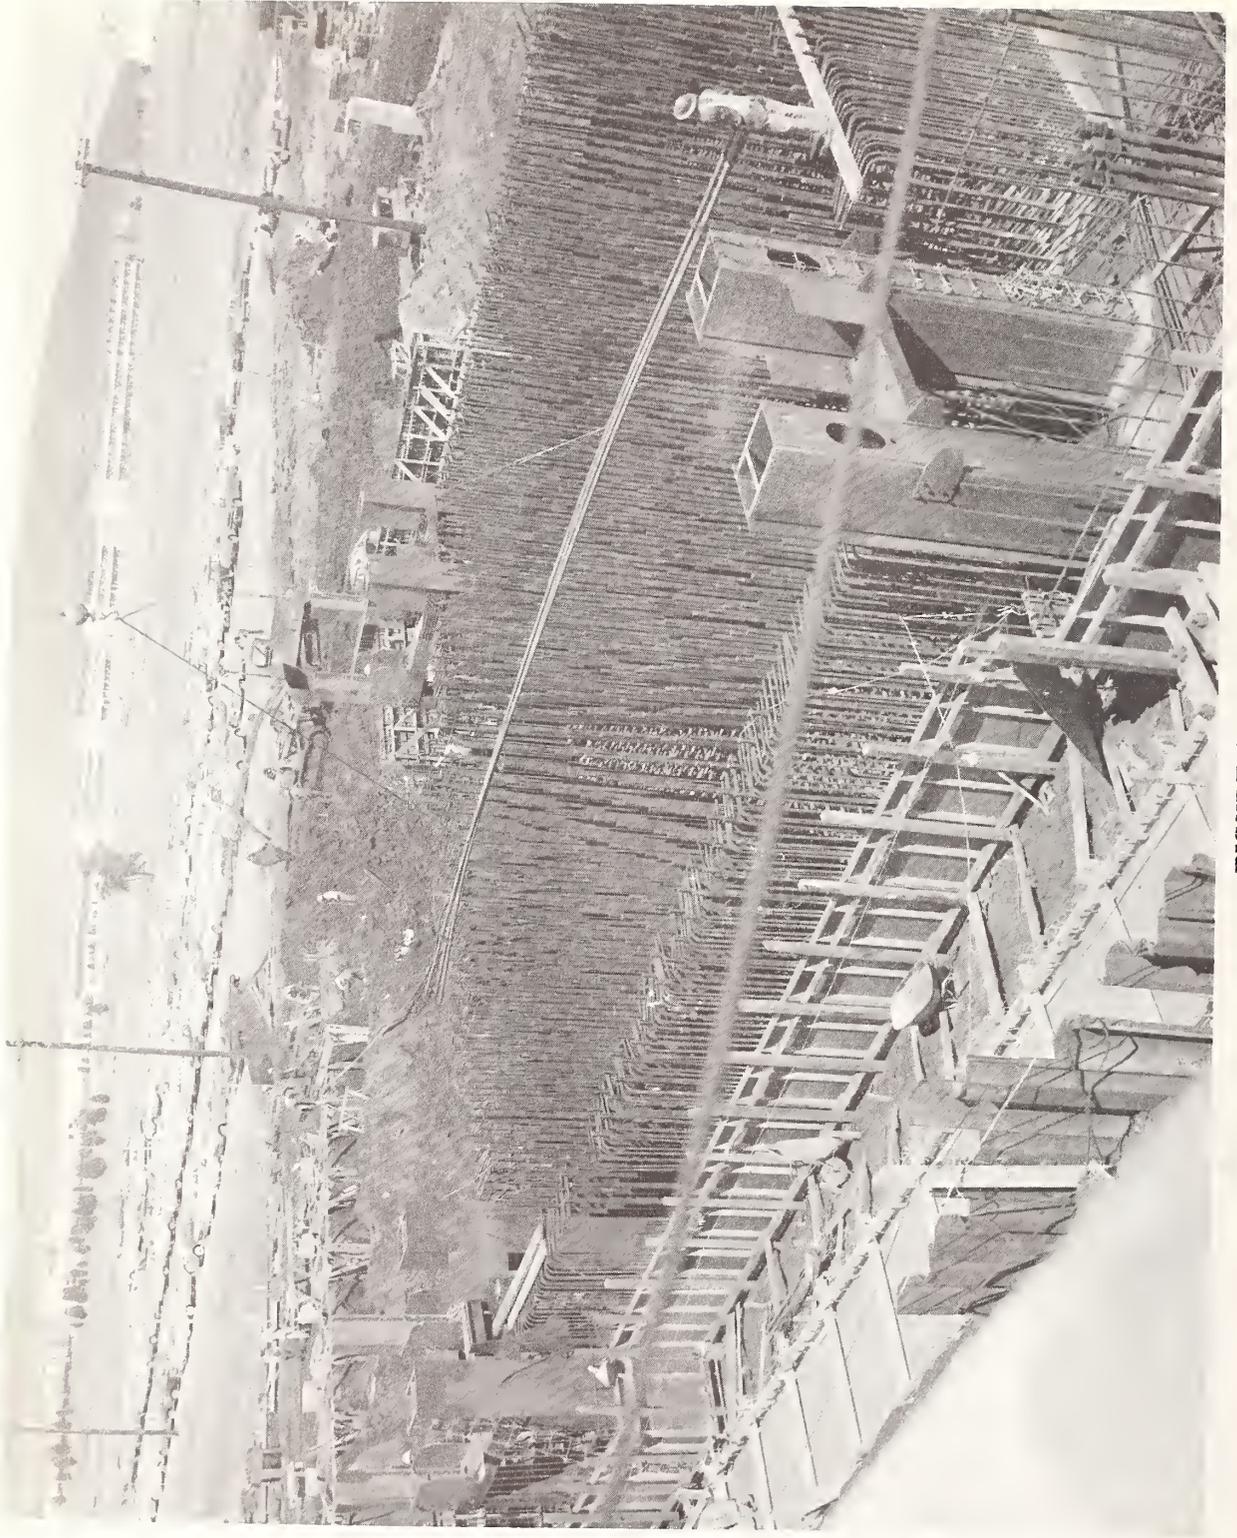
FIGURE 3
STATIC TEST TOWER FOUNDATION CONSTRUCTION

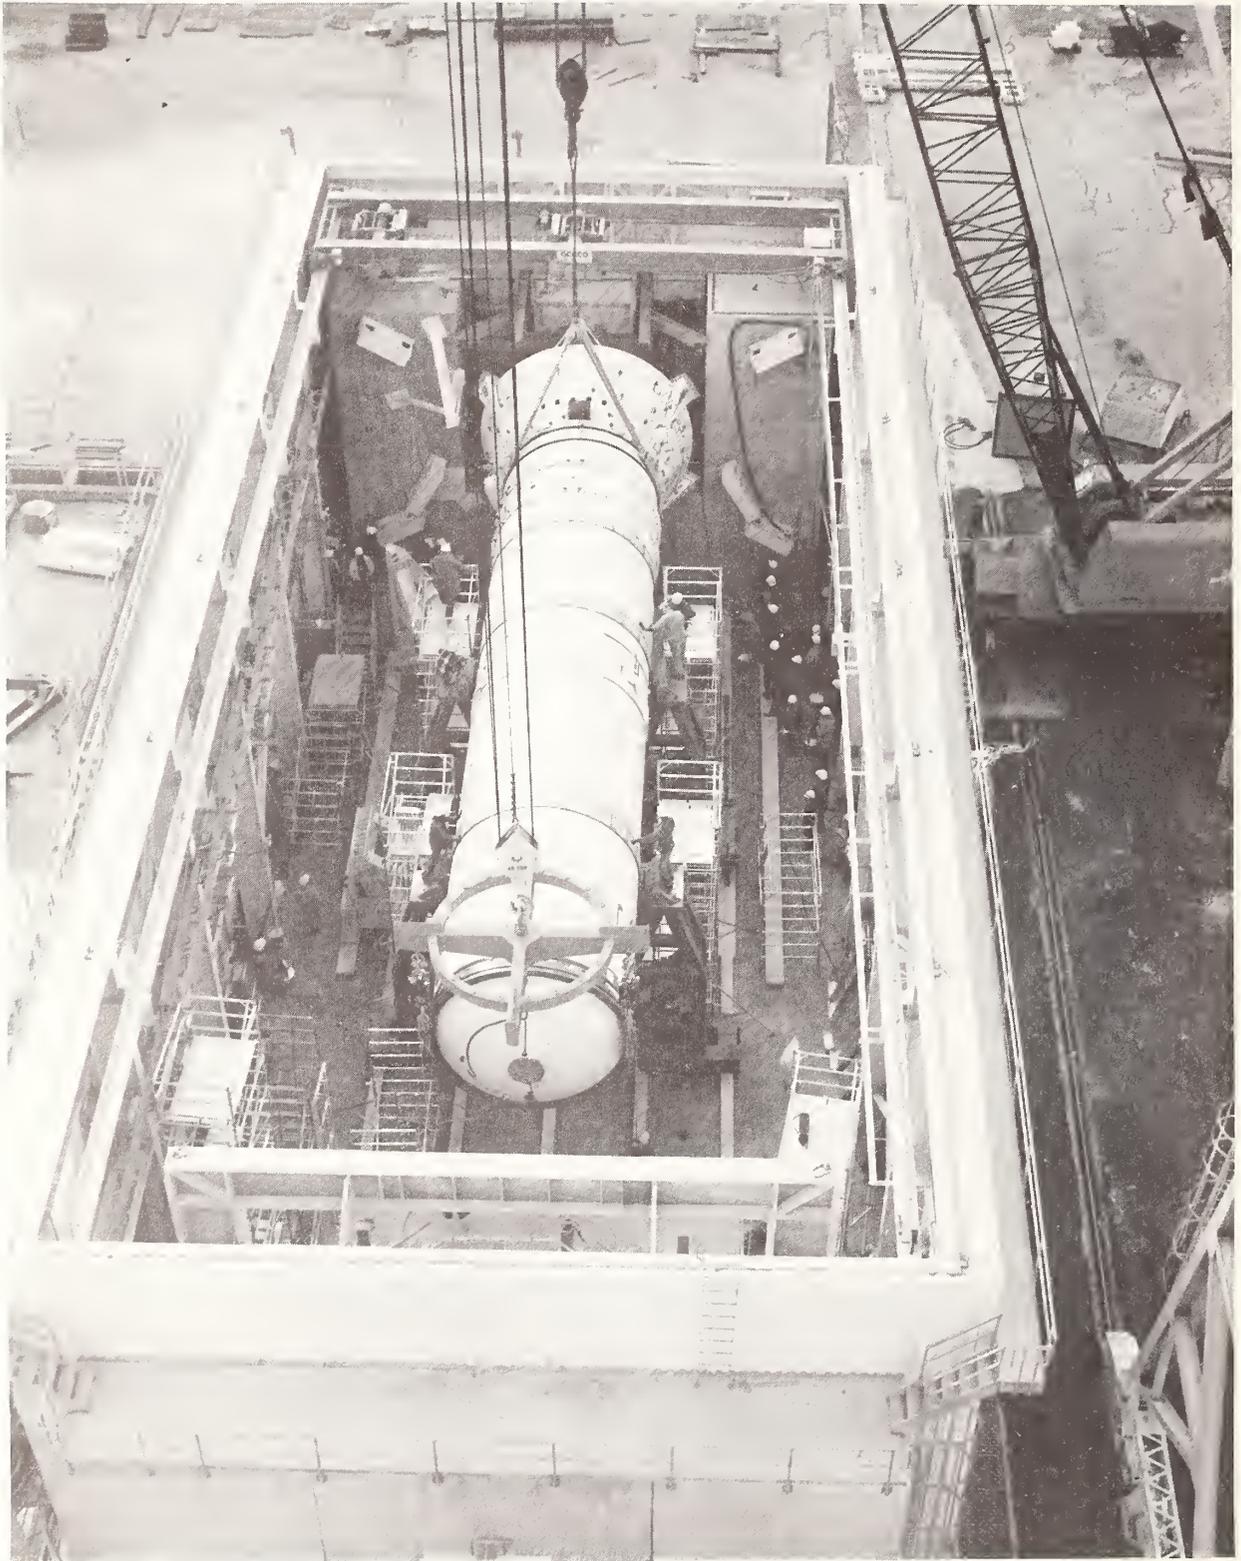
FIGURE 7 STRUCTURAL TEST FACILITY FOR HAZARDOUS TESTS:
AERIAL VIEW OF BUILDING 4572 WITH ROOF REMOVED
VIII-20

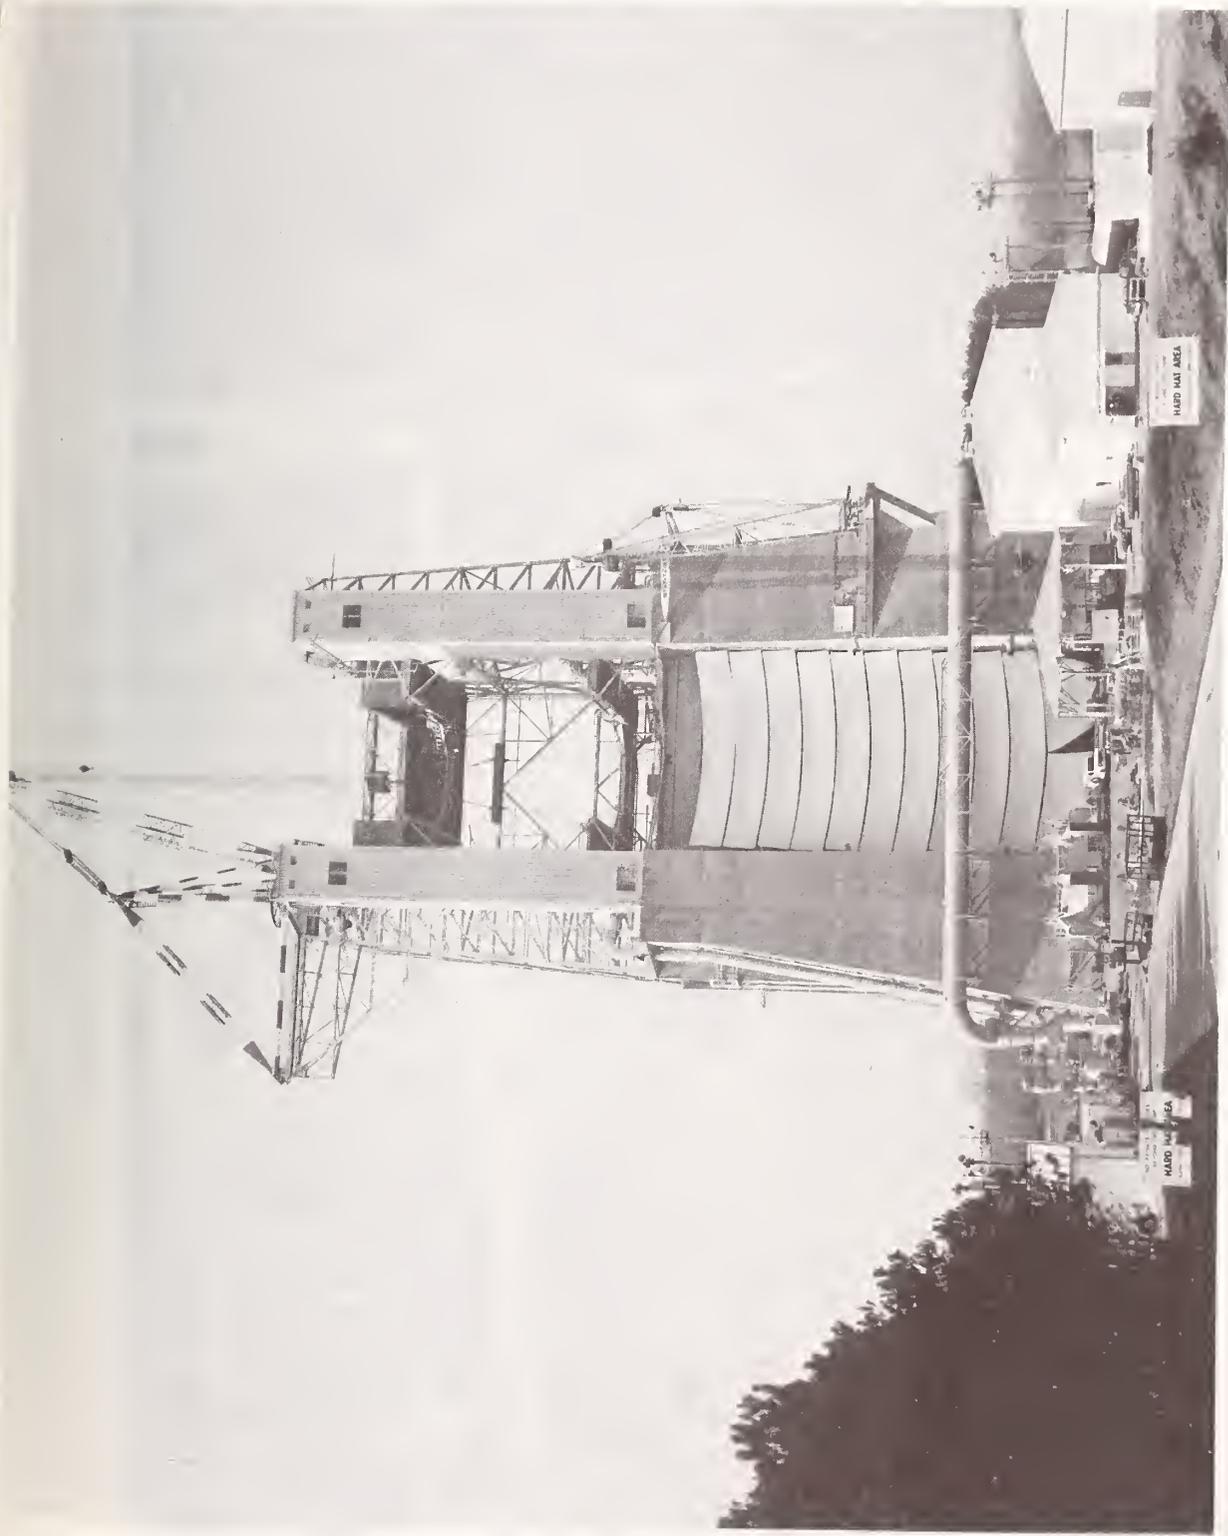
FIGURE 8 OVERALL VIEW OF THE S-1C STATIC TEST STAND

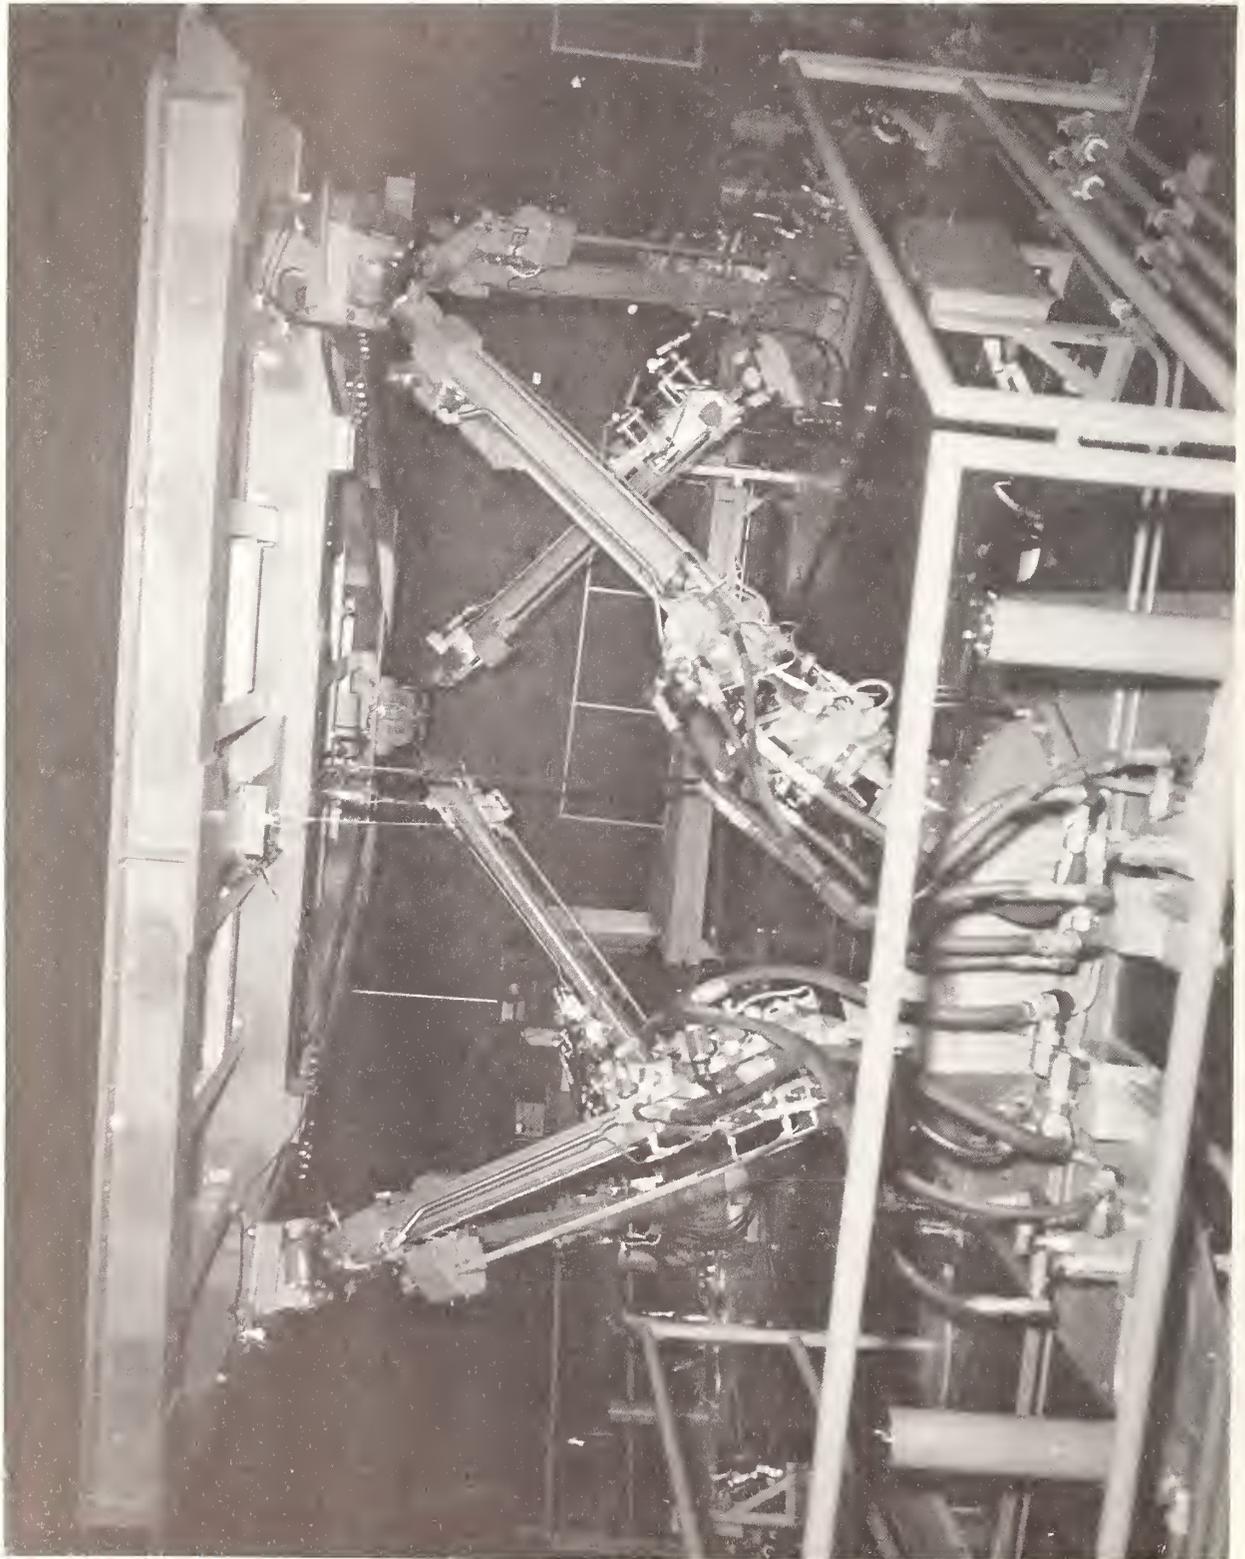
FIGURE 9 SIX-DEGREE-OF-FREEDOM SHAKING TABLE

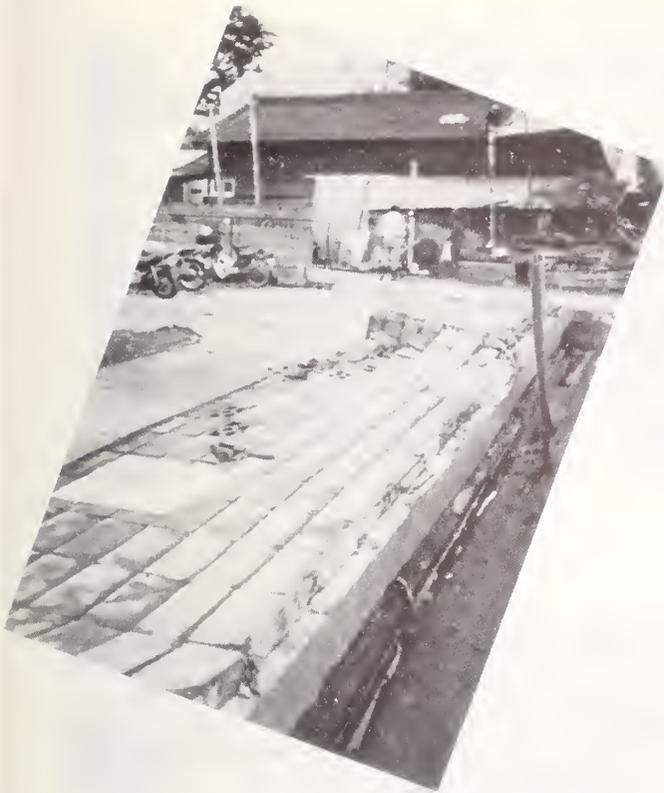
Photo. 4. Overturned Fence at Naga-machi, Sendai

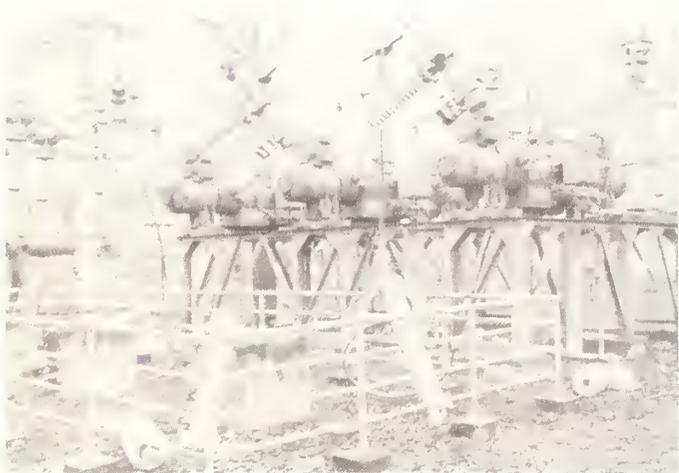
Photo. 16. Broken Insulators at the Sendai Transformer Station

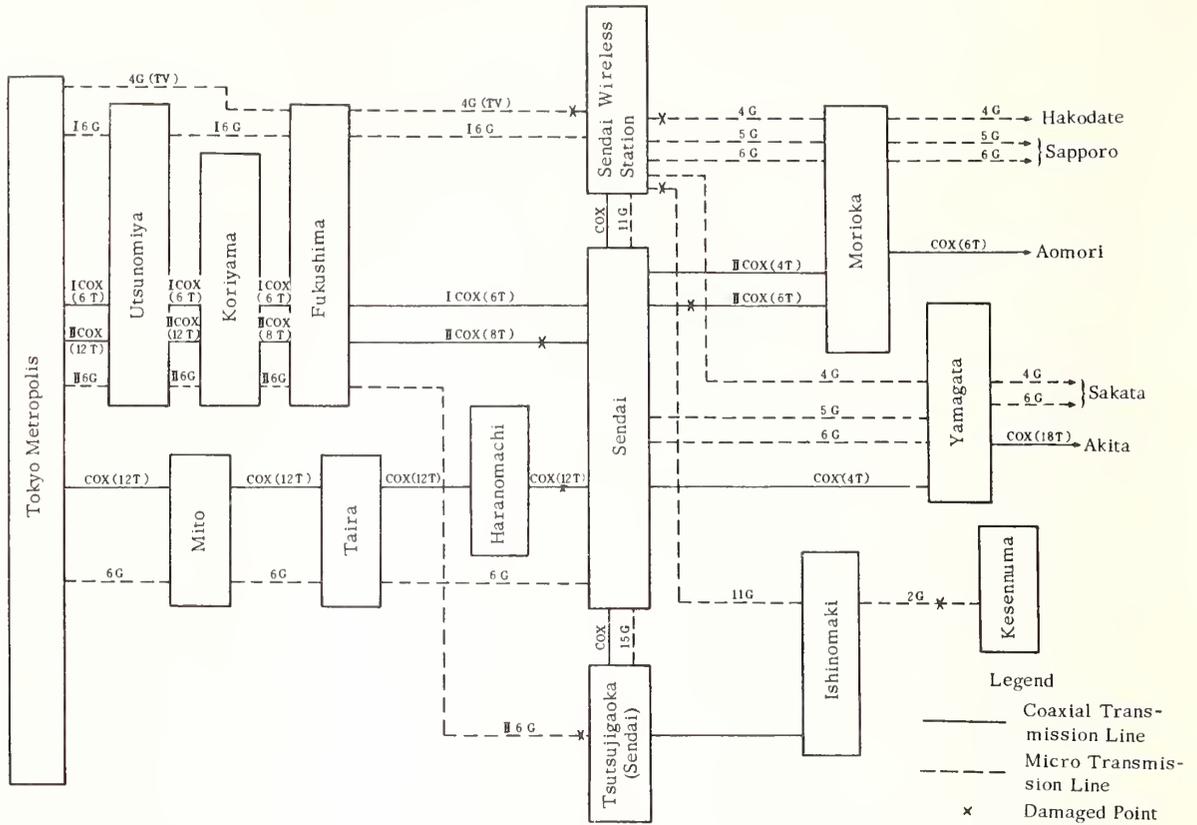
Fig. 1-4 Damage to Long-Distance Transmission Lines (The Nippon Telegraph and Telephone Public Corporation)

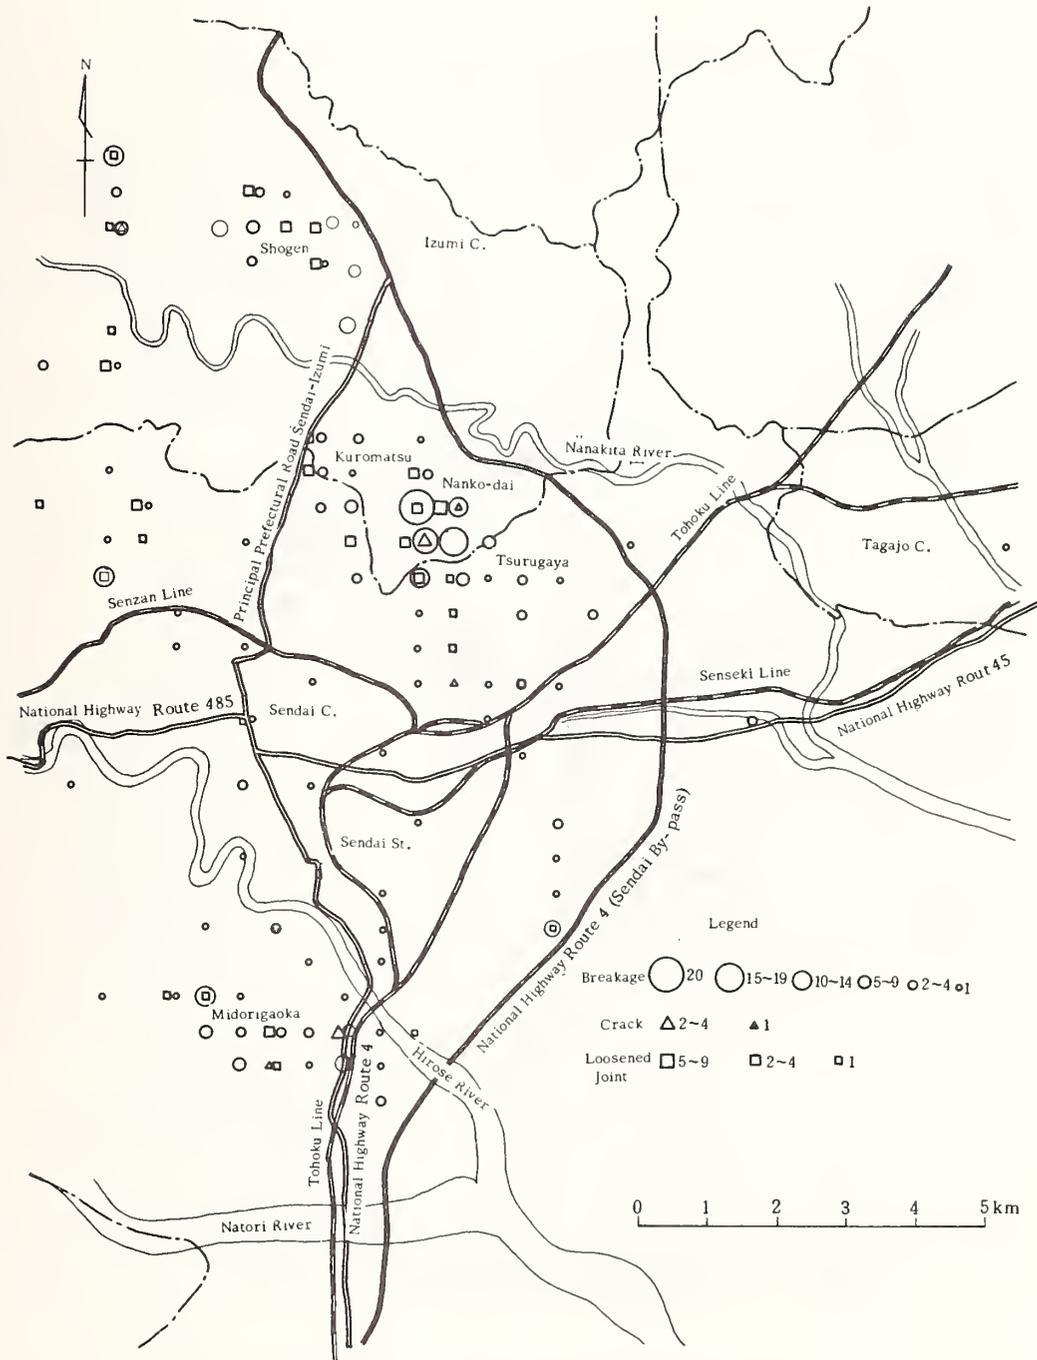
Fig. II-5 Damage Distribution of Gas Pipes

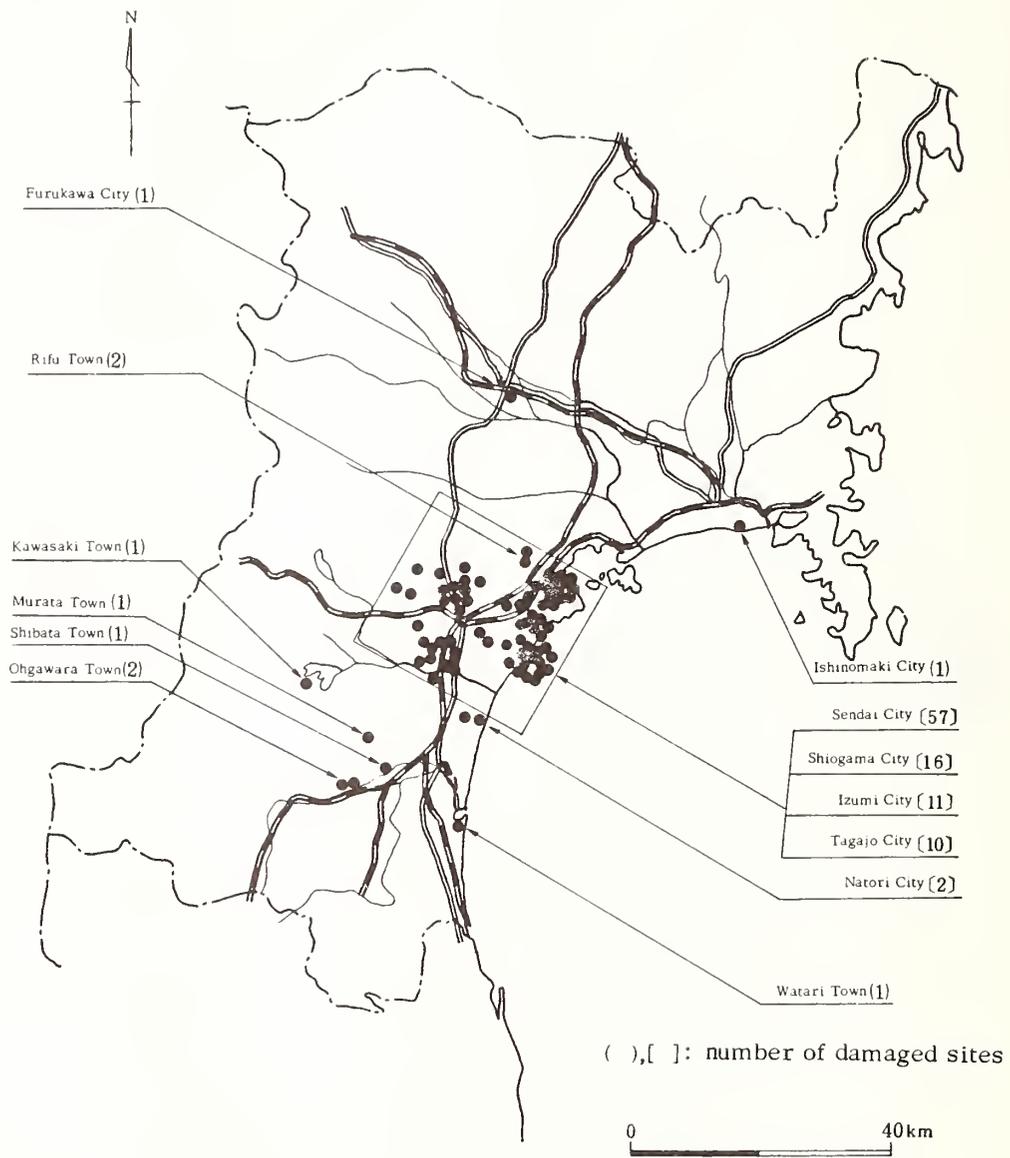
Fig. II-6 Damage Distribution of Sewerage Facilities.

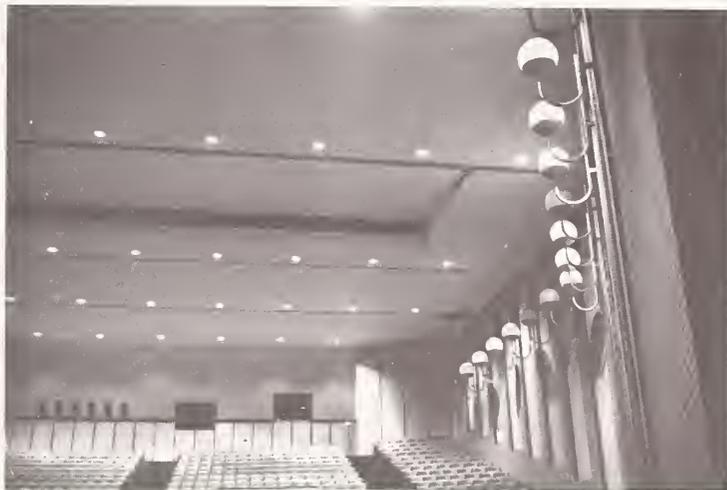
Figure 4. Each portion of this ceiling responded to the 1971 San Fernando earthquake. Note the damage to the plaster at the end of the ceiling strip ventilator openings.

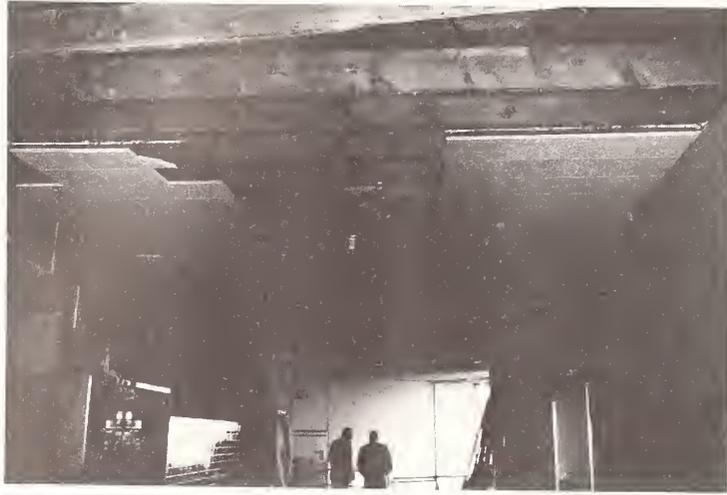
Figure 5. Gypsum board panels became dislodged in the 1964 earthquake in Anchorage, Alaska.

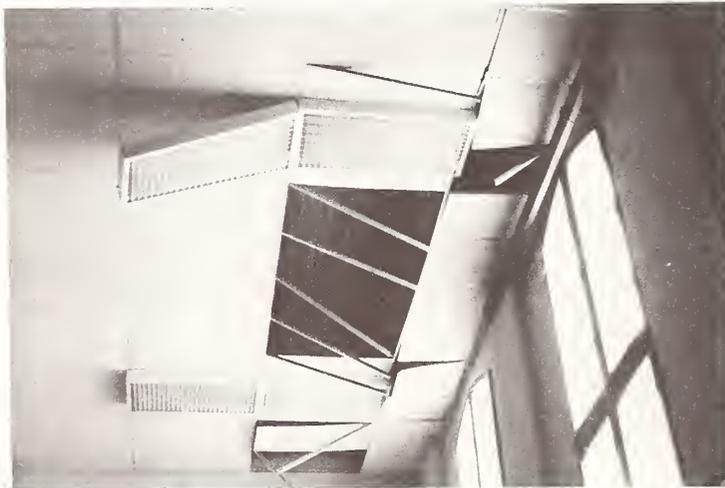
Figure 6. Ceiling damage to the T-bar ceiling system in a post-Field Act school building in the 1969 Santa Rosa earthquake.

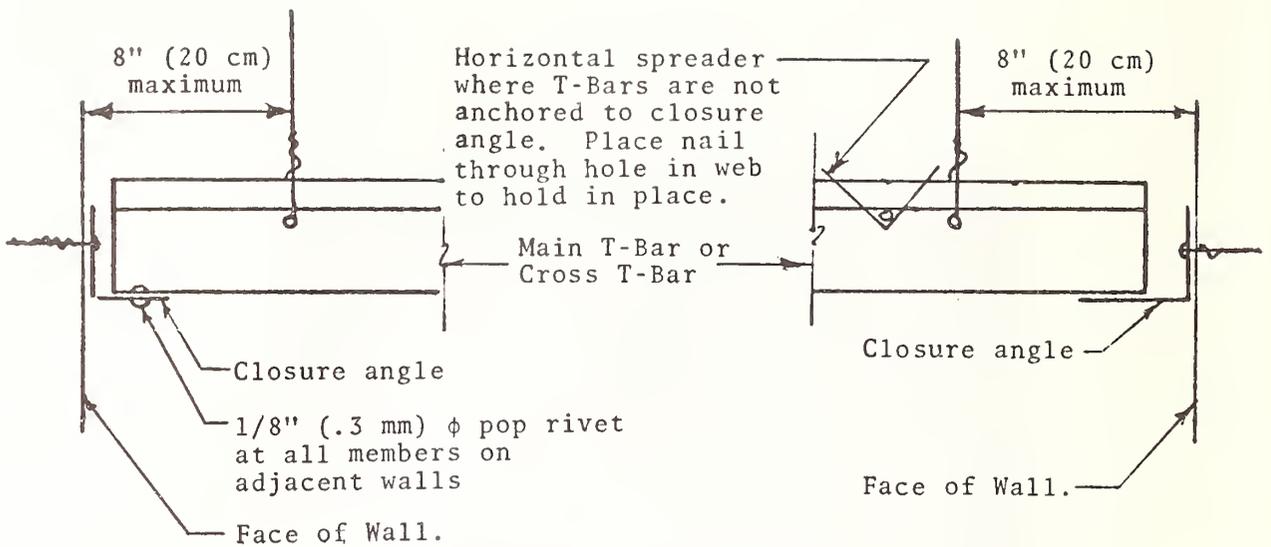
TYPICAL WALL CONDITION

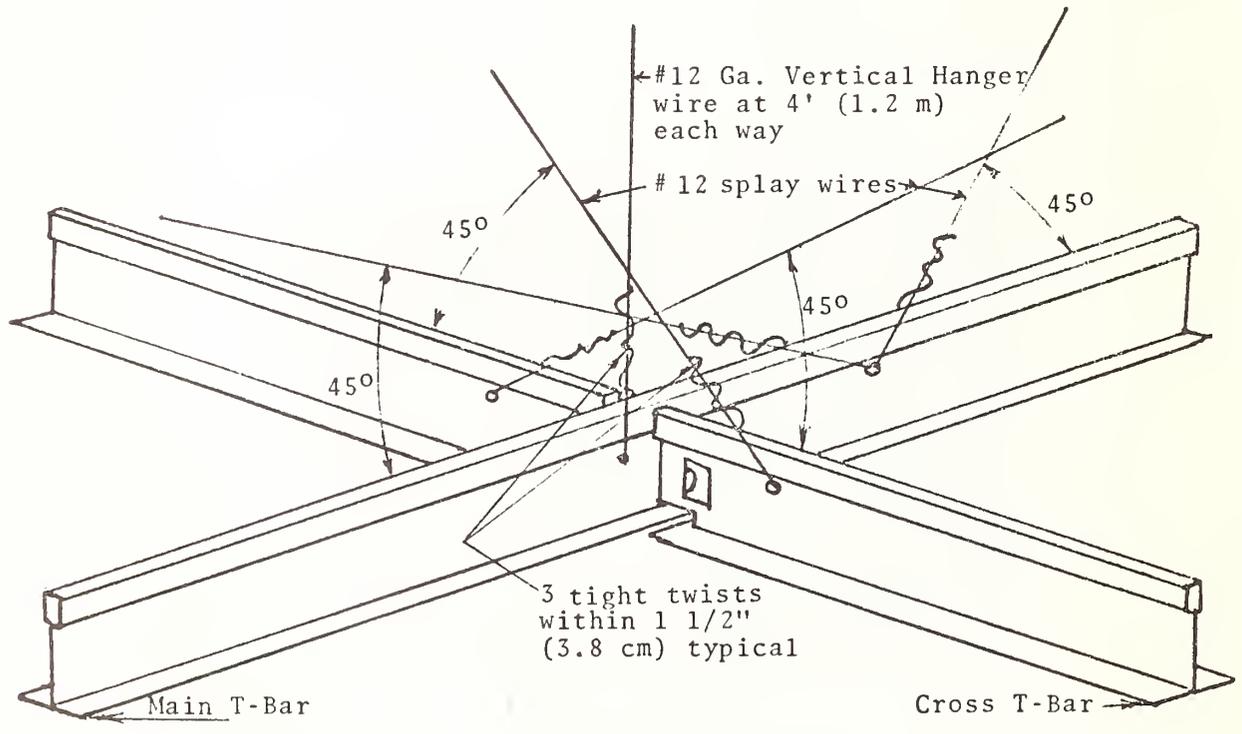
TYPICAL T-BAR INTERSECTION

Splay wires typical 12' (3.67 m) oc each way,
6' (1.82 m) from walls
