NIST Special Publication 1129

**Summary of the 2011 Workshop on
Research Needs for Full Scale Testing
to Determine Vulnerabilities of
Decking Assemblies to Ignition by
Firebrand Showers**

Samuel L. Manzello
Sayaka Suzuki
*Fire Research Division
Engineering Laboratory*

August 2011

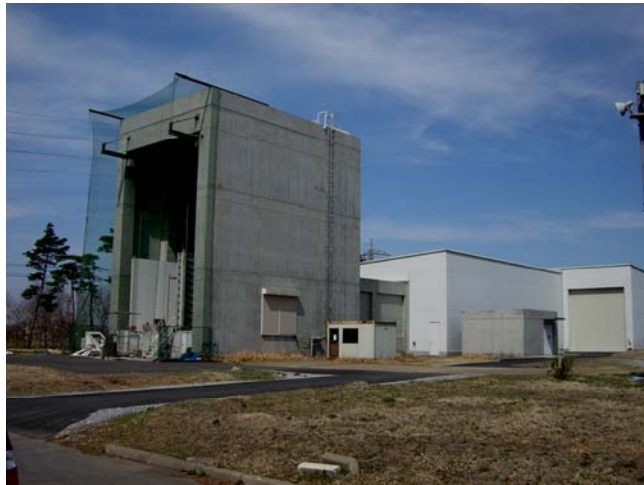
- Fire Research Wind Tunnel Facility (FRWTF)
- Unique facility – investigate influence of wind on fire
 - Constructed more than 10 years before IBHS wind tunnel

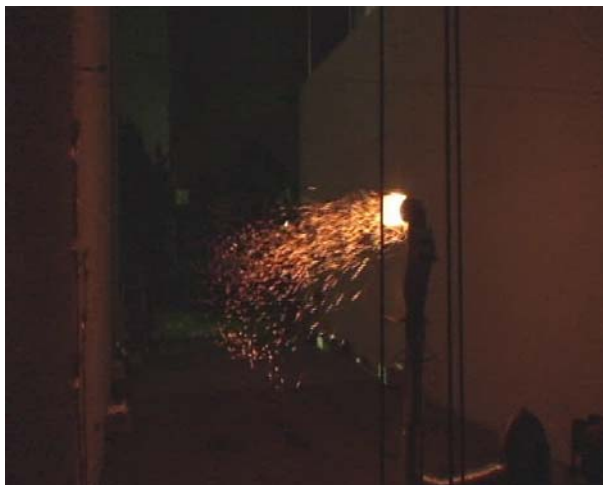
NIST Dragon 龍

First Generation Device

Firebrand size/mass commensurate to full scale tree burns
and actual WUI fire (2007 Angora Fire)

- Another key issue is that the firebrand size and mass produced using the NIST Dragon has been tied to those measured from full-scale tree burns and an actual WUI fire [11].

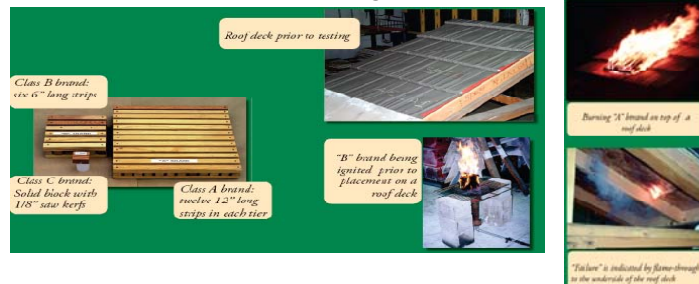
Does not simulate dynamic firebrand attack!

**Japan/USA
Use This Test!**

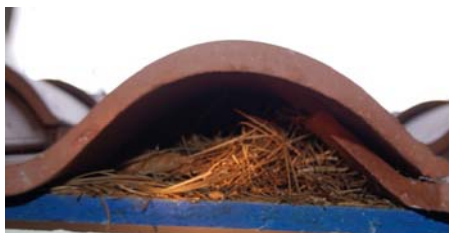
Ceramic Roofing

Aged Roofing Simulated: OSB, then tiles (no tar paper)

U_{∞} (m/s)	OSB/TP/CT No Bird Stops	OSB/TP/CT With Bird Stops	OSB/CT No Bird Stops	OSB/CT With Bird Stops
7	SI	SI	SI to FI	SI
9	SI	SI	SI to FI	SI

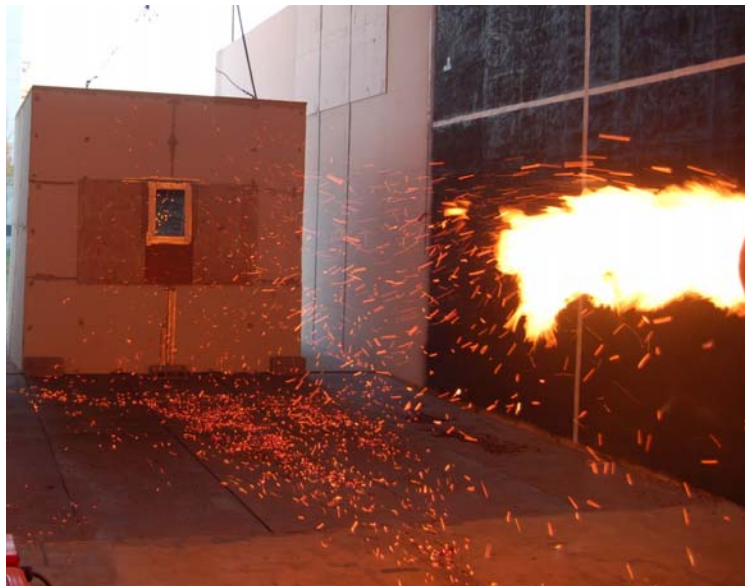
BRI/NIST Full Scale Experiments

20 x 20 mesh (1.04 mm) is shown

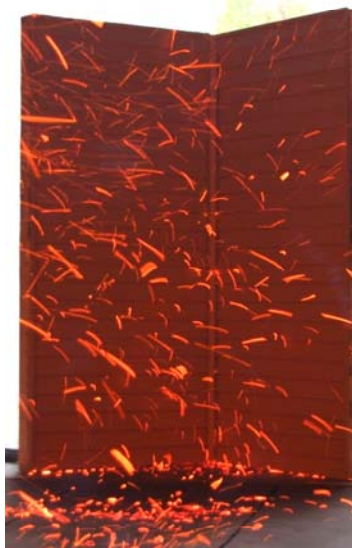
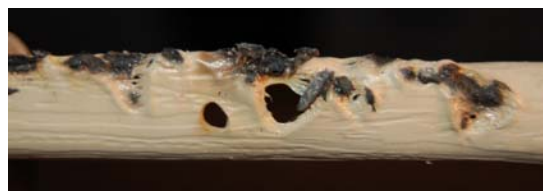
Siding Treatments

- **Corner** - believed that firebrands may become trapped within the corner post and under the siding itself
- OSB, moisture barrier applied (OSB dried; 11 %)

Image of vinyl siding (from bottom)
after firebrand exposure at 7 m/s

U_{∞} (m/s)	Vinyl Siding OSB Sheathing Dried	Vinyl Siding OSB Sheathing Not Dried	Polypropylene Siding OSB Sheathing Dried	Polypropylene Siding OSB Sheathing Not Dried
7	Siding melted/holes Burns on Tyvek OSB NI	Siding melted/holes Burns on Tyvek OSB NI	Siding melted Burns on Tyvek OSB NI	Siding melted Burns on Tyvek OSB NI
9	Siding melted/holes Burns on Tyvek OSB SI	Siding melted/holes Burns on Tyvek OSB NI	Siding melted Burns on Tyvek OSB NI	Siding melted Burns on Tyvek OSB NI

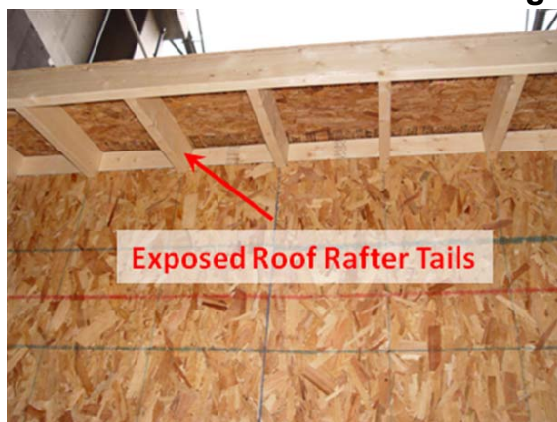
Images of eave assemblies constructed for testing

Open eave construction is thought to the worst possible situation, this configuration was used

Wall Size: 2.44 m by 2.44 m
Eave Overhang: 61 cm (2 ft)

Vent holes: 50 mm (2")
fitted with mesh 2.75 mm opening

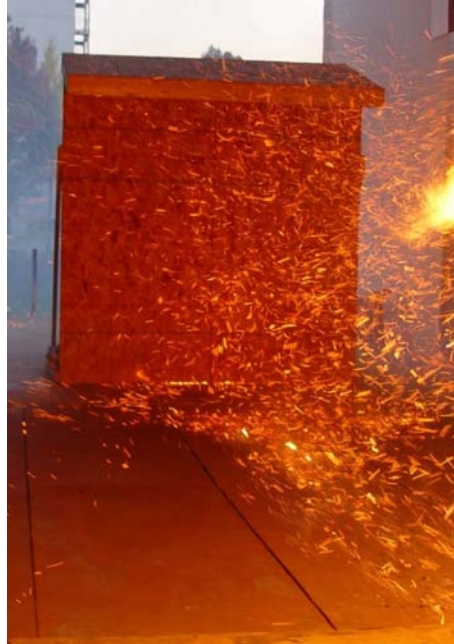
Wall Fitted With Eave Exposed to Firebrand Showers

- The base of the wall actually ignited due to the accumulation of firebrands (9 m/s)
- It was very easy to produce ignition outside the structure since many firebrands were observed to accumulate in front of the structure during the tests
- Although some firebrands were observed to enter the vents, the ignition of the wall assembly itself demonstrates the dangers of wind driven firebrand showers
- The base of wall assembly ignited without the presence of other combustibles that may be found near real structures (e.g. mulch, vegetation)

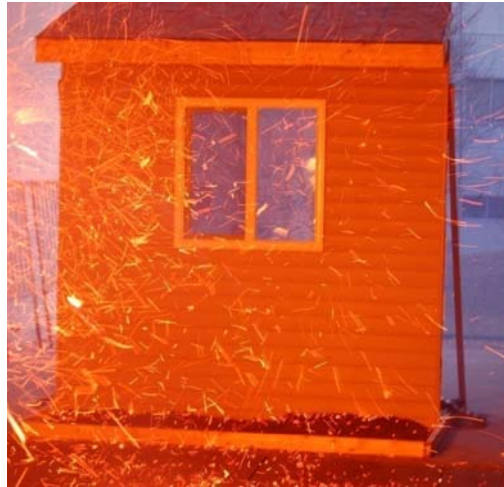
Glazing Assemblies

Do firebrands become trapped, accumulate inside the corner of the framing of glazing assemblies, and lead to window breakage?

Vertically and Horizontally Sliding Window Assemblies
Window Size: 91 cm by 91 cm

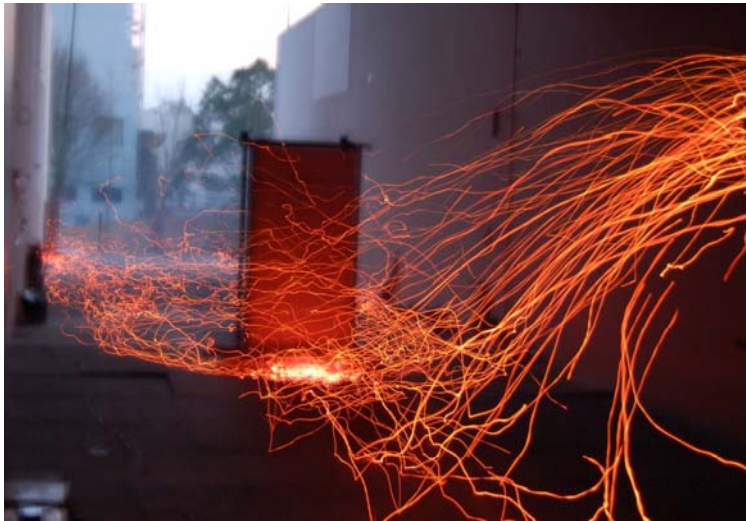
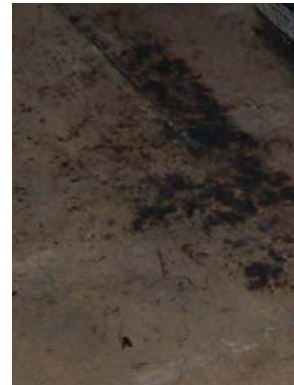
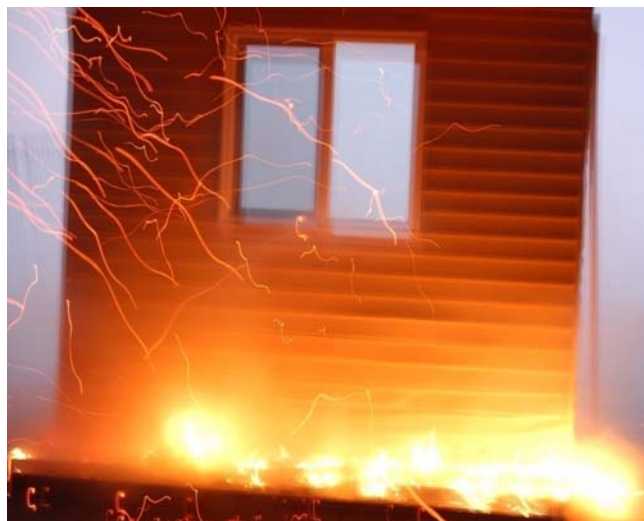
Firebrand Accumulation

Wood Boards Placed
In Front

Easily Ignited!!!

Fine Fuels Near Structure

Wall Ignited

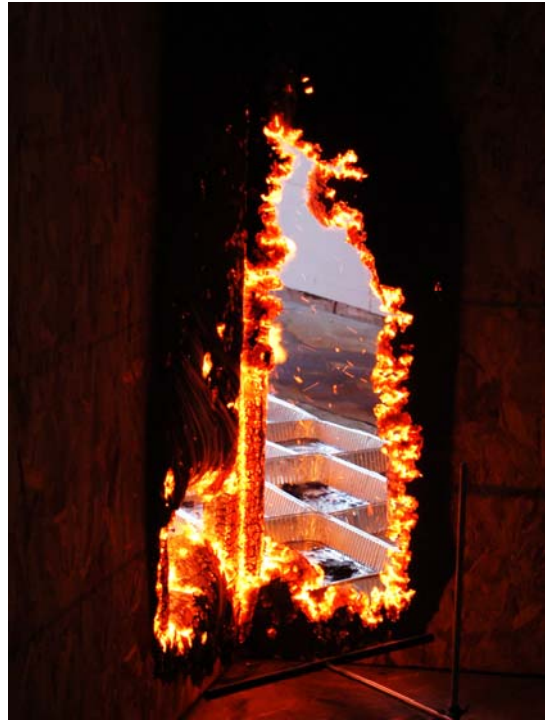
Work in Progress

- Firebrand generation from:
 - Structure Components
