Wind and Seismic Effects

NIST SP 820

PROCEEDINGS OF
THE 23RD JOINT
MEETING OF
THE U.S.-JAPAN
COOPERATIVE PROGRAM
IN NATURAL RESOURCES
PANEL ON WIND AND
SEISMIC EFFECTS

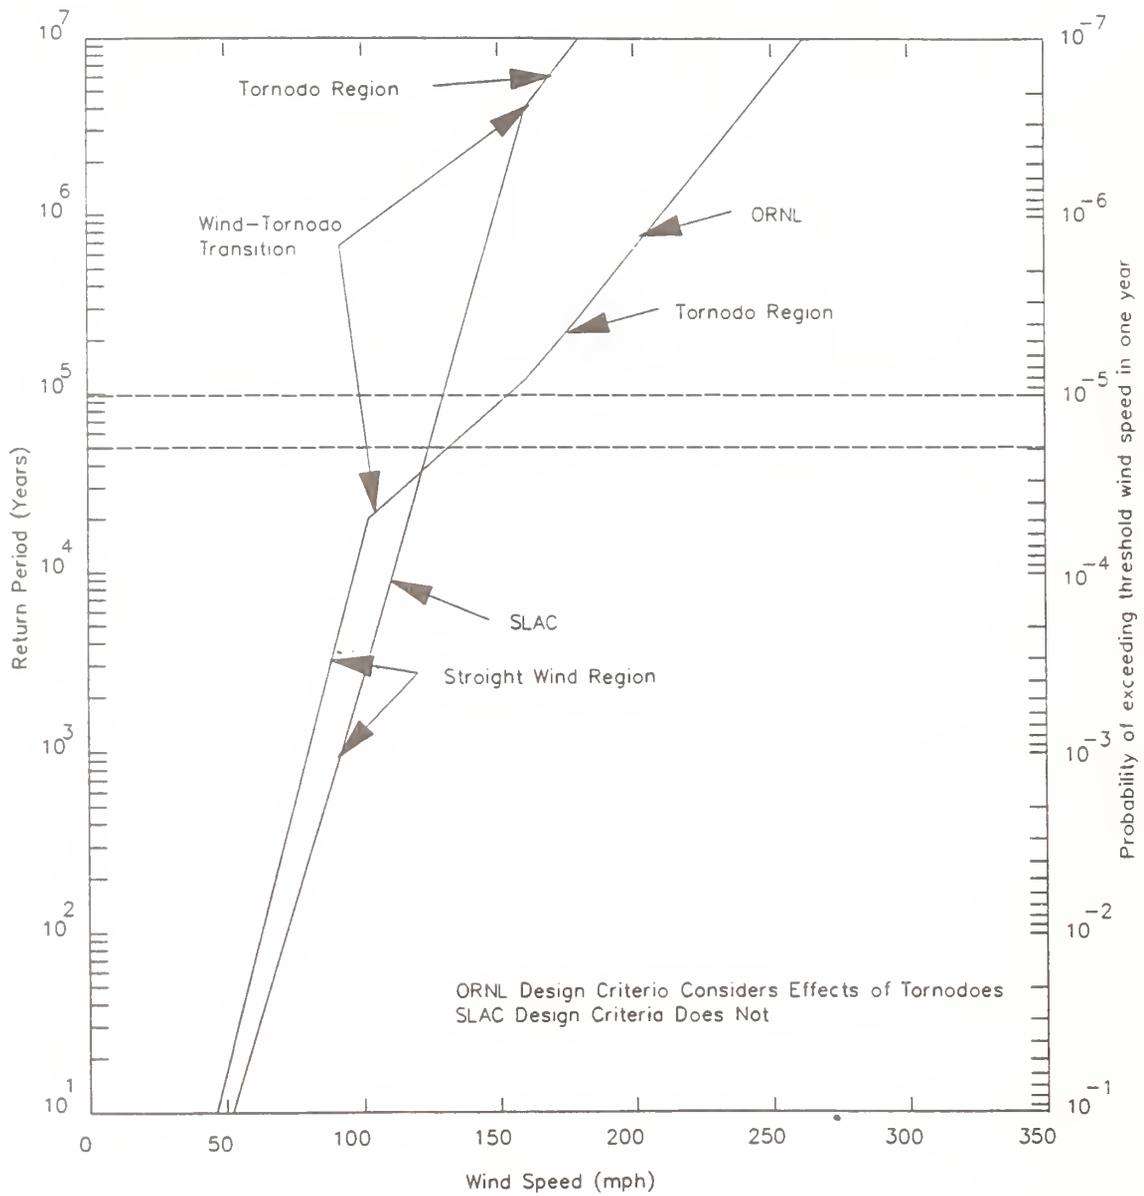
Figure 1. Straight Wind and Tornado Regions of Wind Hazard Curves

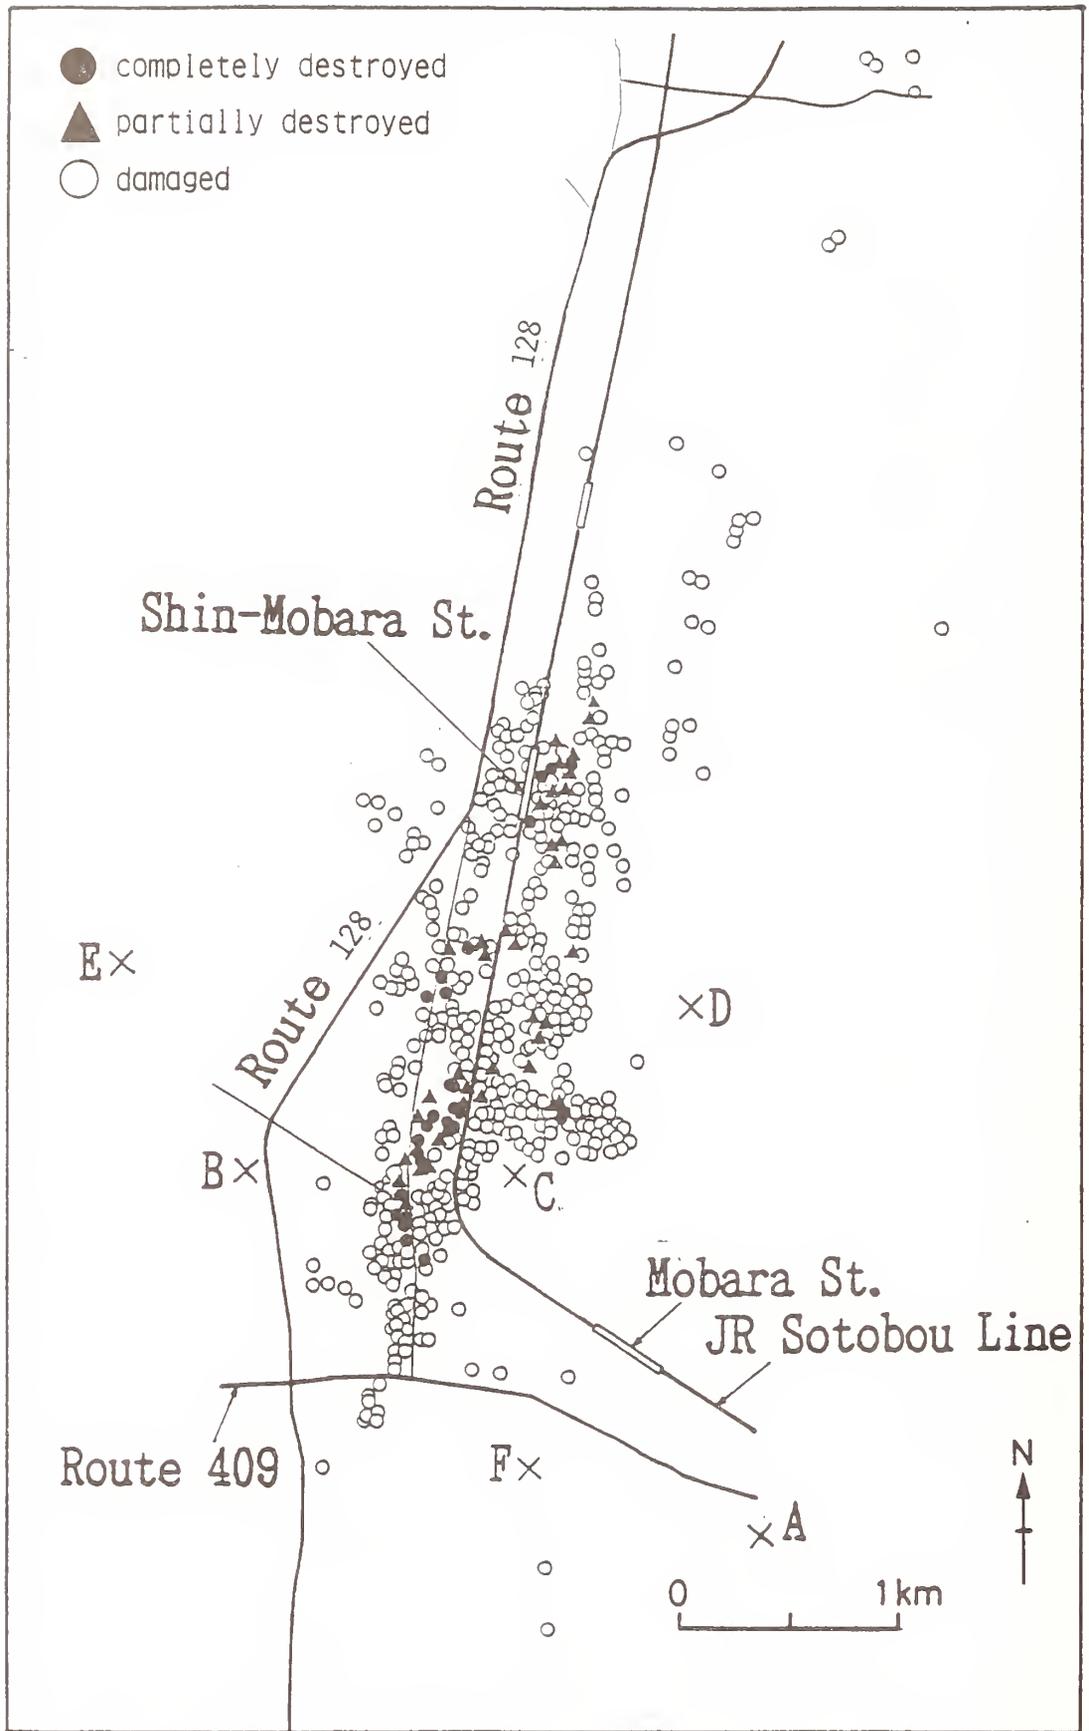
Fig. 3: Damage distribution in the Mobara City.

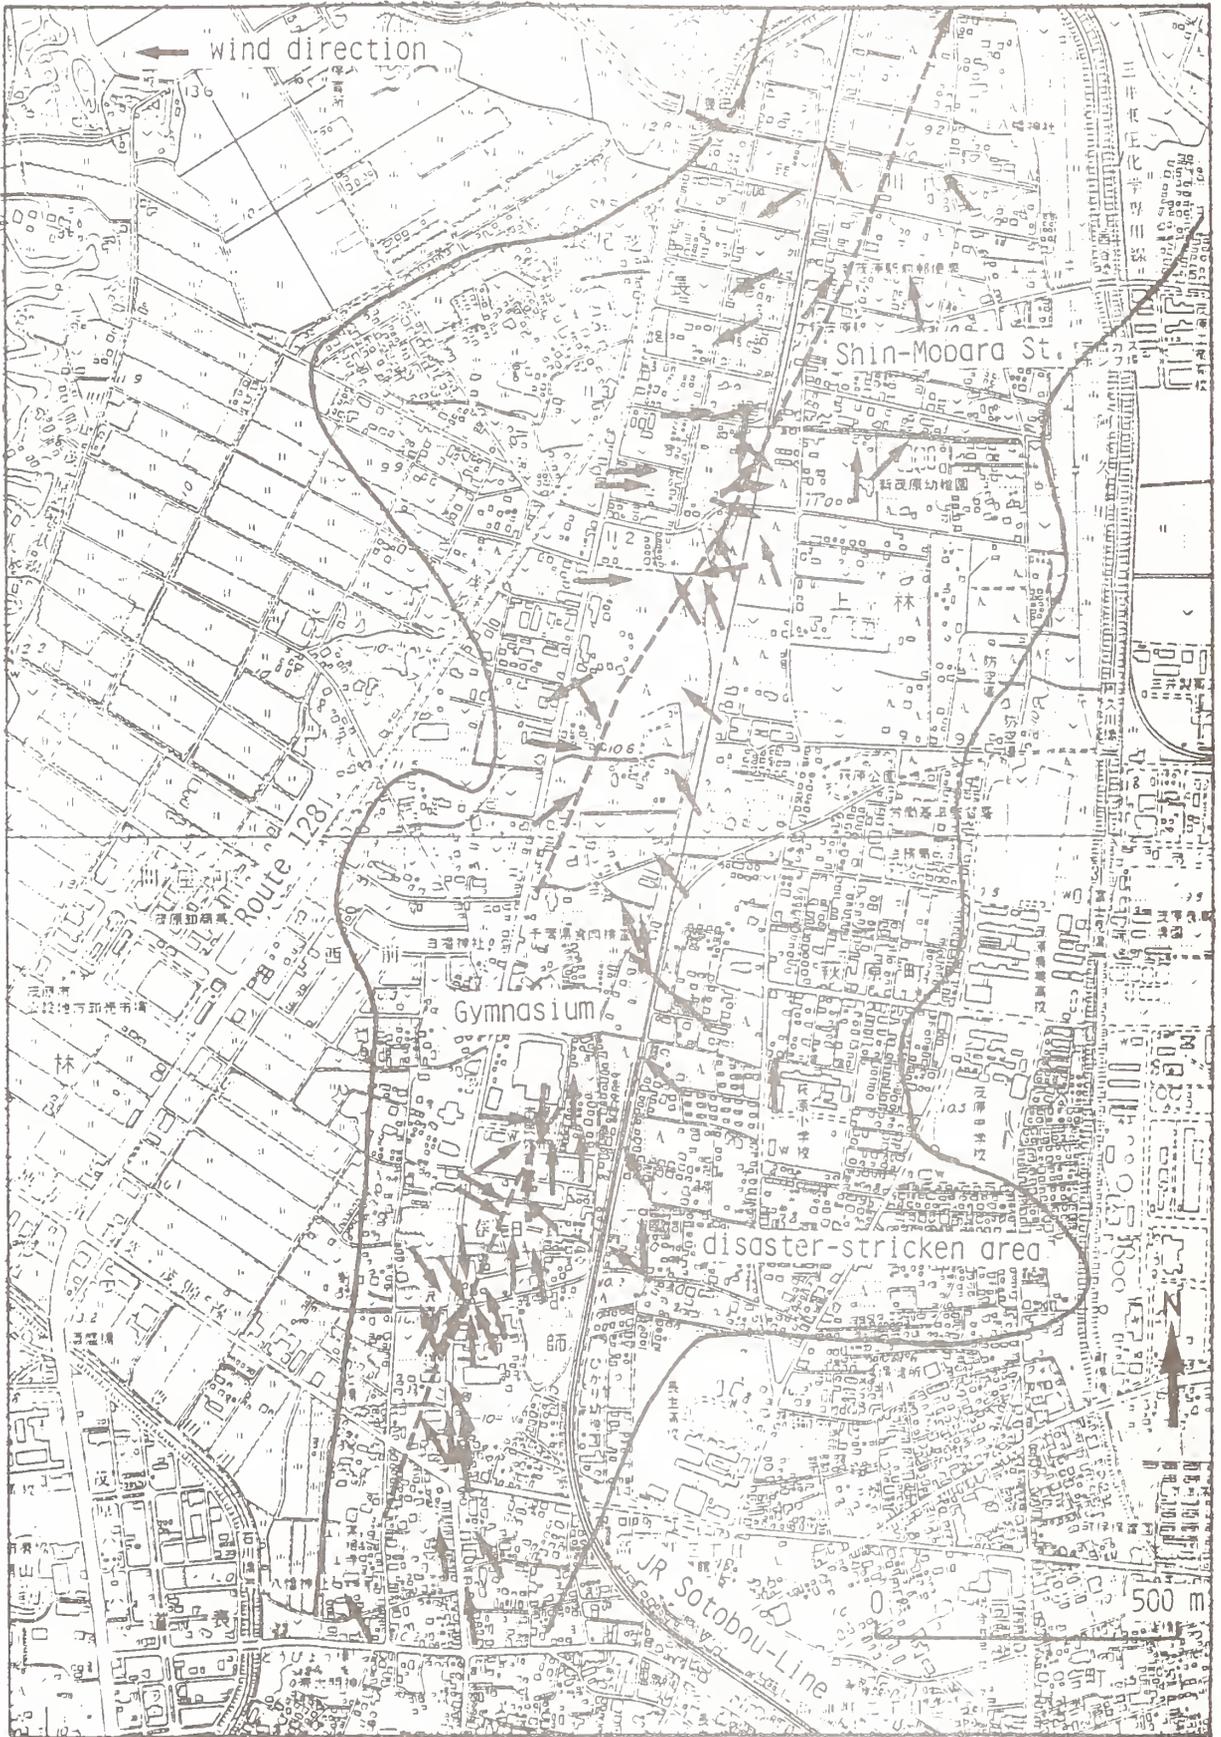
Fig. 5: Distribution of estimated wind directions and the tornado path.

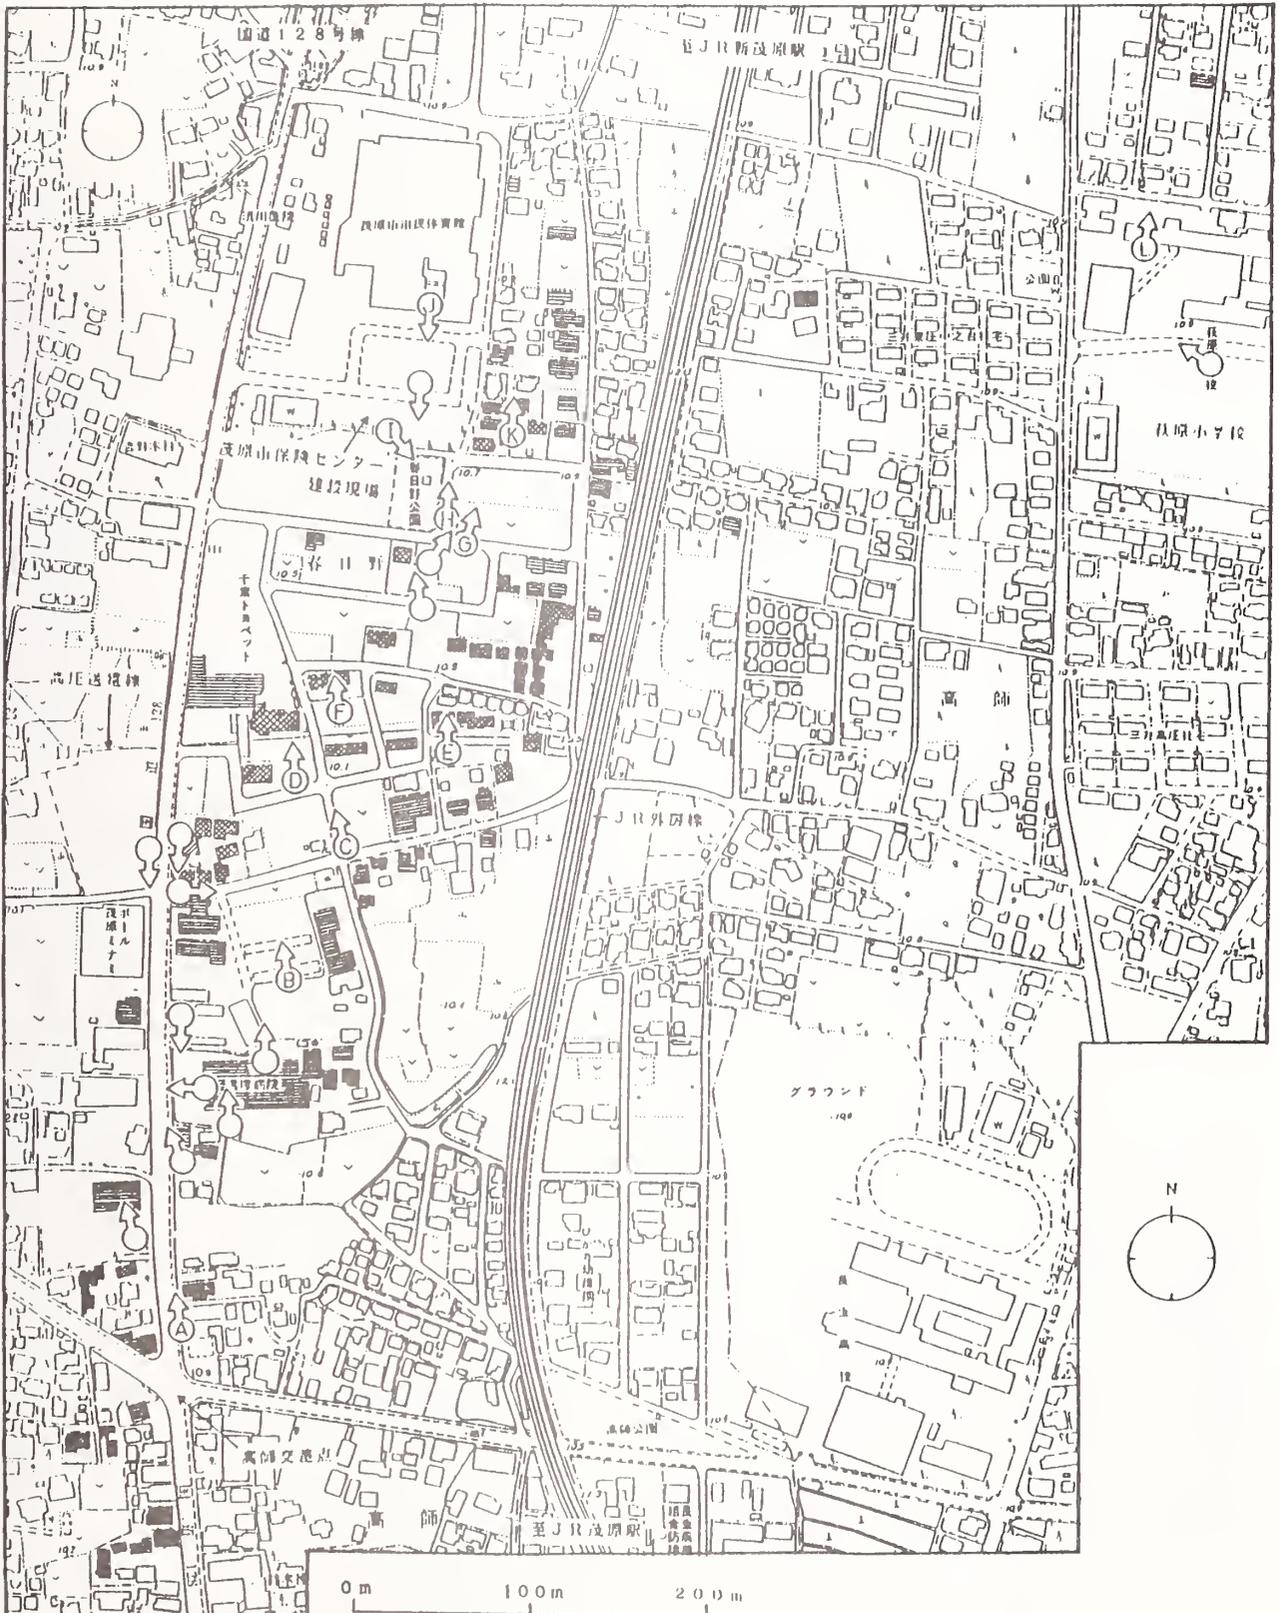
Fig. 6: Distribution of damages to houses in the Takashi Area together with locations of the constructions used for estimating the wind speed. The directions to which the constructions were leaning and fell down are shown by arrows, and the characters in the arrows denote the type of constructions described in Table 1. ■ shows completely destroyed house and ▨ partially destroyed house.

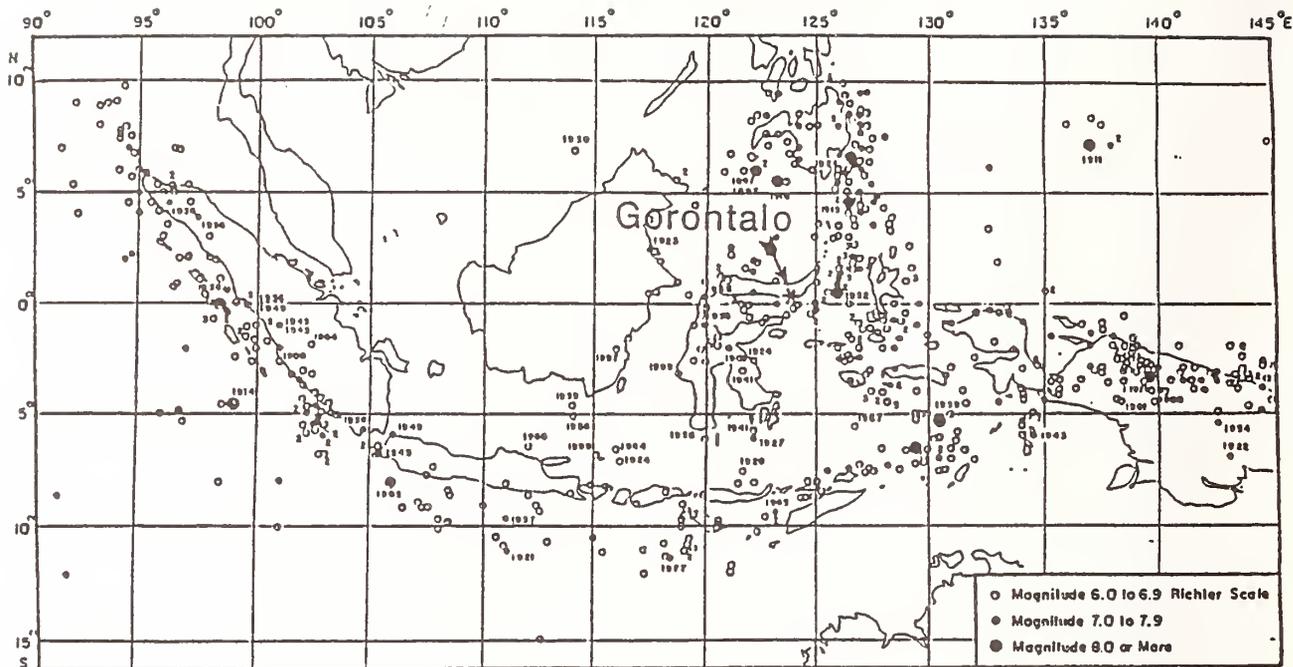
Figure 1. Seismicity of Indonesia showing the major shallow earthquakes 1897-1984 and the location of the selected study area. Note the high rate of seismicity in the Gorontalo area.

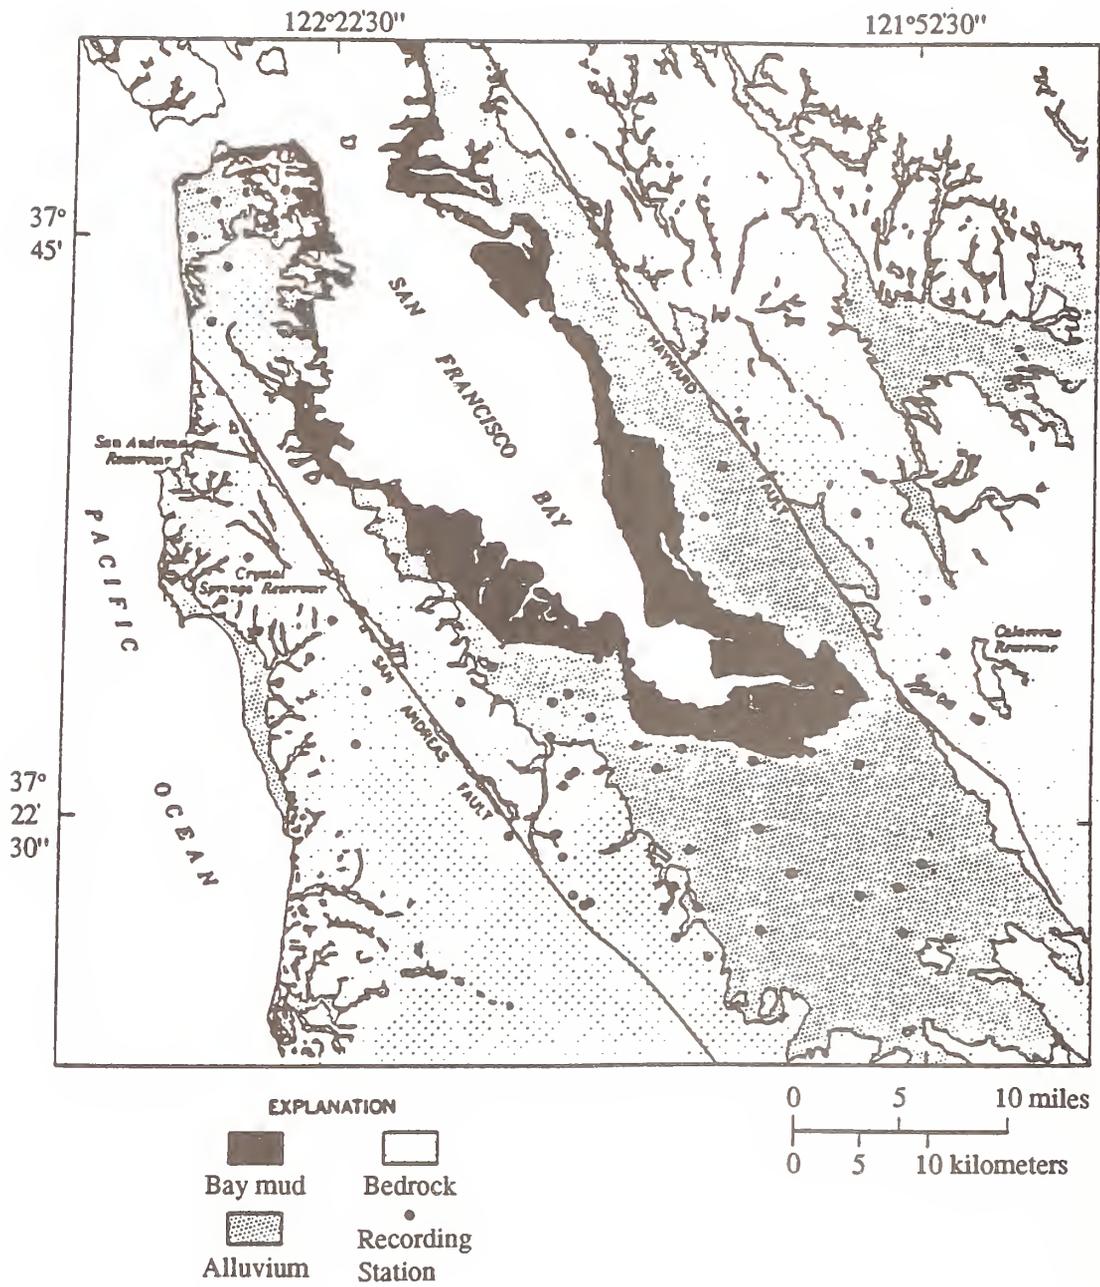
Figure 1. Geological conditions in the vicinity of San Francisco Bay (after Brocherdt, et al., Ref 8).

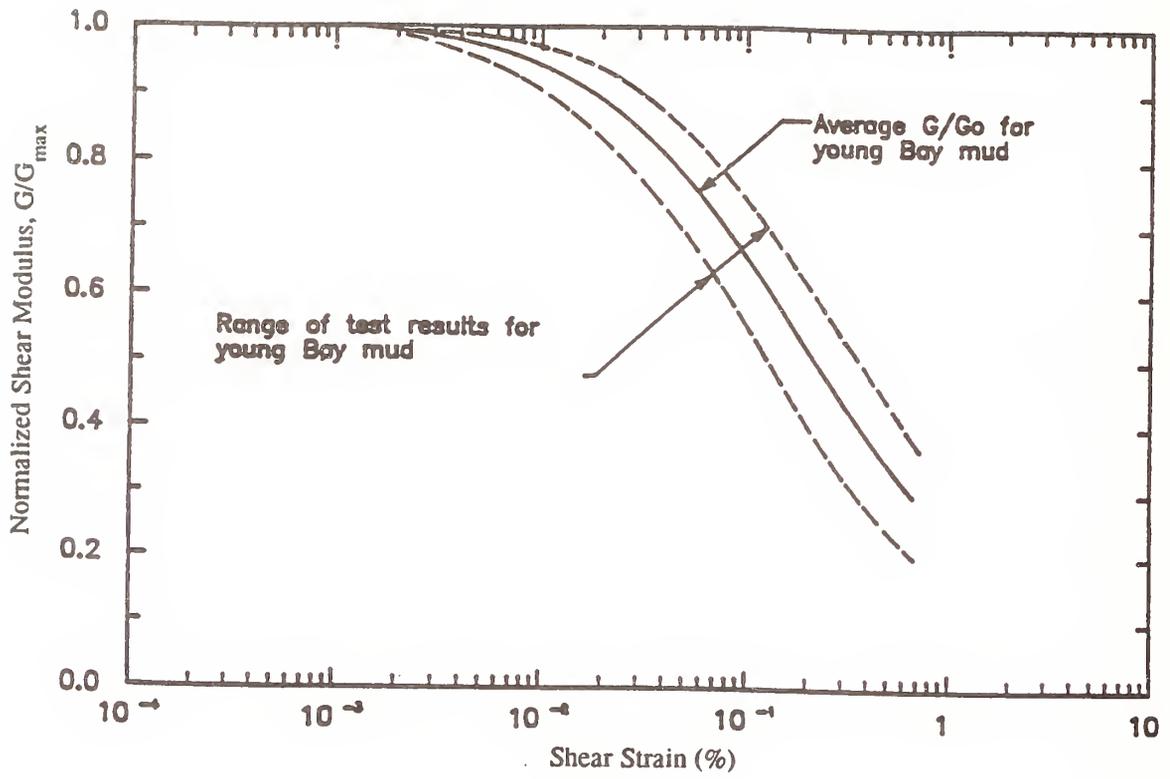
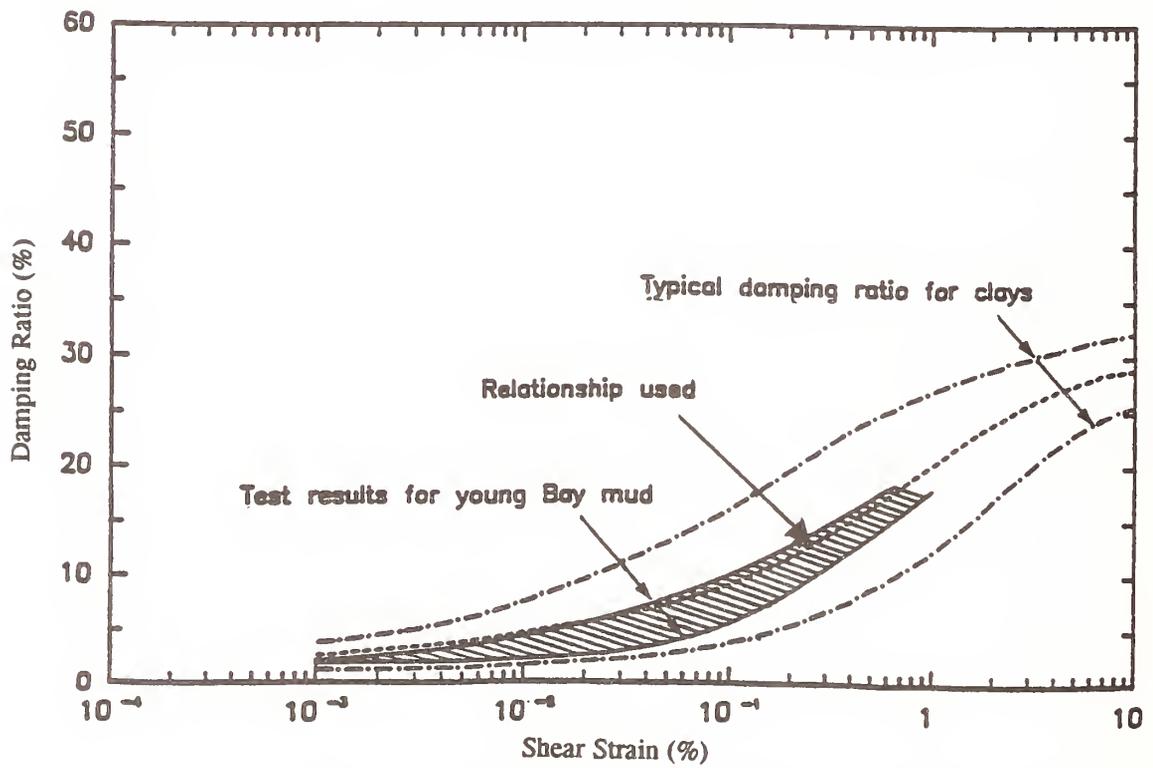
Figure 3. Variation of normalized shear modulus and damping ratio with shear strain for you San Francisco Bay mud (after Seed and Sun, Ref 12).

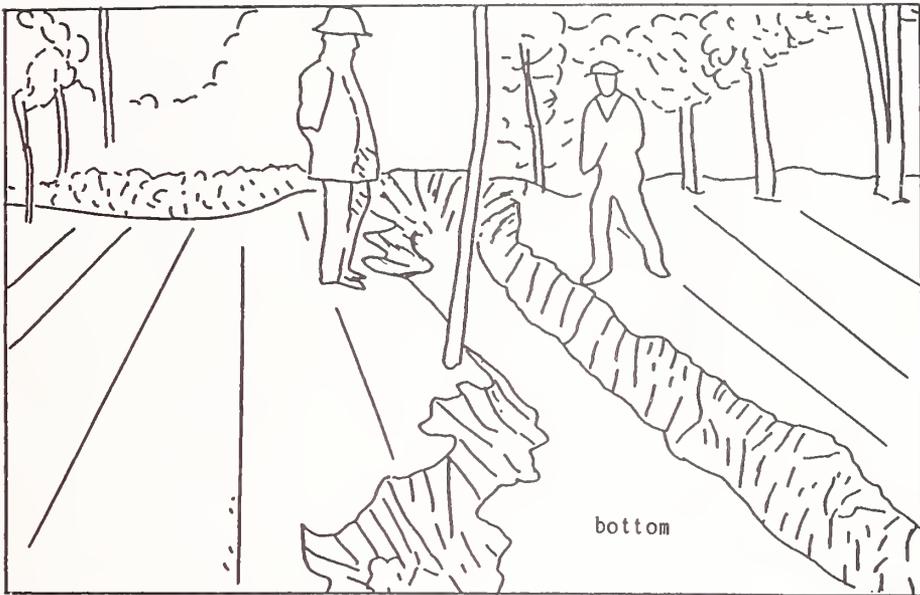
Figure 3. A crack at Kawakubo
Geological Survey Institute(1924)

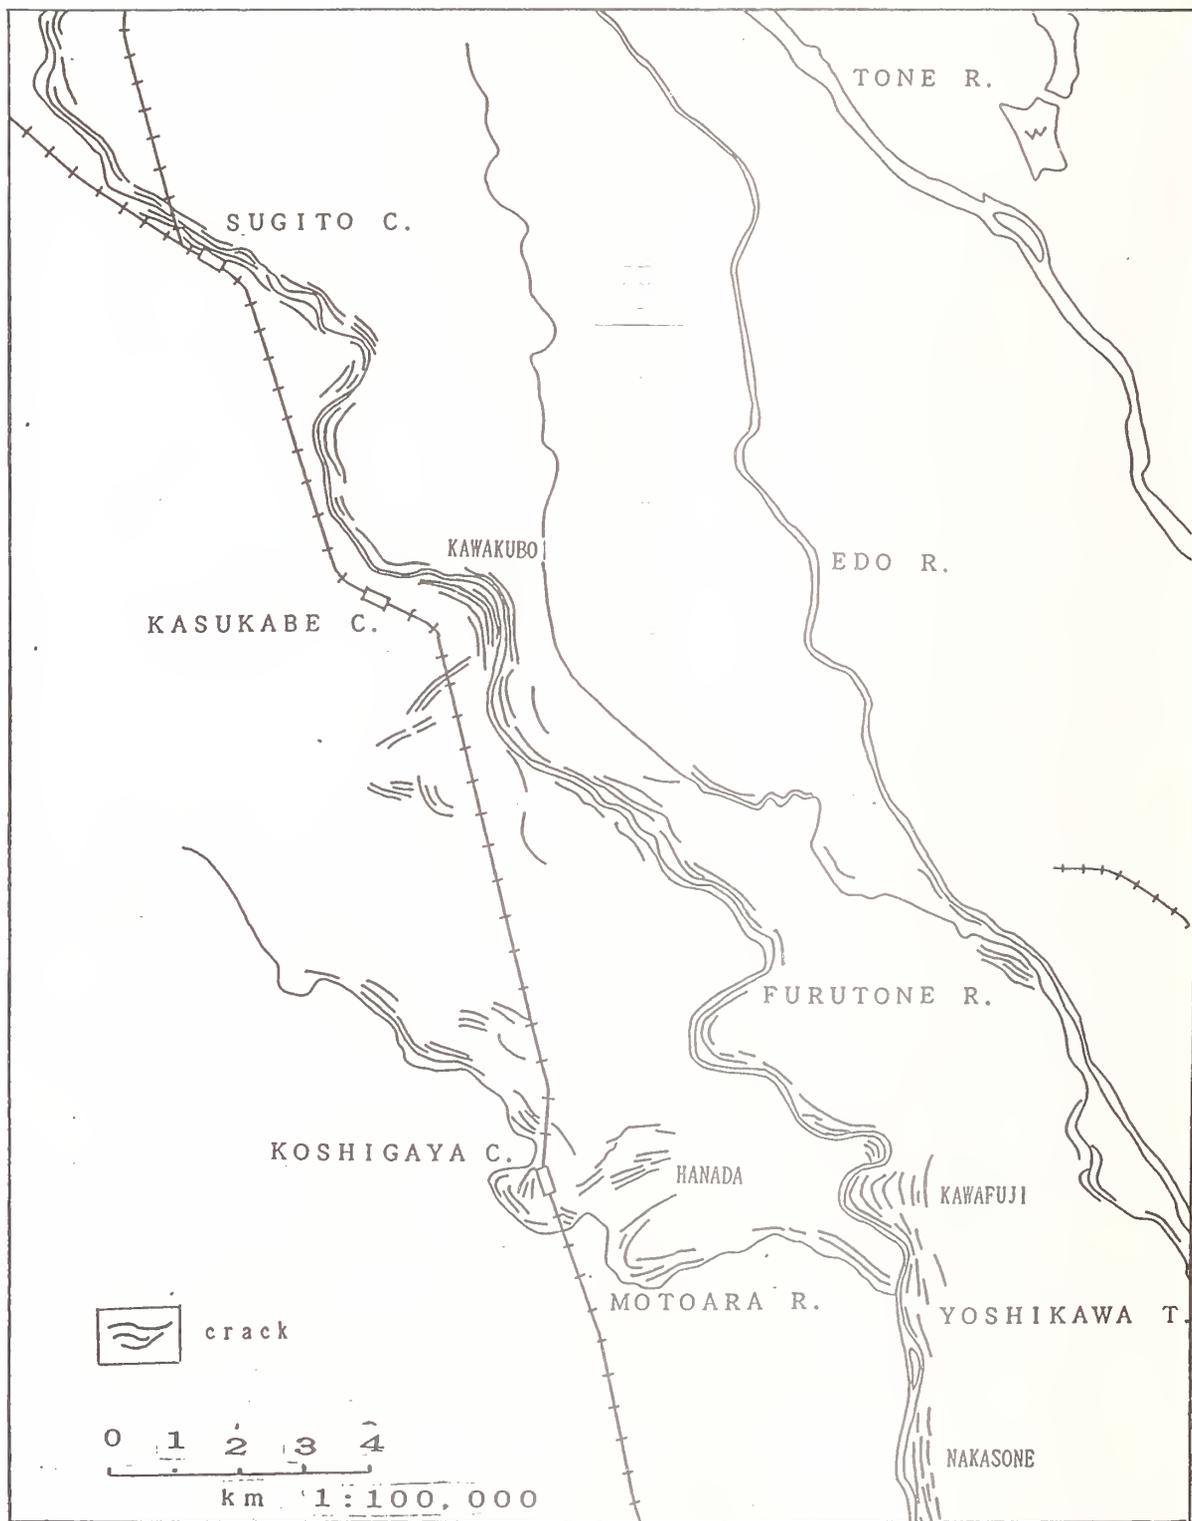
Figure 4. Distribution map of Cracks in the lowland
in the southern area of Saitama pref.

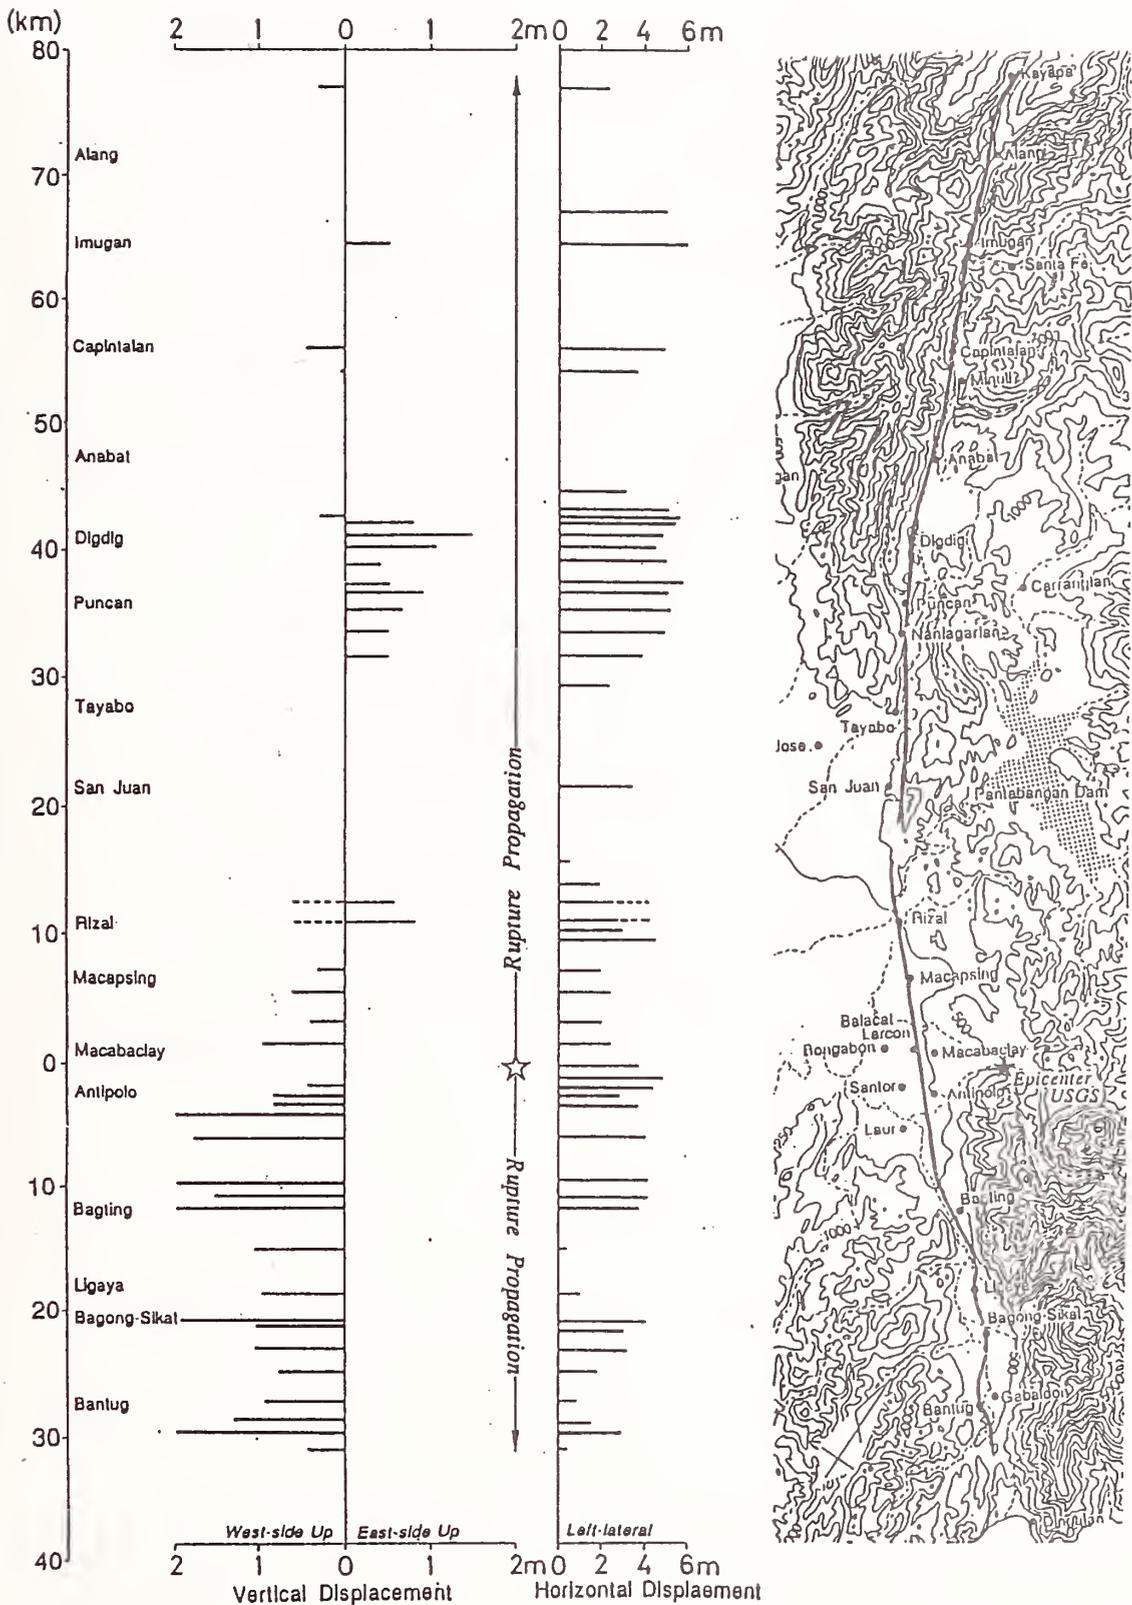
Fig. 2.4 Displacements along the Fault Caused by the 1991 July Earthquake

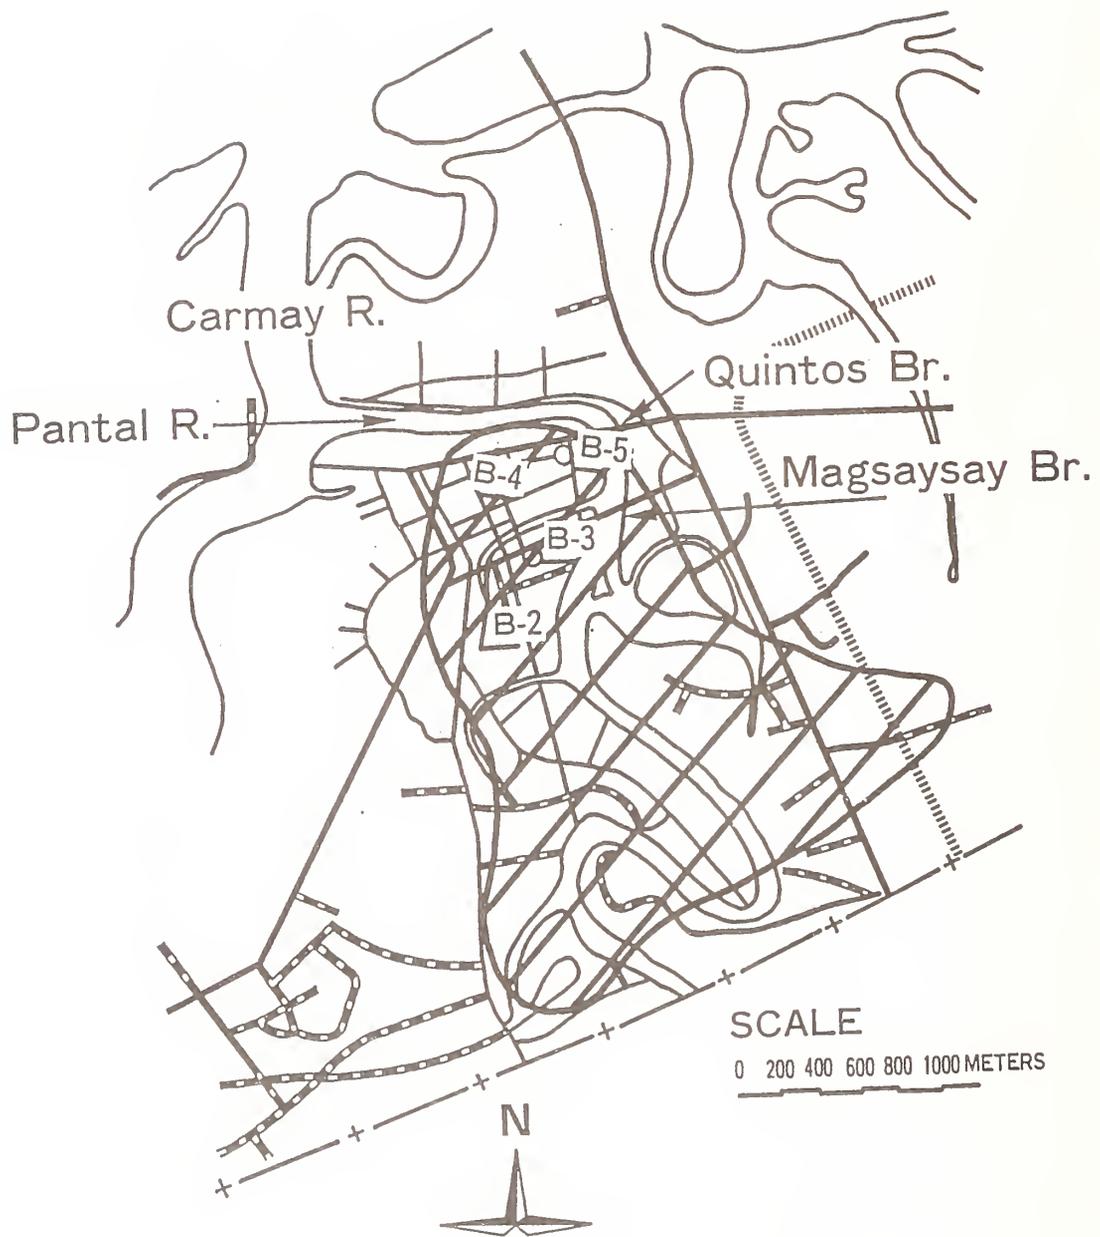
Fig. 3.1 Damaged Area of Dagupan City
due to Liquefaction

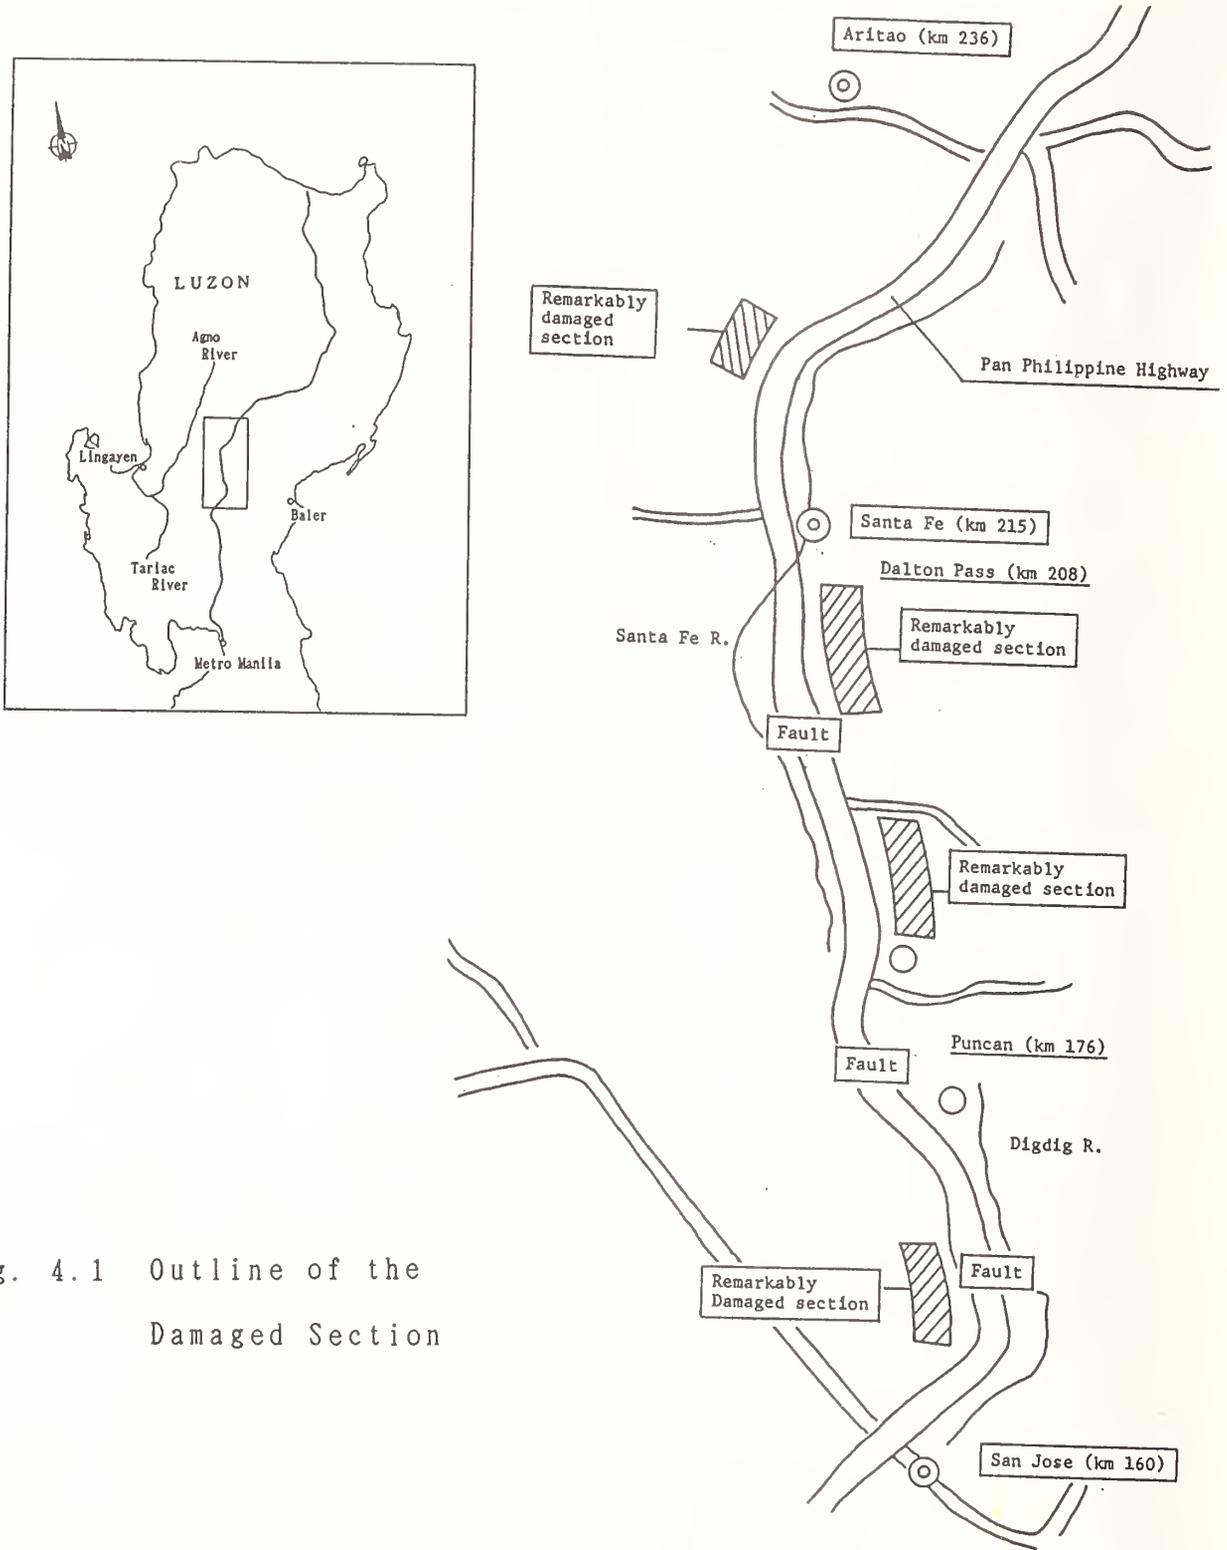
Fig. 4.1 Outline of the Damaged Section

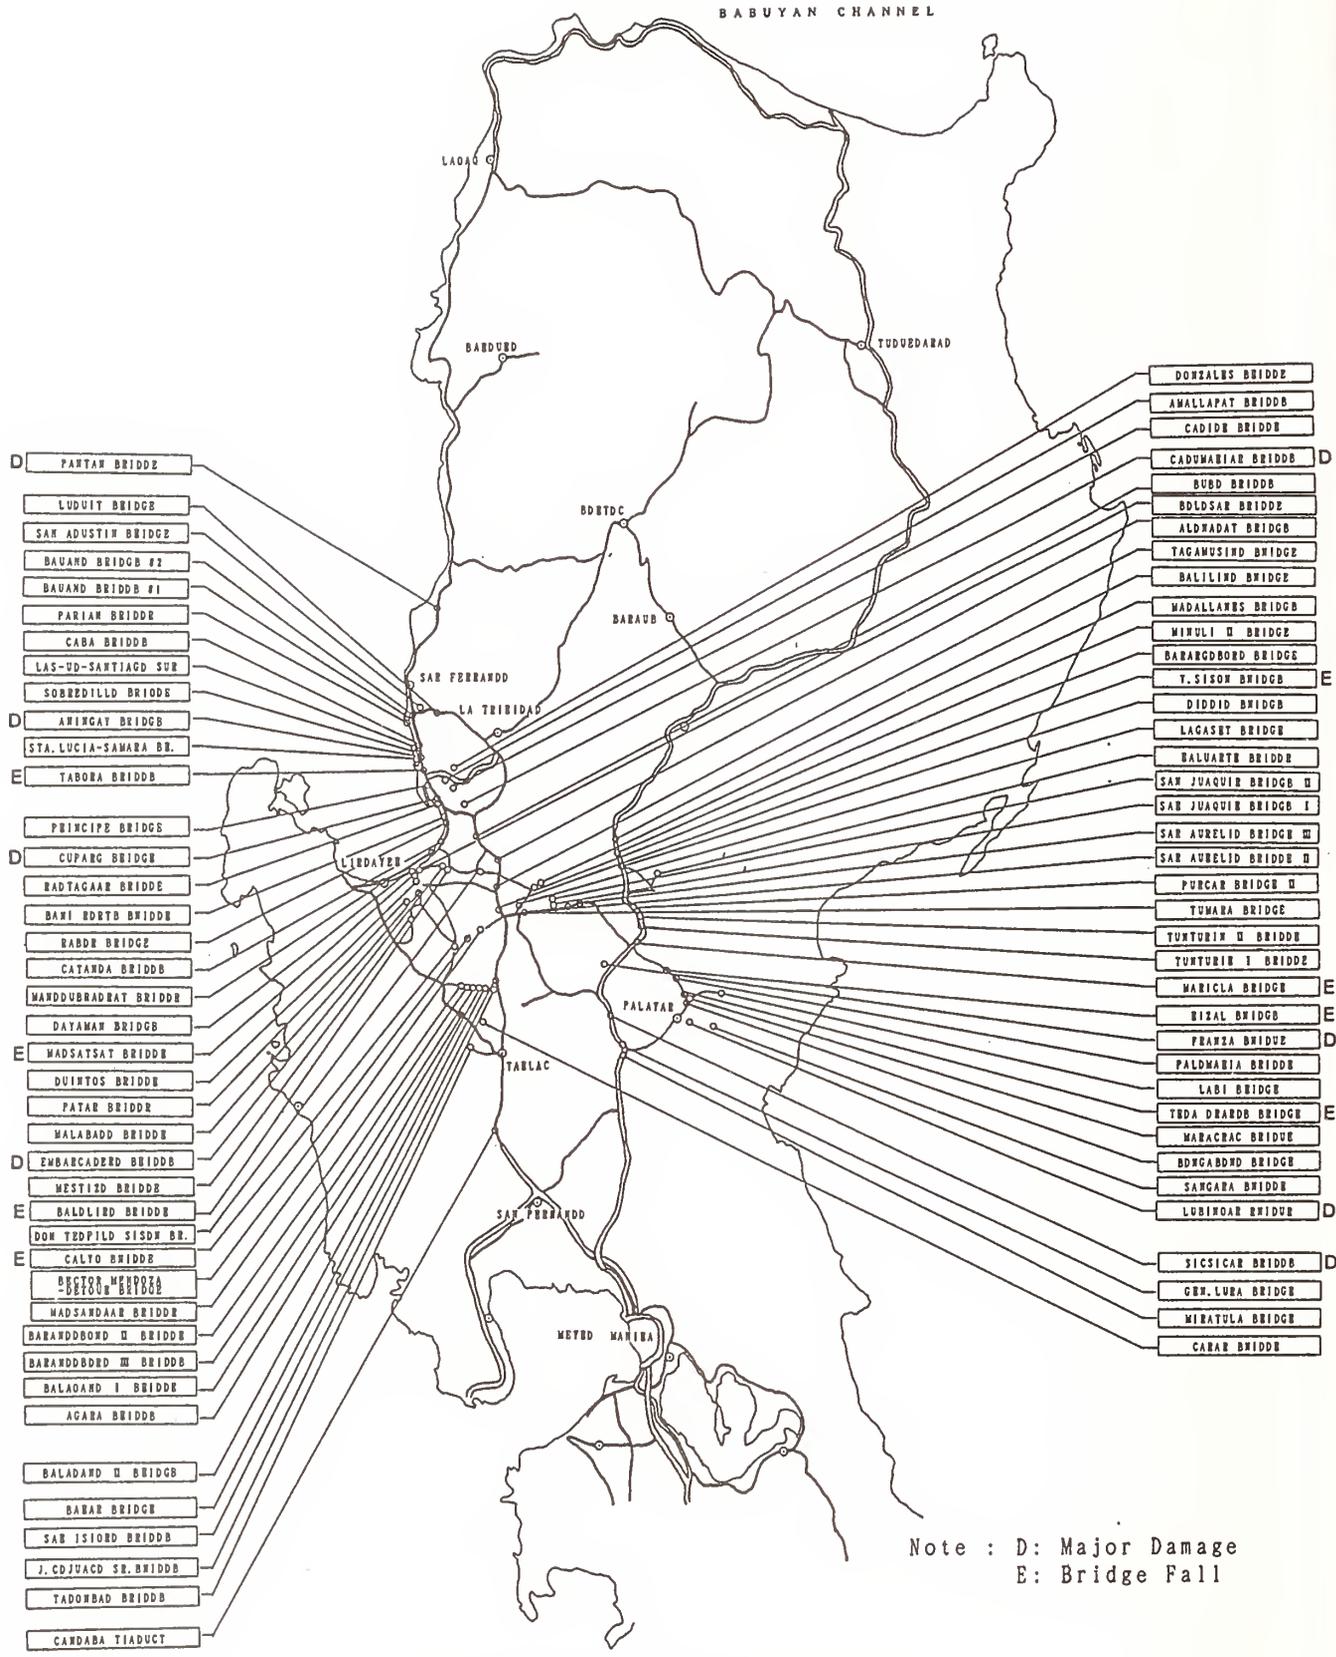
Fig. 5.1 Location of Damaged Bridges
