Wind and Seismic Effects

NIST SP 820

PROCEEDINGS OF
THE 23RD JOINT
MEETING OF
THE U.S.-JAPAN
COOPERATIVE PROGRAM
IN NATURAL RESOURCES
PANEL ON WIND AND
SEISMIC EFFECTS

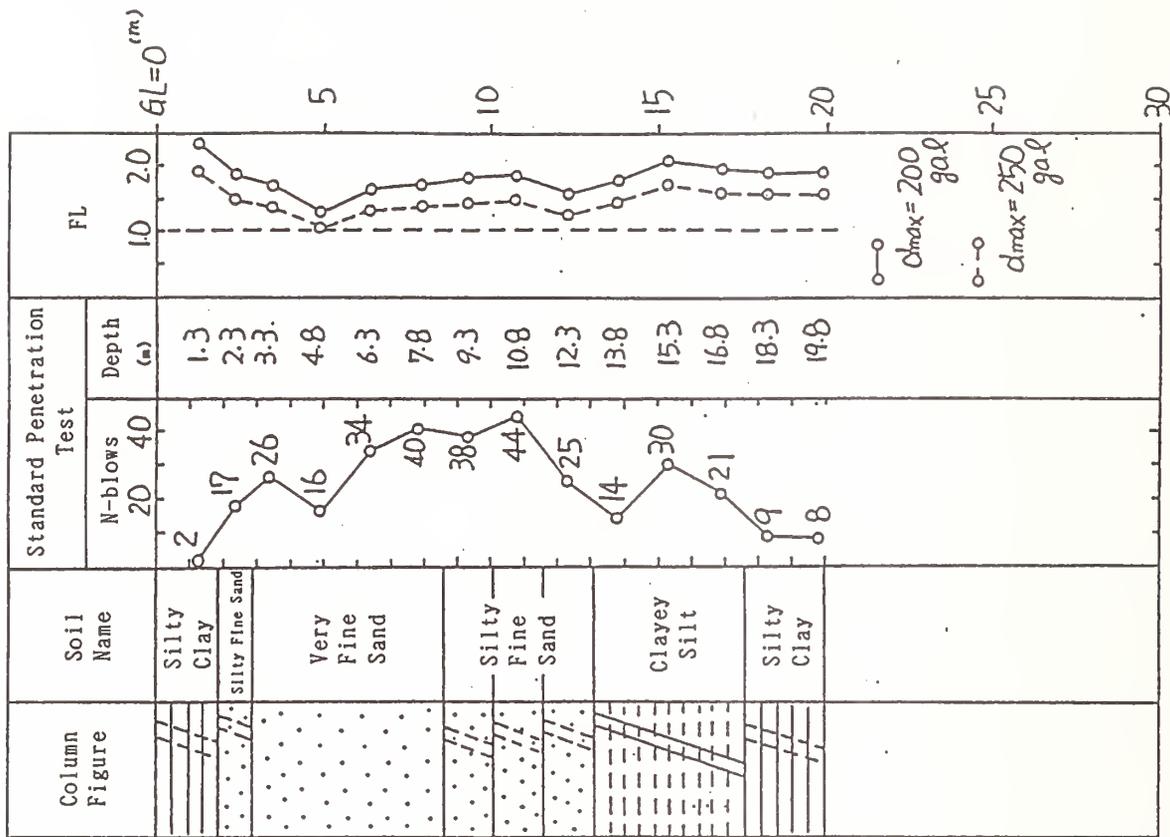
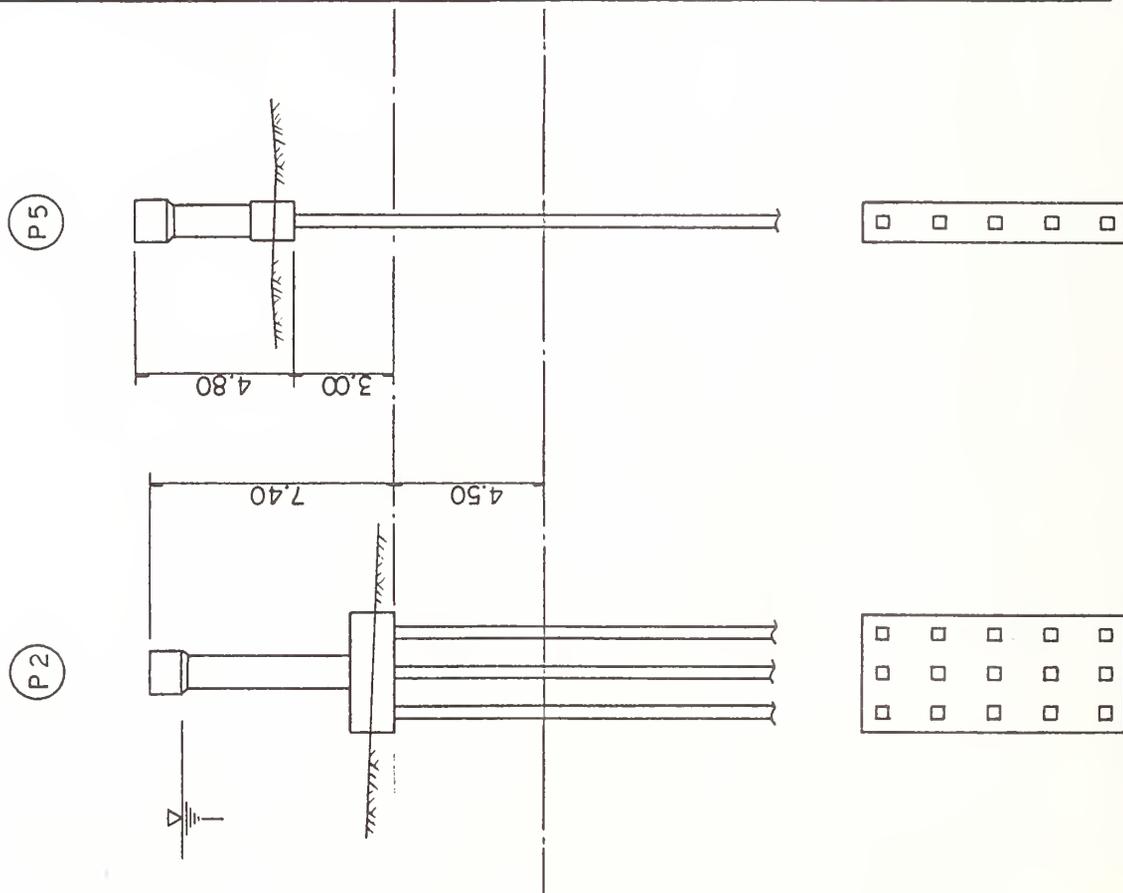
Fig. 5.5 Conditions of Calculation

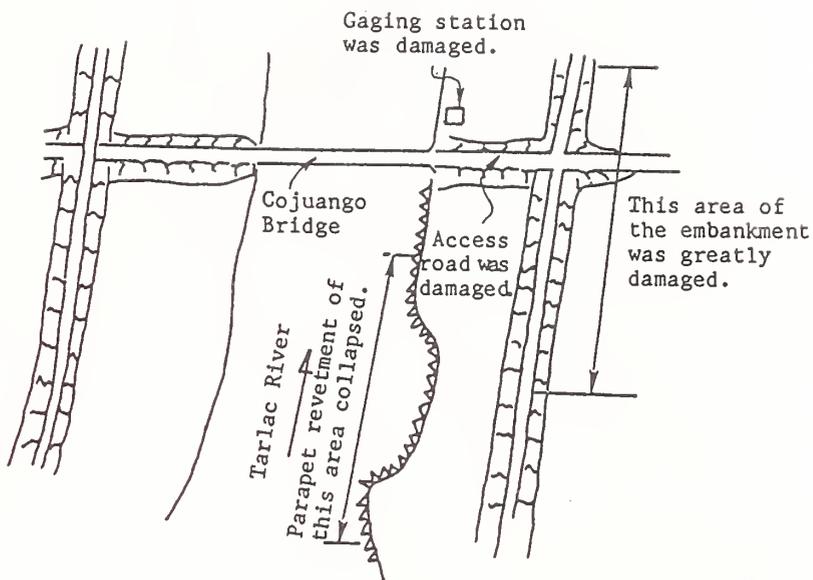
Fig. 6.2 Damaged Site of Tarlac River

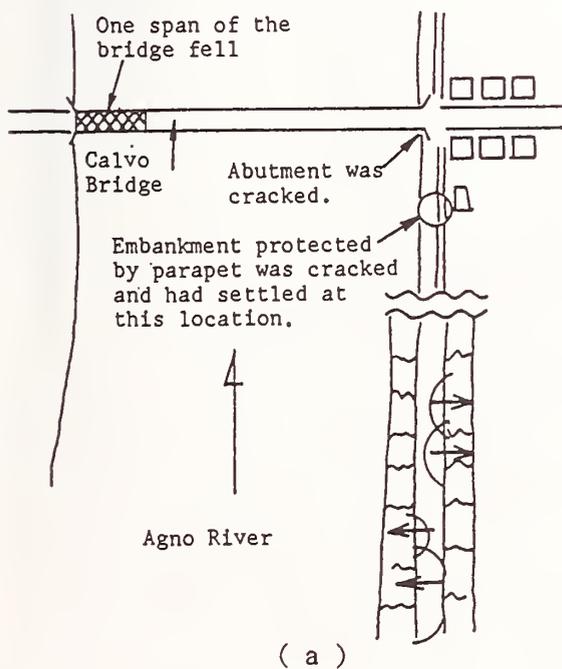
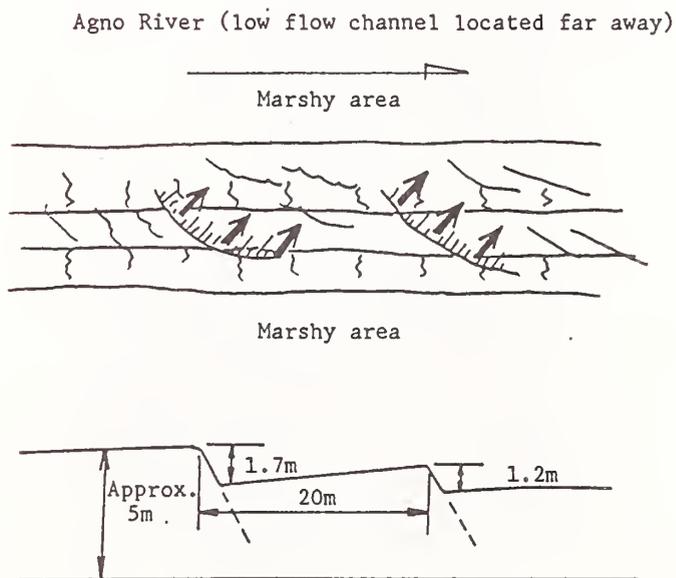
Fig. 6.3 Damaged Sites of Agno River

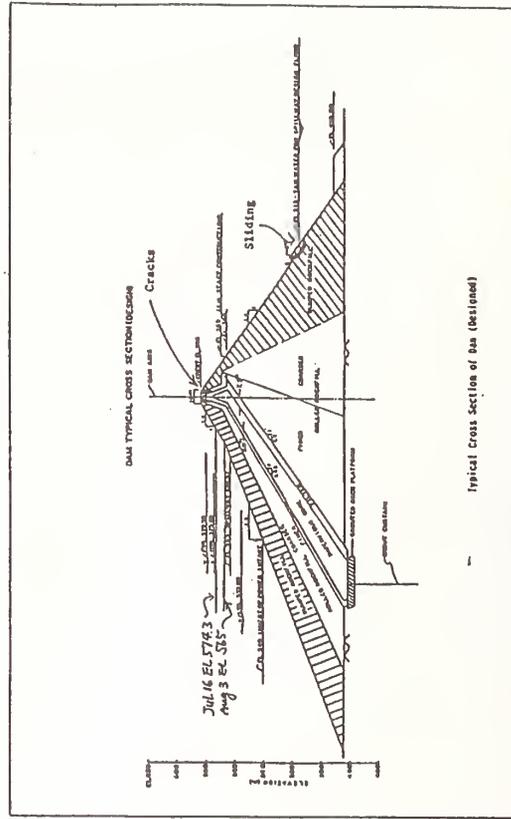
(b) Standard Cross Section of Binga Dam

Fig. 6.5 Damaged Binga Dam

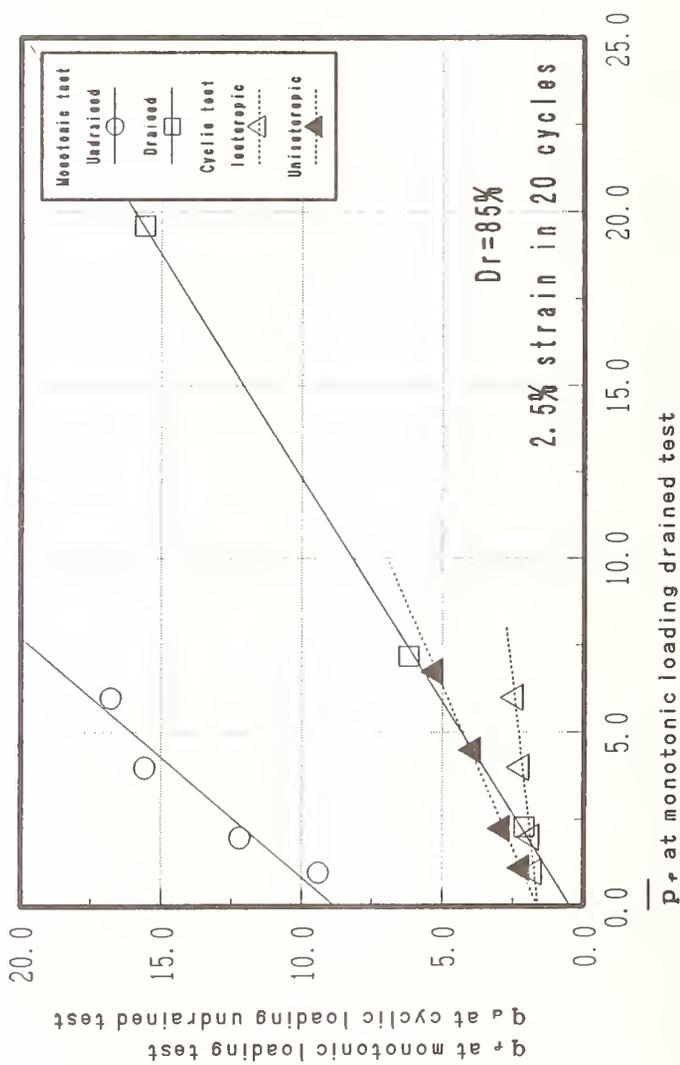
Fig. 8 The relationship between shear strength and normal stress on the failure plane

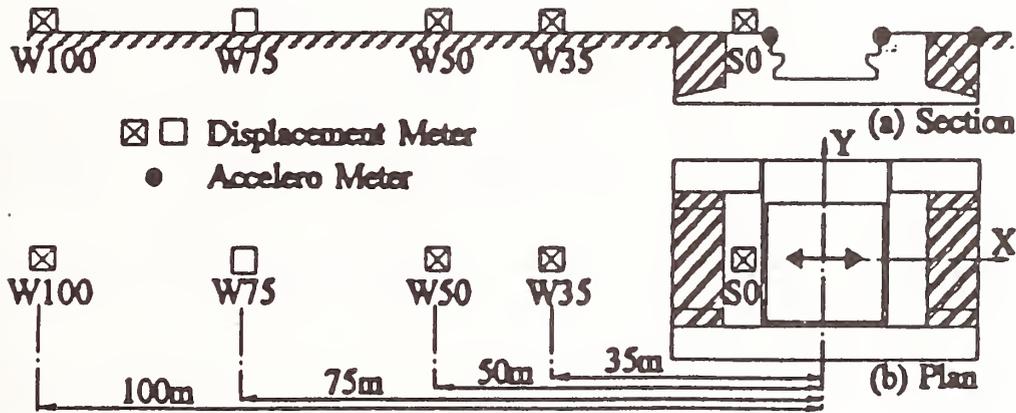
Fig. 3 Location of Sensor

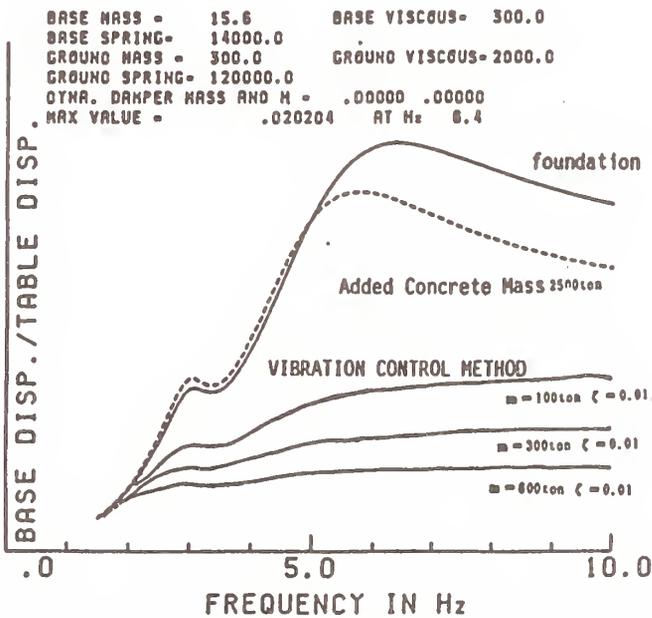
Fig. 15 Calculated Foundation Responses with Vibration Control System

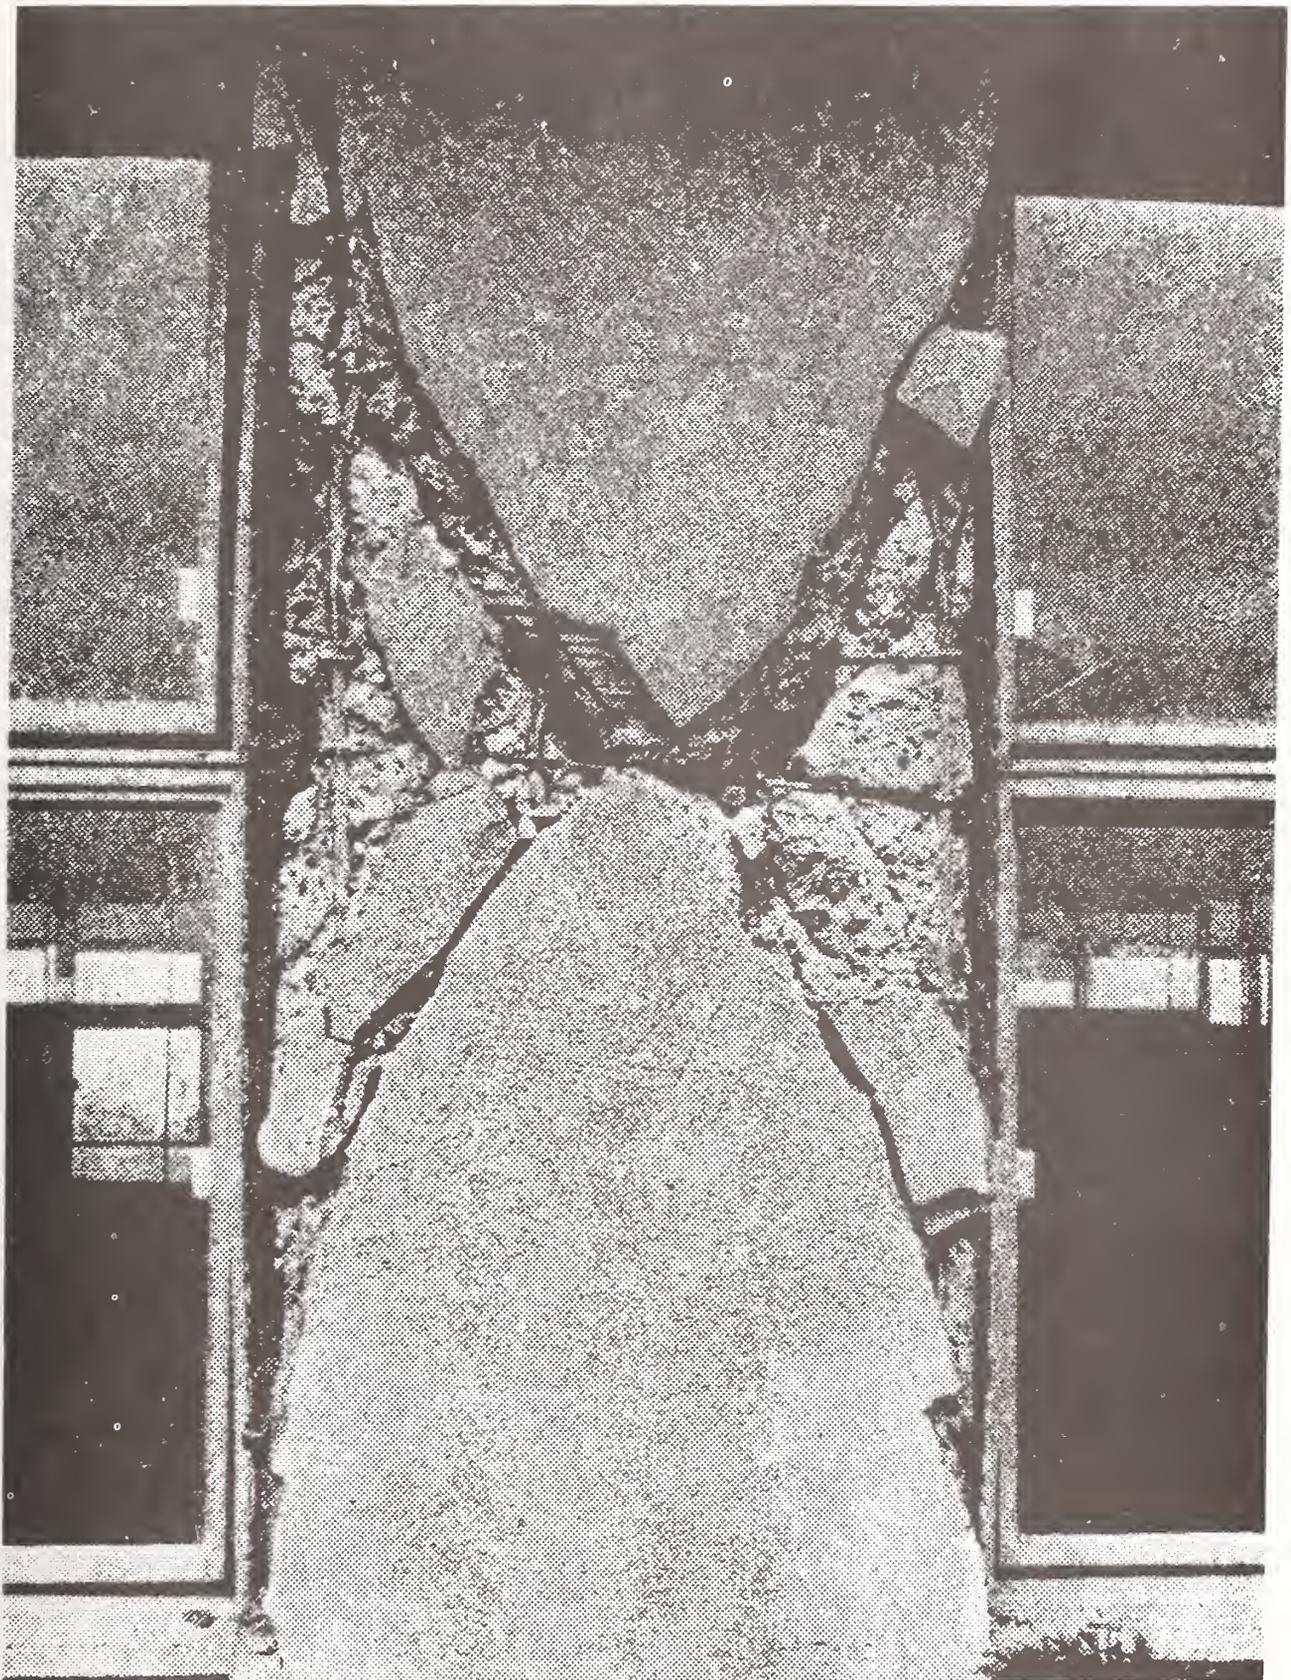
Figure 7. Diagonal Tension Failure in Window Pier
Misawa Commerce High School
Tokachi - Oki Earthquake 1968

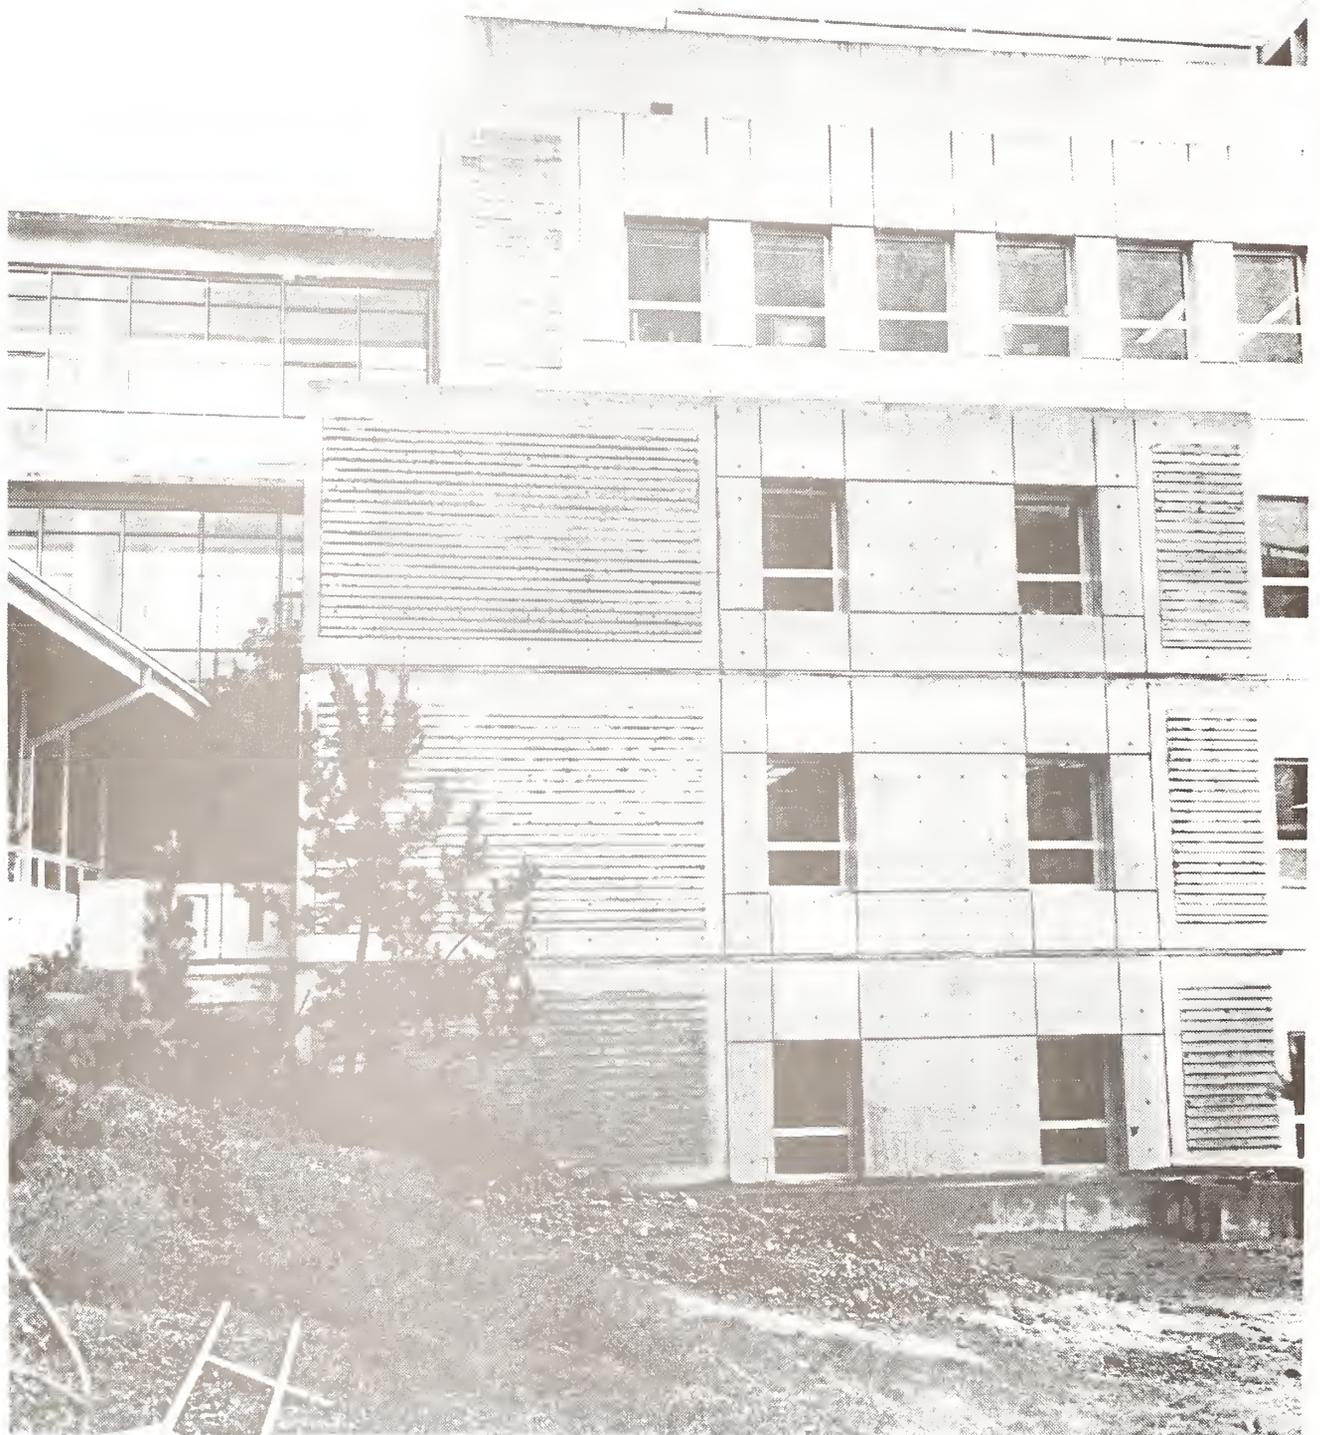
Figure 8. Longitudinal Buttress
Uphill End of Building 50B

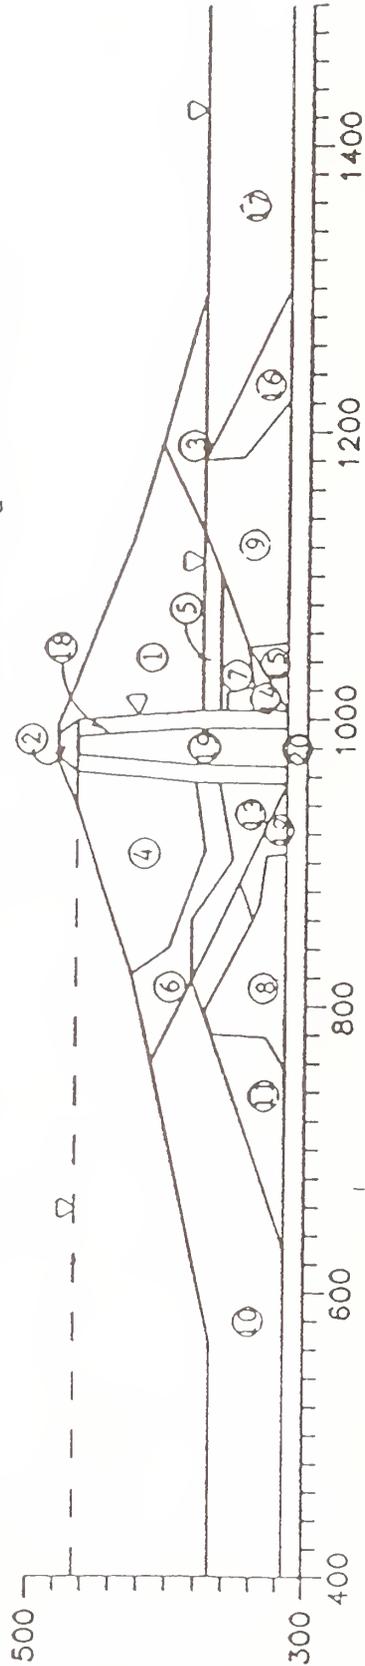
Figure 4. Material zoning for slope stability analyses, design pool and earthquake conditions

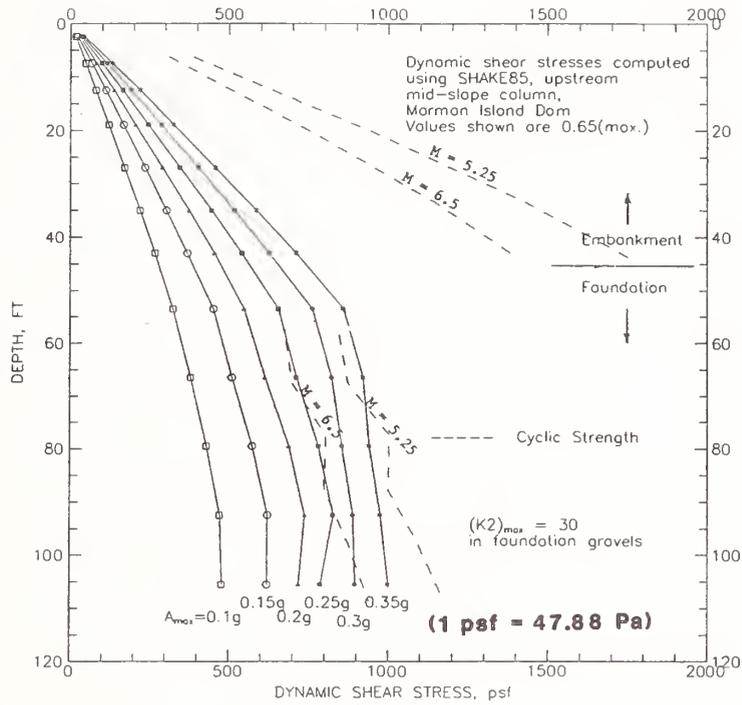
Figure 5. Profiles of average shear stress for upstream, mid-slope column with $(K_2)_{max} = 30$ in foundation gravels, showing cyclic strength profiles for earthquakes ranging in magnitude from 5.25 to 6.5

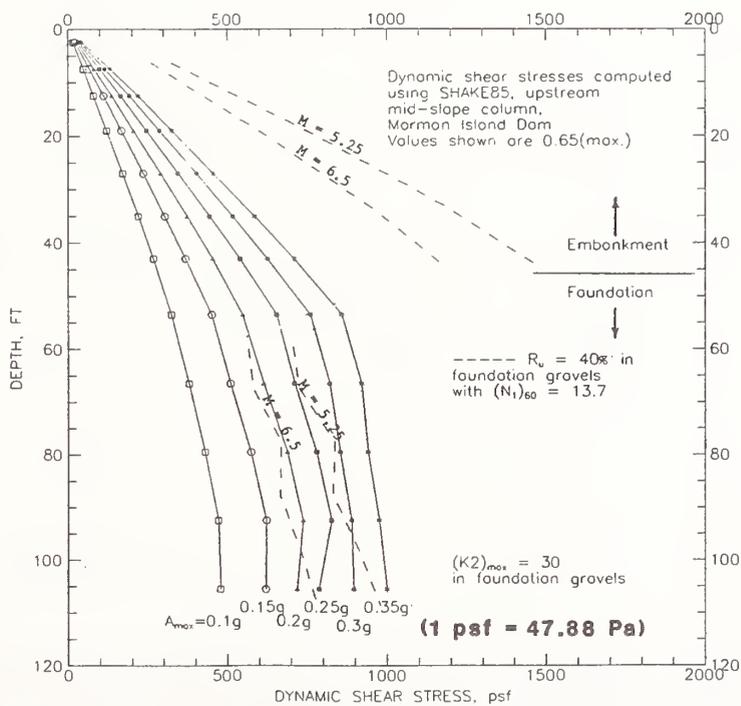
Figure 6. Profiles of average shear stress for upstream, mid-slope column with $(K_2)_{max} = 30$ in foundation gravels, showing cyclic stress profiles required to produce $R_v = 40$ percent with $(N_1)_{60} = 13.7$ for earthquakes ranging in magnitude from 5.25 to 6.5

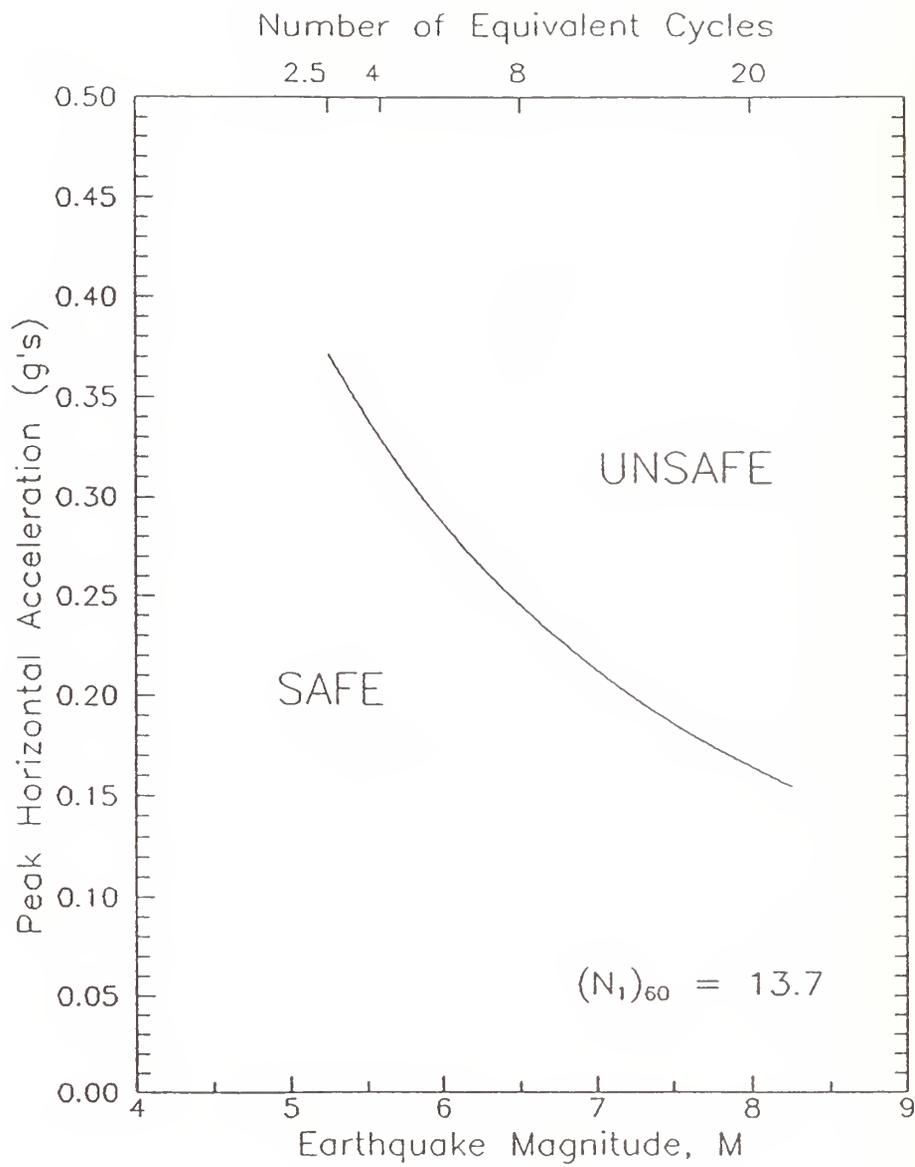
Figure 7. Estimated combinations of a_{max} and earthquake magnitude causing liquefaction of dredged foundation gravels for $(N_1)_{60} = 13.7$

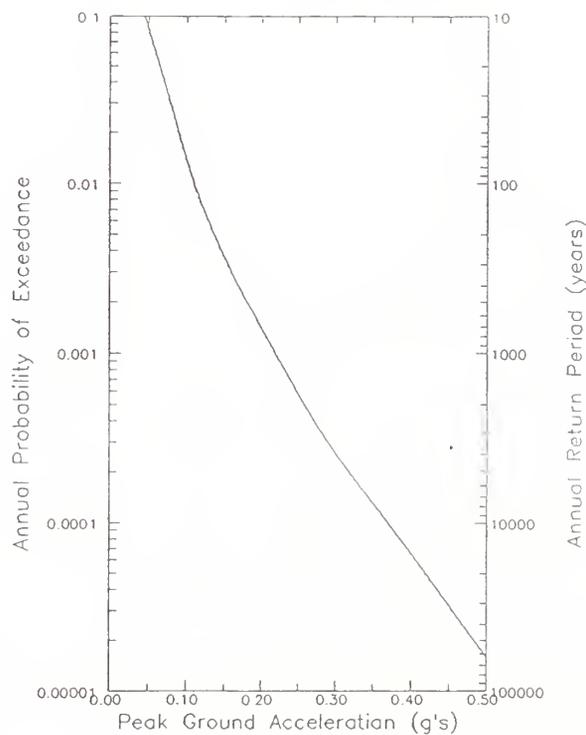
Figure 10. Best estimate of seismic hazard versus peak horizontal acceleration recommended for use in selecting remedial measures

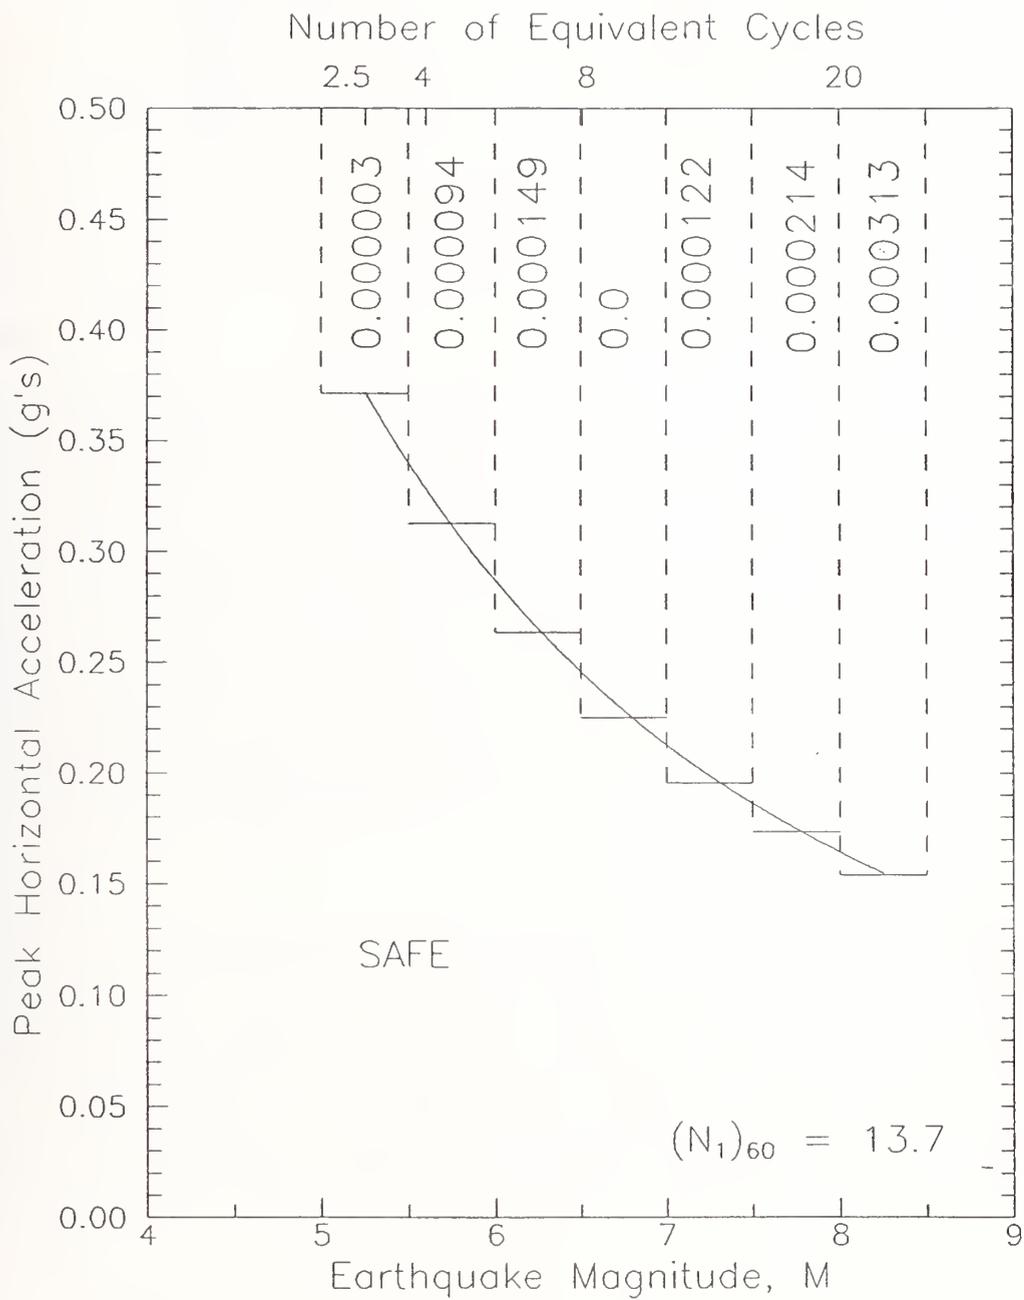
Figure 11. Probabilities of occurrence for different ranges in magnitude at combinations of a_{max} and earthquake magnitude causing liquefaction of dredged foundation gravel for $(N_1)_{60} = 13.7$

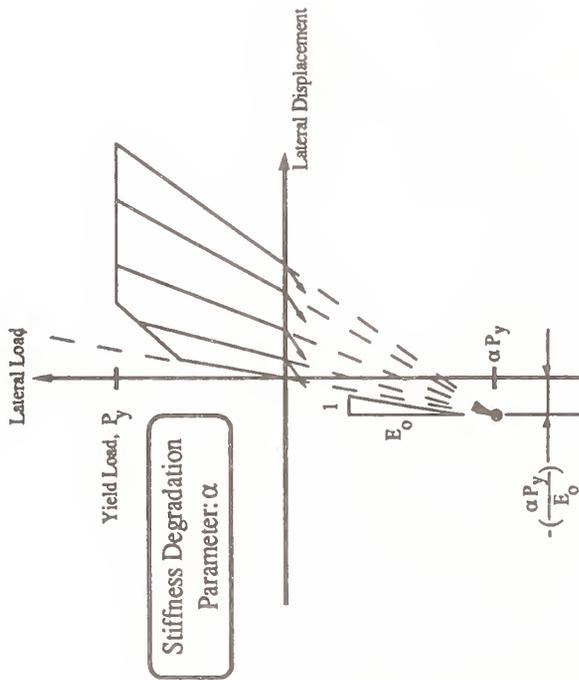
Figure 2. Effect of varying stiffness degradation parameter alpha.

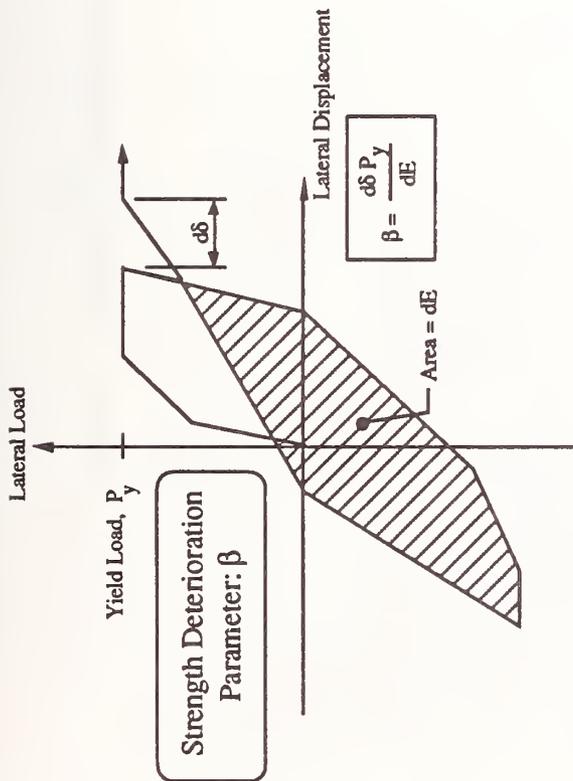
Figure 3. Effect of varying strength deterioration parameter beta.

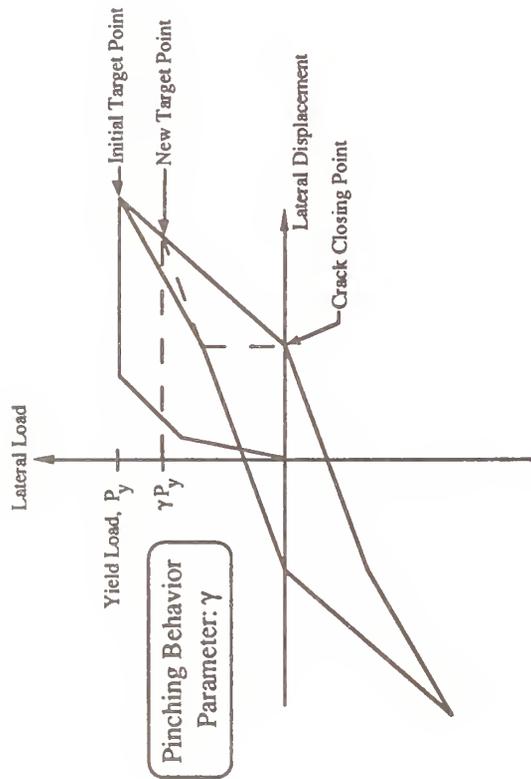
Figure 4. Effect of varying pinching behavior parameter gamma.

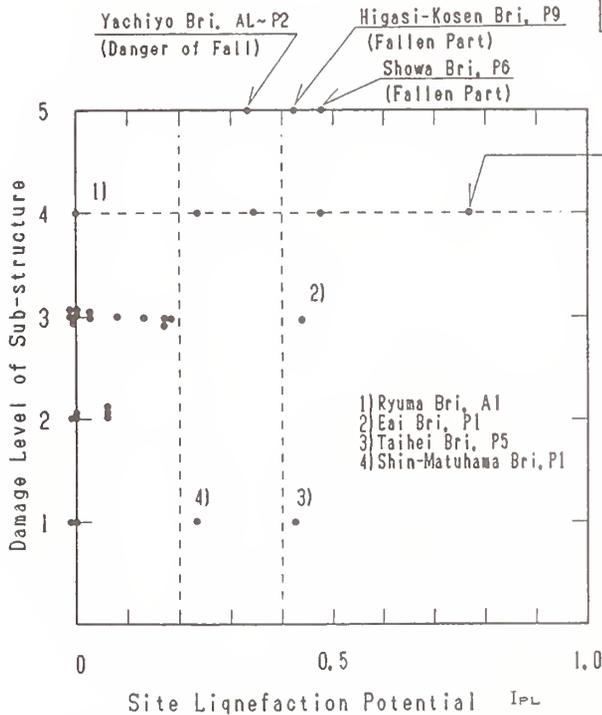
Fig. 1 Relation between Site Liquefaction Potential (r_{HL}) and Damage Level of Substructure

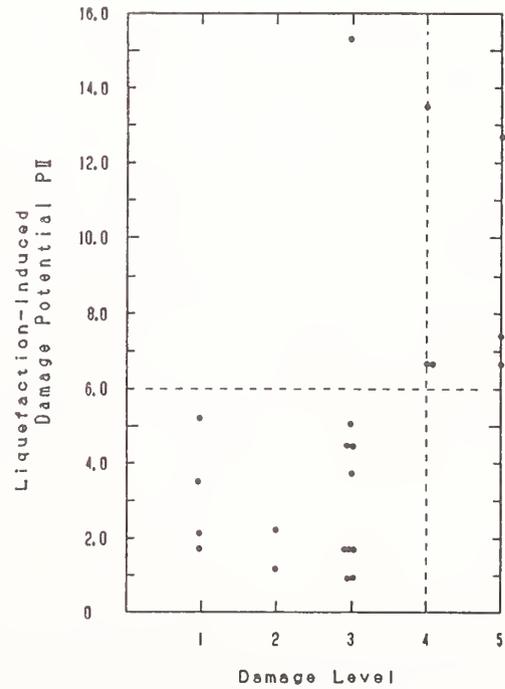
Fig. 4 Relation between Damage Level of Substructure
and Liquefaction-Induced Damage Potential

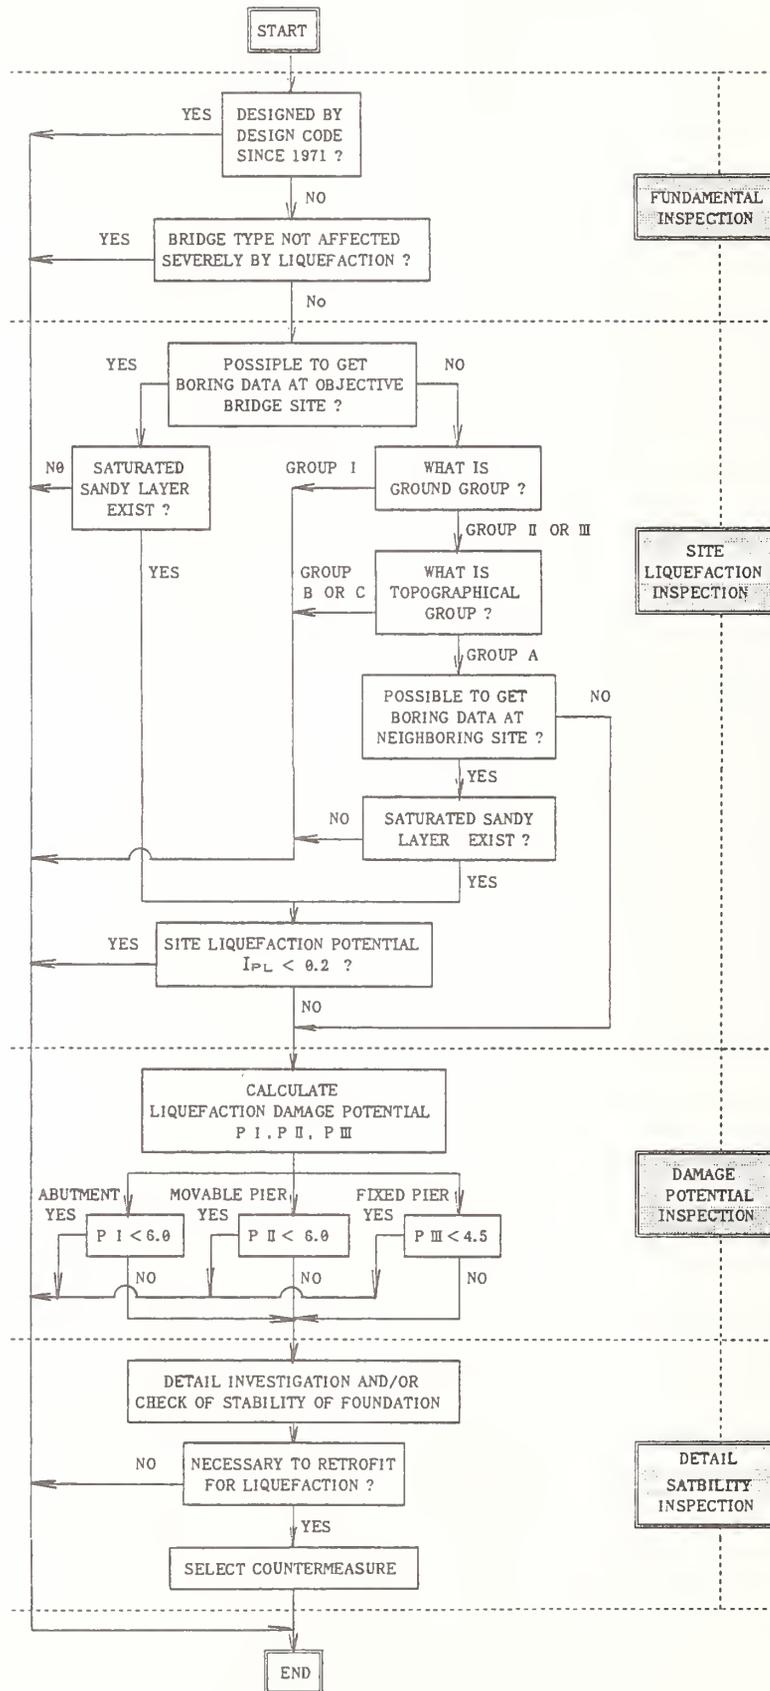
Fig. 5 Example of Flow Chart for Inspecting Earthquake Resistant Potential of Highway Bridge Foundation

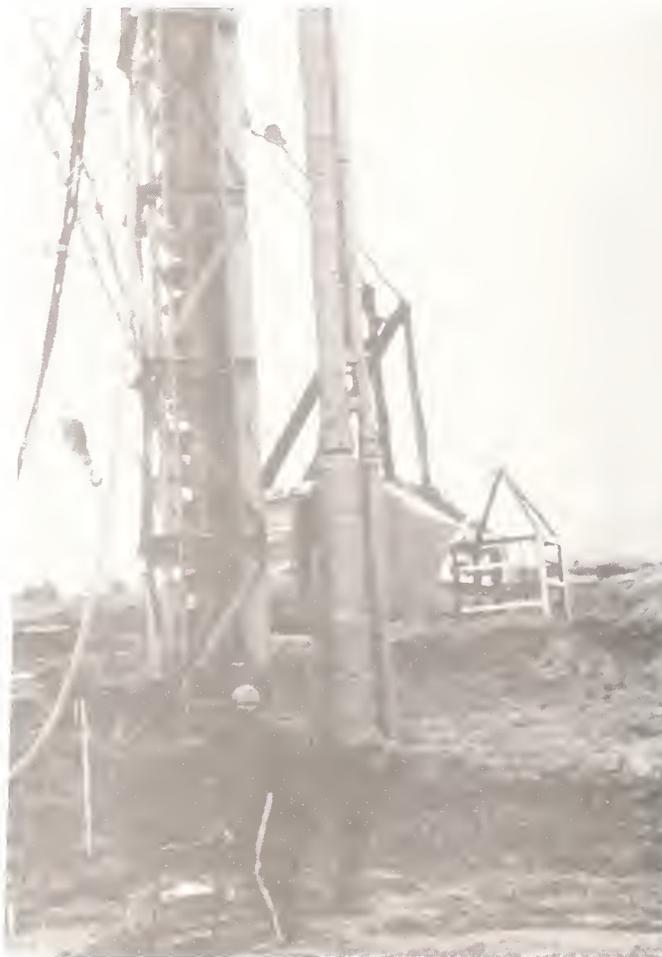
Figure 4. Equipment used to install stone columns to improve foundation conditions.

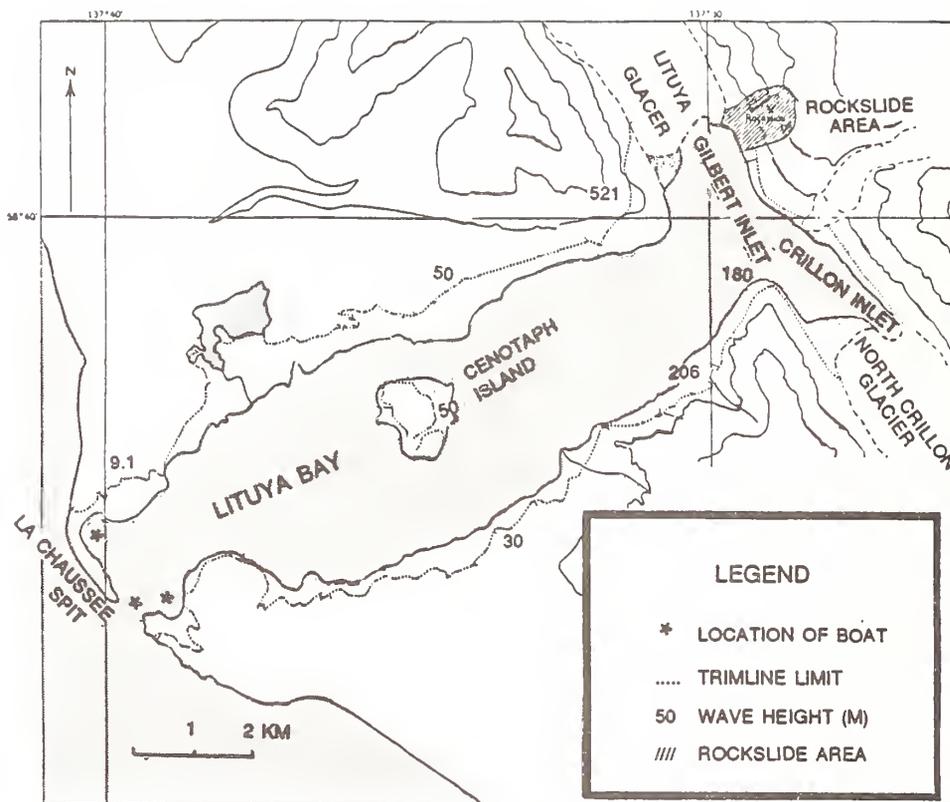
Figure 2. Map of Lituya Bay showing setting, location of boats, and trimline caused by the 1958 tsunami.

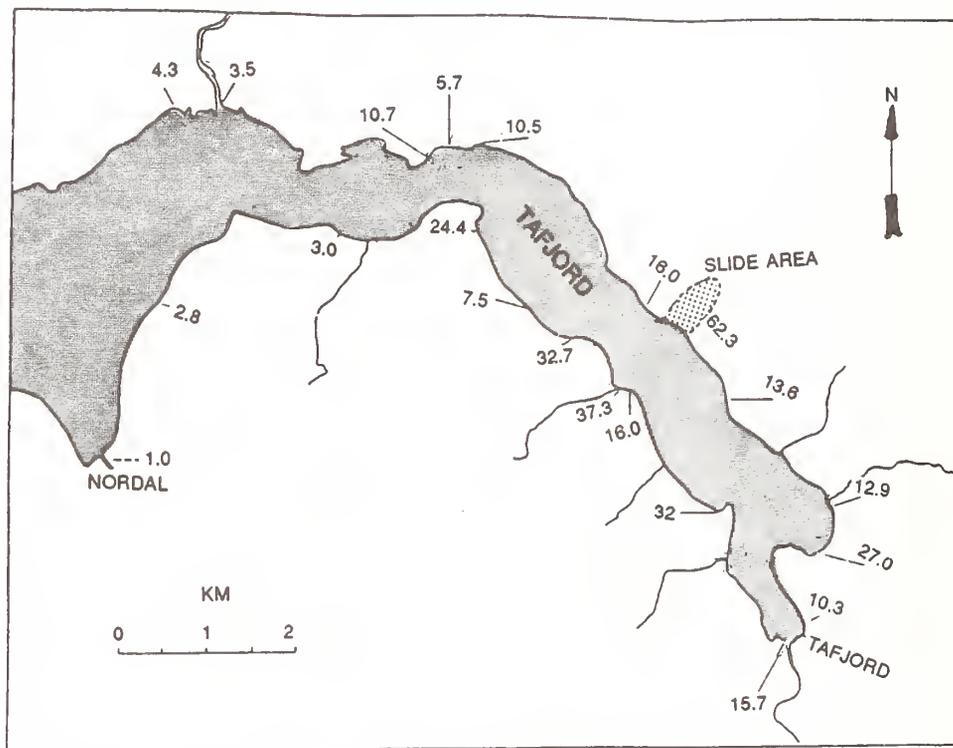
Figure 3. Tafjord showing wave heights in meters produced by the rock slide of 1934.

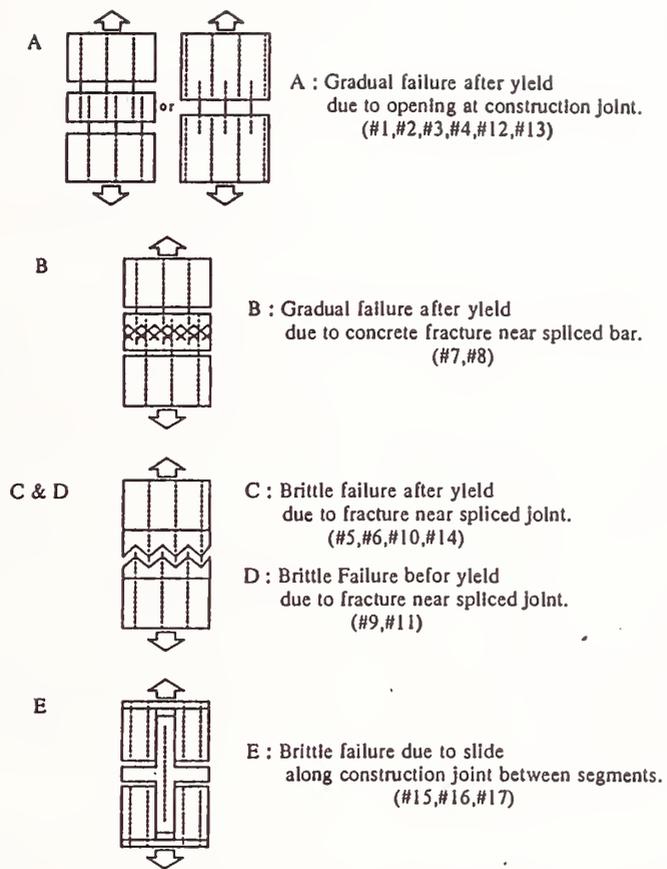
Figure 5: Failure Modes

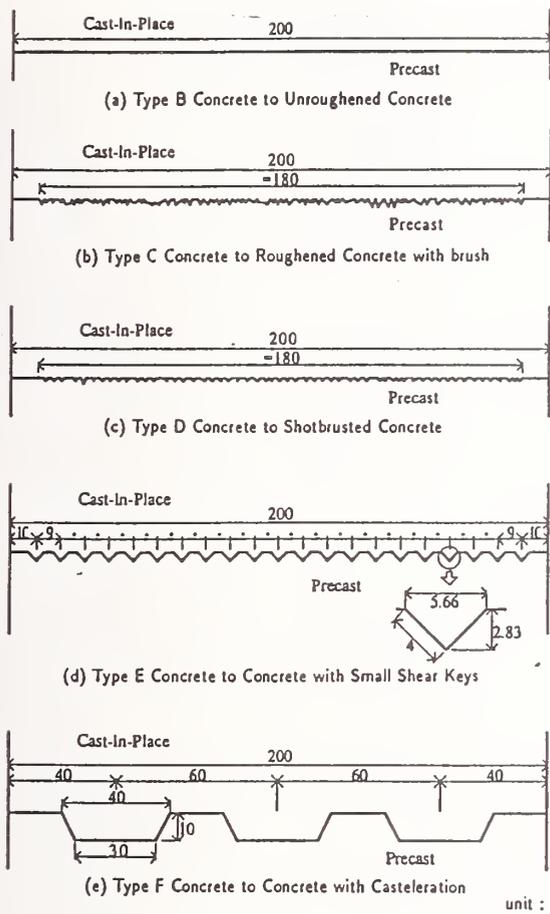
Figure 1: Configuration of Interfaces of Specimens

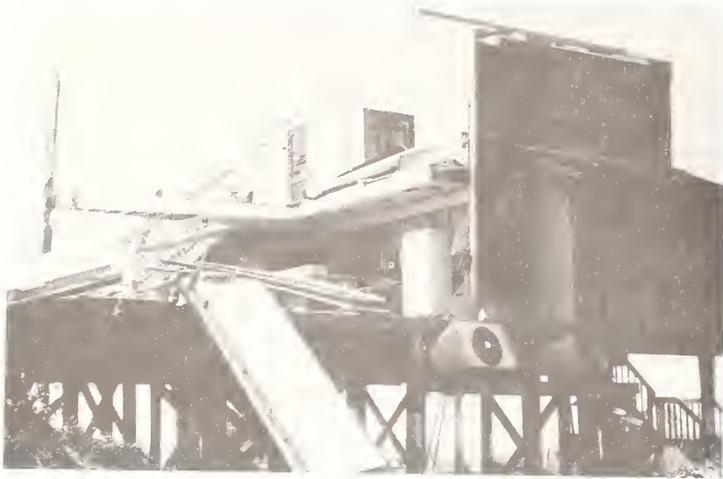
Figure 2. Wood-Framed House, Folly Beach

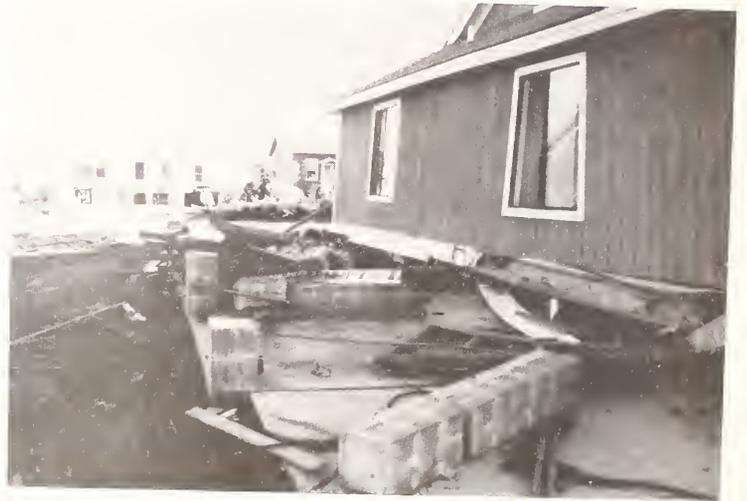
Figure 4. Mobile Home Near Sumter

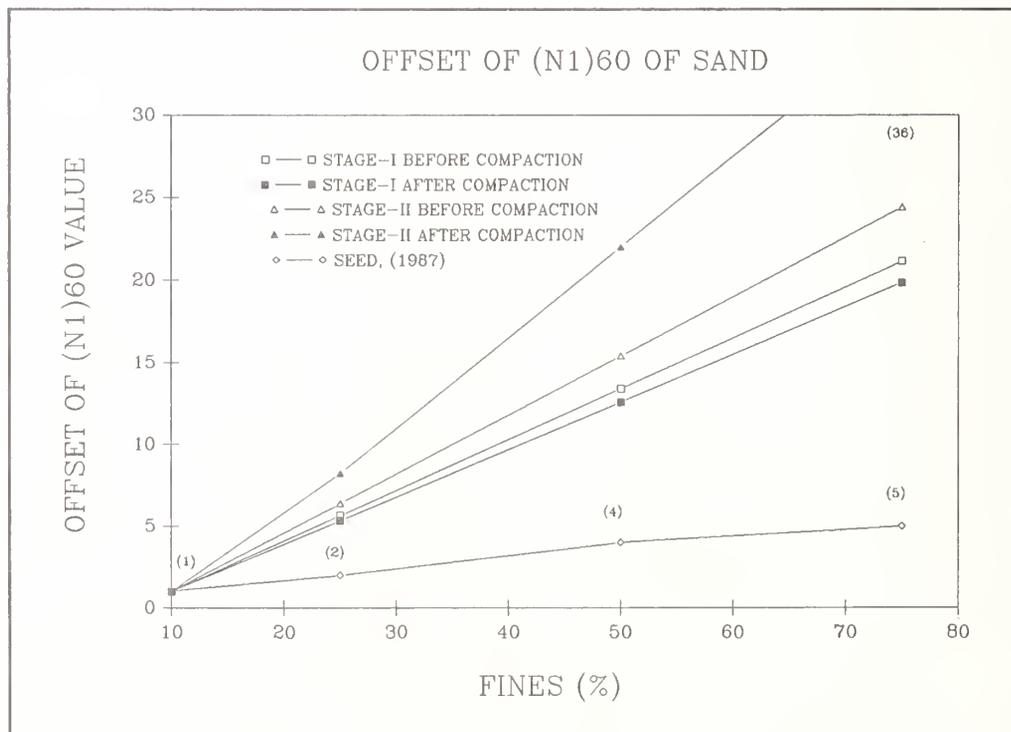
Figure 32. Offset of N_{160} values versus fines content.
