Wind and Seismic Effects

Proceedings of the 26th Joint Meeting

NIST SP 871

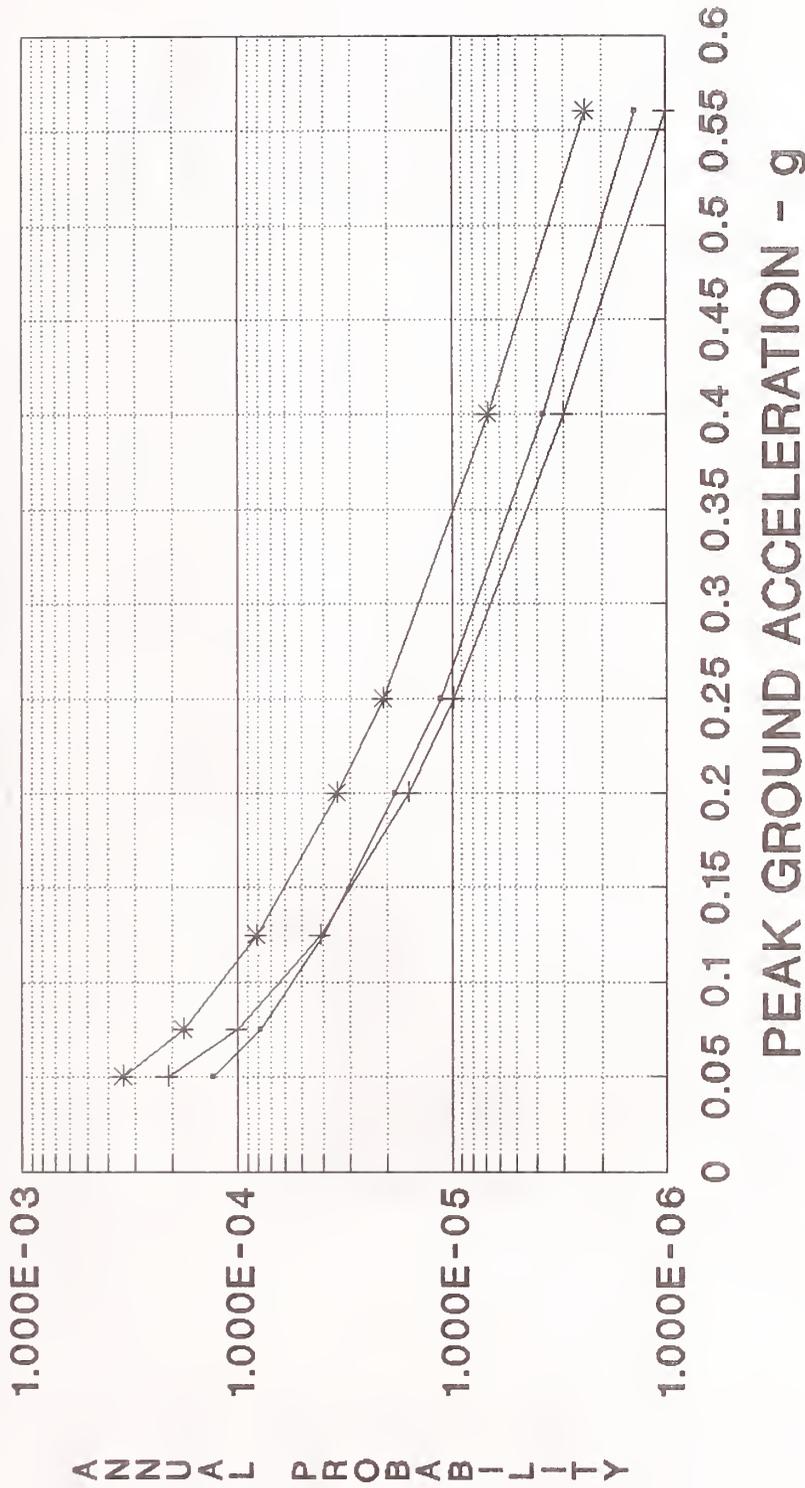
FIGURE 1

— MAG 5 - 6 —+— MAG 6+ —*— TOTAL HAZARD
 PROBABILISTIC SEISMIC HAZARD CURVE FOR KANSAS CITY MISSOURI
 SHOWING THE TOTAL SEISMIC HAZARD AND THE BREAKDOWN OF THE
 TOTAL HAZARD INTO MAGNITUDE 5 TO 6 AND LARGER THAN 6

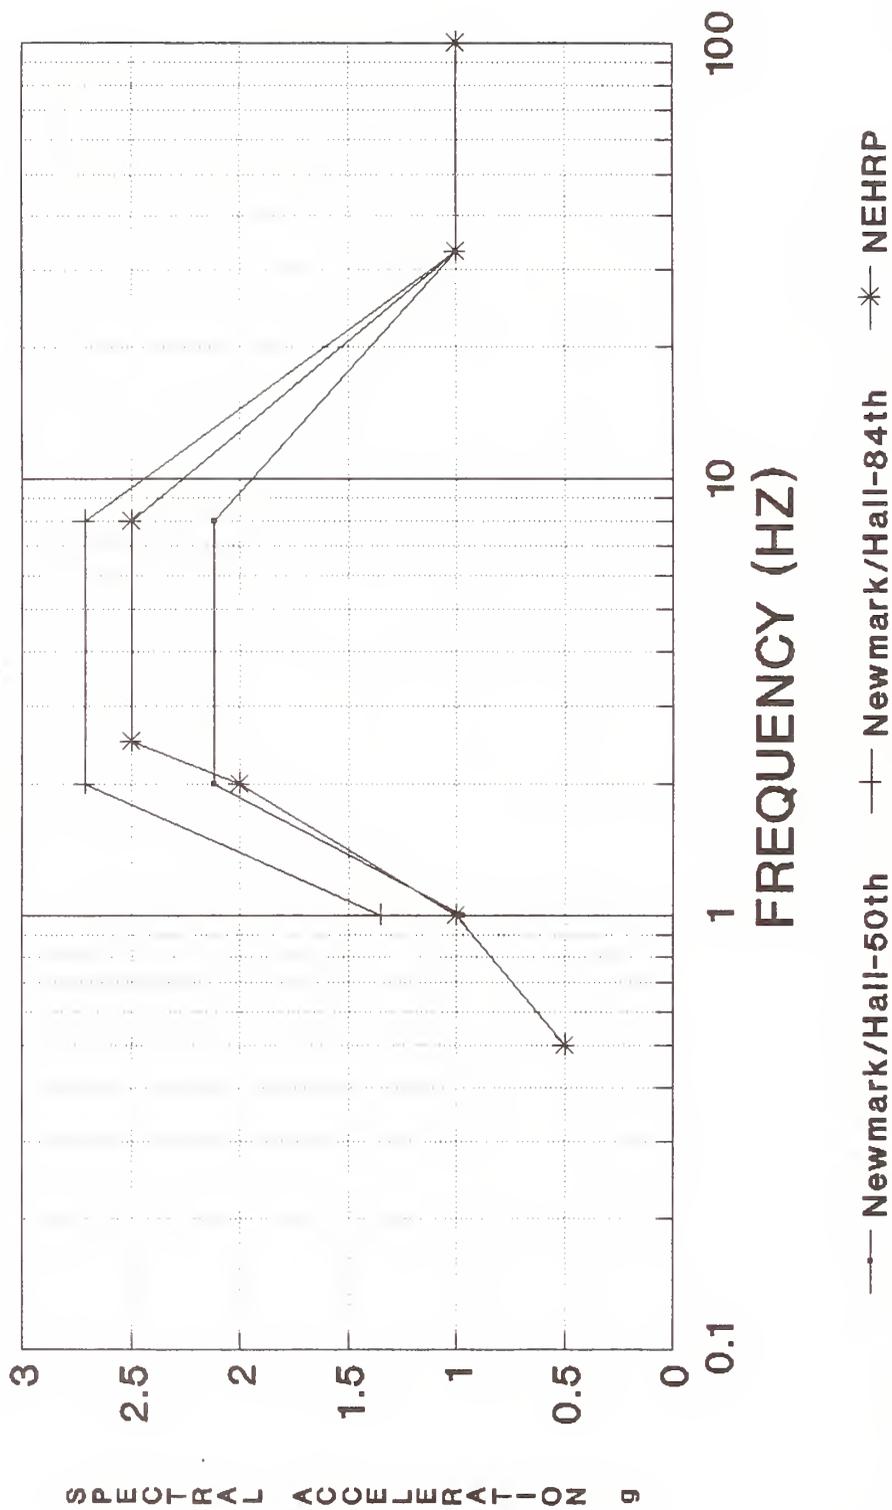
FIGURE 4

RESPONSE SPECTRA SHAPES BASED ON NEWMARK AND HALL (1978) AND
NEHRP (1991) FOR ROCK SITE CONDITIONS

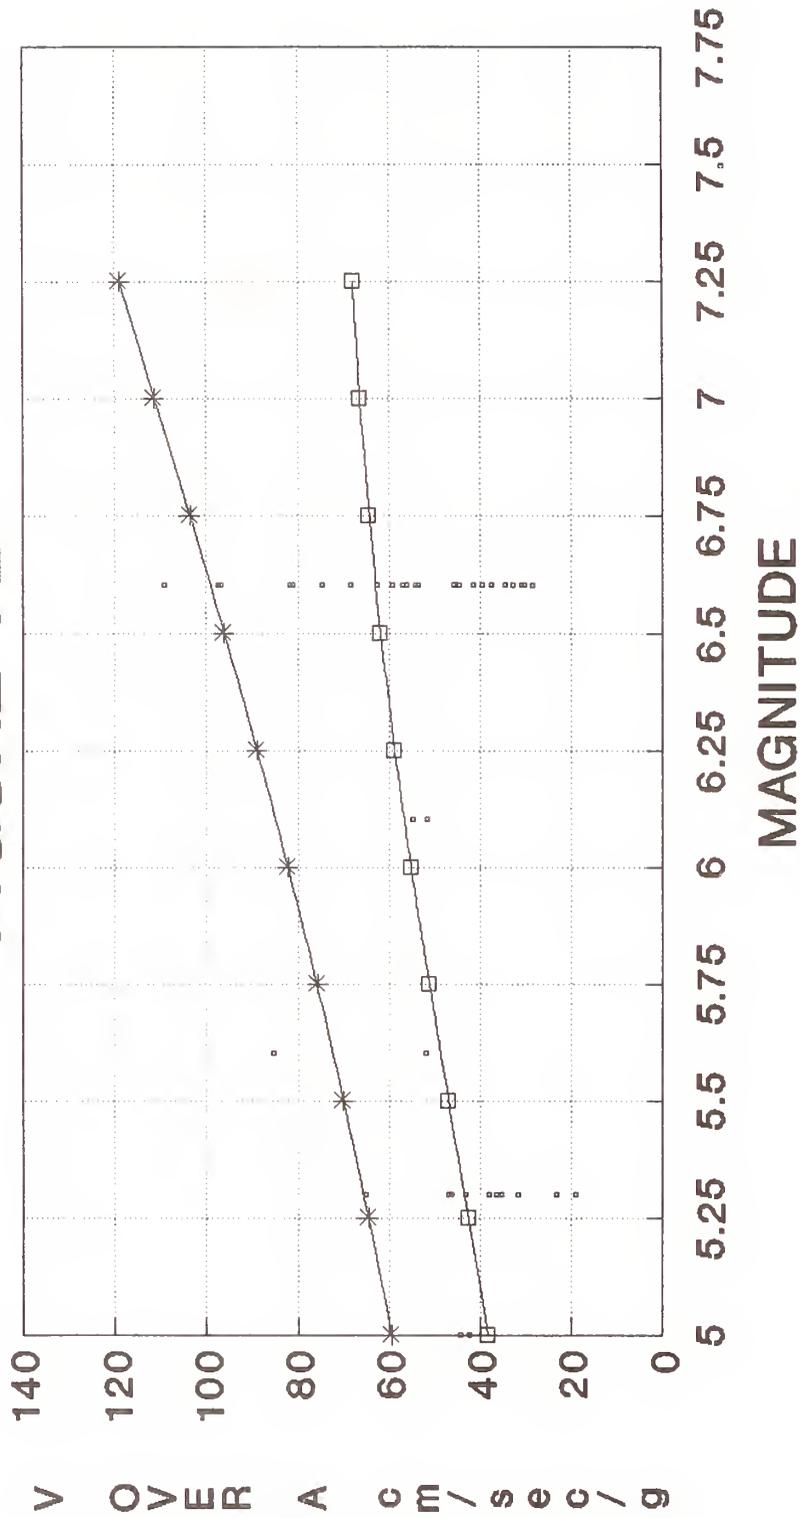
FIGURE 7B

• ROCK DATA —*— CAMP 100 KM —□— CAMP 5 KM
 PLOT OF INDIVIDUAL DATA POINTS FOR ROCK SITES FOR PRE 1972
 STRONG MOTION DATA COMPARED TO V/A BASED ON CAMPBELL
 1990 ATTENUATION MODEL - SHOWING MAGNITUDE DEPENDENT V/A

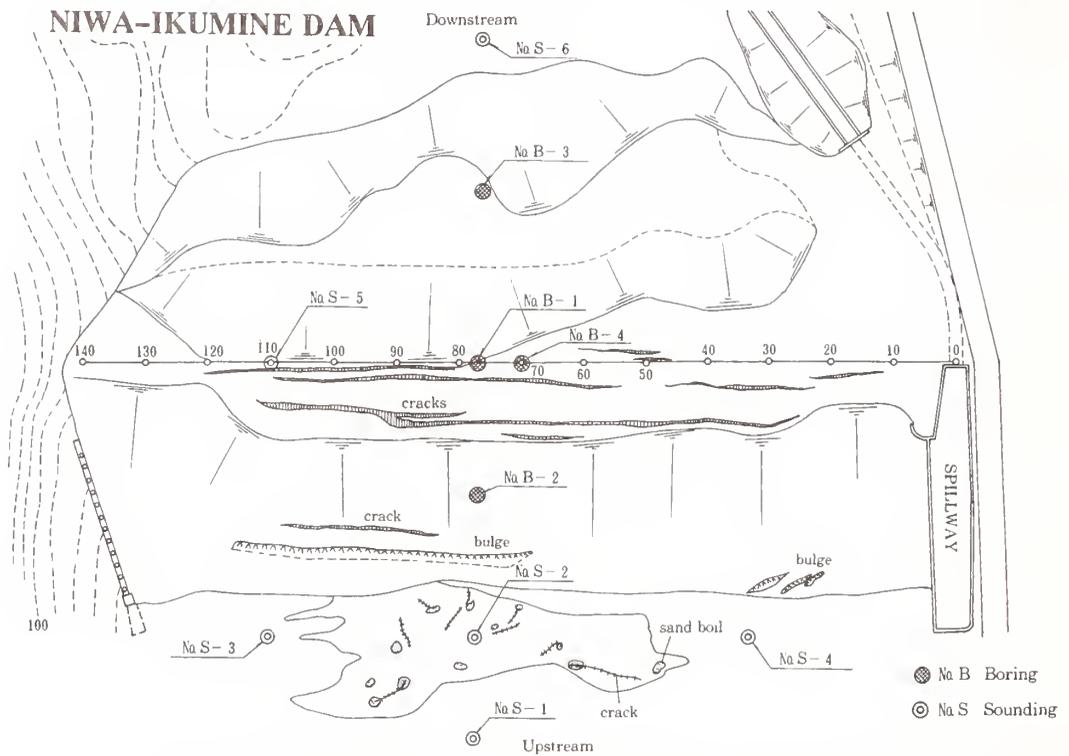
Fig.14 Typical Section Diagram of Niwa-Ikumine Dam

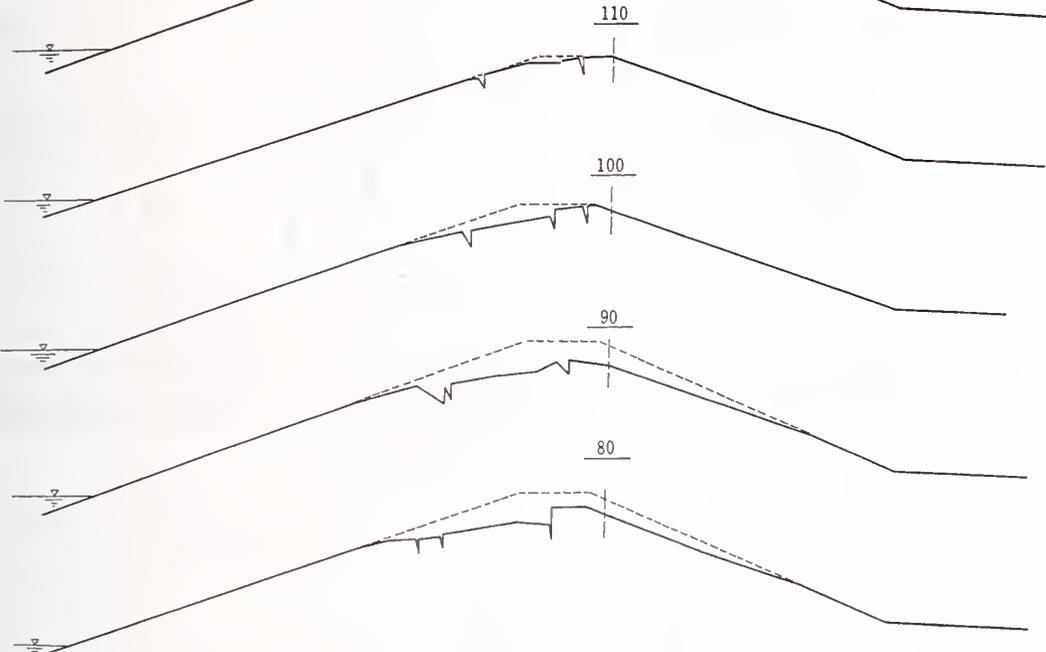
— Section after the earthquake
 - - - Section at the time of completion

Fig.16 Cross Section Diagrams of the Cracked Niwa-Ikumine Dam Body

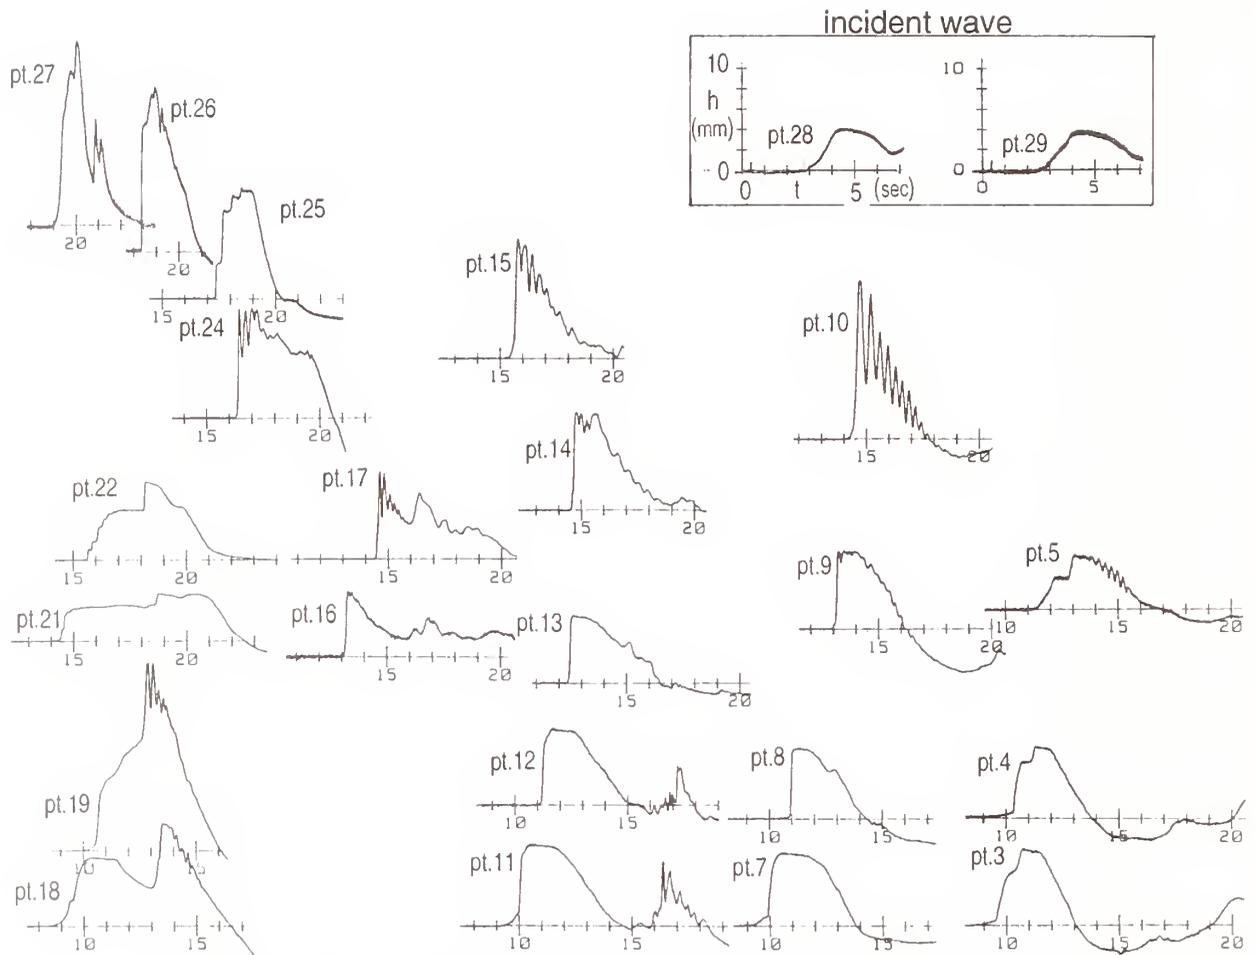
Fig. 9 Tsunami profiles measured with wave gages
(incident wave height : 4mm)

Concerning wave height, the magnification ratio against the incident wave height was about two at pts. 14, 15, 17, 24 and 25. The ratio was about three at pts. 10, 26 and 27. In this way, wave height was magnified near around Hamatsumae. The occurrence of the

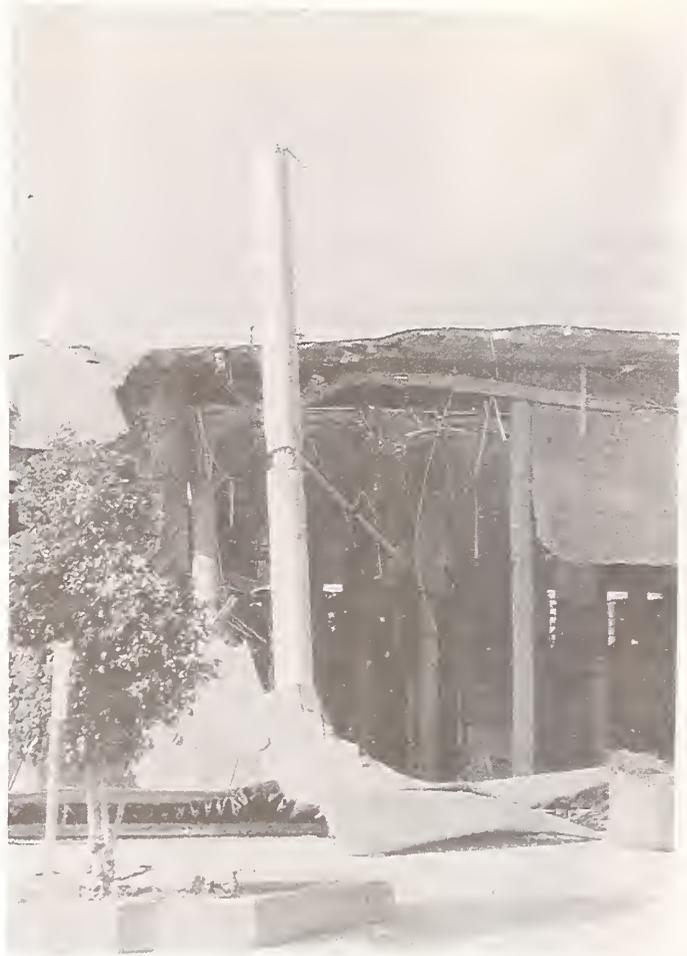
Figure 11 A portion of the concrete waffle slab roof and the interior floor slabs at the Bullock's department store at the Northridge Fashion Center mall fell to the basement, leaving many of the columns standing. No reinforcing steel can be seen in the remaining columns that would have connected the columns to the floor slabs.

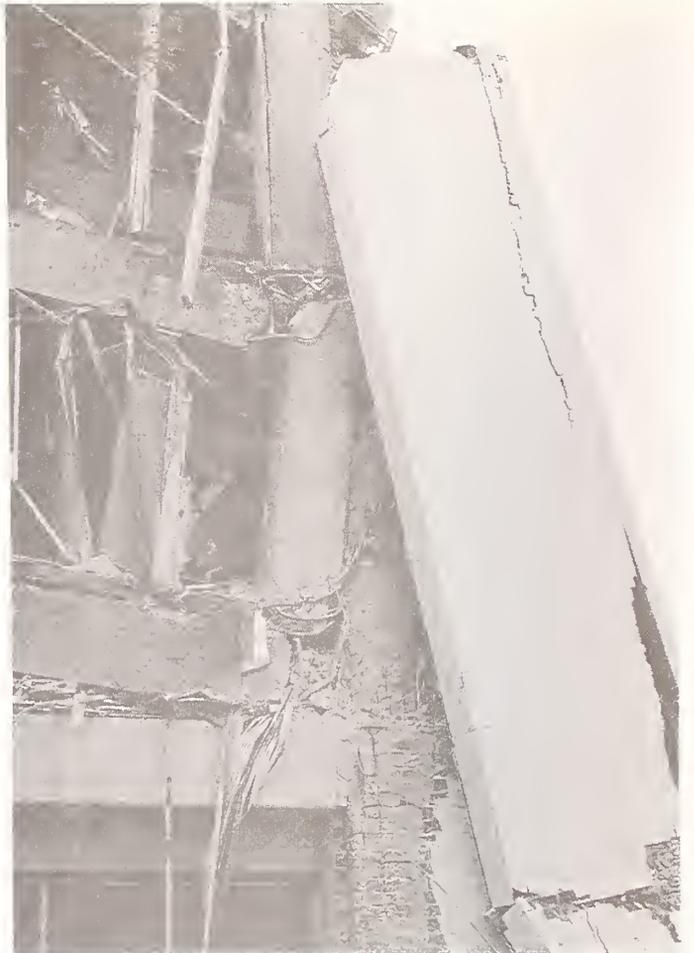
Figure 15 The exposed concrete frame of the Kaiser Permanente building, revealing deep beams, suggests that the building had a strong-beam, weak-column configuration. Except for the second story columns, the columns and beams remained intact while the joints disintegrated.

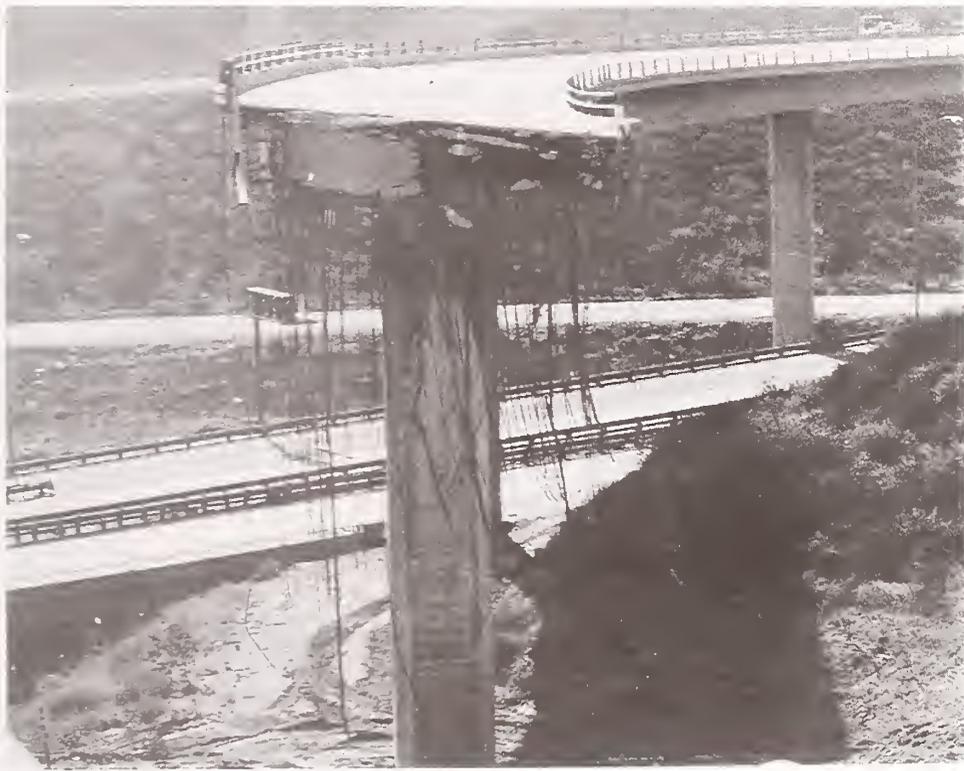
Figure 30 Collapsed portion of the SR14/I5 North Connector Overcrossing, looking east.. Pier 2 was at the left, near the broken hinge on the ground (Courtesy of EERC)

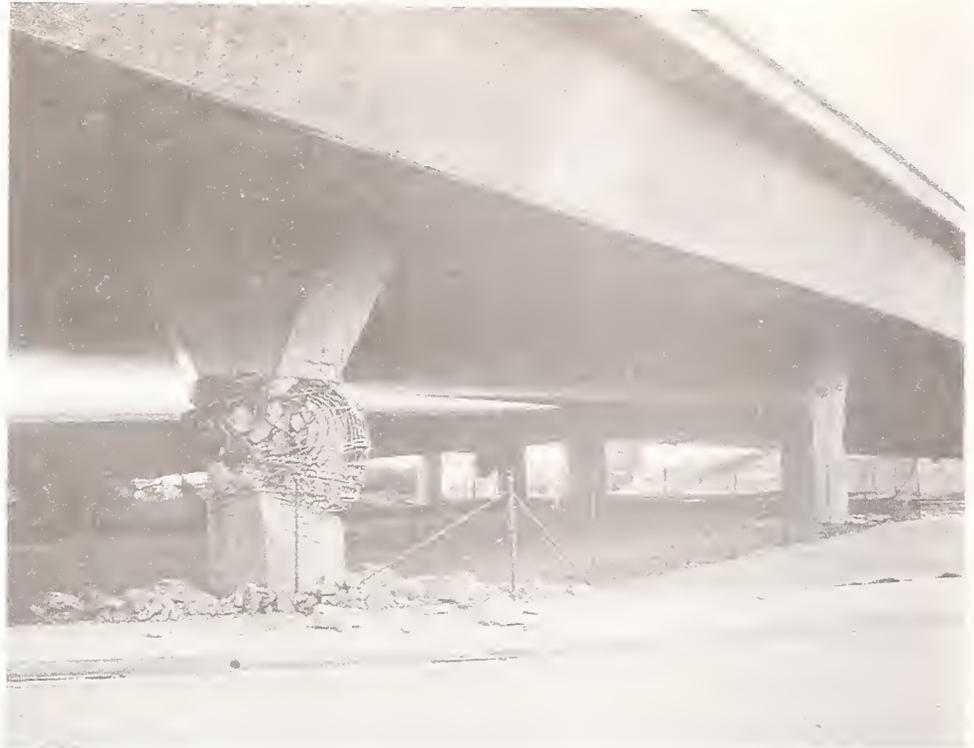
Figure 32 View of crushed Pier 2 and the hinge near Pier 2 (Courtesy EERC)

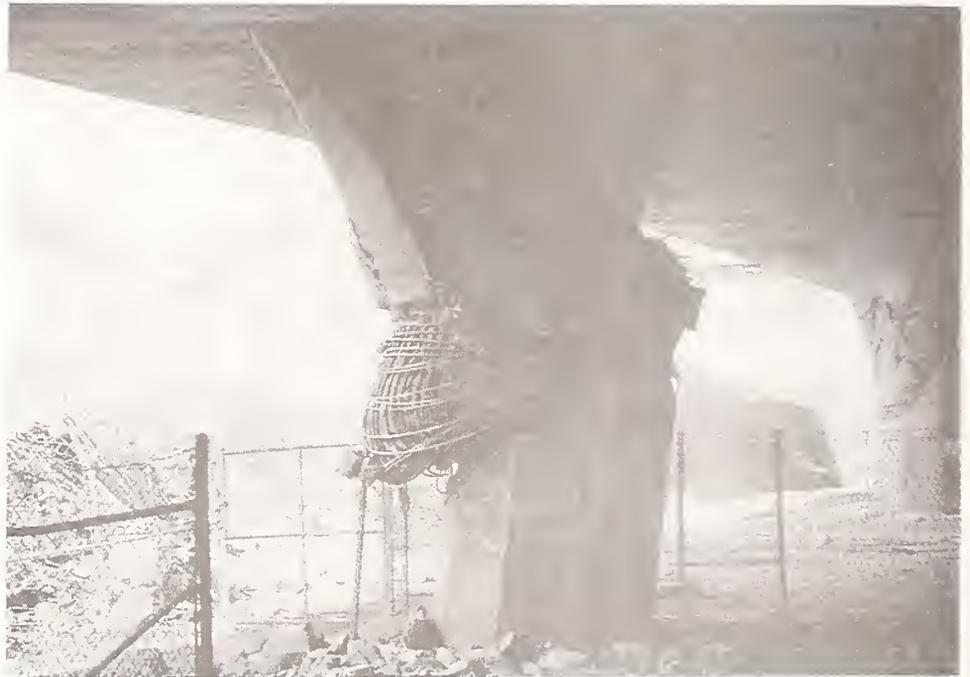
Figure 33 Damage to piers of the SR118 Mission-Gothic Undercrossing, looking to the northwest at the north face of the westbound bridge, Bents 3 (foreground) and 2.

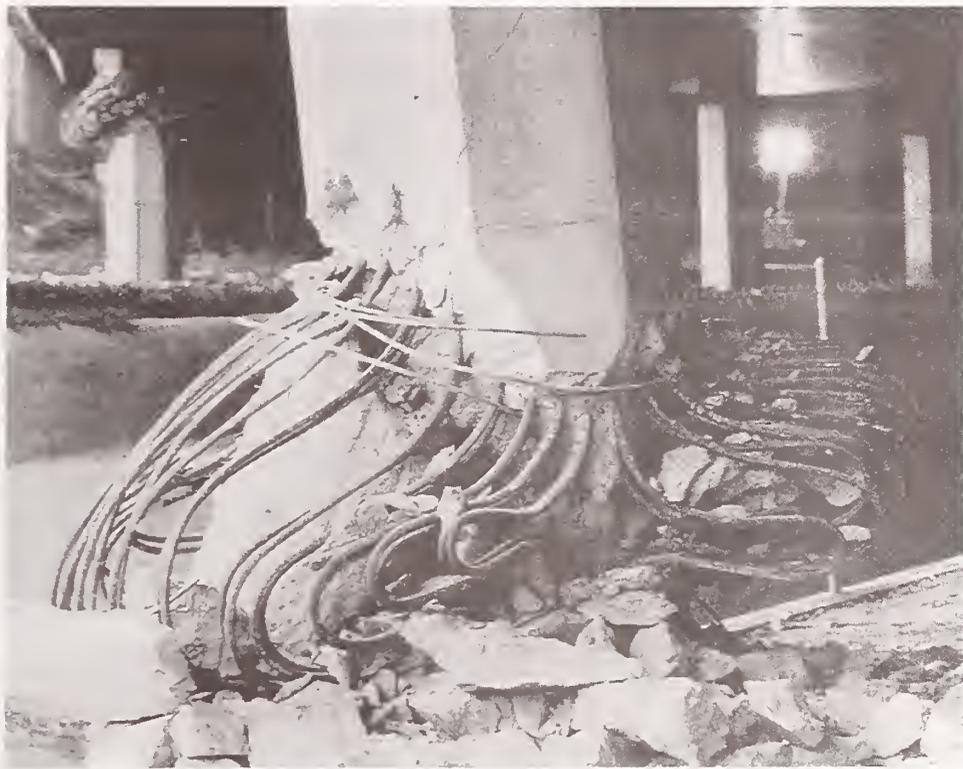
Figure 34 Damage to a pier of the SR118 Mission-Gothic Undercrossing, looking to the northwest at the southernmost pier of Bent 3 of the westbound bridge.

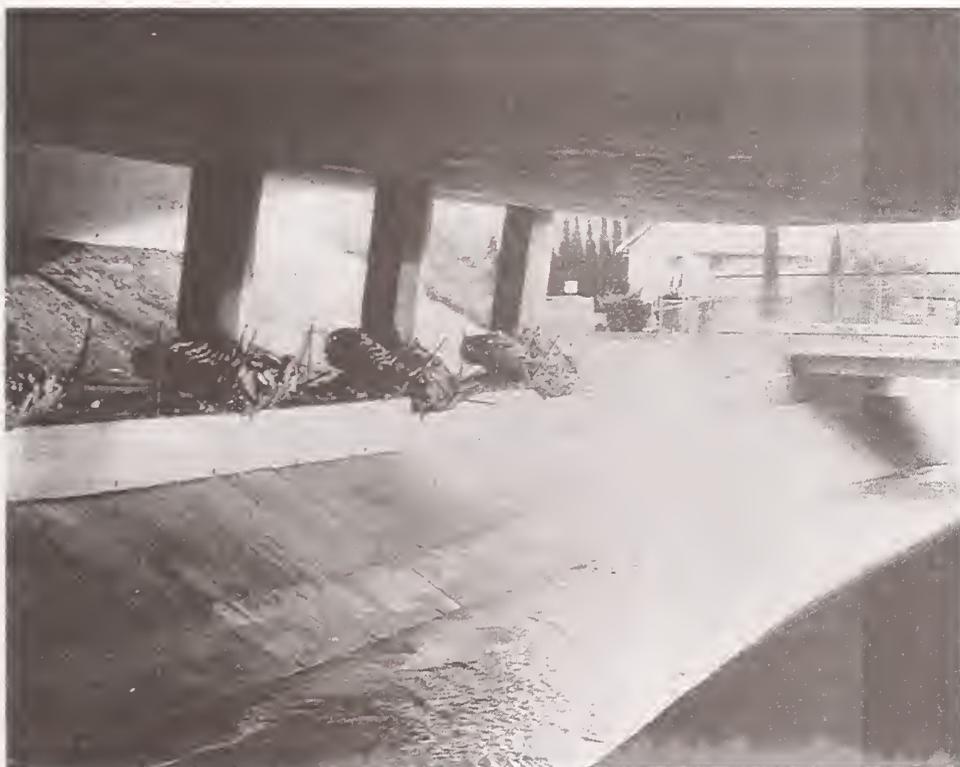
Figure 35 Damage to pier 3S-1 of State Route 118 at Bull Creek Canyon Channel, looking to the northwest

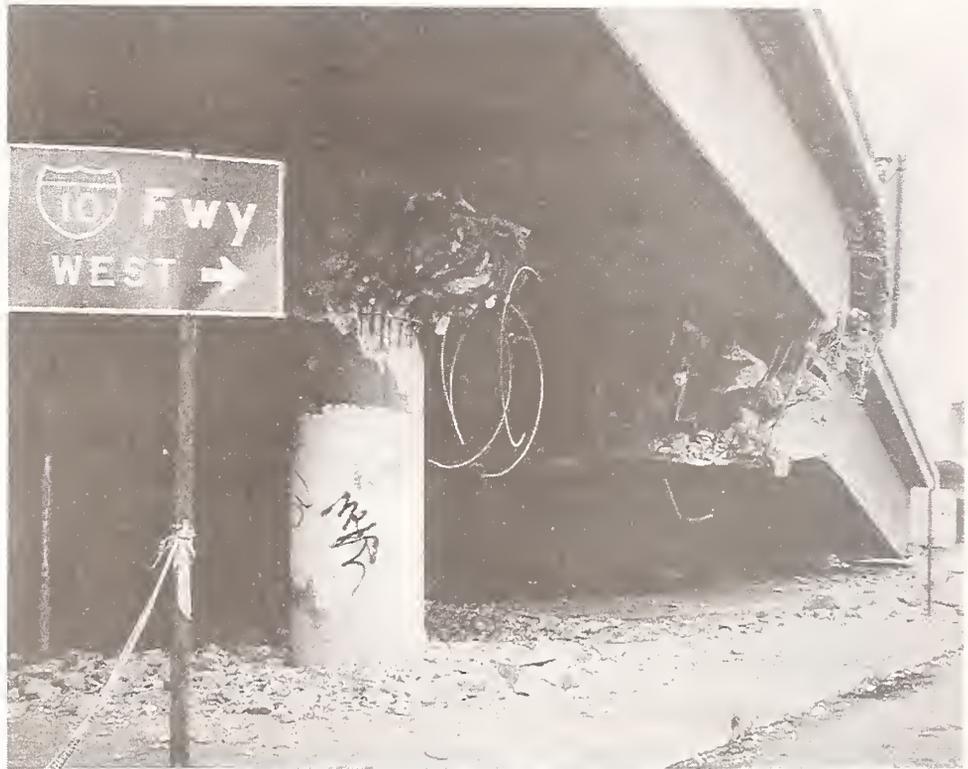
Figure 36 Damage to piers of Bent 3S of State Route 118 at Bull Creek Canyon Channel, looking to the southeast.

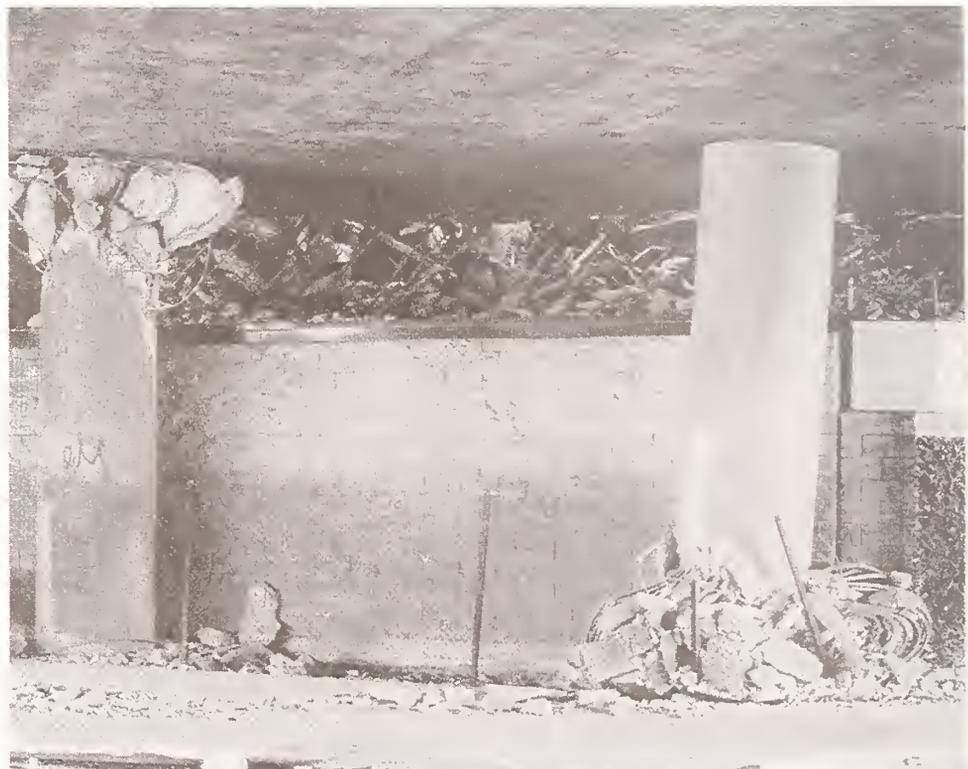
Figure 37 Collapsed westbound lane of I10 at Venice Blvd.; pier of Bent 7 in foreground

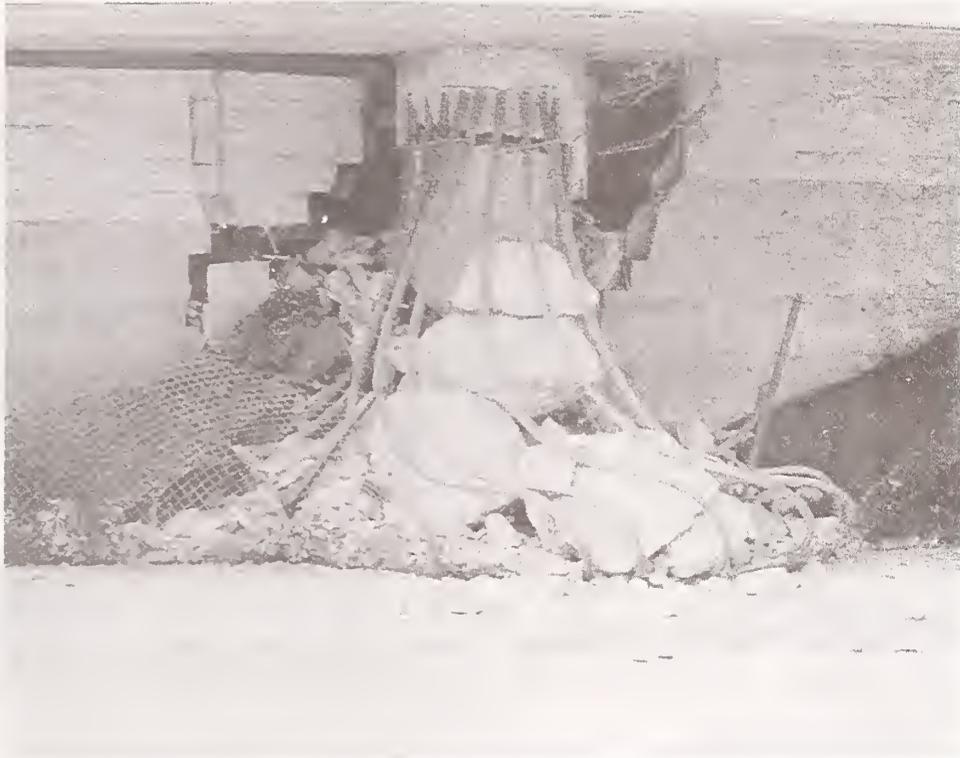
Figure 38 Failed piers in Bent 7 supporting westbound lane of I10 at Venice Blvd.

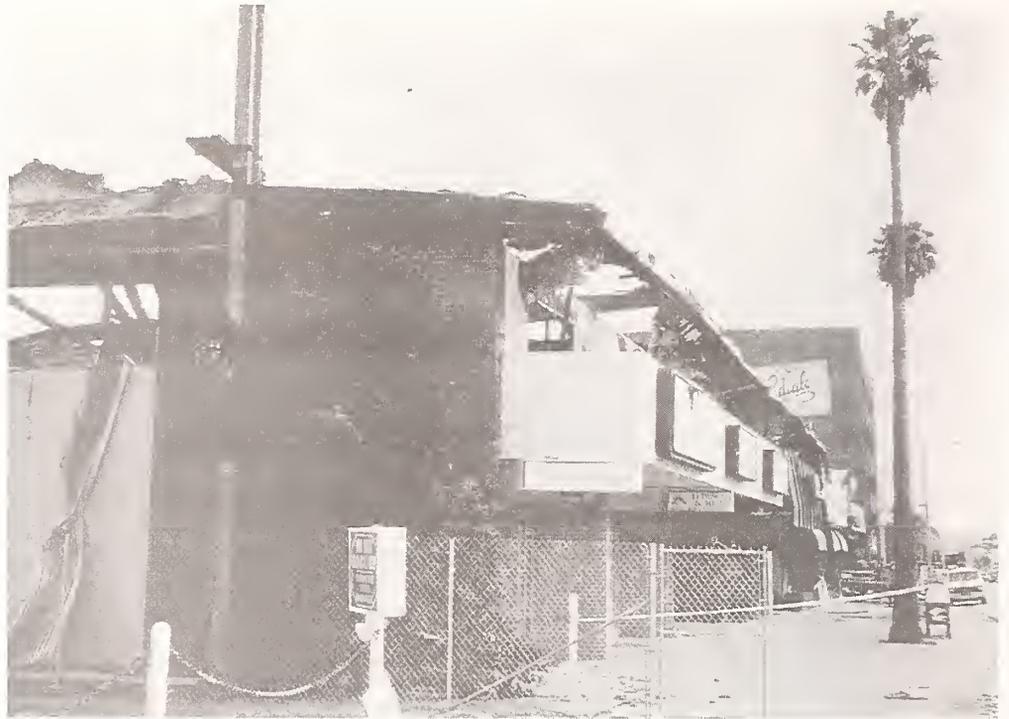
Figure 56 Fire damage in a single story commercial building.

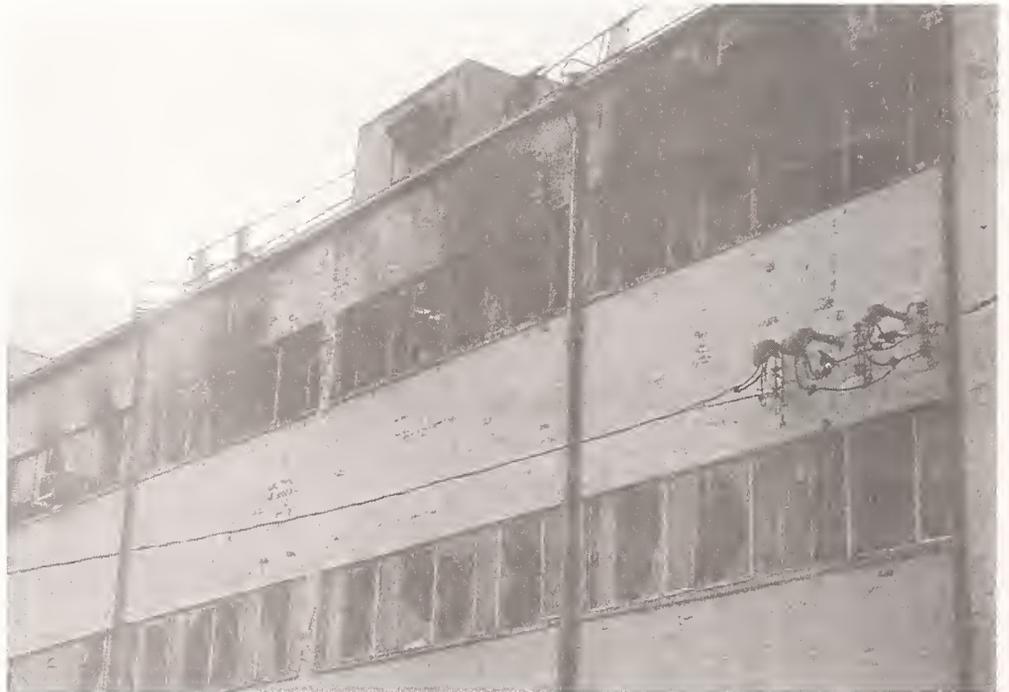
Figure 57 Fire damage in a two story commercial building.

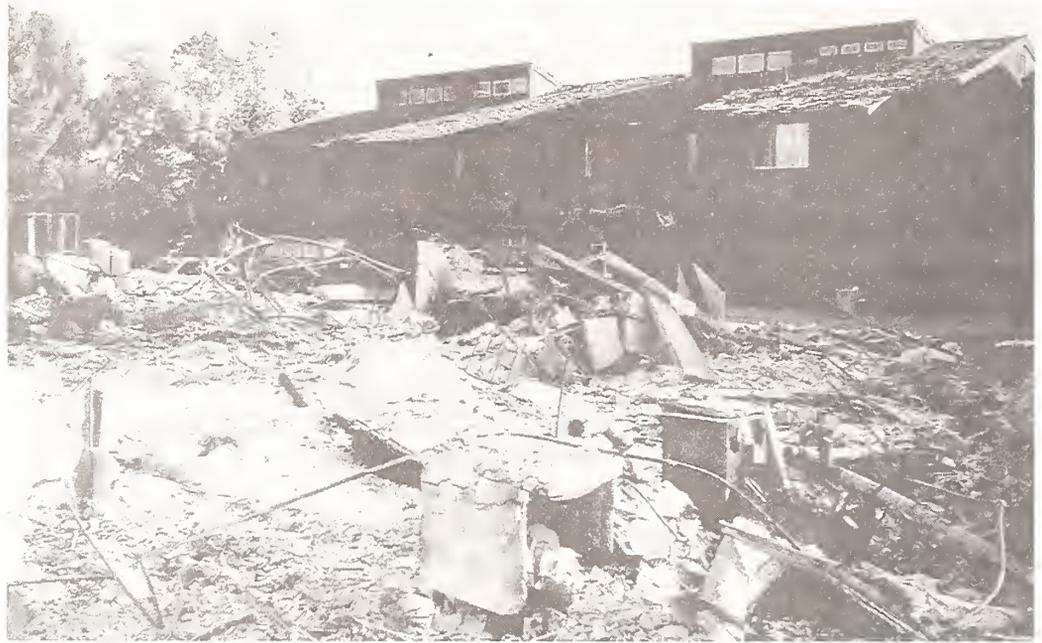
Figure 60 Damaged gas service in a manufactured housing development.

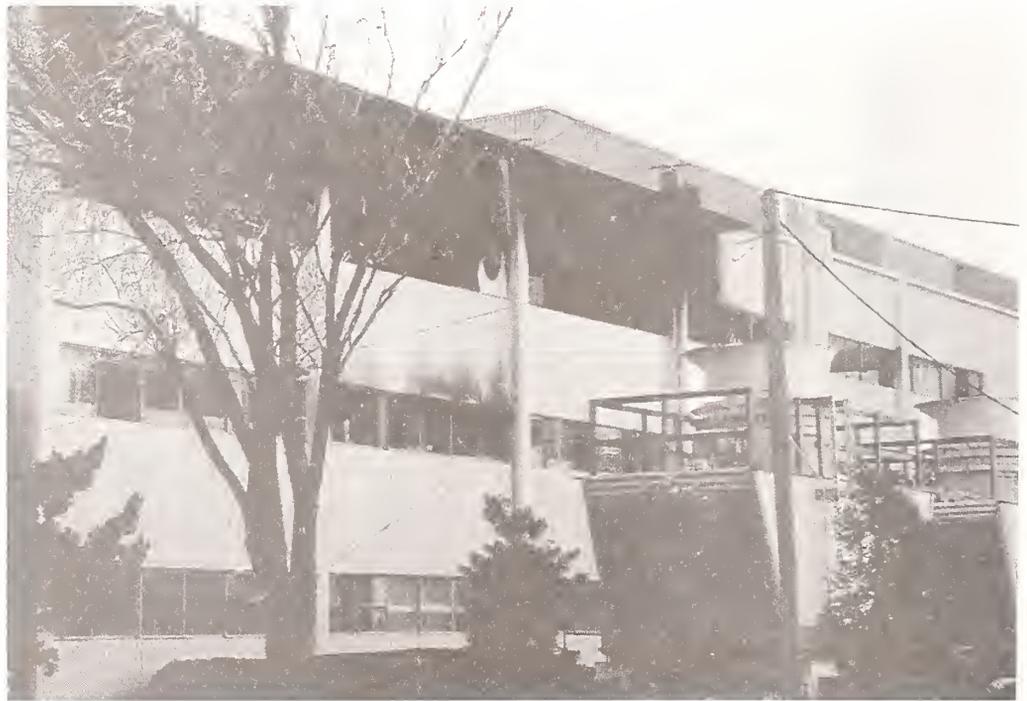
Figure 61 Multi-family residential building destroyed by fire.

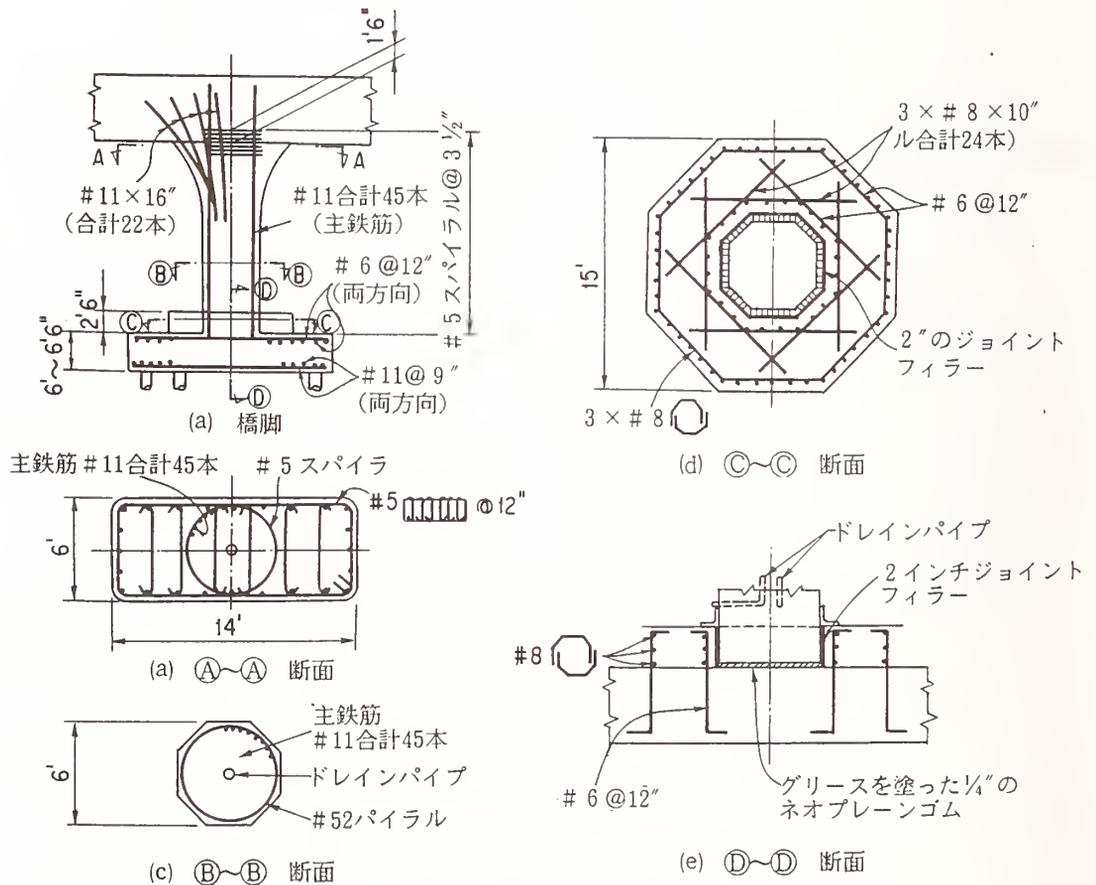
Fig. 4.2 S-118 Mission/Gothic Undercrossing
