Wind and Seismic Effects

NIST SP 904

PROCEEDINGS OF
THE 28TH JOINT
MEETING OF
THE U.S.-JAPAN
COOPERATIVE PROGRAM
IN NATURAL RESOURCES
PANEL ON WIND AND
SEISMIC EFFECTS

Issued August 1996

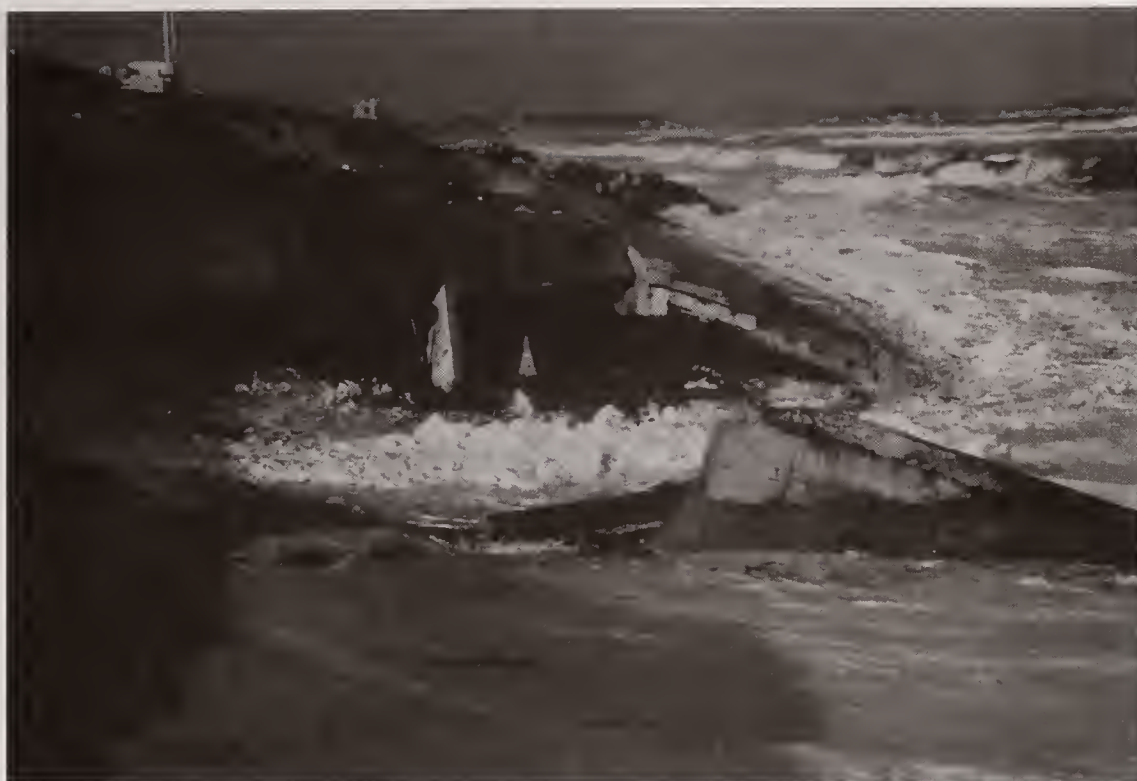
Photo 6 Seawall Damage by Erosion at Oarai Beach

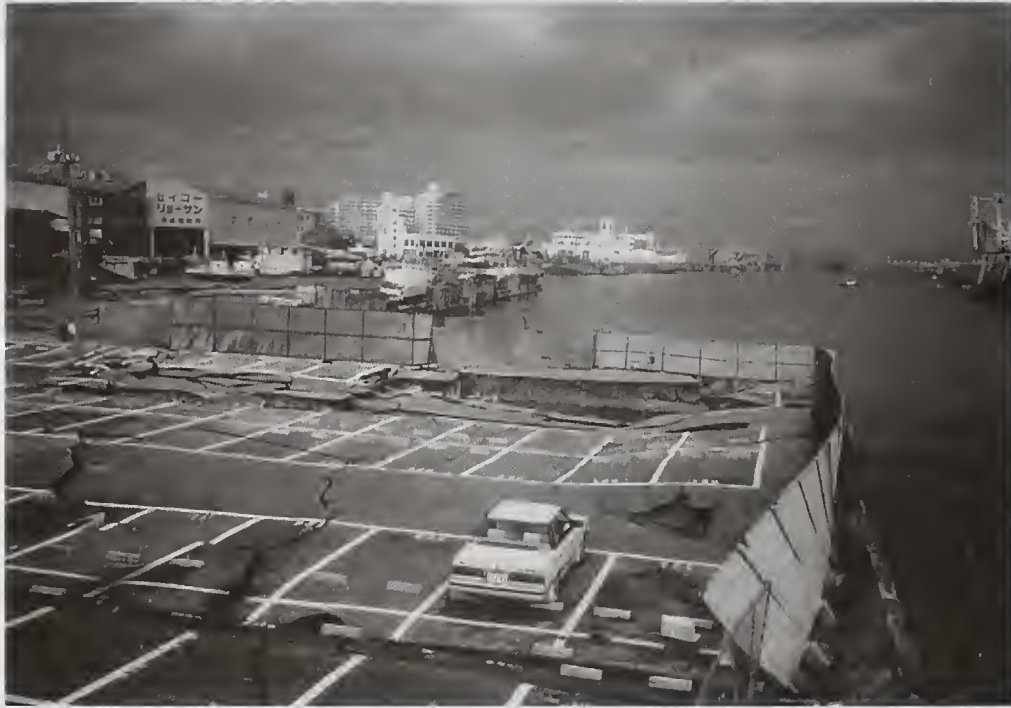
Photo 1 Damage to a Parking Lot at Uozakihama

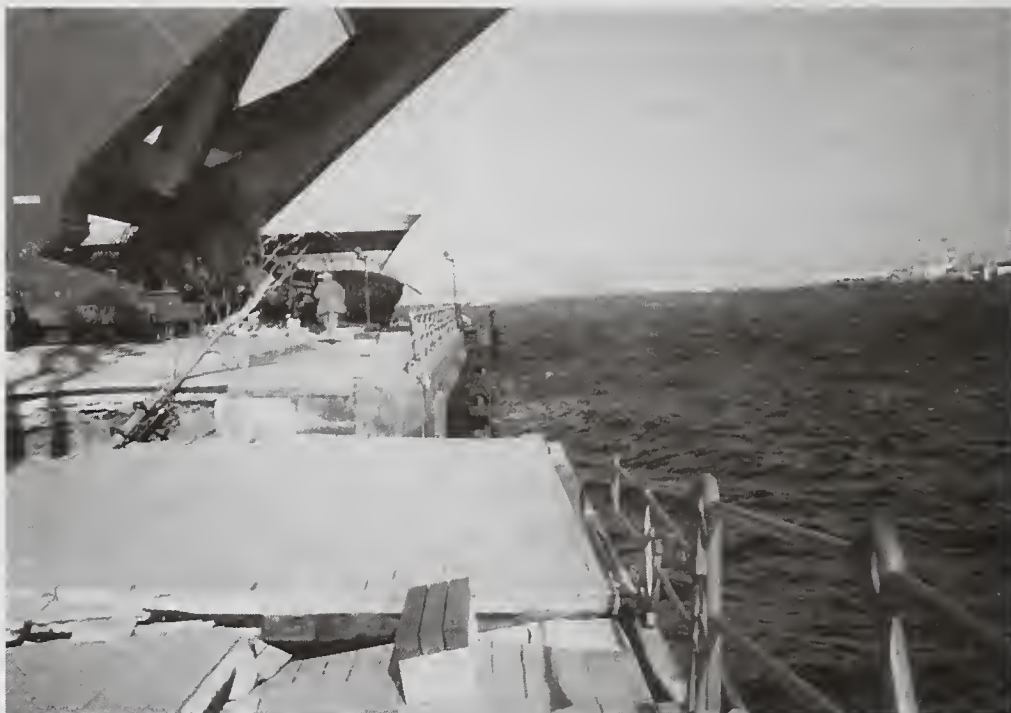
Photo 2 Damage to the North Shore of Port Island
