Installing, Maintaining, and Verifying Your Charpy Impact Machine

Special
Publication
960-4

Materials Science and
Engineering Laboratory

October 2000

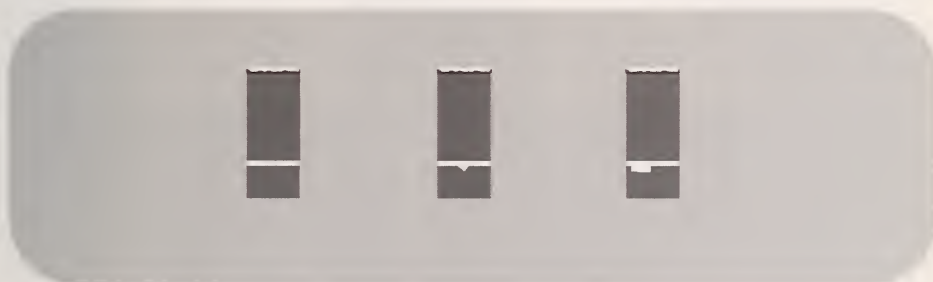
Figure 5. Chipped Anvils.

Sometimes an anvil can be chipped. Figure 5 shows that this condition can be detected easily on all three energy reference specimens. The low-energy specimen is affected the least amount because it is the hardest specimen and therefore has a more brittle fracture. The ductile high-energy specimen will produce higher than normal energy results, and the very ductile super-high-energy specimens are affected most by a chipped anvil. This condition should be detected easily by a visual inspection before using the machine. New anvils are required when an anvil is chipped.

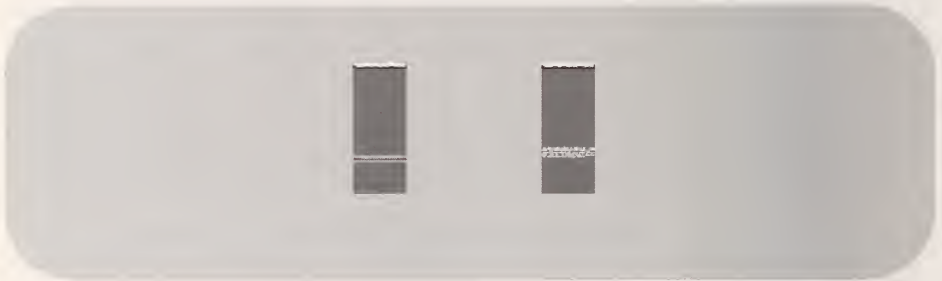
Figure 7. Damaged Anvils.

Under some test conditions, usually for elevated-temperature testing, the anvils can wear to a rough finish that creates excessive friction (Figure 7). This damaged condition is detected best on the high and super-high specimens. Rough anvils usually cause the gouge marks to become wider and push the specimen material to form a ridge that can easily be detected with the fingernail. This damage usually causes artificially high energy results at the high- and super-high-energy levels. Damaged anvils must be replaced.
