Wind and Seismic Effects

Proceedings of the 32nd Joint Meeting

NIST Special Publication 963

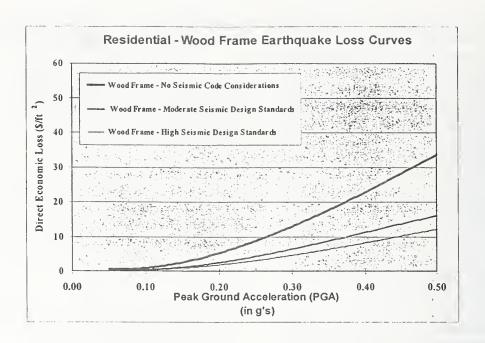
Figure 1 Potential damage to wood frame single-family residence from various levels of ground shaking intensity for three levels of seismic design. The damage is quantified in terms of the economic loss (\$/ft²) and includes the cost to repair the damaged home, the cost to replace damaged contents and any additional temporary living expenses caused by the earthquake.

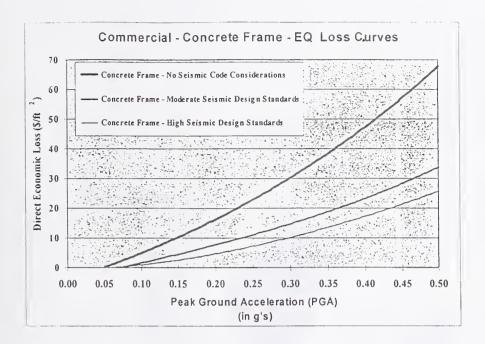
Figure 3. Potential damage to concrete frame office building from various levels of ground shaking intensity for three levels of seismic design. The damage is quantified in terms of the economic loss (\$/ft²) and includes the cost to repair the damaged structure, the cost to replace damaged contents and any additional business interruption expenses caused by the earthquake.

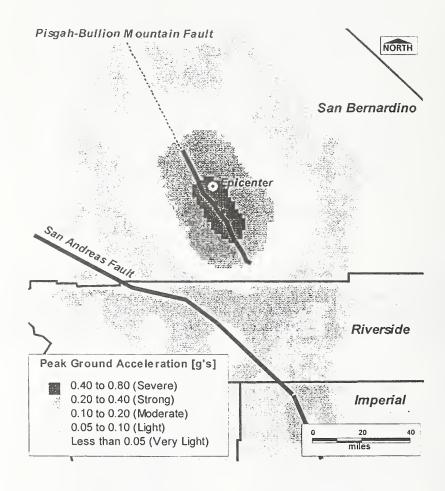
Figure 5. Peak ground acceleration map for the October 16, 1999 Mw 7.2 Hector Mine California earthquake based on real-time TriNet data.

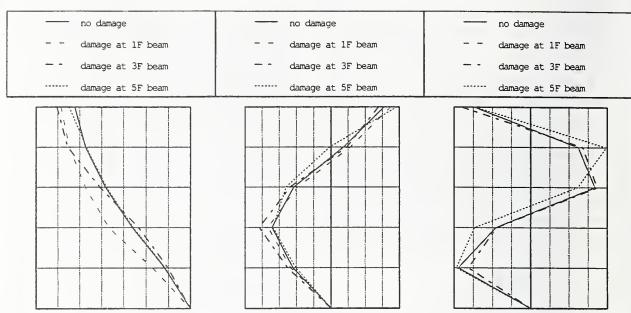
Comparison of 1st mode shapes Comparison of 2nd mode shapes Comparison of 3rd mode shapes Figure 3: Comparison of Mode Shape without damages and Mode Shapes with damages

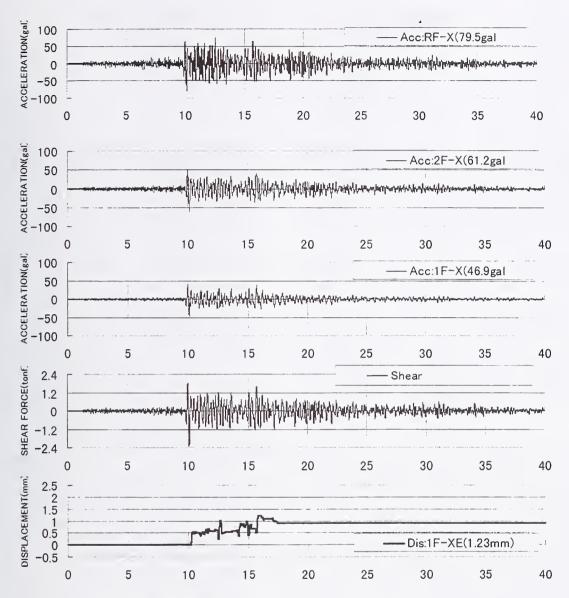
Fig.12 Observed wave forms in 1999.3.26 earthquakes

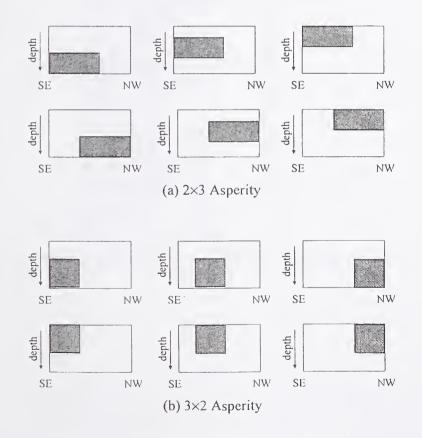
Figure 9 Reassigned Asperity Shape and Locations

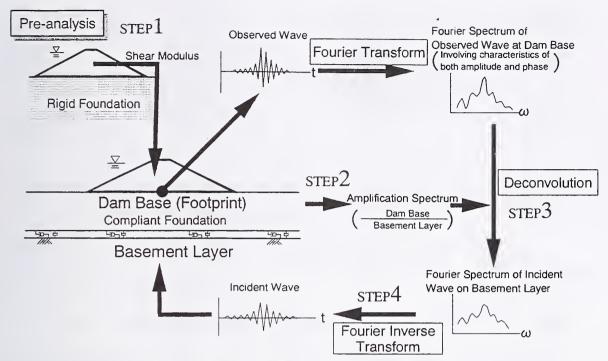
Fig.11 Illustration of the procedure to estimate incident waves

We applied this procedure to the earthquake observations at the Minoogawa Dam during the Kobe Earthquake of 1995. The Minoogawa Dam, a 47.0 m-high rockfill dam, was located about ten kilometers northeast of the earthquake fault. The seismometers installed in the inspection gallery at the base of the dam and at the dam crest recorded acceleration waves during the excitation. Their maximum horizontal accelerations perpendicular to the dam axis were 135 gal in the gallery and 242 gal at the crest. The dam foundation is hard bedrock that has an elastic wave velocity of about 4 km/s. The impedance ratio between the dam and the foundation is about 0.3.

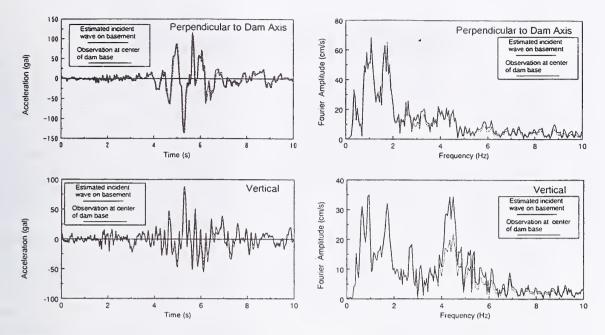
Fig.15 Estimated incident acceleration on basement layer and observed acceleration at dam base

We performed dynamic analysis on the Minoogawa Dam model with a compliance foundation. The incident wave estimated in the previous section was input under the basement boundary of the

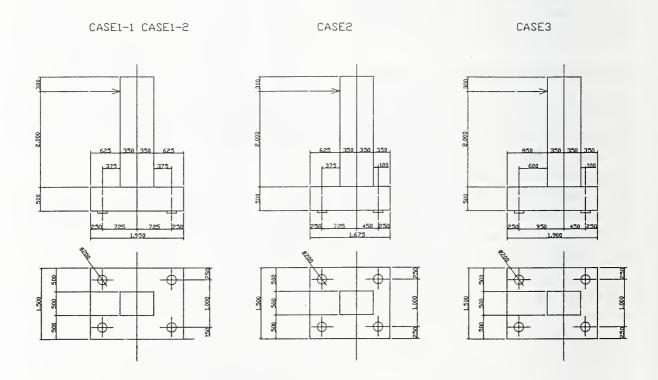
Figure 1. Dimensions of Specimens

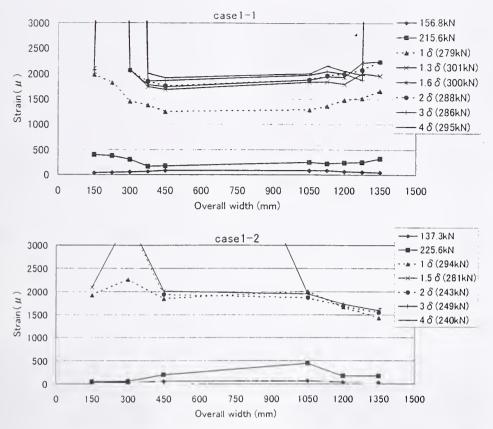
Figure 7. Strain Distribution at A-A' section in Figure 2,3 (Case 1-1 and Case 1-2)

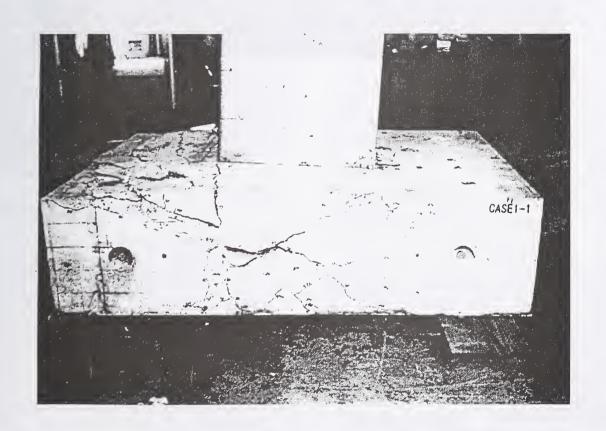
Photograph 1 State of the Failure (Case 1-1)

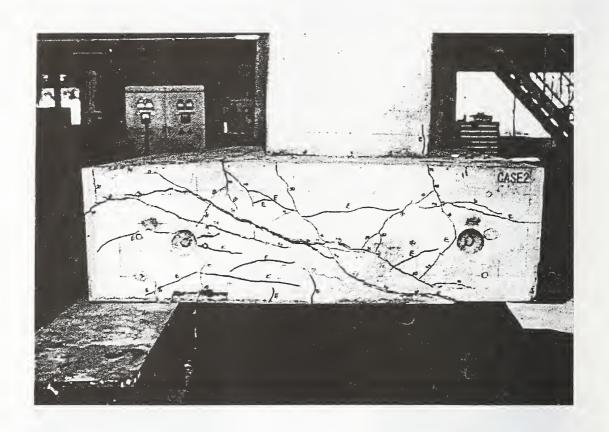
Photograph 2 State of the Failure (Case 2)

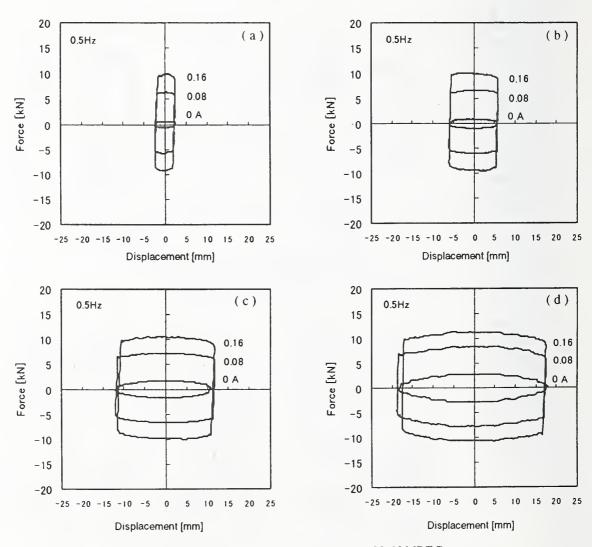
Figure 7 Force-displacement Loops for 20kN MRF Damper

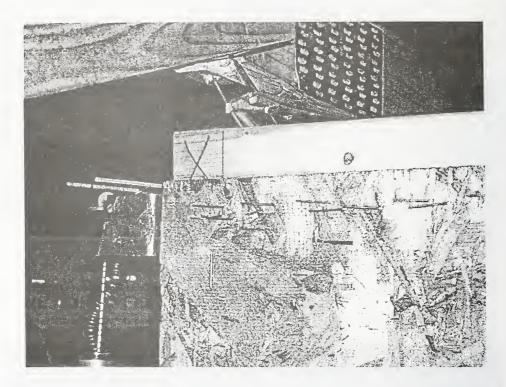
Figure 4. Failure of Toe-nailed Wall-to-Roof Connection

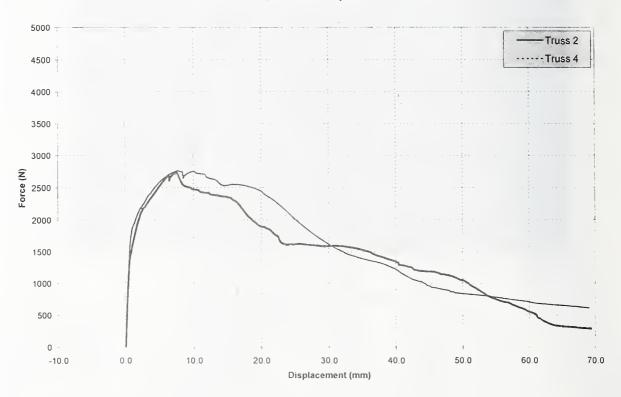
Figure 5. Load Deformation Curve of Toe-nailed Wall-to-Roof Connections

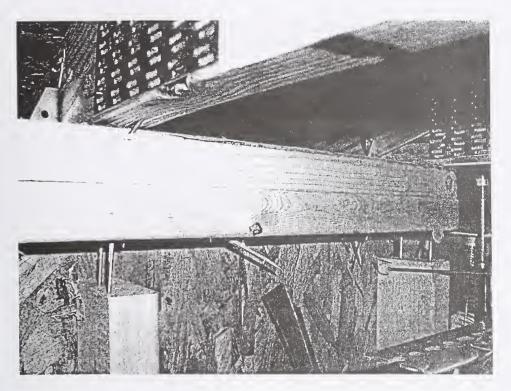
Figure 6. Failure of Wall-to-Roof Connection with a hurricane clip

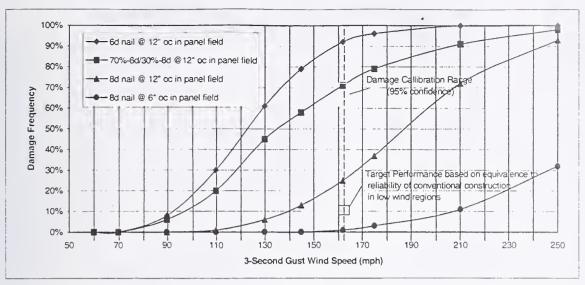
Figure 7
Roof Sheathing Fragility Curves
for One-Story Homes in a Suburban Exposure
(1 mph = 0.447 m/s).

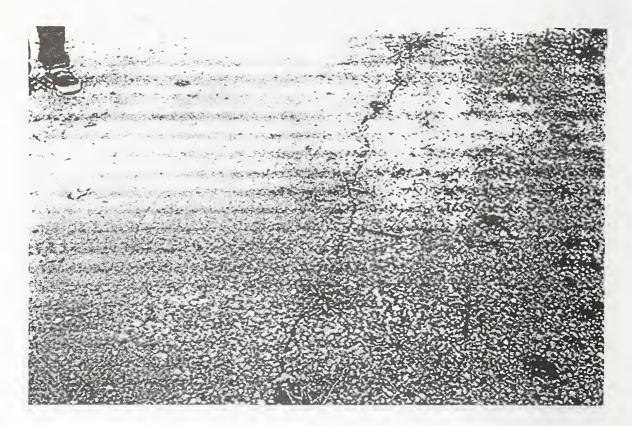
Figure 3. Longitudinal crack near the edge of the crest of Gokce Dam on the upstream side. The location is about at the middle of the dam. The width of the crack was about 7 mm at its greatest

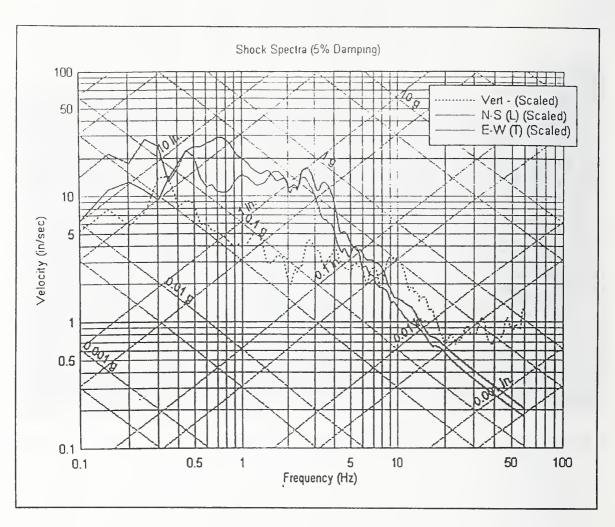
Figure 9. Spectral acceleration for the scaled acceleration time history at the Duzce Station developed for Hasanlar Dam

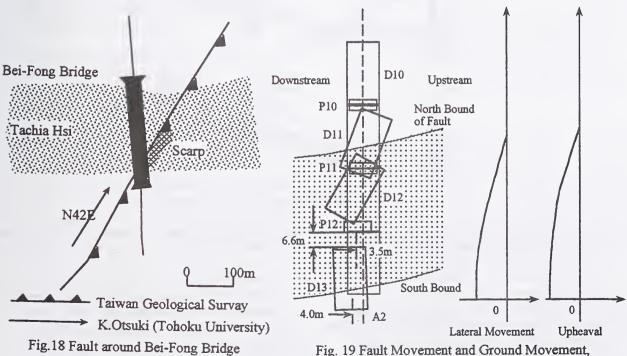
Fig. 19 Fault Movement and Ground Movement, Bei-Fong Bridge

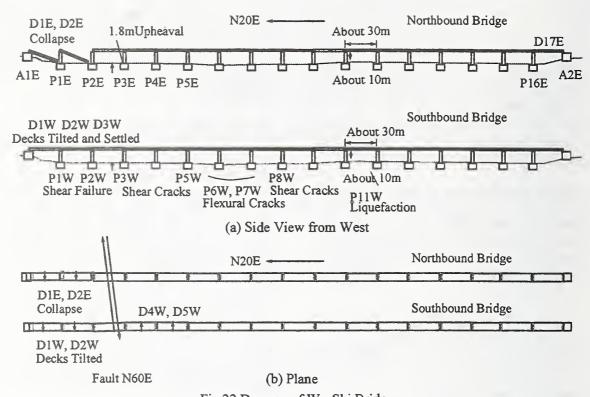
Fig.22 Damage of Wu-Shi Bridge

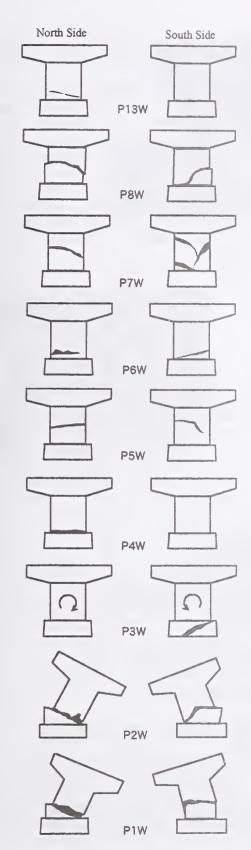
Fig. 23 Failure of Piers, Wu-Shi Bridge

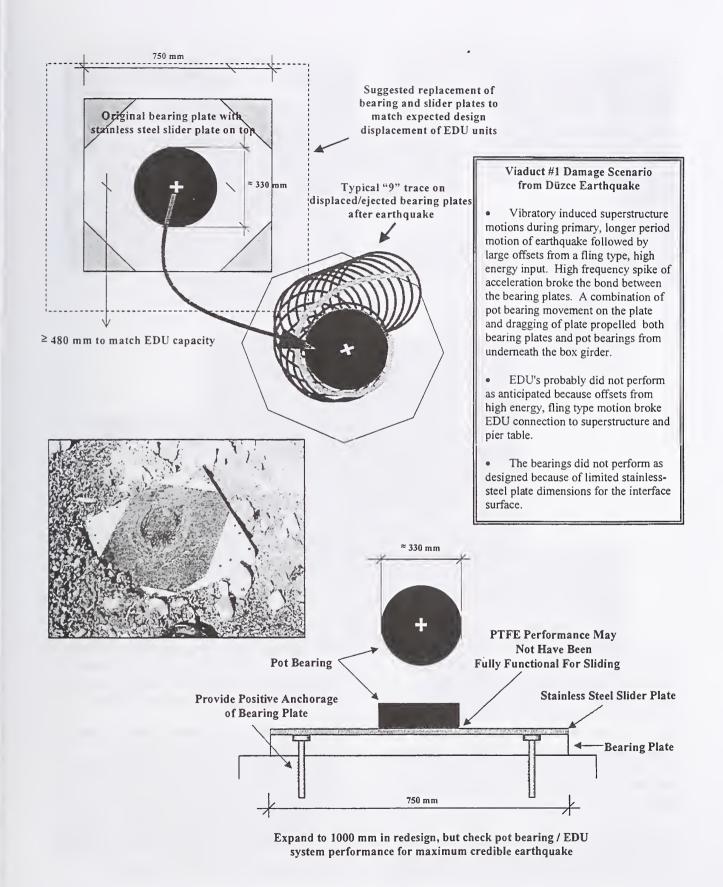
Figure 16: Viaduct #1 Bearing Damage Scenario (based on the site review on 11/30/99)

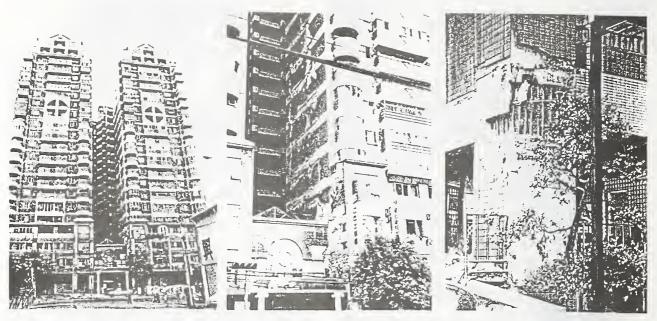
Photo 32 Damage of high-rise multiple building (Fengyuan City, Taichung County)

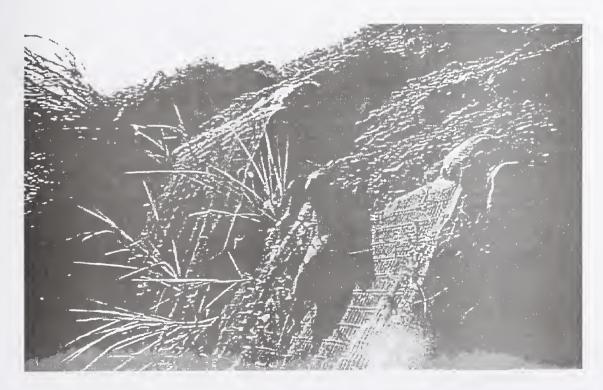
Photo.3 Failure of the reinforcement

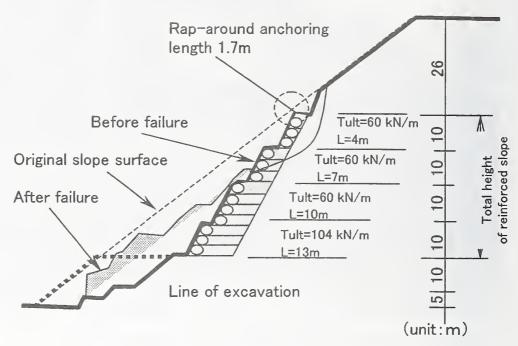
Fig.3 Cross section of the failed geosynthetics-reinforced soil retaining wall

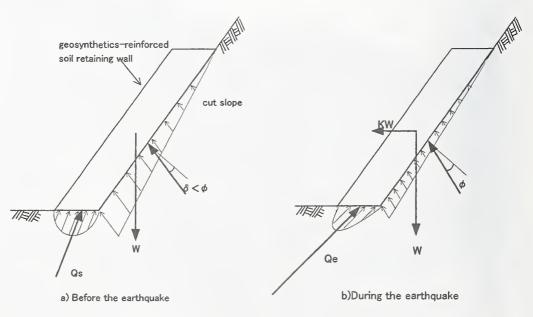
Fig.4 Schematics of forces acting soil retaining wall on the soil retaining wall
