NBS TECHNICAL NOTE **1132**

Solar Energy Systems— Standards for Cover Plates For Flat Plate Solar Collectors

Issued December 1980

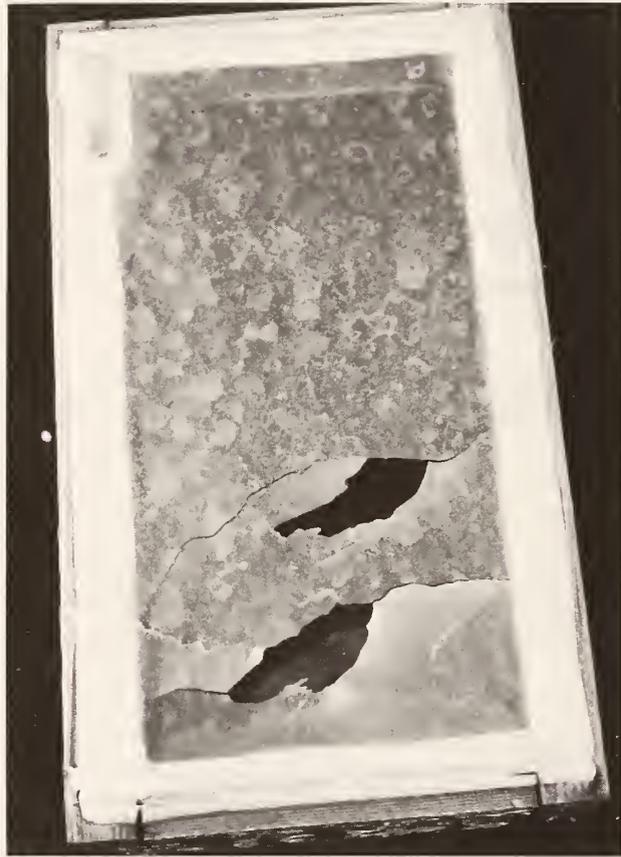
FIGURE 1 DAMAGE TO 0.13MM (0.005 IN) POLY(ETHYLENE TEREPHTHALATE) FILM CAUSED BY HAILSTORM IN NEW RIVER, ARIZONA.

at a test site in New River, Arizona. The material had been exposed 17 months prior to the hail storm. Personnel in the area estimated the hail size to be 13-19 mm (1/2-3/4 in.) in diameter.

Although there have not been many reports of hail damage to solar collectors [6], the risk of hail damage has been of particular concern. Hail storms occur in most regions of the United States and severe storms have caused considerable damage to roofs and other building elements [7]. Figure 1 shows damage incurred by a 0.13 mm (5 mil) poly(ethylene terephthalate) cover material exposed

Embrittlement and cracking, apparently caused by environmental conditions such as sunlight and elevated temperature, have been reported [3, 4]. Stress cracking was observed in polycarbonate cover plates that had been designed with indented sections to provide structural rigidity. Approximately 60-70 percent of the indentations exhibited stress cracking to some degree. Poly(vinyl fluoride) film exhibited embrittlement and yellowing after exposure on collectors that had been subjected to stagnation conditions for several months due to a system failure. Later laboratory examination of the material indicated approximately a 3.5 percent loss of solar transmittance. Poly(ethylene terephthalate) film also exhibited brittleness after exposure to sunlight, see Figure 1.

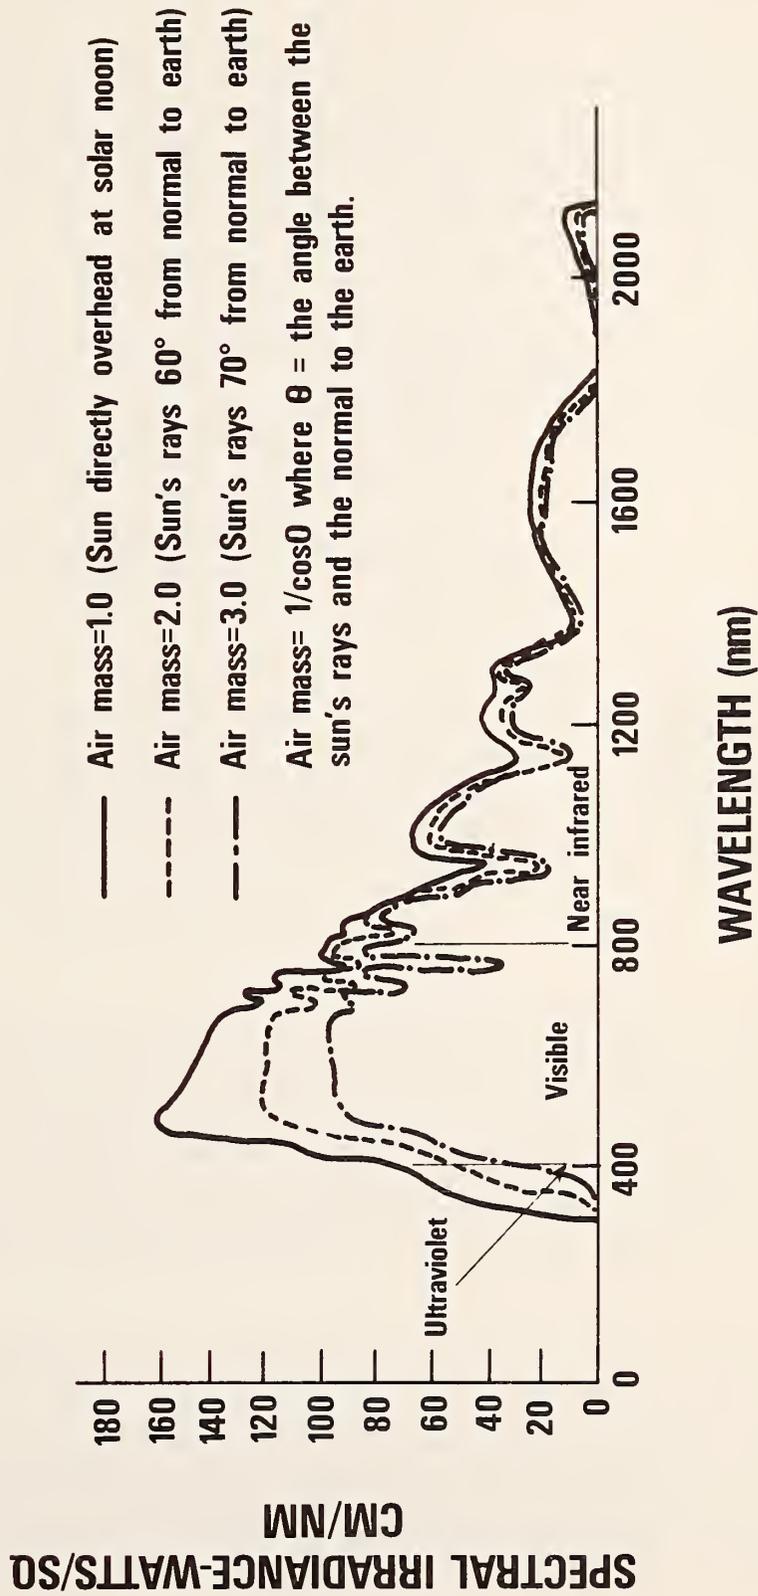
FIGURE 2 Spectral Distribution of Sunlight at Air Masses 1, 2 and 3

The spectral distribution of sunlight is illustrated in figure 2, and the ranges of ultraviolet (UV), visible (VIS) and near infrared (NIR) energy are indicated. Degradation due to ultraviolet radiation has long been of great concern to people designing or using products exposed to sunlight. The solar radiation spectrum band below 400 nm is detrimental to most polymers [14]. The radiation may cause crosslinking, breaking of chemical bonds, and reduction in molecular weight [15, 16]. The polymer damage may be reflected by changes in appearance or in chemical, physical, mechanical or optical properties [17]. To offset degradation due to UV radiation, UV stabilizers are frequently added to polymers or coated on their surface to absorb the UV radiation and inhibit bond breakage.

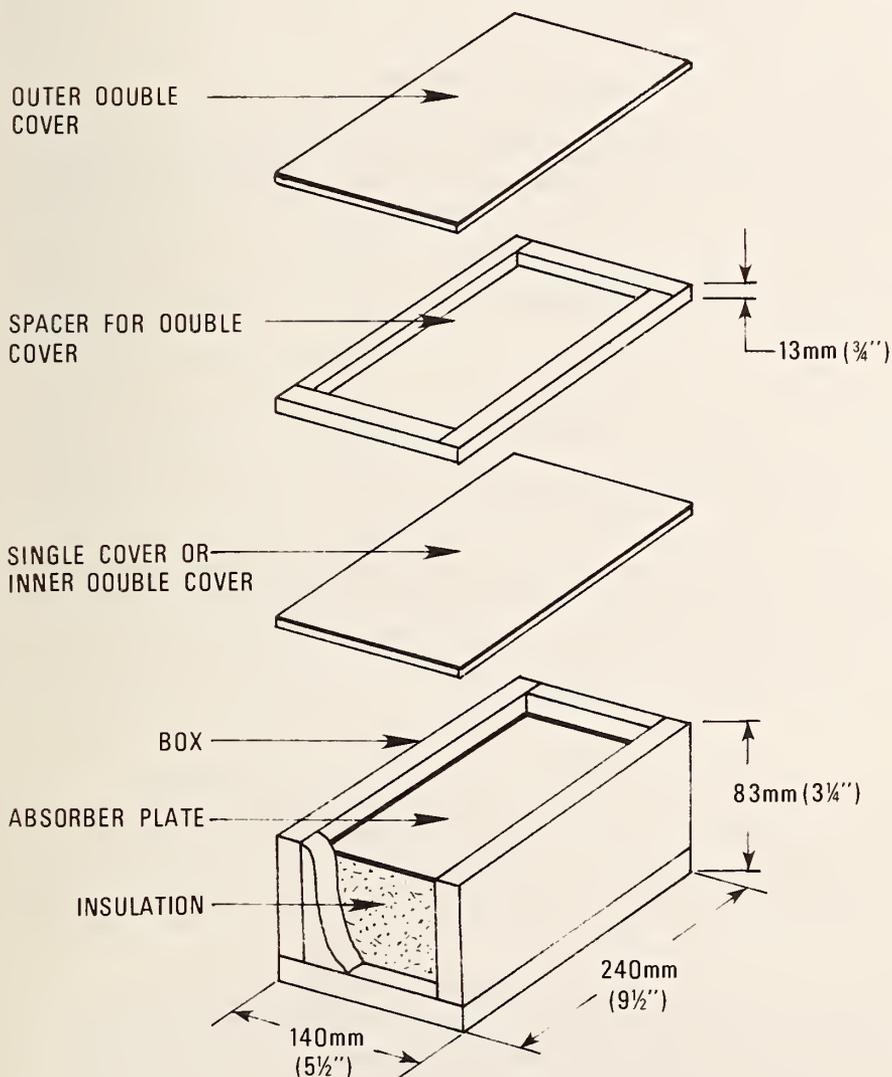
FIGURE 3 Minicollector for Natural Weathering Exposure

VENT HOLES WERE DRILLED
IN THE BOTTOM OF THE BOX
AND THE END OF THE SPACER
TO MINIMIZE MOISTURE
ACCUMULATION

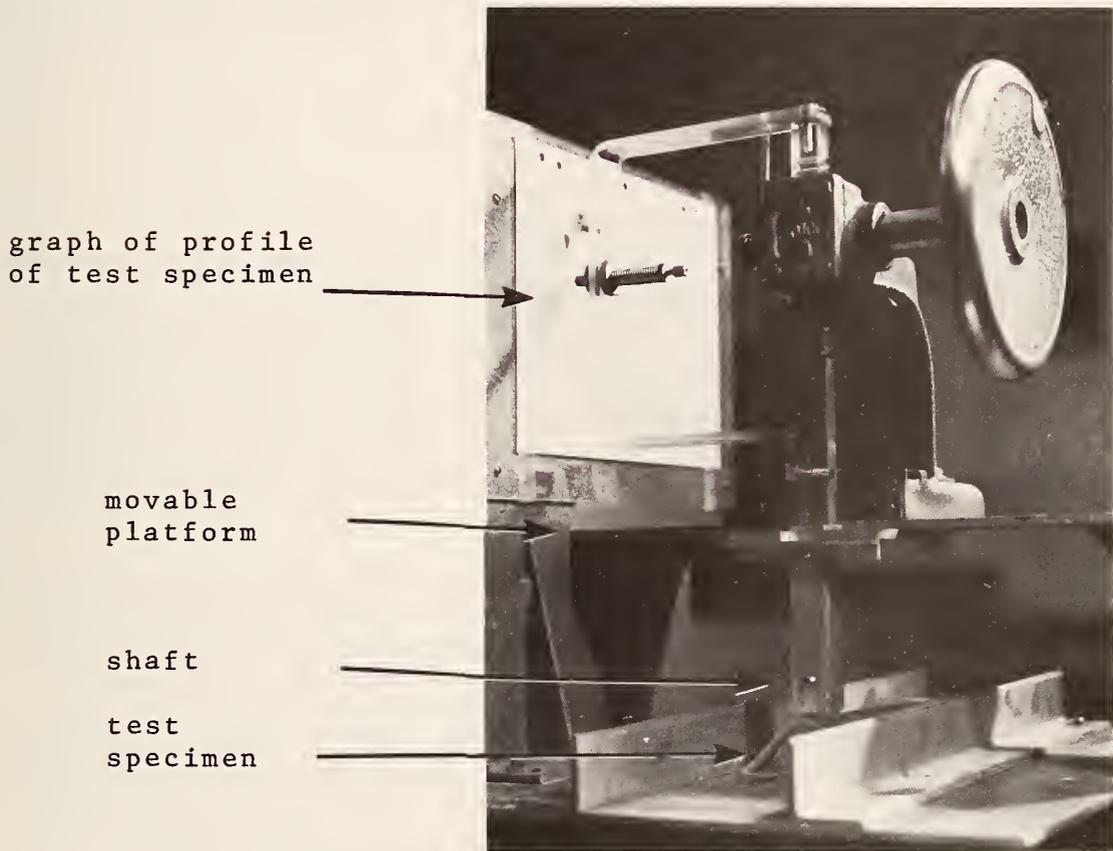
FIGURE 4 APPARATUS FOR WARPAGE MEASUREMENT

The procedure was as follows: 1. The graph paper was placed in the proper location and the plane of the platform surface was drawn on the paper, 2. The test specimen was placed concave side down on the platform with one end against the positioning bar and in a position to assure the shaft would pass over the location with the maximum warpage, 3. The platform was adjusted and the shaft was lowered until the small wheel came in contact with one end of the upper surface of the test specimen, 4. The platform was activated which slowly moved the wheel over the surface of the specimen as the pen graphed a profile of the test specimen.

The maximum warpage was determined by measuring the distance between the plane of the platform surface and the profile of the test specimen. The distance was corrected for the thickness of the test specimen.

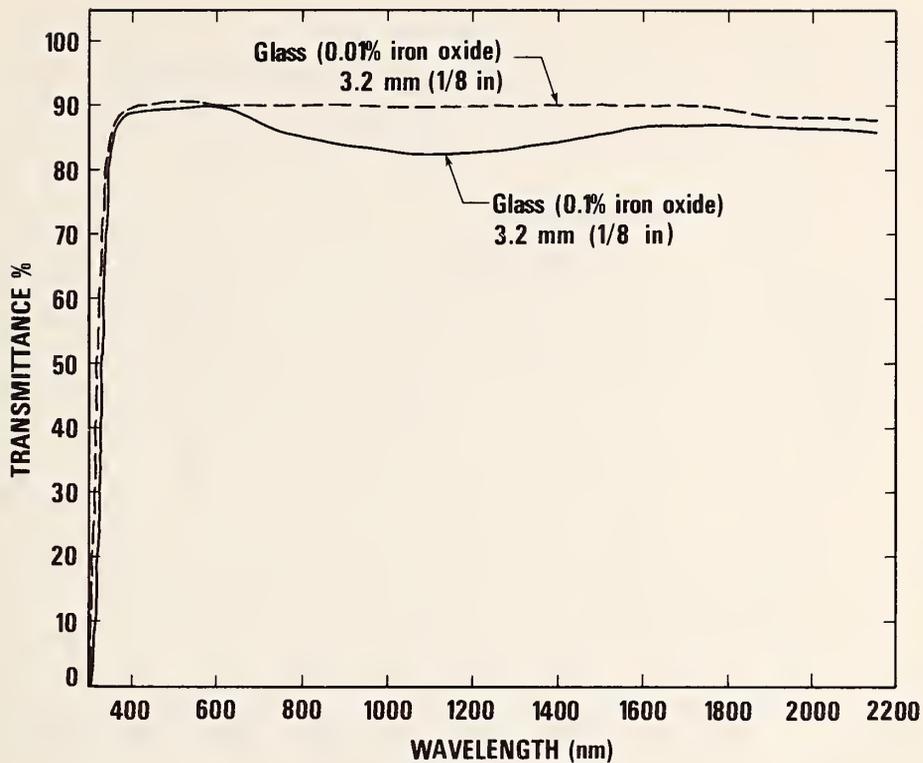
FIGURE 5A SPECTRAL TRANSMITTANCE OF CONTROL TEST SPECIMENS OF TWO GLASS MATERIALS

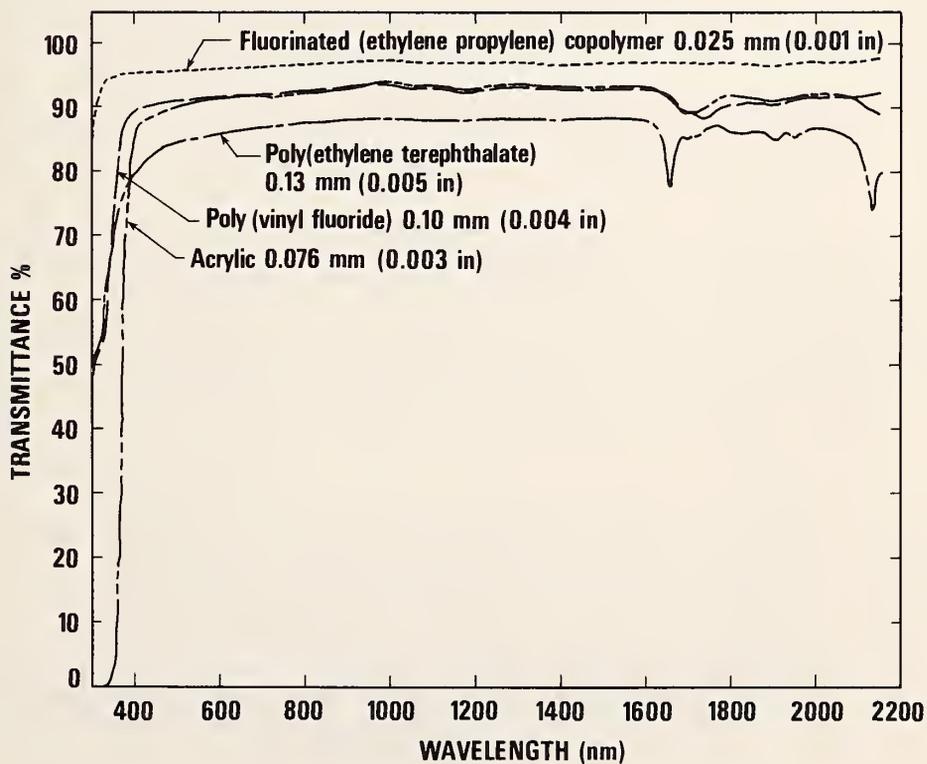
FIGURE 5B SPECTRAL TRANSMITTANCE OF CONTROL TEST SPECIMENS OF FOUR PLASTIC FILMS

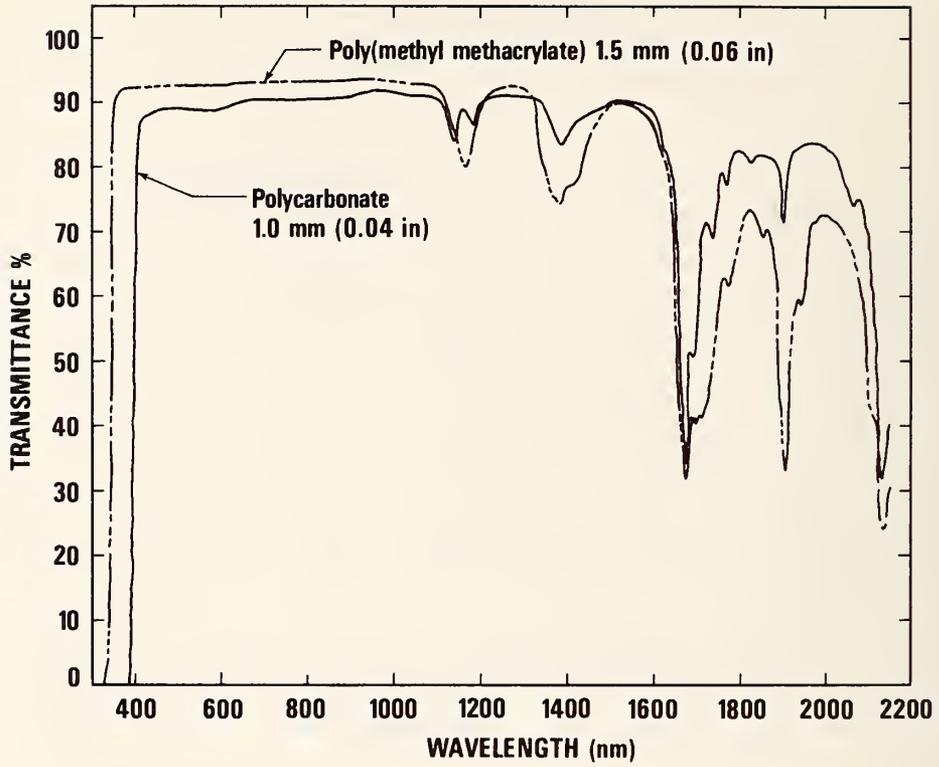
FIGURE 5C SPECTRAL TRANSMITTANCE OF CONTROL TEST SPECIMENS OF TWO CLEAR PLASTIC SHEET MATERIALS

The two clear rigid plastic sheet materials, are shown in figure 5c, whereas, the two fiber reinforced plastics are compared in figure 5d. Among the various materials it is noteworthy to observe the differences in the location of the absorption band in the ultraviolet region (below 400 nm). Absorbing the ultraviolet portion of solar energy can result in deterioration of the material.

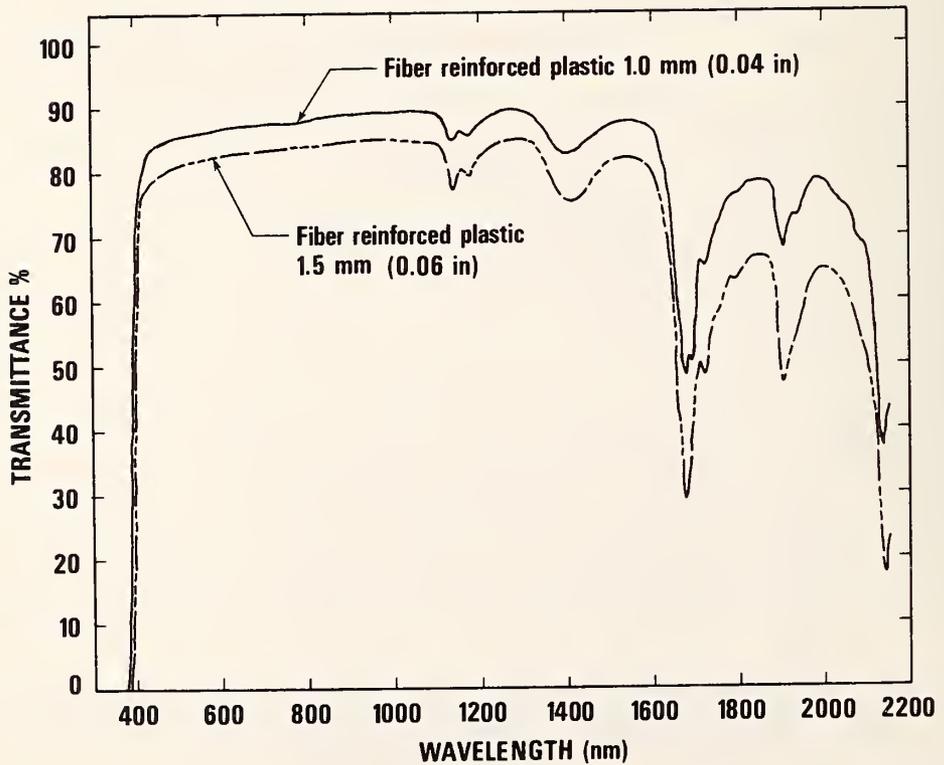
FIGURE 5D SPECTRAL TRANSMITTANCE OF CONTROL TEST SPECIMENS OF TWO FIBER REINFORCED PLASTICS

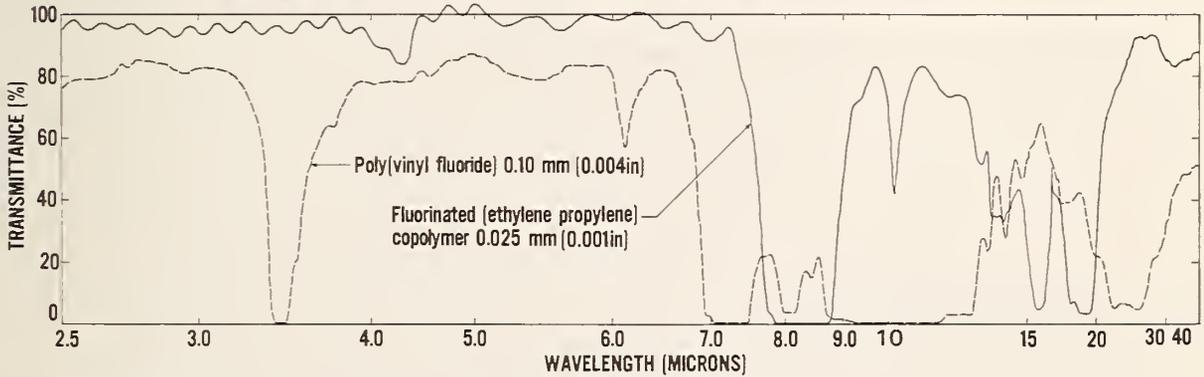
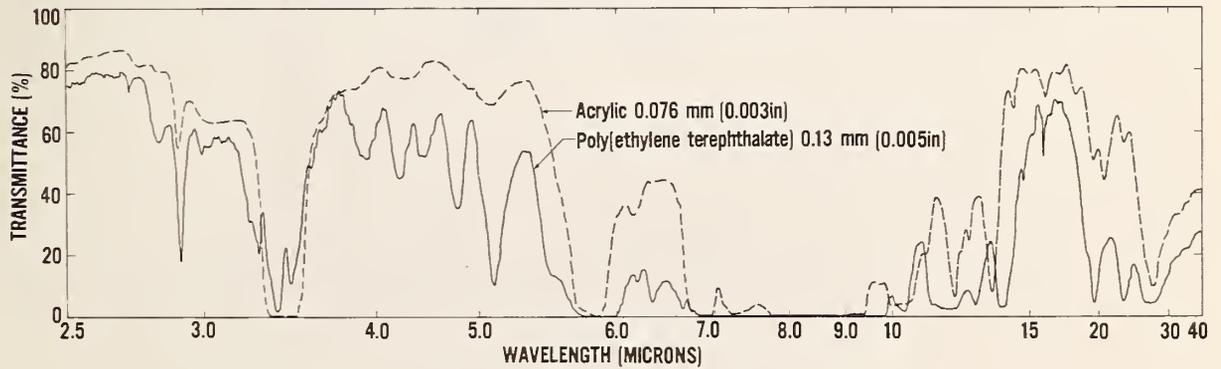
FIGURE 6b Infrared Transmittance of Control Test Specimens of Two Plastic Films

FIGURE 6c Infrared Transmittance of Control Test Specimens of Two Plastic Films

the four film materials, figures 6b and 6c, (i.e., fluorinated (ethylene propylene) copolymer, poly(vinyl fluoride), poly(ethylene terephthalate), and acrylic) transmit significant portions of the infrared energy.

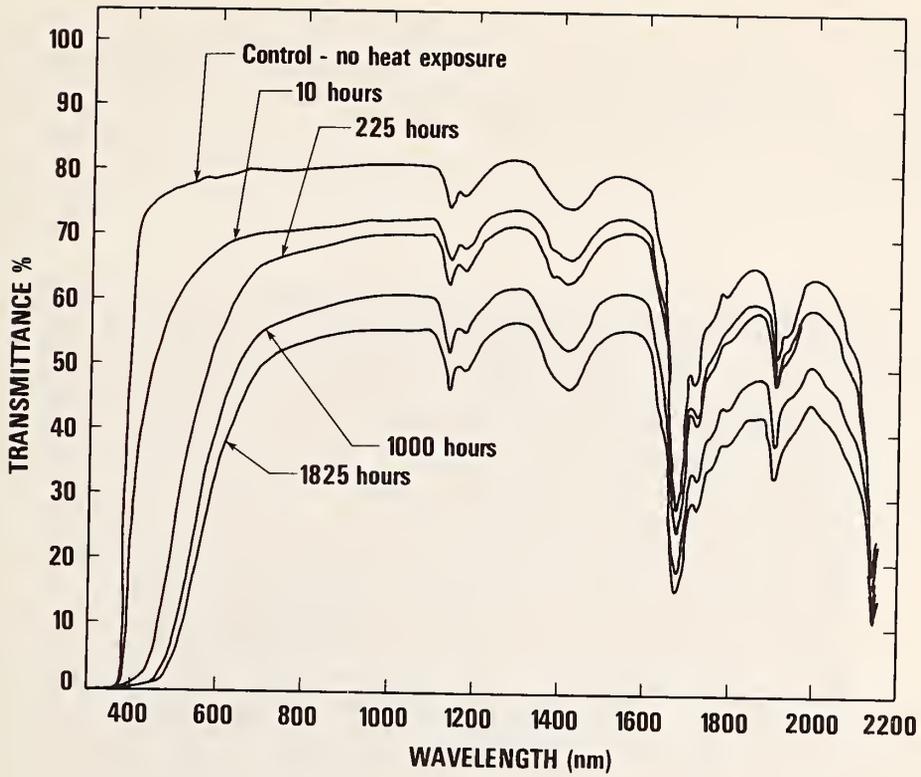
FIGURE 7A SPECTRAL TRANSMITTANCE 1.5MM(0.06IN) FIBER REINFORCED PLASTIC EXPOSED TO 150°C(302°F) FOR FOUR TIME PERIODS

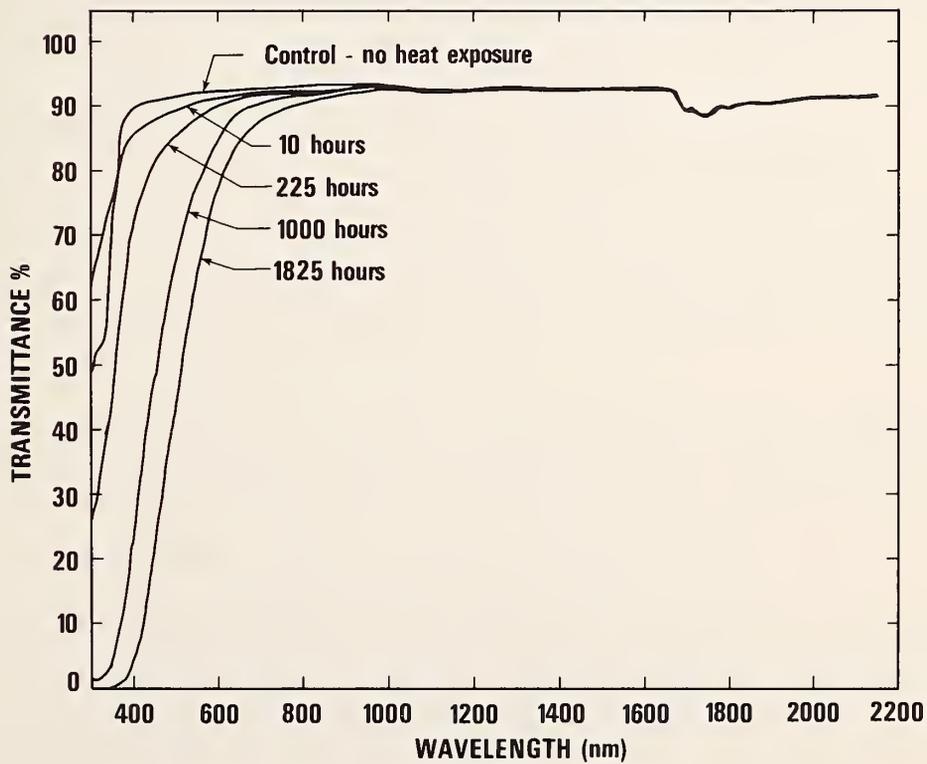
FIGURE 7B SPECTRAL TRANSMITTANCE 0.10MM(0.004IN) POLY(VINYL FLUORIDE) EXPOSED TO 150°C(302°F) FOR FOUR TIME PERIODS

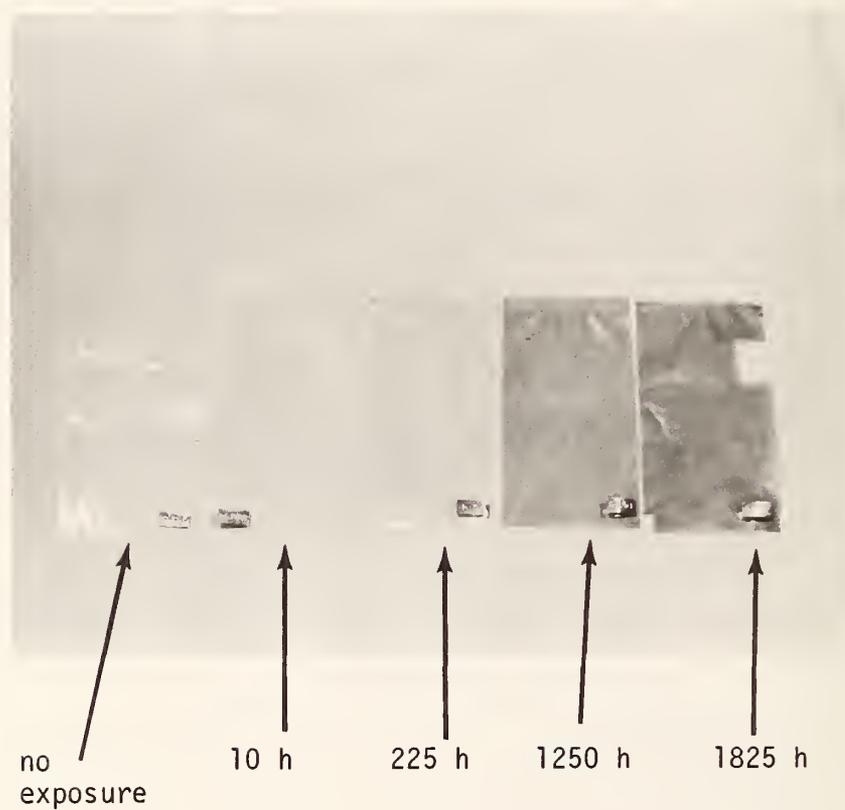
Figure 8 Appearance of Poly(vinyl fluoride) after Exposure at 150°C(302°F) for Various Periods

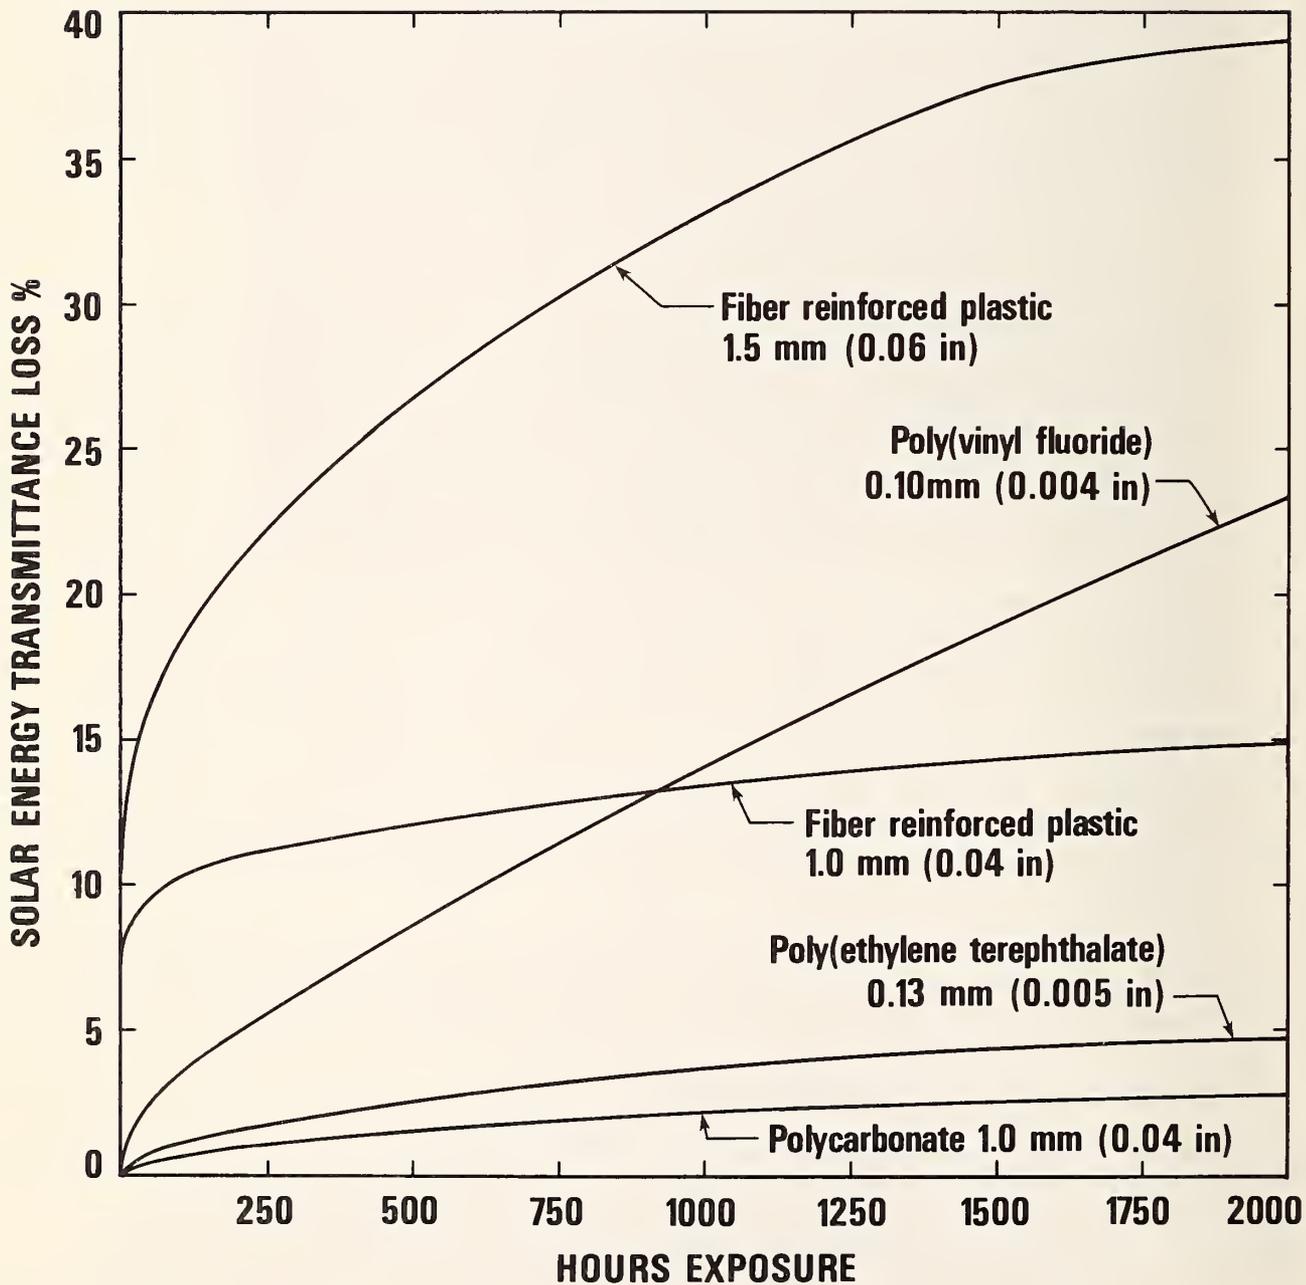
FIGURE 9A RATE OF SOLAR ENERGY TRANSMITTANCE LOSS OF FIVE COVER PLATE MATERIALS EXPOSED AT 150°C(302°F)

The rate of solar energy transmittance loss varied among the materials, as shown in figure 9a. The 1.5 mm fiber reinforced plastic decreased rapidly until about 1500 hours exposure when it leveled off. For the 1.0 mm fiber reinforced plastic material, there was a large immediate loss followed by a gradually increasing loss. These two fiber reinforced materials were not the same resin and were produced by different manufacturers which is the reason for the differences in the test results. The poly(vinyl fluoride) had a fairly uniform rate of transmittance loss while the poly(ethylene terephthalate) and polycarbonate changed more slowly.

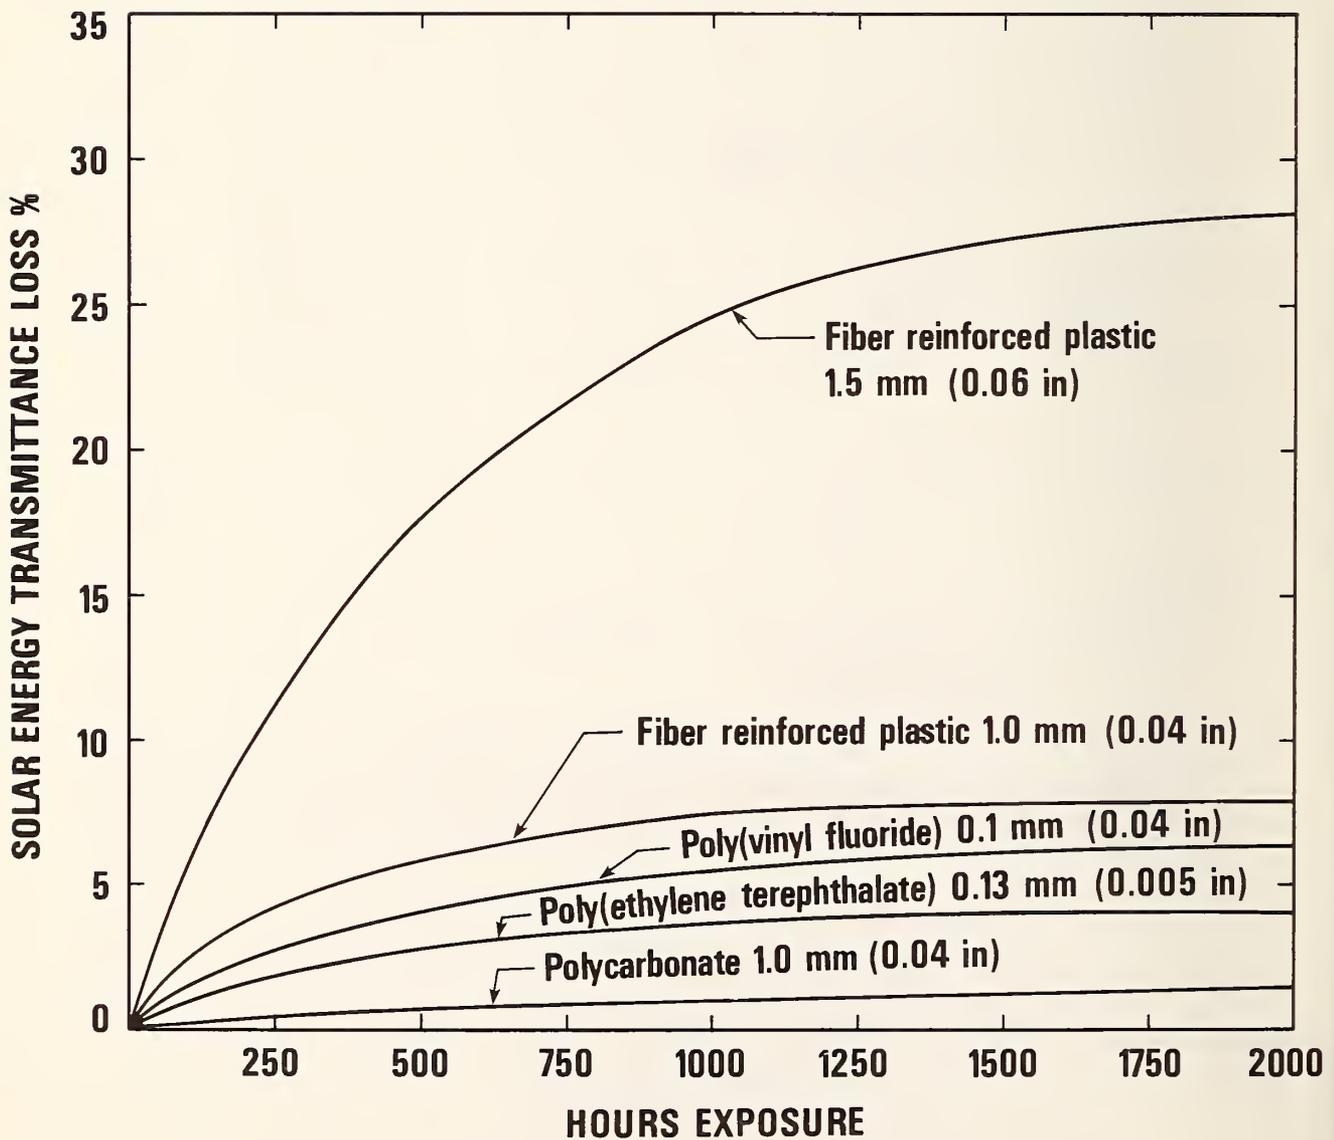
FIGURE 9B RATE OF SOLAR ENERGY TRANSMITTANCE LOSS OF FIVE COVER PLATE MATERIALS EXPOSED AT 125°C (257°F)

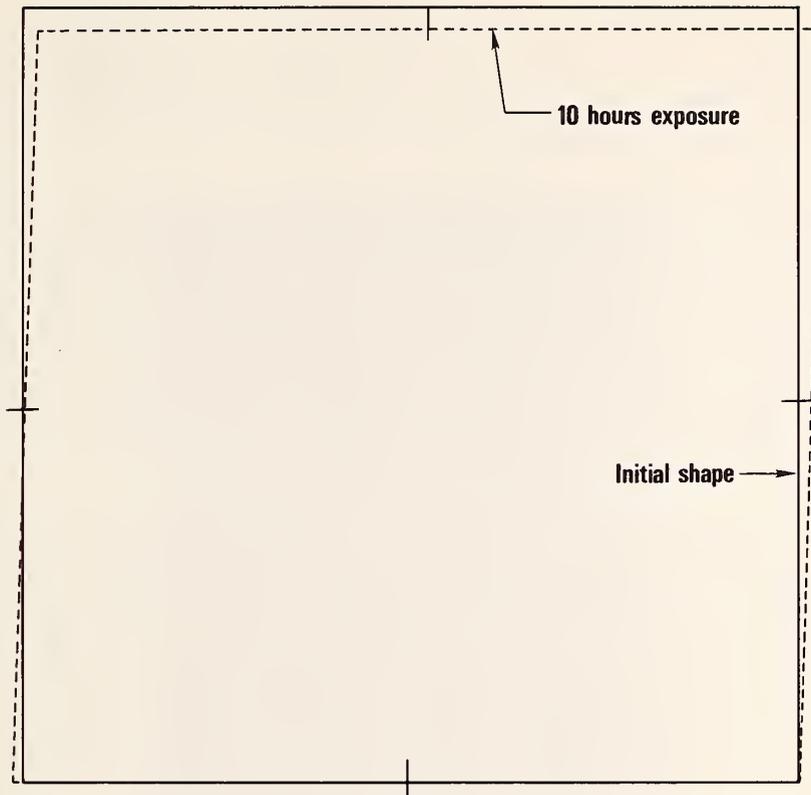
FIGURE 11A LINEAR DIMENSIONAL CHANGES OF FLUORINATED (ETHYLENE PROPYLENE) COPOLYMER EXPOSED AT 150°C(302°F)

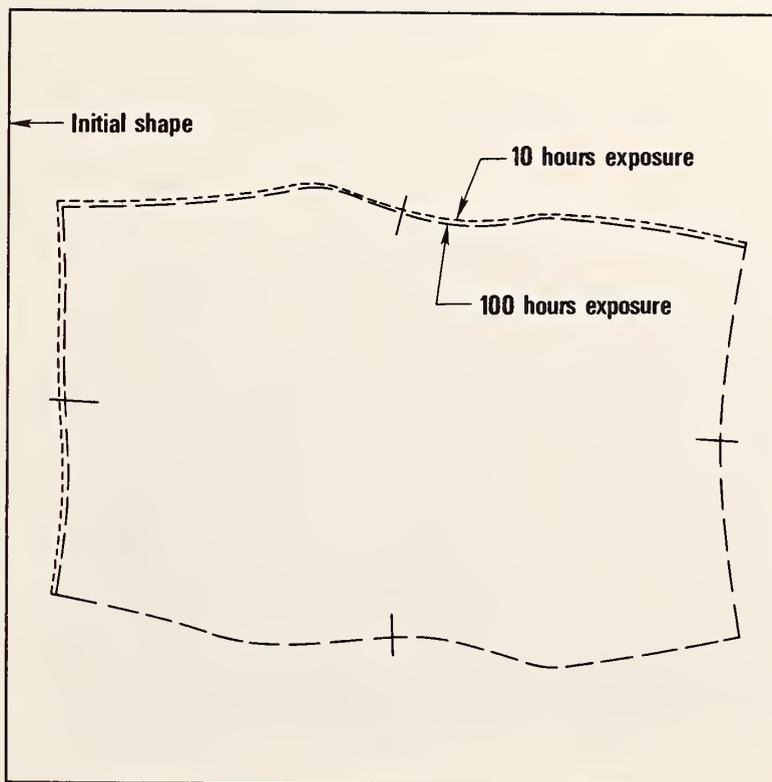
FIGURE 11B LINEAR DIMENSIONAL CHANGES OF ACRYLIC FILM EXPOSED AT 150°C(302°F)

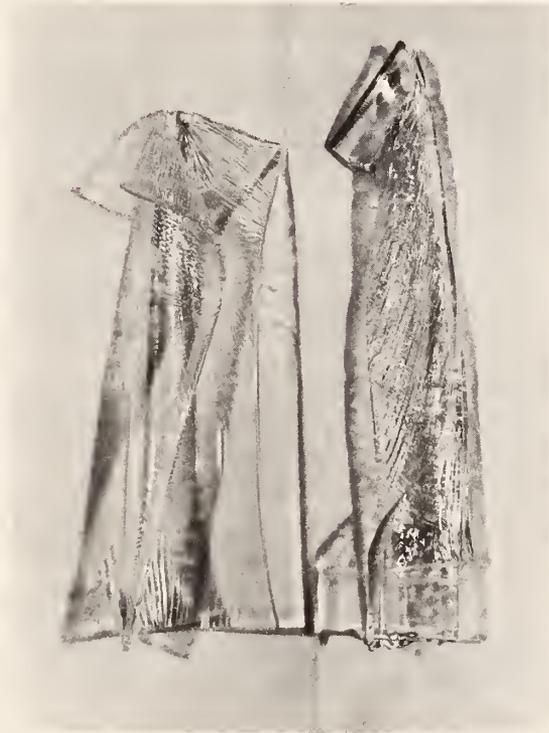
FIGURE 12A APPEARANCE OF POLY(METHYL METHACRYLATE) AFTER 150°C (302°F) HEAT AGING.

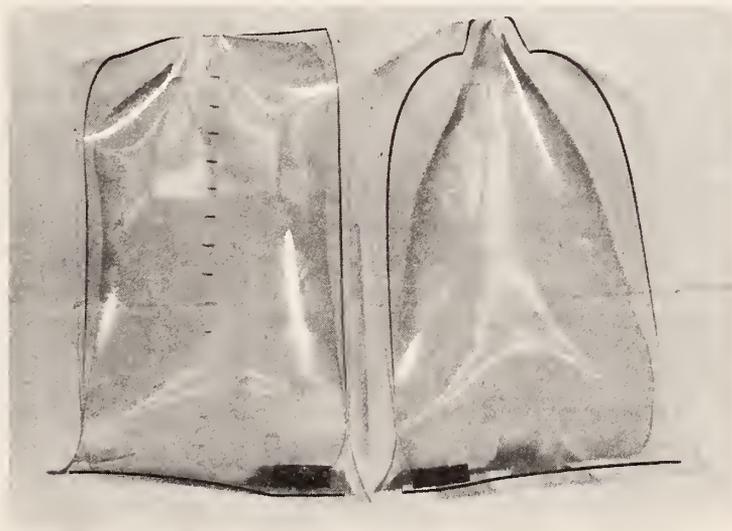
FIGURE 12B APPEARANCE OF POLYCARBONATE AFTER 150°C (302°F) HEAT AGING.

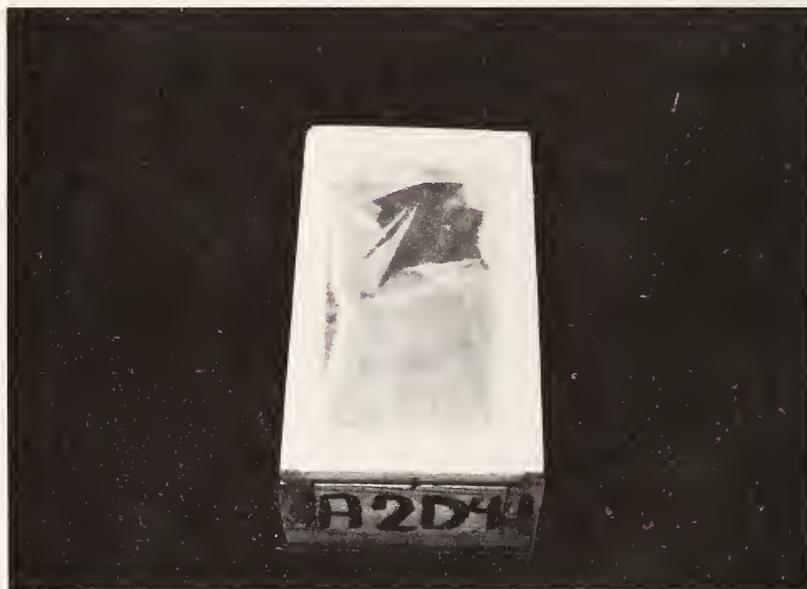
FIGURE 15 A DOUBLE COVER MINICOLLECTOR WITH POLY(VINYL FLUORIDE) COVERS AFTER 18 MONTHS EXPOSURE AT NEW RIVER, ARIZONA.

THE INNER COVER HAS RUPTURED.

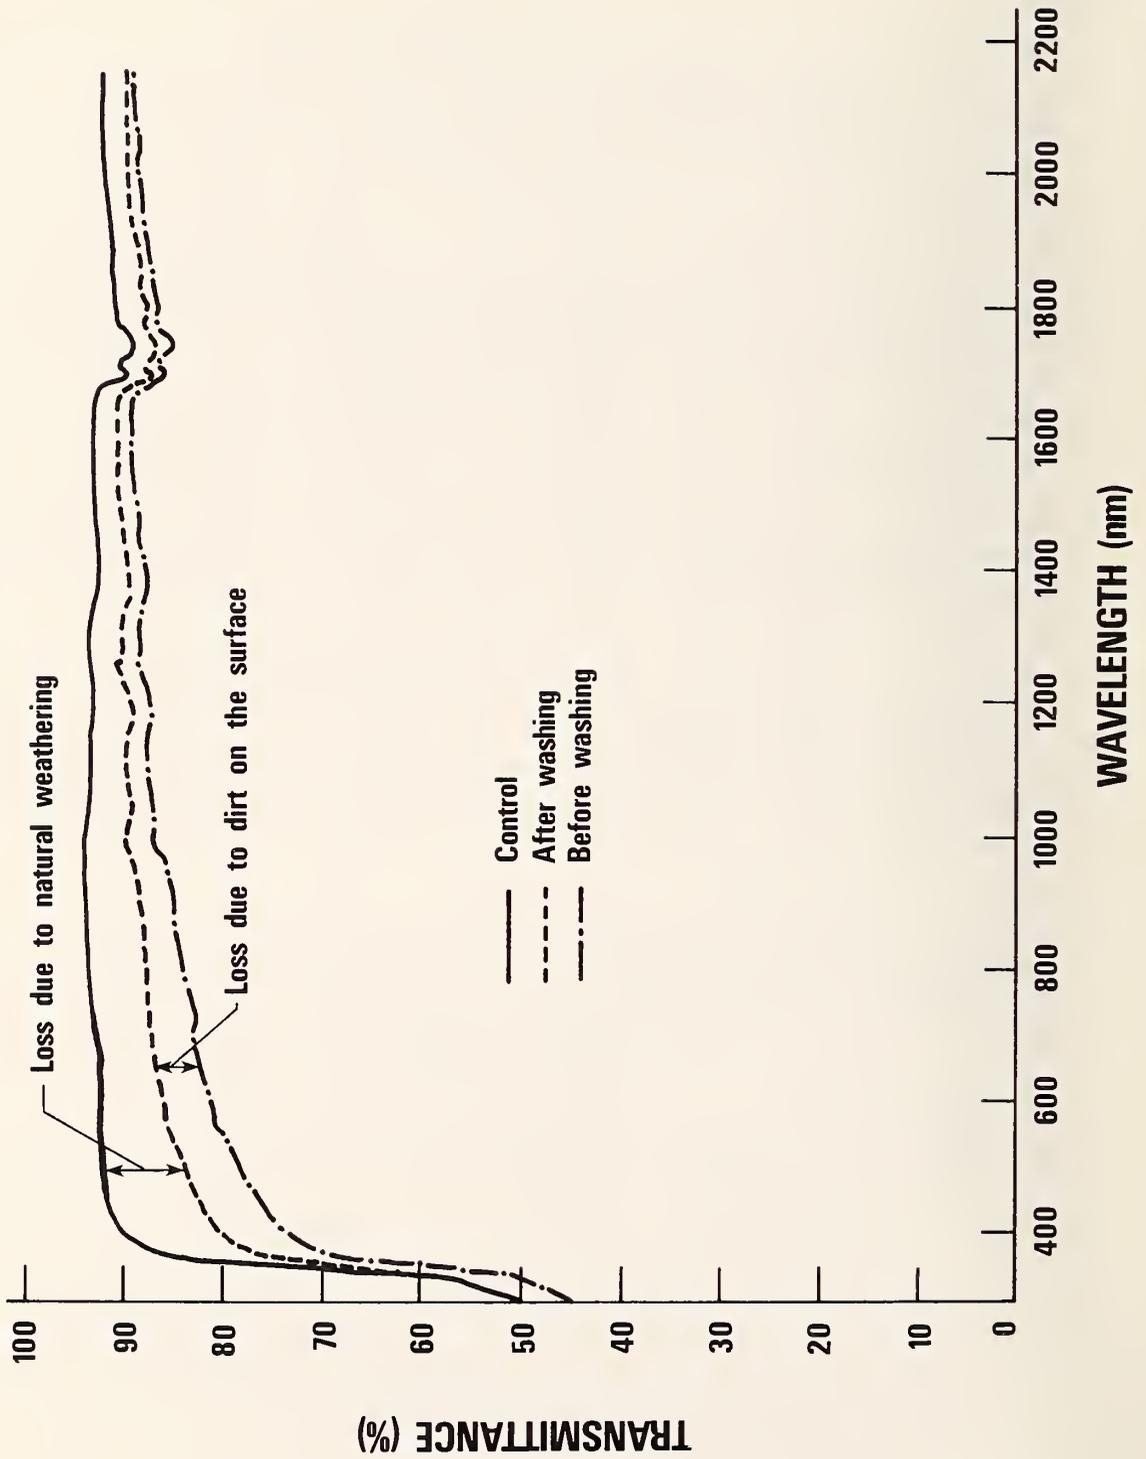
FIGURE 16 COMPARISON OF THE SPECTRAL TRANSMITTANCE OF CONTROL WITH WASHED AND UNWASHED 0.10MM(0.004IN) POLY(VINYL FLUORIDE) EXPOSED TWO YEARS IN GAITHERSBURG, MARYLAND

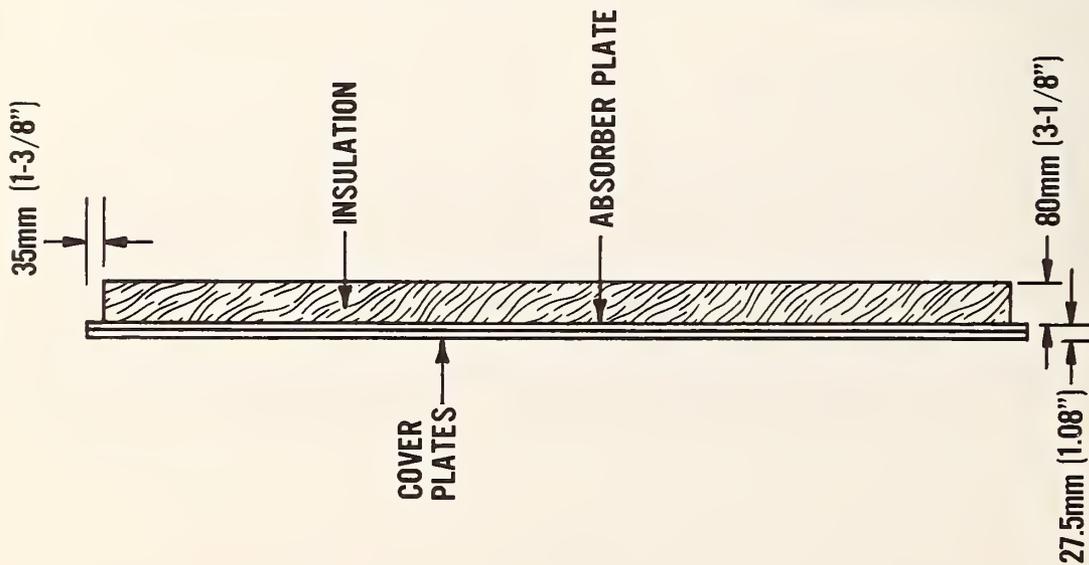
SIDE VIEW

FIGURE A1 Collector on Which Temperature Measurements Were Made

The collector had two glass cover plates and a flat black absorber. A description of the collector is contained in Table A1 and Figures A1 and A2. The location of the thermocouples is illustrated in Figure A2. Solar irradiation across the top of the graph is the sum of the total radiation for previous hour.

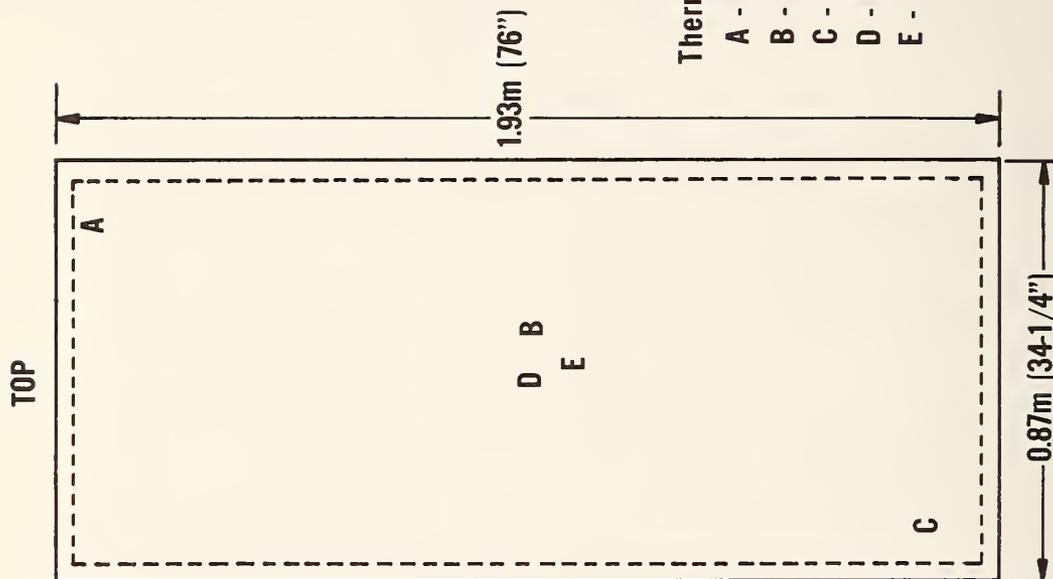
FRONT VIEW

FIGURE A2 Location of Thermocouples on Collector During Stagnation Temperature Monitoring

Thermocouples were attached to the cover plates using aluminum foil backed adhesive tape. The size of the strip of tape used was just large enough to provide secure contact with the surface of the cover plate. By proper positioning of the foil backed tape, the thermocouple junctions were protected from direct exposure to either the reradiation of heat from the absorber plate or direct solar radiation. Installation of the thermocouples on the absorber plate was accomplished by embedding the thermocouple junction in the back of the 3.2 mm (0.125 in) thick aluminum absorber. The thermocouple was inserted into a hole drilled at an angle in the absorber and it was held in place by peening.

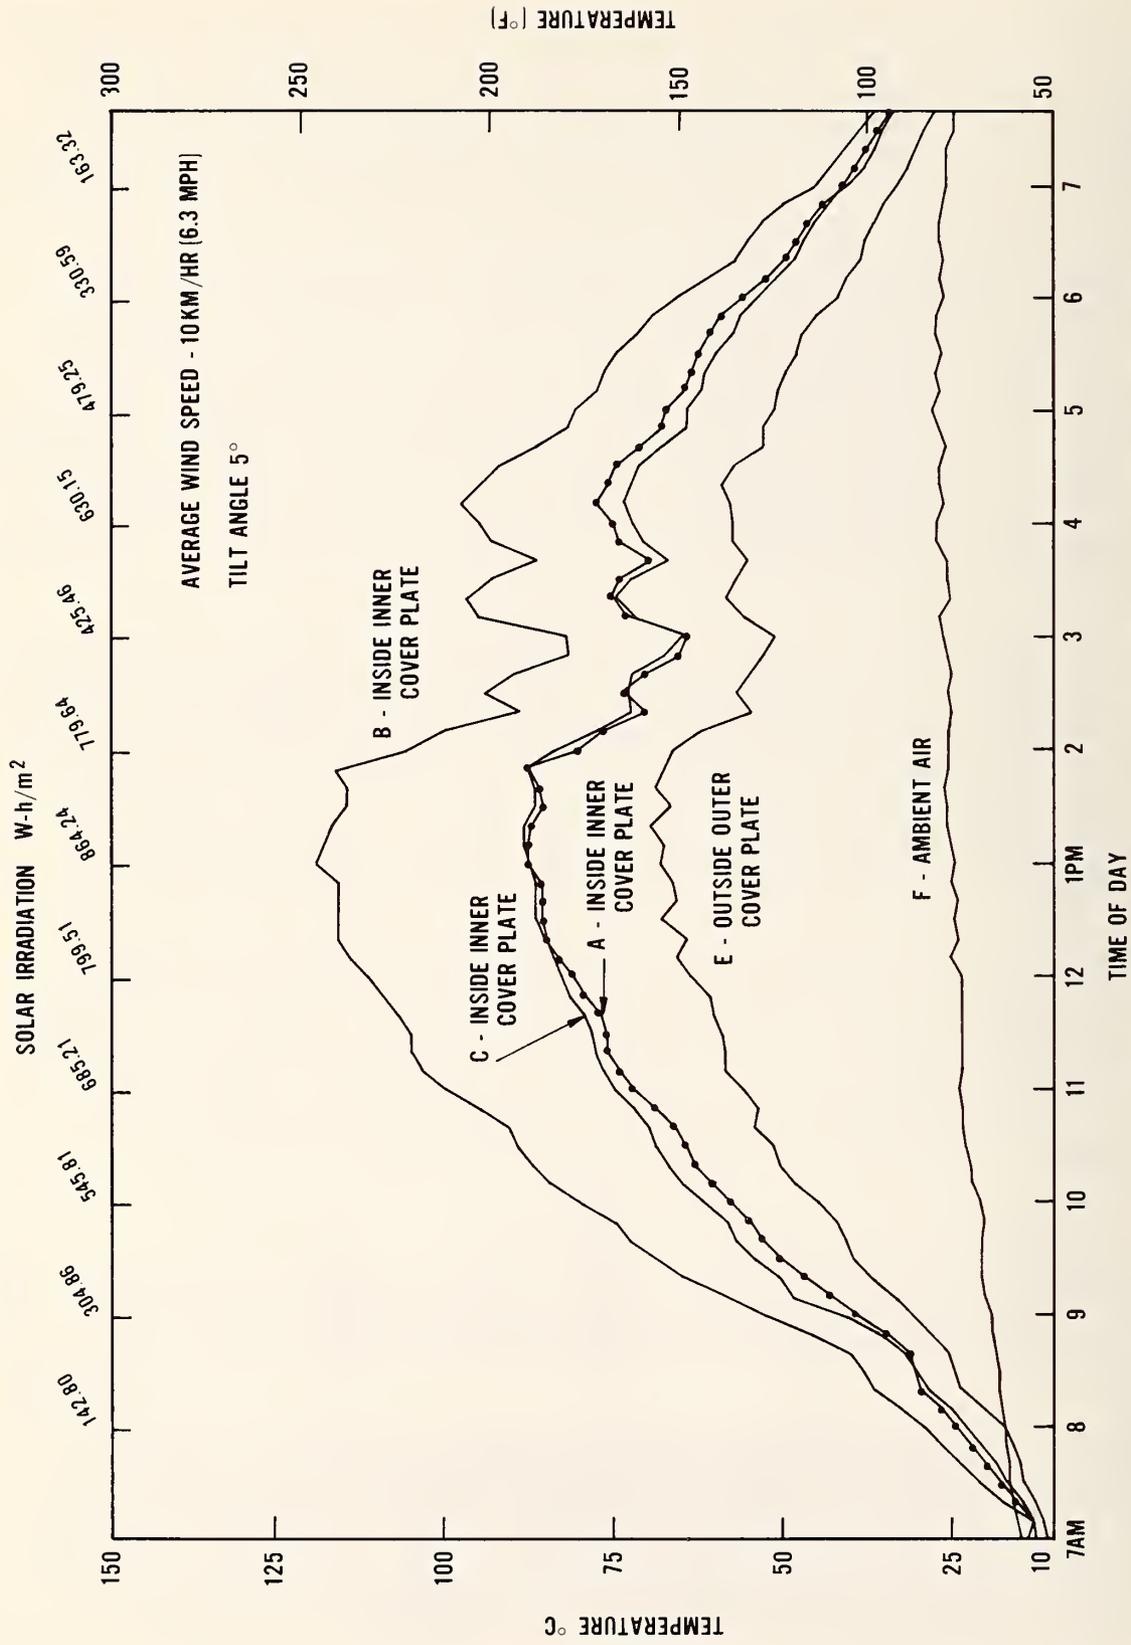
FIGURE A3 Cover Plate Temperatures Measured June 23, 1977, an Collector in Stagnation Condition
