NBS TECHNICAL NOTE **1132**

Solar Energy Systems— Standards for Cover Plates For Flat Plate Solar Collectors

Issued December 1980

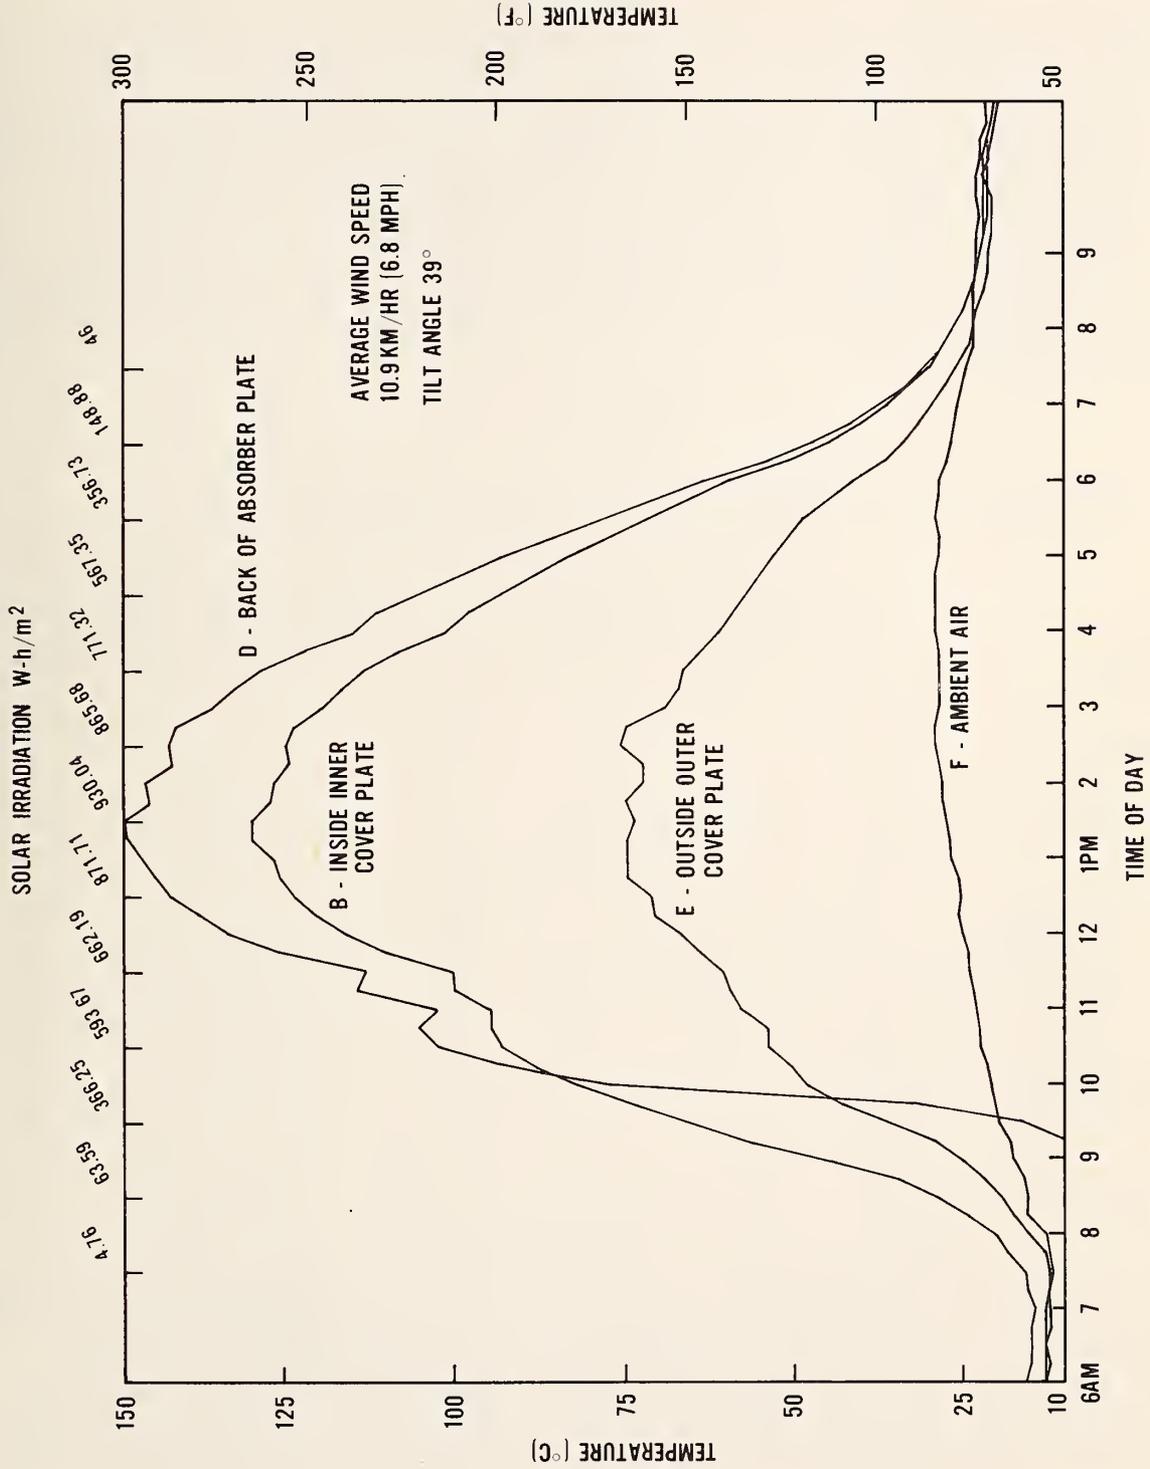
FIGURE A4 Temperatures Measured September 18, 1977, in Center of Collector in Stagnation Condition

The collector had two glass cover plates and a flat block absorber. A description of the collector is contained in Table A1 and Figure A1. The location of the thermocouples is illustrated in Figure A2. Solar irradiation across the top of the graph is the sum of the total radiation for previous hour.

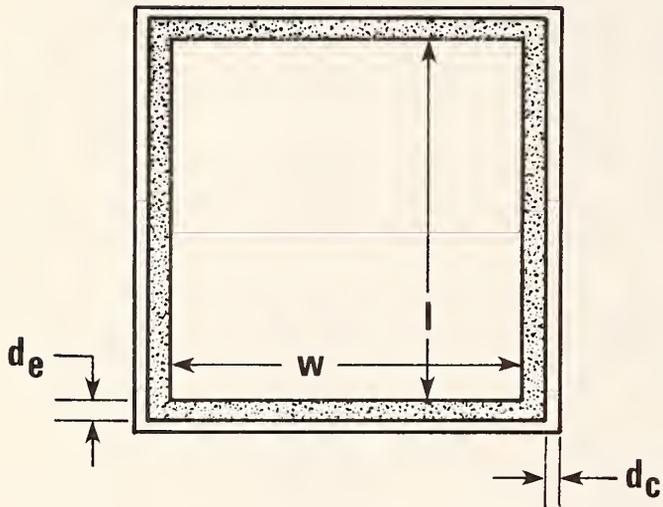
FIGURE B1 TOP VIEW OF EXPOSURE TEST FIXTURE

l = length of aperture inside edge insulation

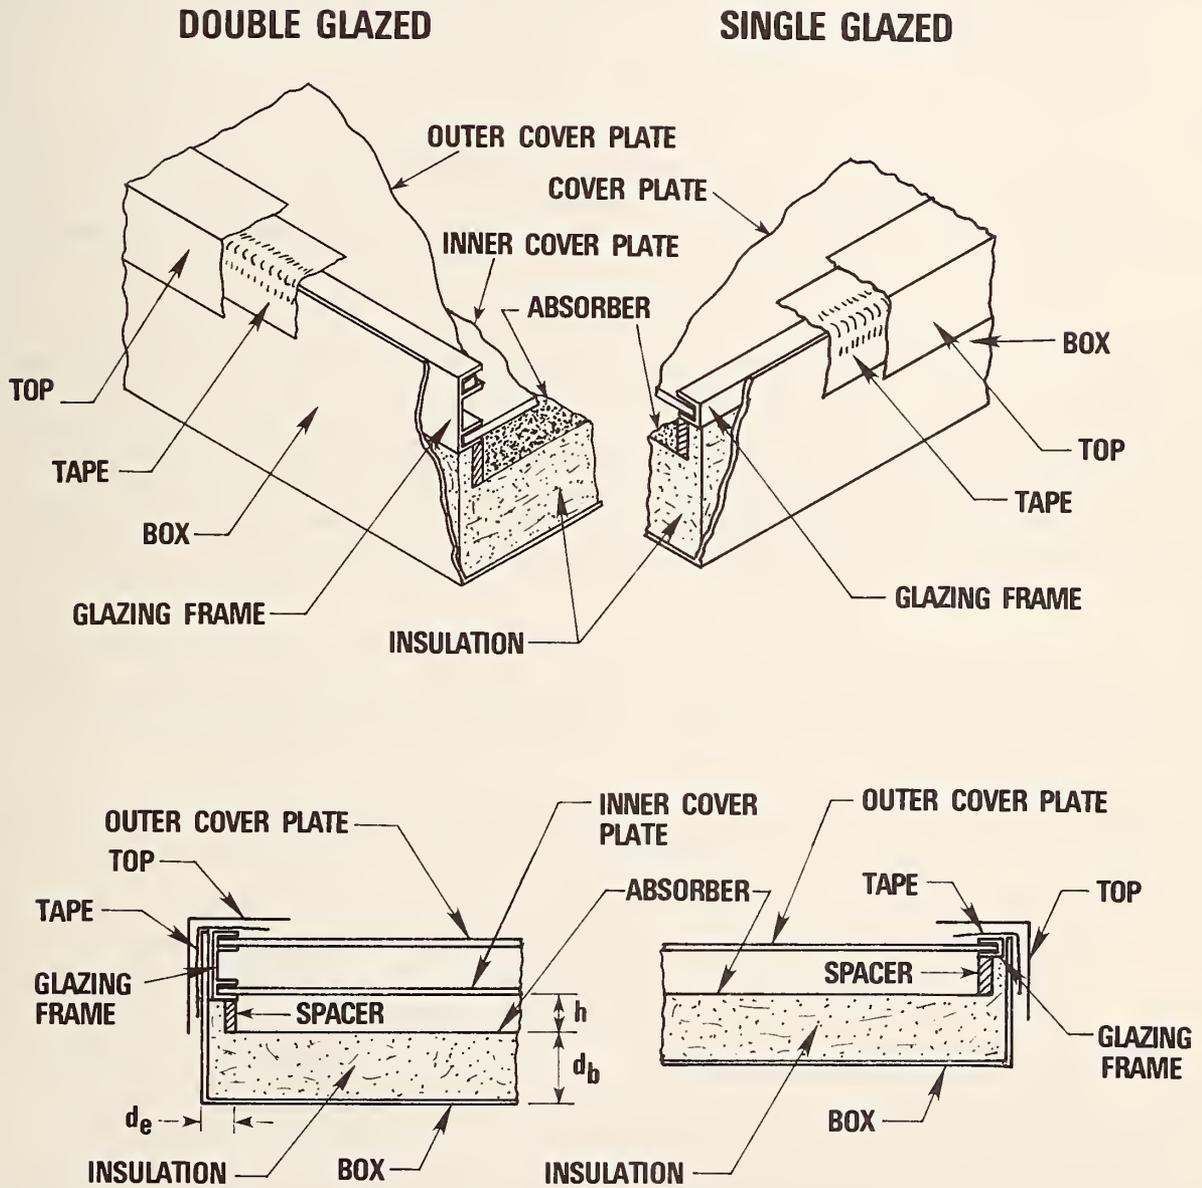
FIGURE B2 NATURAL WEATHERING BOX ASSEMBLY

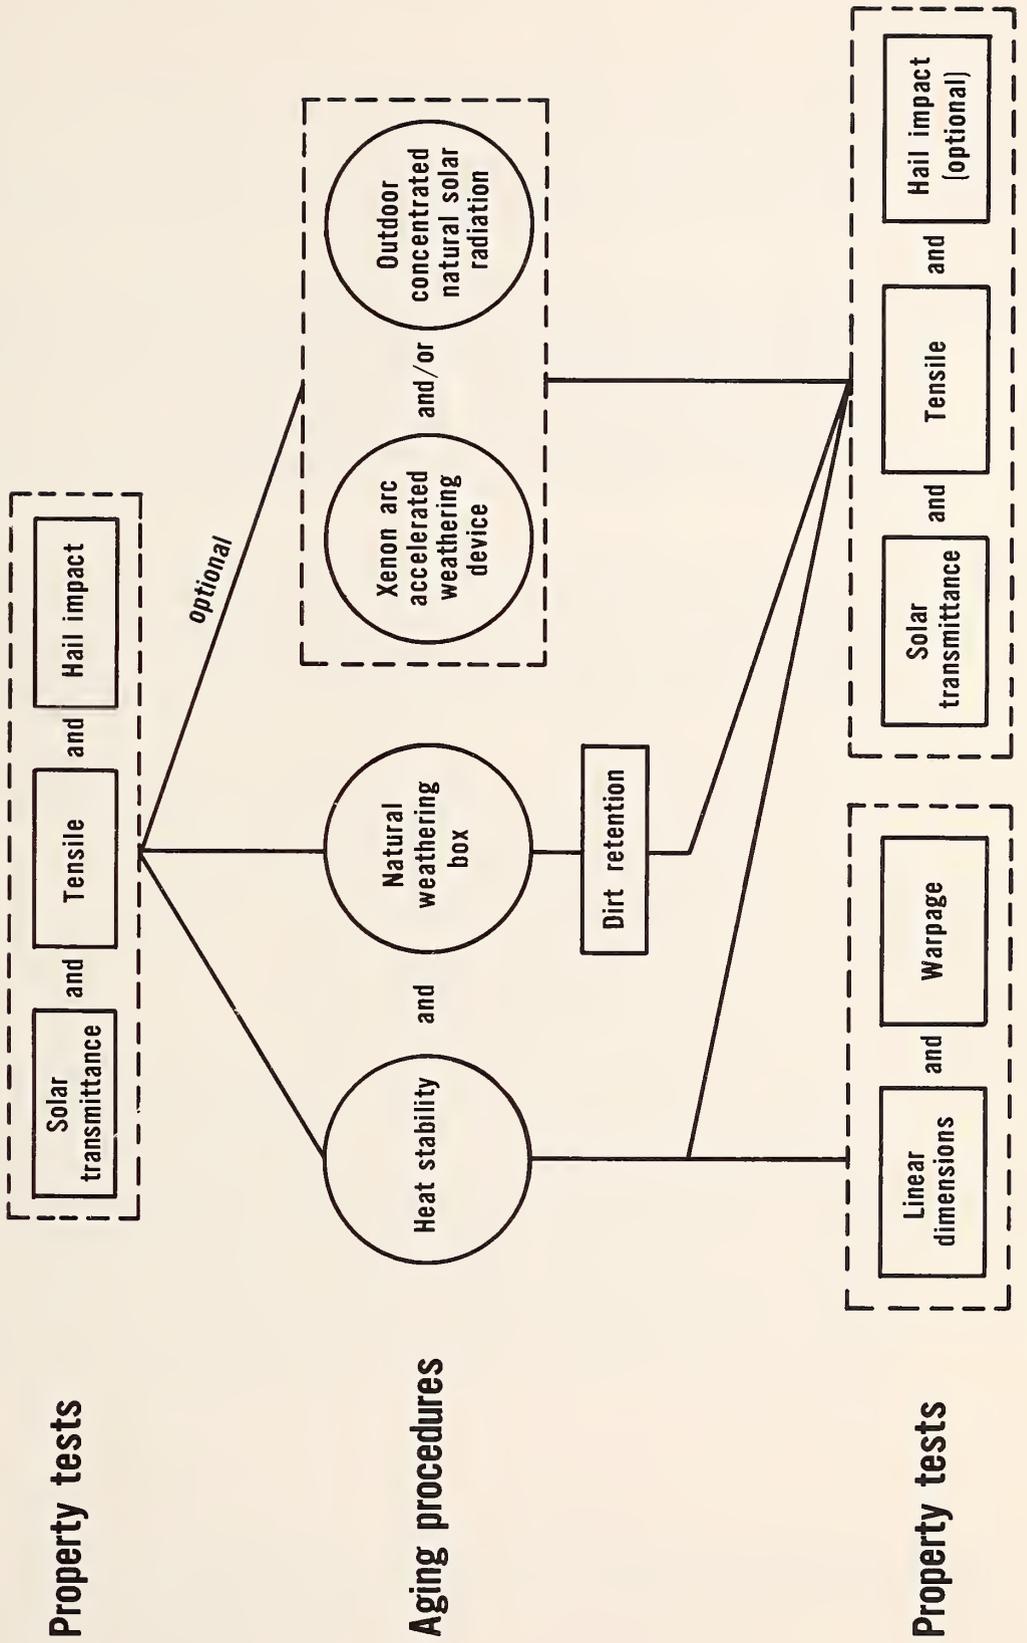
FIGURE C1 SEQUENCE OF TESTING
