NIST TN 1658

Impact of Sprinklers on the Fire Hazard in Dormitories: Sleeping Room Fire Experiments

Daniel Madrzykowski
William D. Walton

January 2010

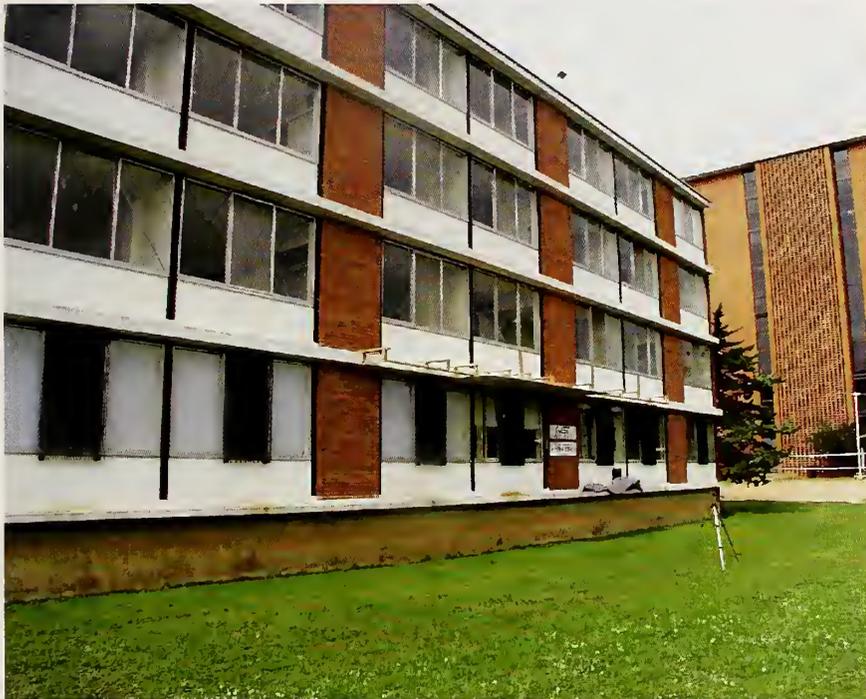
Figure 2.2-1. Photograph of the outside of the northwest wing of the dormitory building, looking southwest.

The first floor of the northwest wing of the building was chosen for the experiments based on the pristine condition of the dorm rooms. Photographs of the exterior and interior of the northwest wing are shown in Figure 2.2-1 and Figure 2.2-2. In Figure 2.2-2 the sleeping rooms are on the left side of the corridor and a courtyard can be seen through the windows on the right.

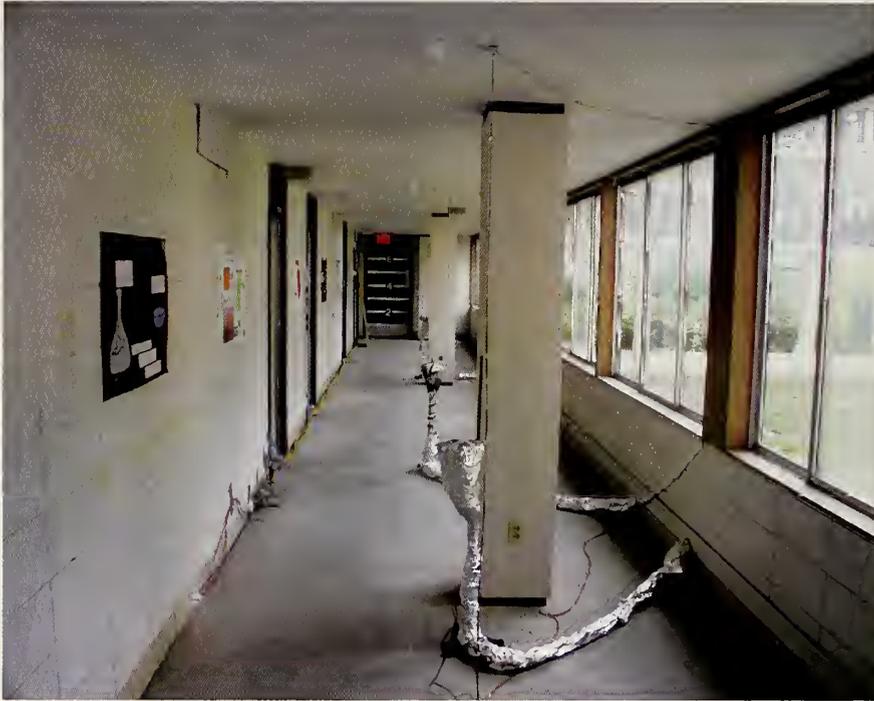
Figure 2.2-2. Photograph of the instrumented corridor in the northwest wing of the dormitory building, looking east.

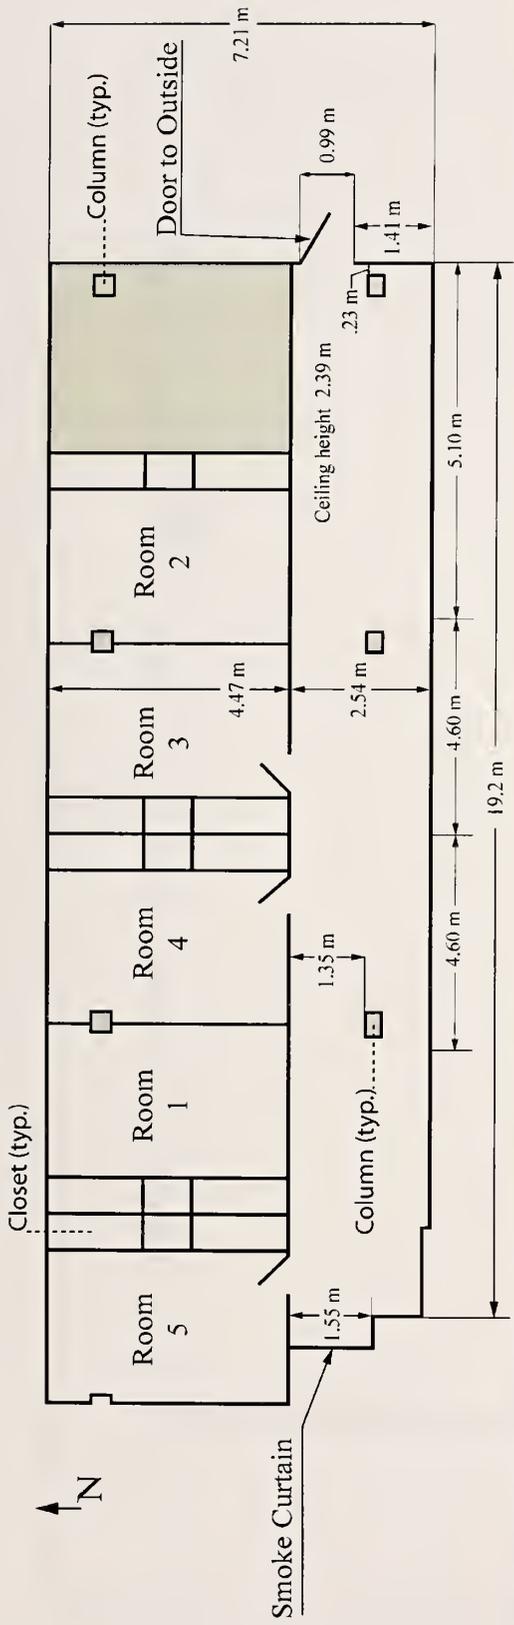
Figure 2.2-3. Floor plan of the northwest corridor

The length of the corridor was 19.81 m (65.00 ft). The corridor was 2.54 m (8.33 ft) wide with a ceiling height of 2.39 m (7.83 ft). The rooms were located on the north side of the corridor. Windows comprised the upper portion of the south wall of the corridor. The single pane windows were 1.33 m (4.38 ft) high with 0.83 m (2.70 ft) window sill height above the floor. A door, 0.98 m (3.23 ft) wide and 2.02 m (6.63 ft) high, provided access to the corridor from the east end of the corridor. This door was kept closed during the fire experiments. A smoke curtain made of gypsum board was installed on the west end of the corridor to limit smoke flow into the portion of the corridor that led to the shower rooms and connected the southwest corridor of the building. An area 1.55 m (5.08 ft) wide and 1.07 m (3.5 ft) was left open under the smoke curtain to prevent pressure increase in the corridor during the fire.

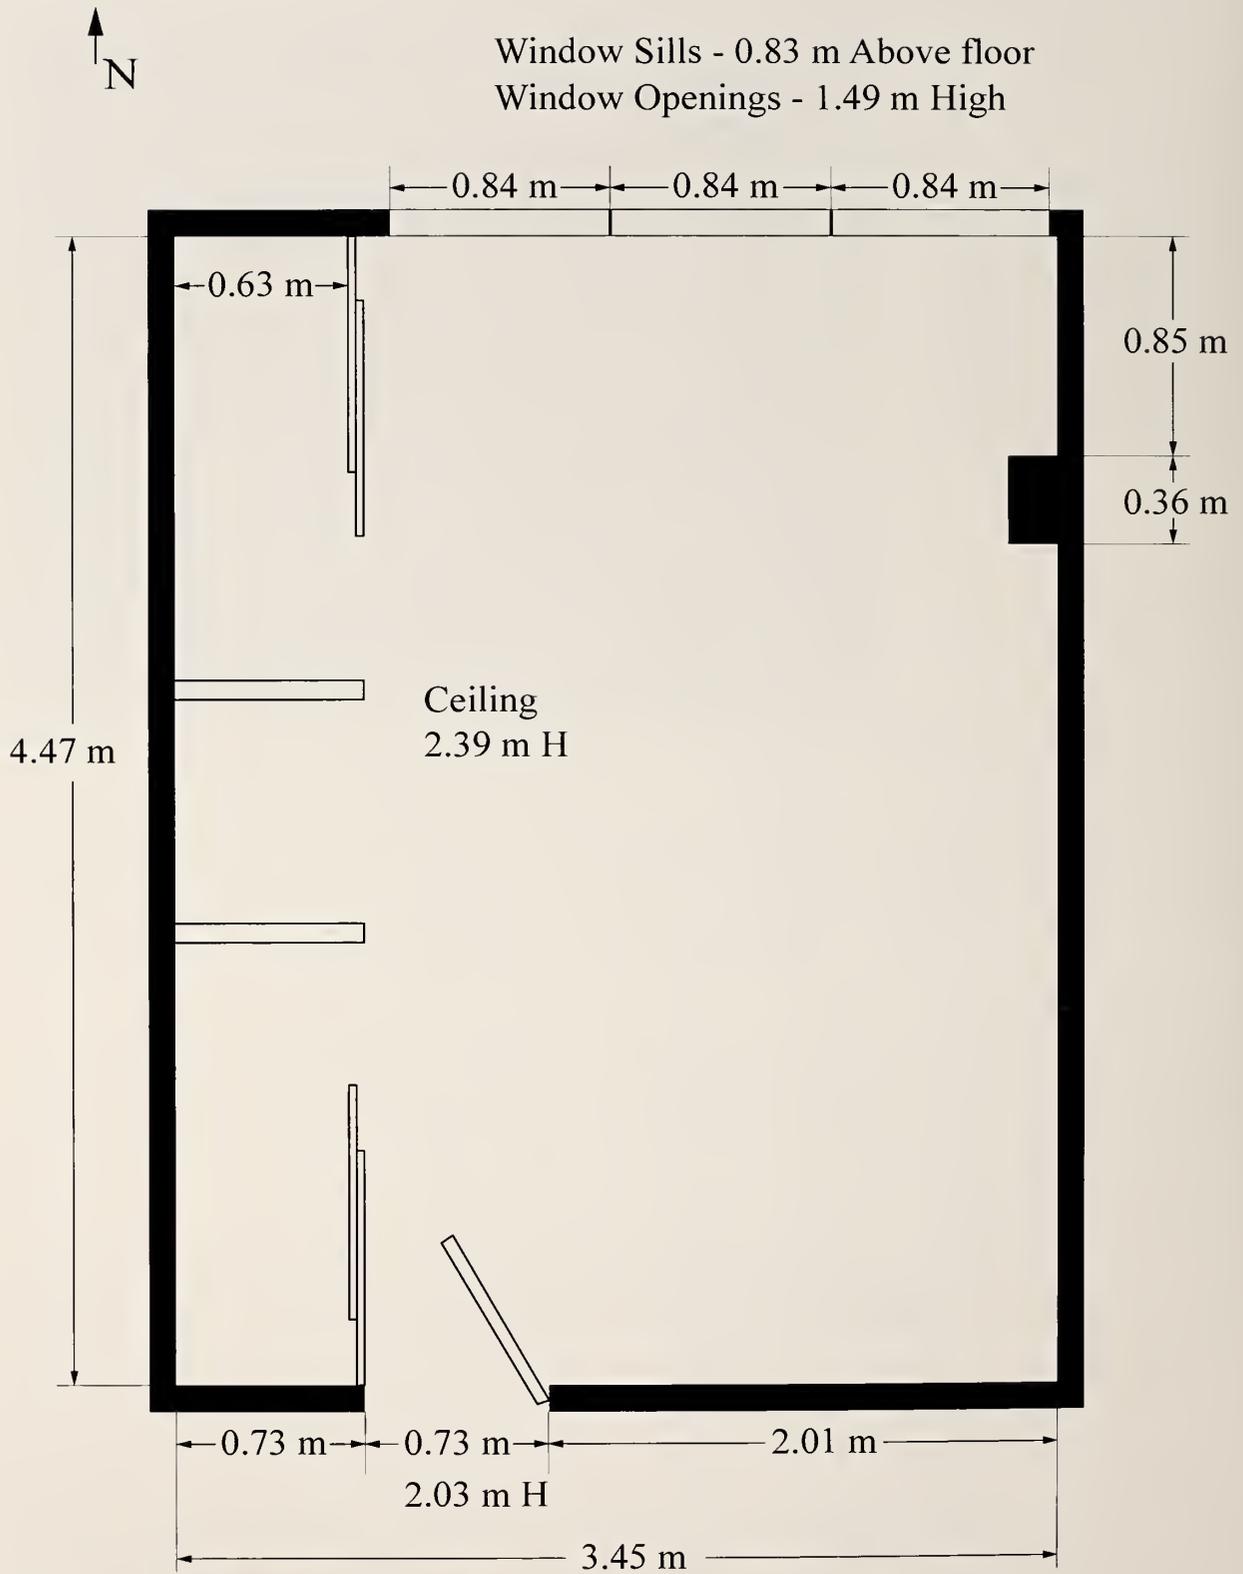
Figure 2.2-4. Floor plan of a typical dorm room used in the experiments

The single pane windows on the exterior wall of the dorm room were composed of three sections of glass 0.84 m (2.77 ft) wide and 1.49 m (4.88 ft) high with a window sill height of 0.83 m (2.71 ft). The glass was mounted in an aluminum frame. The floor plan of a dorm room is given in Figure 2.2-4.

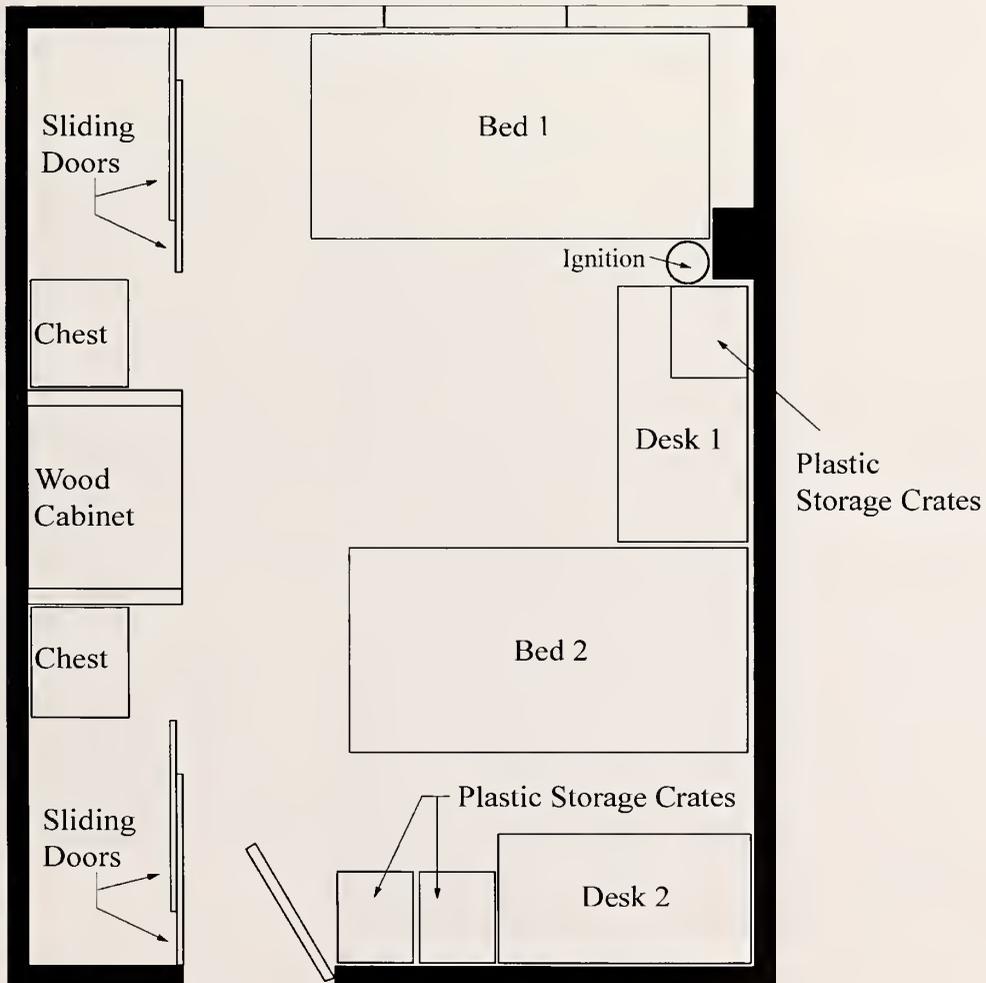
Figure 2.3-1. Furnishing arrangement of a typical dorm room used in the experiments

Each room was furnished in a similar manner. The furnishings were typical of items found in college dormitory sleeping rooms: twin beds, desks, computers, books, clothing, towels, posters, carpeting, a television, and a radio. A complete list of the items in the rooms and a brief description and the mass of each item is given in Table 2.3-1 through Table 2.3-5. The tables are categorized by the type or area of fuel load and include the fixed furnishings and interior finish (Table 2.3-1), the bed fuel package (Table 2.3-2), the desk fuel package (Table 2.3-3), clothing and closet contents (Table 2.3-4), and the ignition fuel package (Table 2.3-5).

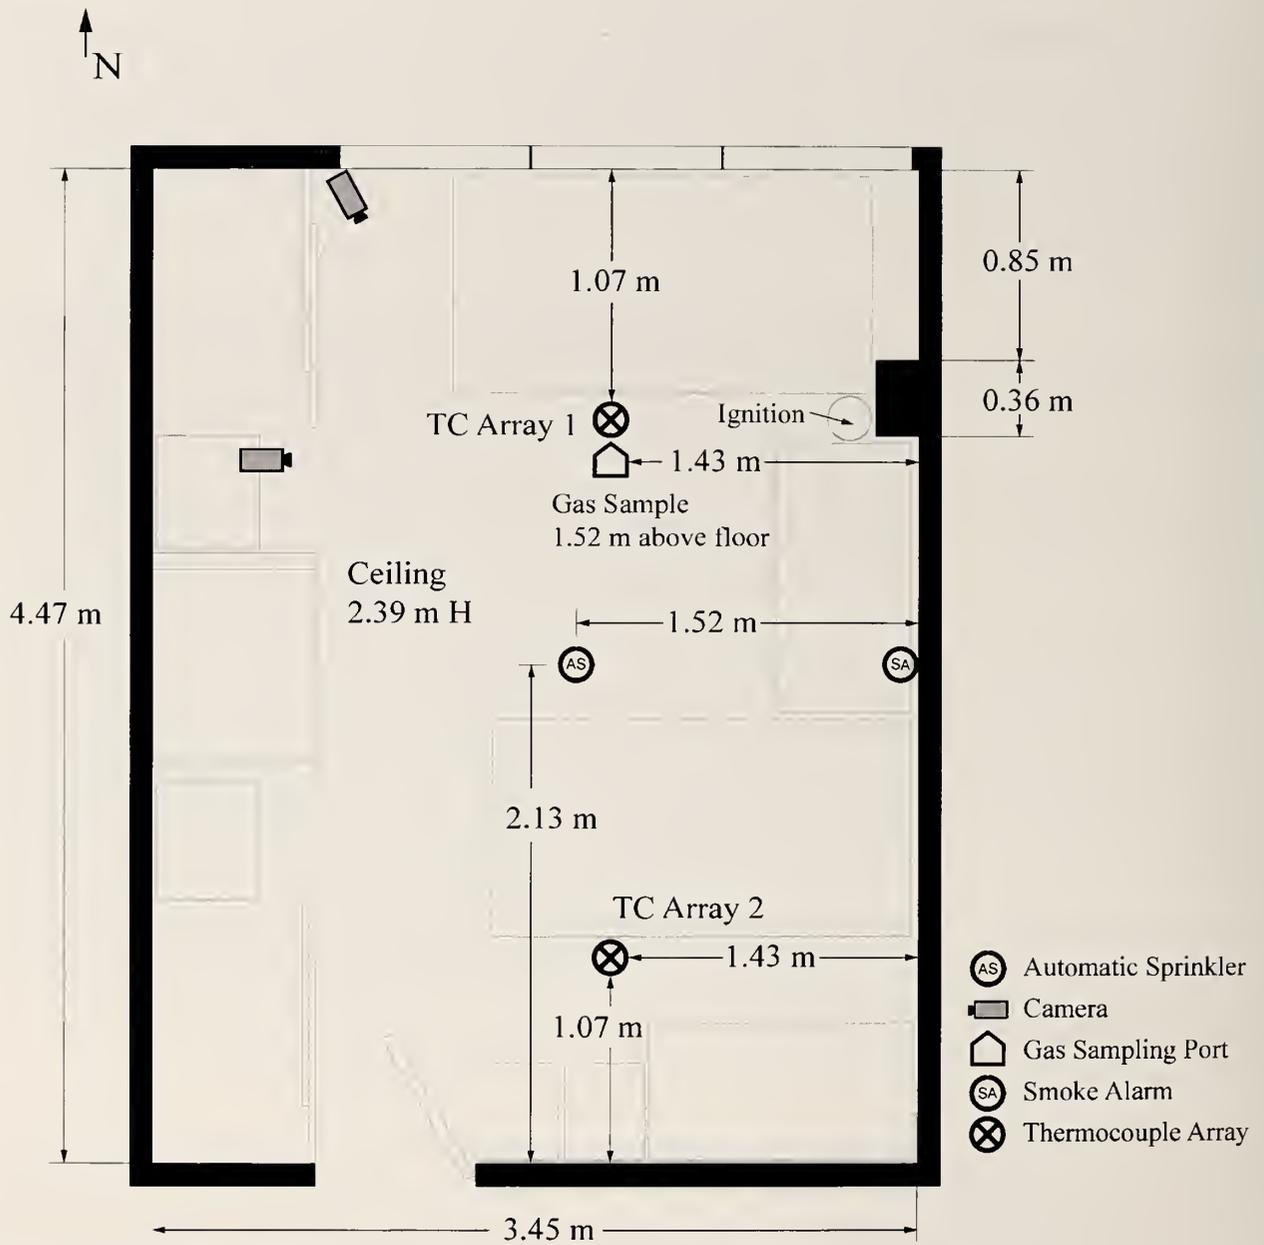
Figure 2.4-1. Floor plan of dorm room with instrumentation locations

Gas concentrations were sampled at two different positions. In each experiment, the sampling line inlets were located adjacent to TC Array 1 and TC Array 4 at 1.52 m (5.0 ft) above the floor. The sampling lines were connected to calibrated vacuum pumps which moved the gas samples through a conditioning system, which removed particulate and moisture from the gas sample.

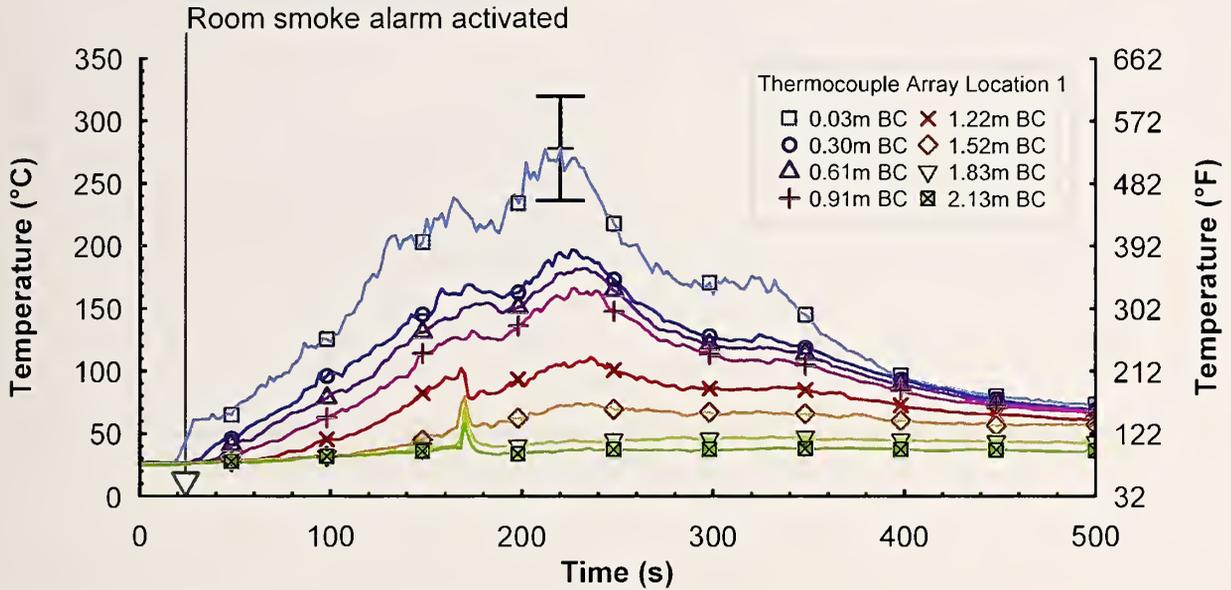
Figure 3.1-1. Temperature versus time data from thermocouple array 1 in Experiment 1, listed by distance below ceiling (BC)

three thermocouples in the array at approximately 165 s after ignition was caused by the flames extending to the plastic crate book shelf on the desk, followed by the collapse of the book shelf and materials to the floor in the vicinity of the TC array 1.

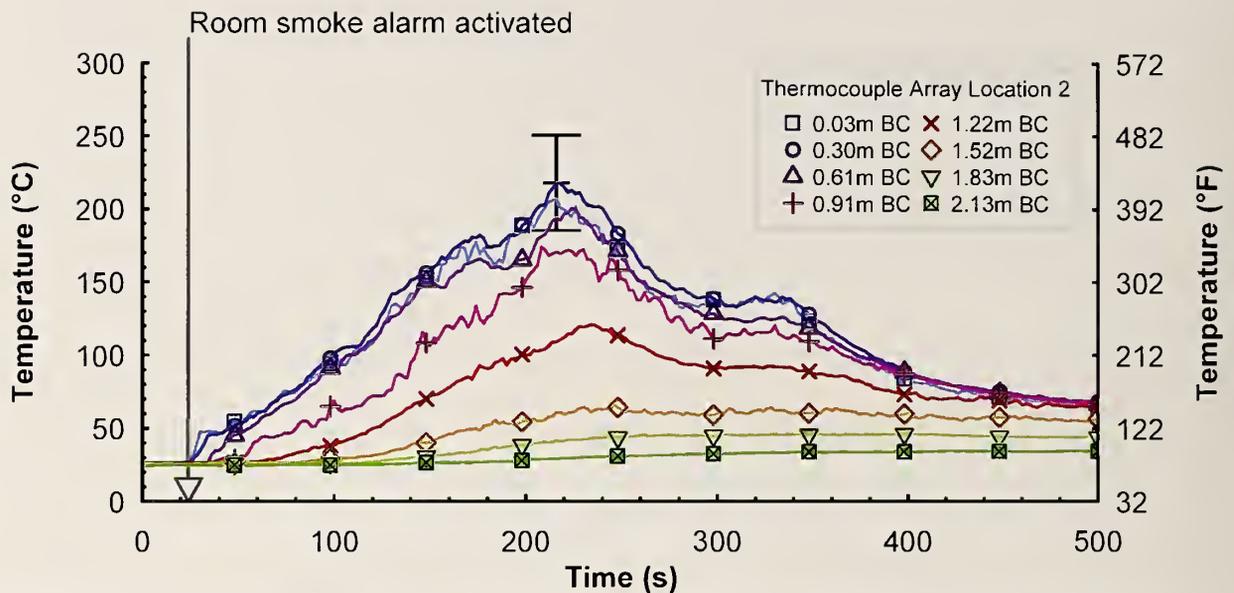
Figure 3.1-2. Temperature versus time data from thermocouple array 2 in Experiment 1, listed by distance below ceiling (BC)

As shown in Figure 3.1-2, the temperatures recorded at thermocouple array 2 had a very similar trend as those from thermocouple array 1. The temperature measurement at array 2 was approximately 50 °C (122 °F) less than the corresponding thermocouple in array 1, except for the thermocouple closest to the ceiling, which was somewhat lower in temperature.

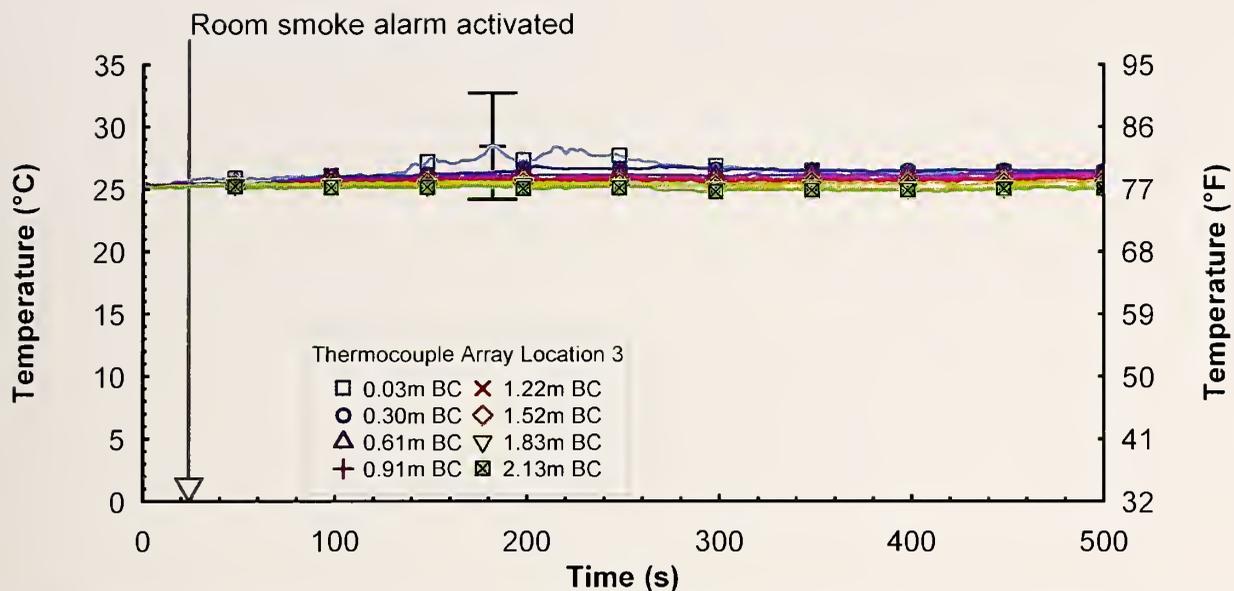
Figure 3.1-3. Temperature versus time data from thermocouple array 3 in Experiment 1, listed by distance below ceiling (BC)

The temperature time histories from the three vertical thermocouple arrays located along the center line of the corridor are given in Figure 3.1-3 through Figure 3.1-5. The closed door to the dorm room limited the flow of hot gases into the corridor. As a result, the temperatures in the corridor did not change significantly during the course of the experiment.

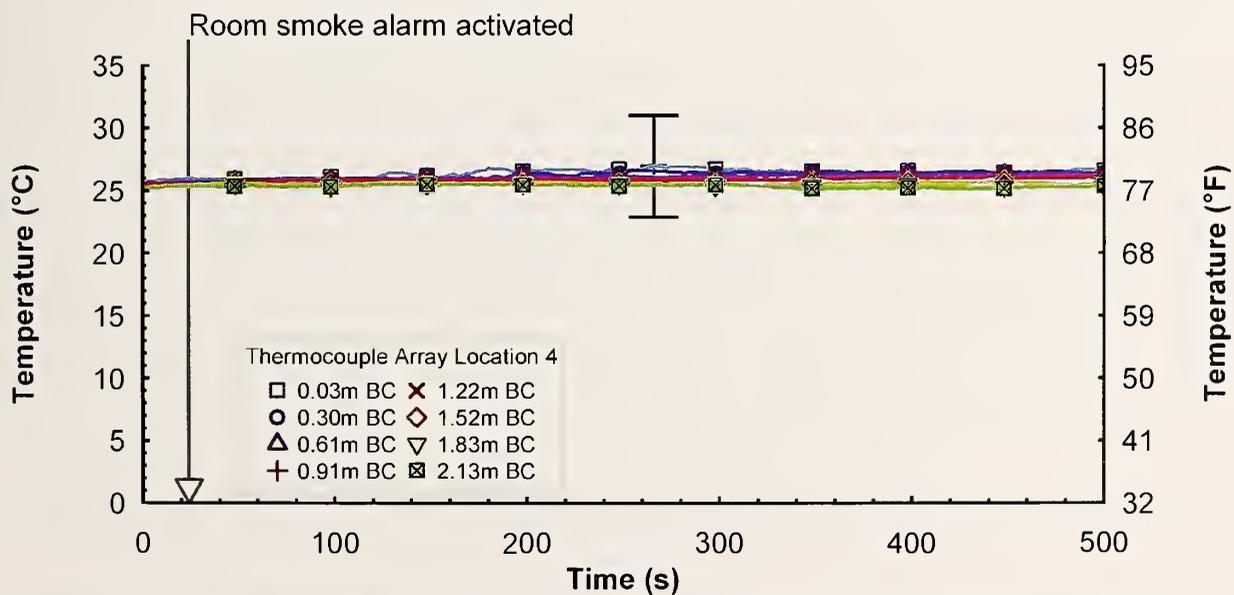
Figure 3.1-4. Temperature versus time data from thermocouple array 4 in Experiment 1, listed by distance below ceiling (BC)

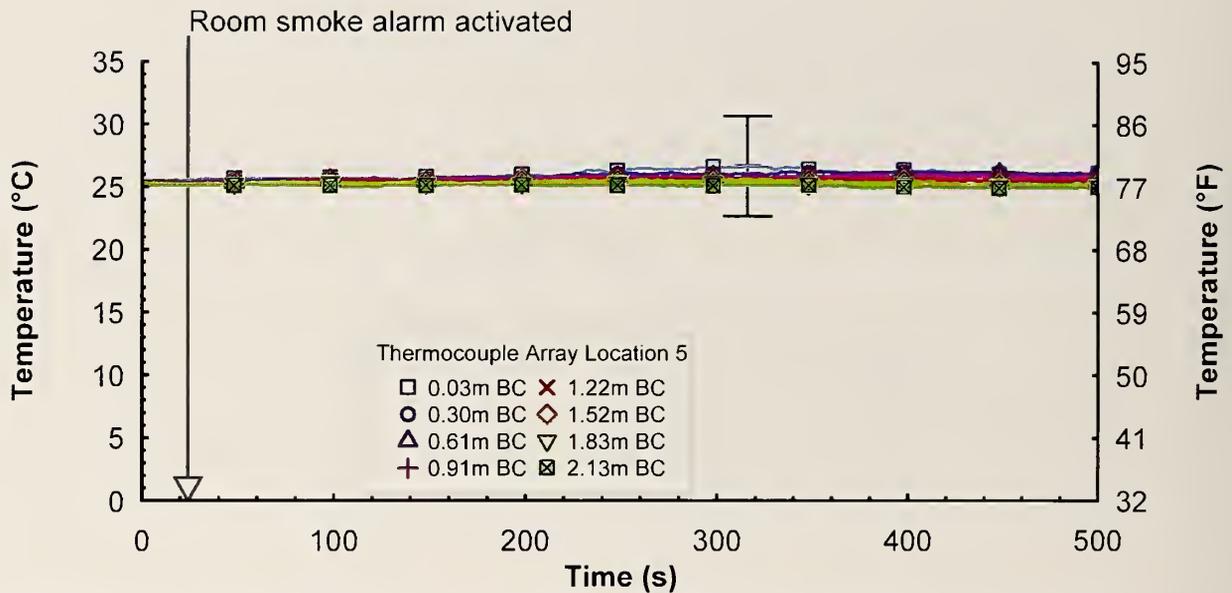
Figure 3.1-5. Temperature versus time data from thermocouple array 5 in Experiment 1, listed by distance below ceiling (BC)

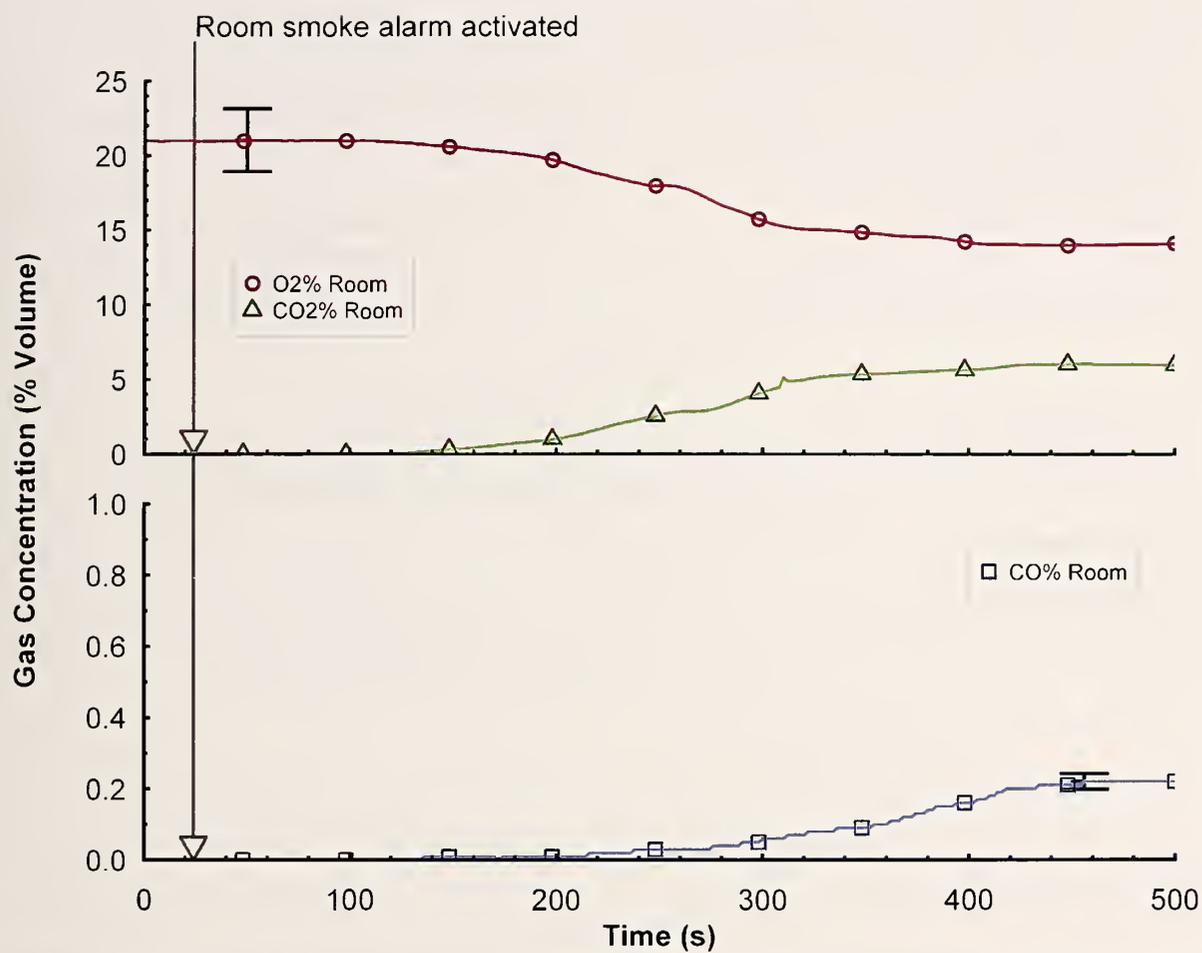
Figure 3.1-6. Relative gas concentrations versus time for the gas sampling point at 1.52 m above the floor at location 1 in Experiment 1

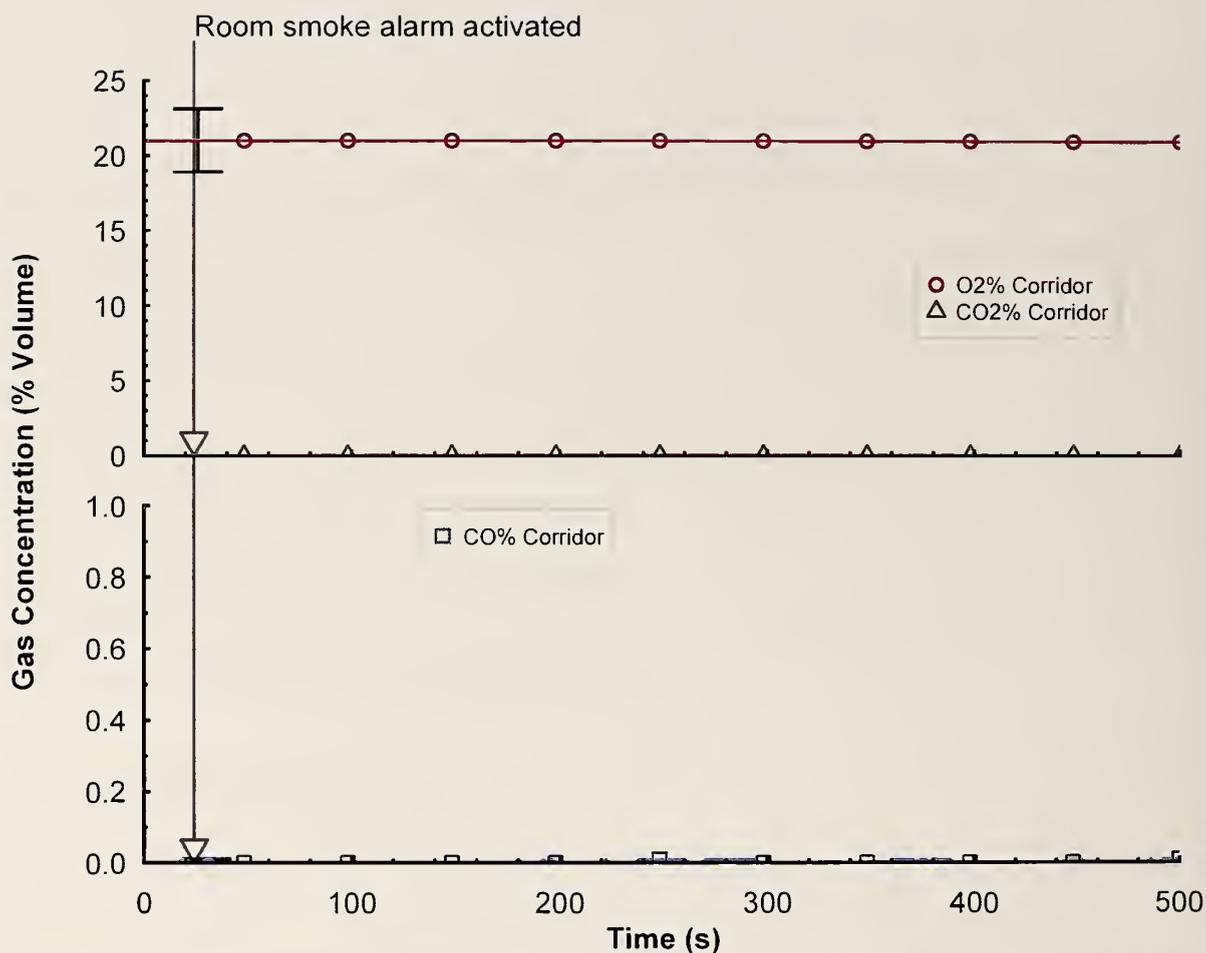
Figure 3.1-7. Relative gas concentrations versus time for the gas sampling at 1.52 m above the floor at location 4 in Experiment 1

Figure 3.1-7 shows the gas concentration data from the corridor sampling location. Again, due to the closed door between the room of fire origin and the corridor, no significant changes in the oxygen, carbon dioxide, or carbon monoxide levels were measured.

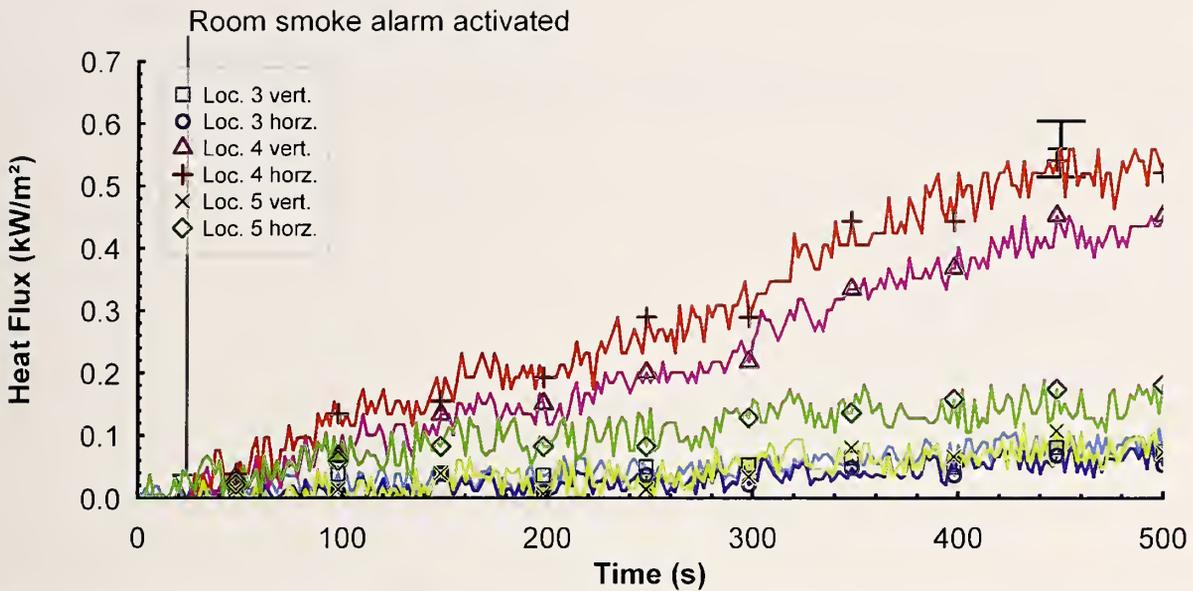
Figure 3.1-8. Heat flux versus time data for the heat flux gauges at locations 3, 4, and 5 in the orientations up (vert) and sideways (horz)

The heat flux data from the three sets of gauges in the corridor is shown in Figure 3.1-8. Adjacent to each thermocouple array in the corridor there were two total heat flux gauges, one aimed at the ceiling (Vertical) and one aimed toward the fire room (Horizontal). The heat flux from the pair of gauges located near array 4, as well as those closest to the room of origin, increased to approximately 0.5 kW/m^2 . As a point of reference, the heat flux from the sun on a sunny day at ground level is approximately 1 kW/m^2 .

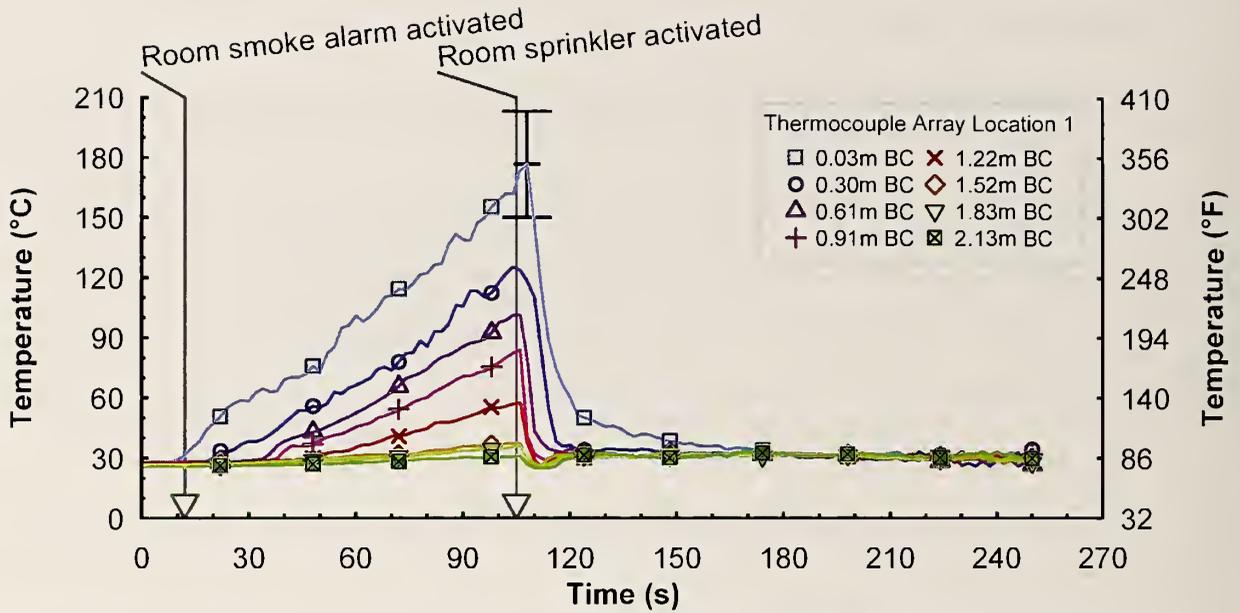
Figure 3.2-1. Temperature versus time data from thermocouple array 1 in Experiment 2, listed by distance below ceiling (BC)

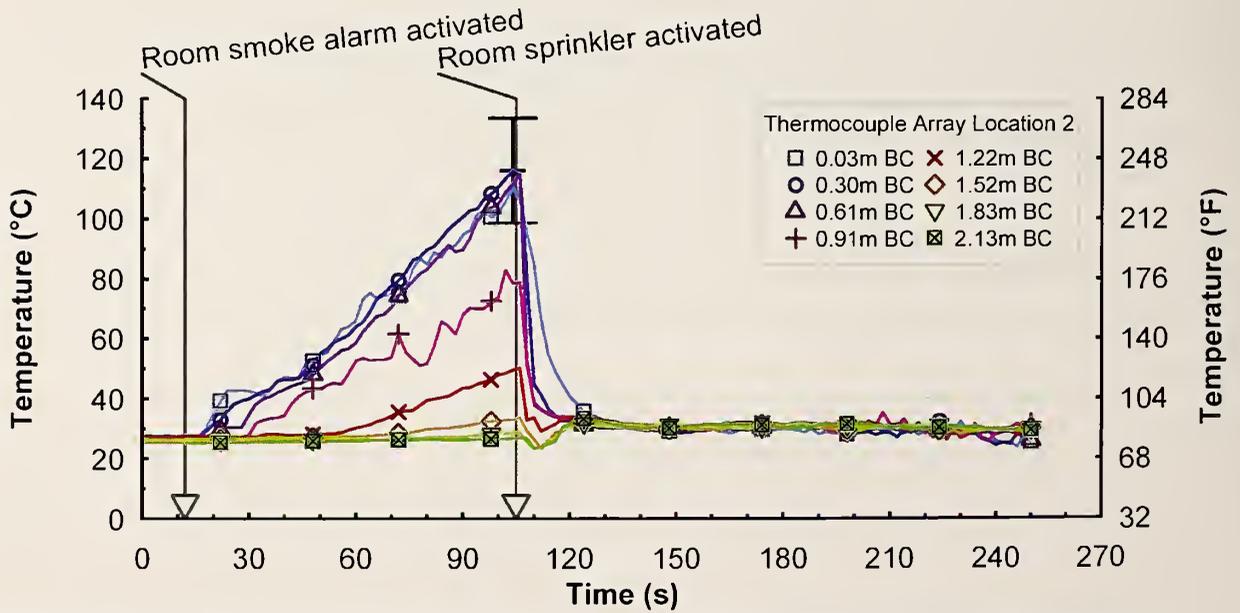
Figure 3.2-2. Temperature versus time data from thermocouple array 2 in Experiment 2, listed by distance below ceiling (BC)

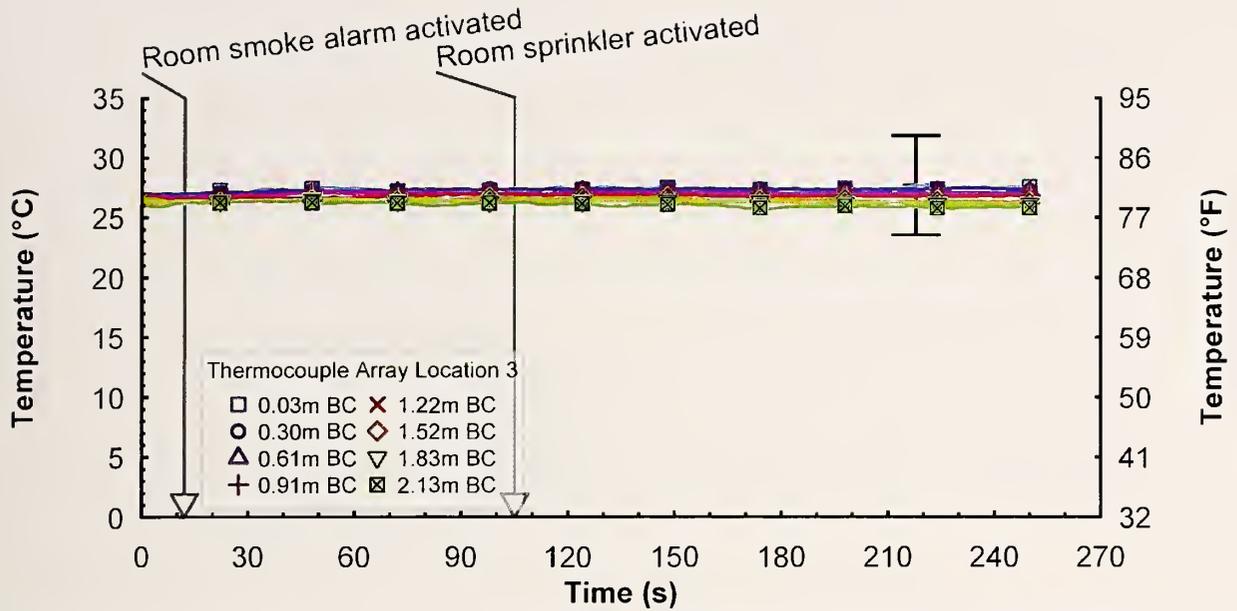
Figure 3.2-3. Temperature versus time data from thermocouple array 3 in Experiment 2, listed by distance below ceiling (BC)

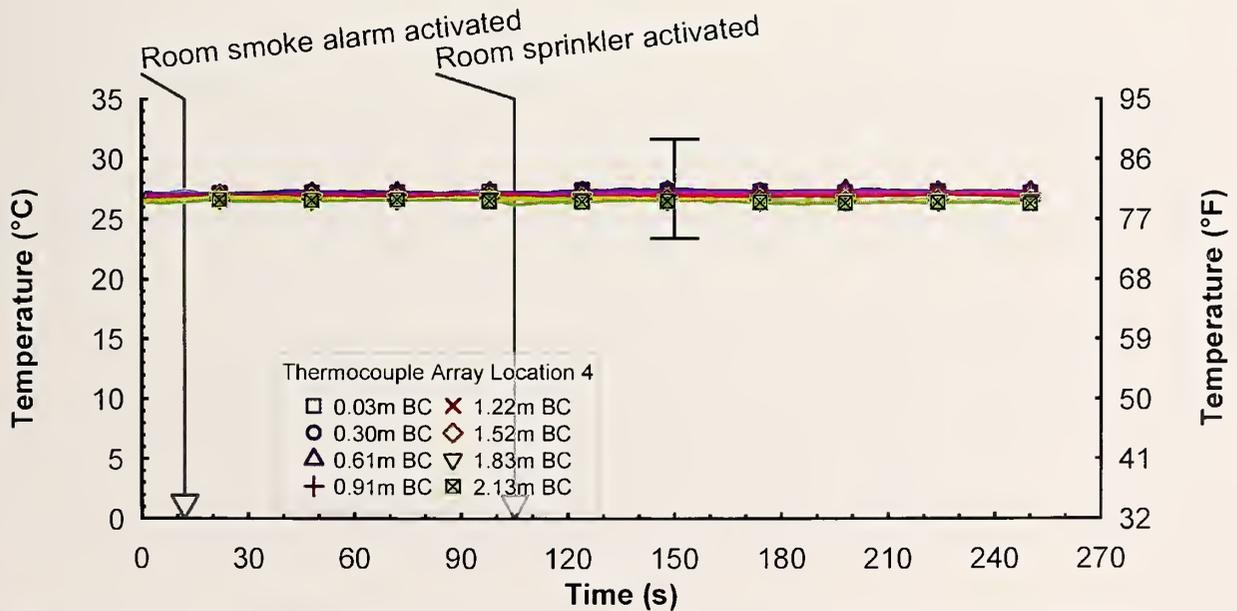
Figure 3.2-4. Temperature versus time data from thermocouple array 4 in Experiment 2, listed by distance below ceiling (BC)

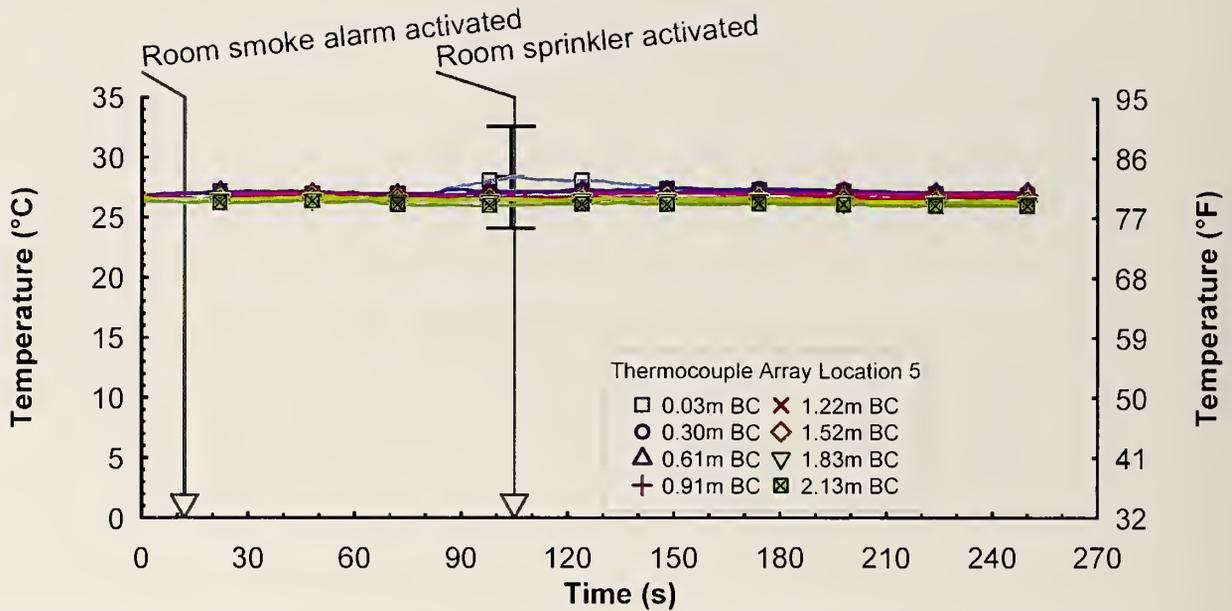
Figure 3.2-5. Temperature versus time data from thermocouple array 5 in Experiment 2, listed by distance below ceiling (BC)

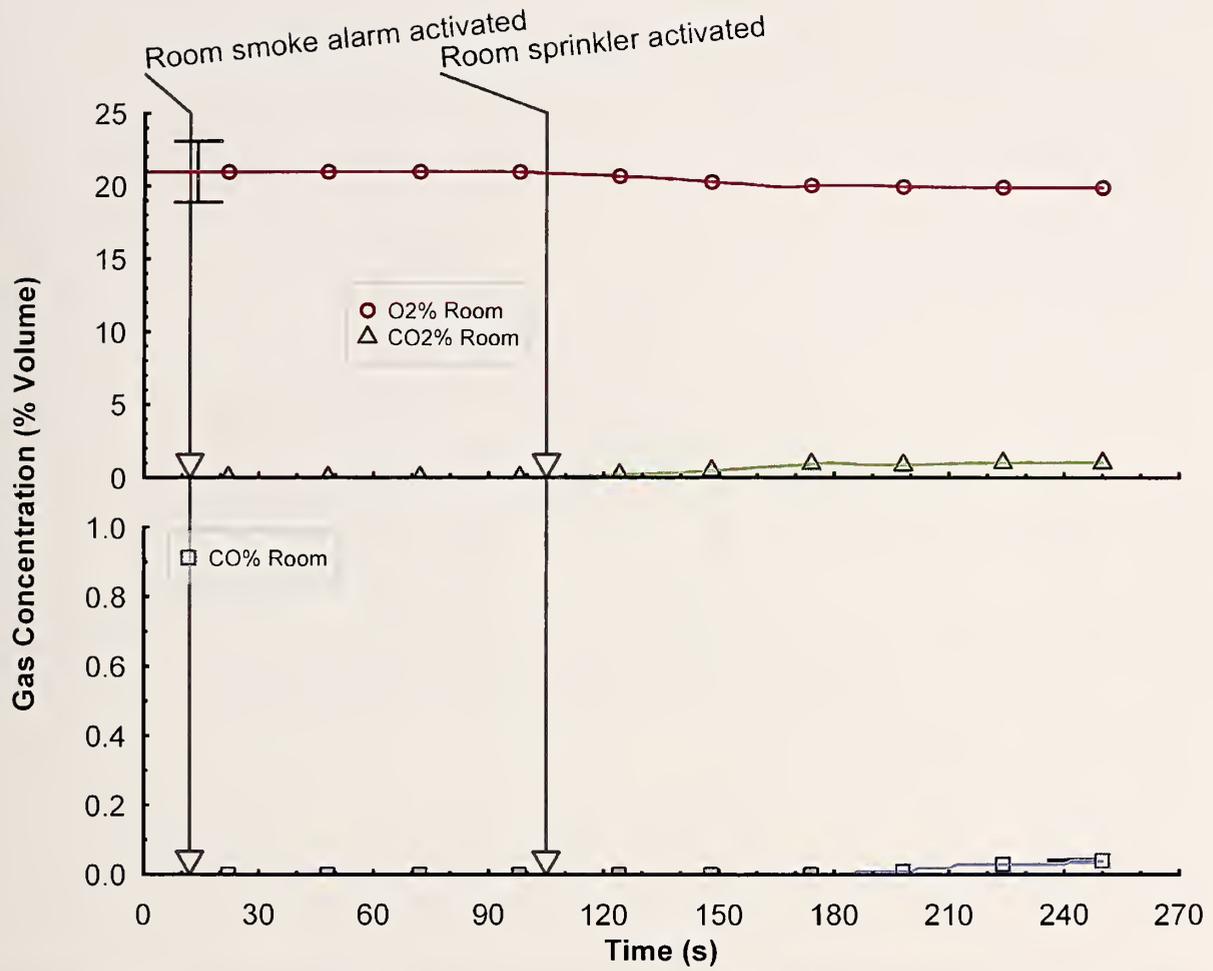
Figure 3.2-6. Relative gas concentrations versus time for the gas sampling at 1.52 m above the floor at location 1 in Experiment 2

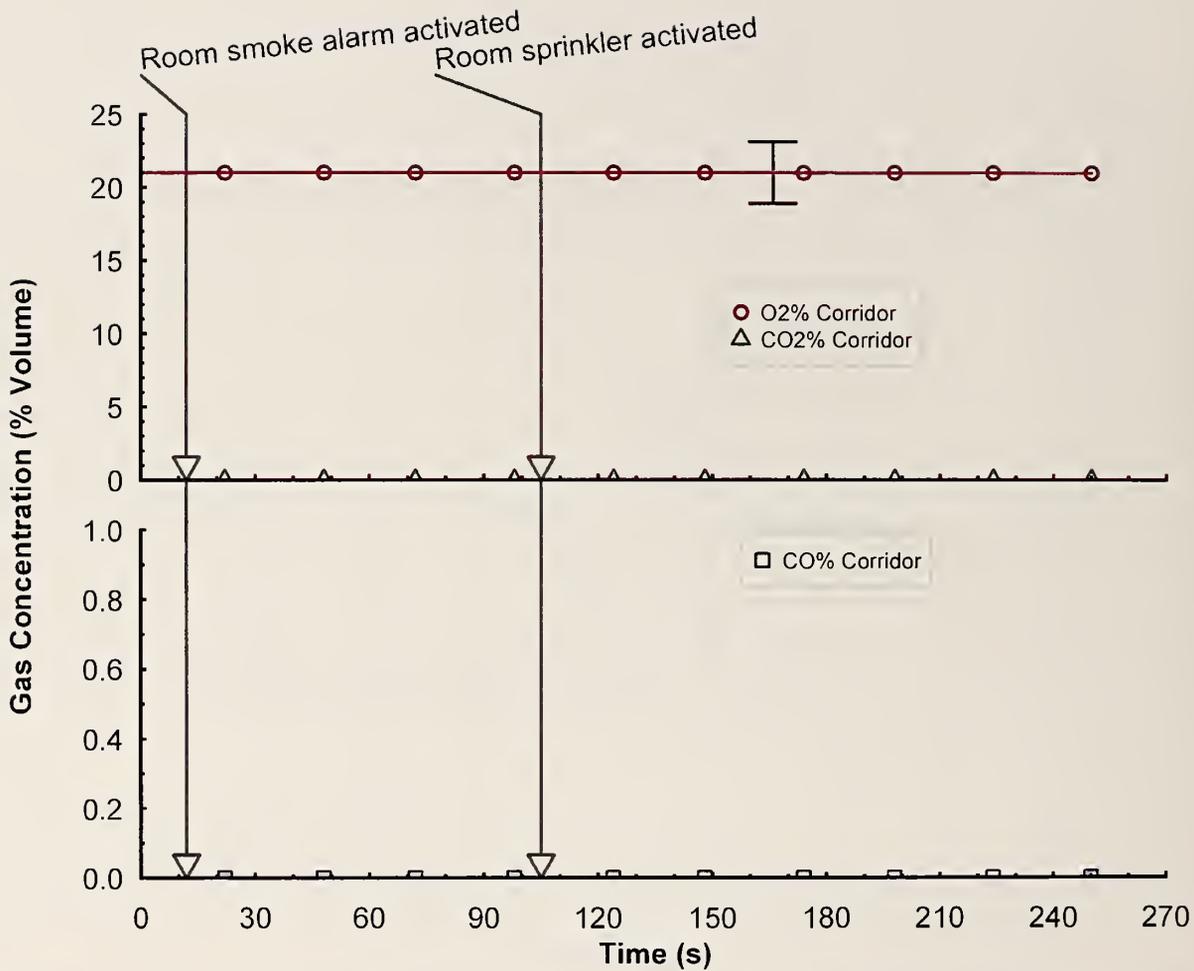
Figure 3.2-7. Relative gas concentrations versus time for the gas sampling at 1.52 m above the floor at location 4 in Experiment 2

The gas concentrations measured from the center of the corridor were consistent with each other in that they did not change. There was no significant change in any of the three gas concentrations because the fire hazard did not impact the conditions in the corridor due to the door to the dorm room being closed.

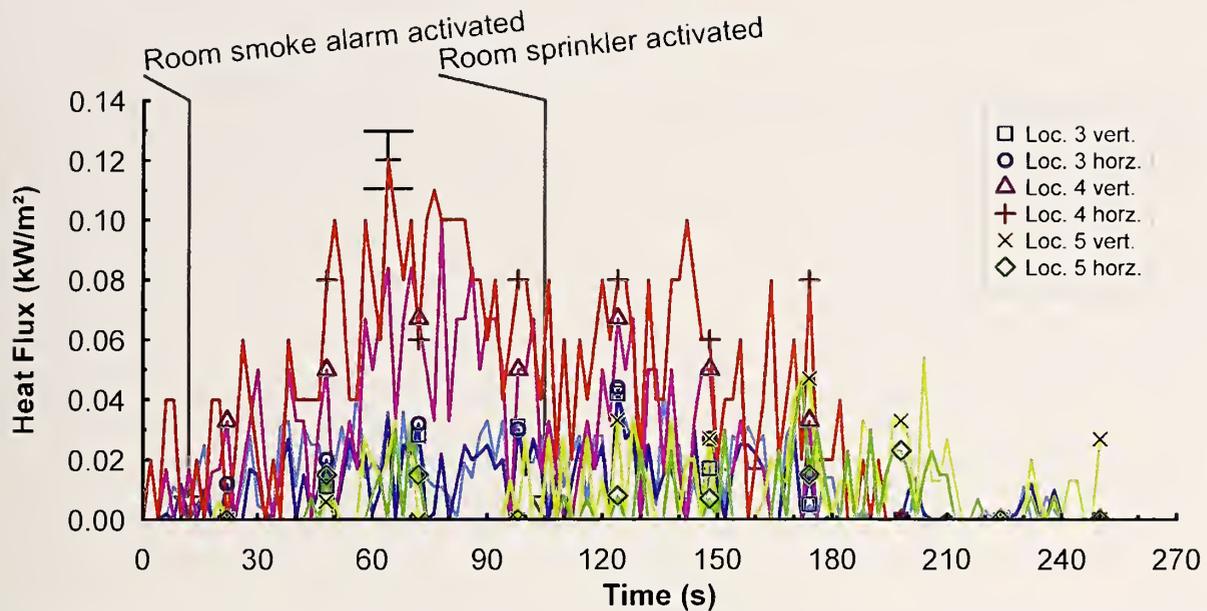
Figure 3.2-8. Heat flux versus time data for the heat flux gauges at locations 3, 4, and 5 in the orientations up (U) and sideways (S) in Experiment 2

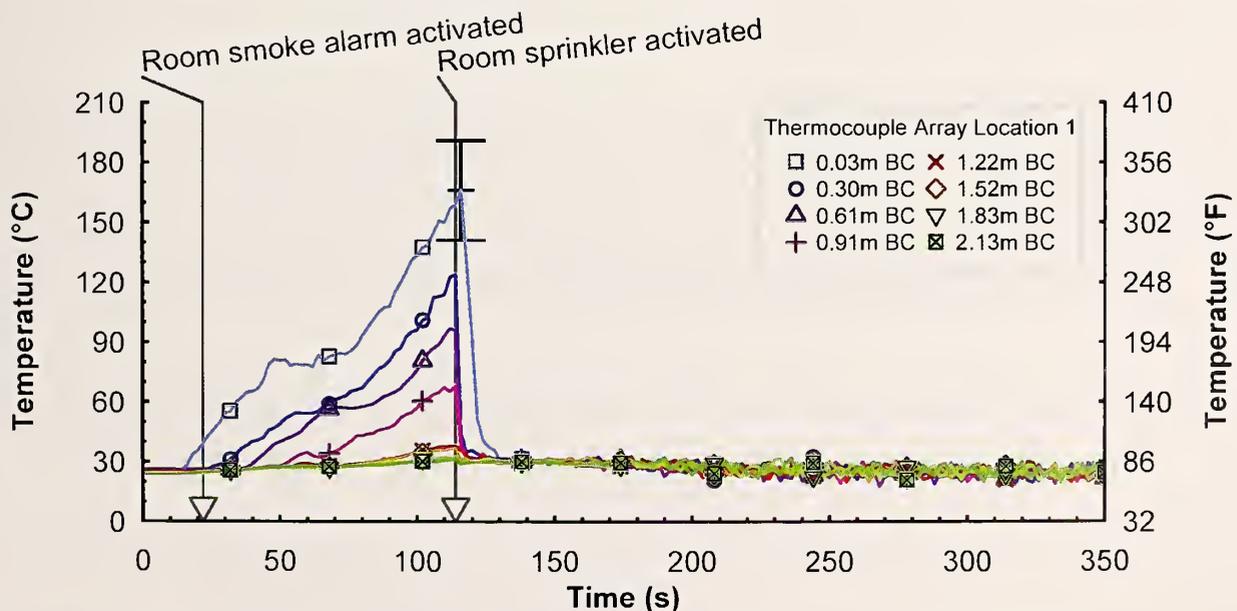
Figure 3.3-1. Temperature versus time data from thermocouple array 1 in Experiment 3, listed by distance below ceiling (BC)
