NIST TN 1658

Impact of Sprinklers on the Fire Hazard in Dormitories: Sleeping Room Fire Experiments

Daniel Madrzykowski
William D. Walton

January 2010

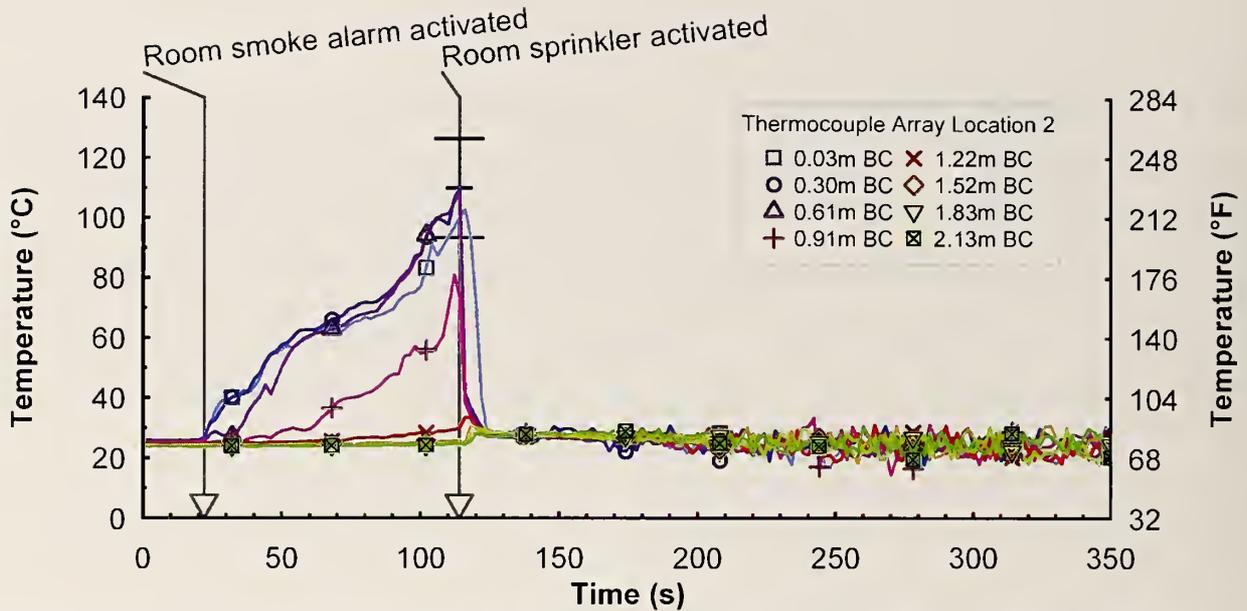
Figure 3.3-2. Temperature versus time data from thermocouple array 2 in Experiment 3, listed by distance below ceiling (BC)

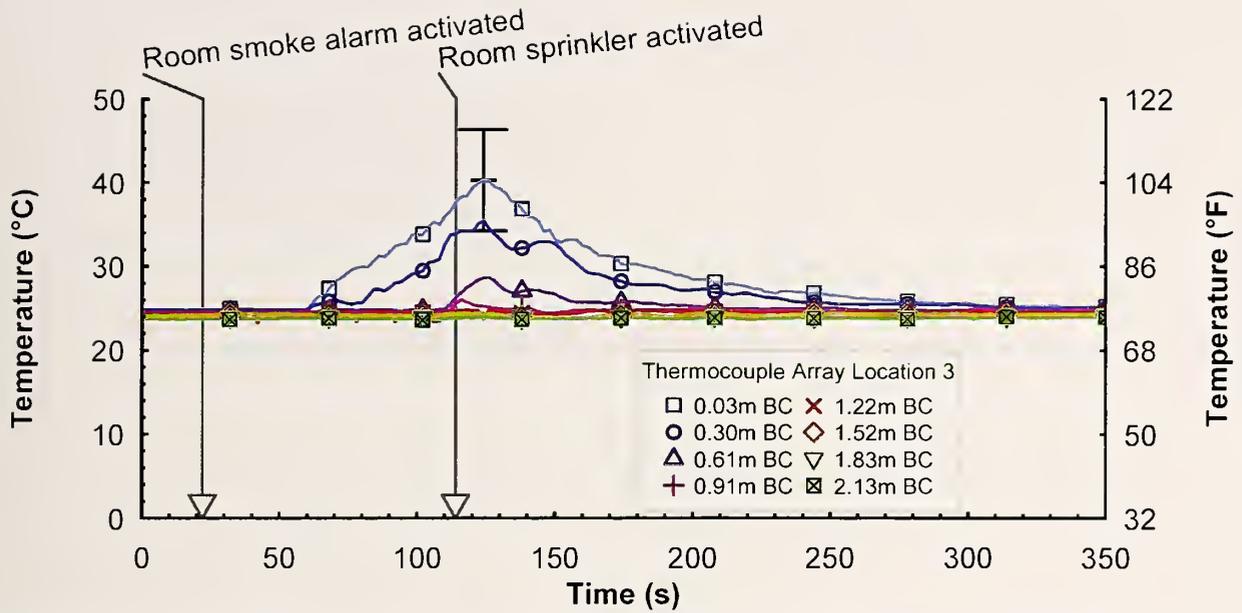
Figure 3.3-3. Temperature versus time data from thermocouple array 3 in Experiment 3, listed by distance below ceiling (BC)

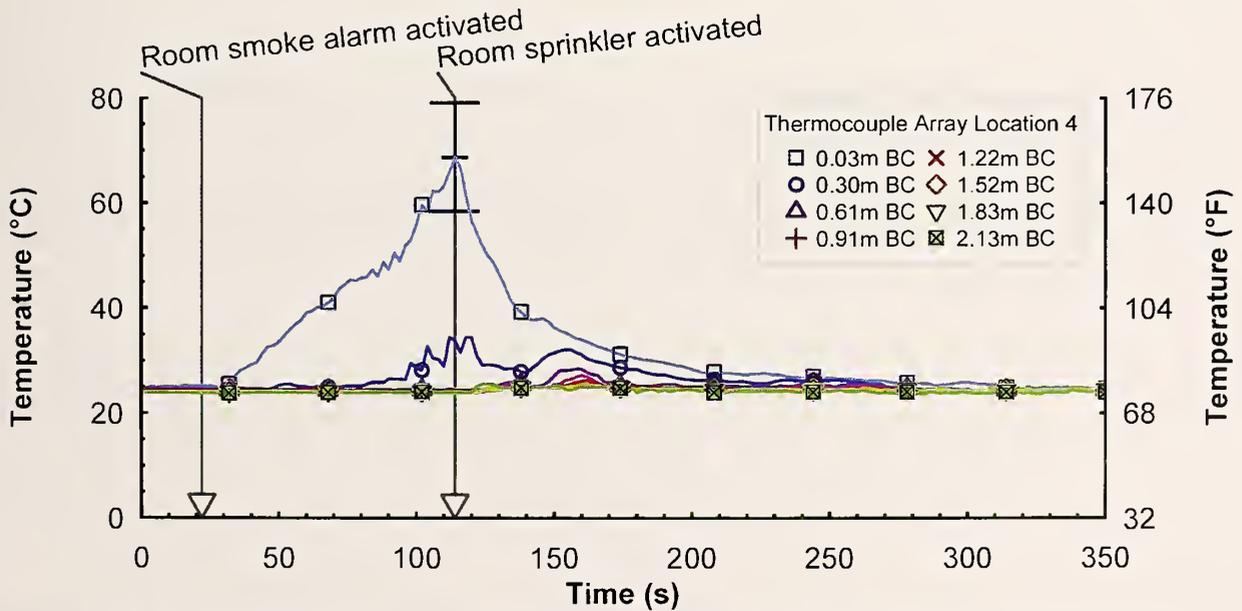
Figure 3.3-4. Temperature versus time data from thermocouple array 4 in Experiment 3, listed by distance below ceiling (BC)

TC array 4 was the closest of the three arrays in the corridor to the open doorway of the burning room. As a result, the hot gases reached TC array 4 first and provided the highest temperature increase at that location. The temperature 0.03 m below the ceiling began to increase at 30 s after ignition as shown in Figure 3.3-4. The peak temperature in the corridor, approximately 70 °C (160 °F), was measured at the same location at about the same time that the sprinkler activated.

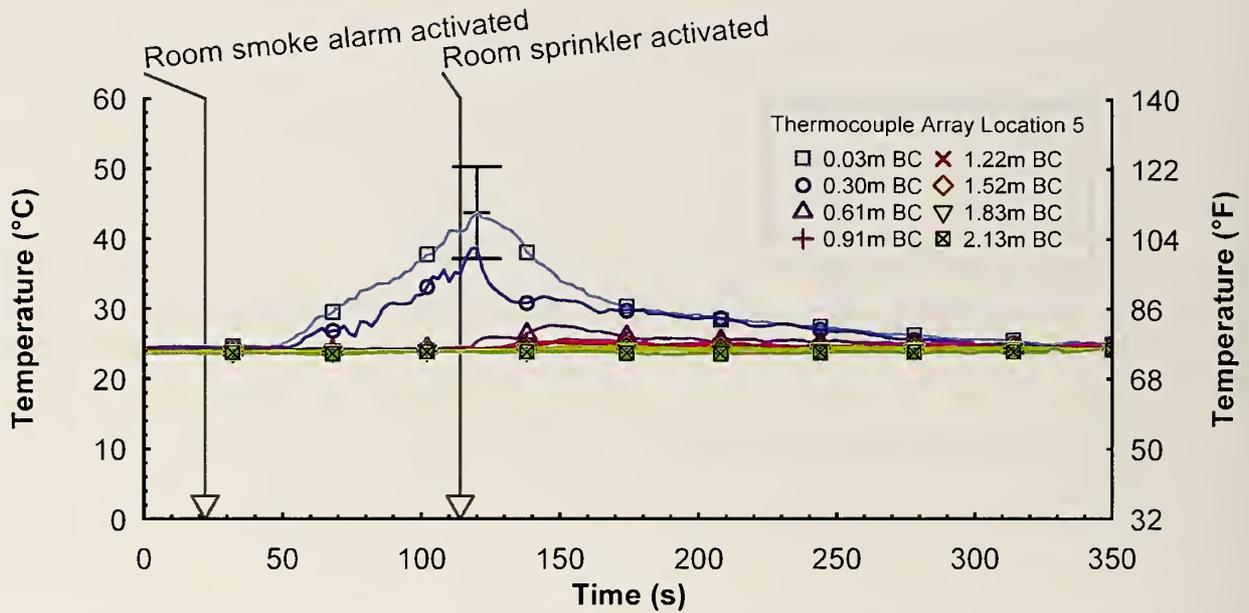
Figure 3.3-5. Temperature versus time data from thermocouple array 5 in Experiment 3, listed by distance below ceiling (BC)

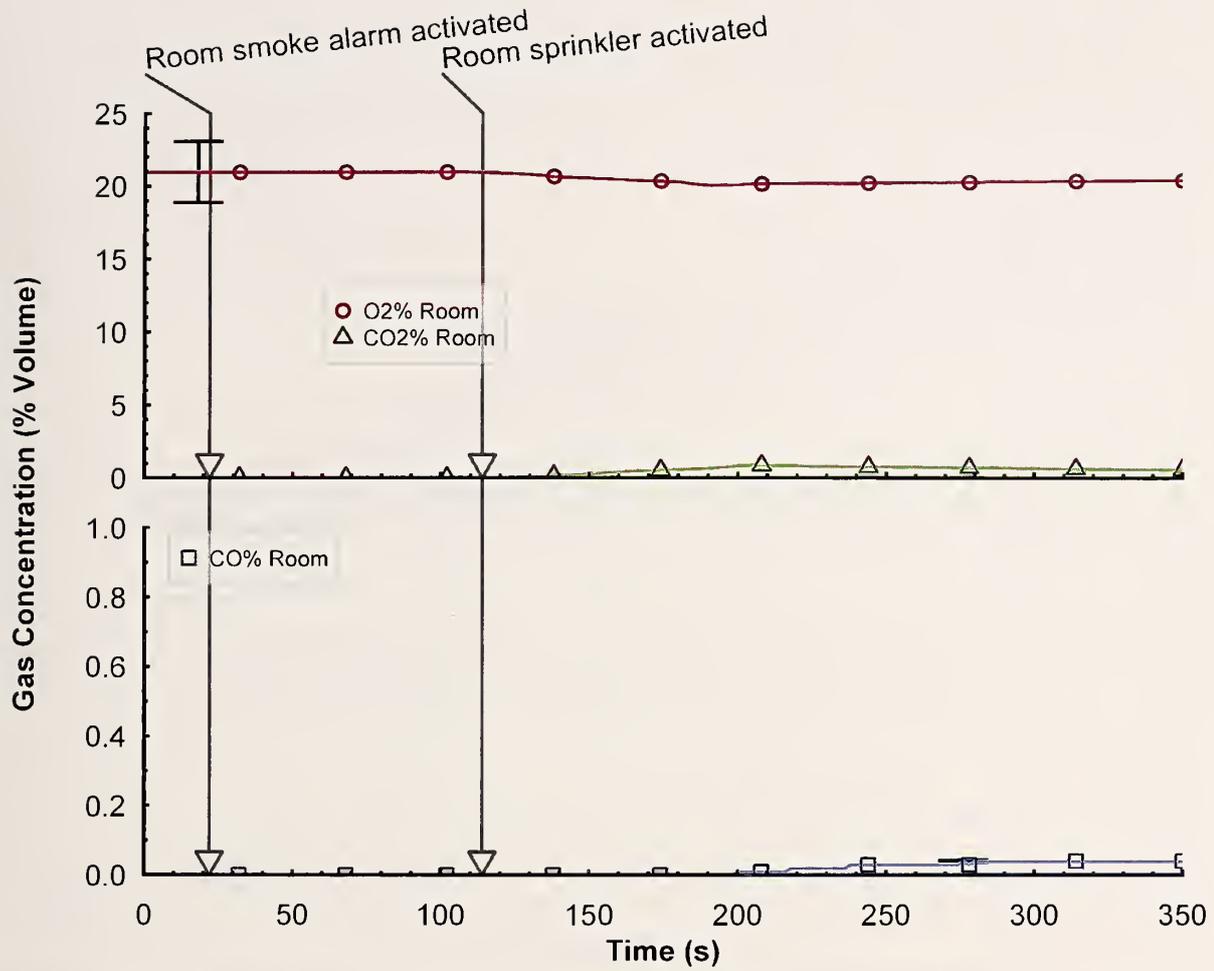
Figure 3.3-6. Relative gas concentrations versus time for the gas sampling at 1.52 m above the floor at location 1 in Experiment 3

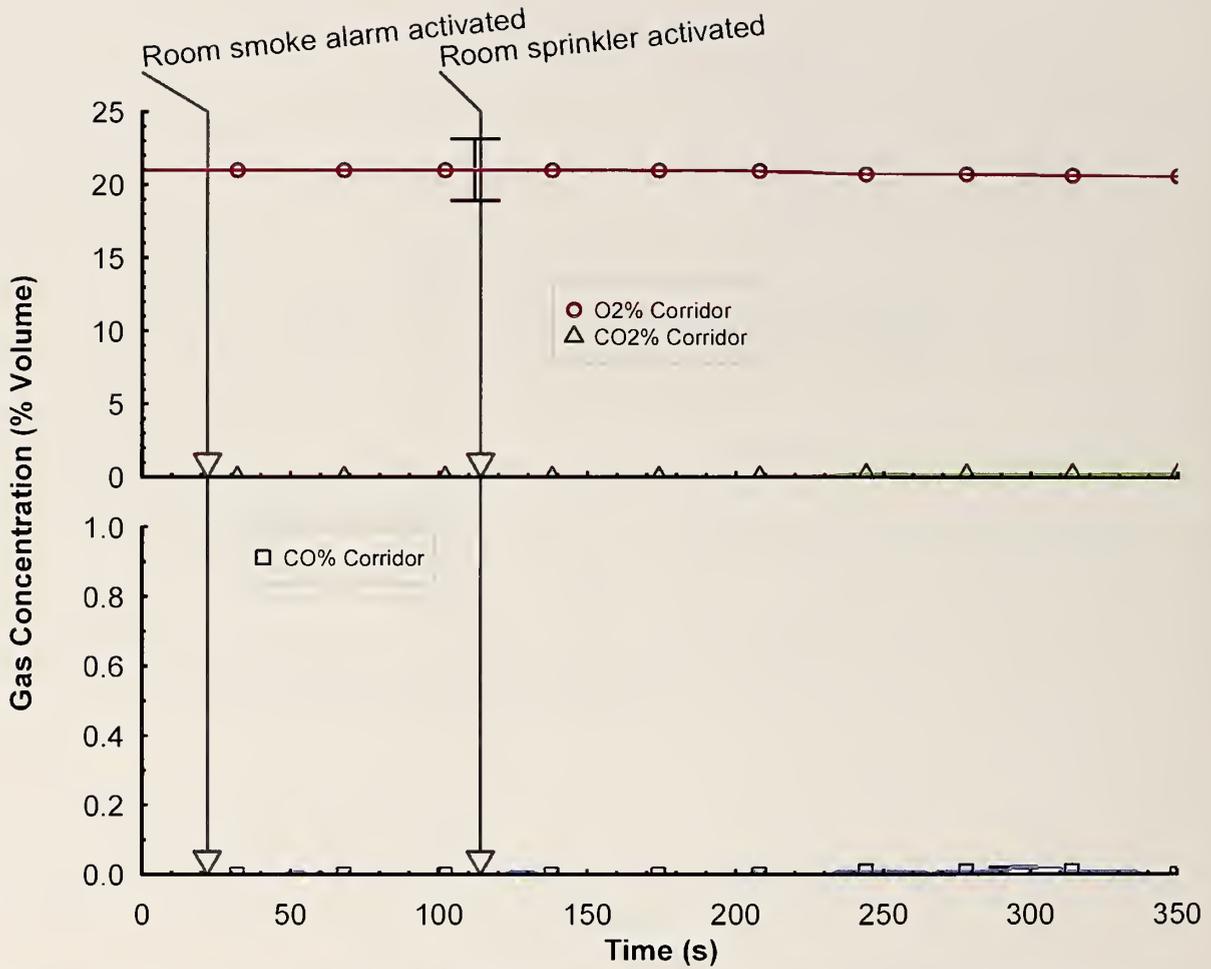
Figure 3.3-7. Relative gas concentrations versus time for the gas sampling at 1.52 m above the floor at location 4 in Experiment 3

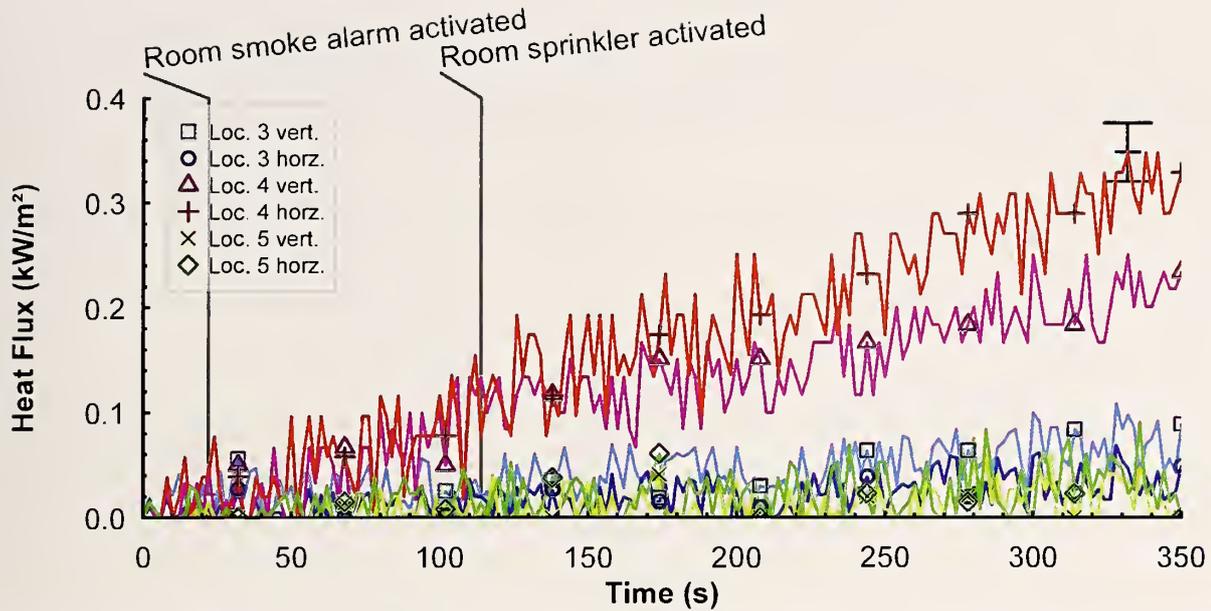
Figure 3.3-8. Heat flux versus time data for the heat flux gauges at locations 3, 4, and 5 in the orientations up (vert.) and sideways (horz.) in Experiment 3

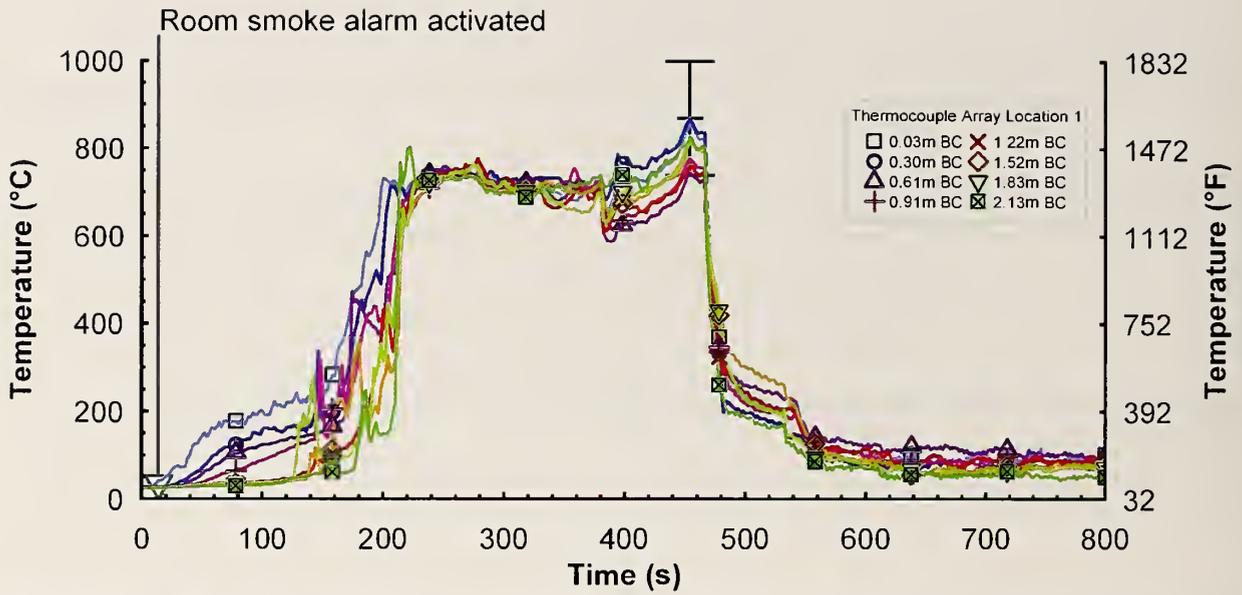
Figure 3.4-1. Temperature versus time data from thermocouple array 1 in Experiment 4, listed by distance below ceiling (BC)

Figure 3.4-1 and Figure 3.4-2 provide the temperature time history for both of the thermocouple arrays located in the dorm room. Both graphs show the steady development of a hot gas layer in the dorm room and rapid progression to a post-flashover condition at approximately 220 s after ignition. At 220 s after ignition, the thermal conditions had transitioned from having a hot layer and a cold layer in the room to having a single well mixed reaction zone with nearly equal temperatures floor to ceiling in excess of 600 °C (1112 °F). This post-flashover burning condition continued until fire fighters began to suppress the fire 465 s after ignition. The fire fighters completed their suppression efforts approximately 85 s later, 550 s after ignition.

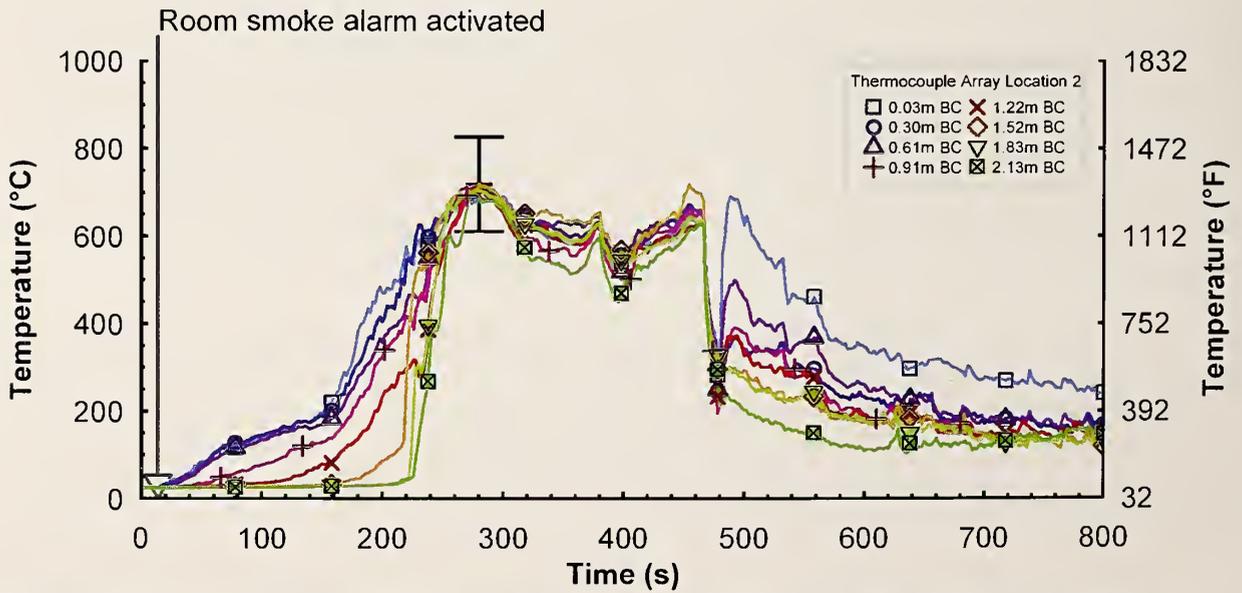
Figure 3.4-2. Temperature versus time data from thermocouple array 2 in Experiment 4, listed by distance below ceiling (BC)

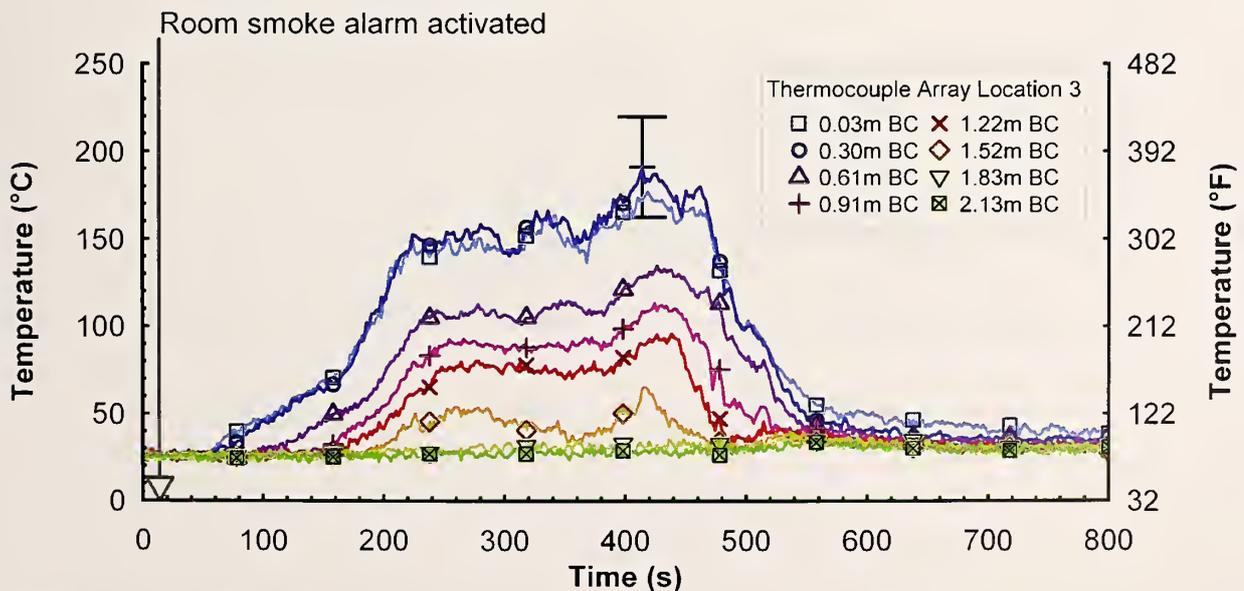
Figure 3.4-3. Temperature versus time data from thermocouple array 3 in Experiment 4, listed by distance below ceiling (BC)

The corridor itself did not transition to flashover, as shown by the thermal gradient with a hot gas layer in the upper portion of the corridor and the near ambient temperatures in the lower portion of the corridor, as shown in Figure 3.4-3 through Figure 3.4-5. This condition began as hot combustion products entered the corridor and continued until suppression. Hence a fire fighter crouching 1.2 m (4.0 ft) or less above the floor as they approached the fire room would be exposed to temperatures of 100 °C (212 °F) or less.

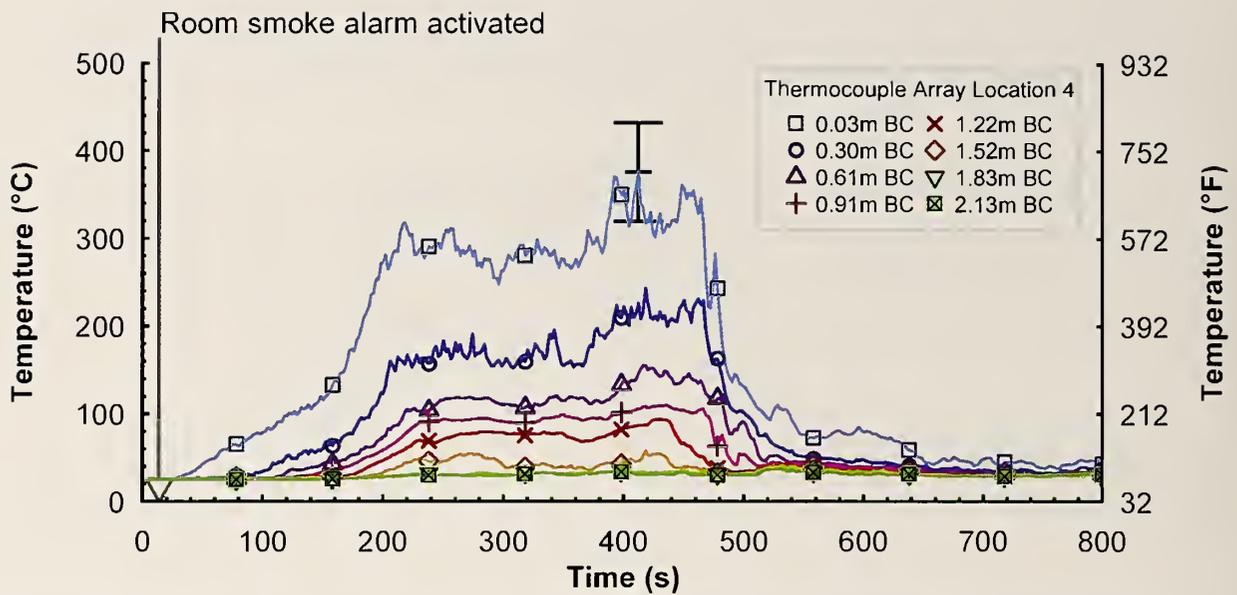
Figure 3.4-4. Temperature versus time data from thermocouple array 4 in Experiment 4, listed by distance below ceiling (BC)

Again TC array 4 was the closest of the three arrays in the corridor to the open doorway of the burning room. As a result, the hot gases reached TC array 4 first and provided the highest temperature increase at that location. The temperature 0.03 m below the ceiling began to increase within 20 s after ignition as shown in Figure 3.4-4. After the dorm room fire transitioned to a post-flashover fire at 220 s after ignition, the peak temperatures near the ceiling in the corridor were on the order of 300 °C (572 °F) until suppression began.

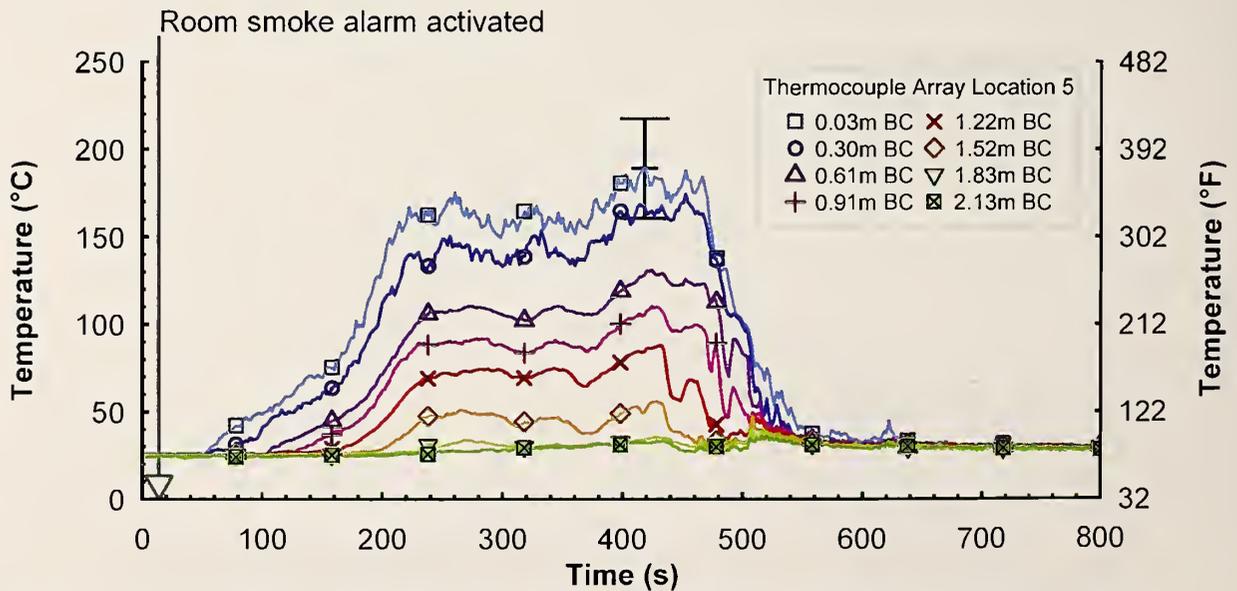
Figure 3.4-5. Temperature versus time data from thermocouple array 5 in Experiment 4, listed by distance below ceiling (BC)

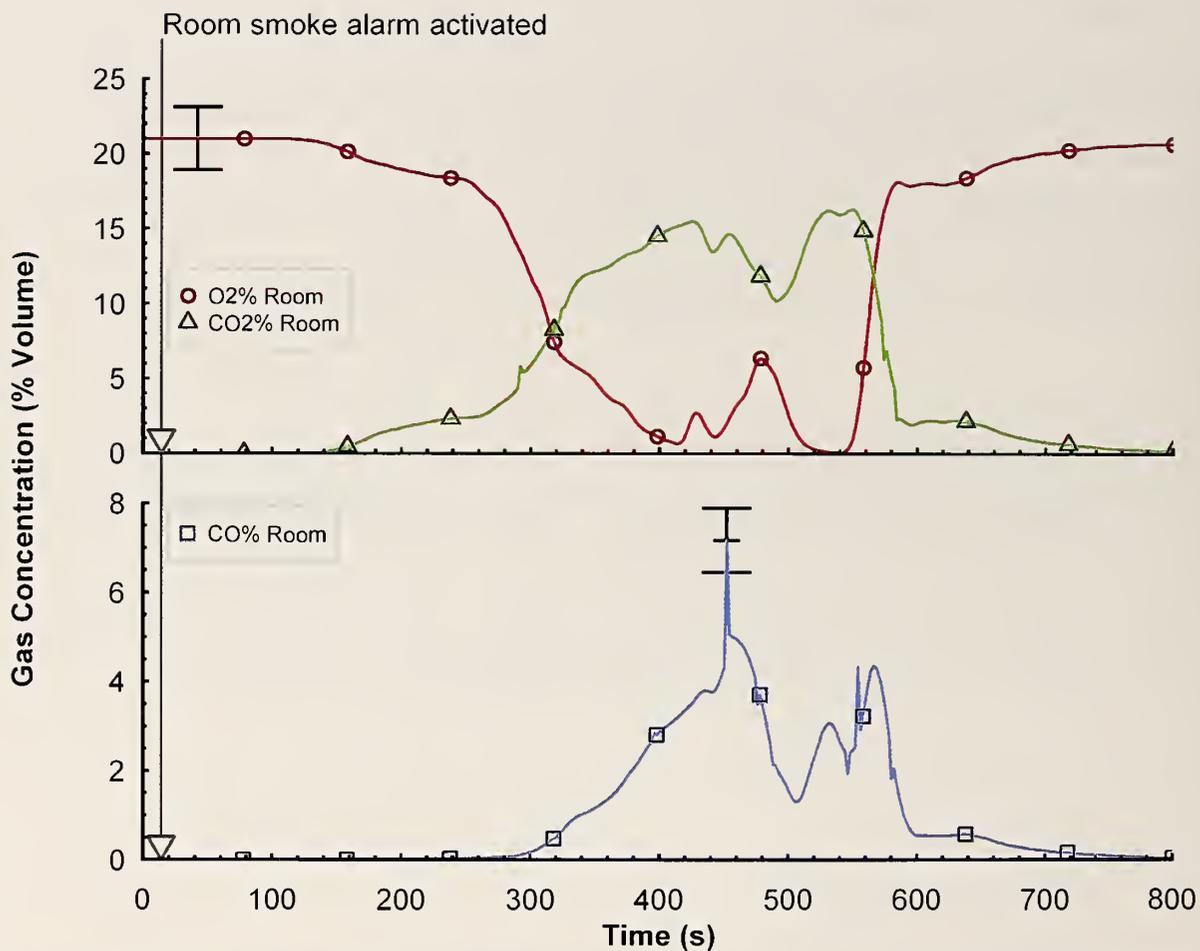
Figure 3.4-6. Relative gas concentrations versus time for the gas sampling at 1.52 m above the floor at location 1 in Experiment 4

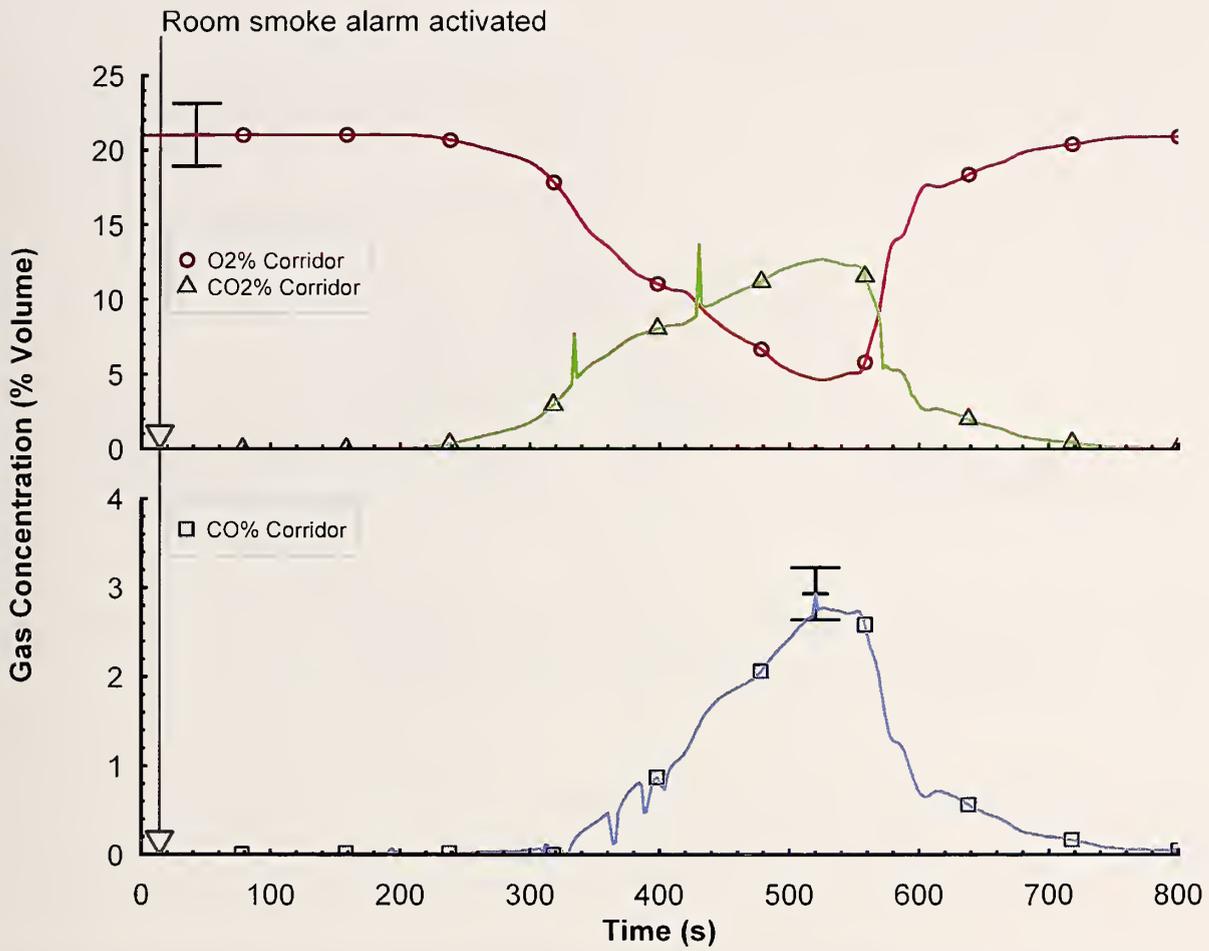
Figure 3.4-7. Relative gas concentrations versus time for the gas sampling at 1.52 m above the floor at location 4 in Experiment 4

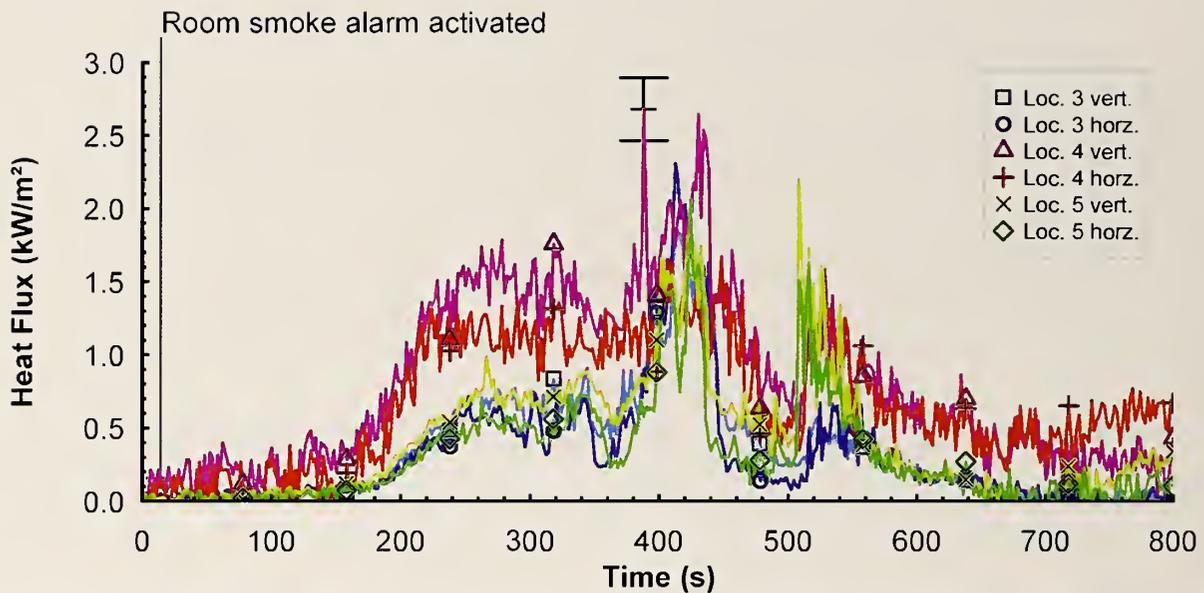
Figure 3.4-8. Heat flux versus time data for the heat flux gauges at locations 3, 4, and 5 in the orientations up (U) and sideways (S) in Experiment 4

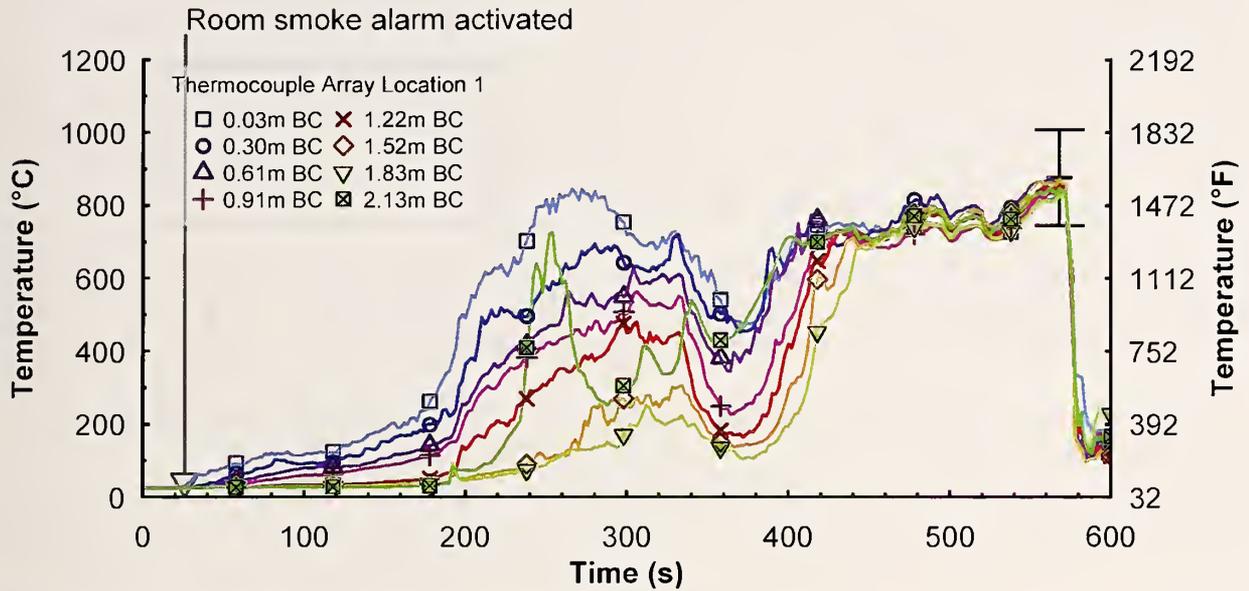
Figure 3.5-1. Temperature versus time data from thermocouple array 1 in Experiment 5, listed by distance below ceiling (BC)

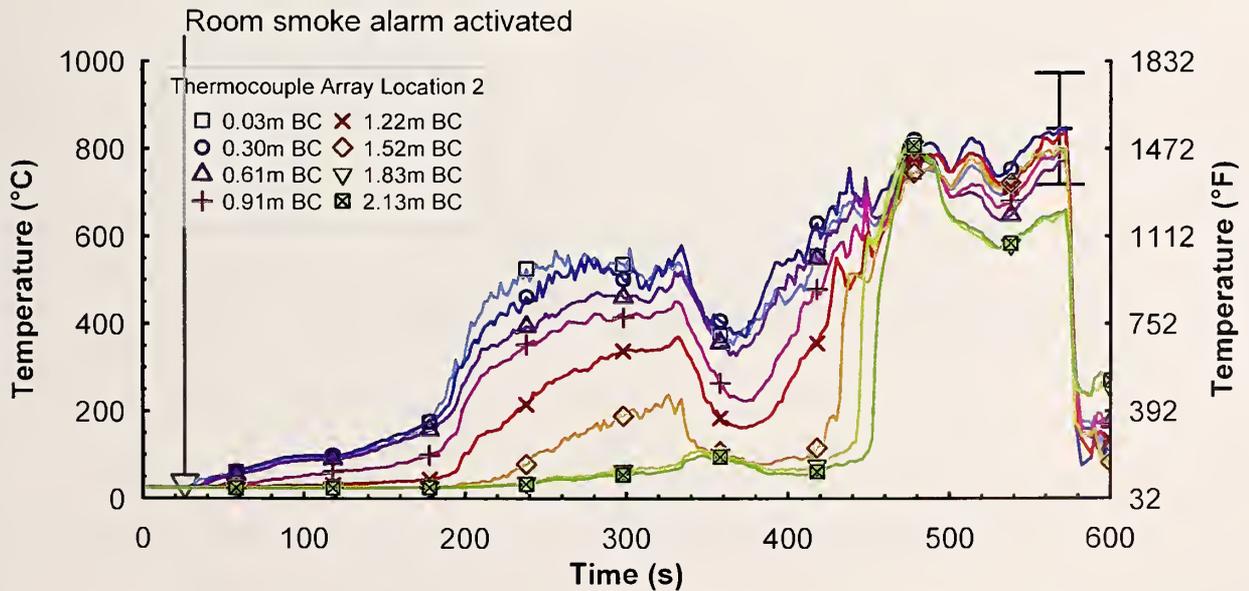
Figure 3.5-2. Temperature versus time data from thermocouple array 2 in Experiment 5, listed by distance below ceiling (BC)

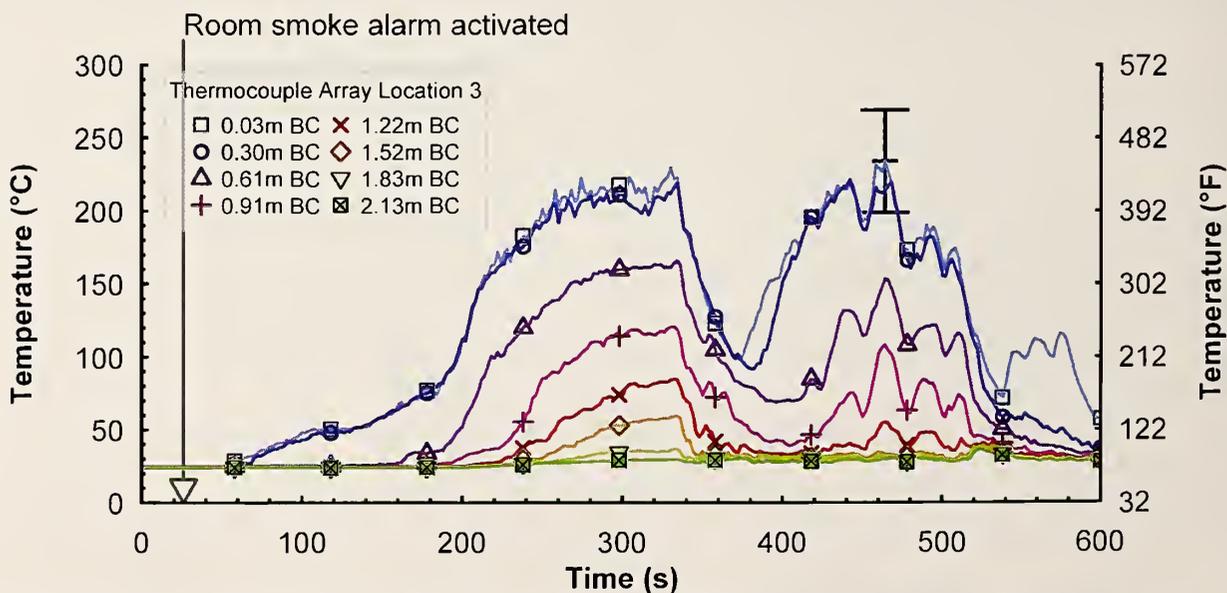
Figure 3.5-3. Temperature versus time data from thermocouple array 3 in Experiment 5, listed by distance below ceiling (BC)

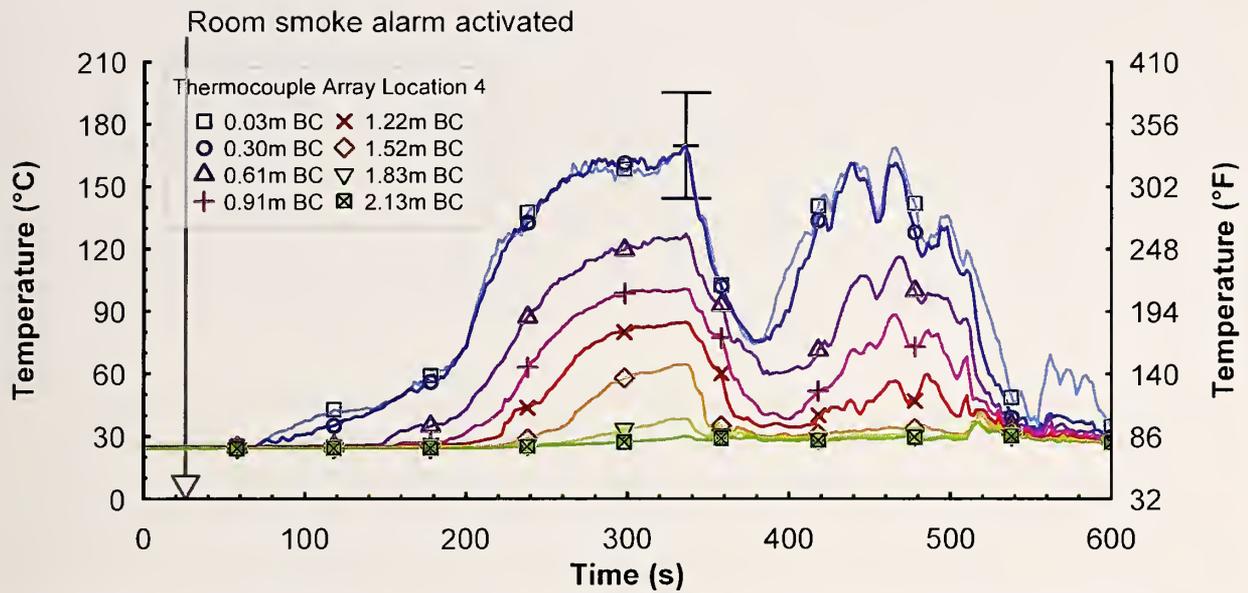
Figure 3.5-4. Temperature versus time data from thermocouple array 4 in Experiment 5, listed by distance below ceiling (BC)

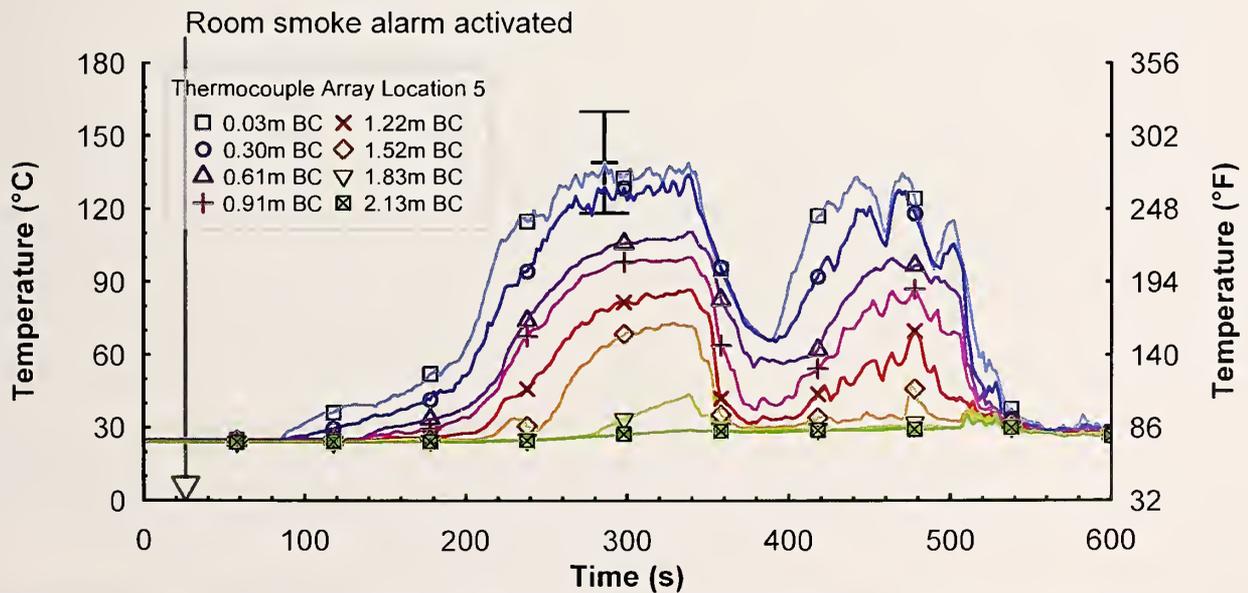
Figure 3.5-5. Temperature versus time data from thermocouple array 5 in Experiment 5, listed by distance below ceiling (BC)

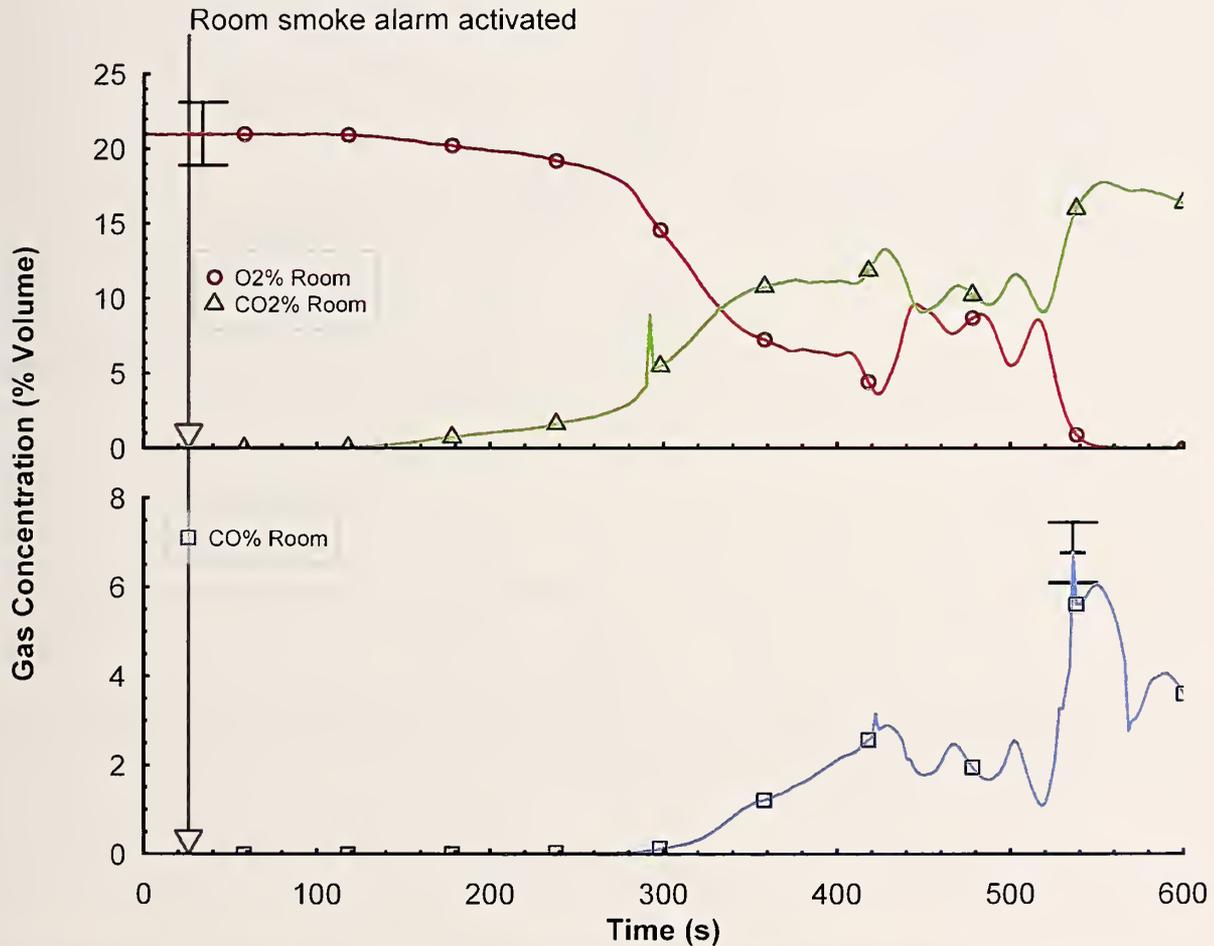
Figure 3.5-6. Relative gas concentrations versus time for the gas sampling at 1.52 m above the floor at location 1 in Experiment 5

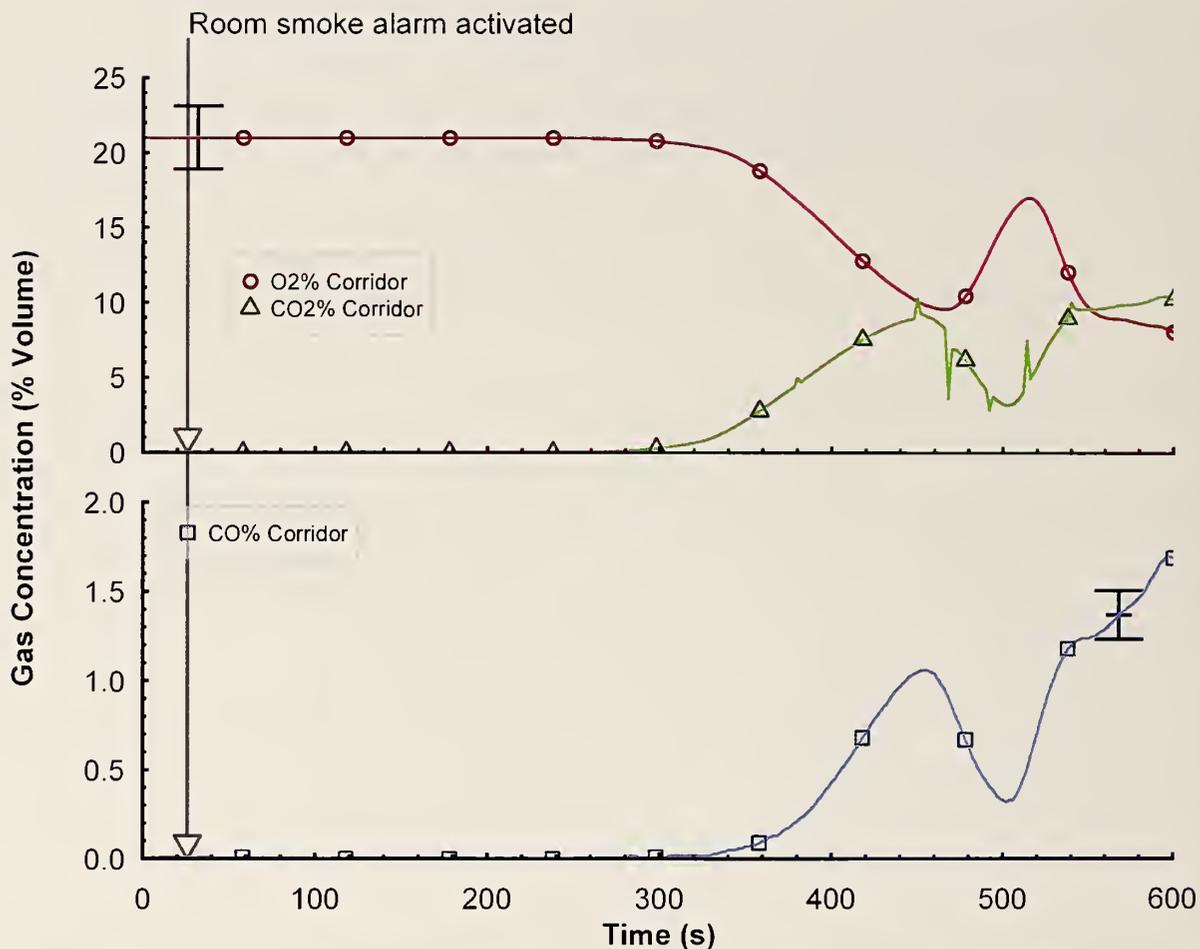
Figure 3.5-7. Relative gas concentrations versus time for the gas sampling at 1.52 m above the floor at location 4 in Experiment 5

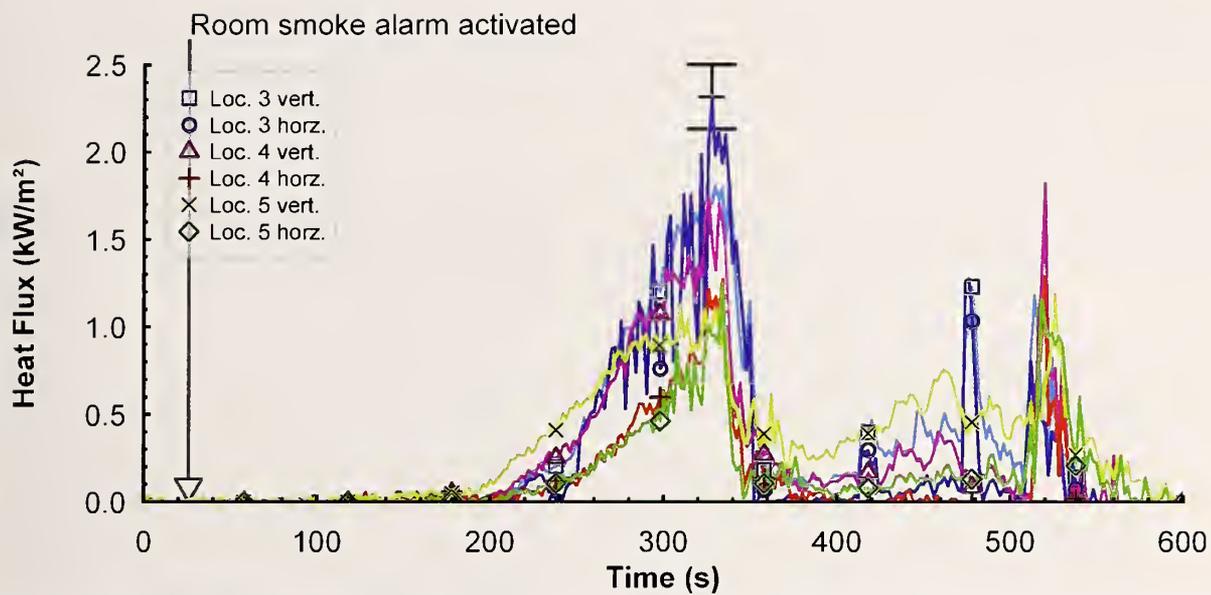
Figure 3.5-8. Heat flux versus time data for the heat flux gauges at locations 3, 4, and 5 in the orientations up (vert.) and sideways (horz.) in Experiment 5

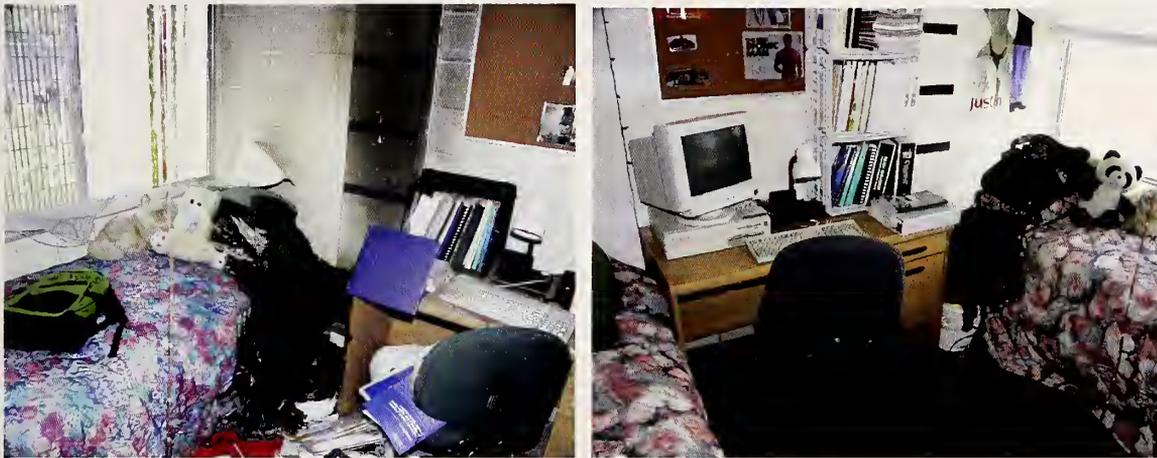
Figure 4.1-1. Post fire photographs of the dorm room for Experiment 1 (non-sprinklered) on the left and Experiment 2 (sprinklered) on the right.

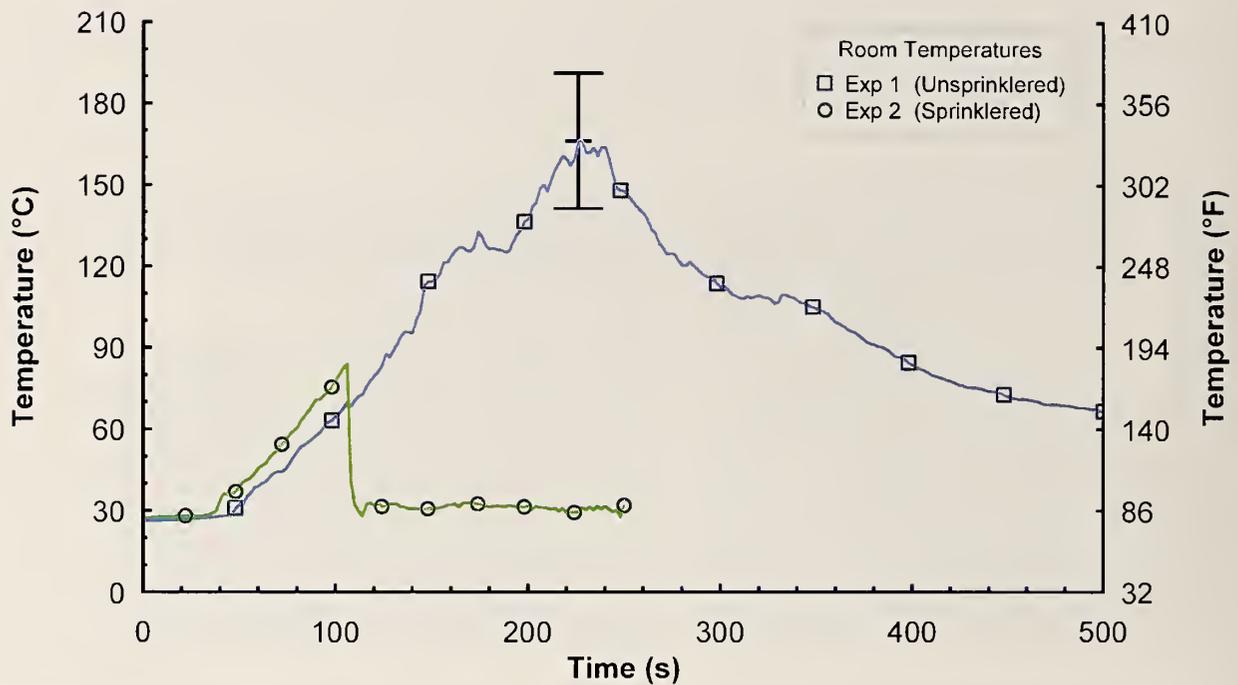
Figure 4.1-2. Temperature versus time data from thermocouple array 1 from Experiment 1 and 2 at approximately 1.5 m (5 ft) above the floor.

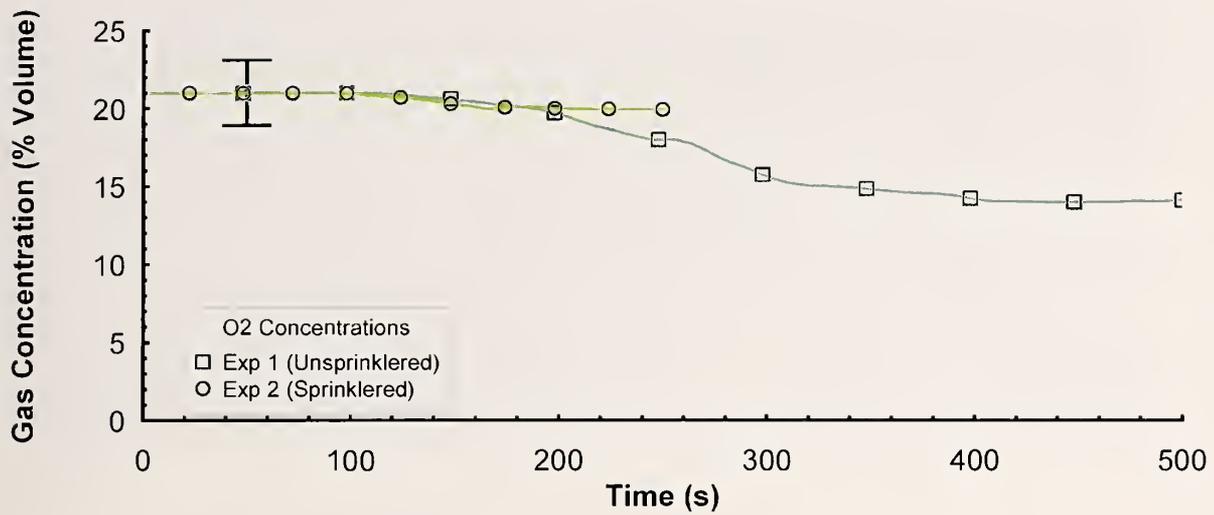
Figure 4.1-3. Oxygen concentrations versus time in the dorm room from Experiment 1 and 2 at approximately 1.5 m (5 ft) above the floor.
