NIST TN 1658

Impact of Sprinklers on the Fire Hazard in Dormitories: Sleeping Room Fire Experiments

Daniel Madrzykowski
William D. Walton

January 2010

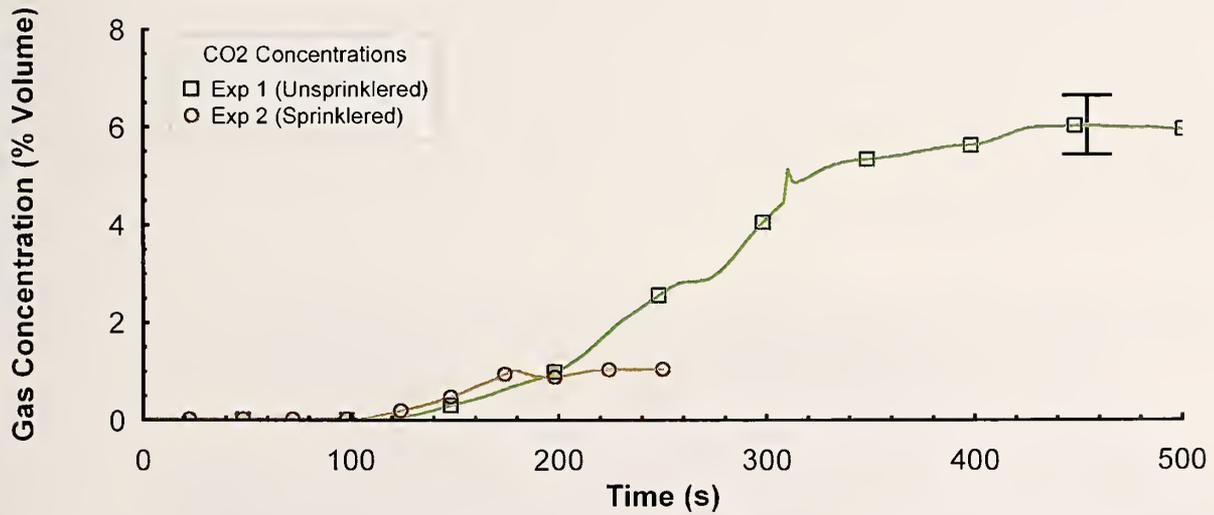
Figure 4.1-4. Carbon dioxide concentrations versus time in the dorm room from Experiment 1 and 2 at approximately 1.5 m (5 ft) above the floor.

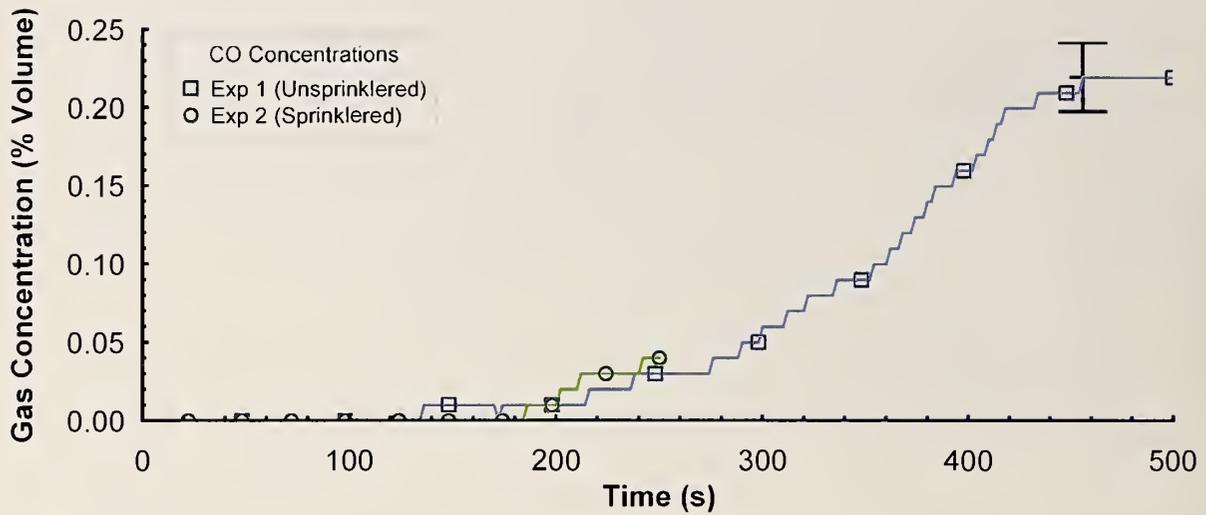
Figure 4.1-5. Carbon monoxide concentrations versus time in the dorm room from Experiment 1 and 2 at approximately 1.5 m (5 ft) above the floor.

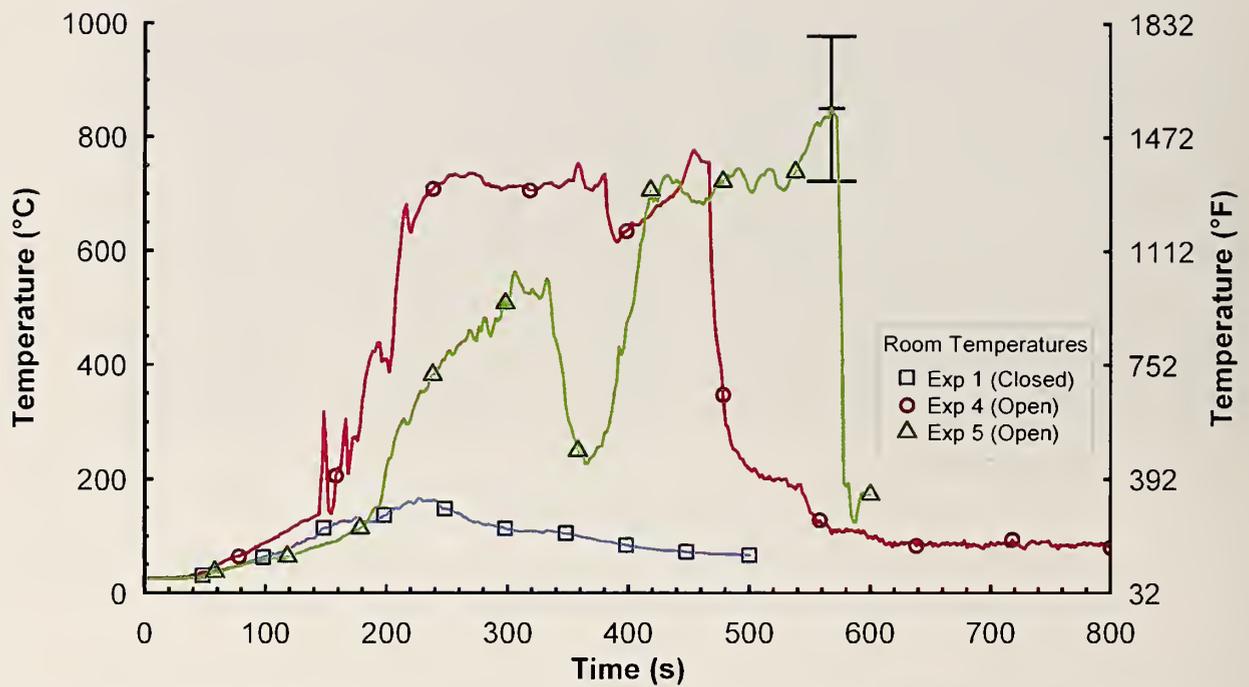
Figure 4.2-3. Temperature versus time data from thermocouple array 1 from Experiment 1, 4 and 5 at approximately 1.5 m (5 ft) above the floor.

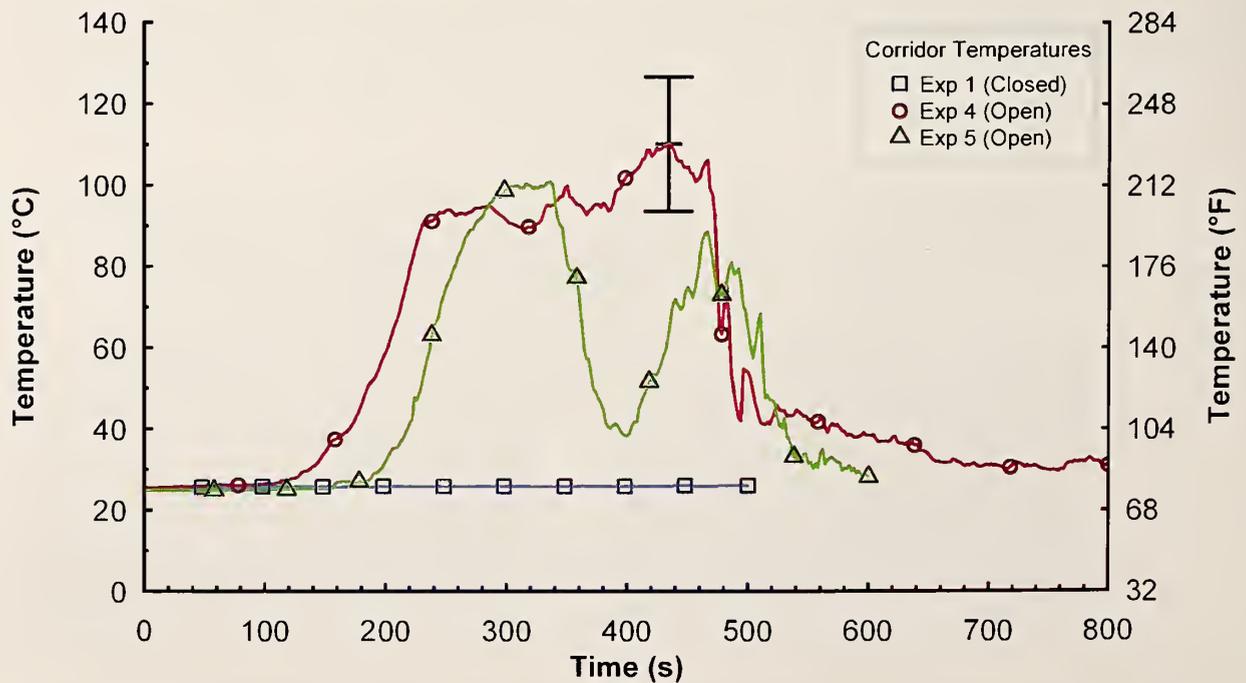
Figure 4.2-4. Temperature versus time data from thermocouple array 4 from Experiment 1, 4 and 5 at approximately 1.5 m (5 ft) above the floor.

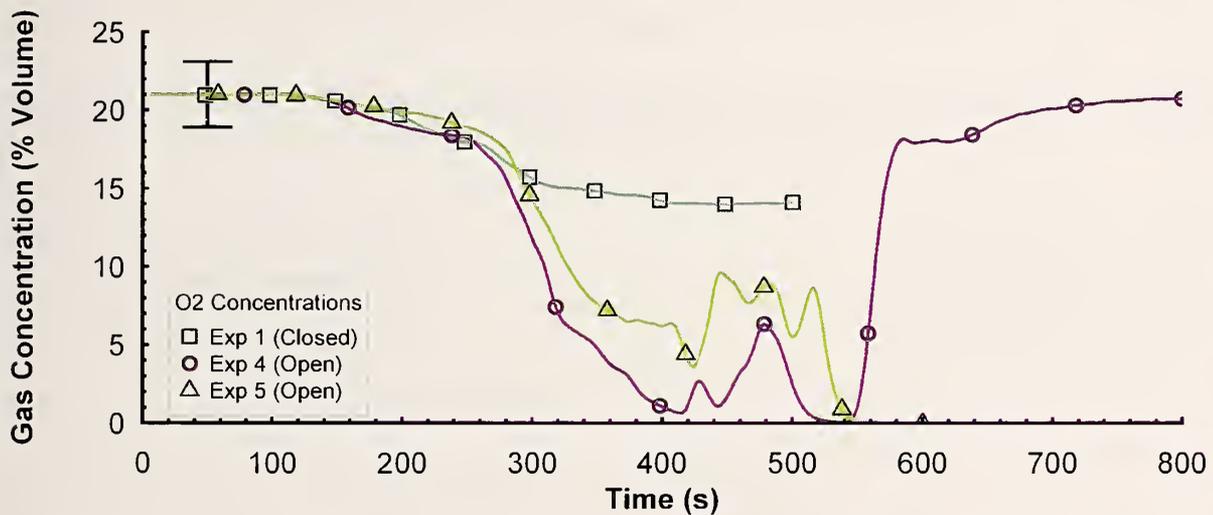
Figure 4.2-5. Oxygen concentrations versus time in the dorm room from Experiment 1, 4 and 5 at approximately 1.5 m (5 ft) above the floor.

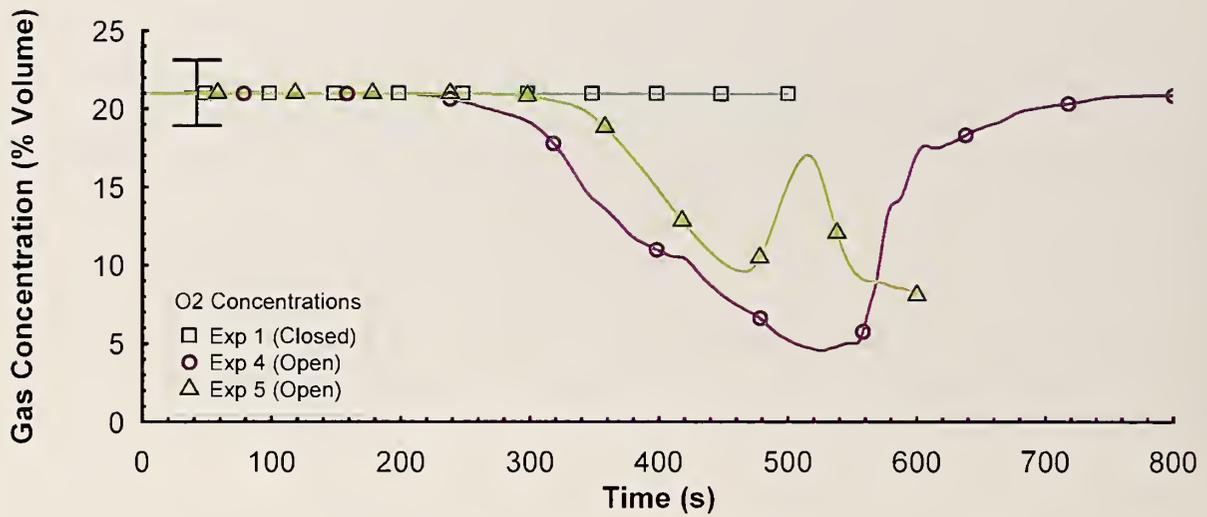
Figure 4.2-6. Oxygen concentrations versus time in the corridor from Experiment 1, 4 and 5 at approximately 1.5 m (5 ft) above the floor.

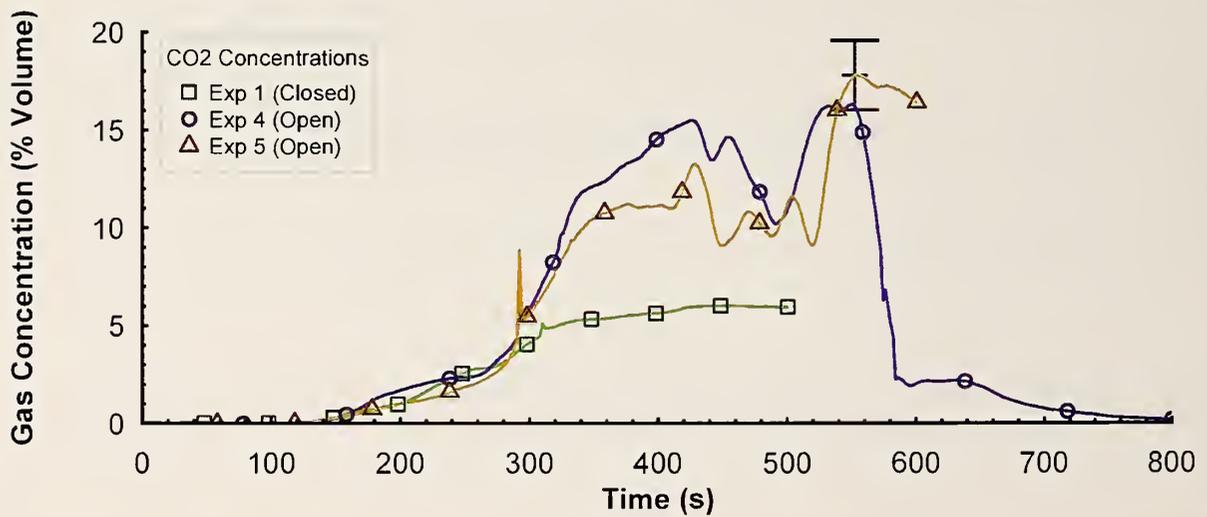
Figure 4.2-7. Carbon dioxide concentrations versus time in the dorm room from Experiment 1, 4 and 5 at approximately 1.5 m (5 ft) above the floor.

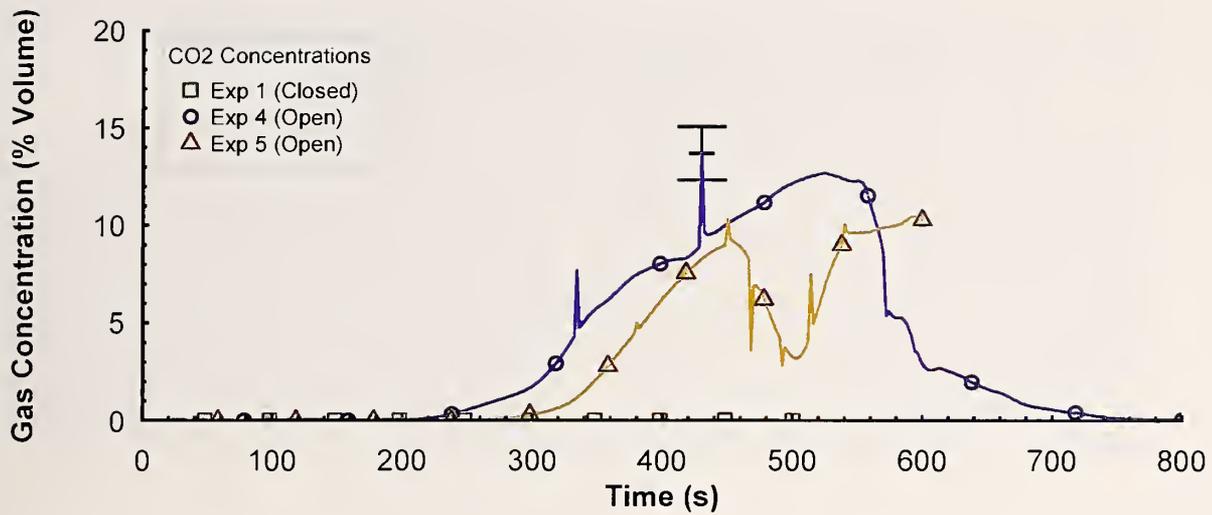
Figure 4.2-8. Carbon dioxide concentrations versus time in the corridor from Experiment 1, 4 and 5 at approximately 1.5 m (5 ft) above the floor.

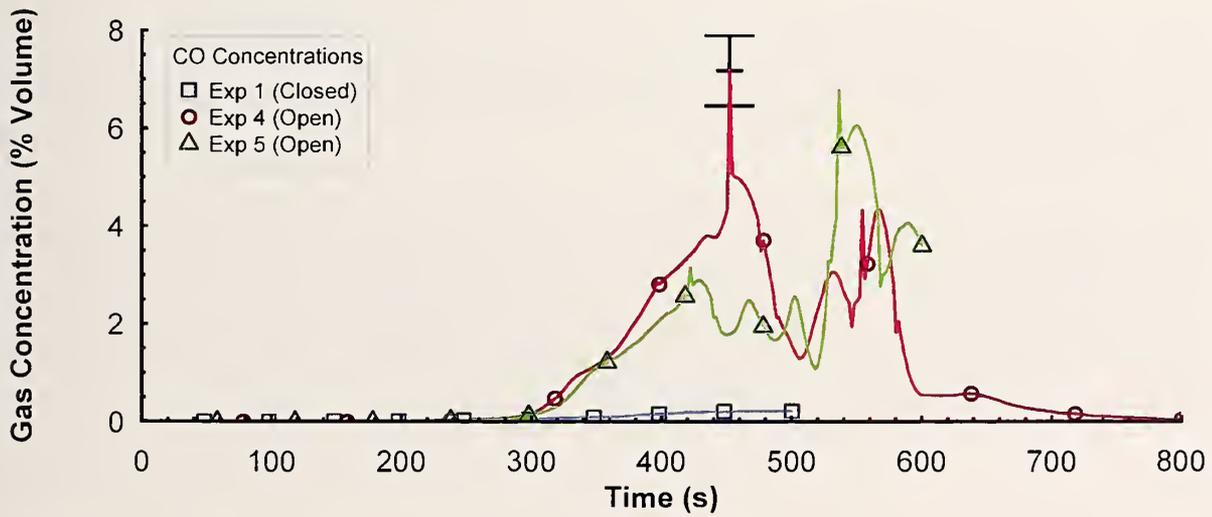
Figure 4.2-9. Carbon monoxide concentrations versus time in the dorm room from Experiment 1, 4 and 5 at approximately 1.5 m (5 ft) above the floor.

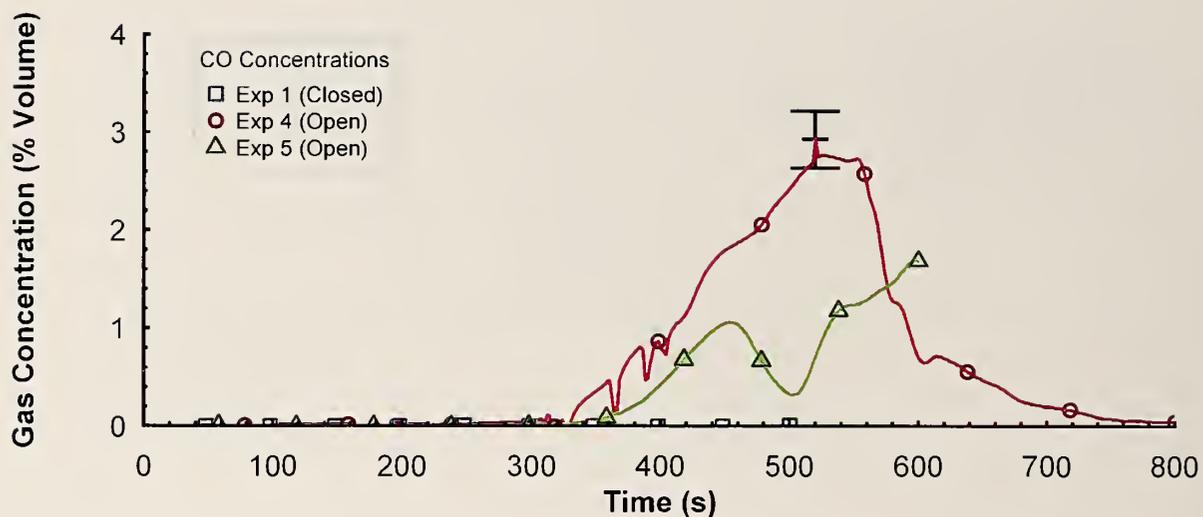
Figure 4.2-10. Carbon monoxide concentrations versus time in the corridor from Experiment 1, 4 and 5 at approximately 1.5 m (5 ft) above the floor.

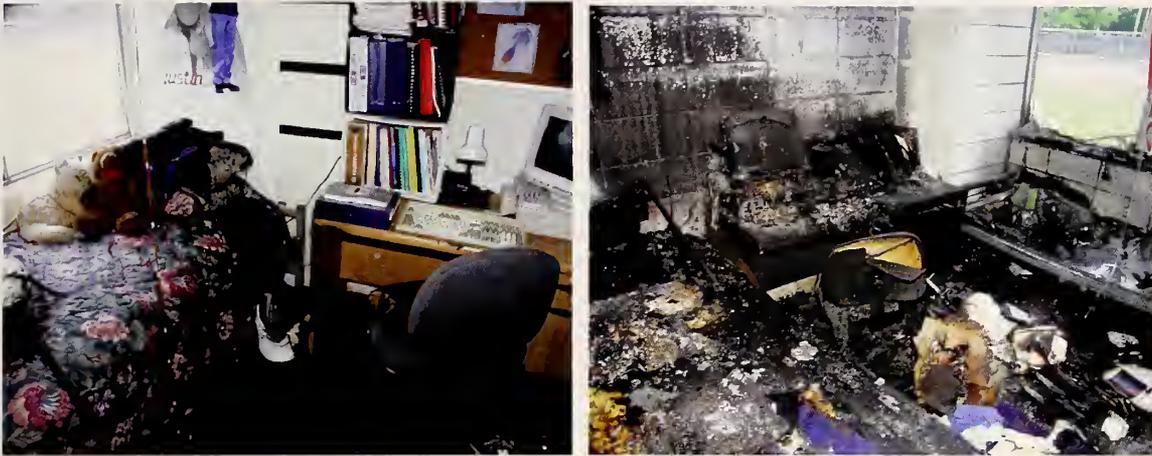
Figure 4.3-1. Post fire photographs for Experiment 3 (sprinklered) on the left and Experiment 4 (non-sprinklered) on the right.

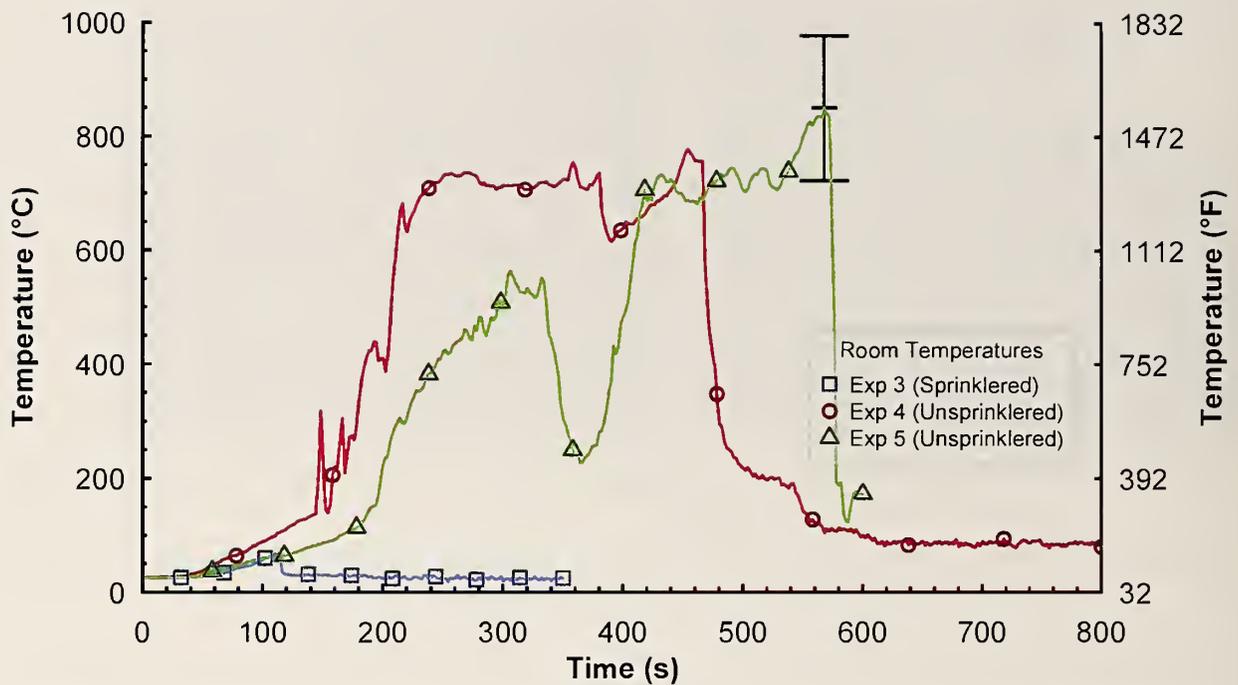
Figure 4.3-2. Temperature versus time data from thermocouple array 1 from Experiment 3, 4 and 5 at approximately 1.5 m (5 ft) above the floor.

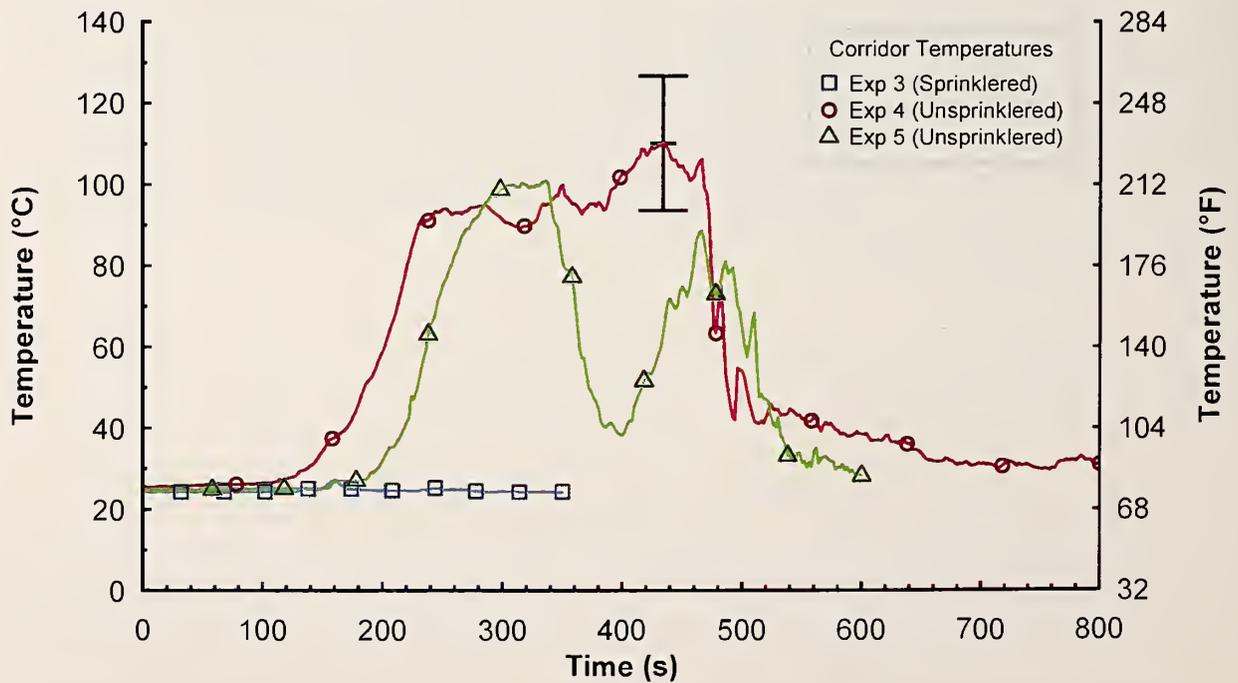
Figure 4.3-3. Temperature versus time data from thermocouple array 4 from Experiment 3, 4 and 5 at approximately 1.5 m (5 ft) above the floor.

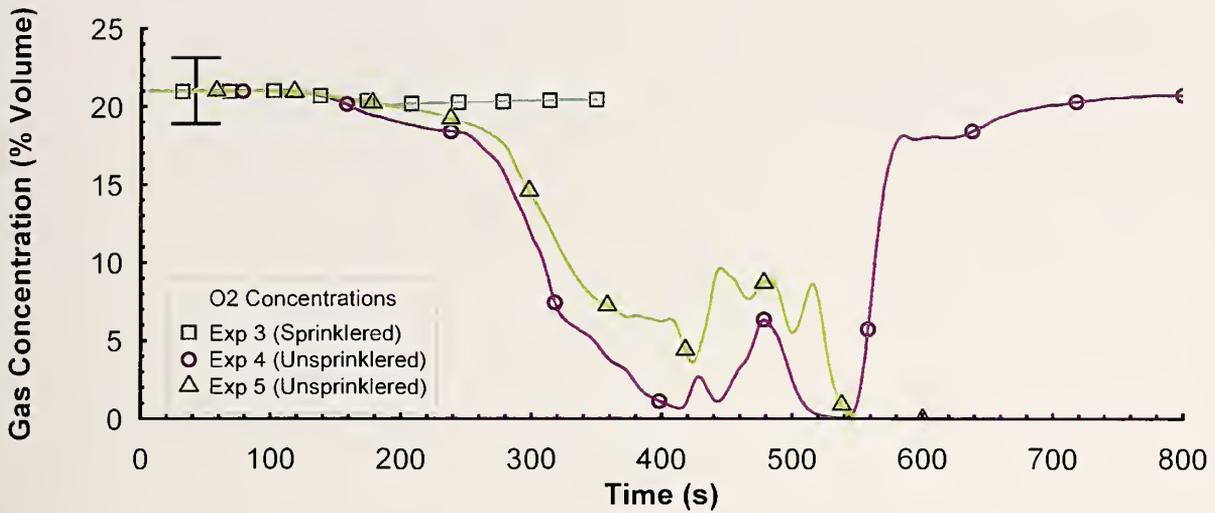
Figure 4.3-4. Oxygen concentrations versus time in the dorm room from Experiment 3, 4 and 5 at approximately 1.5 m (5 ft) above the floor.

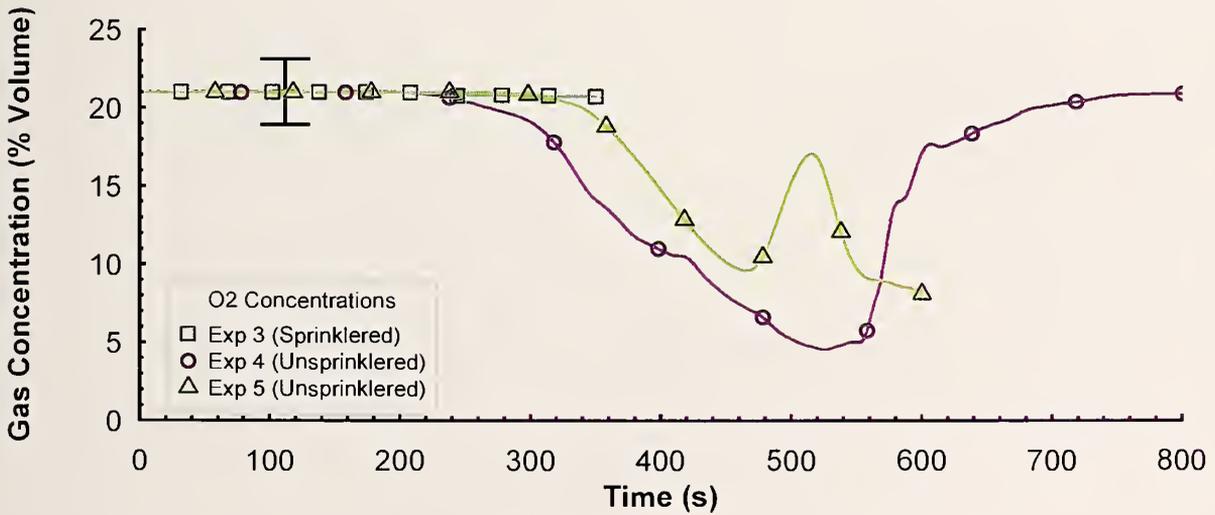
Figure 4.3-5. Oxygen concentrations versus time in the corridor from Experiment 3, 4 and 5 at approximately 1.5 m (5 ft) above the floor.

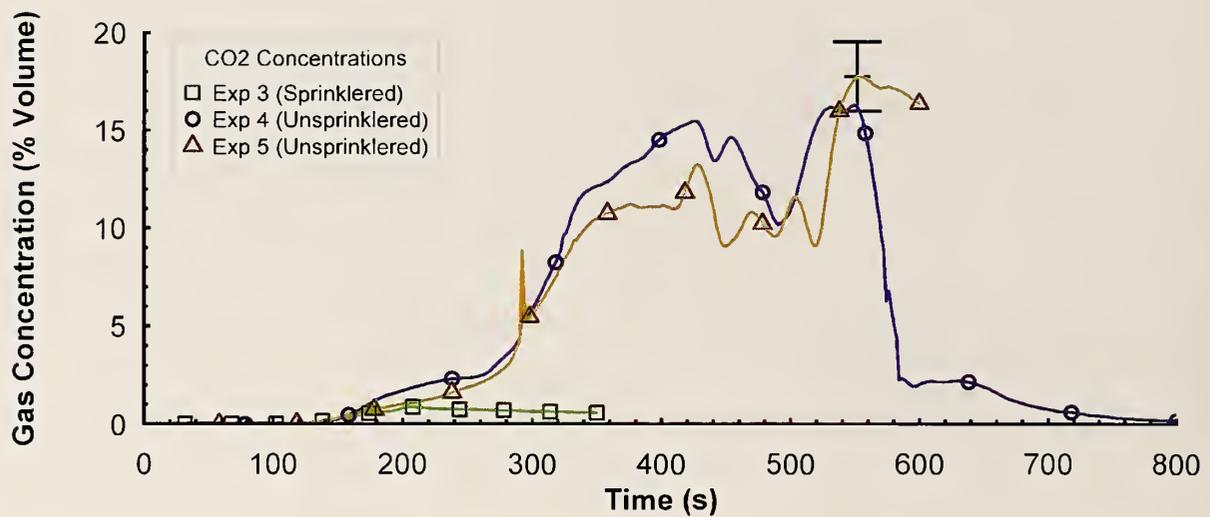
Figure 4.3-6. Carbon dioxide concentrations versus time in the dorm room from Experiment 3, 4 and 5 at approximately 1.5 m (5 ft) above the floor.

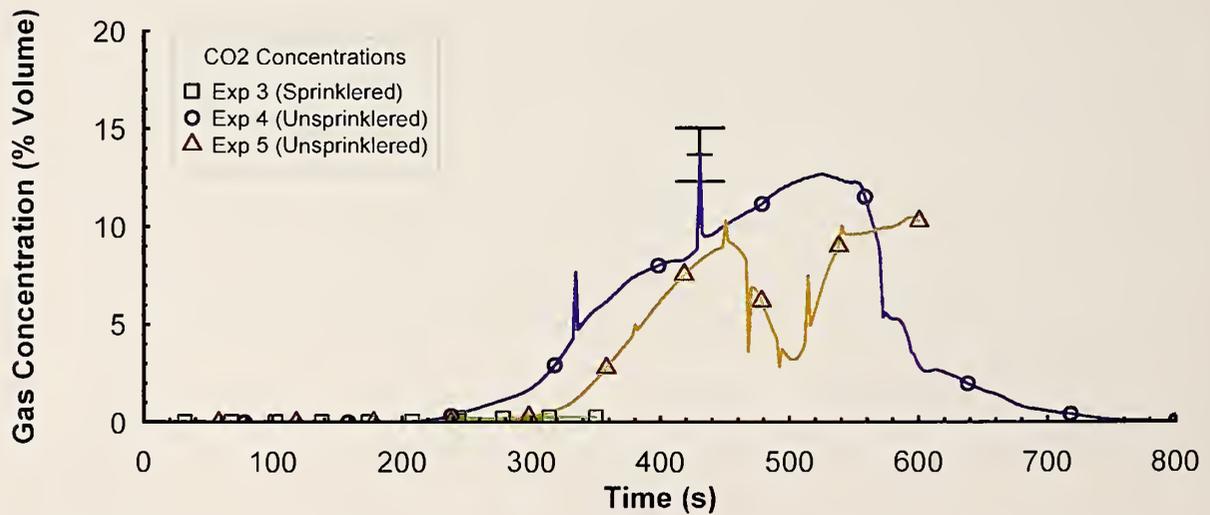
Figure 4.3-7. Carbon dioxide concentrations versus time in the corridor from Experiment 3, 4 and 5 at approximately 1.5 m (5 ft) above the floor.

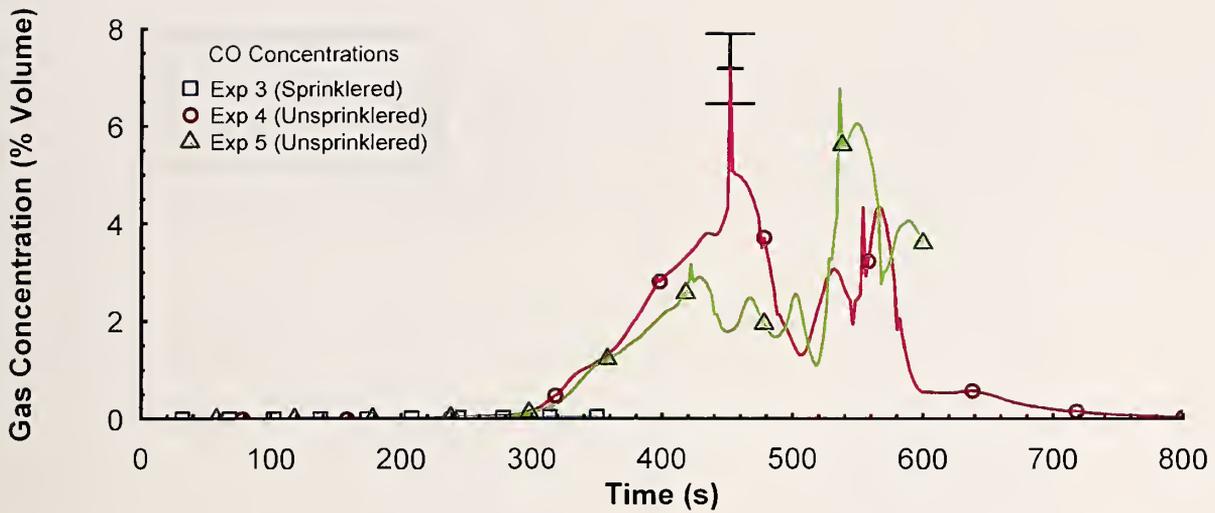
Figure 4.3-8. Carbon monoxide concentrations versus time in the dorm room from Experiment 3, 4 and 5 at approximately 1.5 m (5 ft) above the floor.

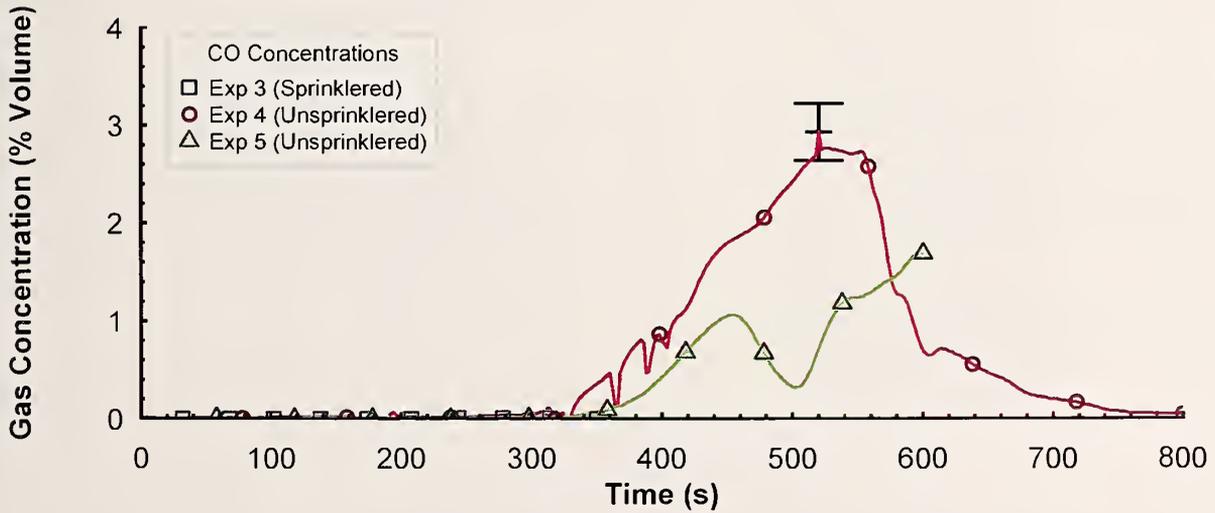
Figure 4.3-9. Carbon monoxide concentrations versus time in the corridor from Experiment 3, 4 and 5 at approximately 1.5 m (5 ft) above the floor.
