TECHNOLOGIC PAPERS OF THE BUREAU OF STANDARDS, No. 314

SHEAR TESTS OF REINFORCED CONCRETE BEAMS

WILLIS A. SLATER, Engineer Physicist
ARTHUR R. LORD, Consulting Engineer, Cooperating
ROY R. ZIPPRODT, Associate Engineer

This paper gives results of tests carried out on reinforced concrete beams in the establishment of a basis for design of concrete ships during the World War.

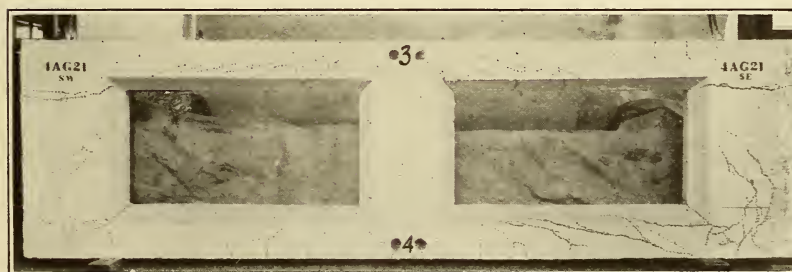
FIG. 13.—Failure of beams 4AG9 and 4AG21

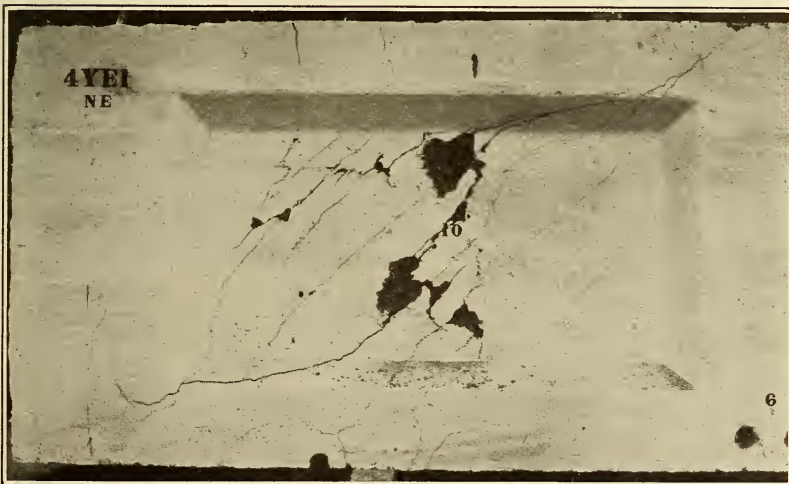
FIG. 22.—*Failure of beam 4YE1 by vertical shear combined with diagonal compression*

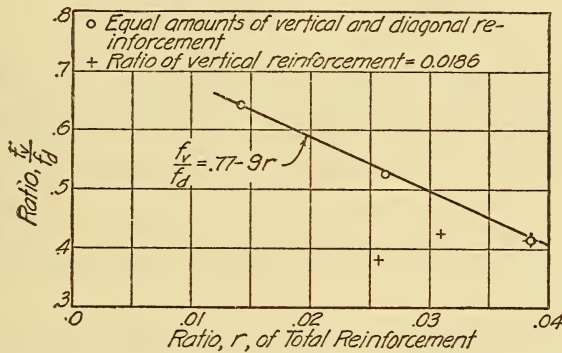
FIG. 43.—Average ratios of stress in vertical to stress in diagonal tension reinforcement

It was found that for a given load the tensile stress in the vertical bars was in all cases less than that in the inclined tension bars of the same beam. The ratio of these stresses is shown in Figure 42 for all loads for all the beams having both sets of bars. In Figure 43 the average ratios for the five groups are plotted as ordinates and the sum
