NBSIR 87-3640

# Investigation of L'Ambiance Plaza Building Collapse in Bridgeport, Connecticut

Occupational Safety and Health Administration U.S. Department of Labor Washington, DC 20001

Issued September 1987

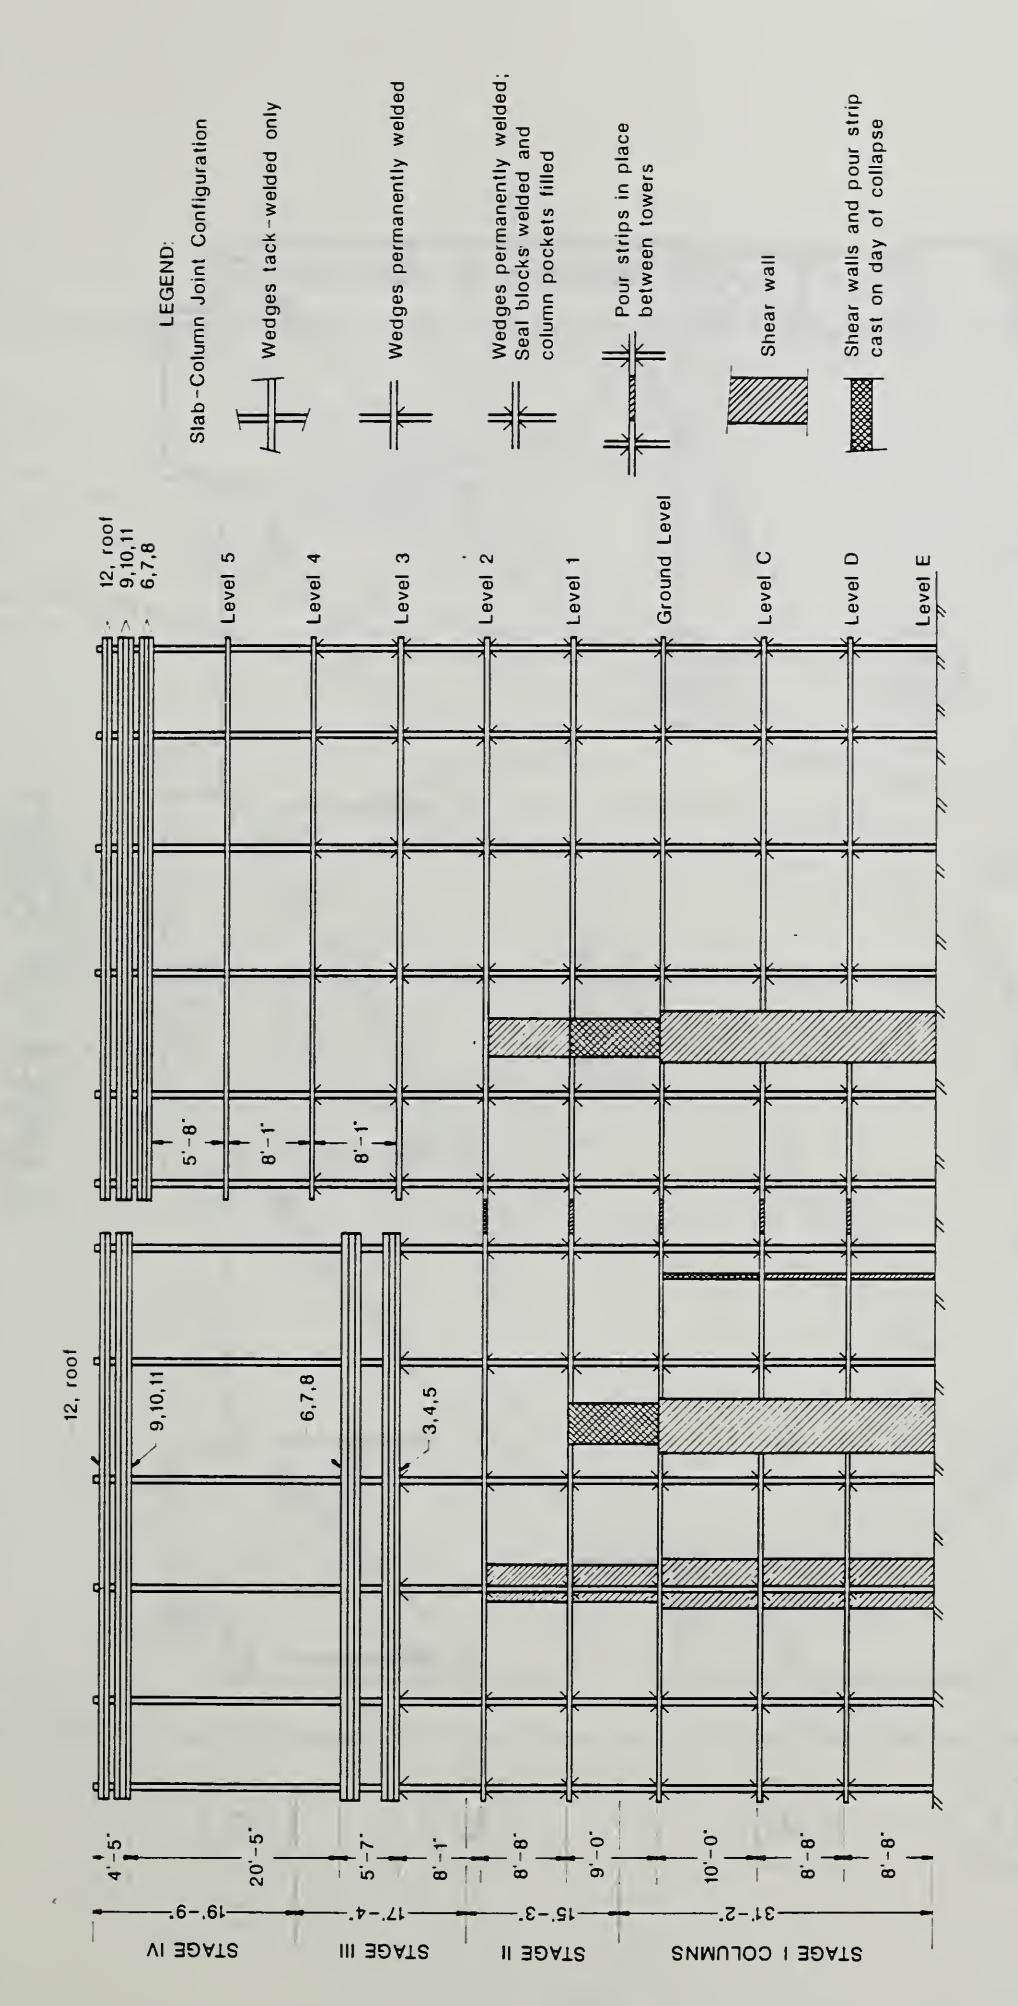
Figure 4.2.1 State of construction at time of collapse - viewed from the South

The possibility of sidesway buckling of the west tower is considered in this section. It is necessary to check this mode of failure since there was no evidence that the west tower, at the time of collapse, had effective lateral bracing above the shear wall at level 2 as indicated in figure 4.2.1.

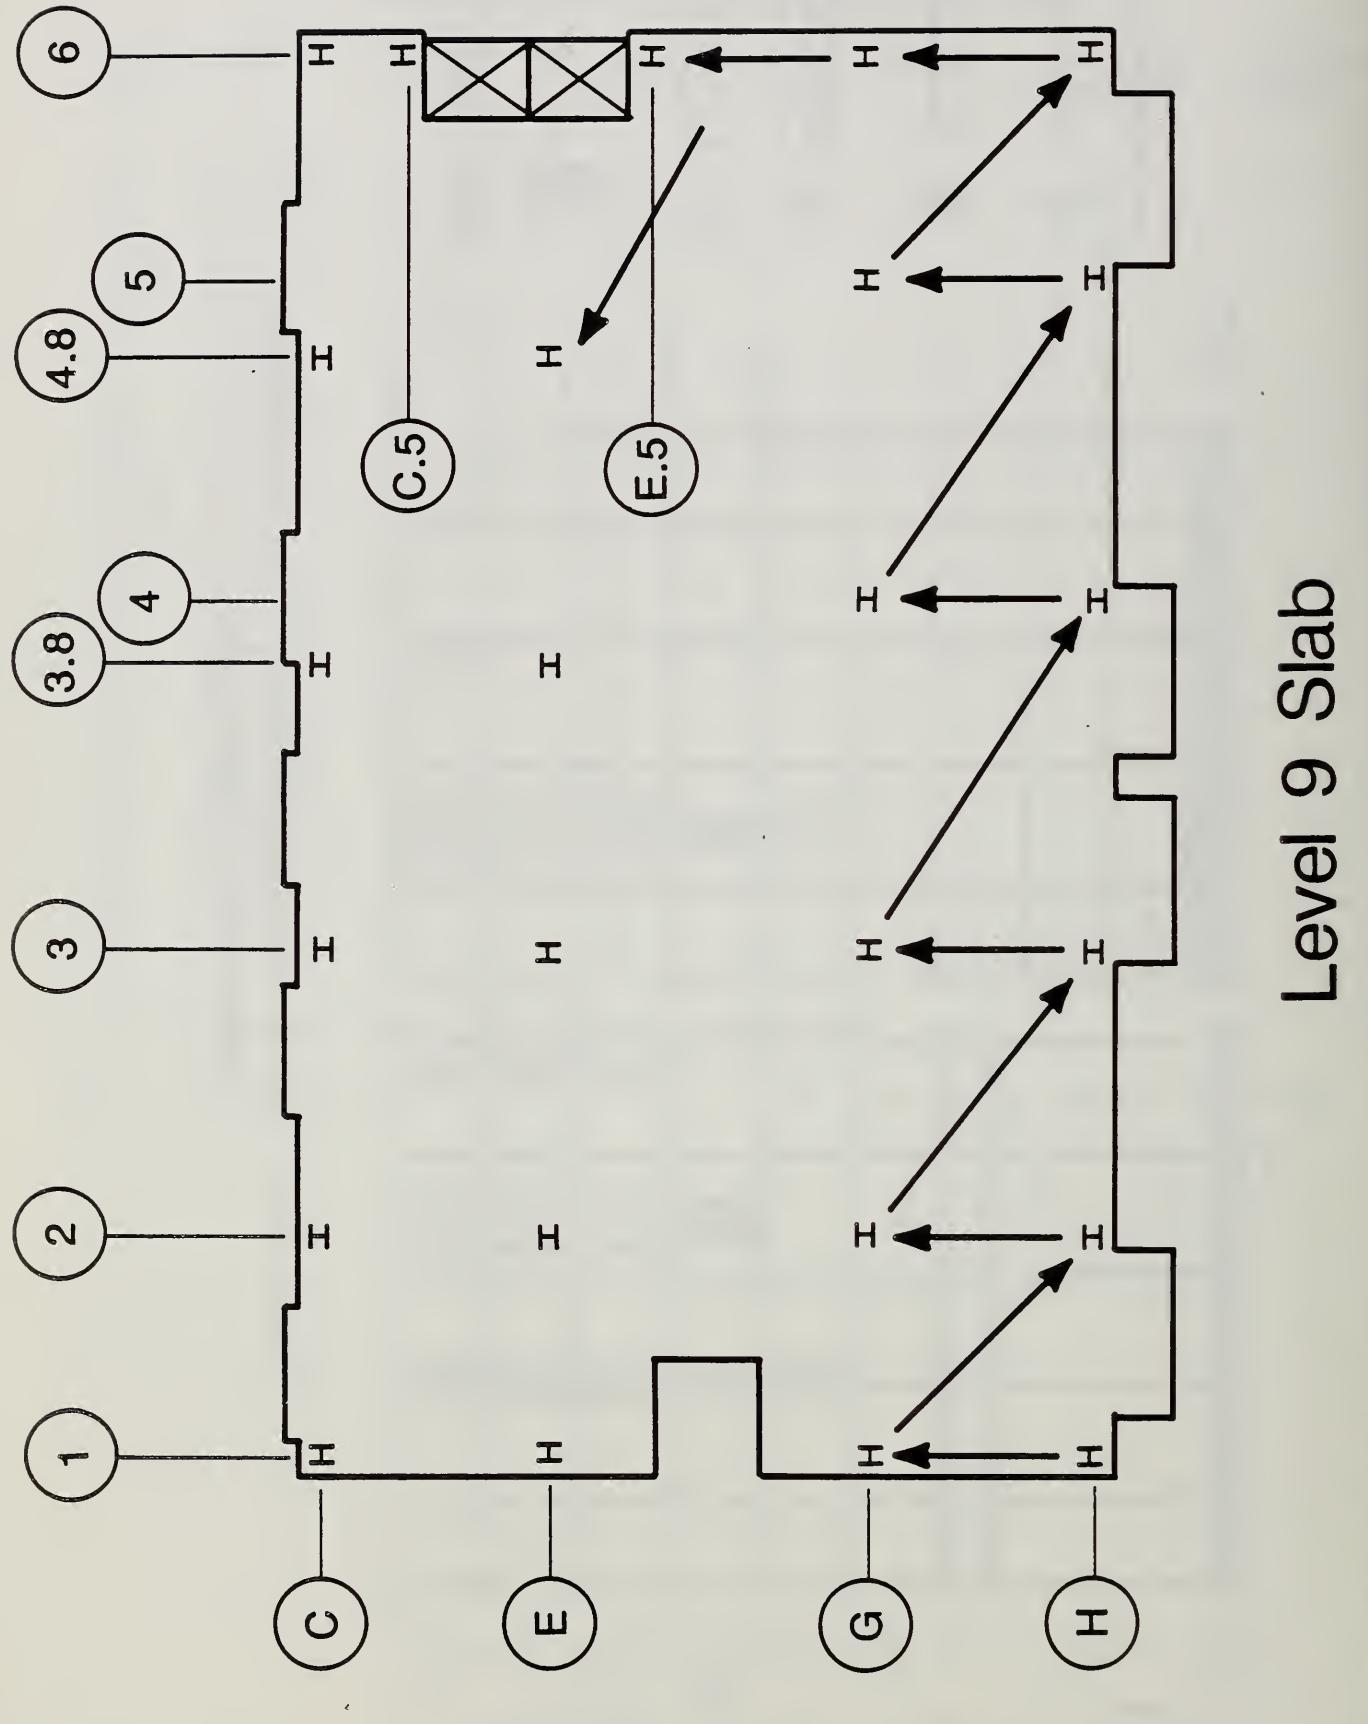
Figure 4.2.2

At the time of the collapse, workmen were installing wedges to hold slabs 9/10/11 in this position temporarily. Wedges had been installed along column lines G and H and an ironworker (#14 in figure 4.3.1) was installing temporary wedges at column E4.8. A floor plan of the west tower showing the locations and sequence for which wedges had been installed to support the group of slabs for levels 9/10/11 is shown in figure 4.2.2.

# Sequence of placement of wedges immediately prior to collapse

- West tower. I evels 9.10.11

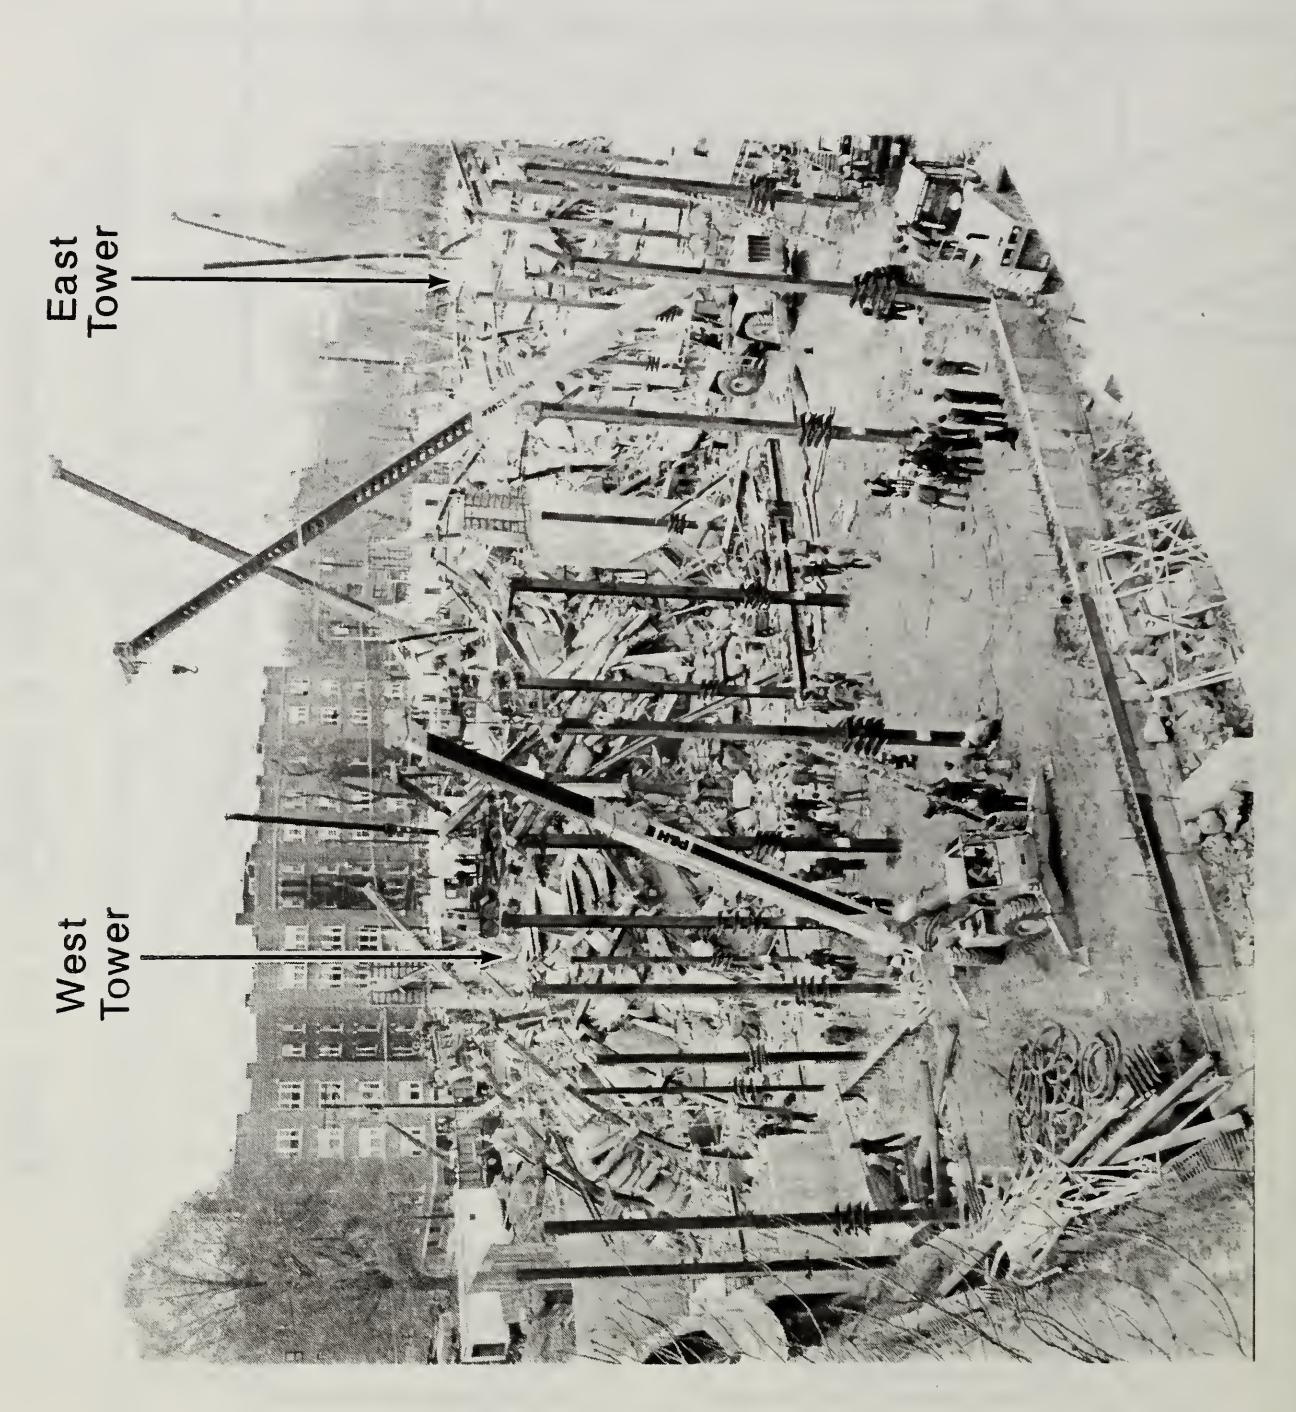
Figure 4.4.1 Overview of collapsed structure - View to the Northeast

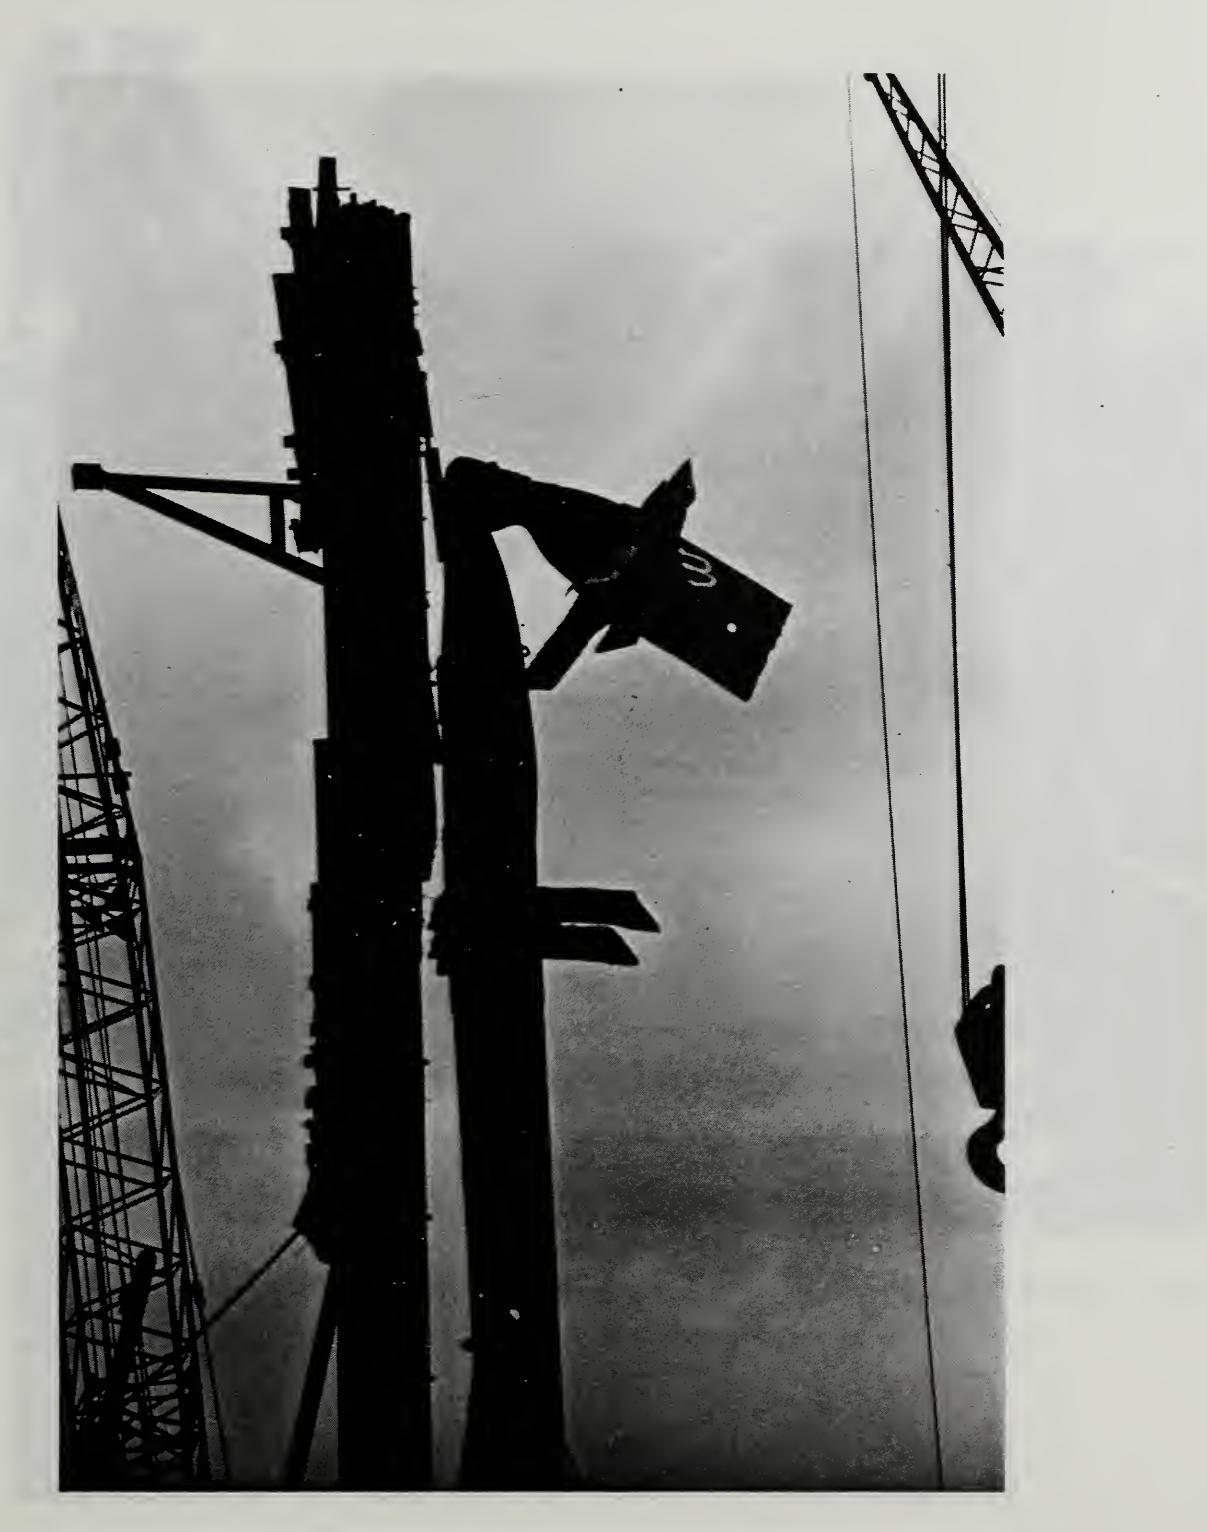
Figure 4.4.2 Column C3 bending about the strong axis -View to the East, shearwall on left

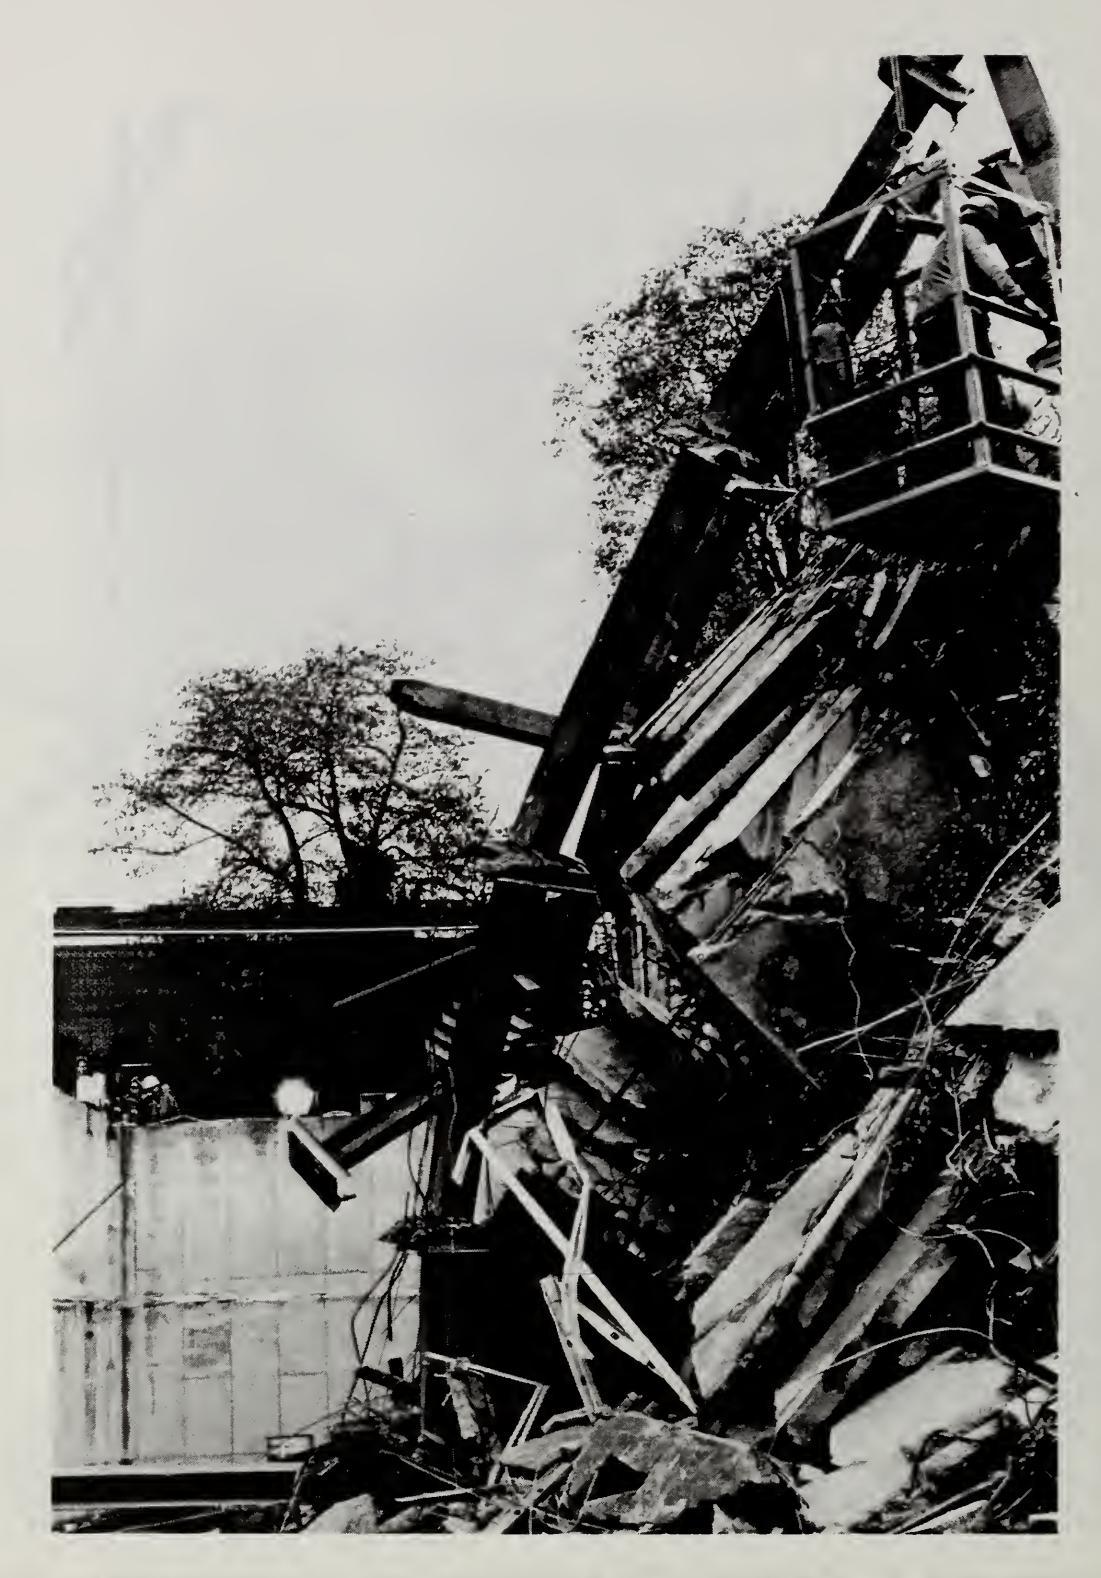
Figure 4.4.3 Deflected shape of column E1 - View to the North

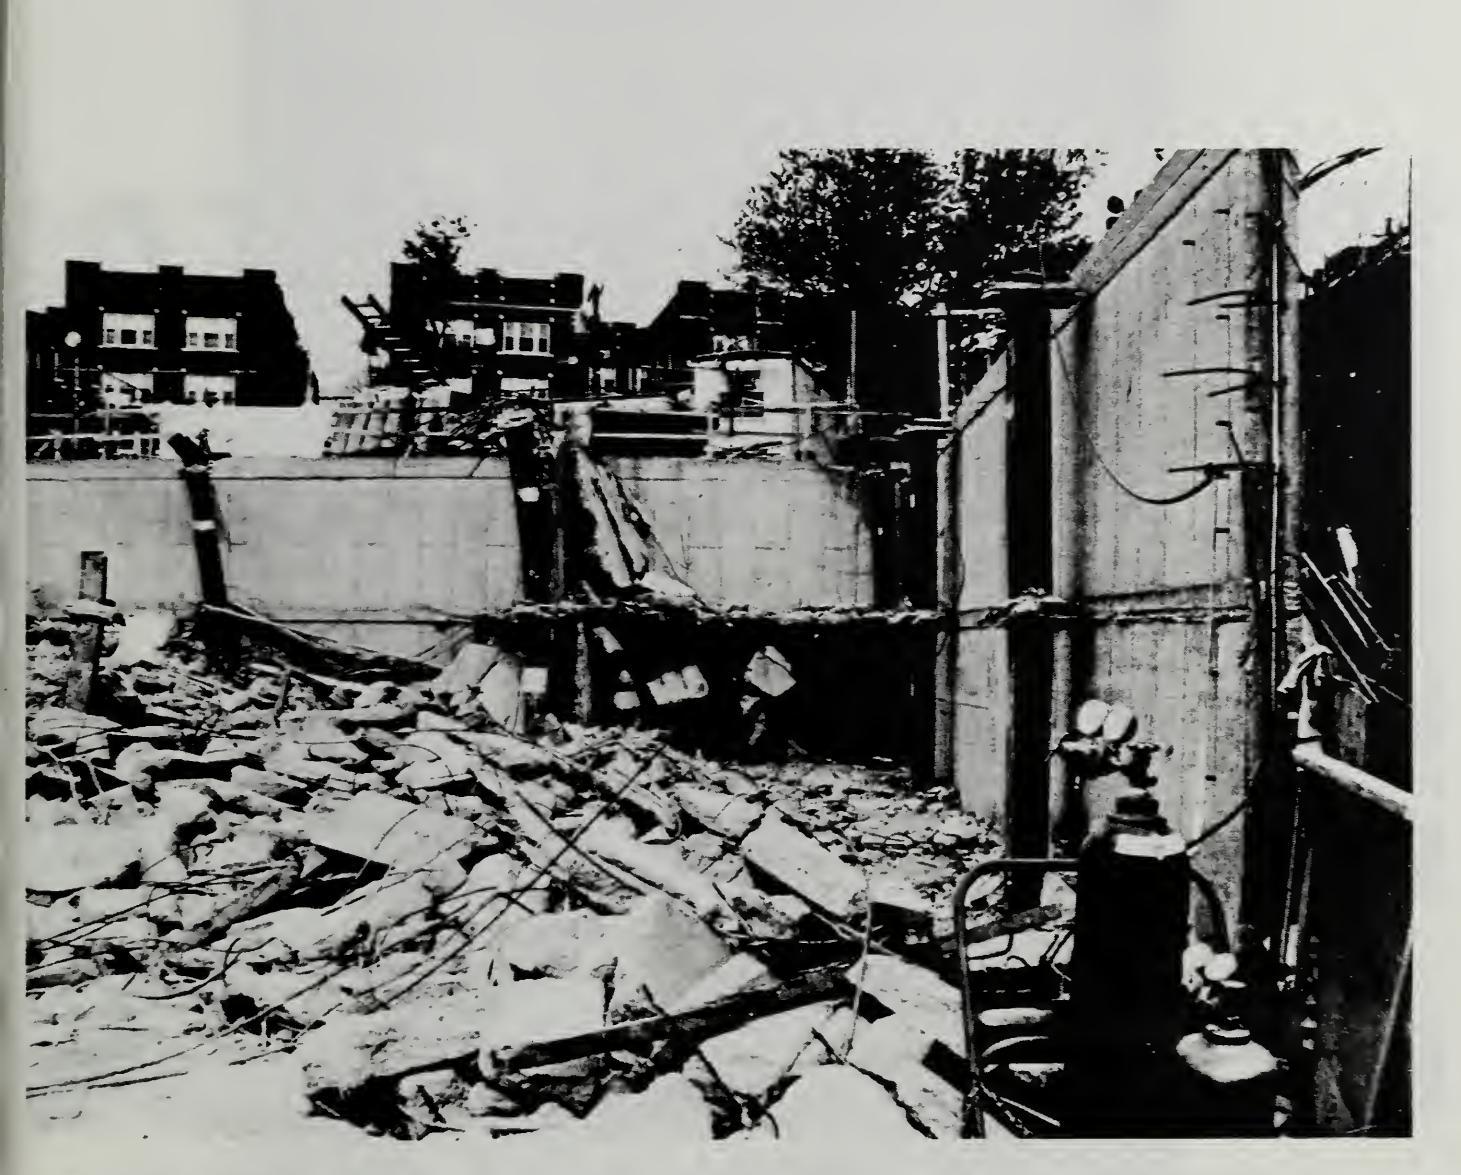
Figure 4.4.4 East perimeter columns at Levels E and D. East tower-View to the North; photo taken after rescue operations complete

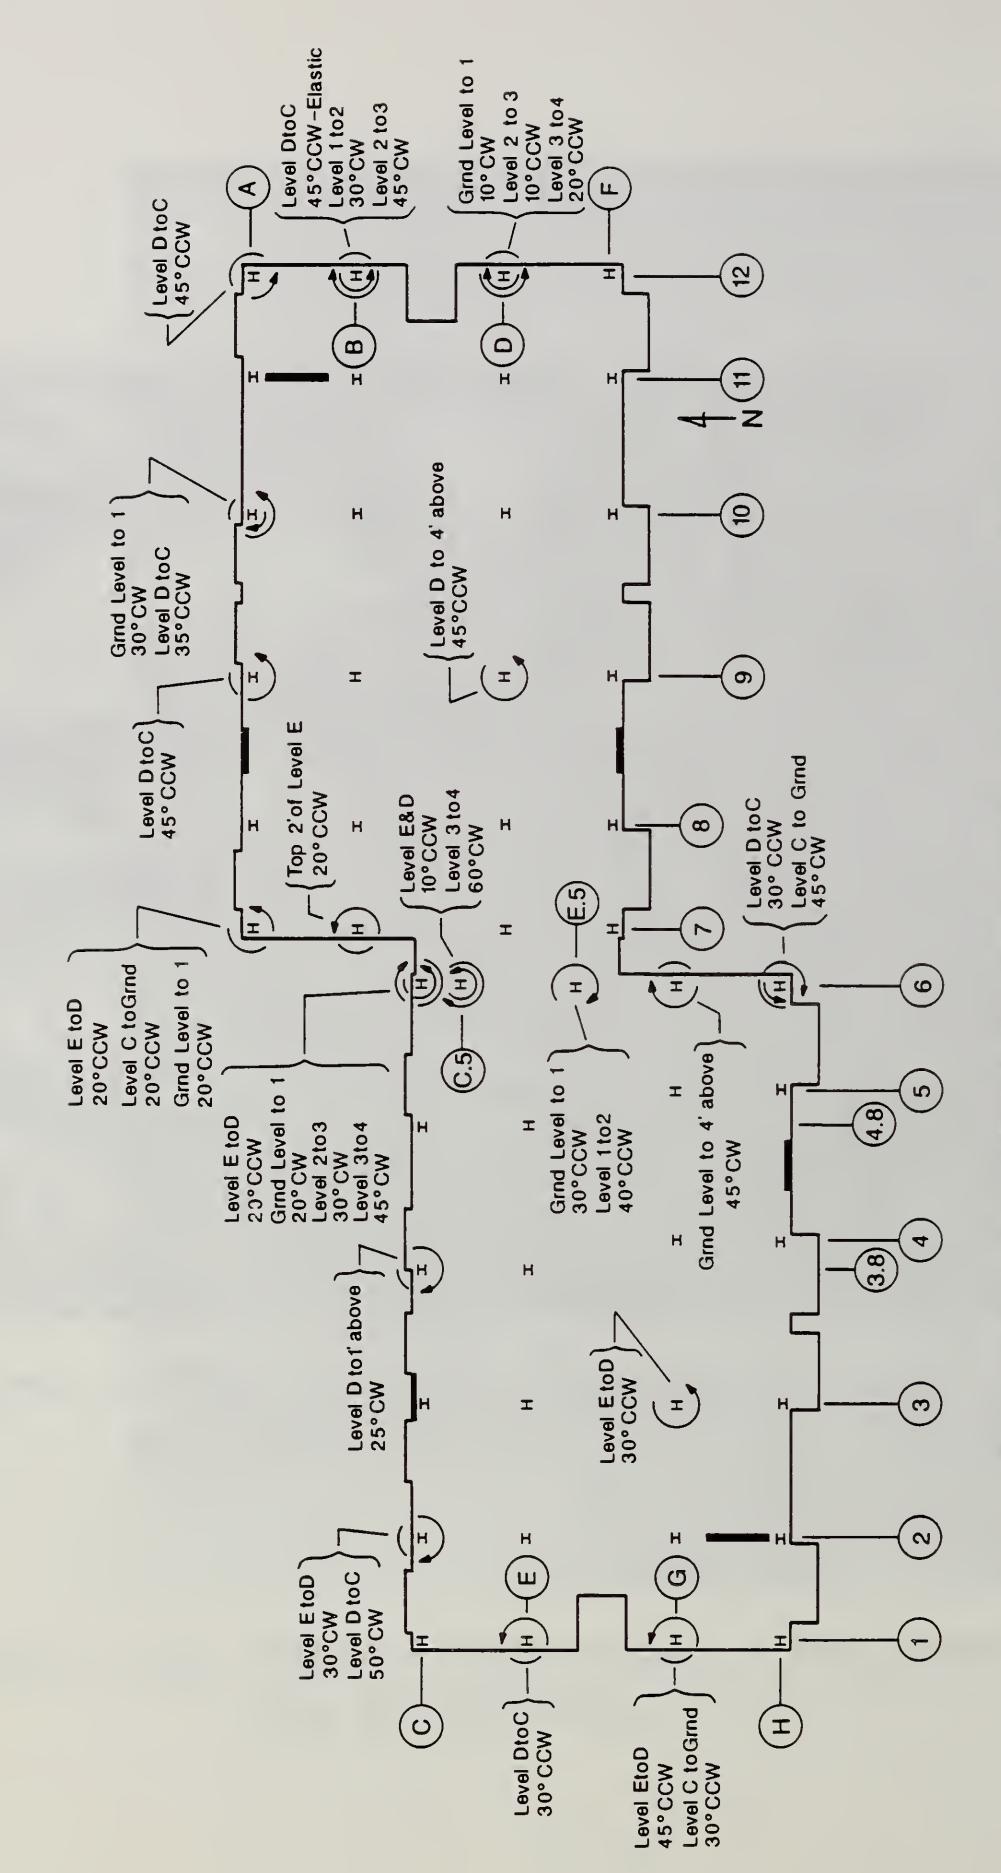
Figure 4.4.7 Pattern of perimeter column twists

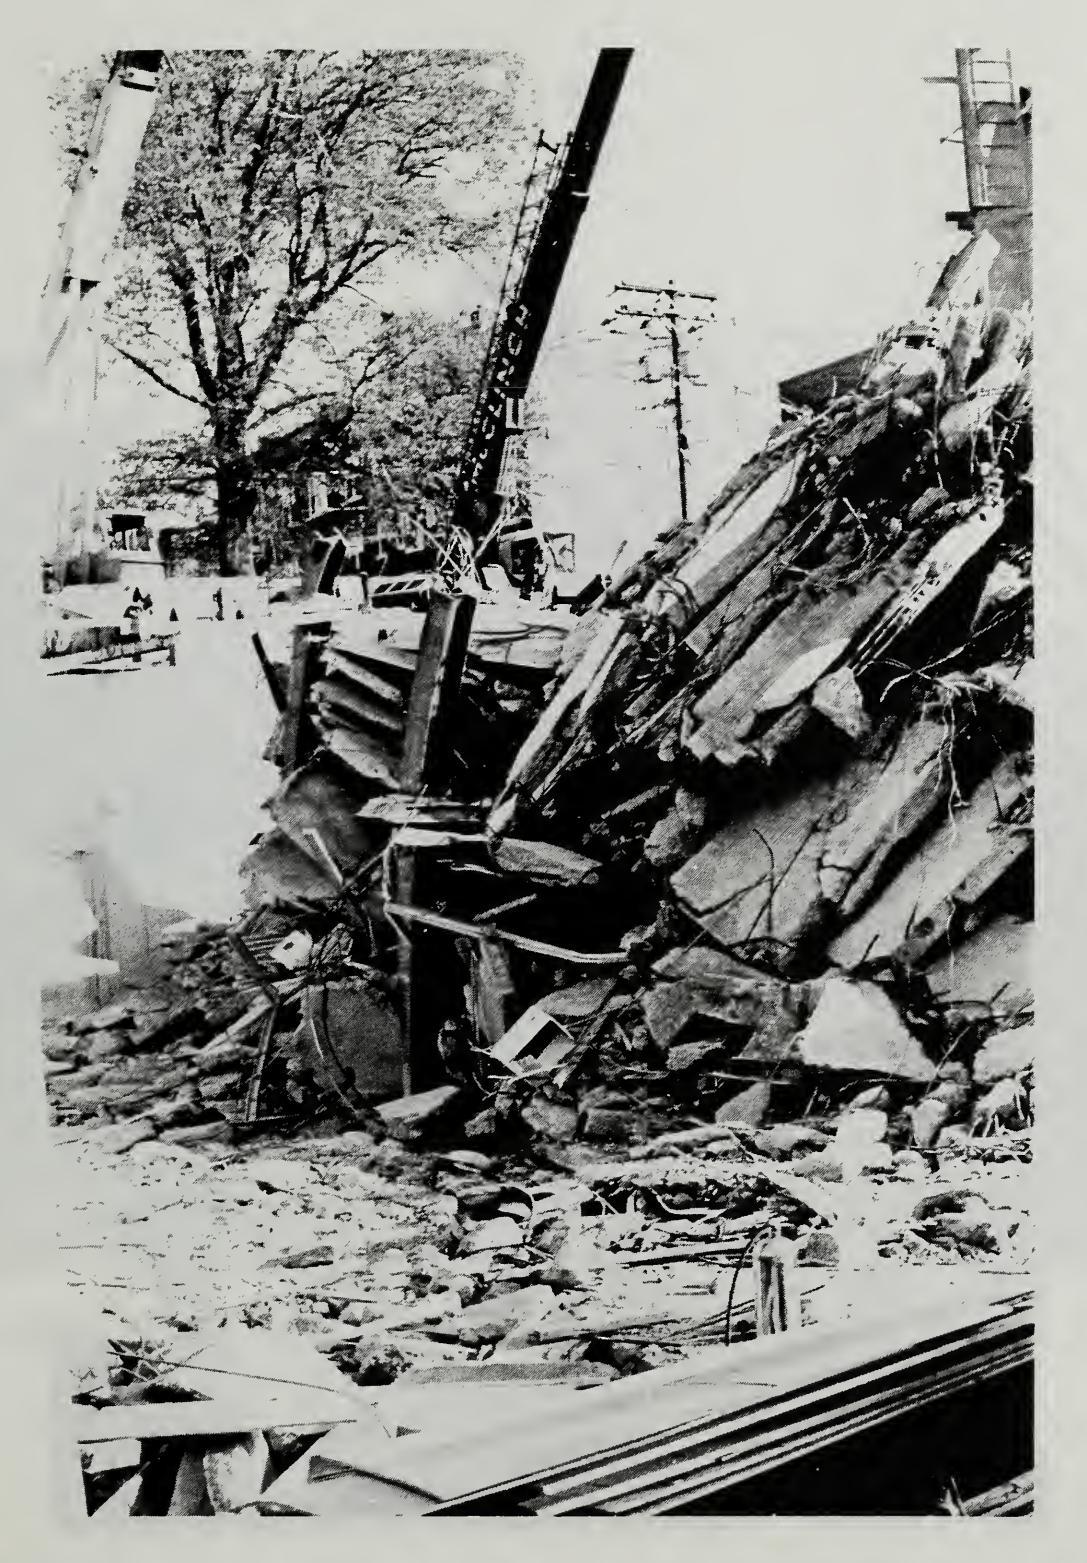
Figure 4.4.8 Lower level floor slabs at Northwest corner of West tower - View to the North; column E1

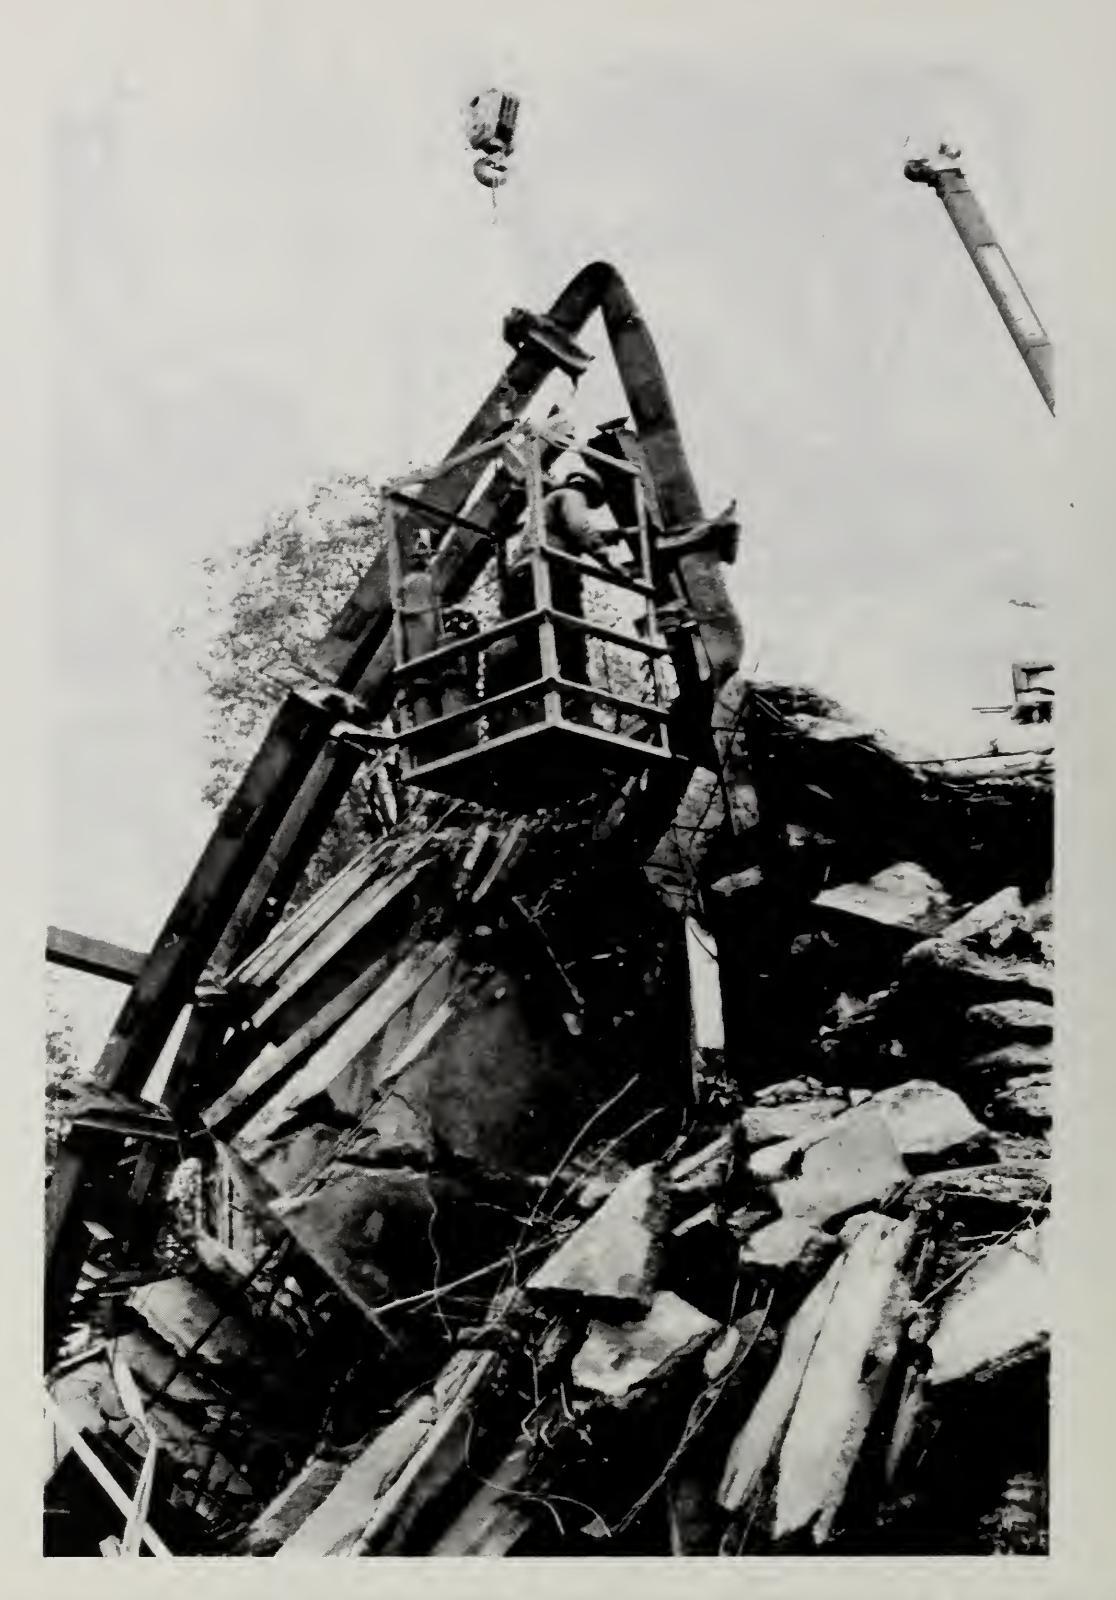
Figure 4.4.9 Upper floor slabs on Northwest corner of West tower - View to the North; column E1

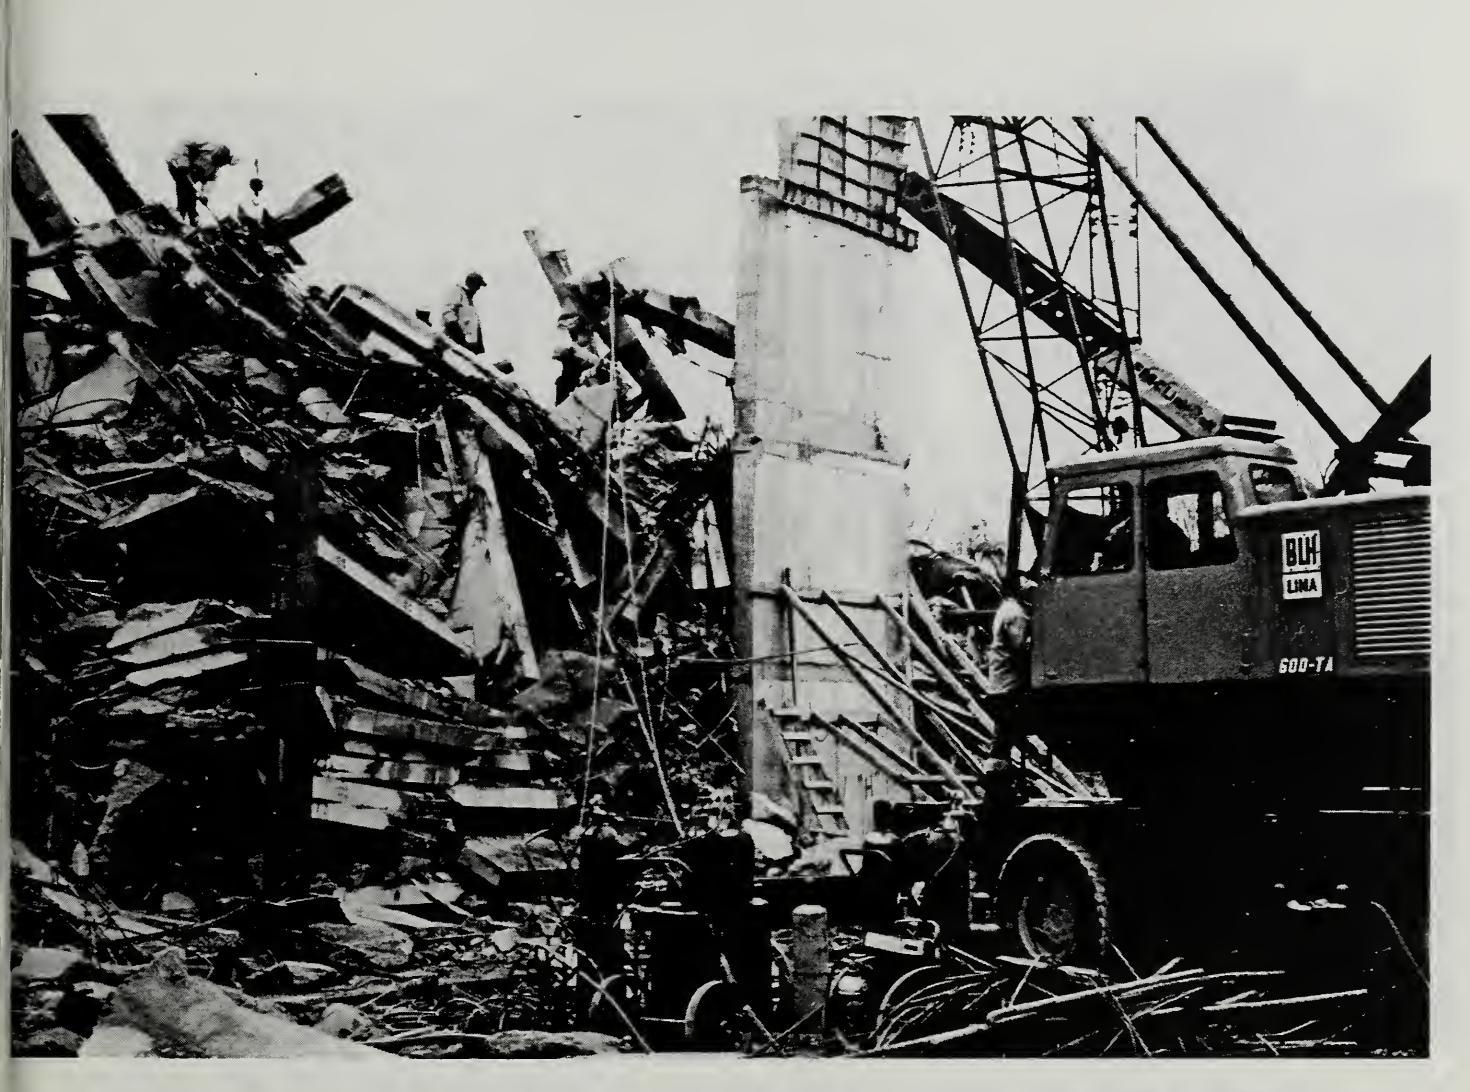
Figure 4.4.10 Lower level floor slabs in center portion of West tower - View to the Northeast

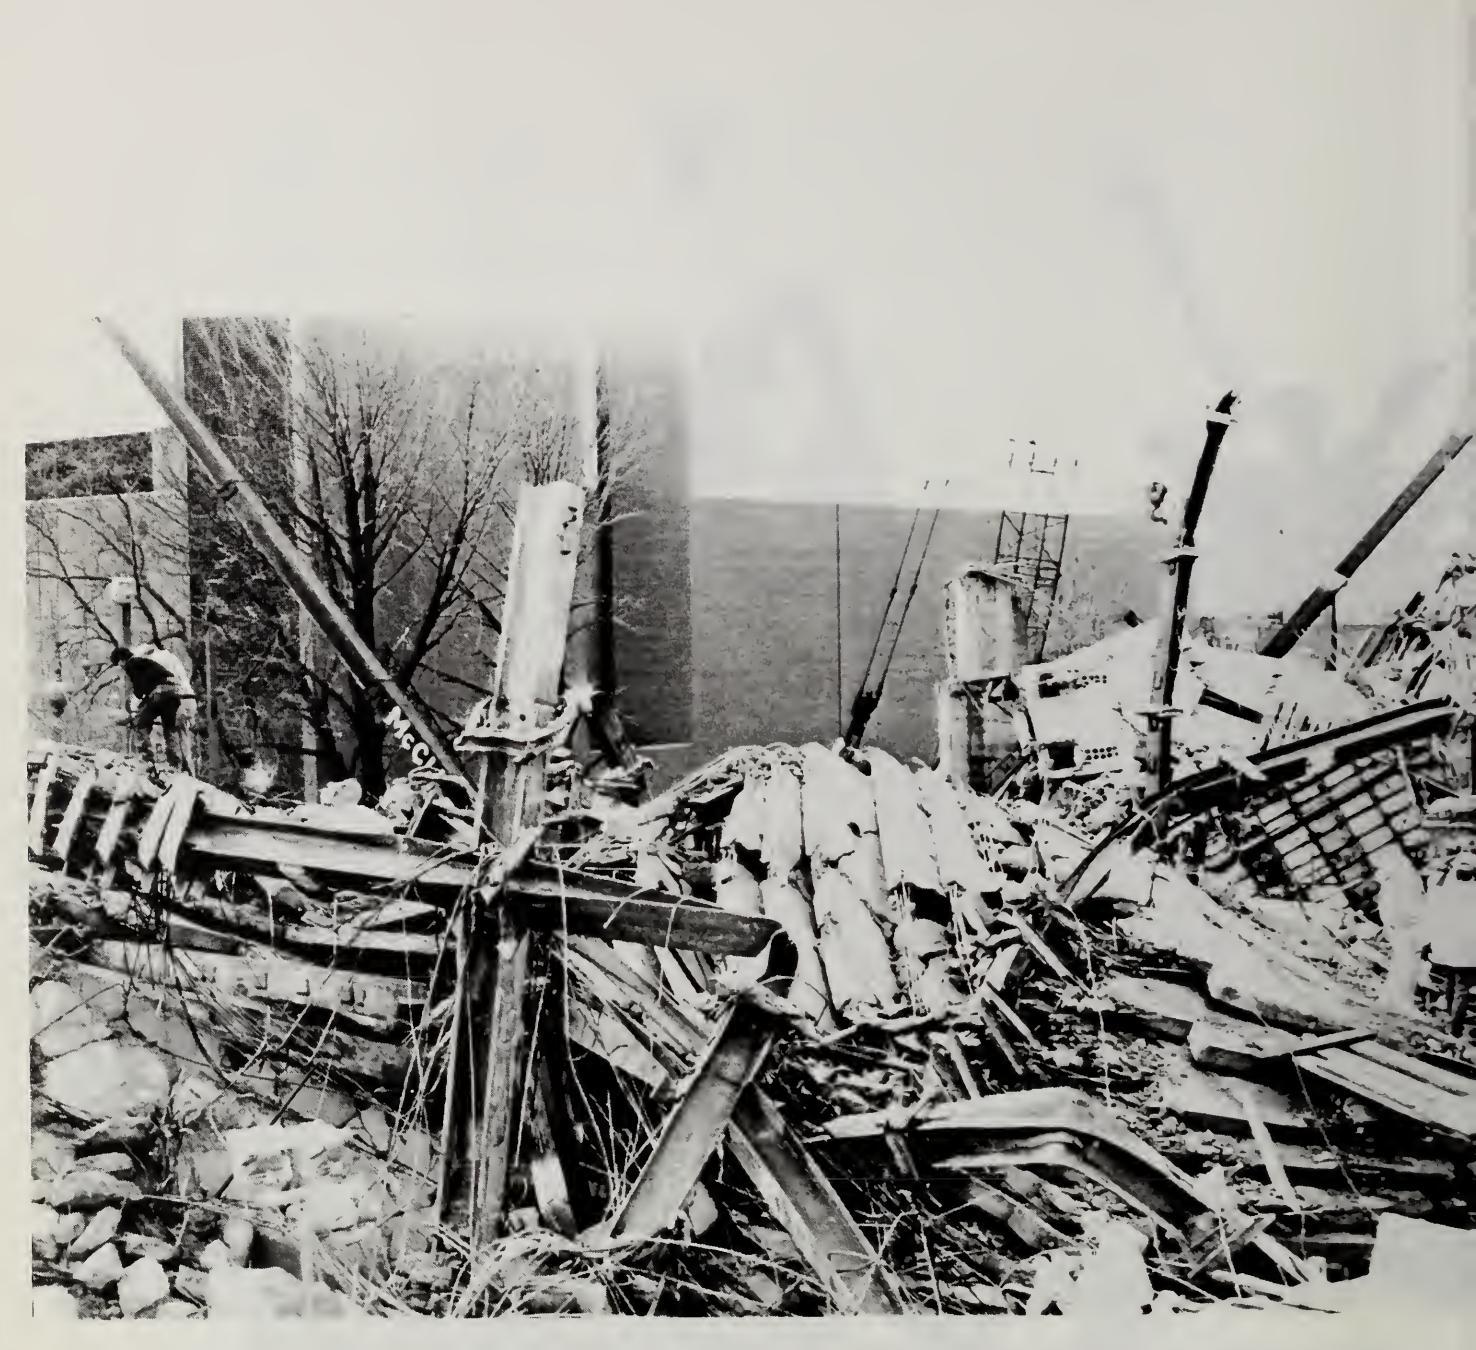
Figure 4.4.11 Floor slabs in the central portion of East tower -View to the Southwest

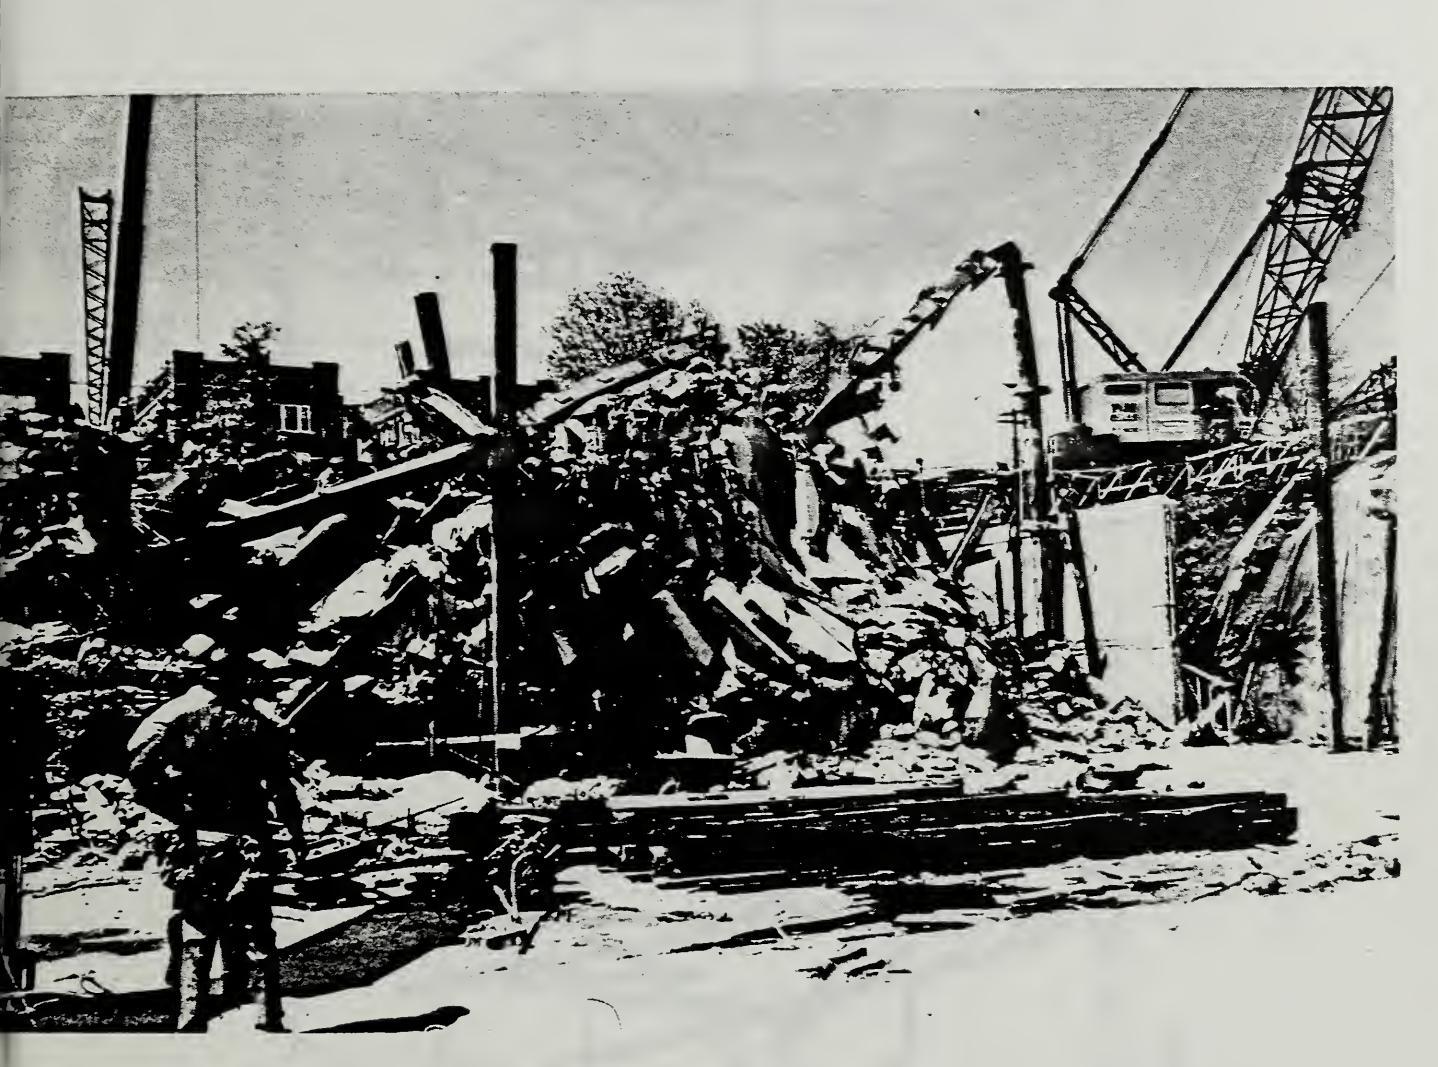
Figure 4.4.12 Floor slabs in Southeast corner of East tower - View to the Northeast
