NBSIR 87-3640

# Investigation of L'Ambiance Plaza Building Collapse in Bridgeport, Connecticut

Occupational Safety and Health Administration U.S. Department of Labor Washington, DC 20001

Issued September 1987

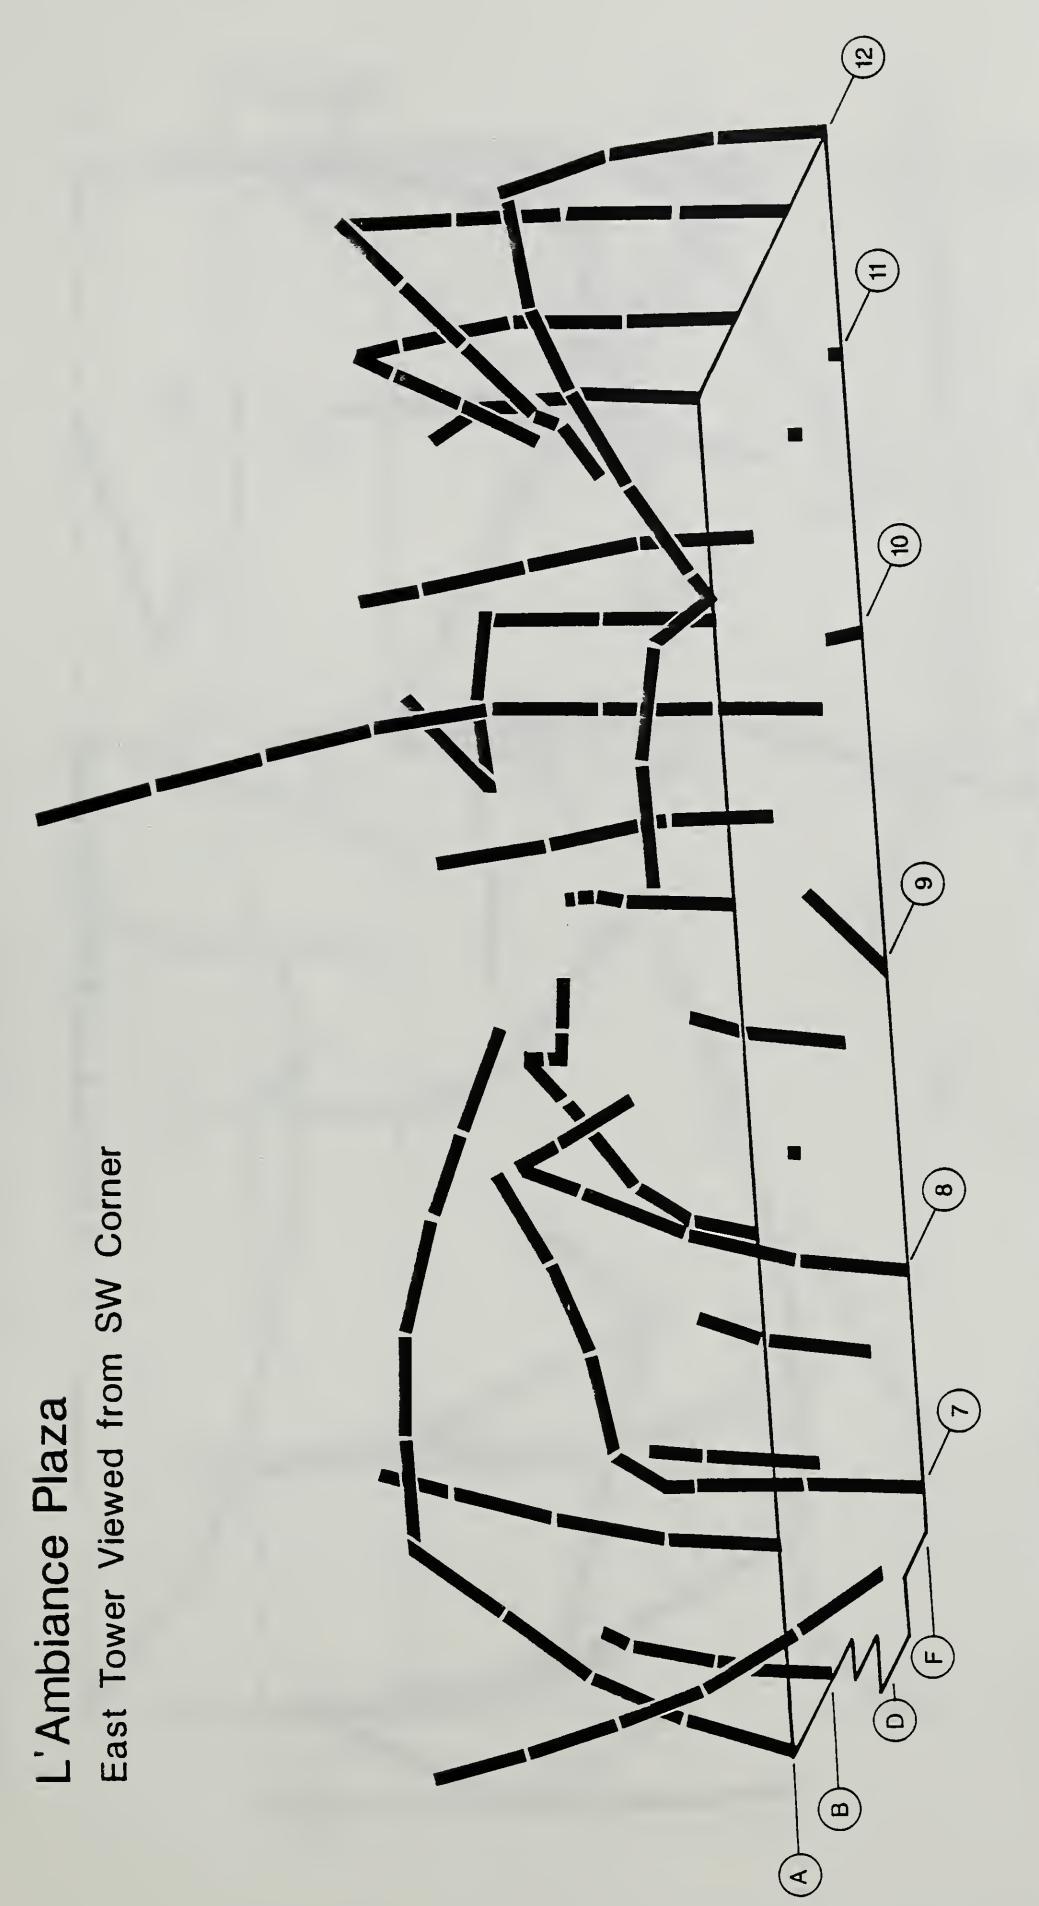
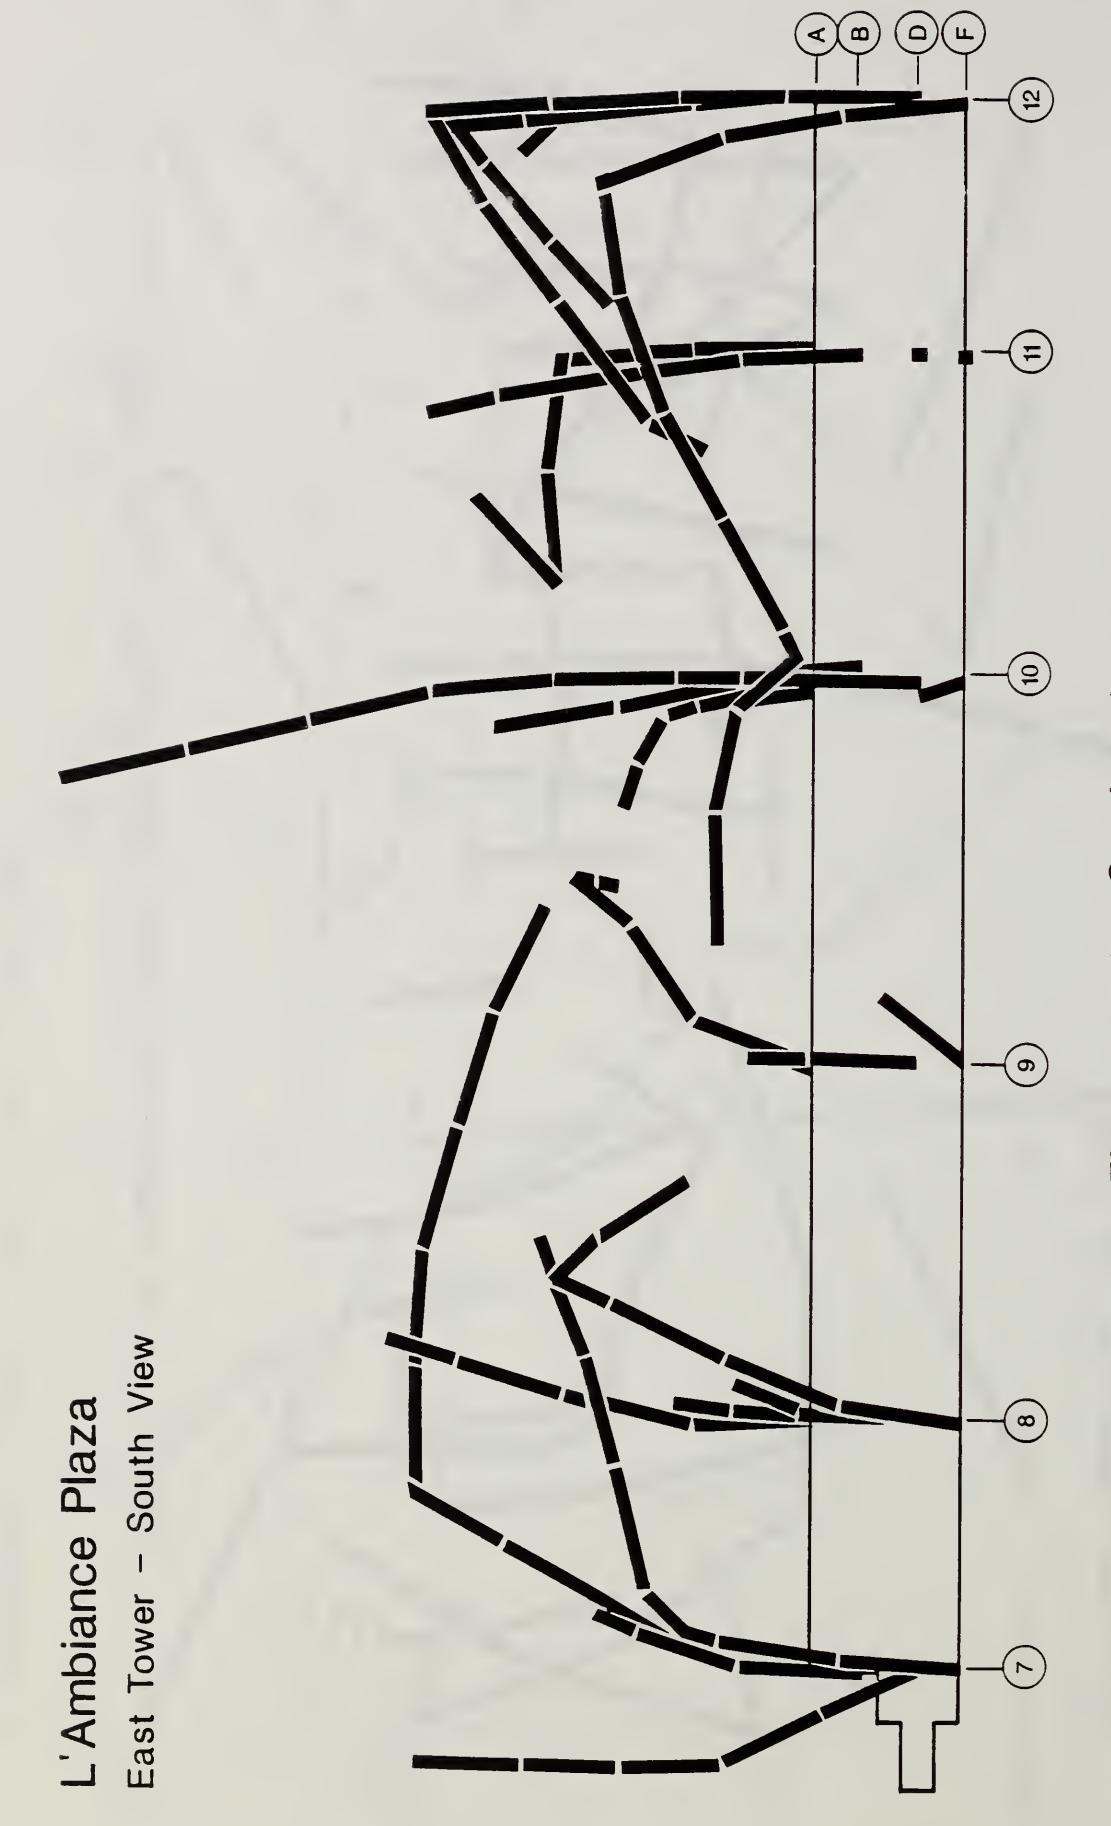
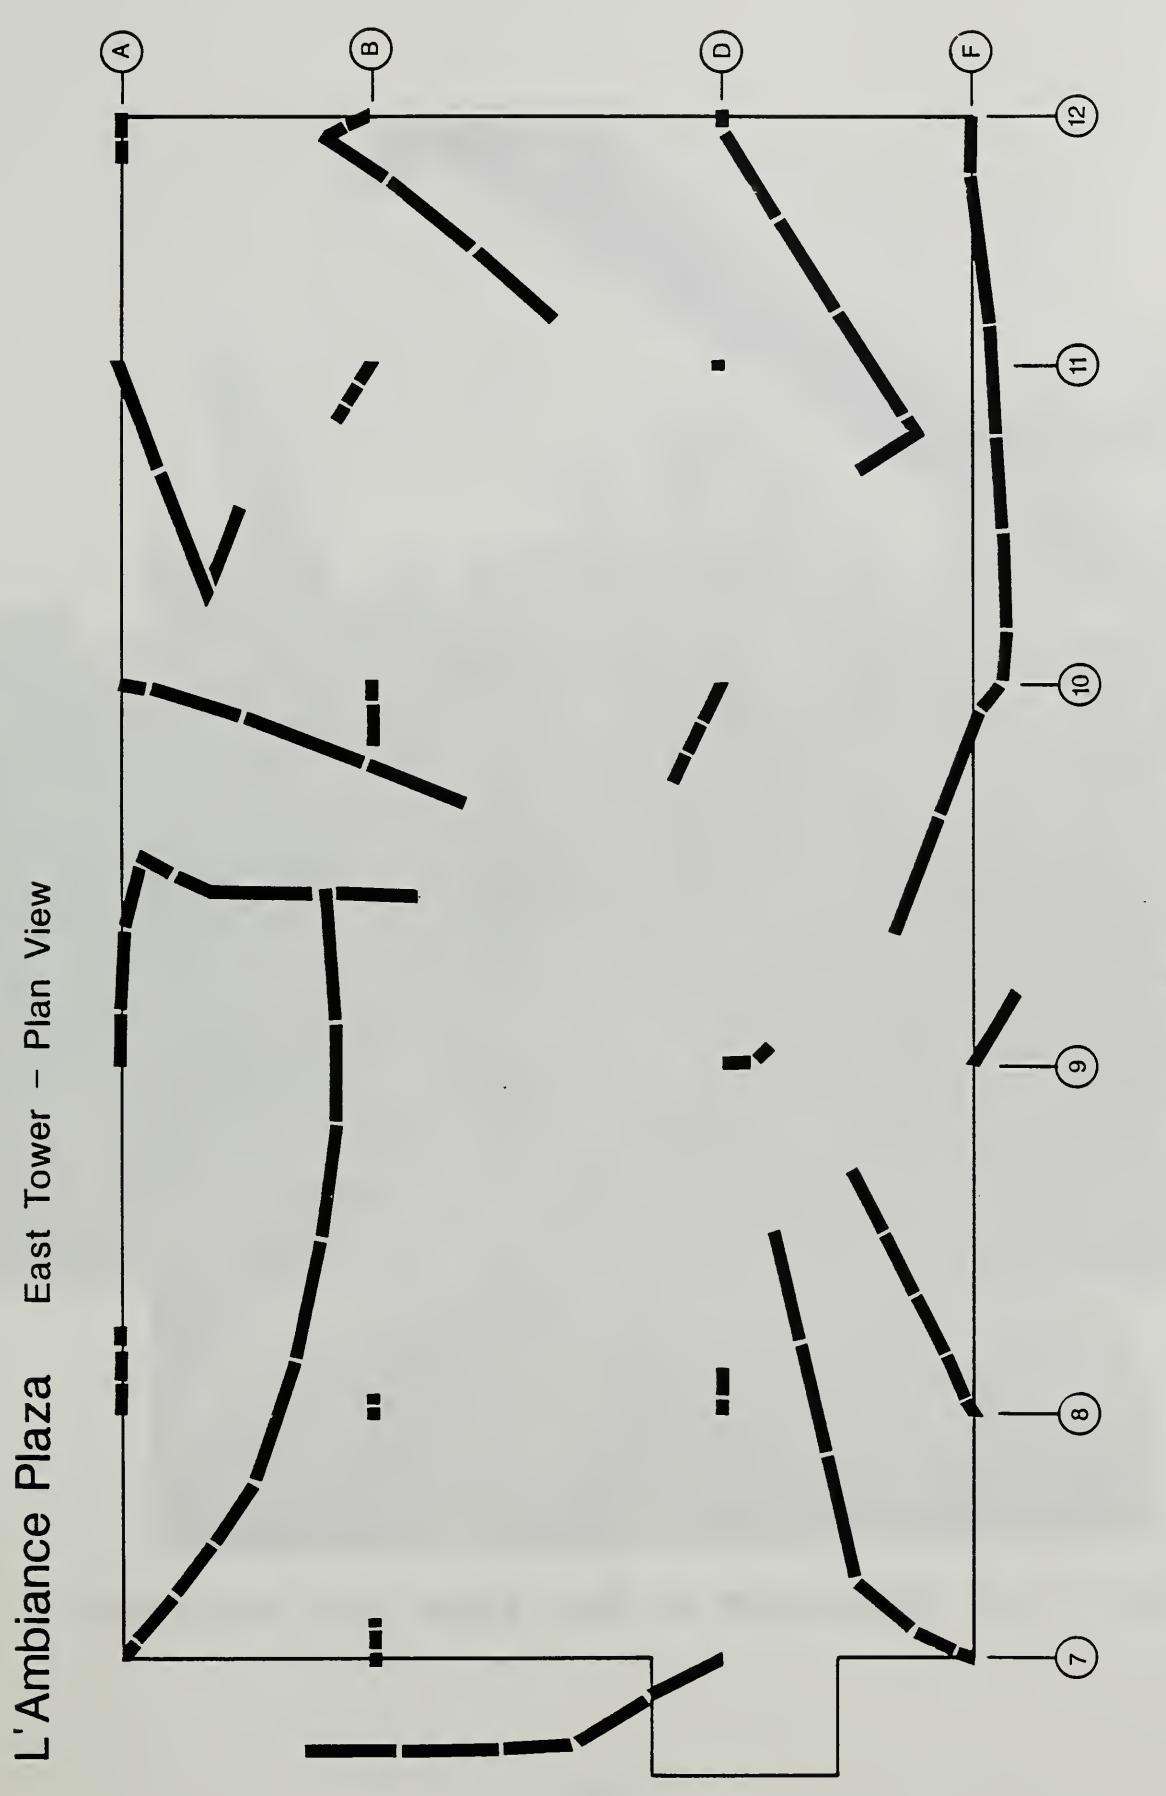
Figure 4.4.14 Pattern of column deformations - East tower

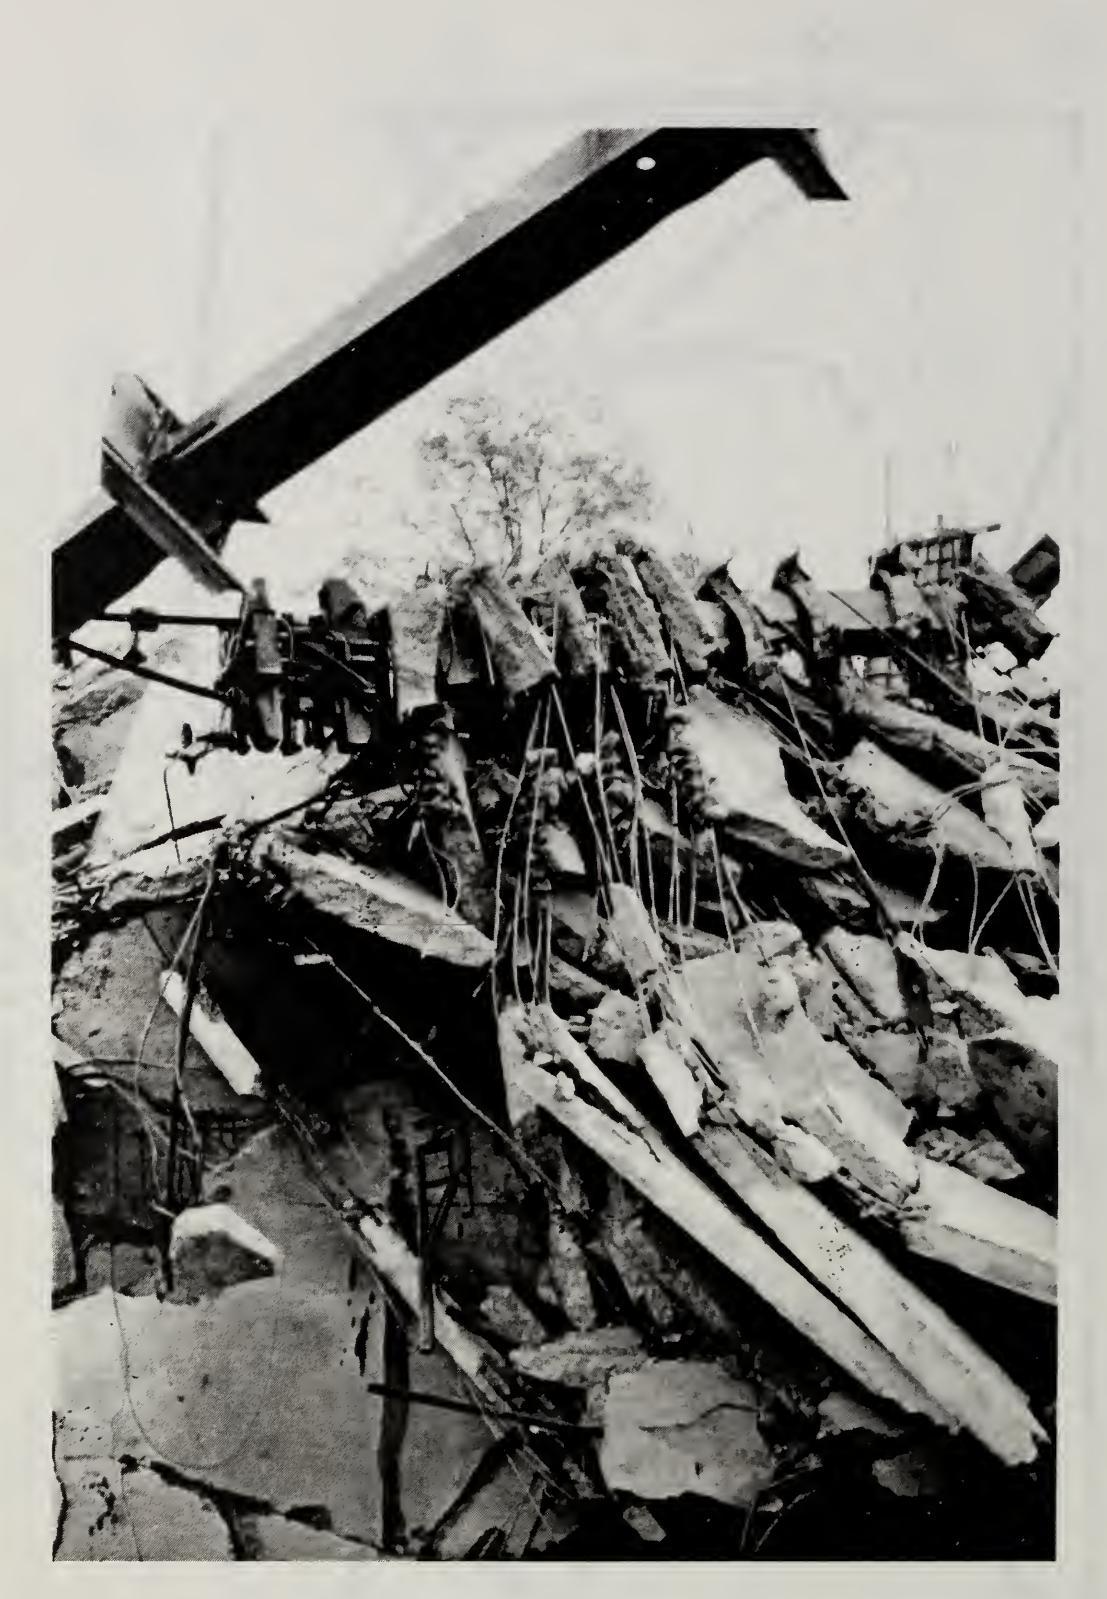
Figure 4.4.15 Separation of floor slabs from shearheads

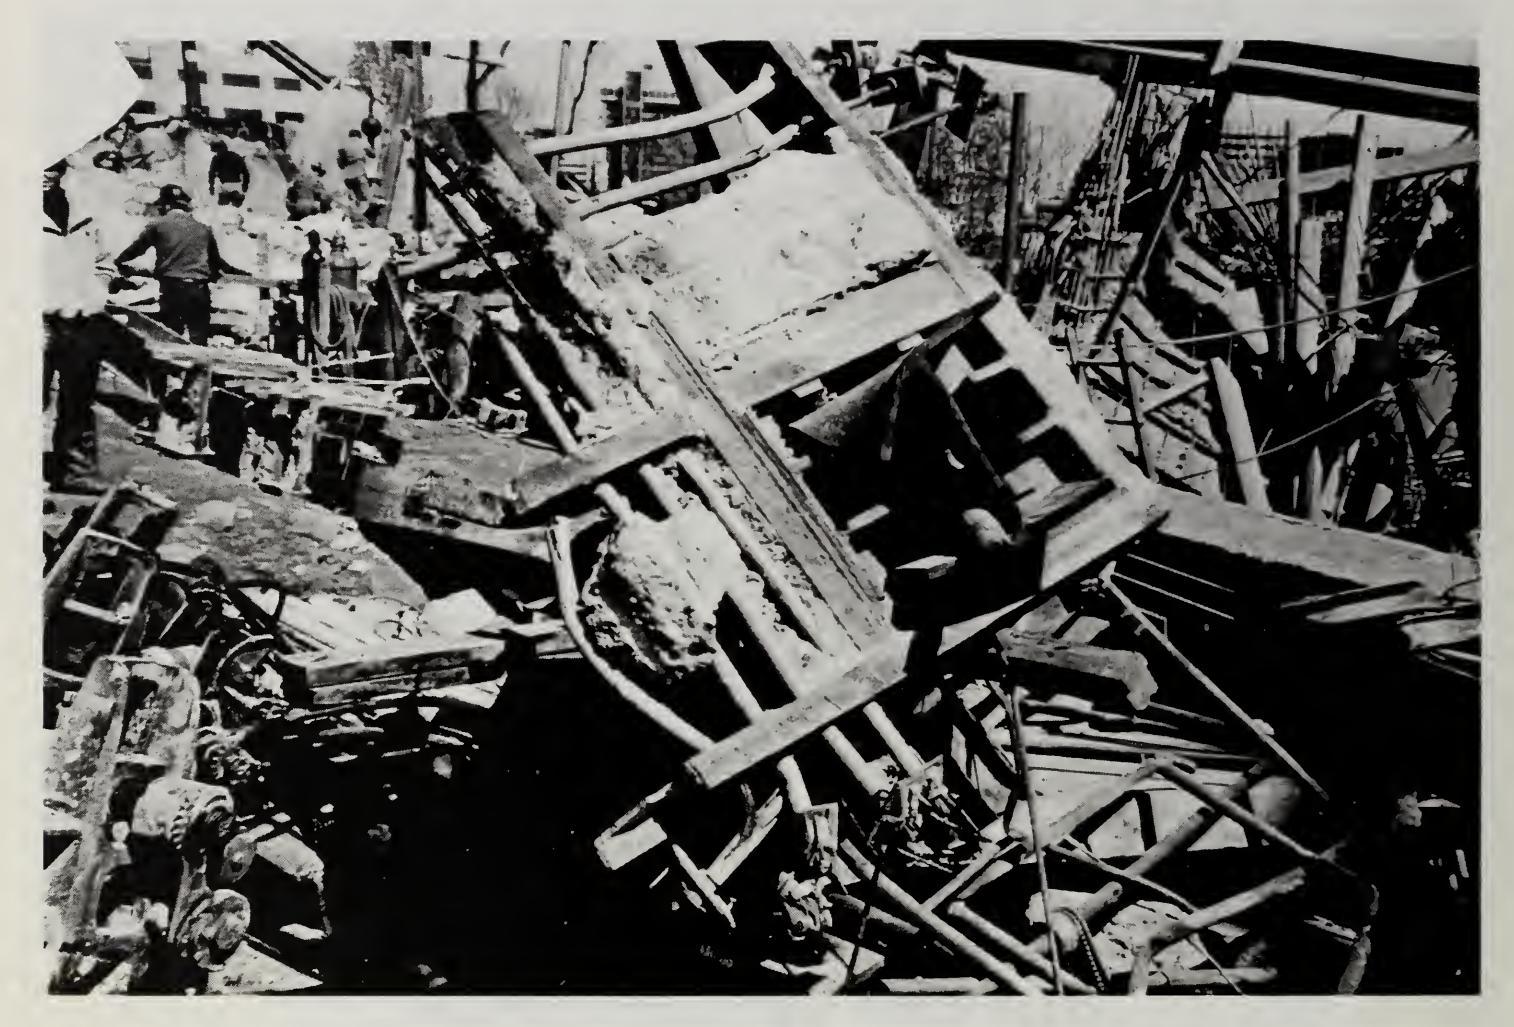
Figure 4.4.21 Corner column shearhead detail

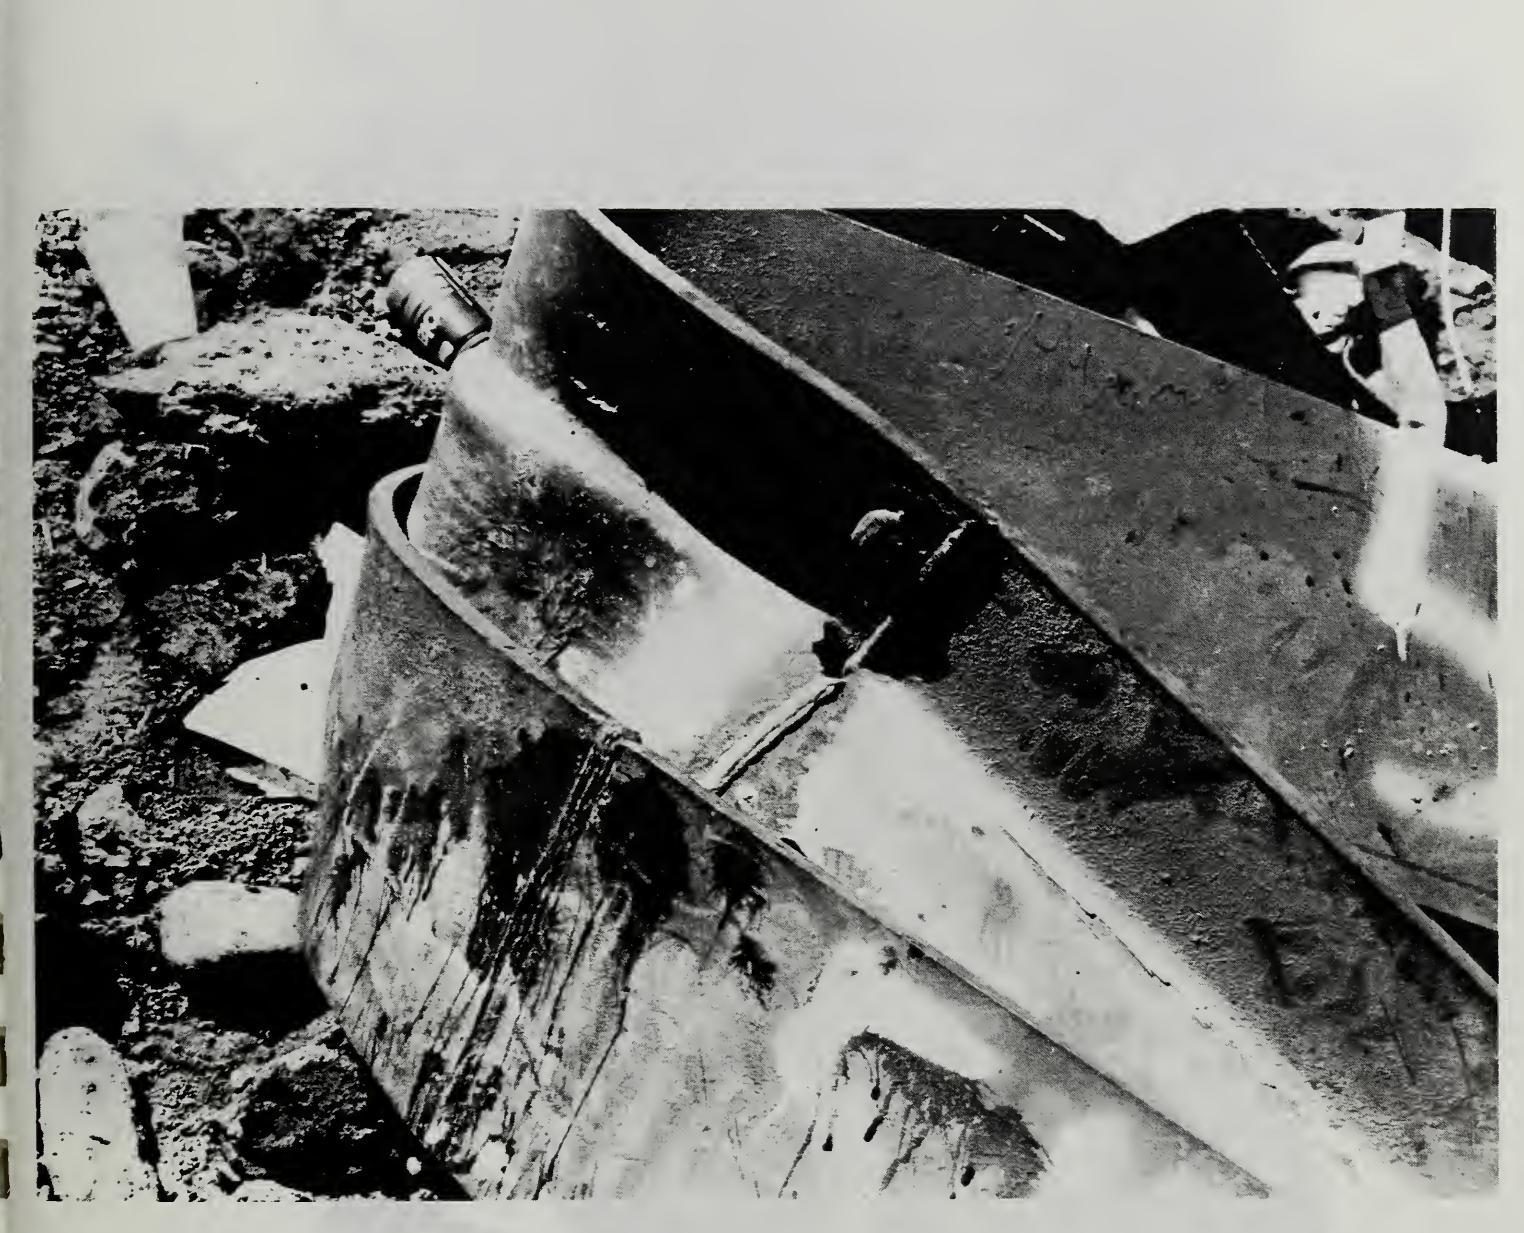
Figure 4.4.22 Deformation at column splice

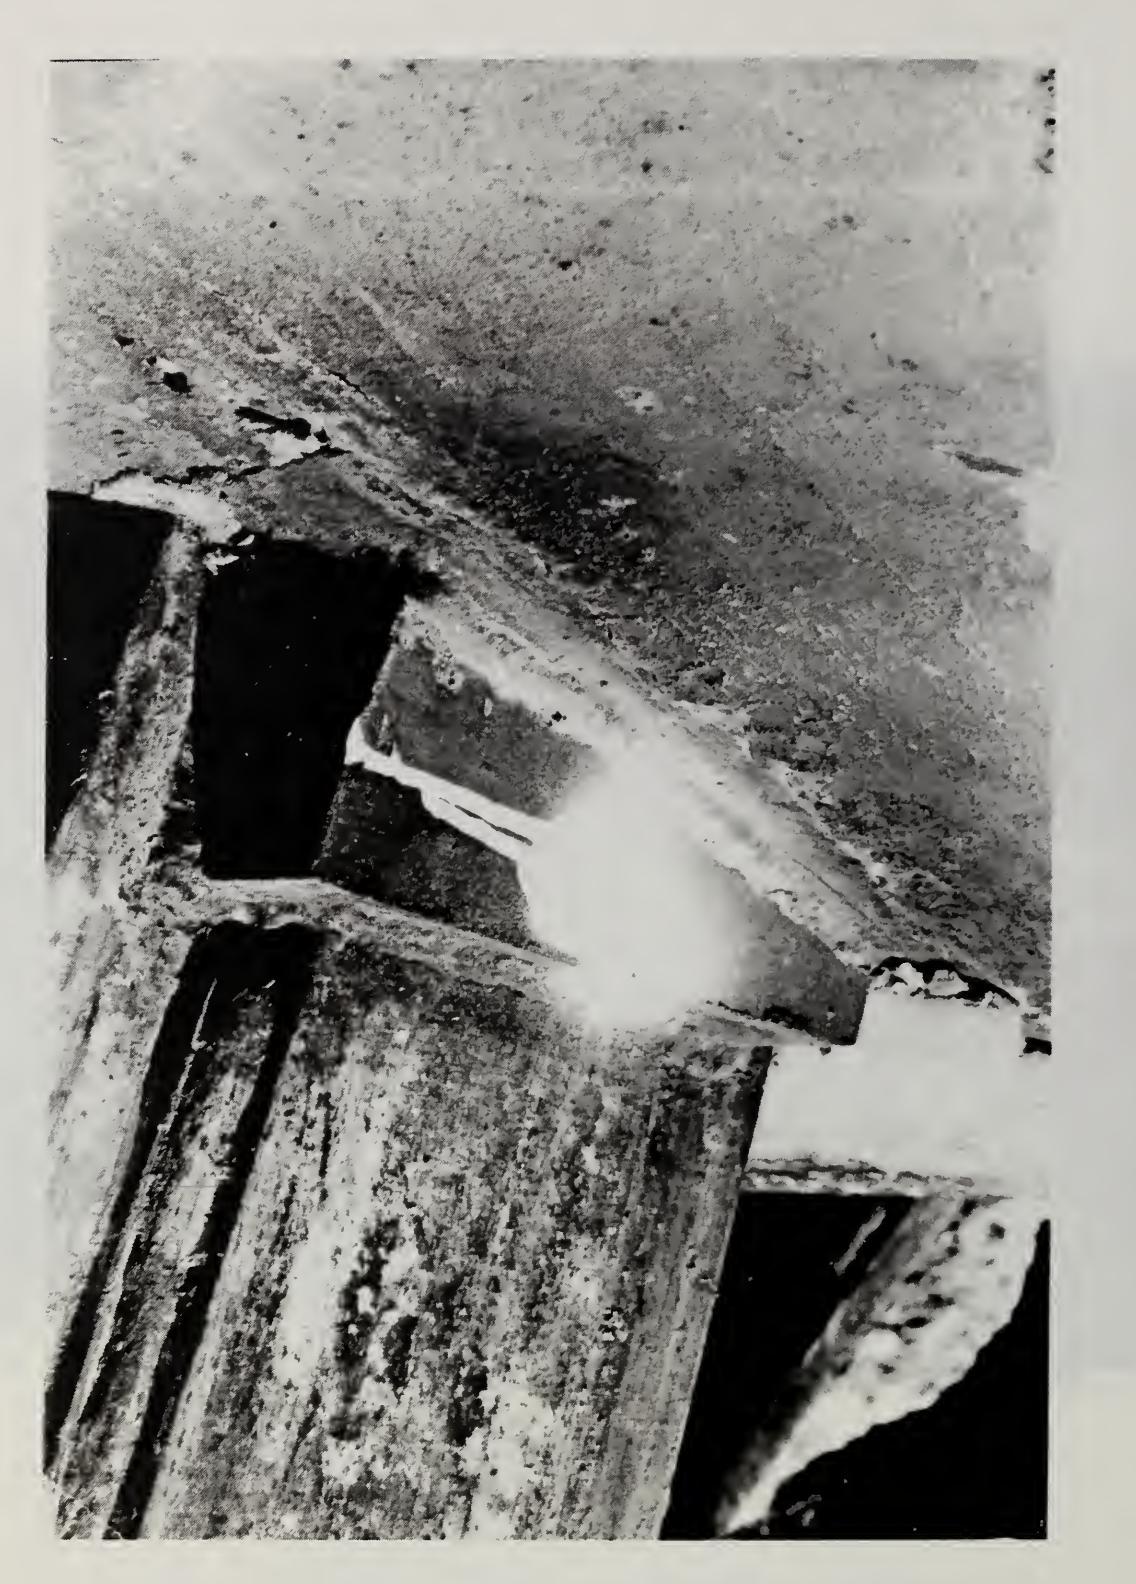
Figure 4.4.23 Intact shearhead support

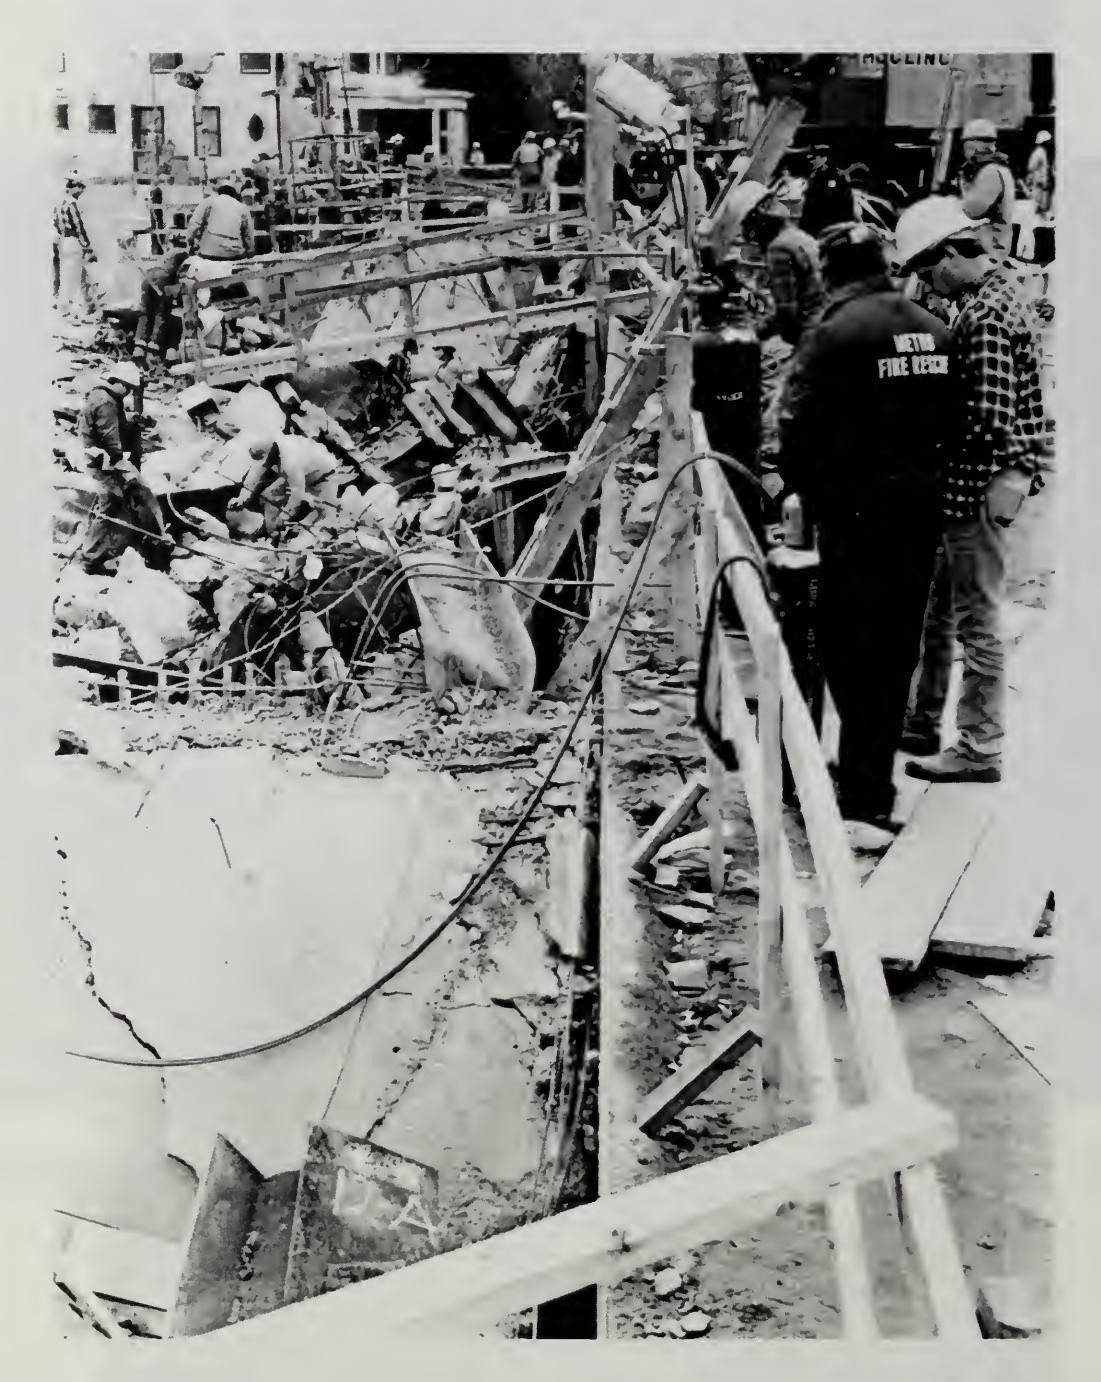
Figure 4.4.29 Basement wall on North side of East Tower - viewed from the East, May 1, 1987

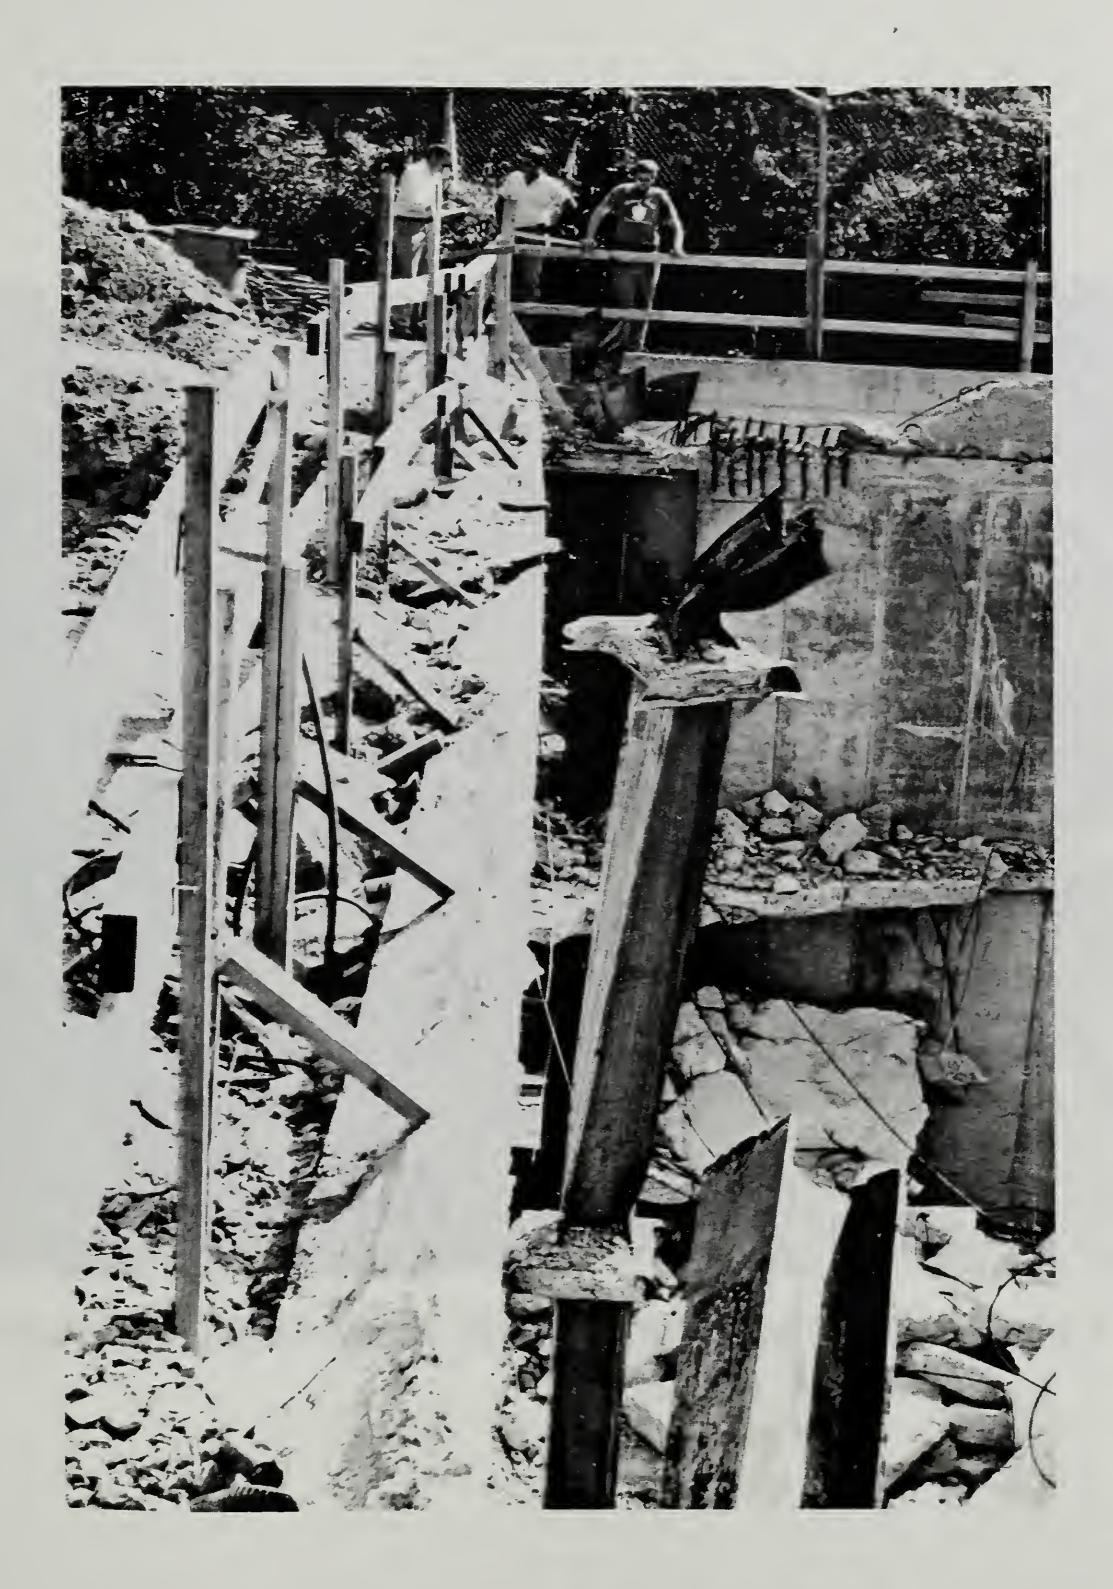
Figure 4.4.30 Basement wall on North side of East Tower - viewed from the West, July 22, 1987

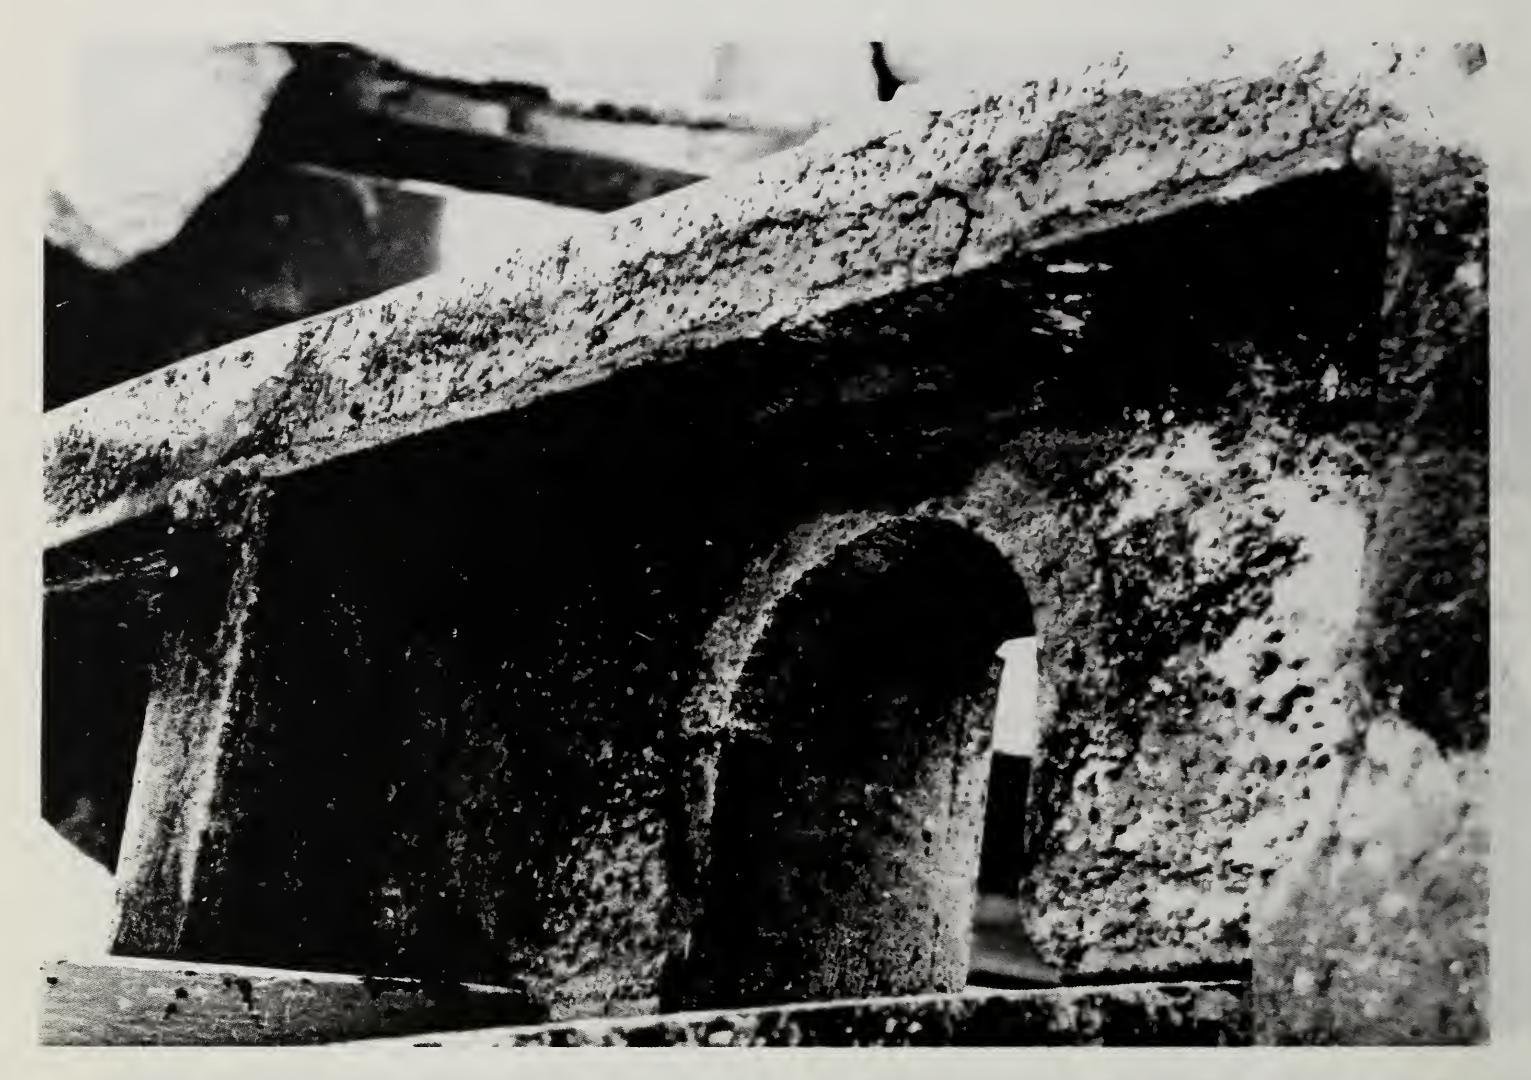
Figure 4.4.33 Typical indentation in underside of lifting angle

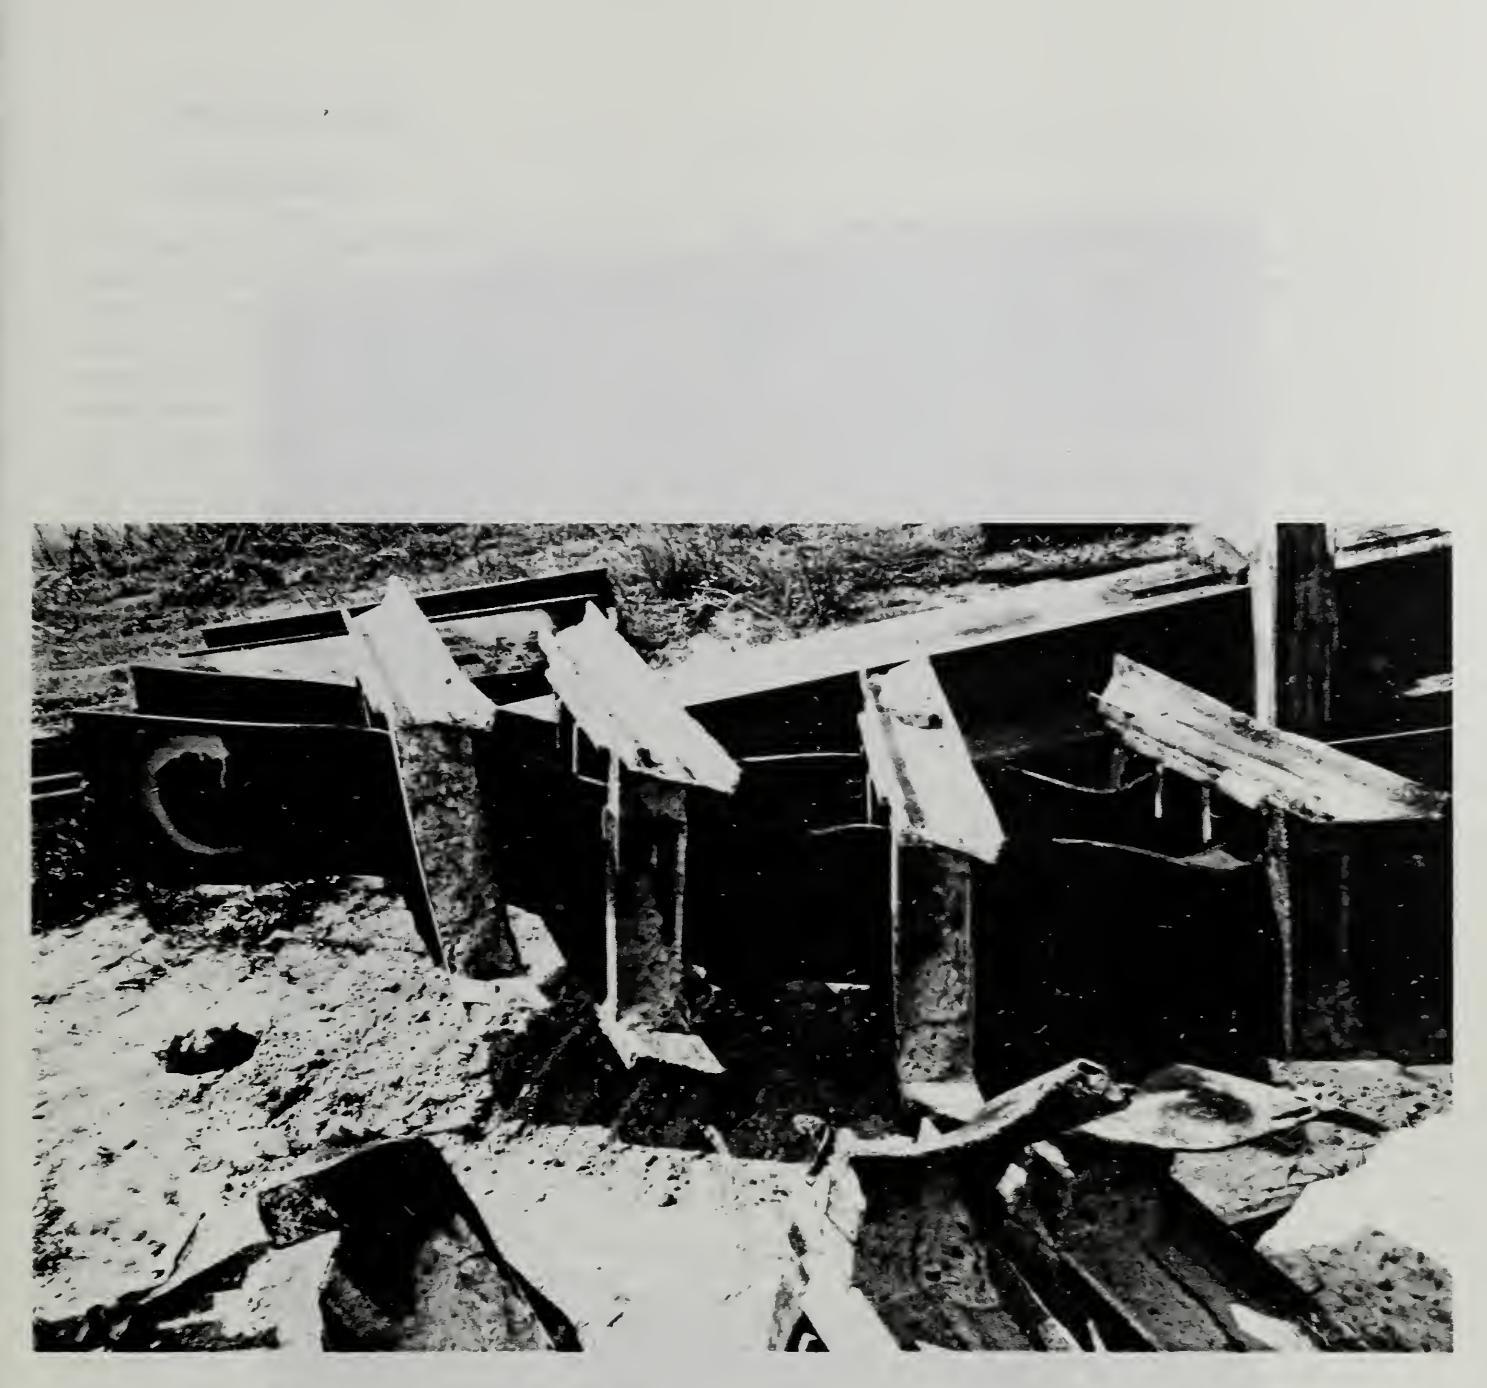
Figure 4.4.34 Deformation of column C4.8 in stage IV

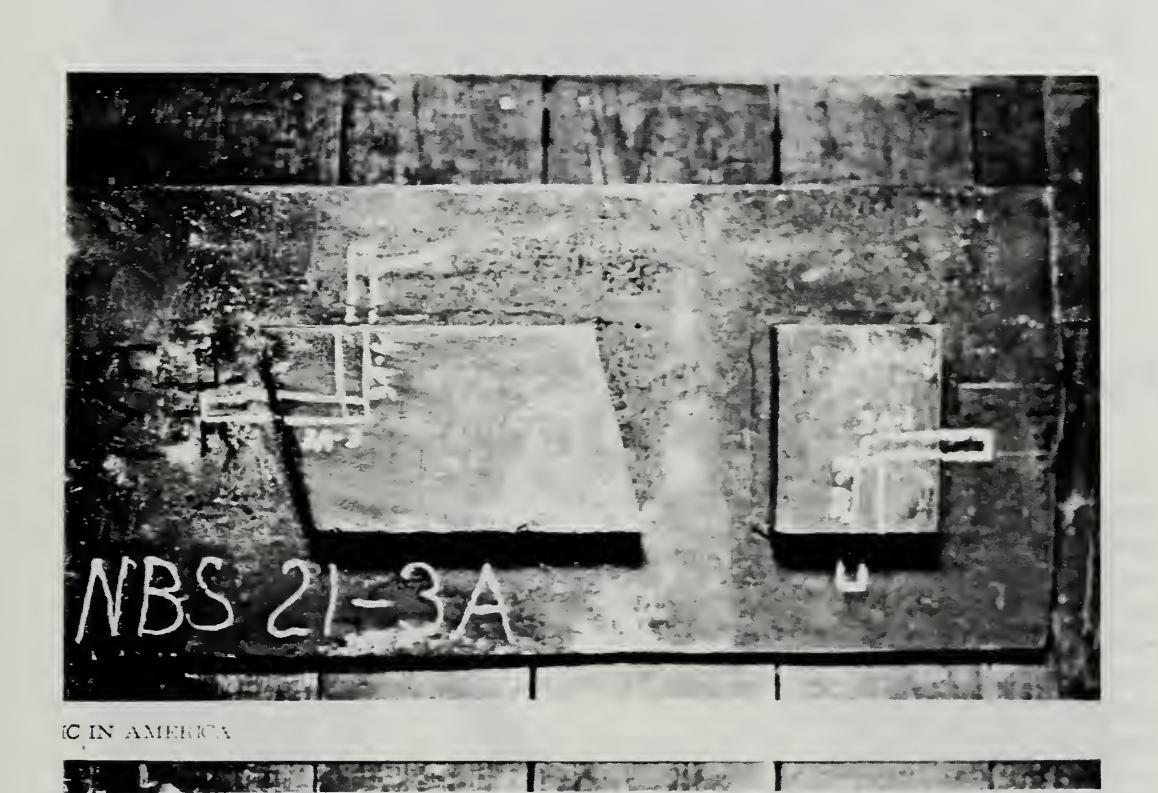
Four specimens were obtained from weld block/column sample NBS 21-3A shown in figure 5.4.2. A metallographic examination of the welds confirmed evaluations made on the basis of visual examinations. There was an apparent region of lack of fusion in specimen NBS 21-3A-2 as shown in figure 5.4.3. There were several flaws in the weld of specimen NBS-21-3A-3, including lack of penetration, slag inclusion, and a void. These flaws can be seen in figure 5.4.4. Some lack of penetration was also noted in specimen NBS 21-3A-1.

Figure 5.4.2 Weld block/column sample NBS 21-3A

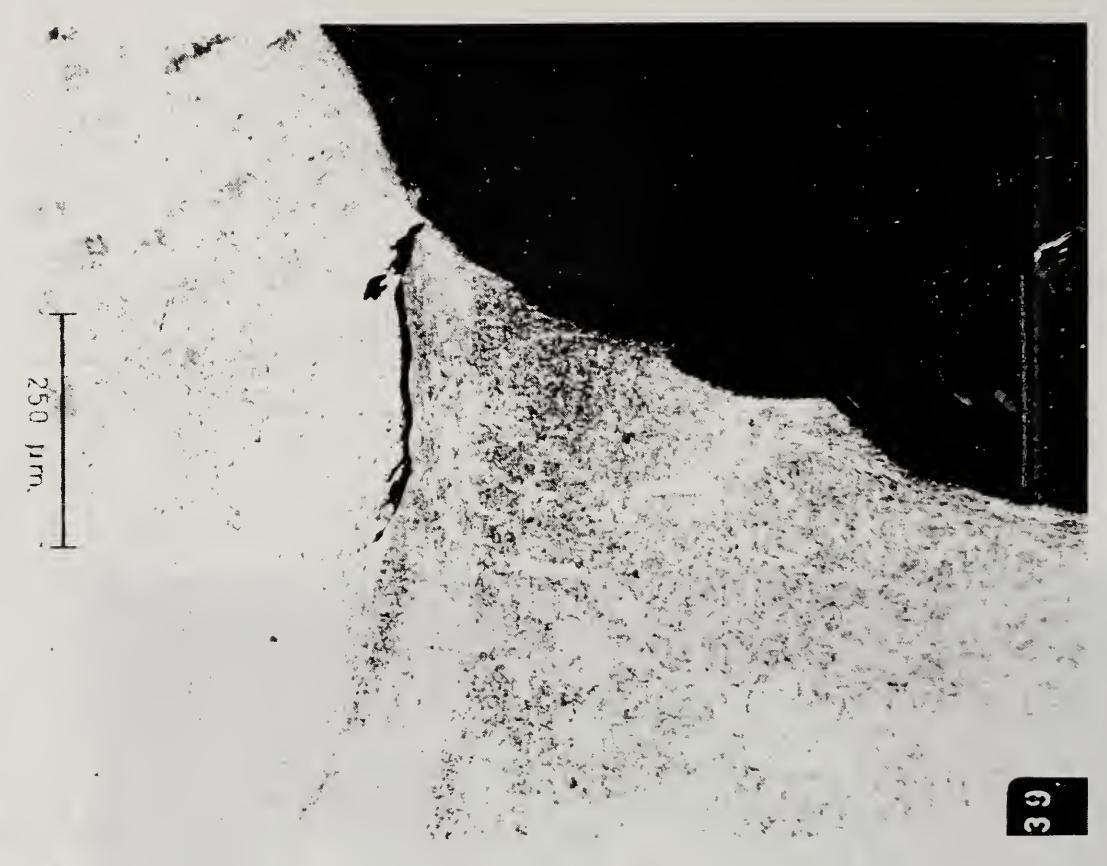
Figure 5.4.3 Cross section showing weld in sample NBS 21-3A-2 (x 100)
