NBSIR 87-3640

# Investigation of L'Ambiance Plaza Building Collapse in Bridgeport, Connecticut

Occupational Safety and Health Administration U.S. Department of Labor Washington, DC 20001

Issued September 1987

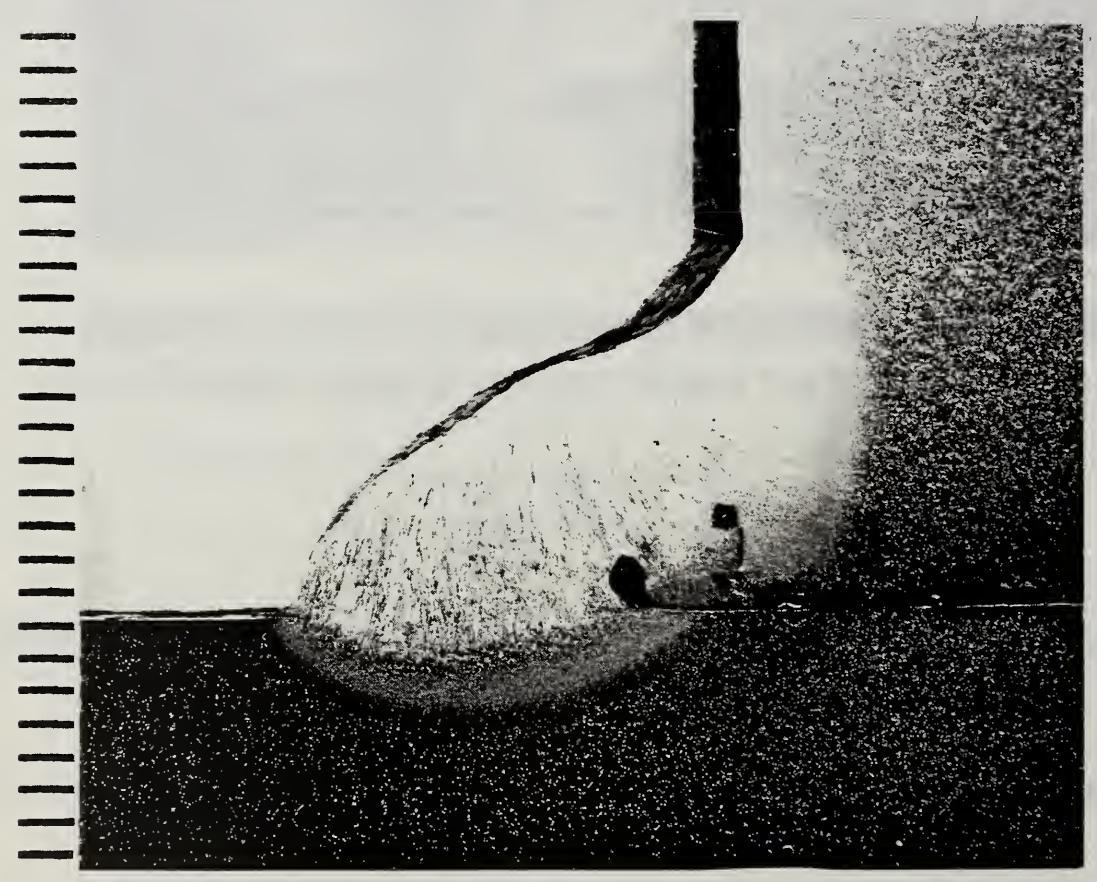
Four specimens were obtained from weld block/column sample NBS 21-3A shown in figure 5.4.2. A metallographic examination of the welds confirmed evaluations made on the basis of visual examinations. There was an apparent region of lack of fusion in specimen NBS 21-3A-2 as shown in figure 5.4.3. There were several flaws in the weld of specimen NBS-21-3A-3, including lack of penetration, slag inclusion, and a void. These flaws can be seen in figure 5.4.4. Some lack of penetration was also noted in specimen NBS 21-3A-1.

Figure 5.4.4 Cross section showing weld in sample NBS-3A-3 (x 4)

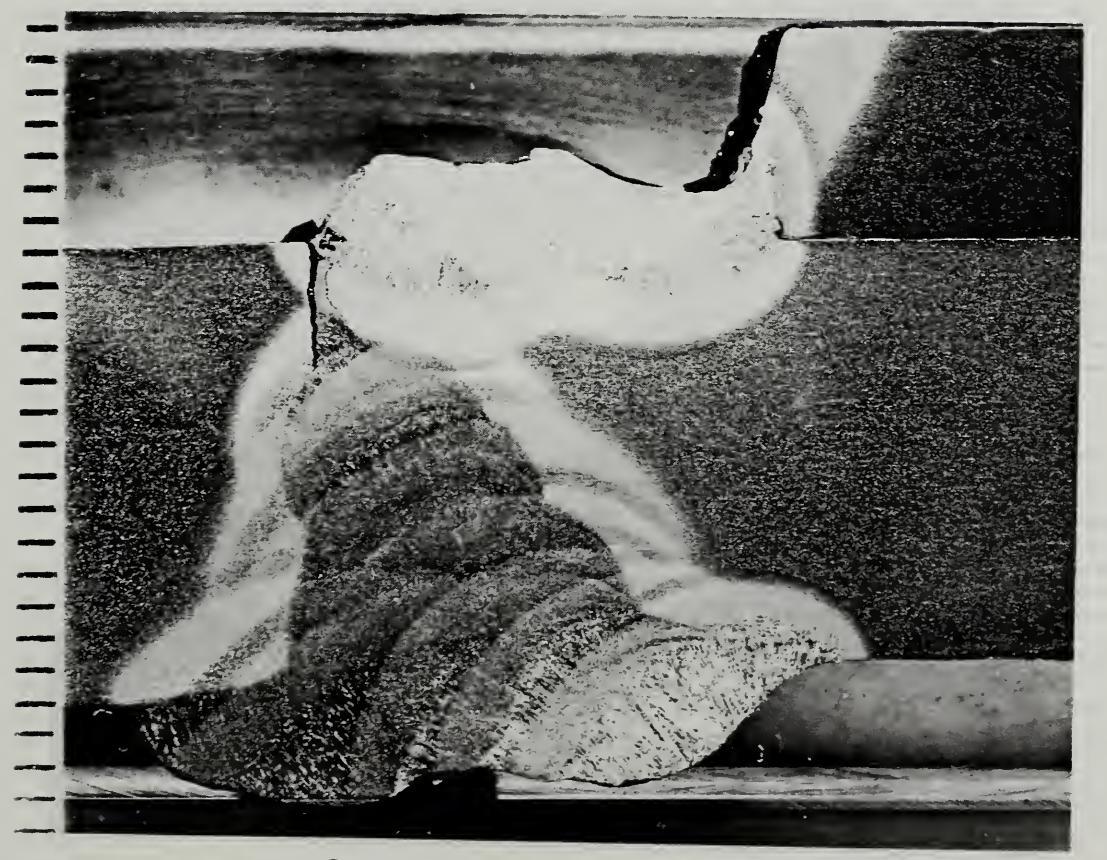
showing the weld appears in figure 5.4.6. At the upper part of the joint as shown in the figure, the weld is displaced laterally from the joint. The extent of the unwelded part of the joint is shown at higher magnification in figure 5.4.7. The unwelded joint may have extended as a crack into the weld. The microstructure here consists primarily of granular bainite. There was incomplete penetration of the weld in the other column welded joints examined as well. The joint in specimen NBS 6-Fl is shown in figure 5.4.8. There are both voids and lack of penetracion in this weld. There may also be some slag inclusions. The weld in sample NBS 6-W1 exhibited a lack of penetration near the center, and a crack in the weld emanated from the region of no penetration. A cross section through this weld is shown in figure 5.4.9. A lack of penetration was also found in sample NBS 4-F1, as shown in figure 5.4.10. The weld in sample NBS 4-W1, shown in figure 5.4.11, exhibits lack of penetration, lack of fusion, and cracking through the weld metal. There was a small region of no penetration in the weld in specimen NBS 8-F1. Sections through specimens 5-W1, 5-F1 and 8-W1 were also examined. No significant lack of penetration, lack of fusion or inclusions/voids were detected in these samples. Some martensite was found in the HAZ associated with the last weld pass in specimen NBS 4-F1.

Figure 5.4.6 Cross section showing weld in specimen NBS 8-T1 (x 4)

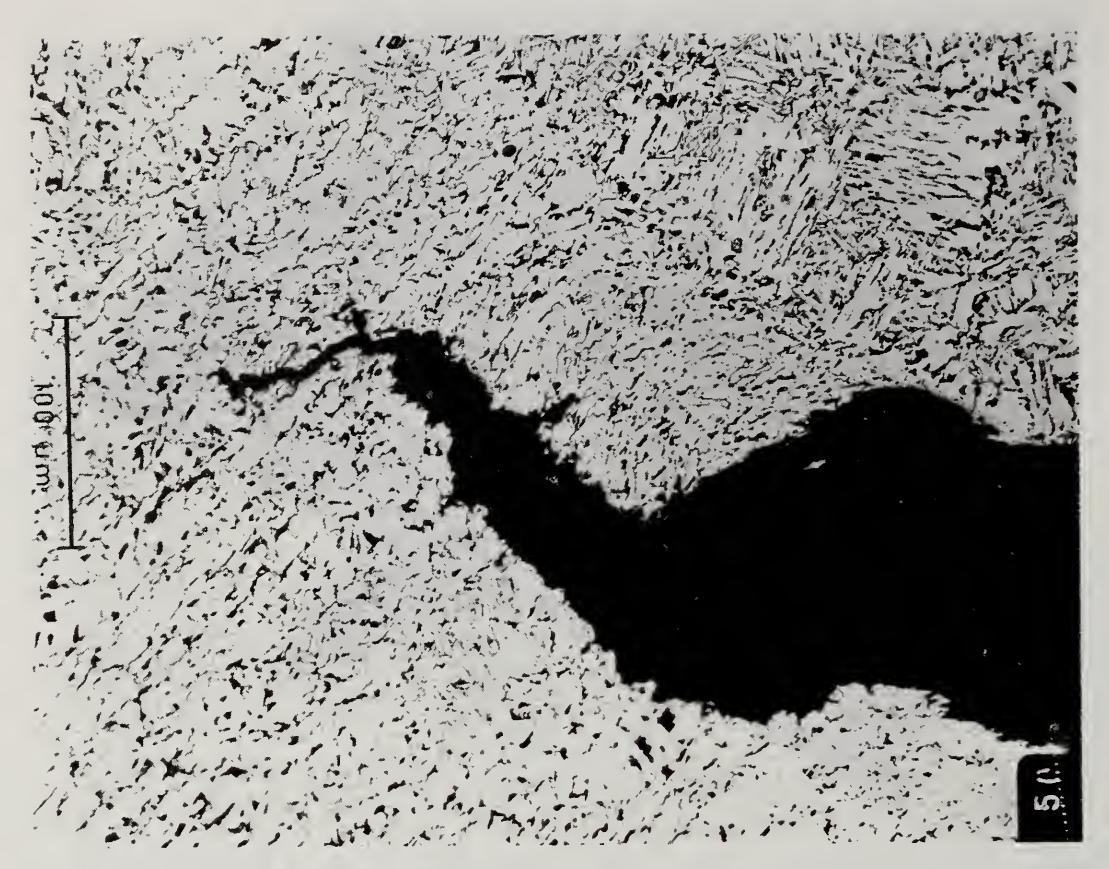
Figure 5.4.7 Cross section showing weld in specimen NBS 8-T1 at higher magnification than in Figure 5.4.6

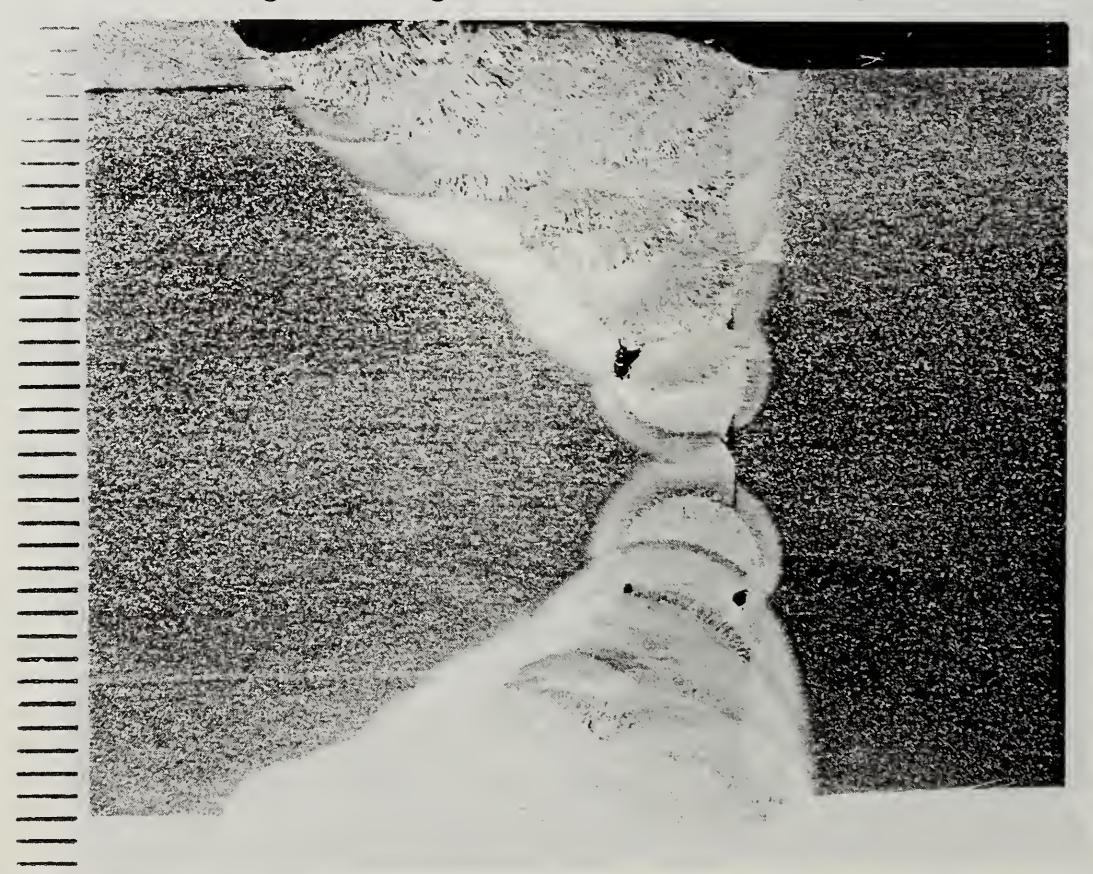
Figure 5.4.8 Cross section showing the weld in specimen NBS 6-F1(x 4)

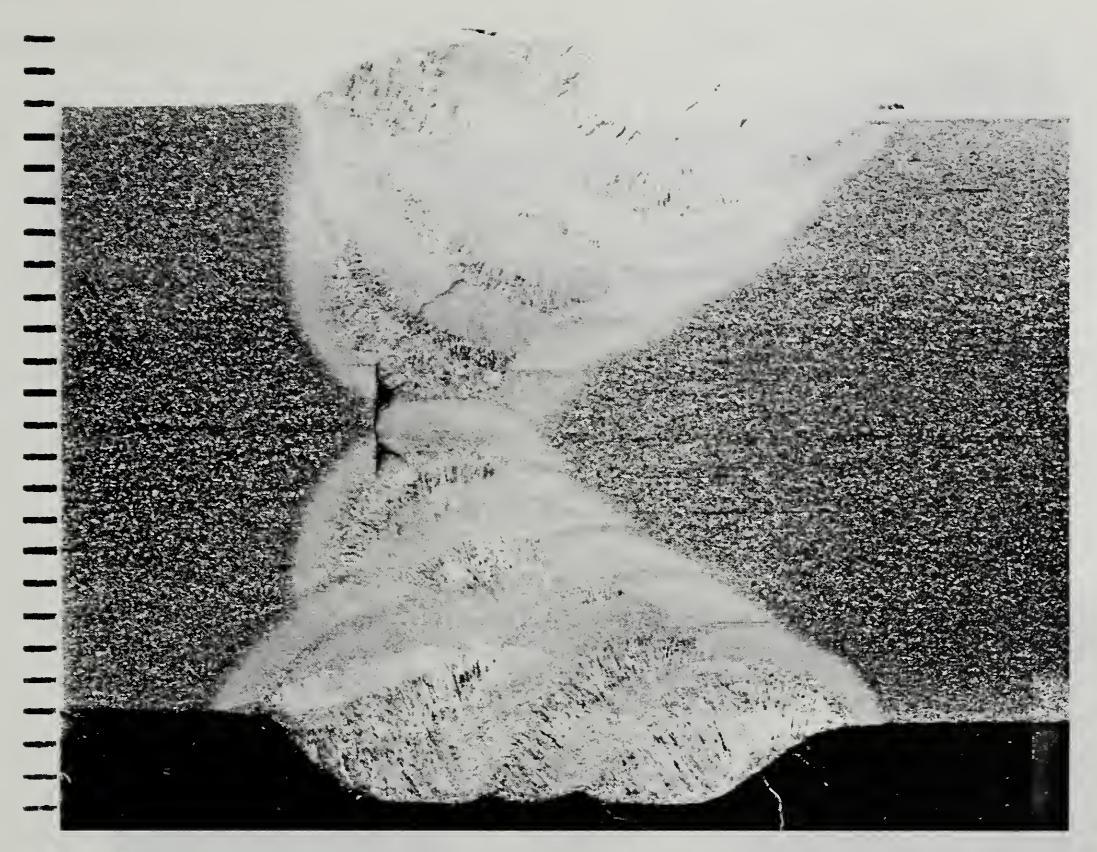
Figure 5.4.9 Cross section showing the weld in specimen NBS 6-W1 (x 4)

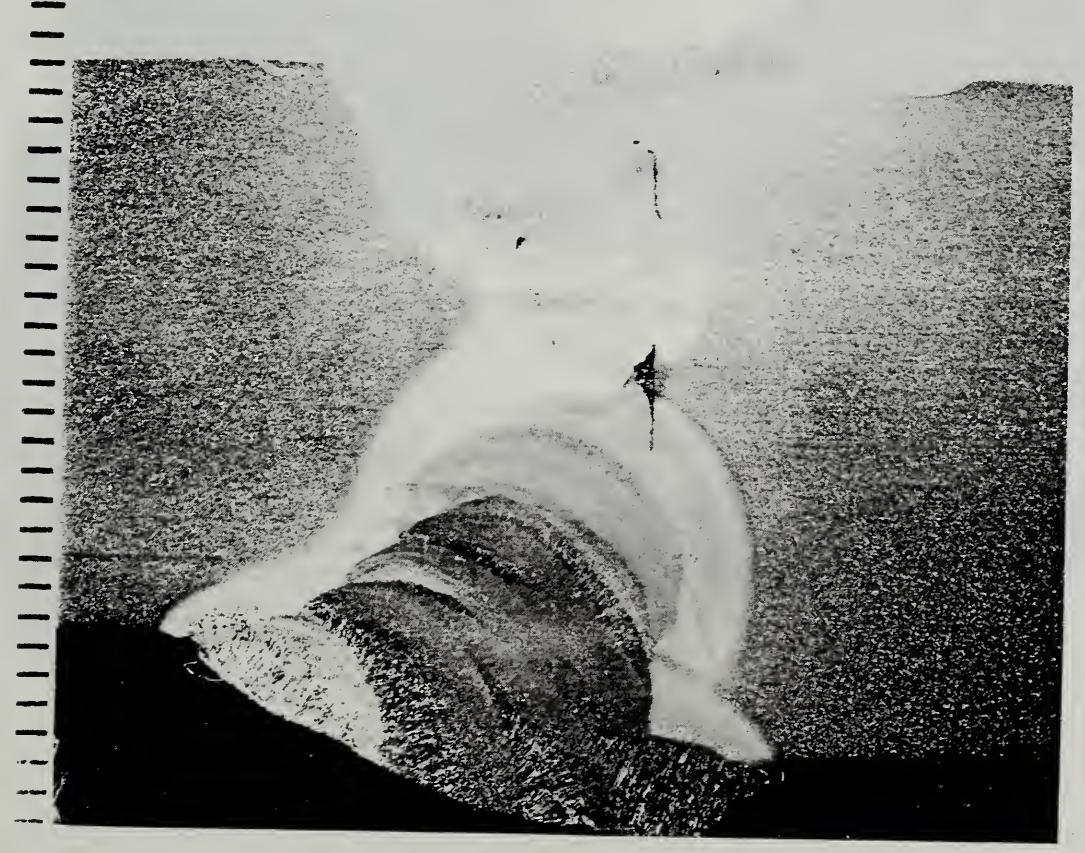
Figure 5.4.10 Cross section showing the weld in specimen NBS 4-F1(x 4)

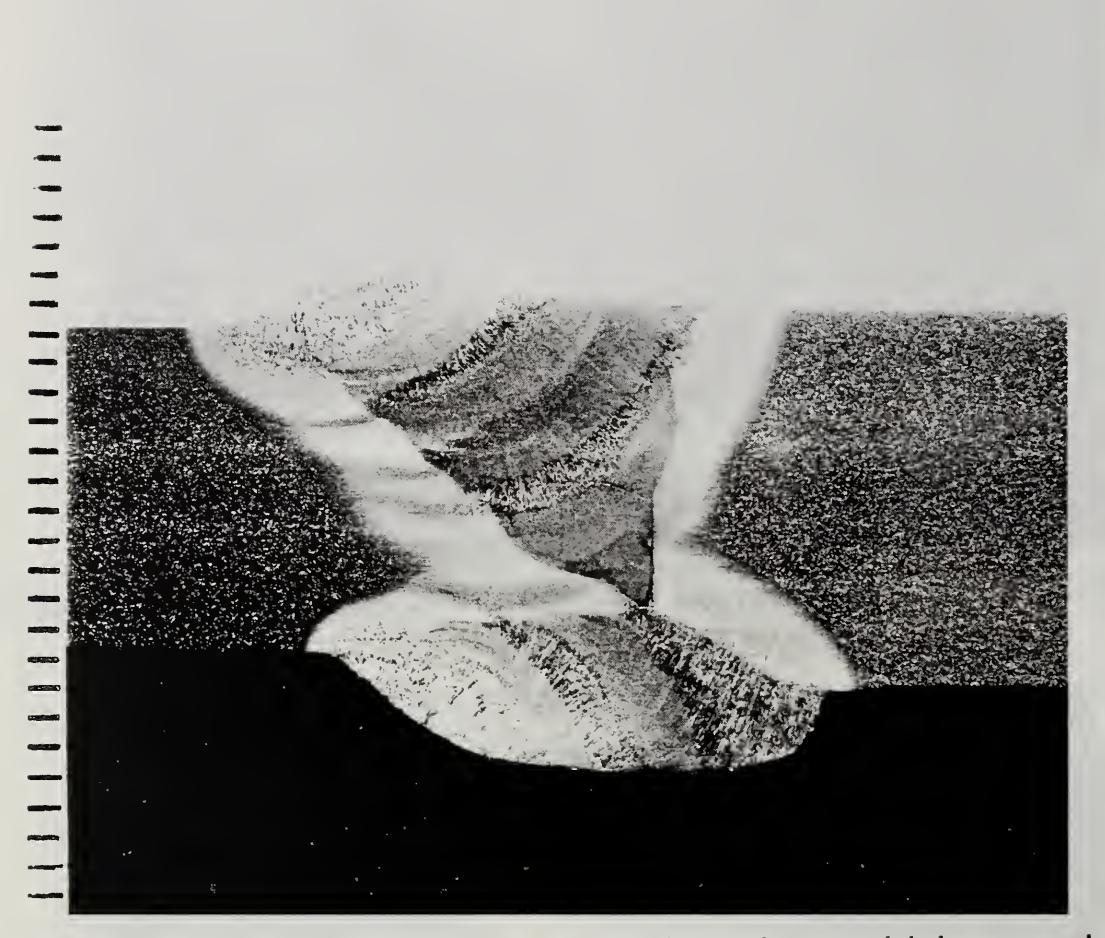
Figure 5.4.11 Cross section showing the weld in specimen NBS 4-W1(x 4)

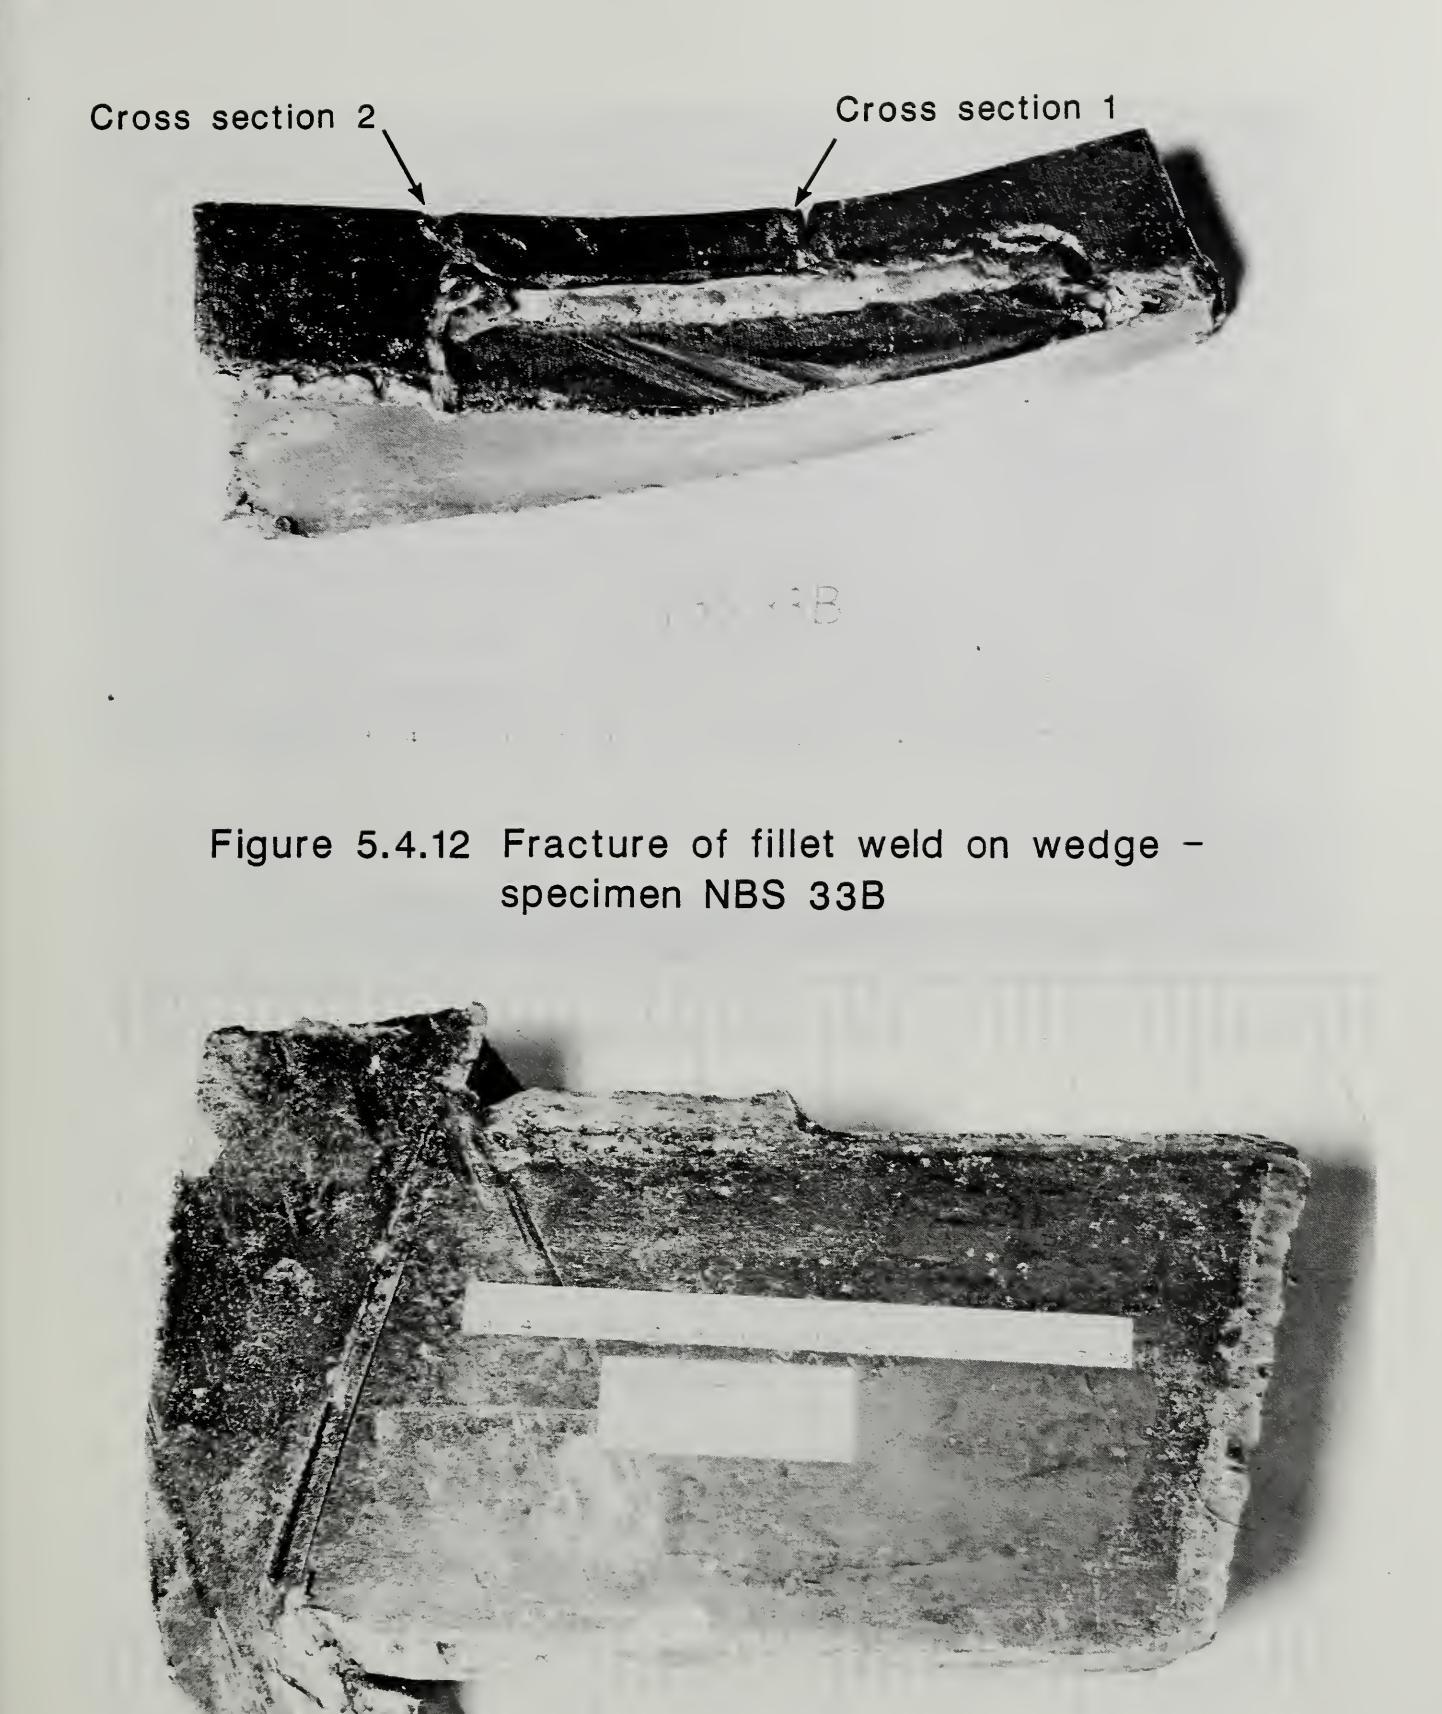
Fractography was performed on two specimens, NBS 33B and NBS 33A. Specimen 33B shown in figure 5.4.12 was a wedge found loose in the debris after the collapse. The wedge had been fully welded to the shearhead, weld block, and column flange prior to failure. Specimen 33A, shown in figure 5.4.13, was a wedge found loose in the debris. The specimens were sectioned to facilitate macroscopic inspection and microscopic inspection in a scanning electron microscope (SEM).

Figure 5.4.13 NBS specimen 33A, weld block/wedge sample from debris

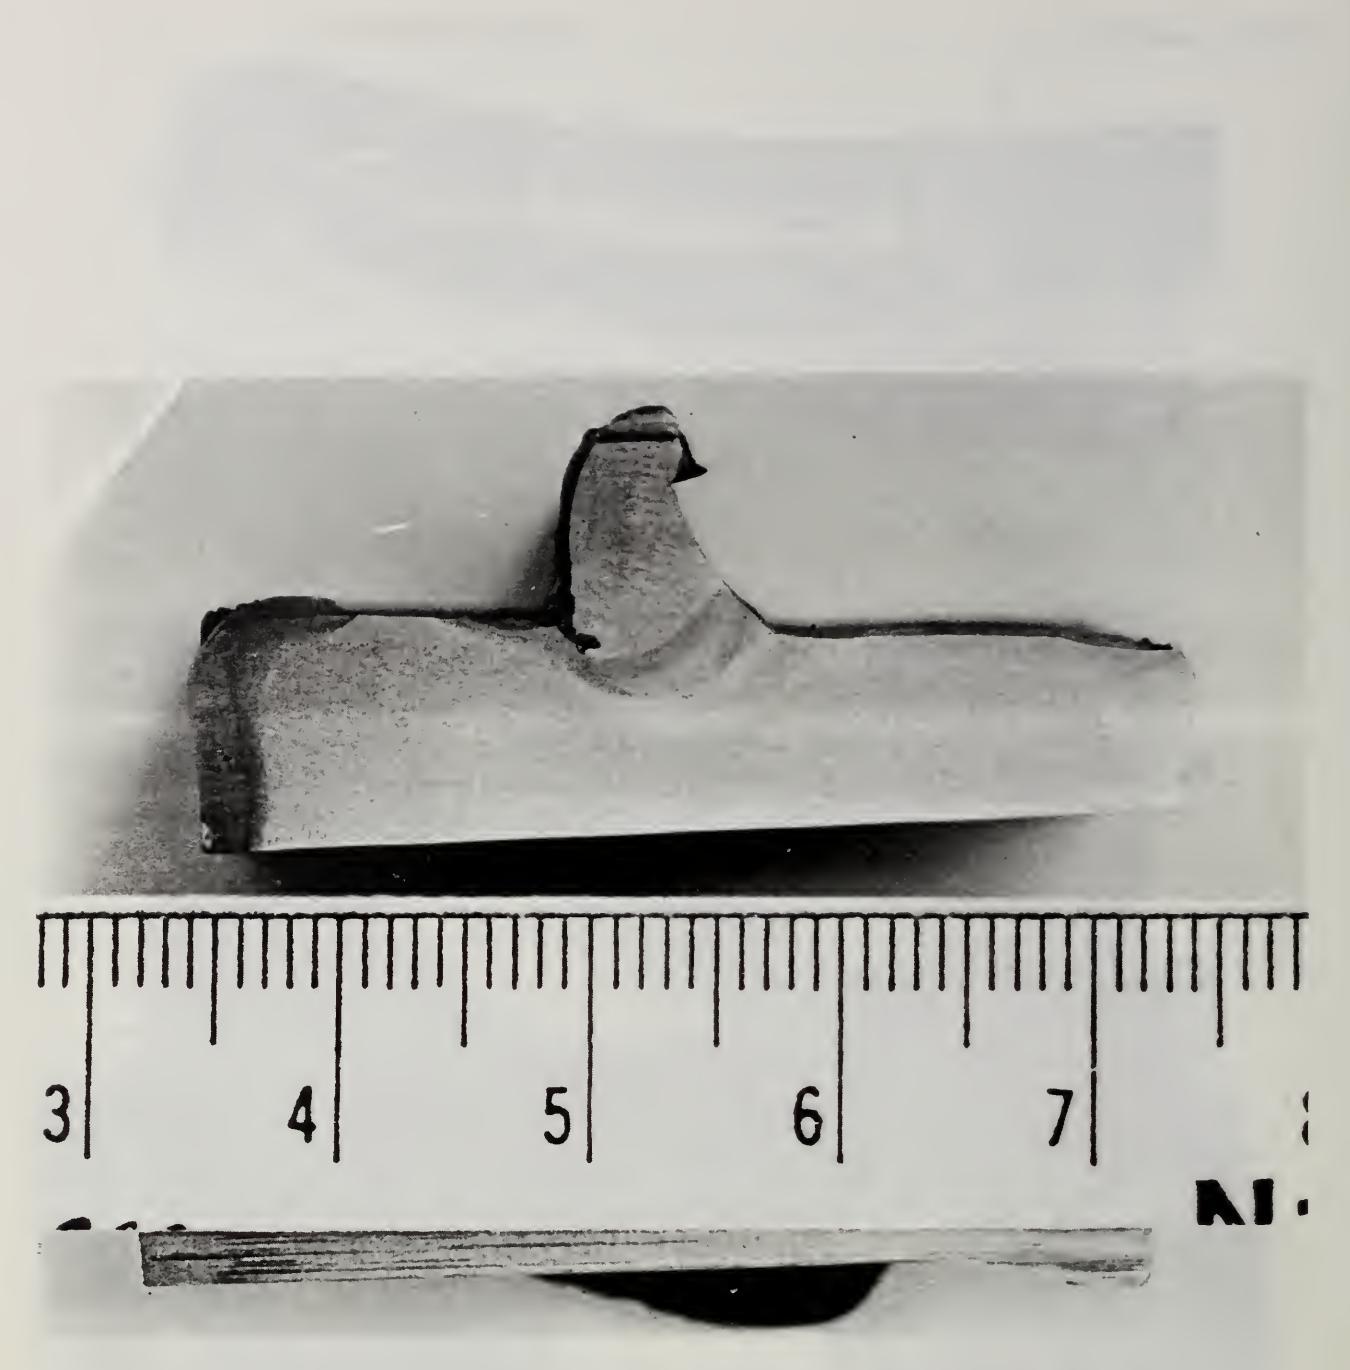
Macroscopic examination of the wedge, specimen 33B, revealed substantial deformation. Both the point and heel of the wedge were bent downward (toward the ground when oriented in the structure), indicating that substantial plastic deformation occurred during failure. There were angled gouges on the surface of the wedge where it contacted the weld block. These gouges indicated the wedge slid in both the wedging direction (along the flange surface on the column) and normal to the flange (away from the flange surface) during failure. The ratio of the movement is about 3 times in the wedging direction to that normal to the flange. There were indications that the wedge also rotated about the edge of the weld block as it failed.

Figure 5.4.14 Metallographic cross section #1 - specimen NBS 33B

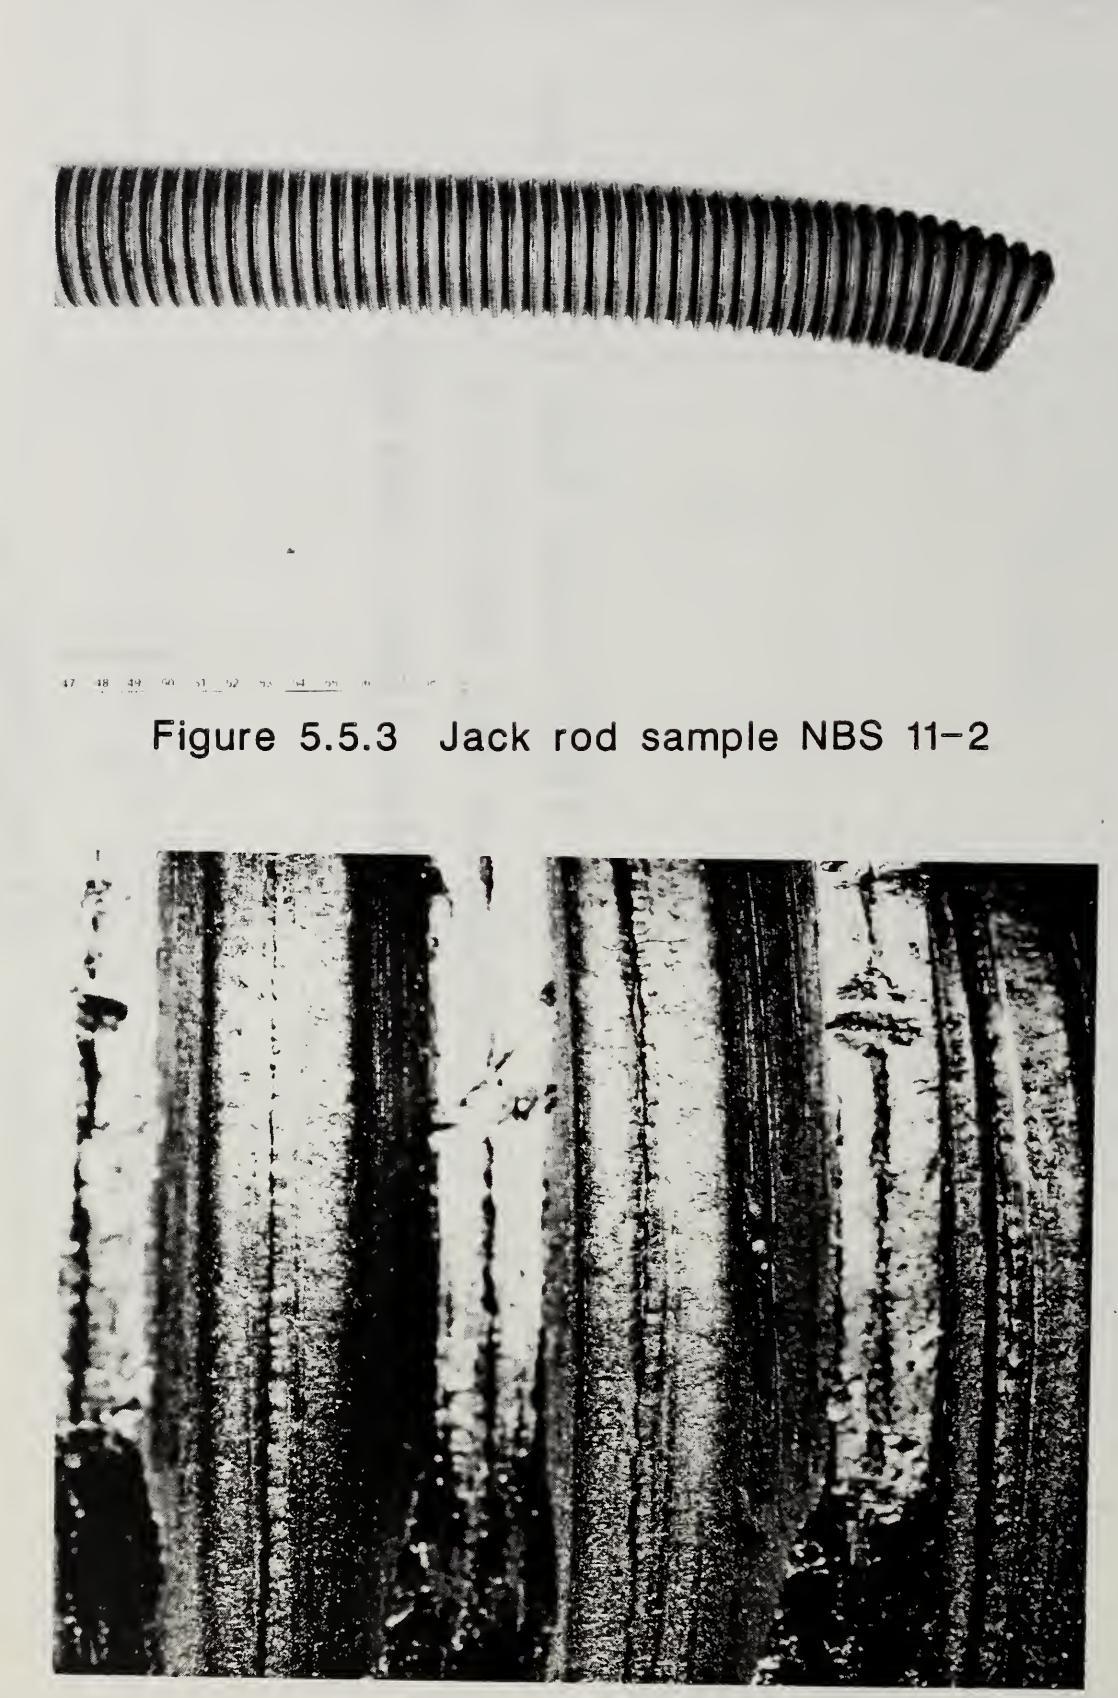
Figure 5.5.4 Jack rod on tension side showing lap seam from thread rolling operation (x 3)

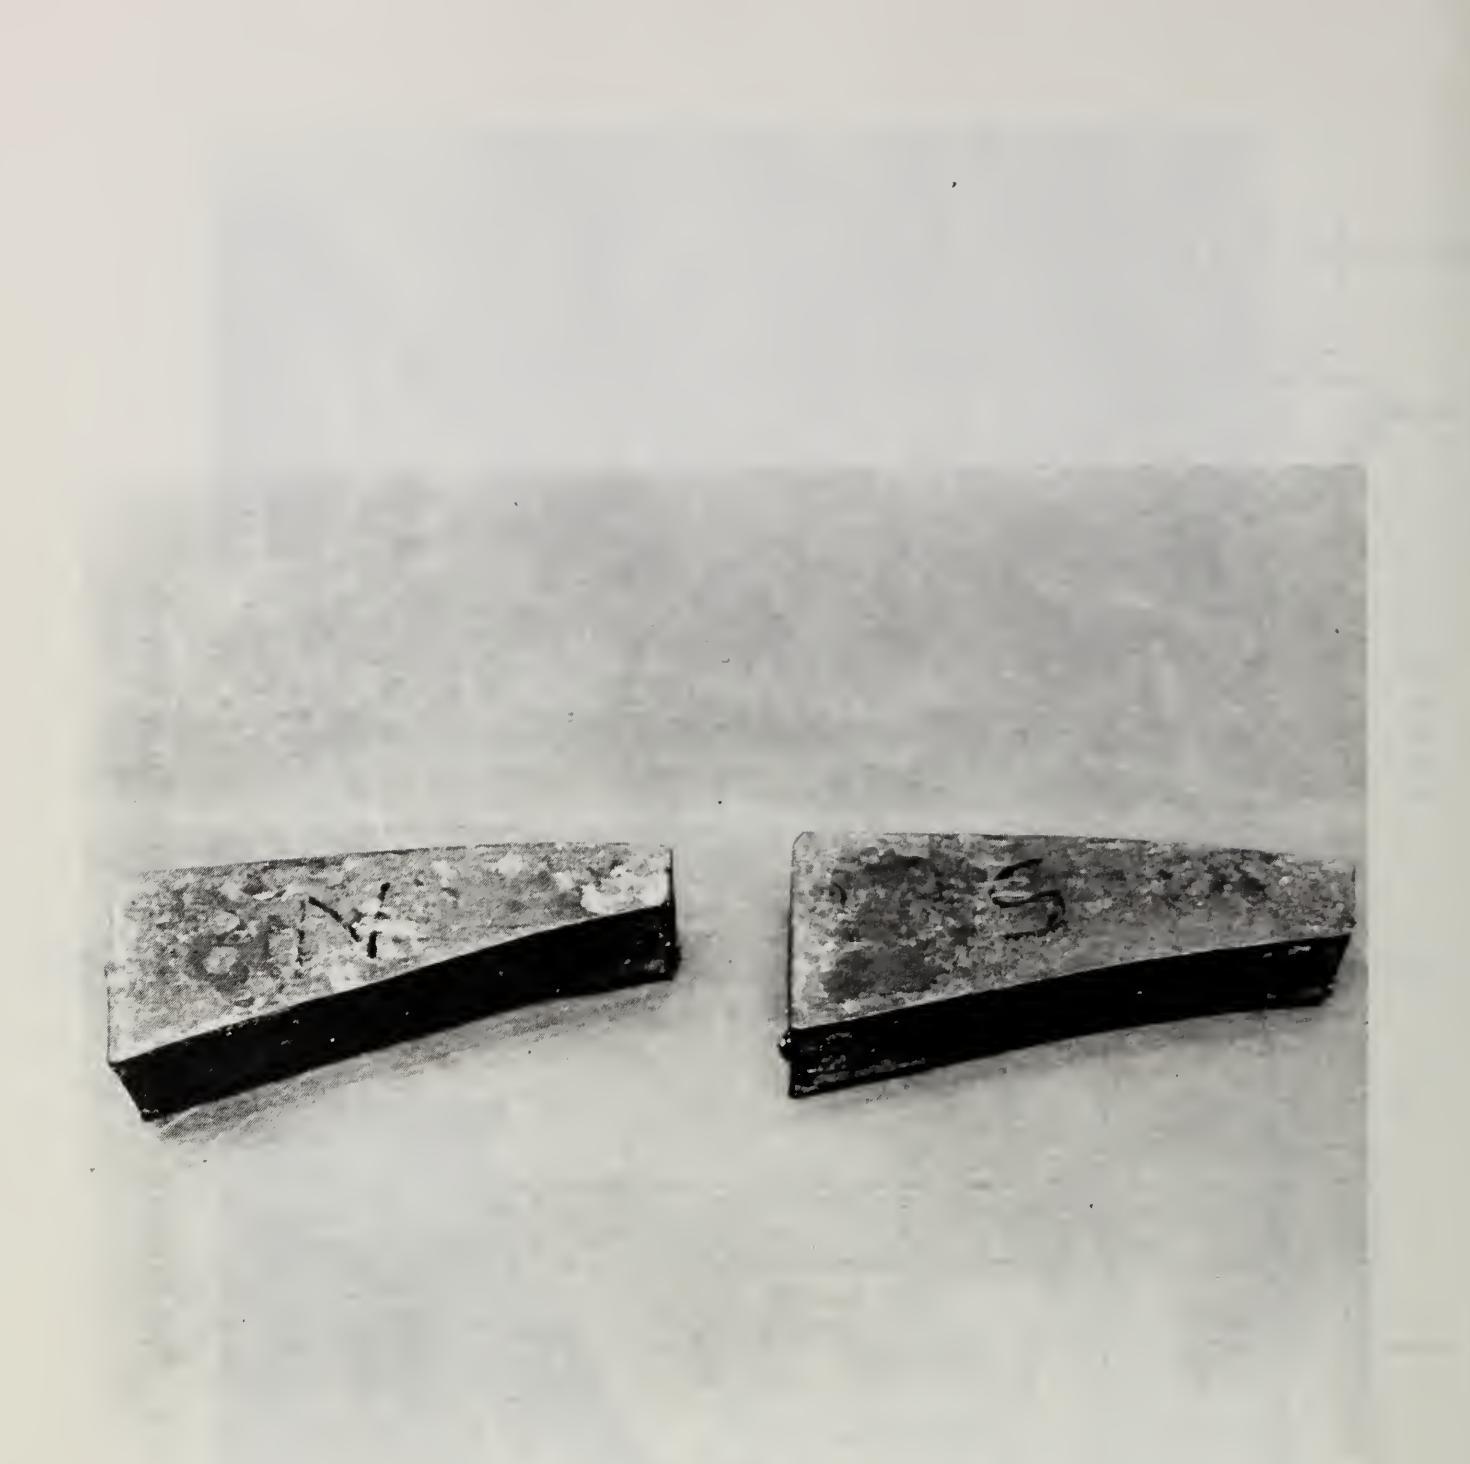
Figure 5.5.10 Deformation of wedges in test of shearhead

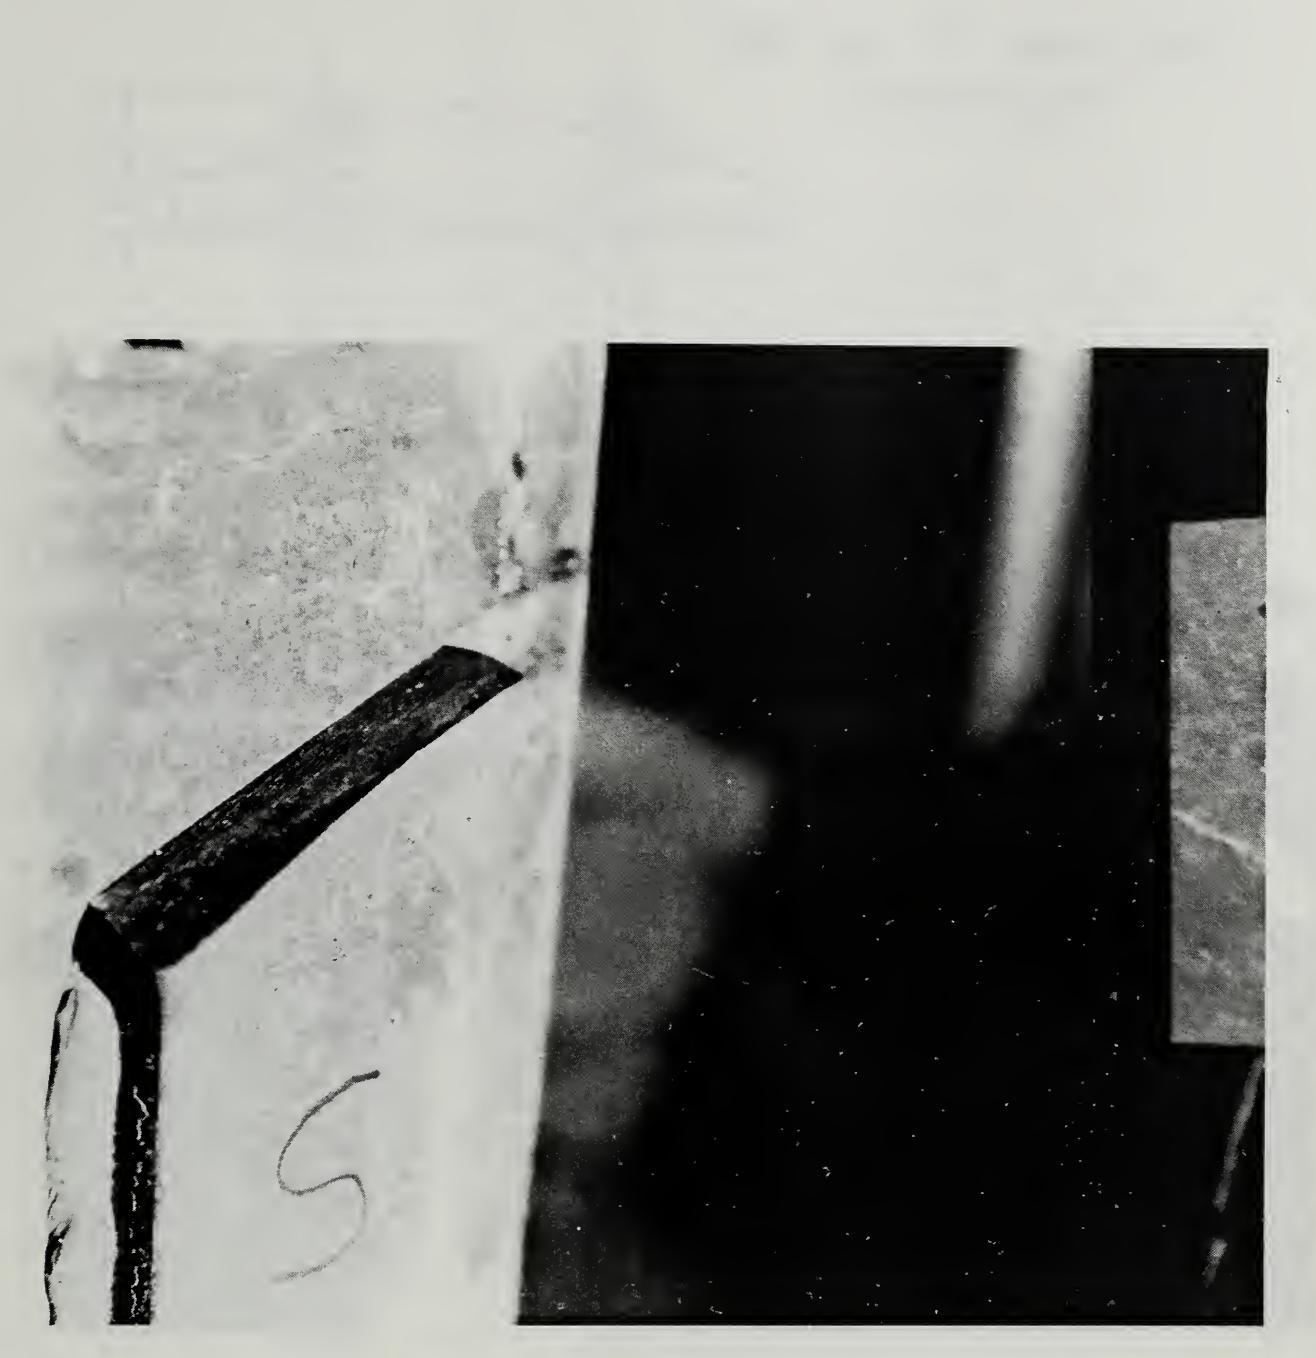
Figure 5.5.11 Weld block deformation in test of shearhead

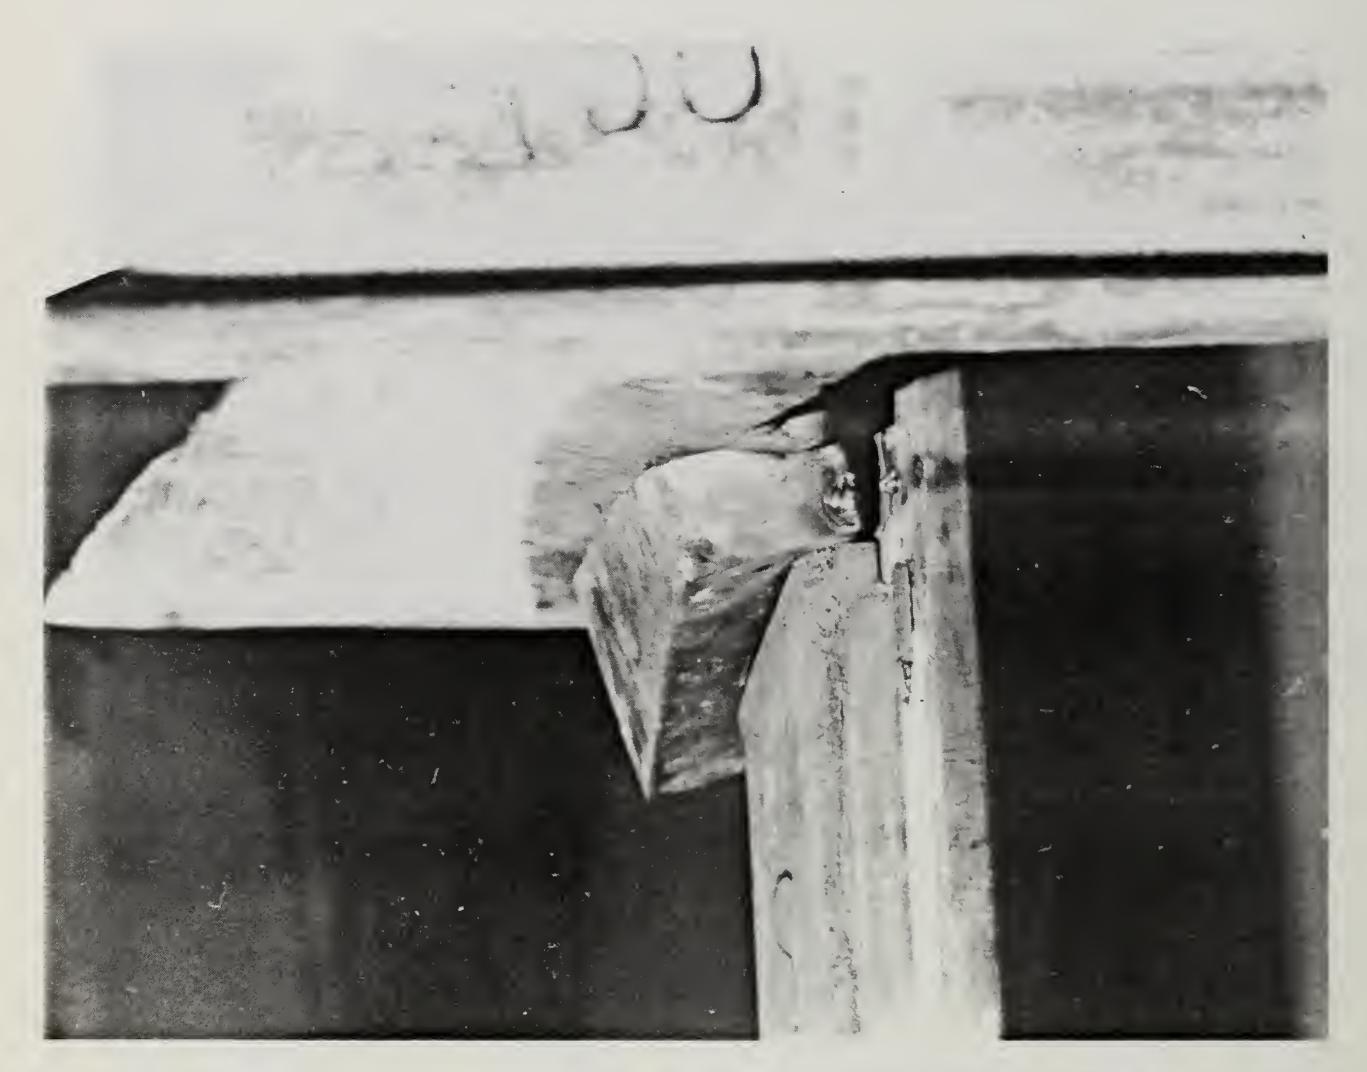
Figure 5.5.12 Deformation of shearhead channel in test of shearhead

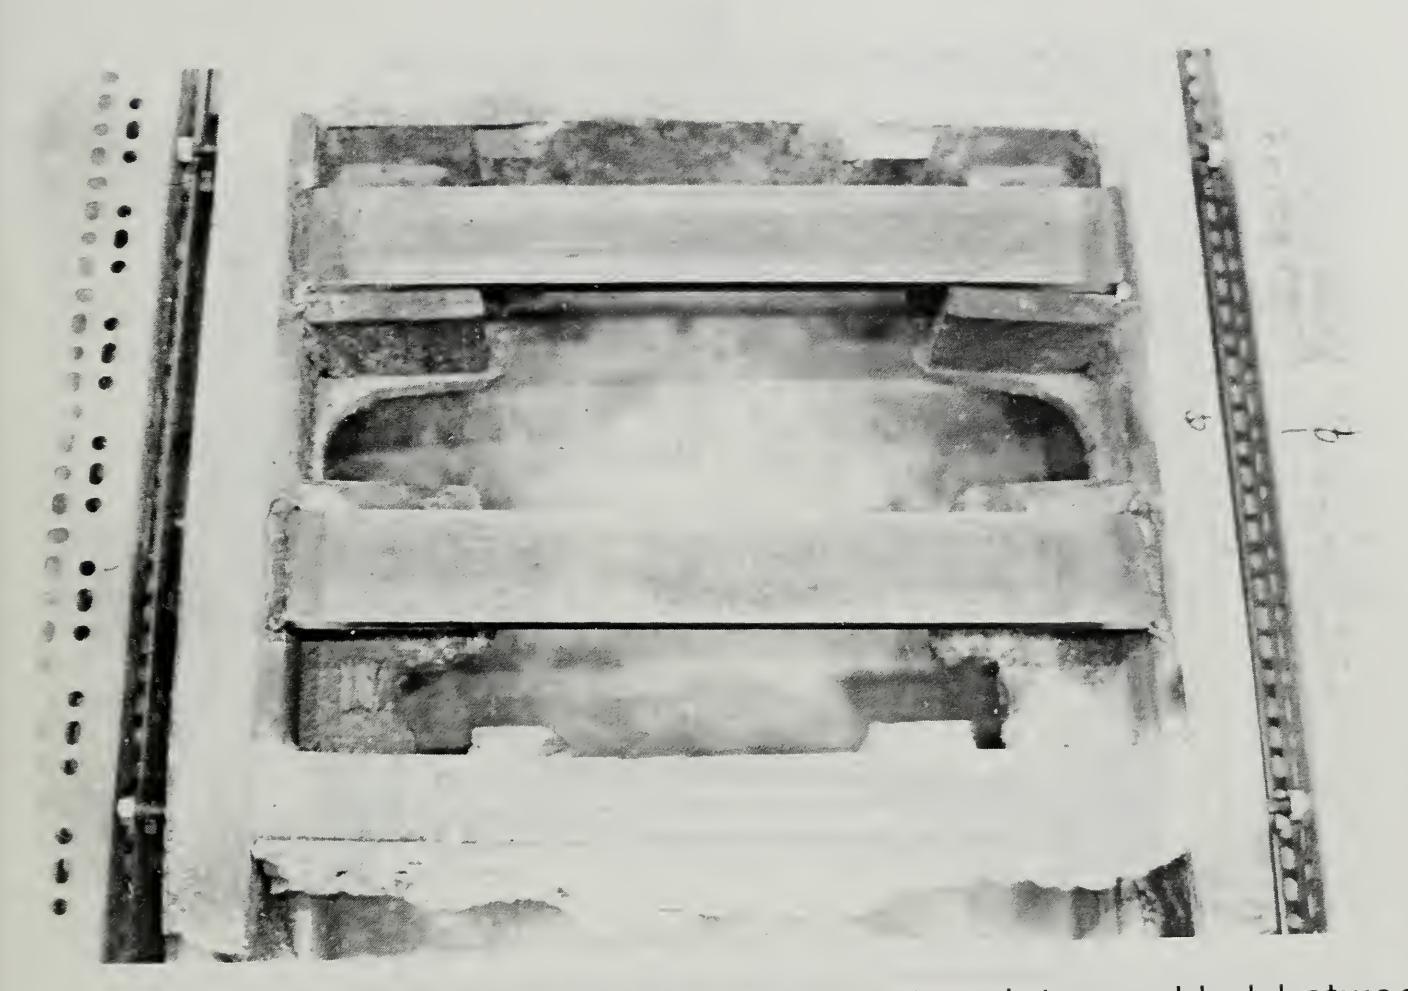
Figure 5.5.15 Shearhead No. 3 stiffened by plates welded between legs of lifting angles
