NBSIR 87-3640

# Investigation of L'Ambiance Plaza Building Collapse in Bridgeport, Connecticut

Occupational Safety and Health Administration U.S. Department of Labor Washington, DC 20001

Issued September 1987

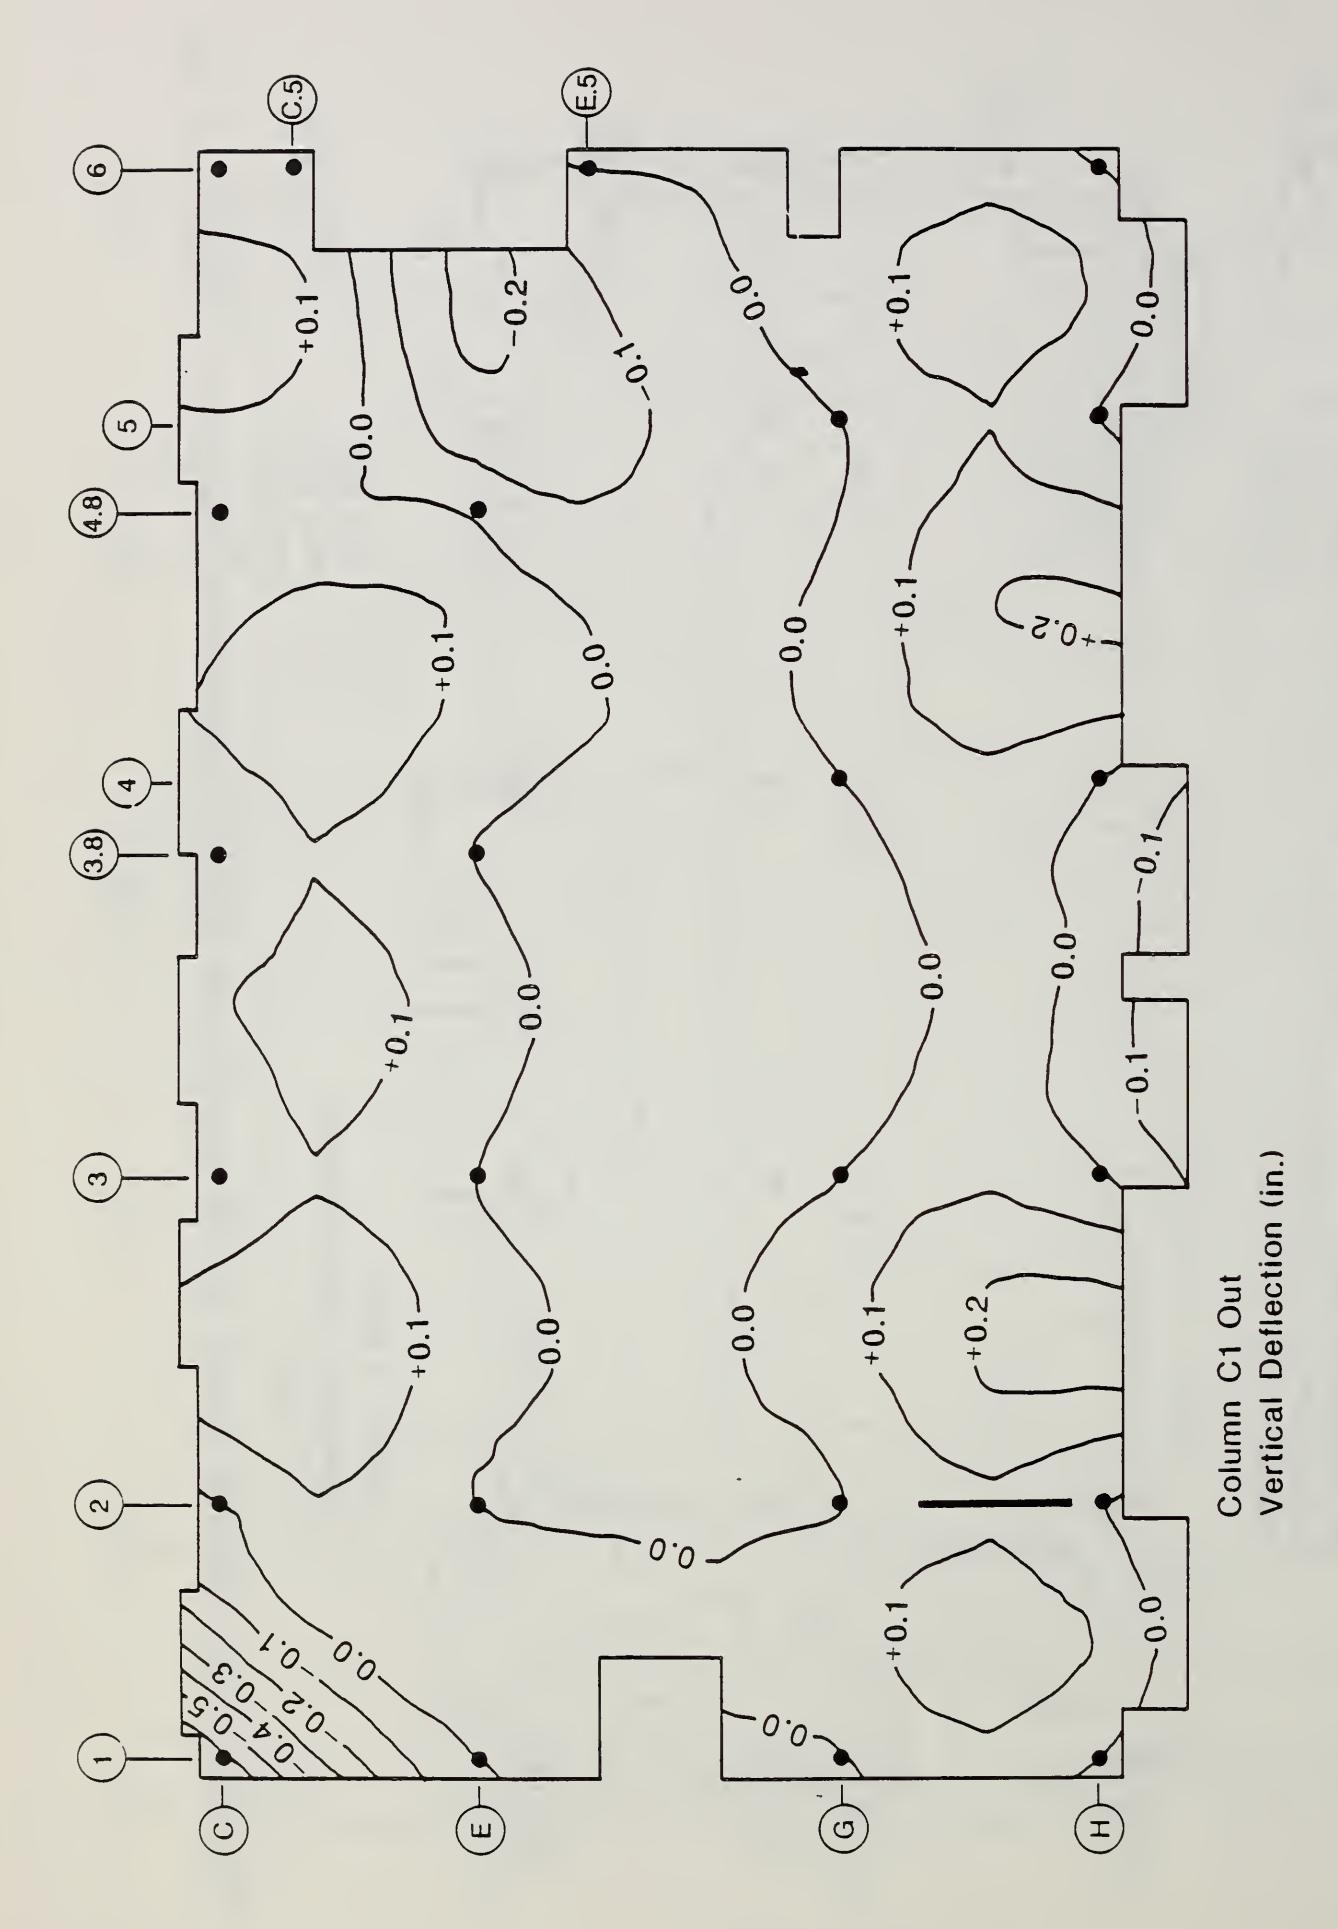
Figure 7.2.6 Deflection of slab - column C1 out

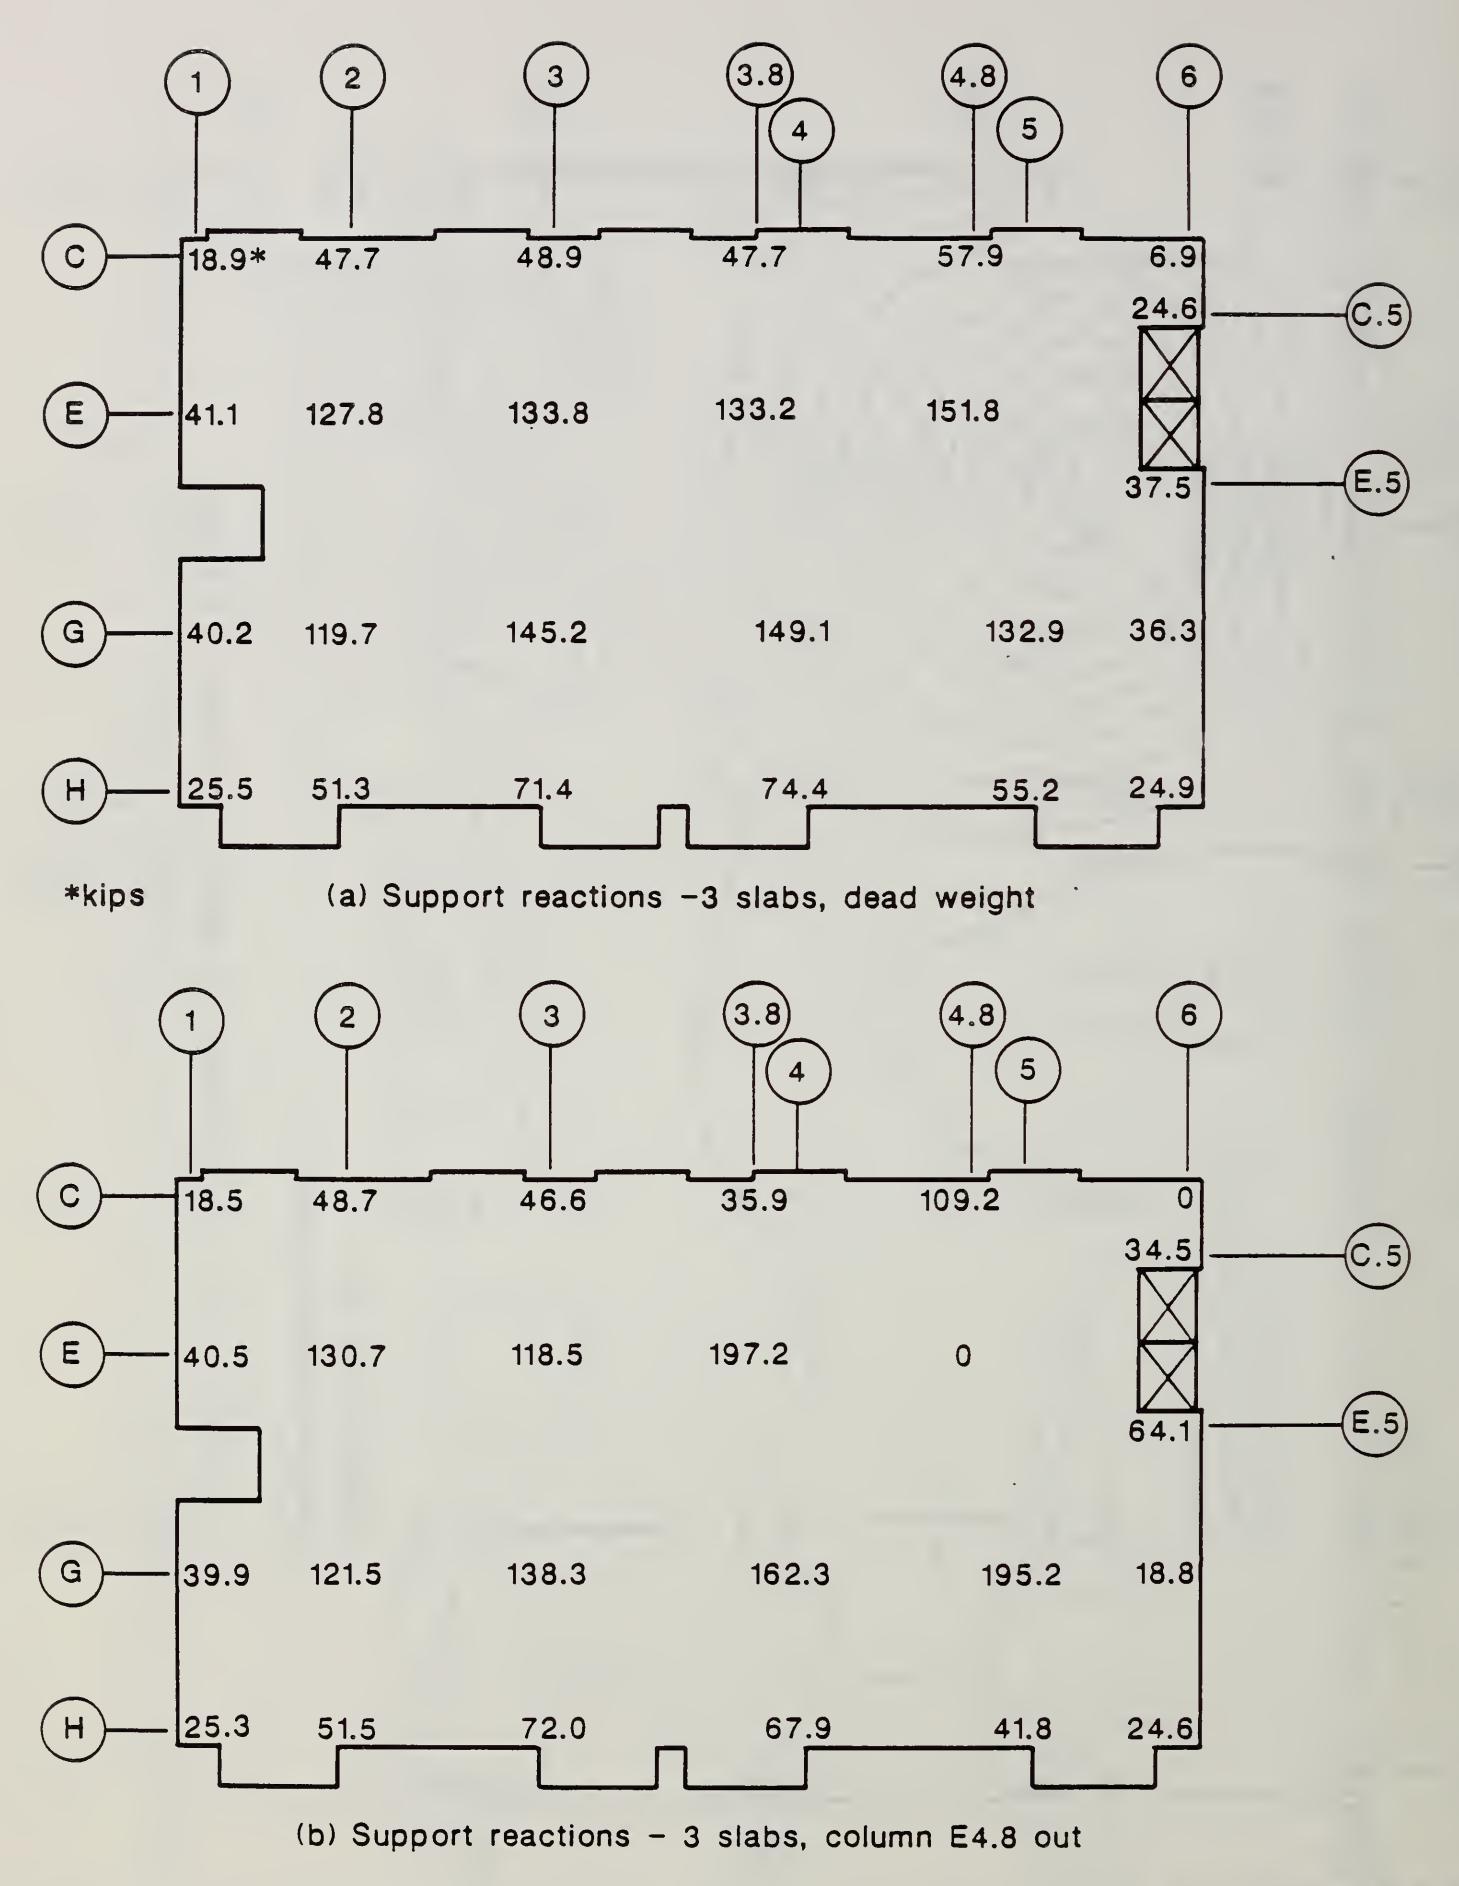
Figure 7.2.10 Support reactions due to loss of support at column E4.8

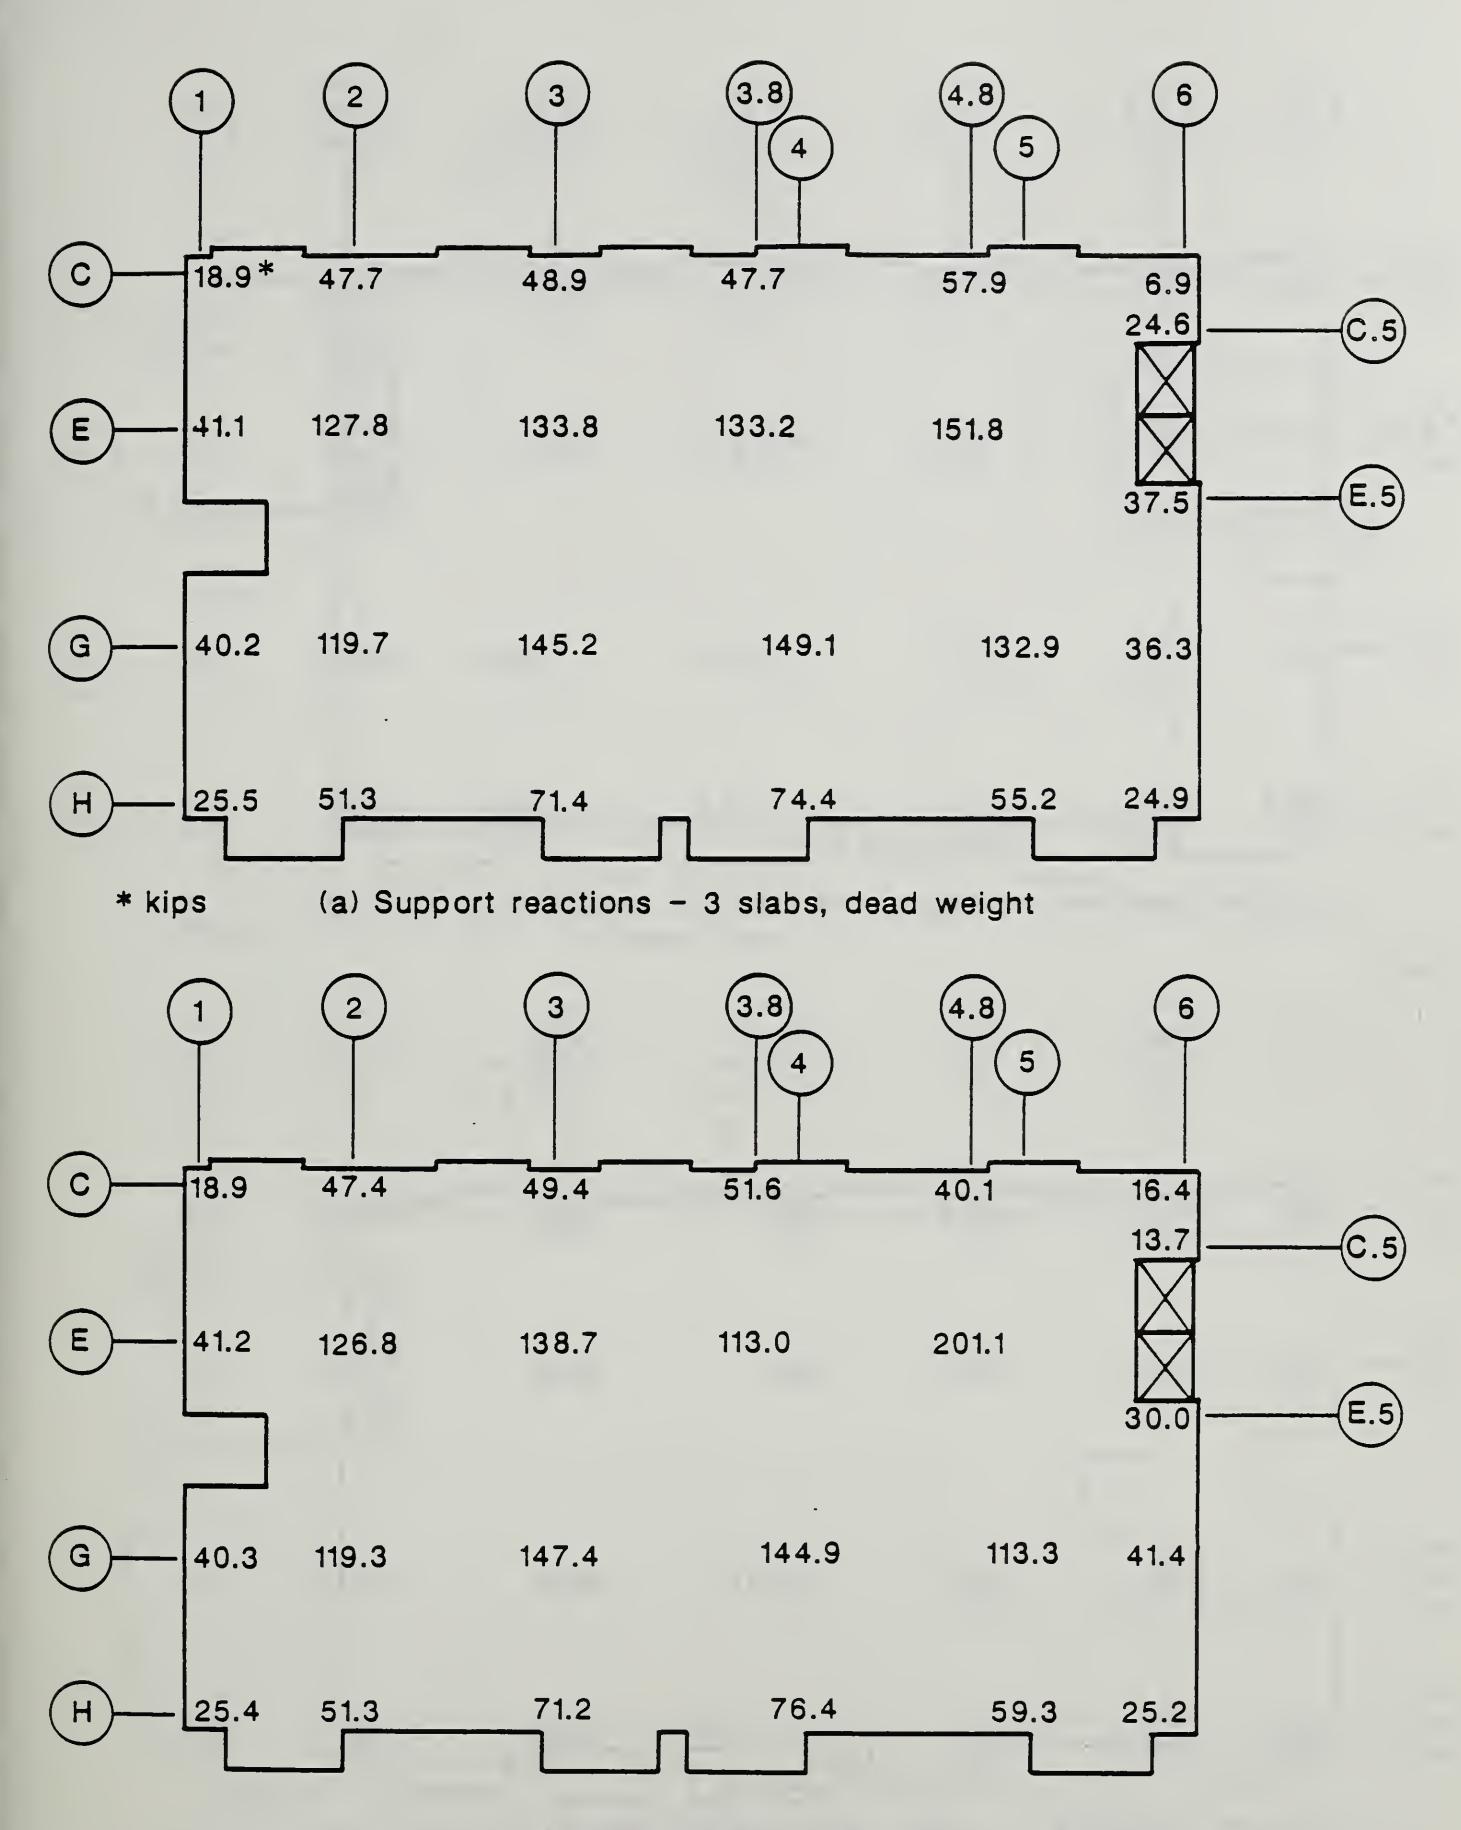
(b) Support reactions - 3 slabs, raise slabs 1/2" at column E4.8 Figure 7.2.11 Support reactions due to jacking slab at column E4.8

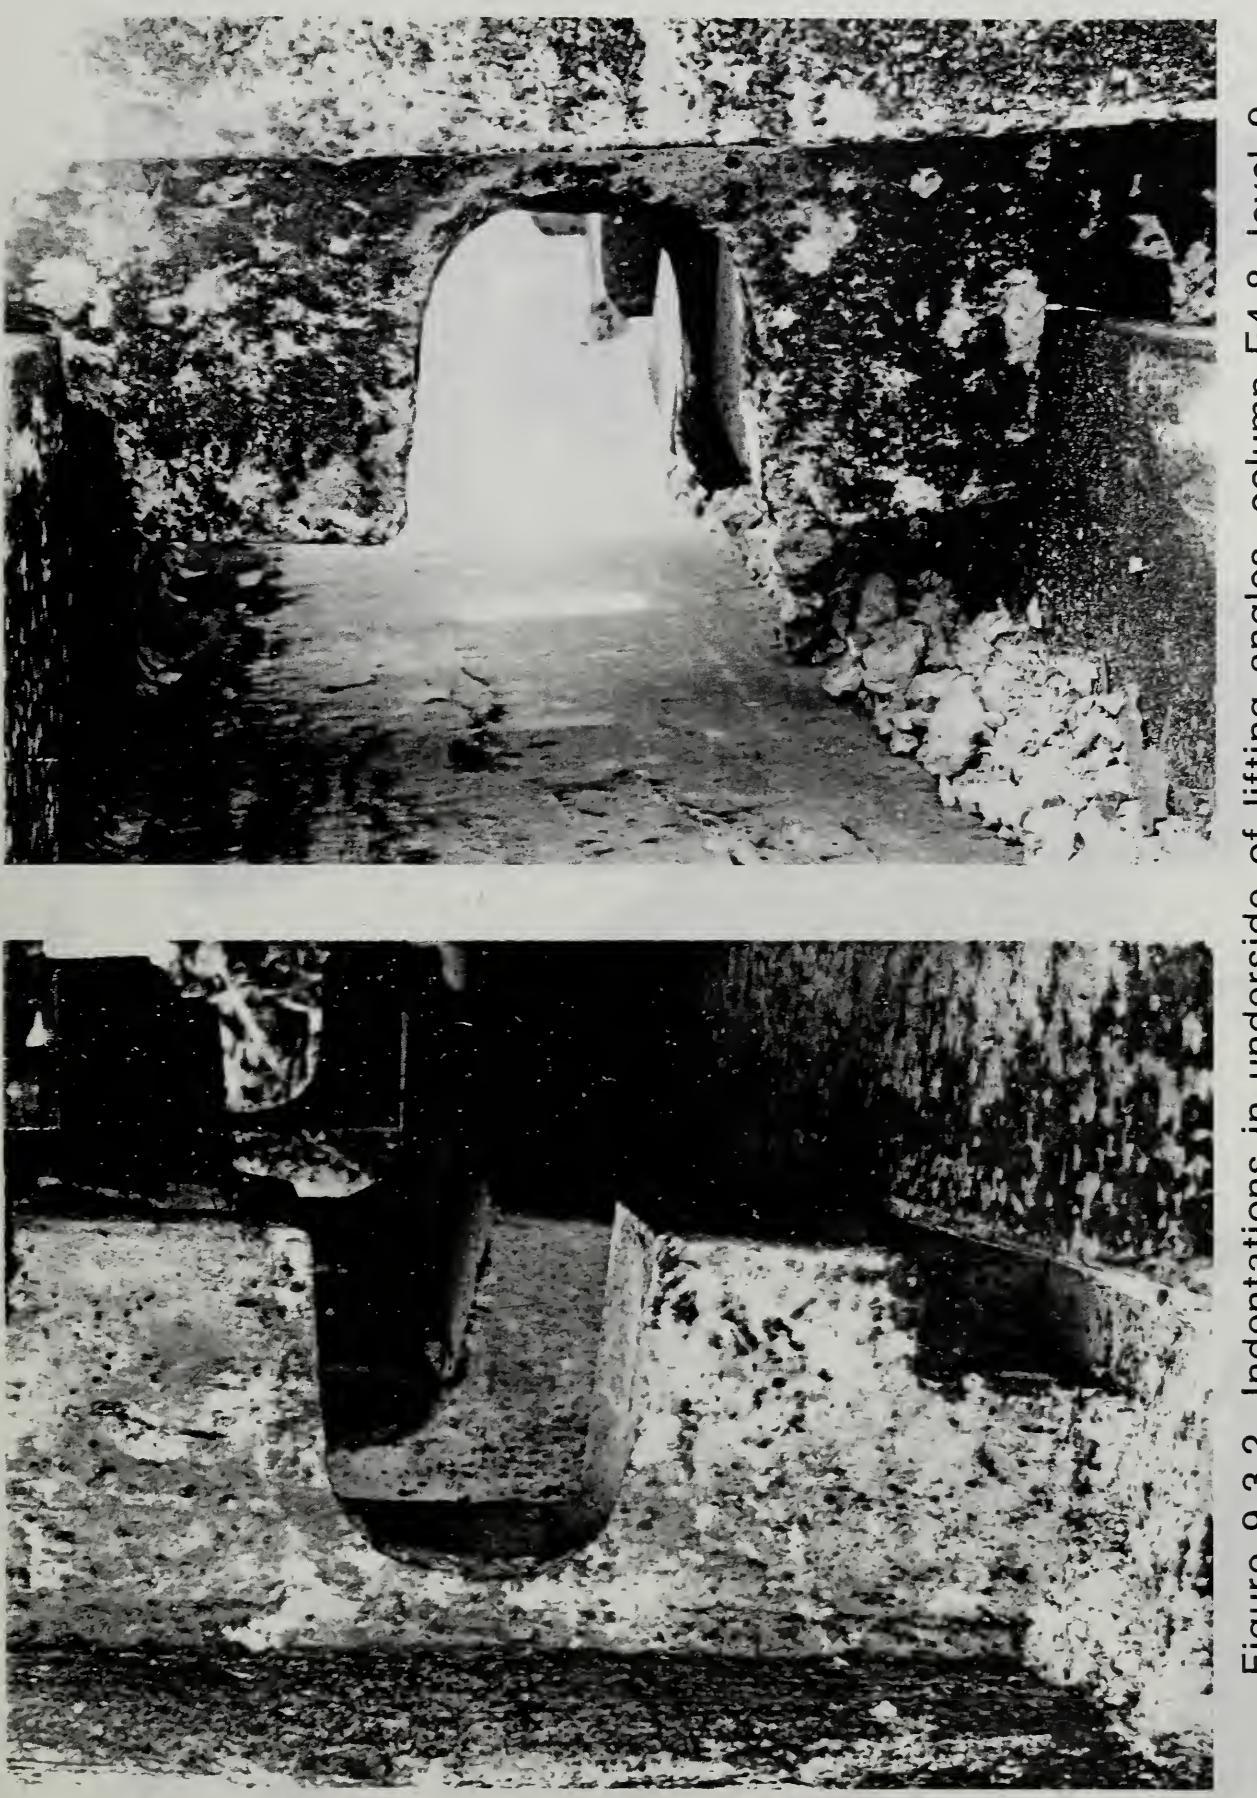
As has been noted in the discussion of test results in Section 5.5.5, a jack load of 190 kips (845 kN) acting on the type X51 shearheads of column E3.8 would produce very significant rotations of the lifting angles, possibly leading to kick out of one or both of the lifting nuts. The bottom surfaces of the lifting angles of the shearhead at slab 9, column E3.8, are shown in figure 9.3.3. The marks on these surfaces show that kick out did indeed occur. This sudden release of energy would be expected to raise dust from the surfaces of the concrete slabs and the noise associated with the kick out experienced in the lifting assembly tests described in Section 5.5.5 could readily be described as steel breaking under stress. This is consistent with the eyewitness accounts (#3 and #4 - figure 4.3.1). The surviving witness working at column E4.8 at the time of the collapse (#14 - figure 4.3.1) noted that the first indication of a problem was a loud noise either right above his head (E4.8) or more towards the center of the slab (E3.8). Due to load redistribution, loss of a jack at either E3.8 or E4.8 would lead to failure of the other jack. As floor slabs 9/10/11 moved downward, the shears and moments in the slabs adjusted to the new support conditions. Because the posttensioning tendons now were located in the compression side of the slabs, the tendons adjacent to columns E3.8 and/or E4.8 became ineffective and flexural cracks developed in the bottom face of the slabs. This explains the sudden appearance of cracks in the slab directly above the workmen who were installing wedges at column E4.8. The underside of shearhead 10, column E3.8, is shown in figure 9.3.4 and that of shearhead 11 is shown in figure 9.3.5. It appears that one of the lifting nuts glanced off of the web and became partially lodged under shearhead 10. As the slabs moved downward due to loss of support at column E3.8, the lifting nut was again kicked out from under a lifting angle. The imprint on the underside of shearhead 11 suggests that this process was repeated for a third time. It was not possible to confirm this sequence of events with lifting nut impact points on the web because the top section of column E3.8 could not be positively identified. The likely progression of the collapse through the upper levels of the west tower is described in the following paragraphs.

Indentations in underside of lifting angles, column E4.8, level 9 Figure 9.3.2

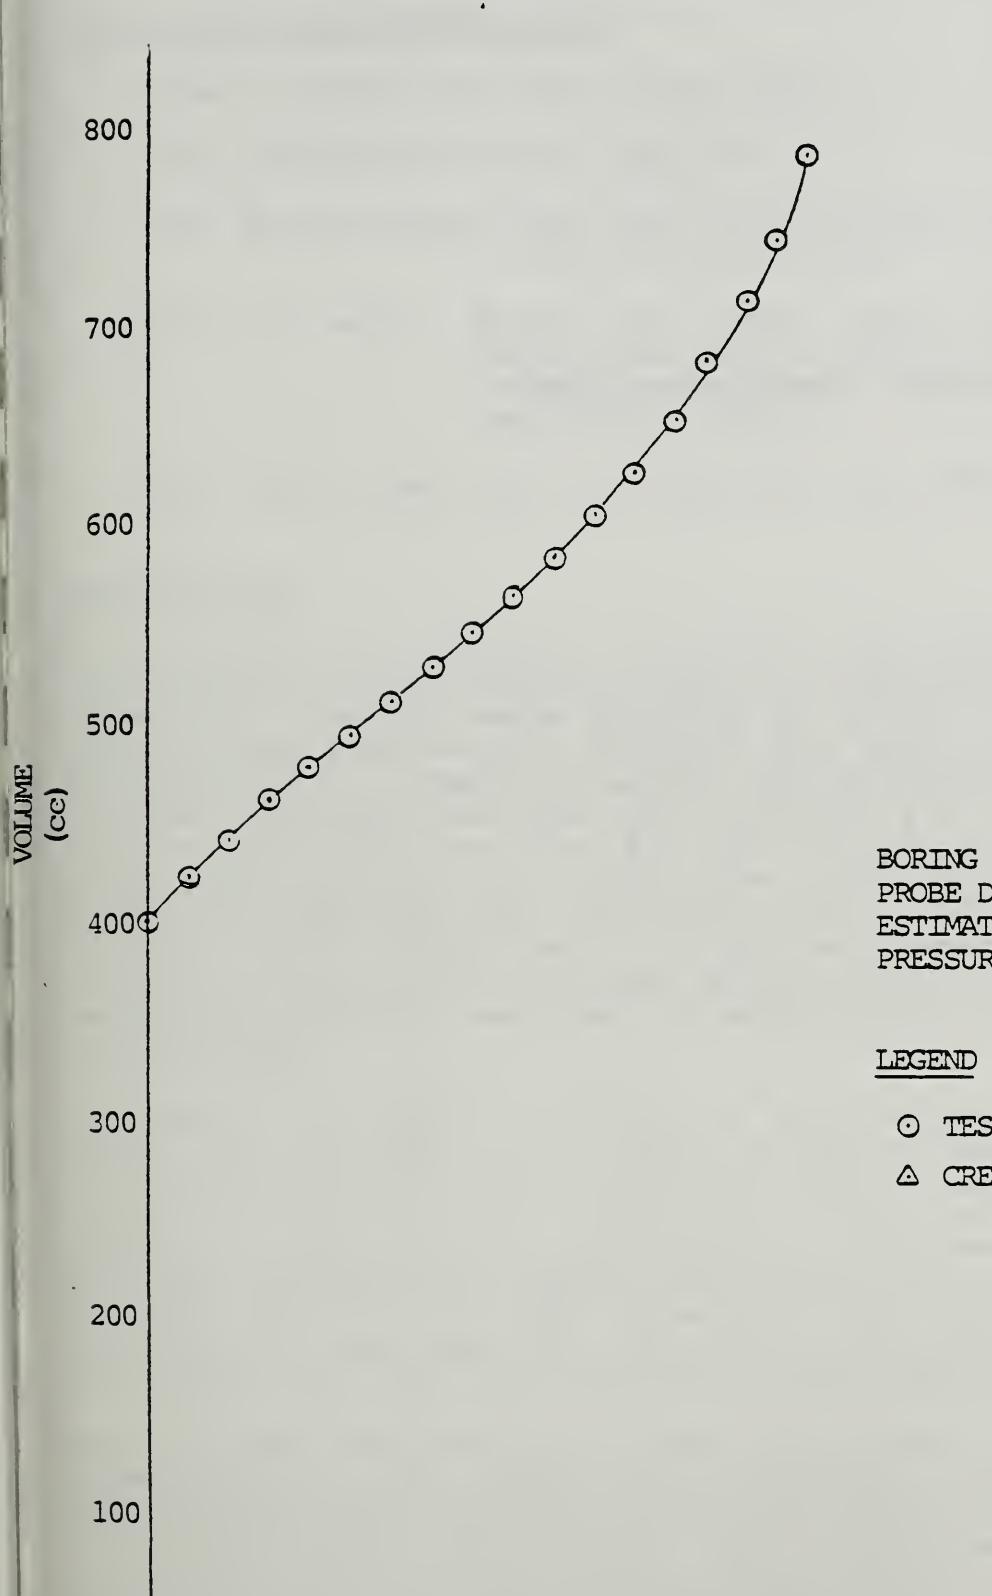
Figure 1

# PRESSUREMETER TEST RESULTS

BORING NUMBER: B-10F PROBE DEPTH: 3.9 to 5.9 FT ESTIMATED LIMIT PRESSURE: 7 tsf PRESSUREMETER MODULUS: 80 tsf
