**Failure Analysis of Welded Steel Moment Frames
Damaged in the Northridge Earthquake**

NISTIR 5944

January 1997
Building and Fire Research Laboratory
National Institute of Standards and Technology
Gaithersburg, MD 20899

A study was performed to characterize the origin of fracture and material properties of welded steel moment frame (WSMF) connections damaged in the Northridge earthquake. Sixteen connection fractures were obtained from five different buildings in the Los Angeles area which suffered damage in the earthquake. These fractures represented a variety of the types of fractures observed in post-earthquake building inspections. The mechanical and physical properties of the connection members and weld metal were determined including composition, strength, and fracture toughness. A fractographic examination of the fracture surfaces was performed to locate and characterize the fracture origin and determine the fracture mechanism. A fracture analysis was performed using linear elastic fracture mechanics. The analysis indicated that in all cases fracture resulted from crack instability which developed within the weld metal at the weld root at an incomplete fusion flaw contigu

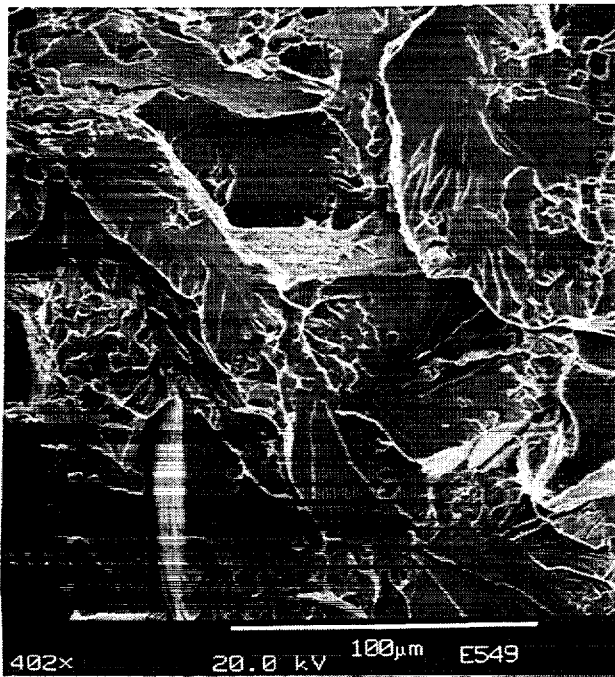
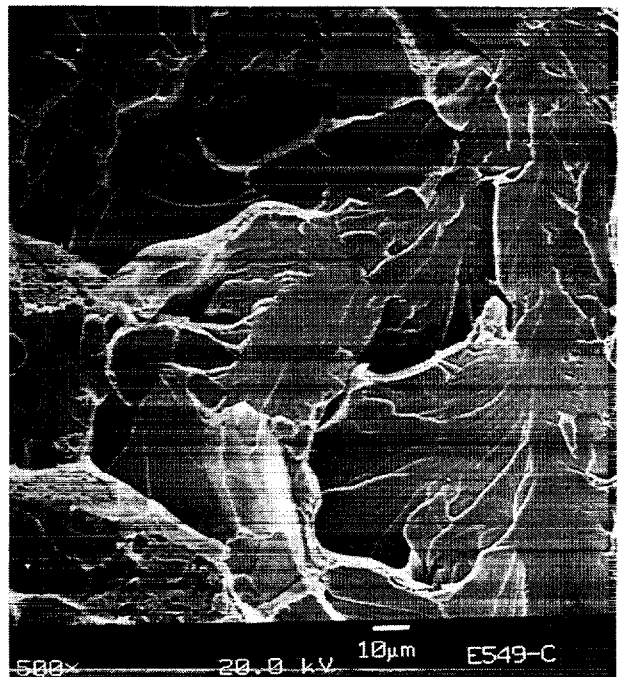
Figure 56 - SEM micrographs obtained immediately adjacent to the crack origin in Sample E549. (Areas "A" and "C" in Figure 55) (Mag. 402X & 500X)
