Lightning and Surge Protection of Photovoltaic Installations

Two Case Histories: Vulcano and Kythnos

François D. Martzloff

June 1989

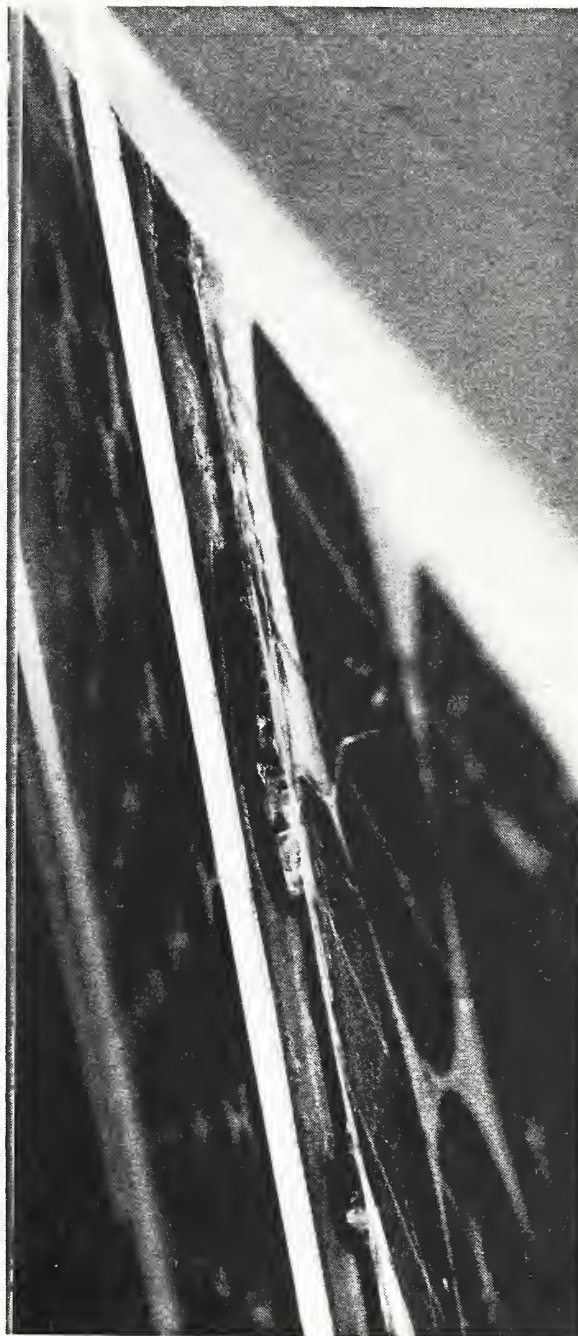
3-38 Side view of left edge

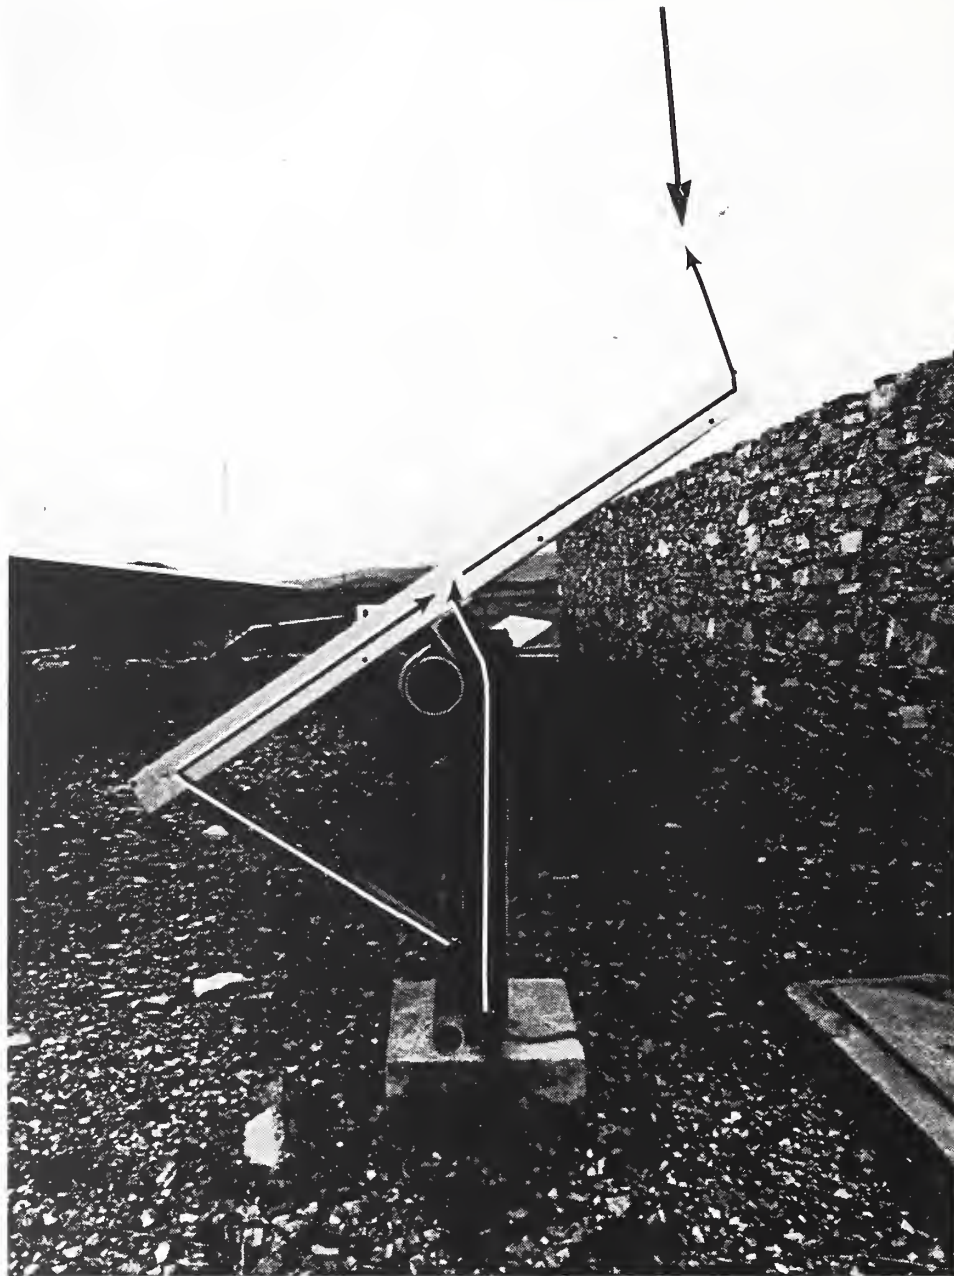
3-39 Side view of array, with hypothetical current paths to ground
