OBSERVATIONS ON THE BEHAVIOR OF BUILDINGS IN THE ROMANIA EARTHQUAKE OF MARCH 4, 1977

NBS SPECIAL PUBLICATION 490

U.S. DEPARTMENT OF COMMERCE / National Bureau of Standards

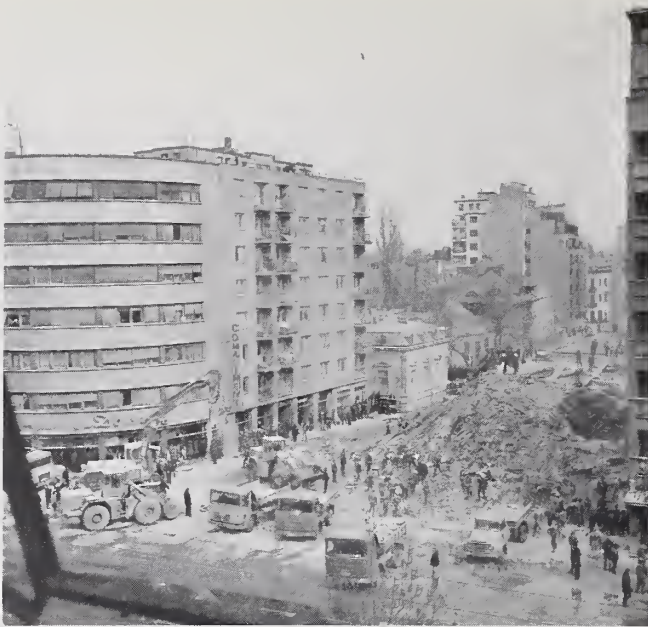
2.3.3 Reinforced Concrete Shear Wall Buildings

torsional effects. This difference provides a possible explanation of collapses of end units that were triggered by failures at the lower story levels (Figures 3.7 and 3.8). In addition, the pounding could have been aggravated by the fact that the end building was higher in certain cases, than the adjacent building.

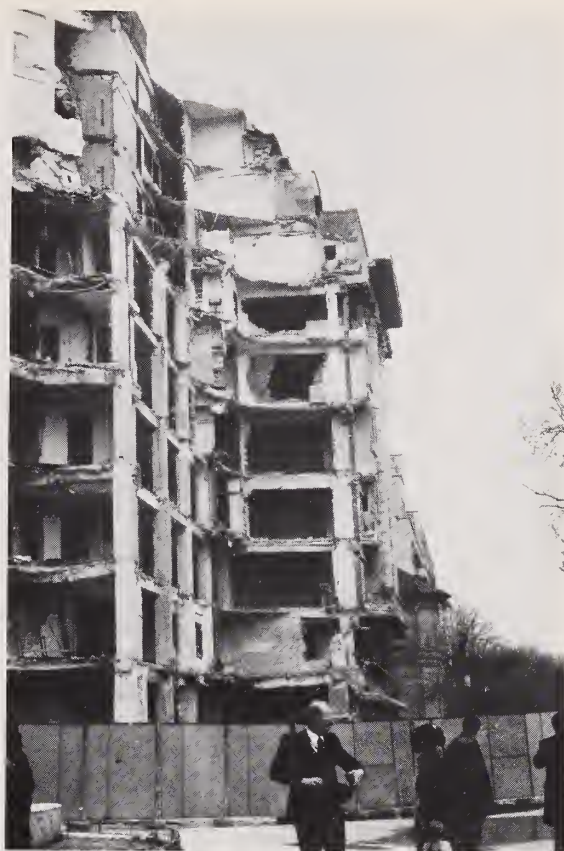
Figure 3.16. View of Dunres building looking north.

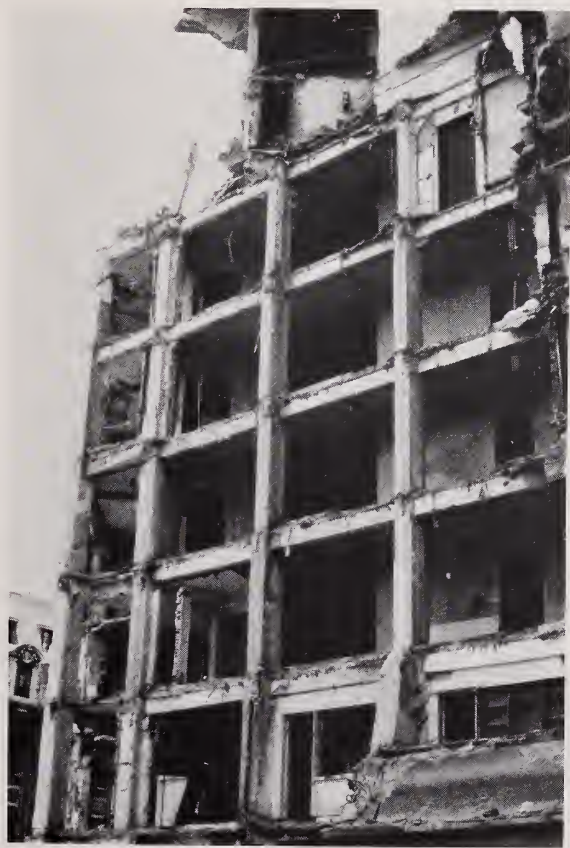
Figure 3.17. Close-up view of Dunres building.

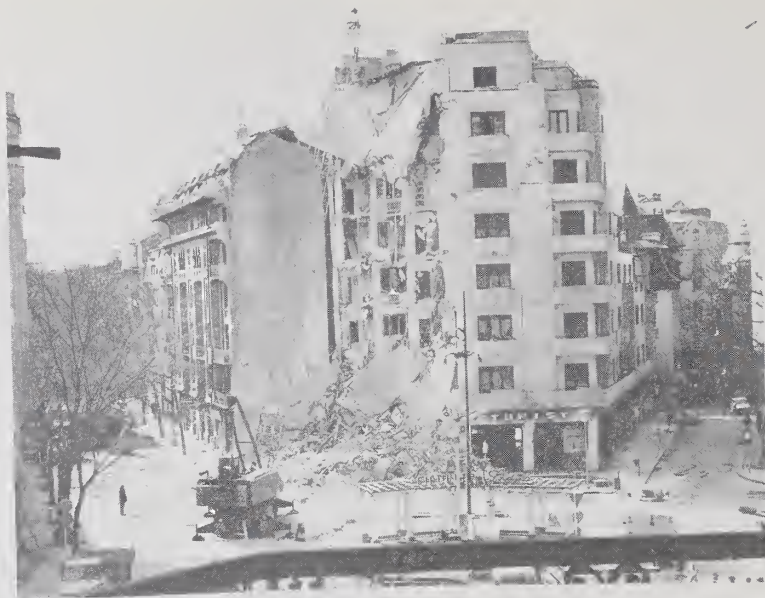
Figure 3.18. Partial collapse of Lido building.

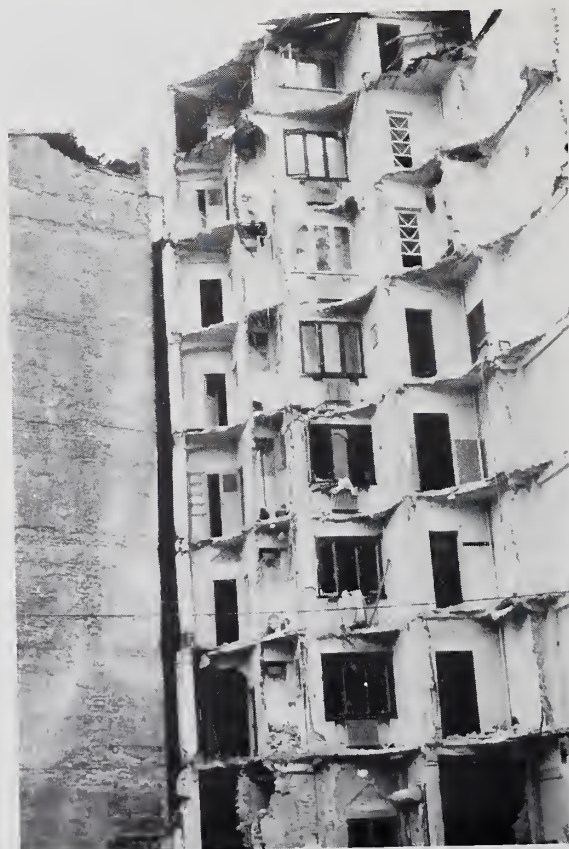
Figure 3.19. Close-up view of Lido building after removal of suspended wreckage.

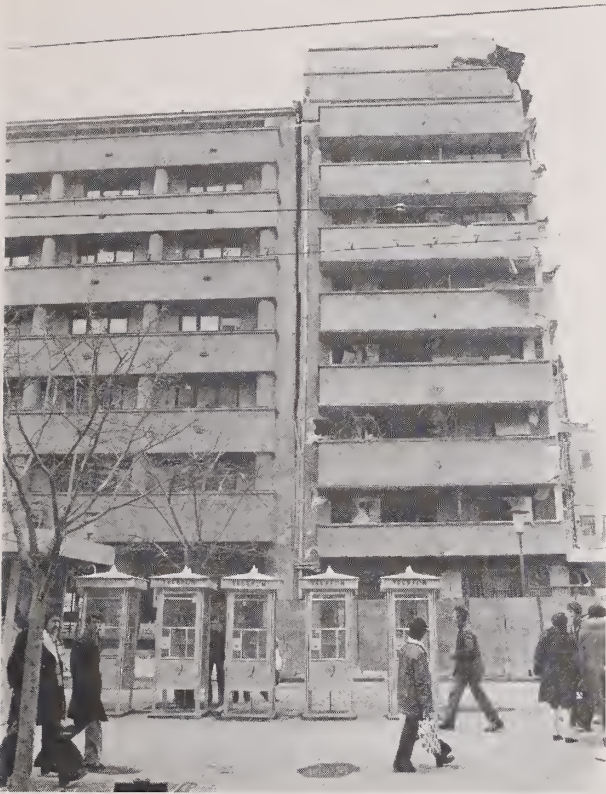
Figure 3.25. Pounding damage to other structures in the Casata building block.

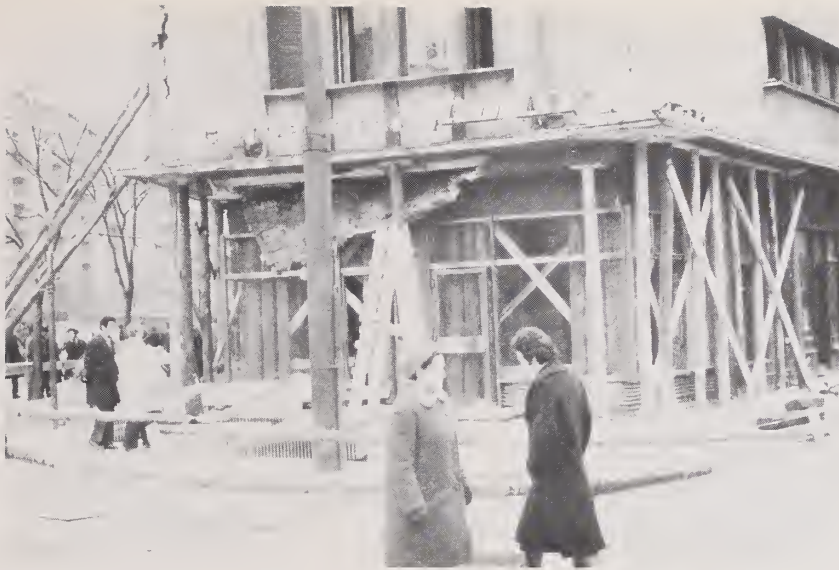
Figure 3.28. General view of the Turist building after the earthquake.

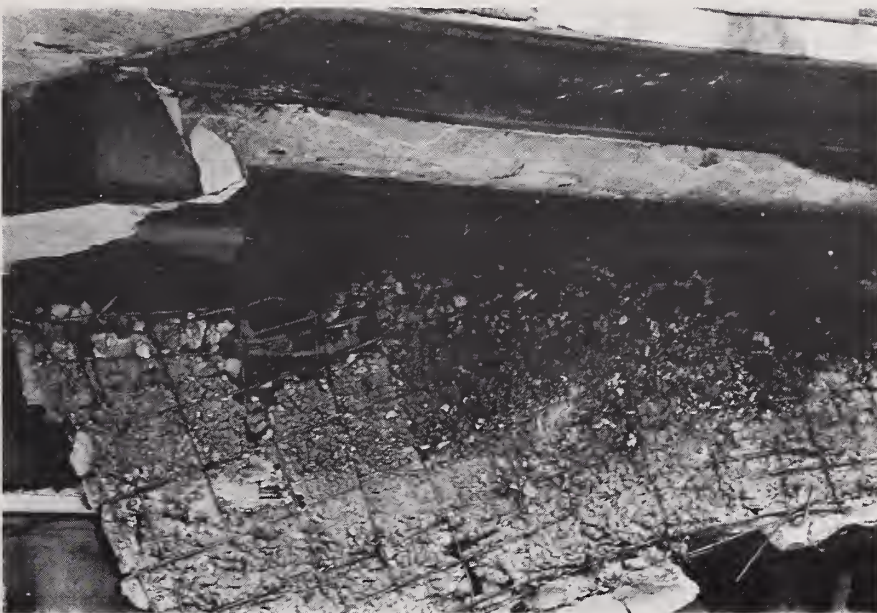
Figure 3.29. Close-up view of detached soffit of the canopy over the sidewalk.

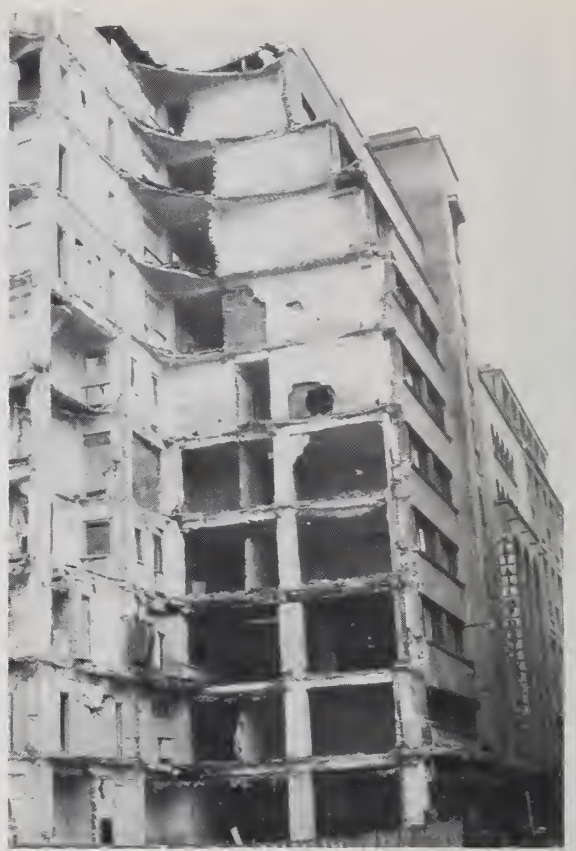
Figure 3.35. Left view of the collapse Metalimport building.

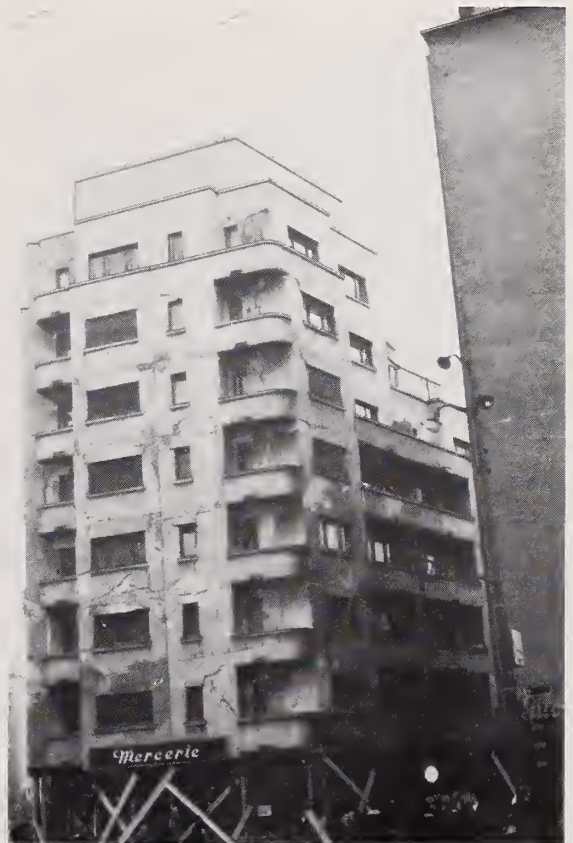
Figure 3.37. Another view of Mercerie building showing configuration of upper story setbacks.

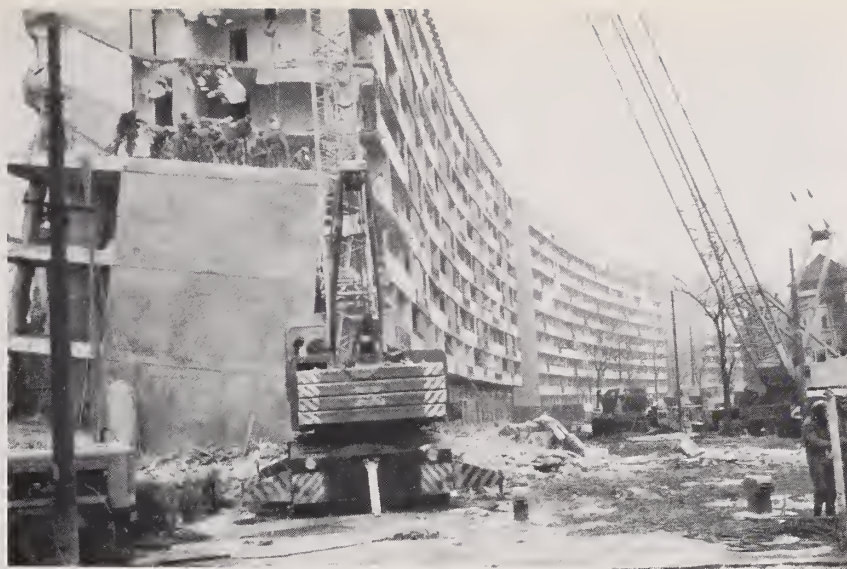
Figures 3.40 through 3.45 present several photographs of the building taken from different angles at the time of the visit, except for the rear corner view shown in Figure 3.41, which was taken by an INCERC crew

Figure 3.40. End view of partially collapsed Lizeanu building taken from Lizeanu Street looking towards east.

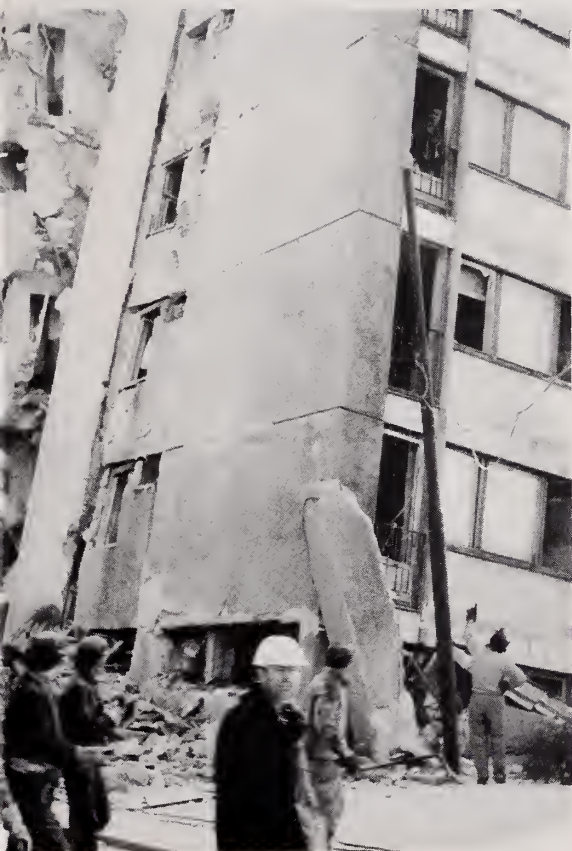
Figure 3.41. Rear view of collapsed portion of Lizeanu building before removal of debris.

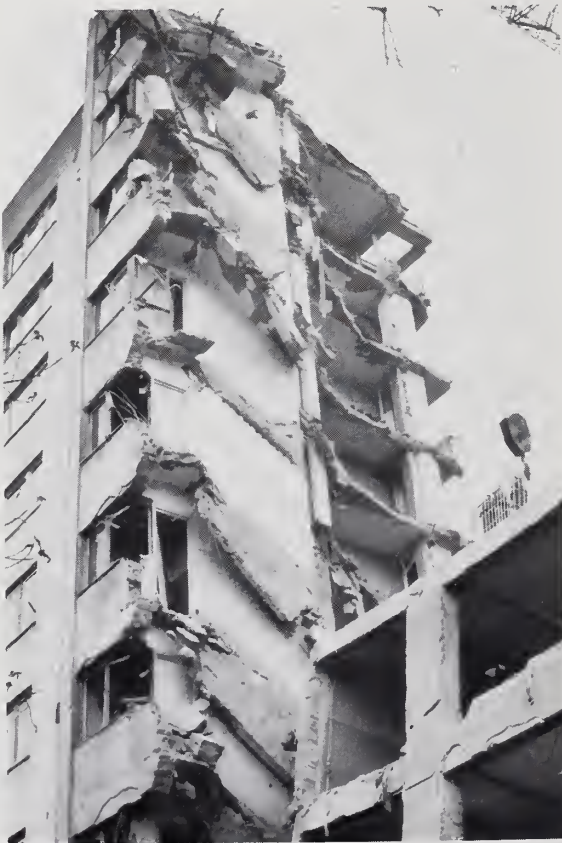
Figure 3.43. Close-up view of region collapsed stairs.

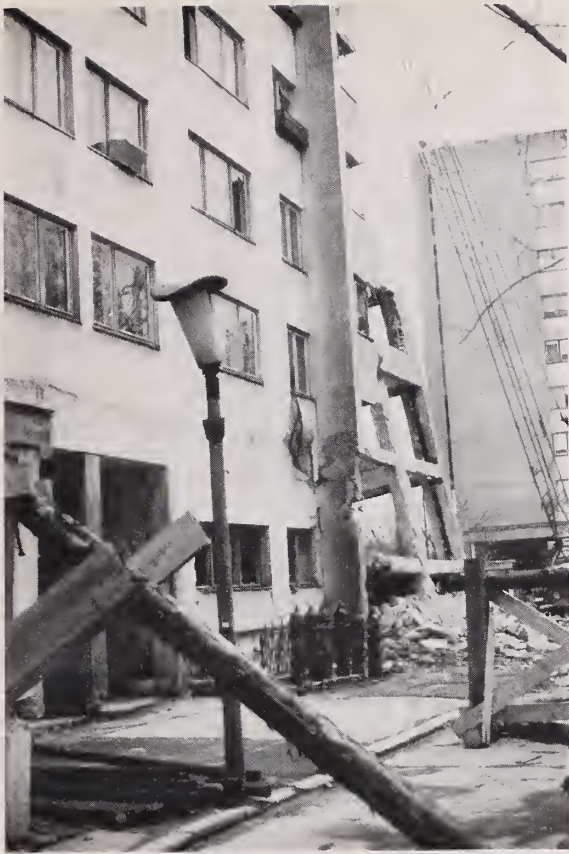
Figure 3.44. Rear view of collapsed end bays looking west.

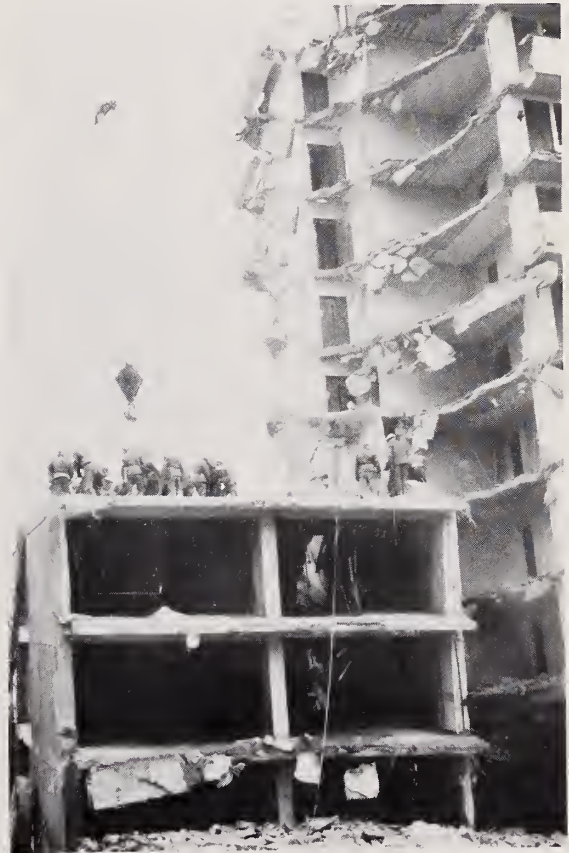
Figure 3.45. Front view of the collapsed bays taken from Stefan Cel Mare Avenue looking north.

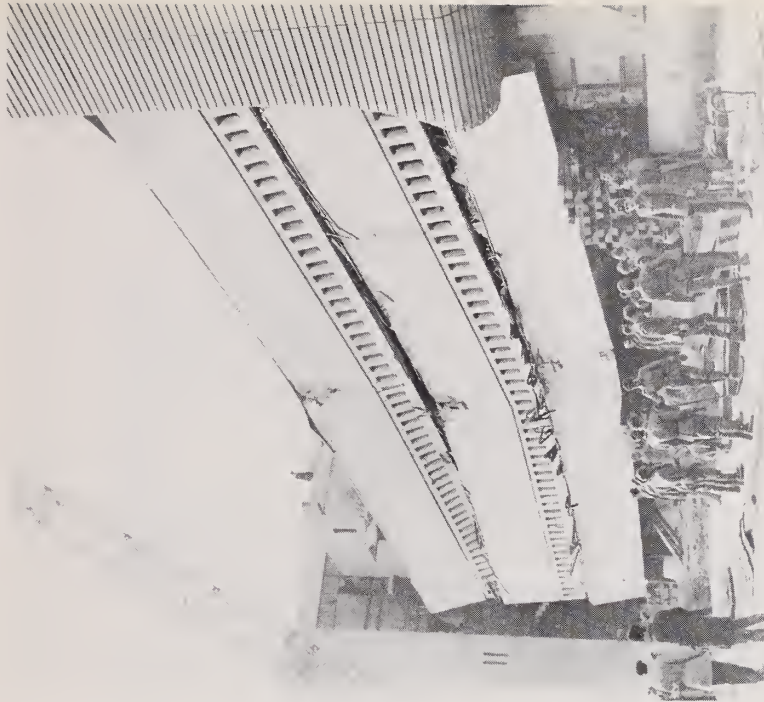
Figure 3.49. Northwest view of the computer center building after the earthquake.

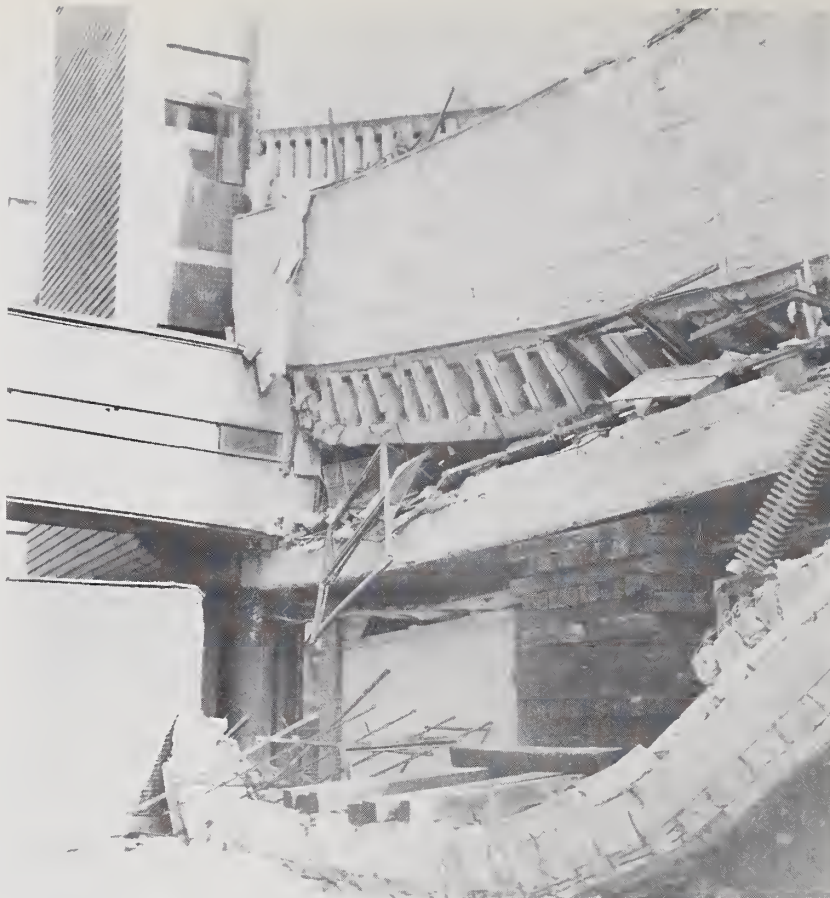
Figure 3.50. South side of computer building after the earthquake-

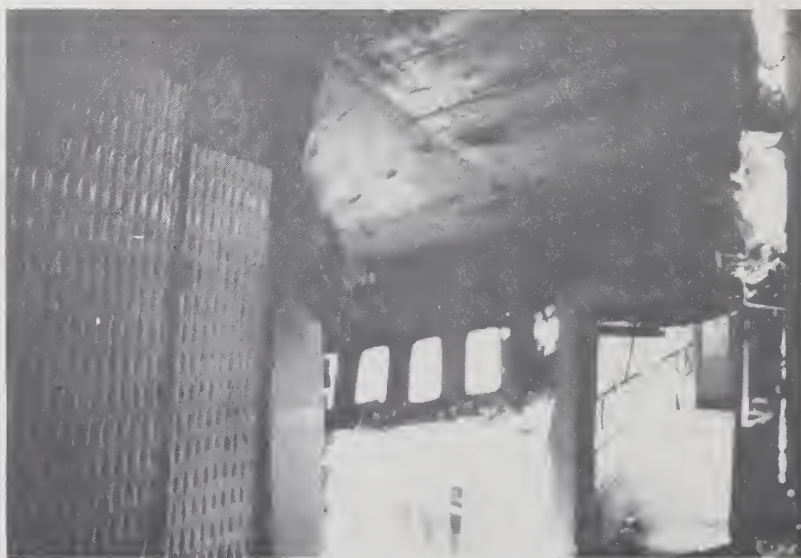
Figure 3.51. Interior view of second story wreckage.

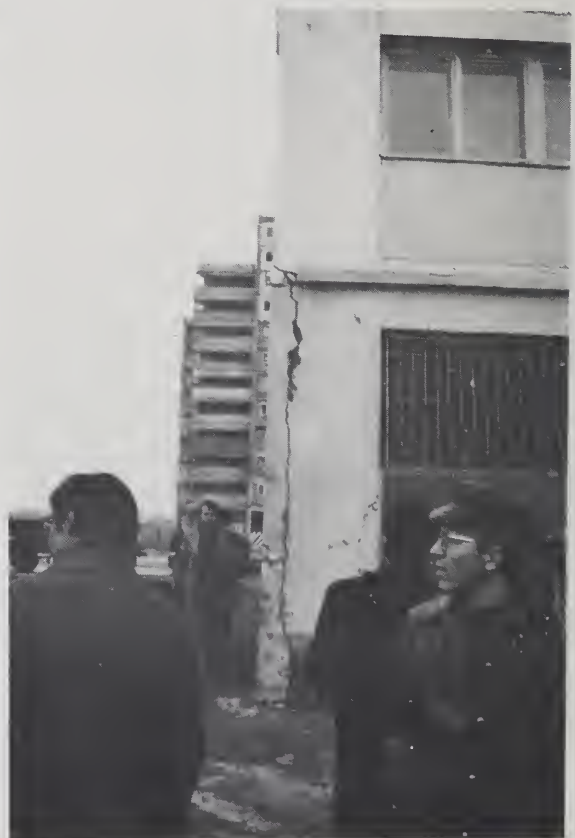
Figure 3.59. View of rear corner of Building 16 showing detached insulation wall.

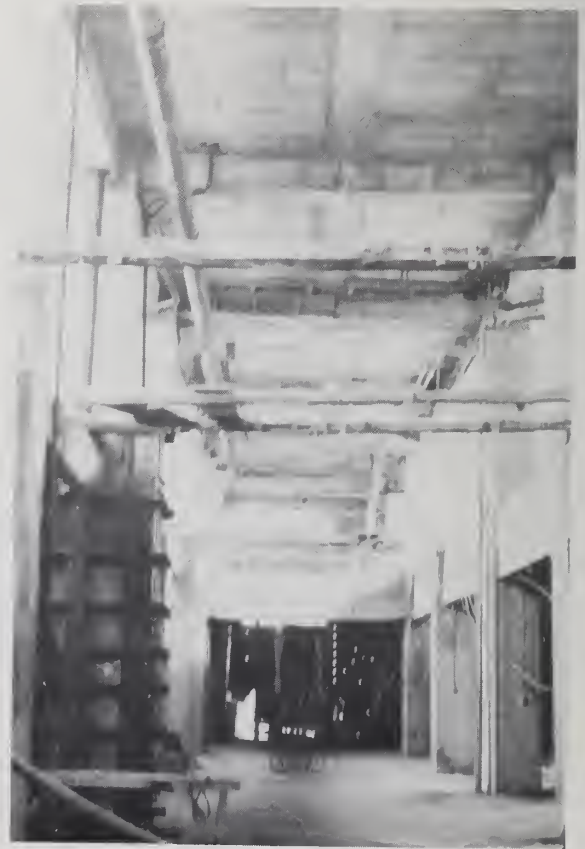
The ground floor of this building was actually two stories in one, with a built-in mezzanine accessed from within (Figures 3.63 and 3.69). The longitudinal bay nearest the street was two stories (about 8m) high as seen in Figure 3.63 and, therefore, the unsupported length of front exterior columns in the transverse (approximately N-S) direction was twice that of columns at other locations. Without shear walls in this area, the lateral resistance of the first two stories was entirely dependent on continuous frame action.

Figure 3.63. General view of longitudinal bay within the first story of the building.

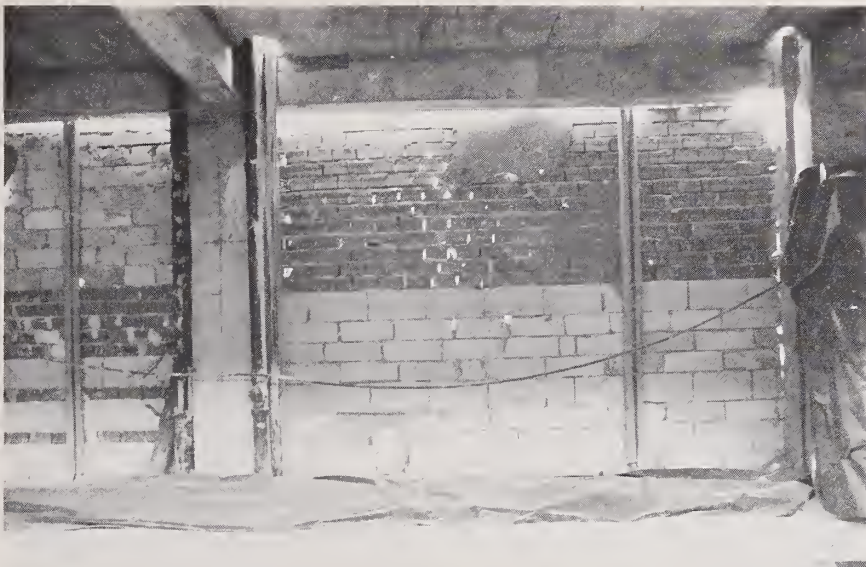
This was another instance where low quality workmanship and materials were found in the construction of masonry filler walls, as well as walls built exterior to the frame (Figures 3.62 and 3.68). Appearance is not a factor here because the walls are plastered before the structure is put in service. However, it seems that the structural integrity of the walls

Figure 3.68. Exterior masonry walls at the first story level.

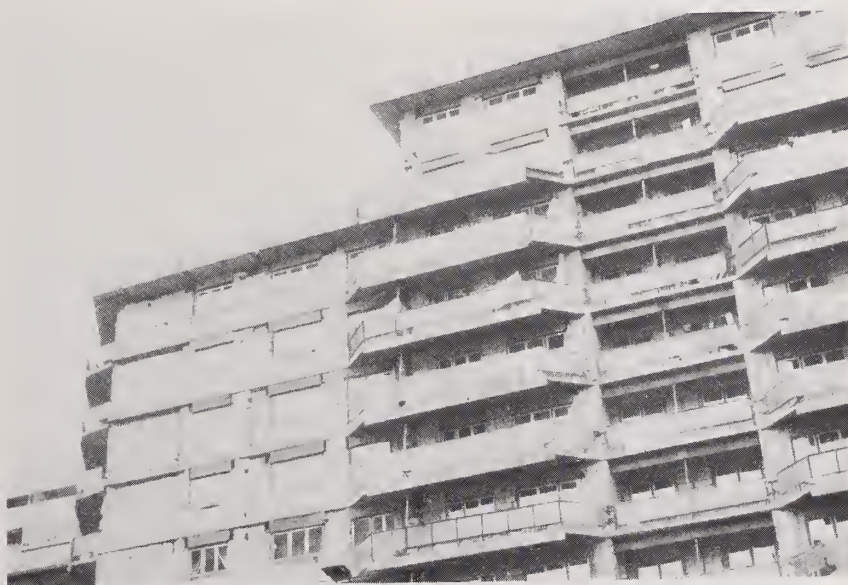
Figure 3.77 provides a further illustration of the general lack of emphasis placed on the quality of masonry construction when used in filler walls, parapets and other non-load bearing applications. Exposed concrete columns at several locations suggests that there may have been considerable shedding of masonry units from the walls of this building during the earthquake. Figure 3.78, which is the rear view of the same building, shows substantial pounding damage to this structure and the one adjacent to it, including the partial collapse of several masonry filler walls and possibly structural damage to a fifth story corner column in the adjacent building. In the building further to the left (Figure 3.79), many of the piers that had been already repaired but not plastered over, showed classical X cracking patterns.

Figure 3.77. Exterior view of multistory apartment building.

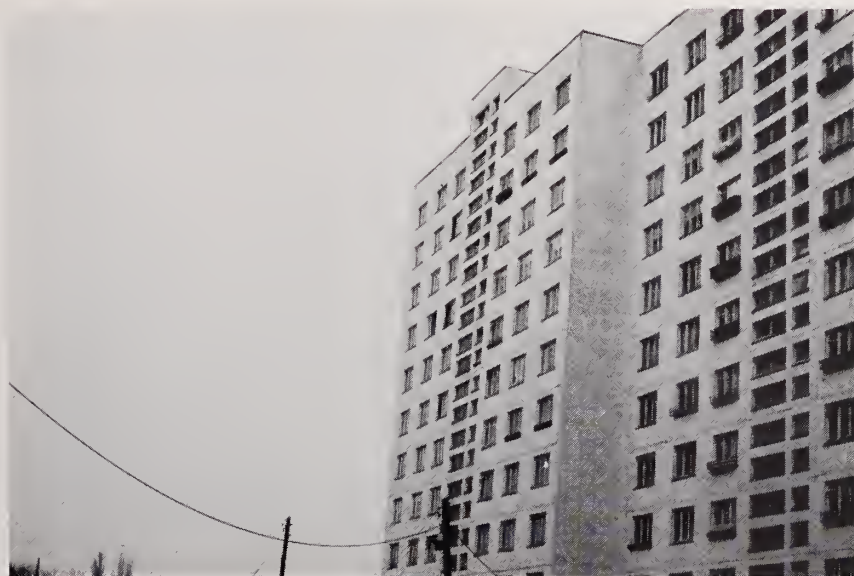
In this general area, several other instances of pounding damage were witnessed, such as shown in Figures 3.80 and 3.82 to 3.84. The former was a frame building located next to a shear wall structure which showed no visible signs of exterior damage (Figure 3.81). The most severe pounding damage observed had occurred as a result of the collision between a taller frame building and a shorter structure having adjacent corners.

Figure 3.81. Front view of 10-story shear wall building.

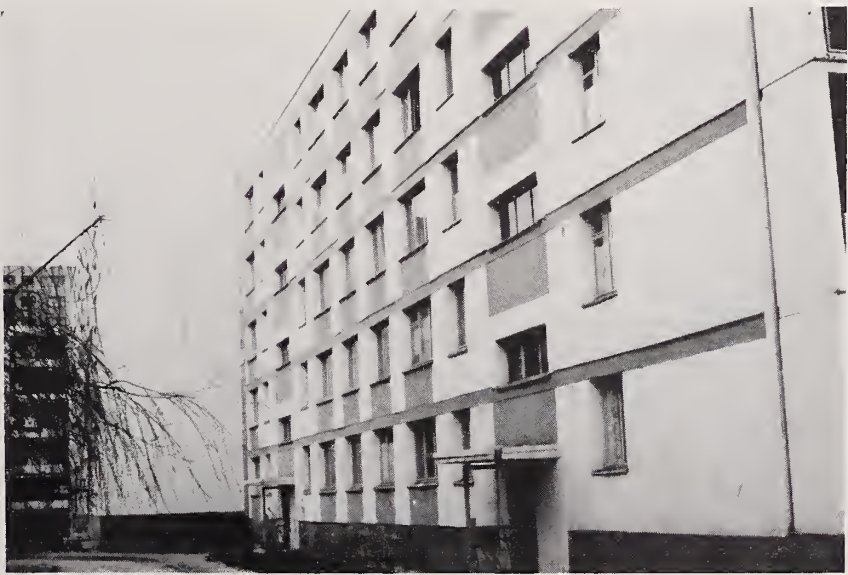
A number of apartment buildings of relatively recent construction were examined in the southern part of the city near Boulevard Magurele. These buildings are collectively identified by the number 19 on the map shown in Figure 2.2. The first building was a 5-story precast panel structure shown in Figures 3.85 and 3.86. No evidence of damage, not even signs of hairline cracks, was found inside or outside the building.

Figure 3.85. Front view of 5-story large panel building.

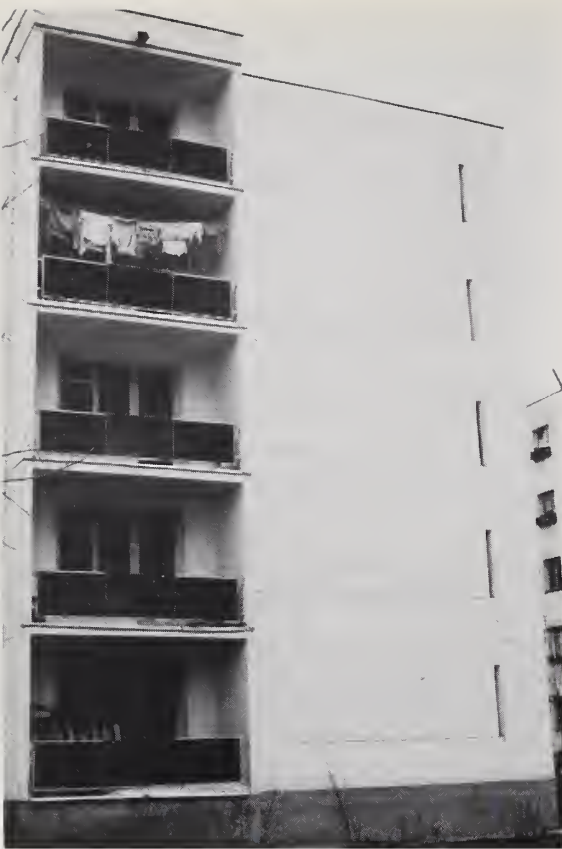
Figure 3.86. End view of 5-story panel building.

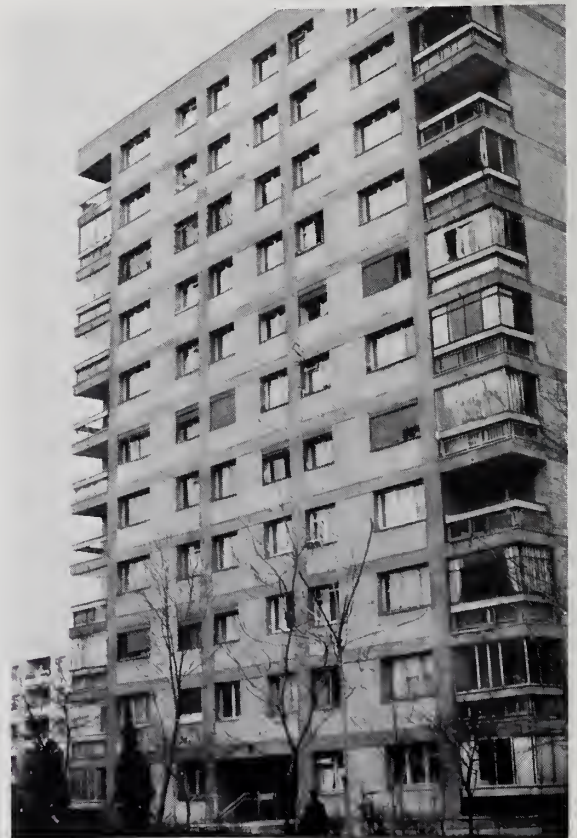
The second building, shown in Figure 3.87, was a 10-year old cast-in-place concrete shear wall structure in which breakage of window glass and appearance of hairline cracks near the first story stairway landing were the only visible signs of damage. This observation was also corroborated by the superintendent of the building. Because the first story was used for residential purposes, its stiffness was more compatible with the rest of the structure than would have been the case had that area been designed for store usage. Note the superior quality of the exposed masonry used in the construction of the end wall of the building.

Figure 3.87. Eleven-story shear wall building.

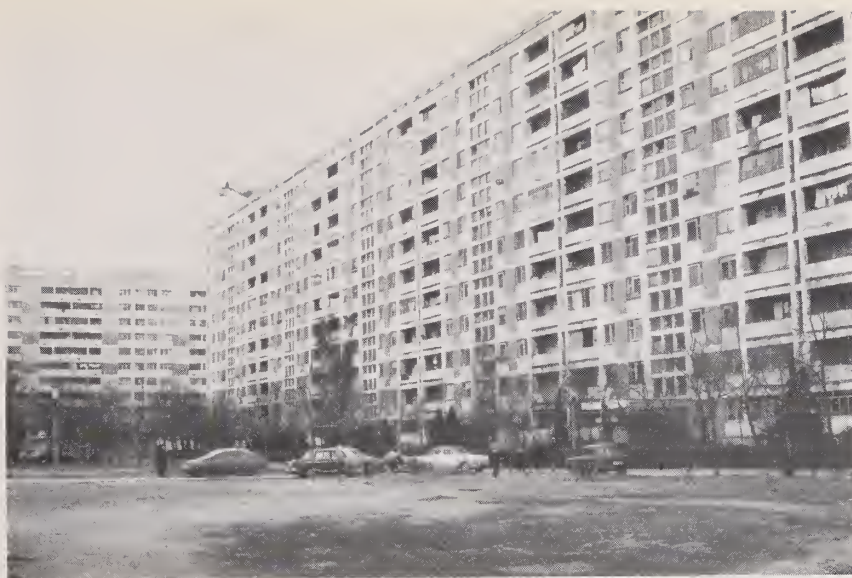
Figure 3.88 is a view showing some of the other typical layouts used in multistory apartment construction in this section of the town. Insofar as could be discerned by cursory visual examination, there were no conspicuous signs of major exterior damage to these structures.

Figure 3.88. Row of 11-story apartments.

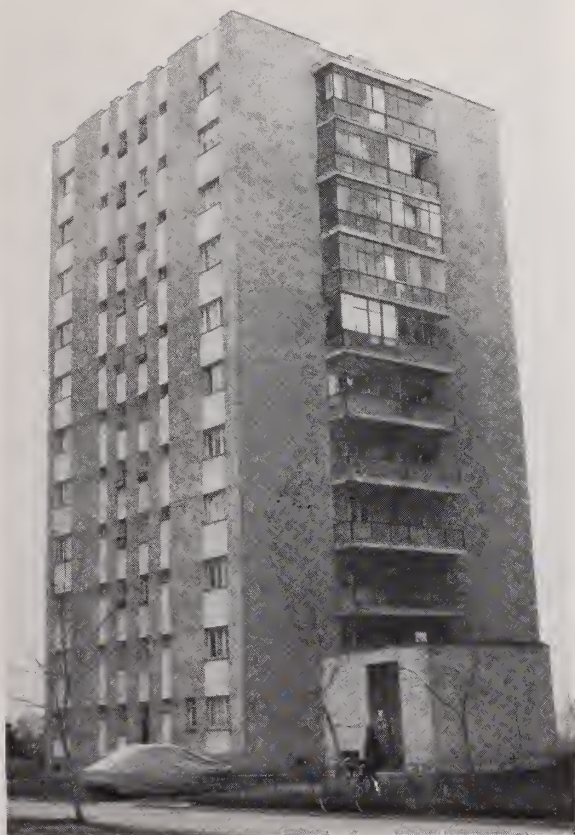
The third building, shown in Figure 3.89, was a 4-year old slip-formed shear wall structure which was likewise used exclusively for residential

Figure 3.89. Eleven-story slip-formed shear wall building.

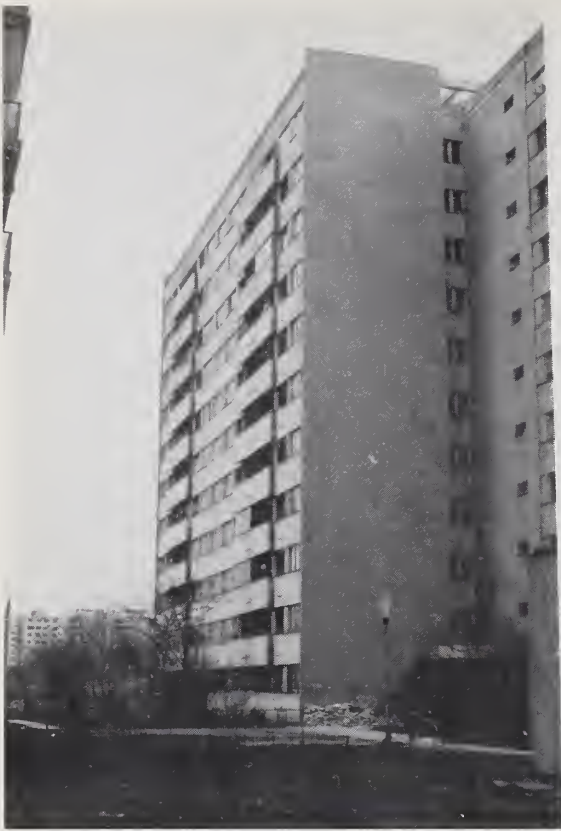
Figure 3.90. Another 11-story slip-form shear wall building.

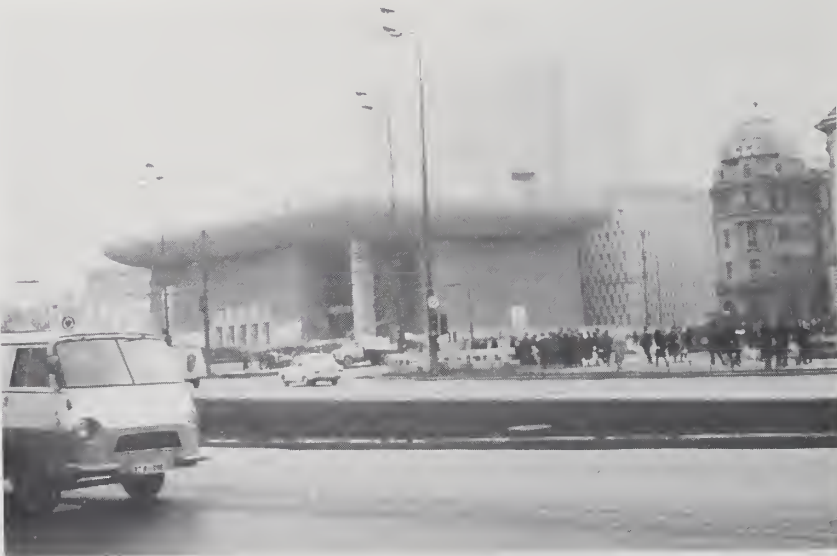
Figure 3.91. National Theater next to Intercontinental Hotel.

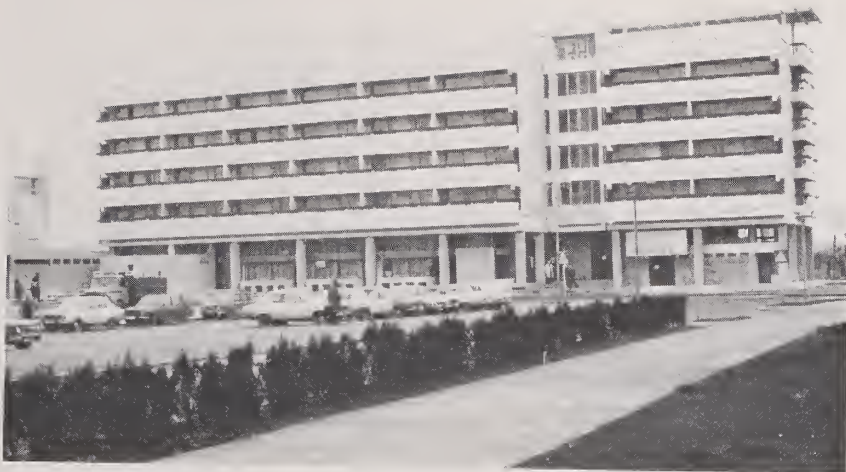
Figure 3.92. Five-story hotel on campus of National Center for Physics in Magurele.

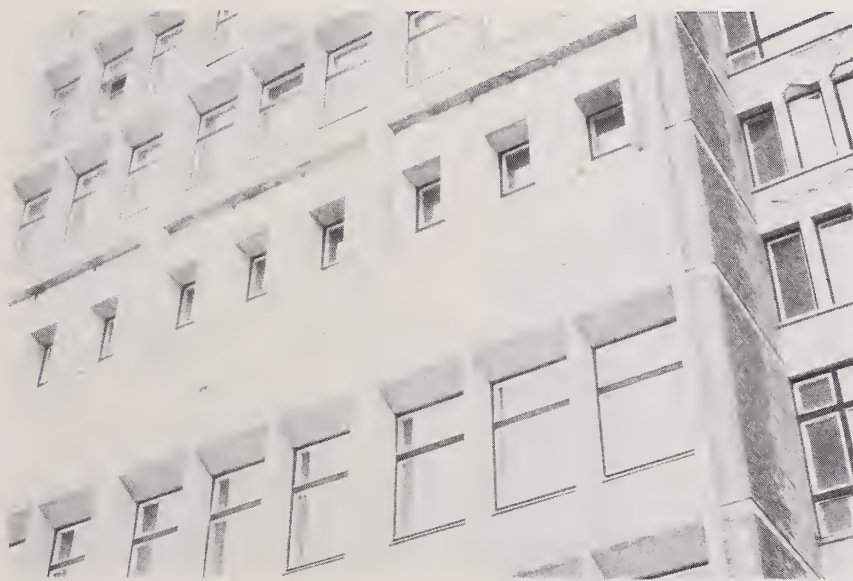
Secondly, potential hazards to pedestrians and dwellers from falling debris in an earthquake can be reduced by improving the quality of materials and workmanship used in the construction of masonry walls for non-structural applications. Examples of exposed masonry construction of superior quality (see Figures 3.90 and 3.93, for instance), suggest that the skills required to bring about such improvements are at hand.

Figure 3.93. Superficial damage of multistory building on campus of National Center for Physics.

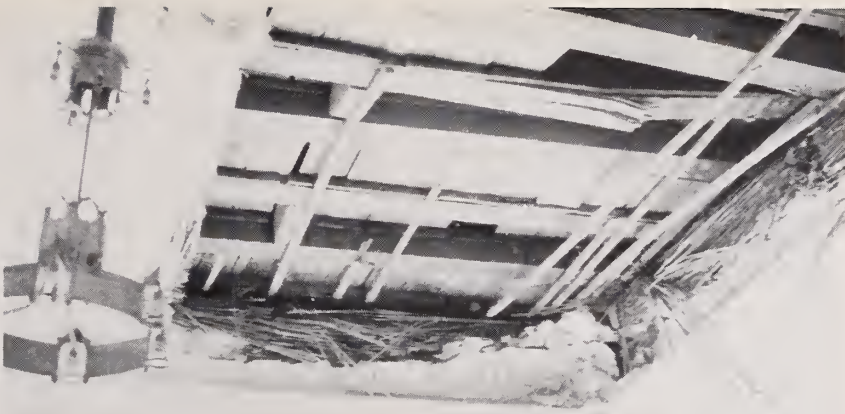
The second historical structure examined was the art museum (Figures 3.99-3.103). It was a massive masonry bearing wall building with a heavy timber floor system. Most of the damage was attributed to the collapse of the chimneys that had fallen inside and outside of the building. Figure 3.99 shows the damage caused to the exterior facade and balcony by a fallen chimney. In one instance, a cupola had fallen into the building and had damaged the flooring below. Figure 3.100 exhibits the exposed timbers of a floor damaged by falling debris. The floor joists were approximately 0.3m square, spaced at about 0.6m on centers. Falling debris had also caused breakage of a decorative skylight above one of the first story rooms (Figure 3.101). The brick walls in the first story, which were about 0.5m to 0.7m thick, were not seriously cracked, although a good deal of decorative plaster had spalled off both walls and the ceiling.

Figure 3.100. Partial collapse of the second story floor of the museum.

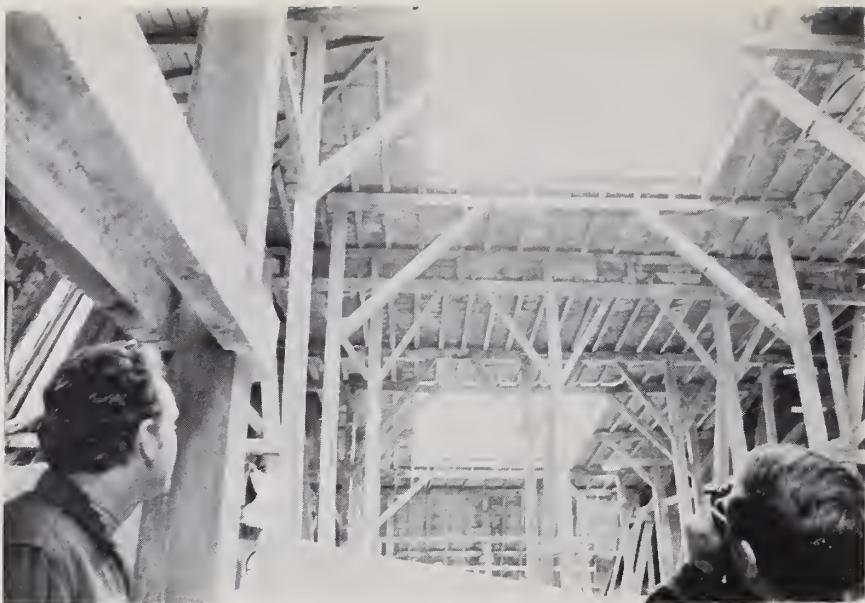
The attic of the building was accessed by narrow stairs that had been seriously damaged. Within the attic, the high-pitched timber roof was supported by a timber framing system laterally stiffened by knee braces as shown in Figure 3.102. At a few locations splitting of knee

Figure 3.102. Timber framing of the roof within the museum attic.

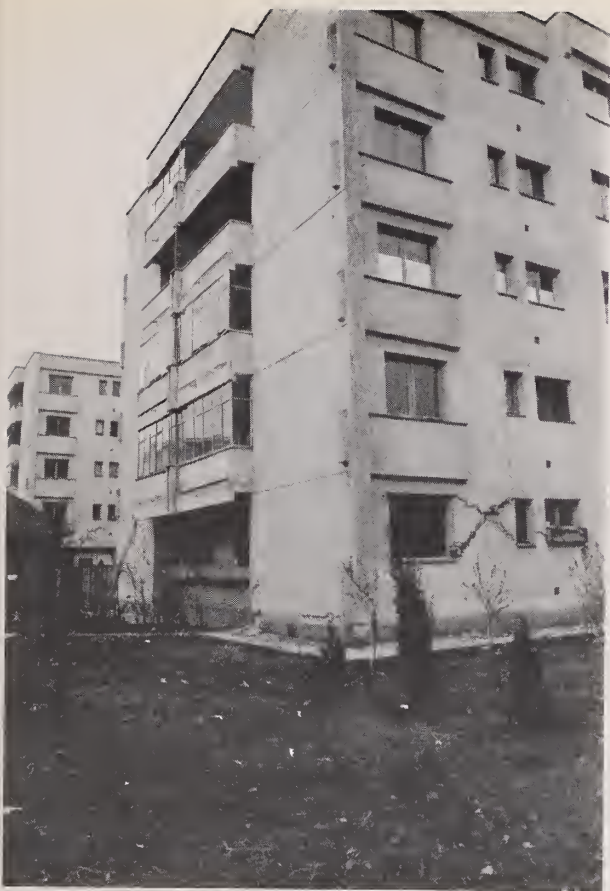
The third building examined was a 5-story unreinforced masonry load-bearing wall system. Two of the wings of the building shown in Figures 3.104 and 3.105 exhibited cracking of first story piers. The latter also shows the development of a major vertical crack between two first story abutting walls at one corner of the building. It appeared that most of the damage had occurred in the first story where many of the exterior piers exhibited severe diagonal cross cracking as shown in Figure 3.106. By reference to this figure, two distinct modes of failure can be identified. In each of the four different instances shown, the wide pier had attained its collapse limit state, characterized by through tension cracking along the diagonal(s), while the slender pier located next to it had developed horizontal flexure cracks at the ends (a first limit state), without appreciably losing its vertical load-bearing capacity.

Figure 3.104. General view of load-bearing masonry apartment building.

Inside the first story, the solid interior walls were not as severely damaged (Figure 3.107) but most lintels above openings had received a good pounding (Figure 3.108). One of the repair schemes that was being considered for this building was the application of gunite over wire mesh on both sides of the first and second story walls. The Romanian engineers also expressed interest in learning more about the structural rehabilitation methods used in the United States, particularly tuckpointing of masonry and use of epoxy resins in the repair of concrete and masonry cracks.

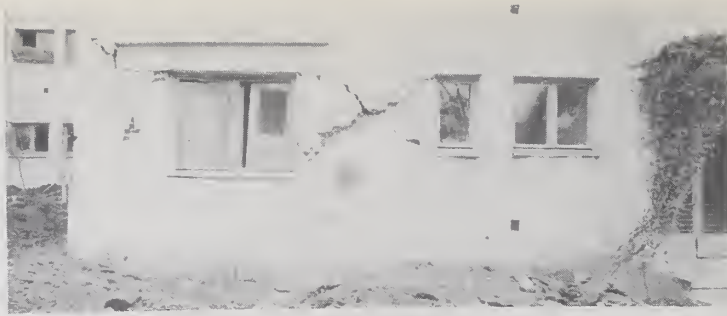
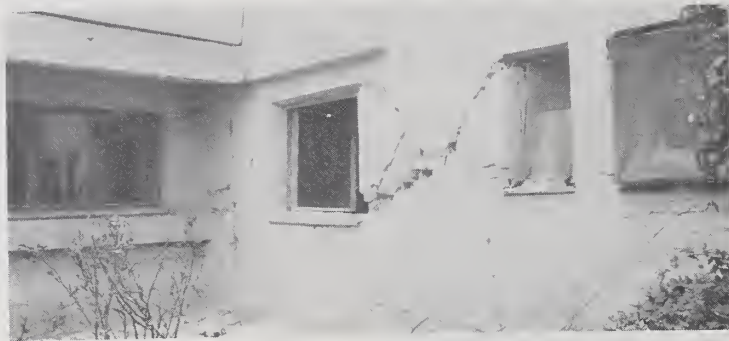
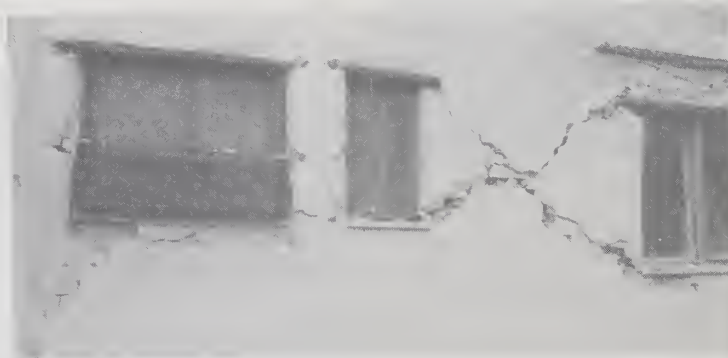
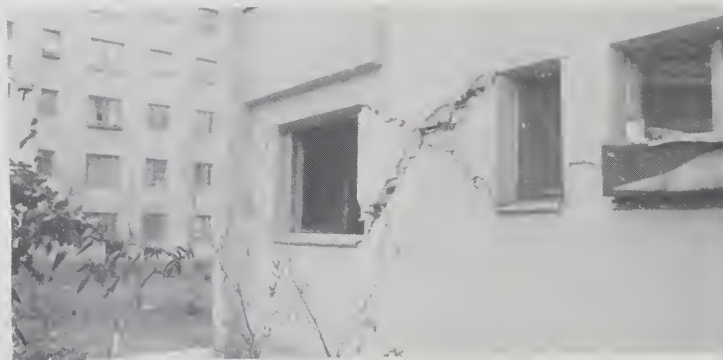
Figure 3.106. Failure of first-story piers.

Figure 3.107. Damage of interior masonry wall.
