NIST Special Publication 901

The January 17, 1995 Hyogoken-Nanbu (Kobe) Earthquake

*Performance of Structures, Lifelines, and Fire
Protection Systems*

Riley Chung, Team Leader and Editor

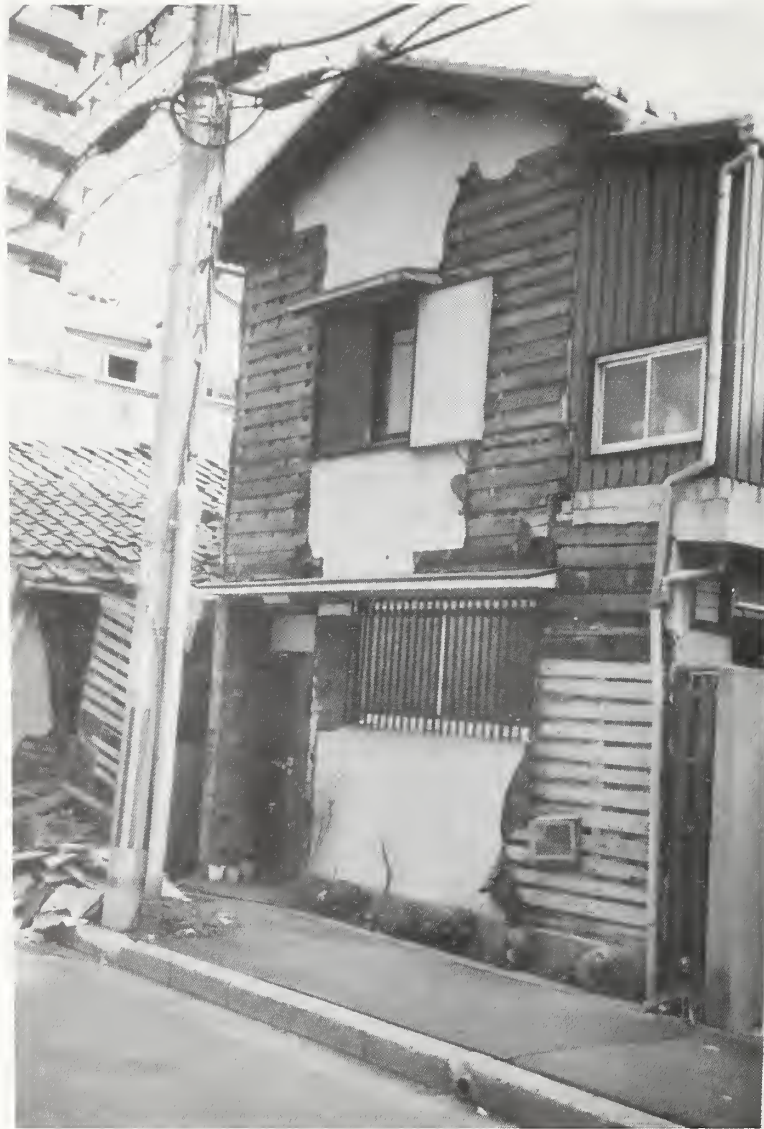
Figure 3.3.5 An Ohkabe house with only architectural design. Note a shadow of diagonal bracing on the left side of second story.

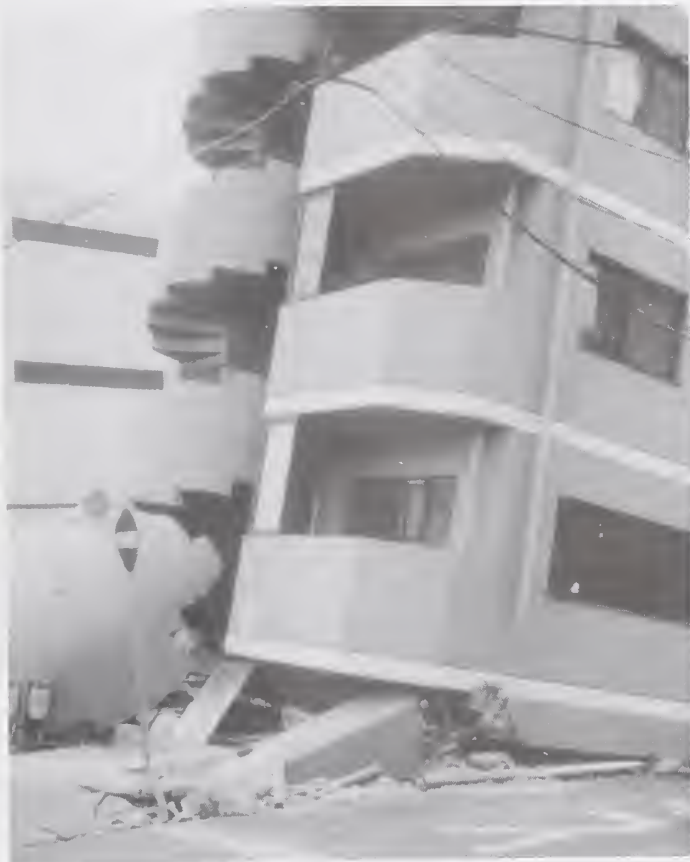
Figure 3.4.15 Collapsed first story.

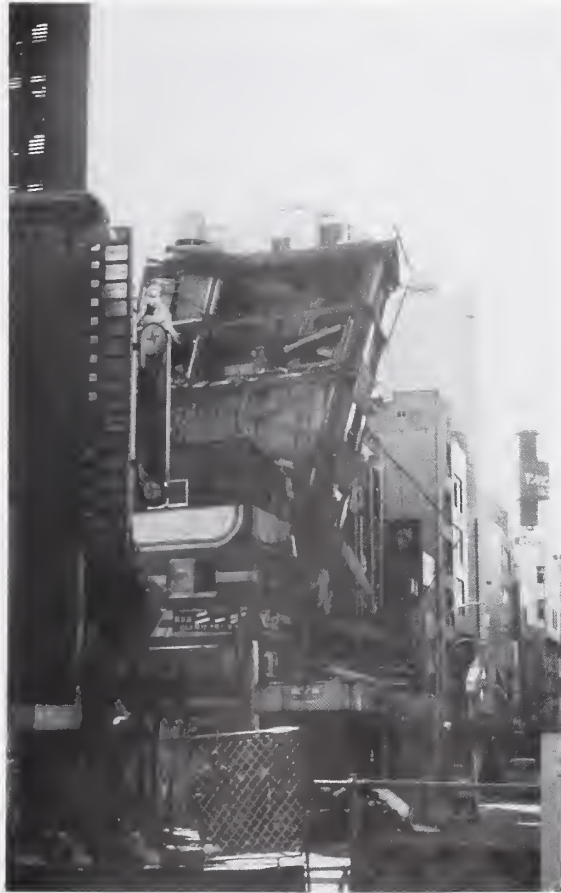
Those braced frame structures which did not have infilled walls were more flexible. One of the more striking failures in downtown Kobe was a seven-story braced frame system (Figure 3.5.10) with autoclaved lightweight concrete panels for cladding (Figure 3.5.11). This building had a very narrow platform with one bay in the east-west direction and two bays in the north-south direction. However, the building drifted severely toward north (stiffer direction) due to fracture of numerous braces (each approximately 6 mm x 75 mm in cross section) at bolted connections to gusset plates which are welded to the columns. In the upper floors, it can be seen that the braces in tension, which attempted to prevent displacement of the building toward the north, fractured through the bolt hole. The building remained standing only due to the presence of bolted shear connections for the beams, which managed to resist some lateral load.

Figure 3.5.10 Partial failure of a 7-story steel braced frame structure. Braces failed in tension at the bolted connections. Significant rust is evident in most closeups (see next four slides) around the vicinity of these bolt holes which may have permitted widespread fracture of the brace plates (approximately 6mm x 75mm plate).

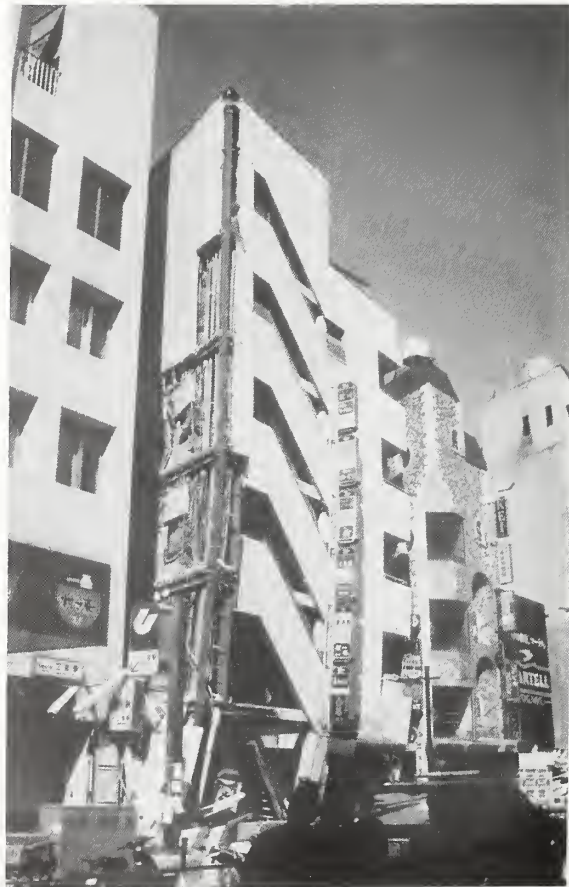
One example of moment frame structures which did suffer severe damage was a seven-story Nari Hiro Building in downtown Kobe (Figure 3.5.17). Figure 3.5.18 shows a closeup view of the southwest column, second story junction showing lateral buckling of the first story column. This, however, was a result of more dramatic weld failures on the east face of the building.

Figure 3.5.17 "Nairo Hiro" Building, a seven-story steel moment frame structure in downtown Kobe.

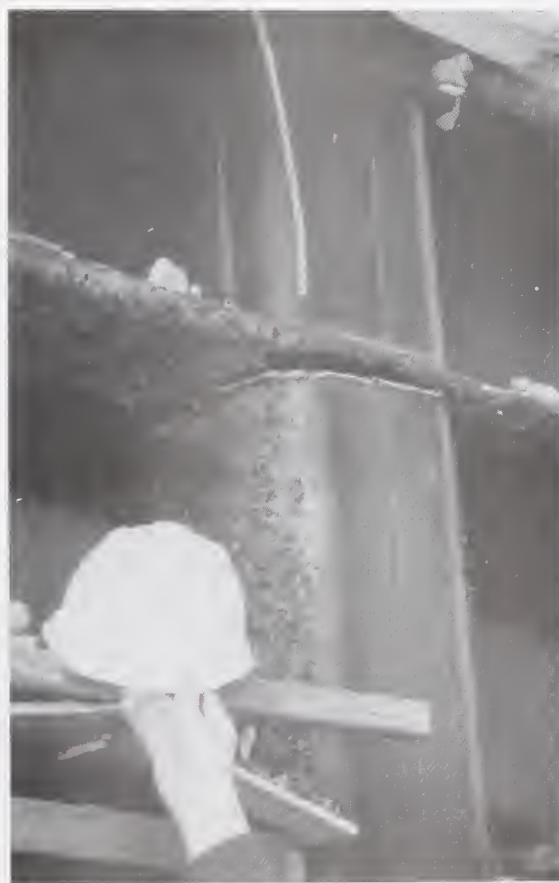
Figures 3.5.19 show details of a beam stub-to-column connection failure on the east face of the same building. Figures 3.5.20 and 3.5.21 show first floor column to second story column joint fillet weld failure.

Figure 3.5.21 Closeup photo of column fillet weld failure in the Nairo Hiro building .

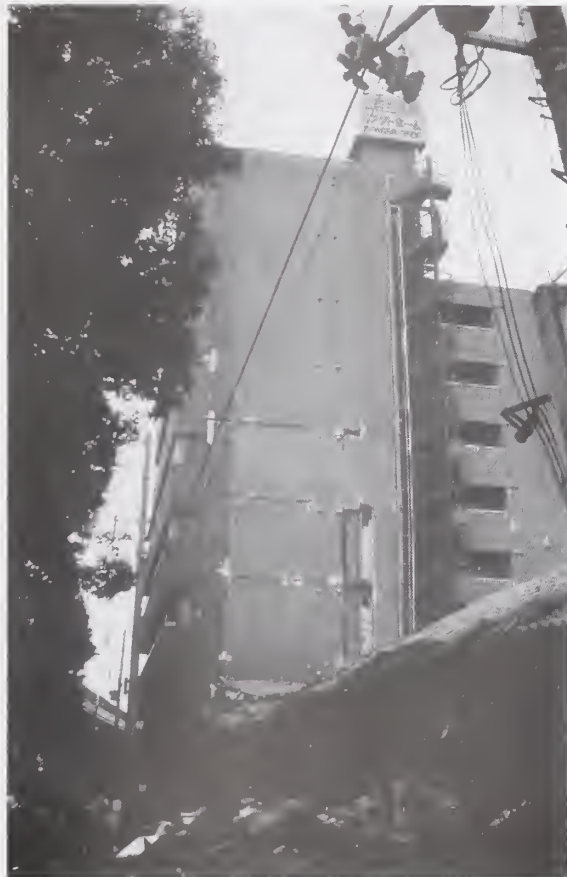
Figure 3.5.26 East face of the Liberty apartments.

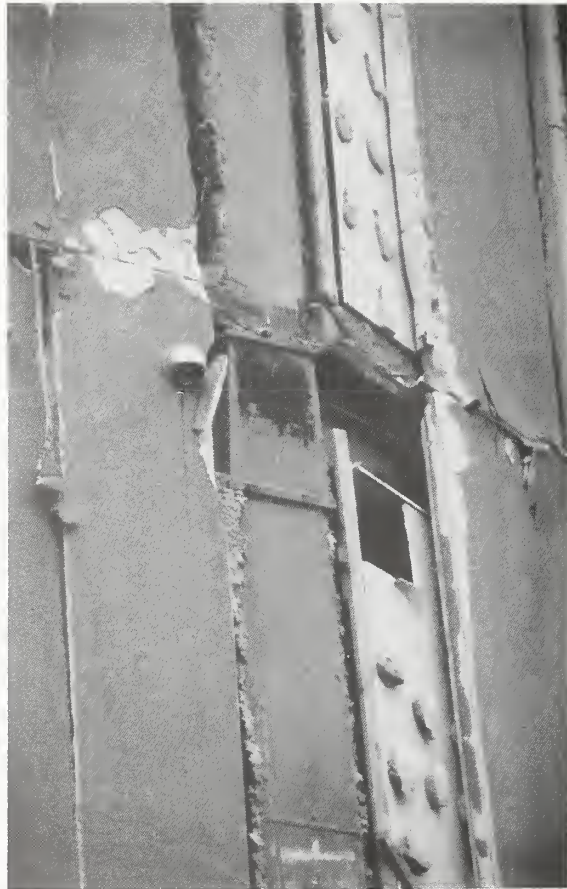
Figure 3.5.27 Closeup photo showing locally yielded third floor column joint in the Liberty apartment complex.

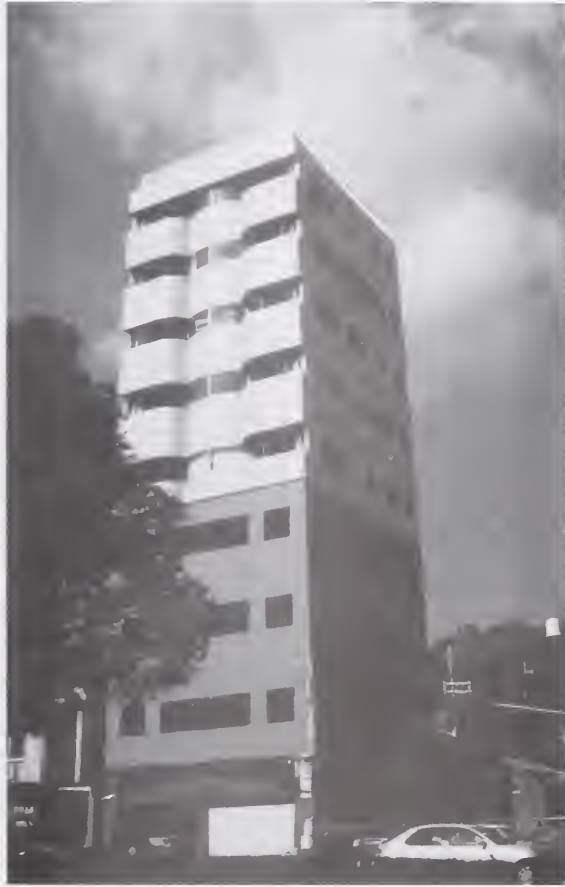
Figure 3.5.30 Nine-story Pacific Power Corporation building in Kobe.

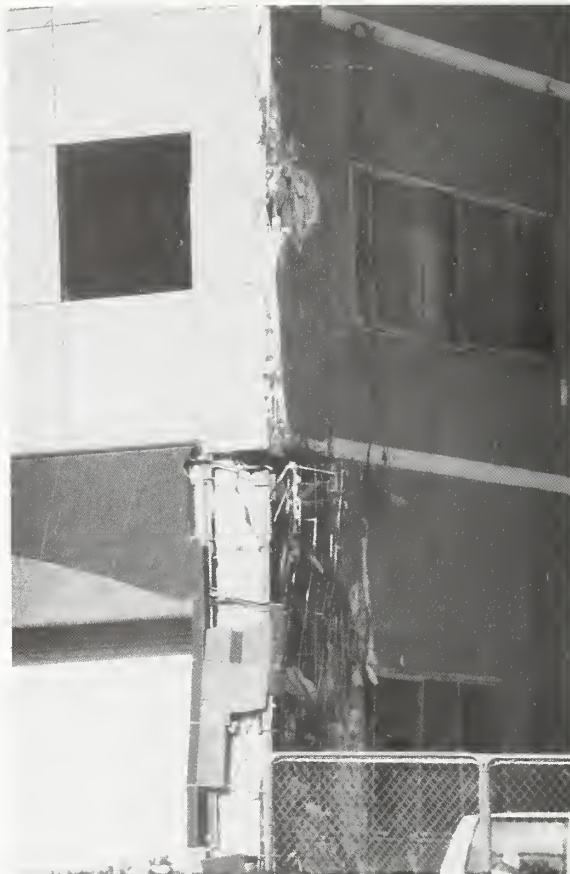
Figure 3.5.31 Detail of southeast corner of Pacific Power Corporation building.

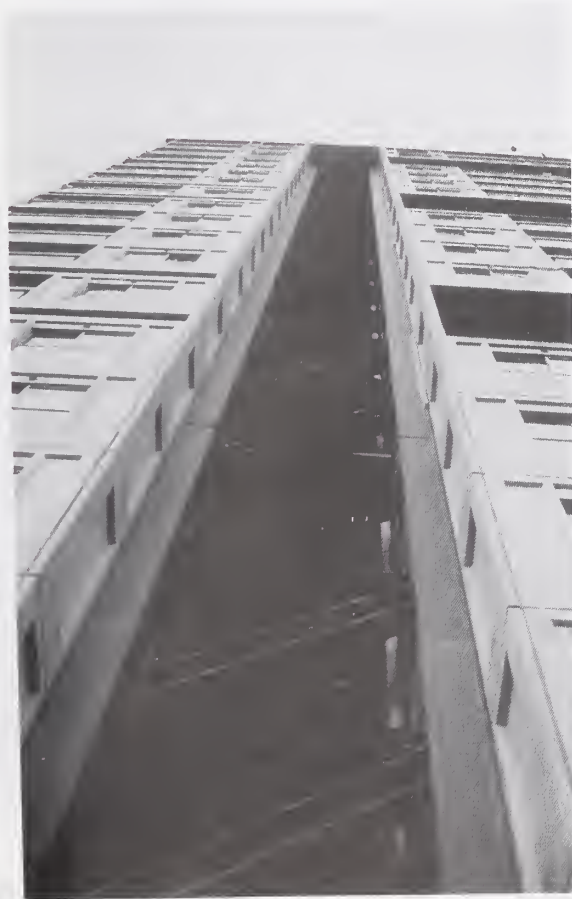
Figure 3.5.40 Load-carrying system: truss-like frames made of heavy steel sections.

A final note concerning steel structures are the questions raised by the extensive base metal and weld failures observed at the Ashiya Hama Seaside Town (AHST) complex in Ashiya City. A number of thick column sections and diagonal bracing members sustained brittle failures. These failures echo problems first observed in steel structures in the United States following the Northridge earthquake.

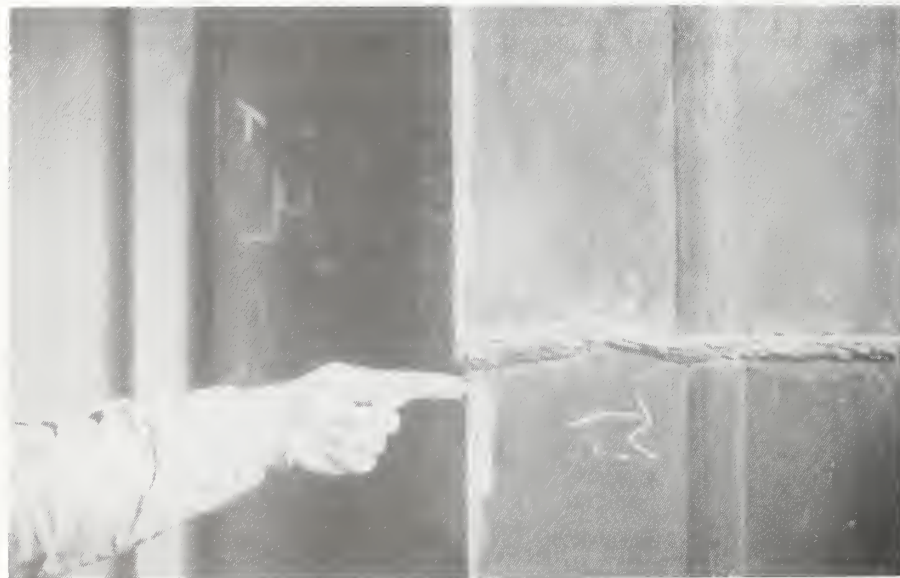
Figure 3.5.42 A repaired column immediately after the earthquake (Portland Cement Association).

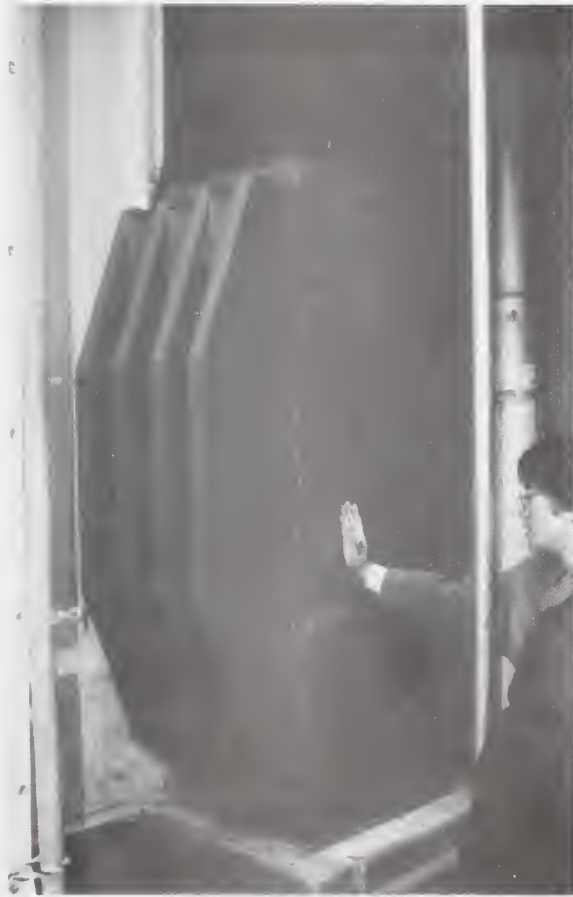
Figure 3.5.43 A column repaired not only with full-penetration weld, but also with stiffeners added.

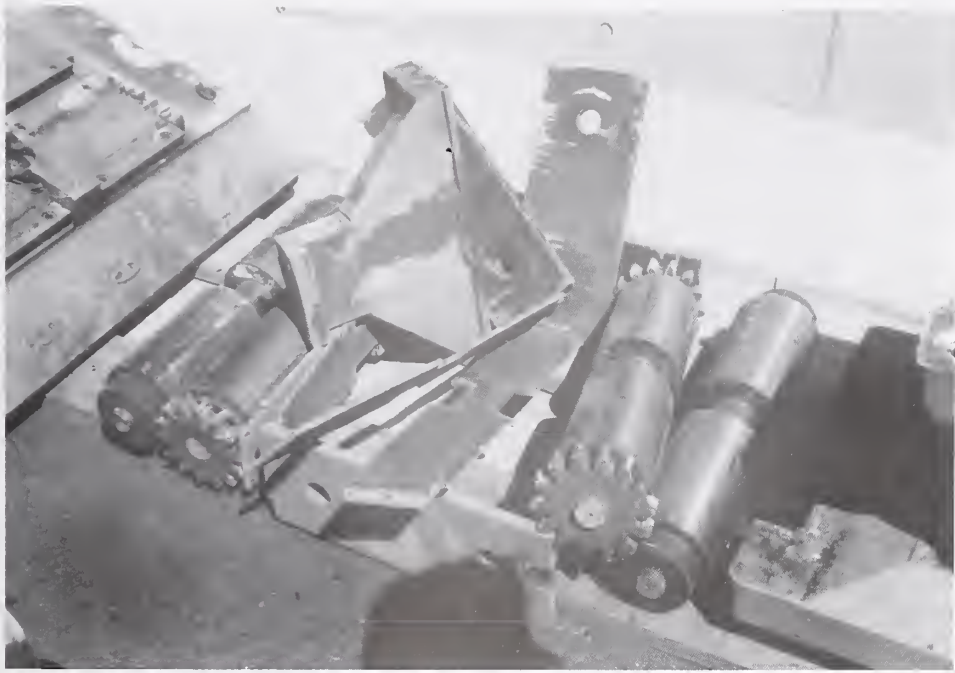
Figure 4.2.3

Damaged expansion bearings from under approach spans, Nishinomiya-ko Bridge, showing nested rollers and guide rails.

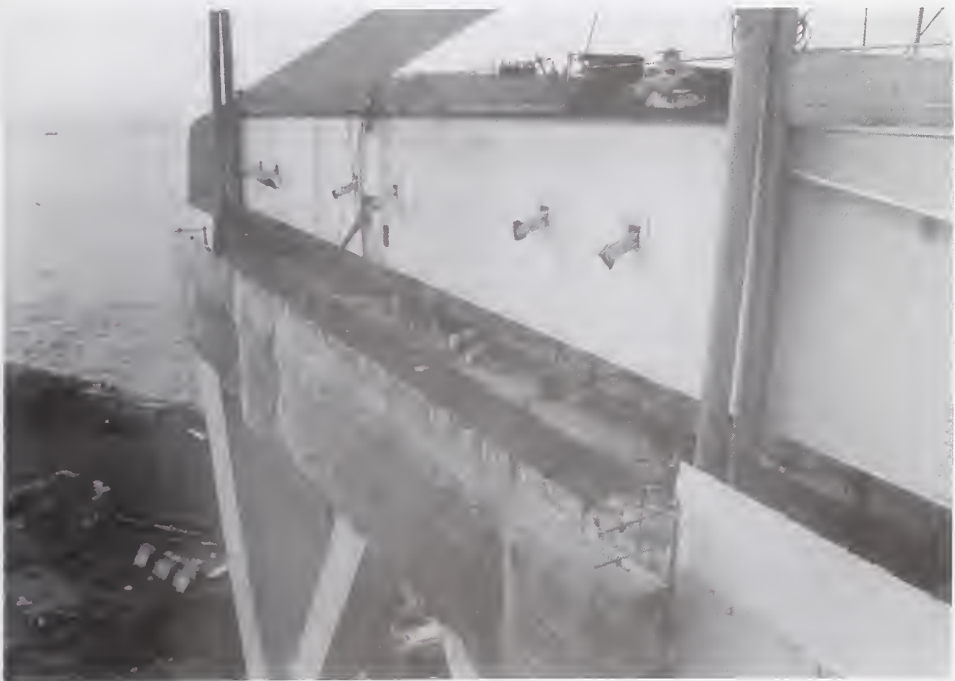
Figure 4.2.4

Cap beam of Pier 111, Nishinomiya-ko Bridge, showing cross-girder of arch and failed restrainers.

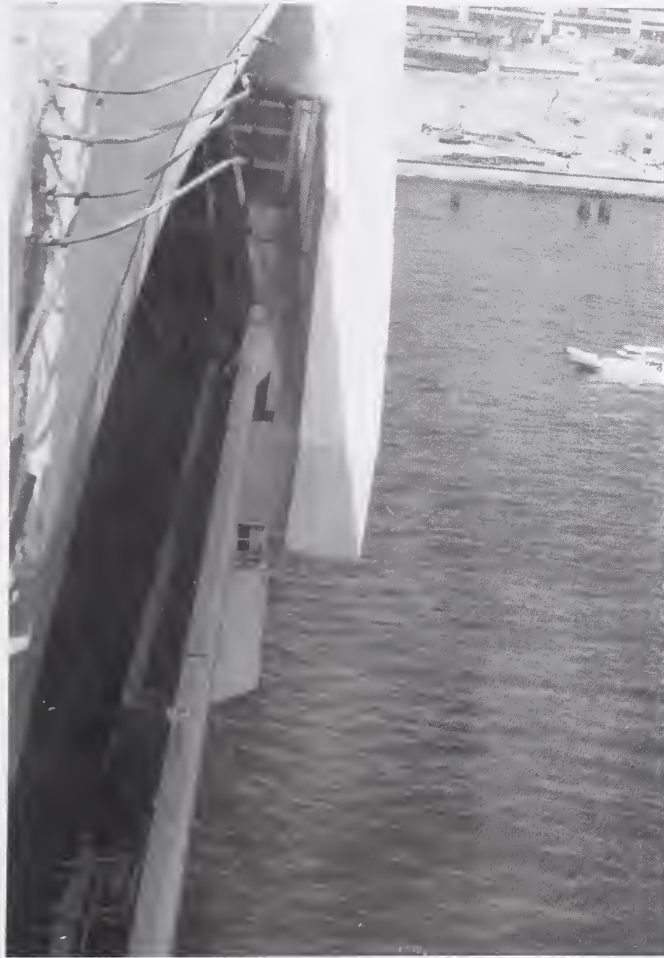
Figure 4.2.7 Lateral offset at east face of South Pier, Rokko Island Bridge.

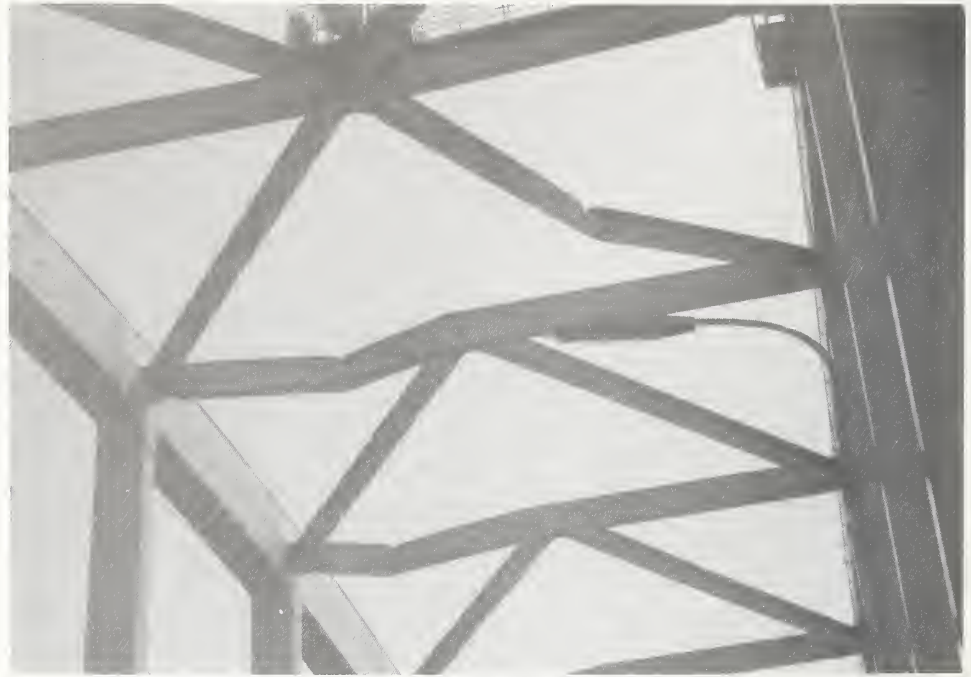
Figure 4.2.8 Buckled cross-members in Upper Chord, Rokko Island Bridge.

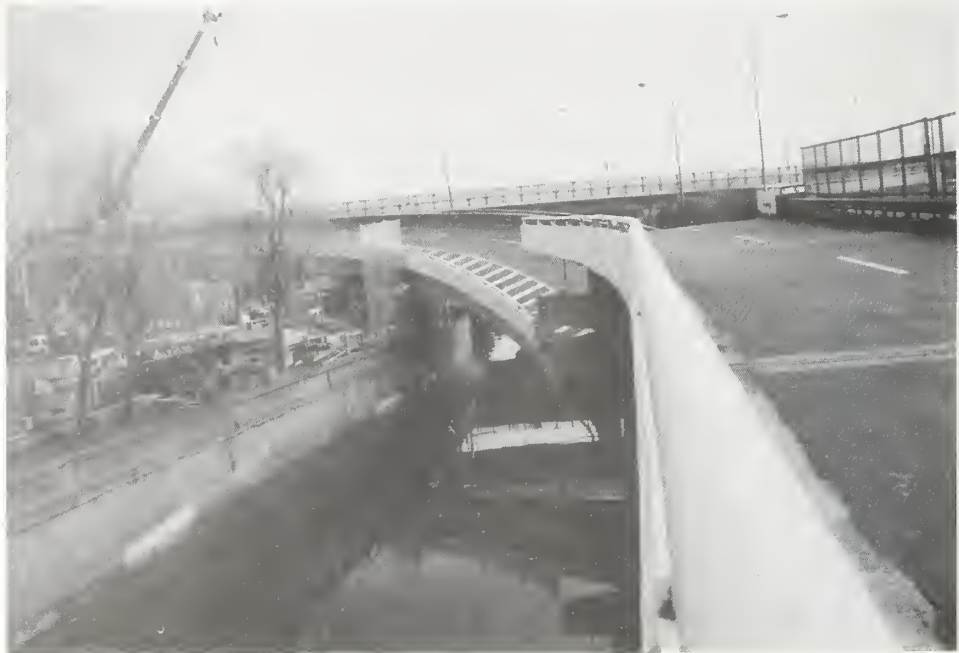
Figure 4.2.28 Collapse of Northeast Ramp at the Minatogawa Interchange.

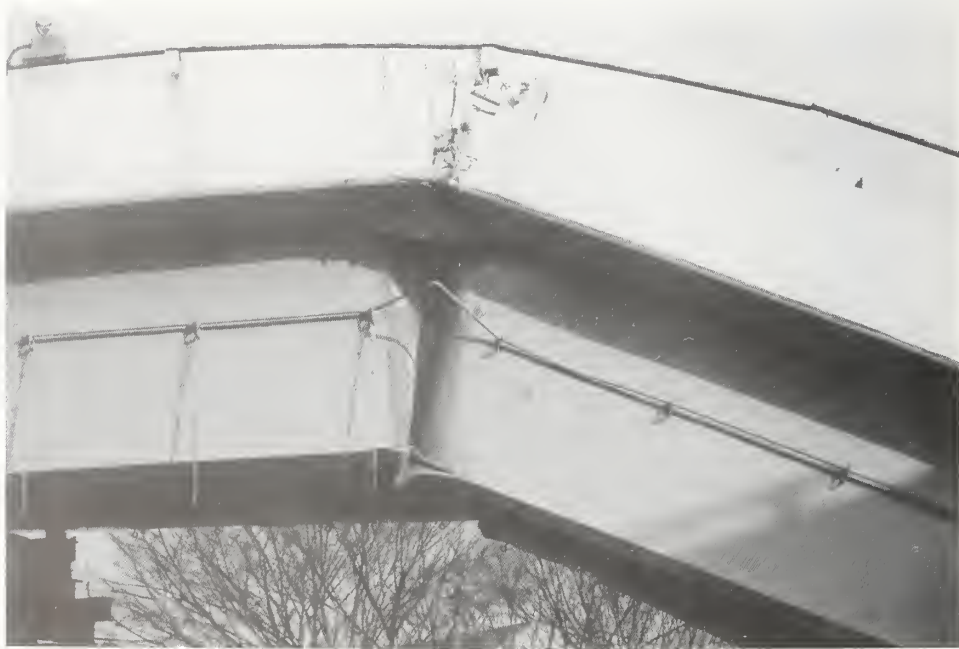
Figure 4.2.29 Girder web failure due to unseating of the Southeast Ramp at Minatogawa Interchange.

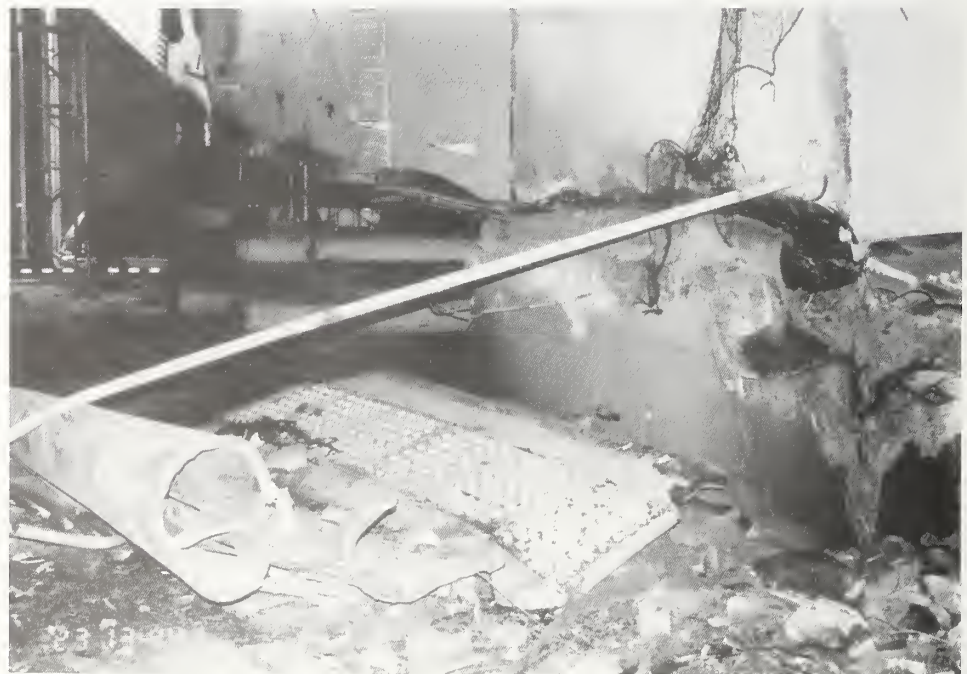
Figure 4.2.34 Pier 55, Route 3 near Tateishi showing buckled steel plate on ground.

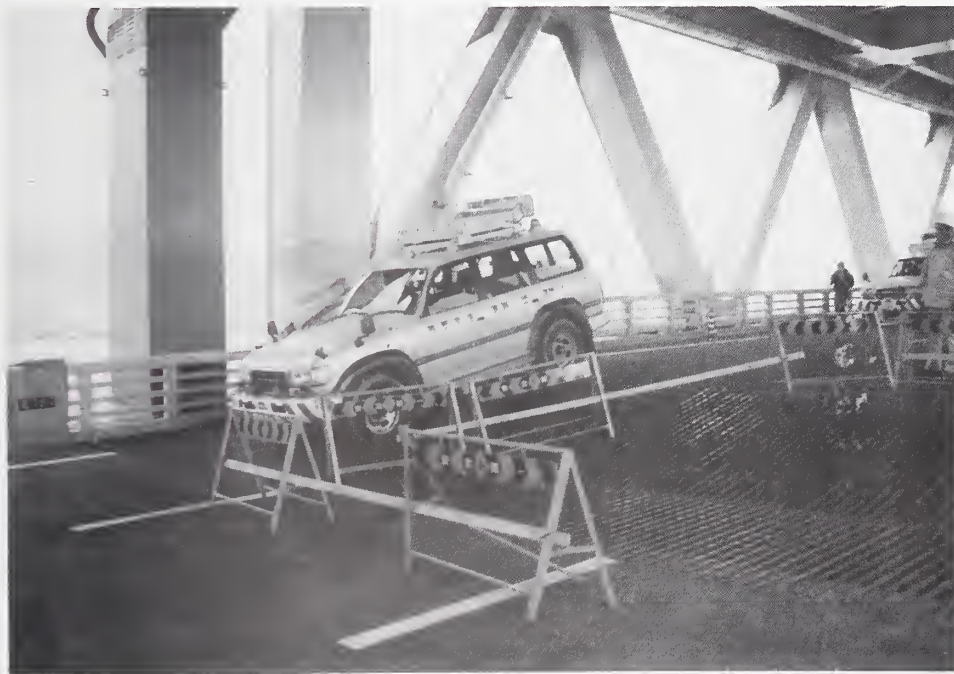
Figure 4.2.50

Uplift at the west end (Pier 187) of the main girder of the Higashi-Kobe Bridge due to failure of the dead load tie-down.

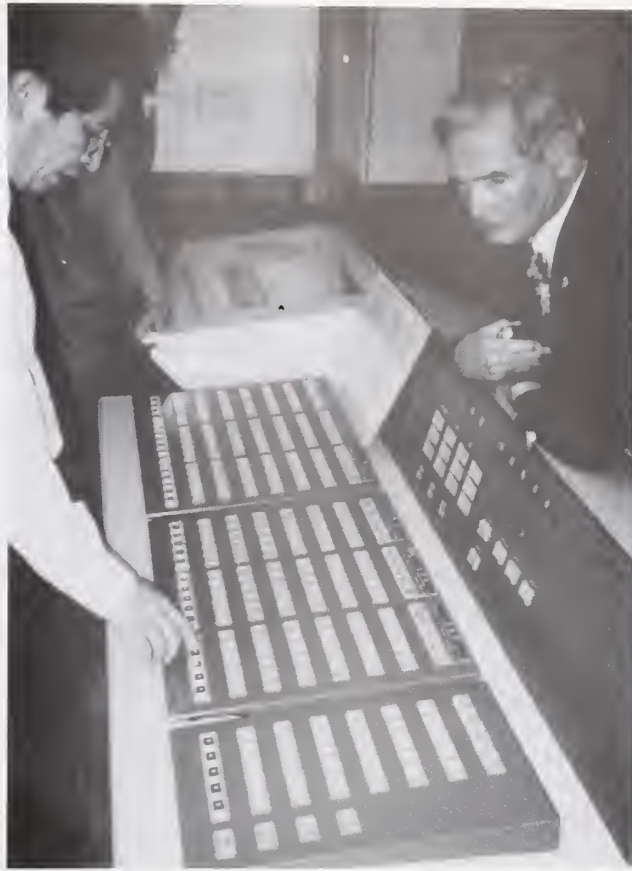
Photo 6 Control Panel for earthquake valves to provide flexibility to control automatically or by operations staff in Okuhirano Control Center.

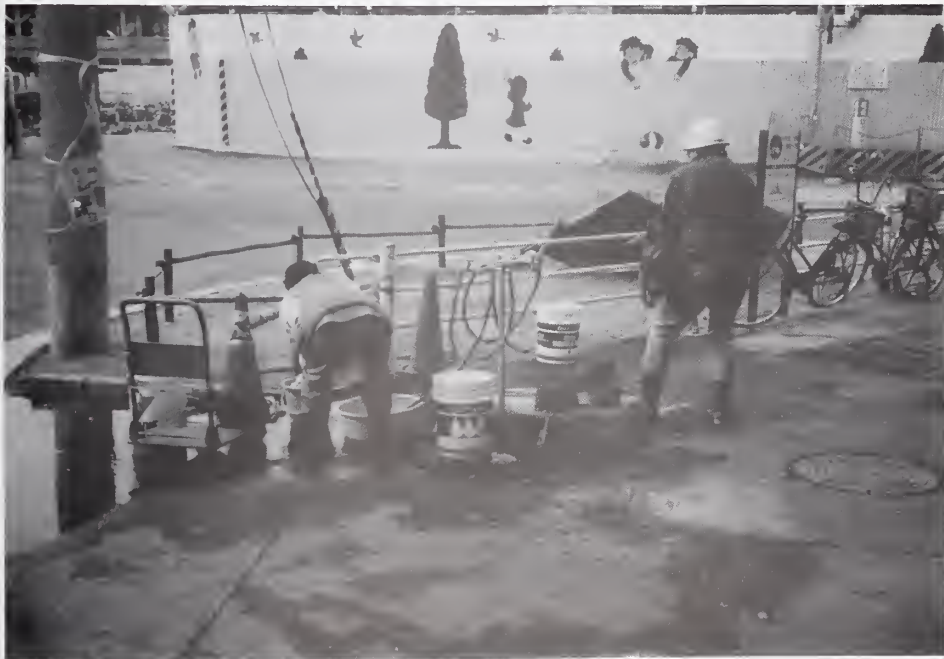
Photo 7 Person collecting water from central water distribution point near the collapsed Daikai Subway Station.

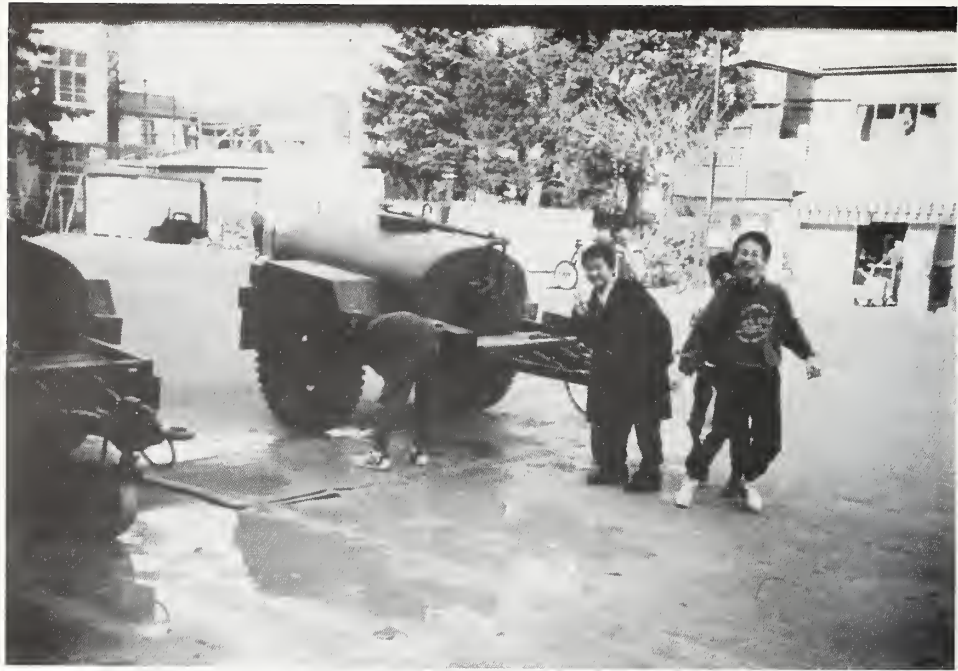
Photo 8 Emergency water supply delivered in tank trailer.

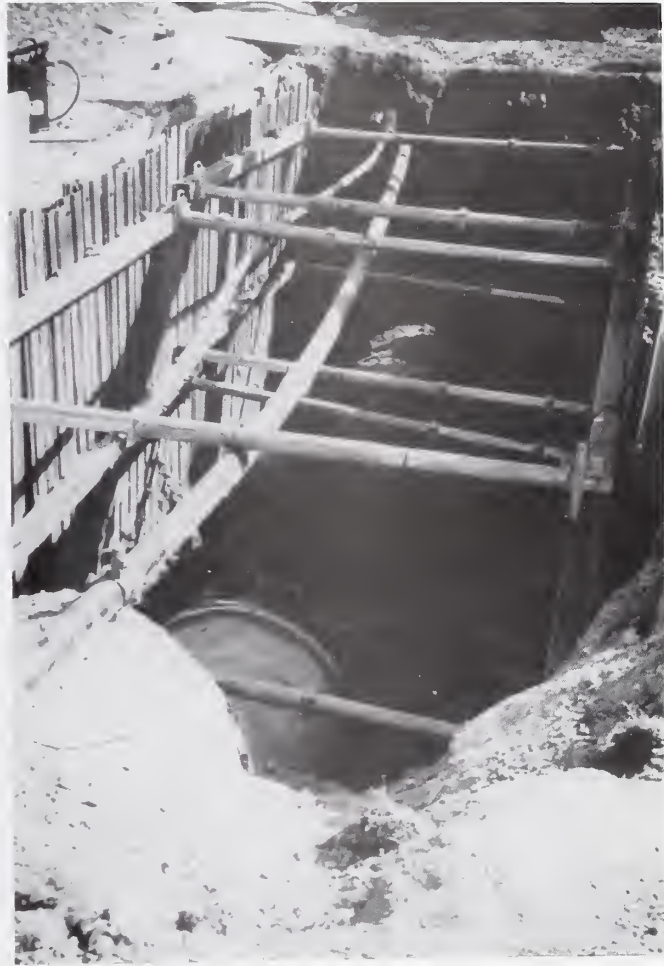
Photo 10 Repair of one of the three 1.2 m treated water lines leaving the Uegahara/Hanshin Plants site.

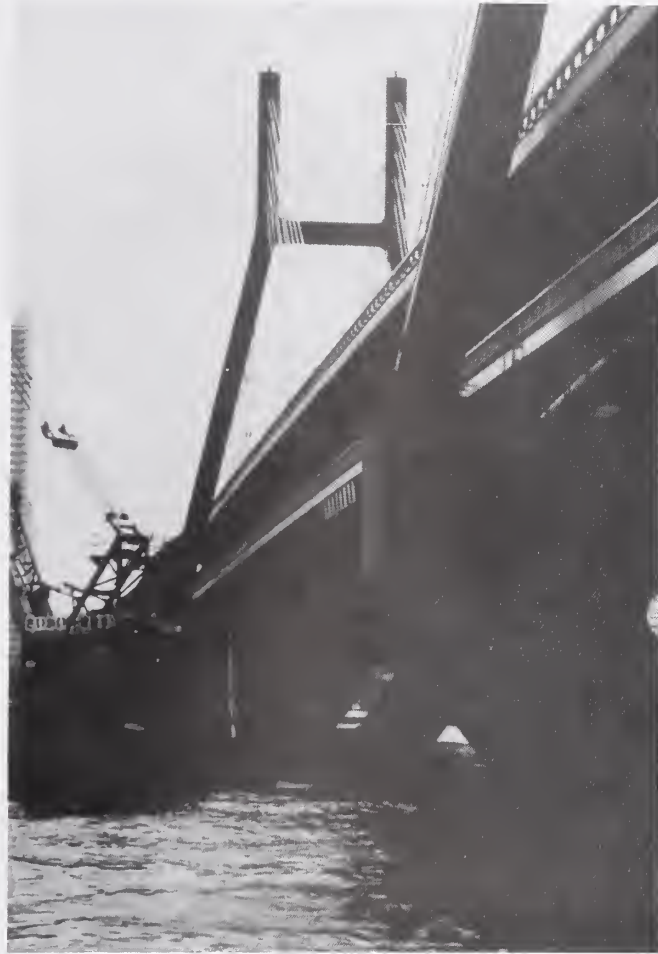
Photo 15 Pipe hanging from bridge to Rokko Island (just to the right of crane cab).

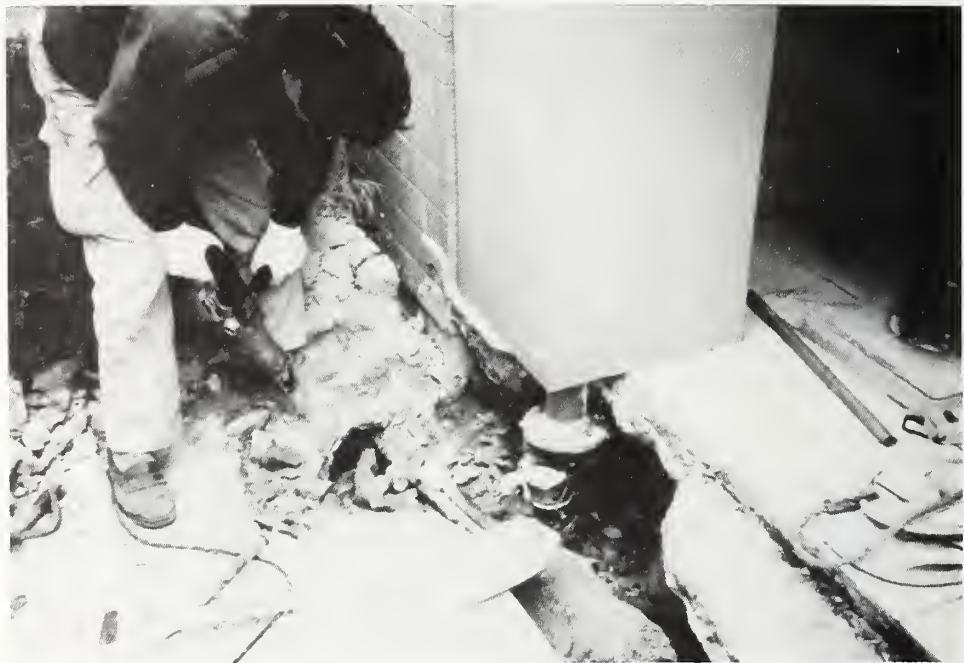
Photo 22 Repair of utility connections in mid-Rokko Island.

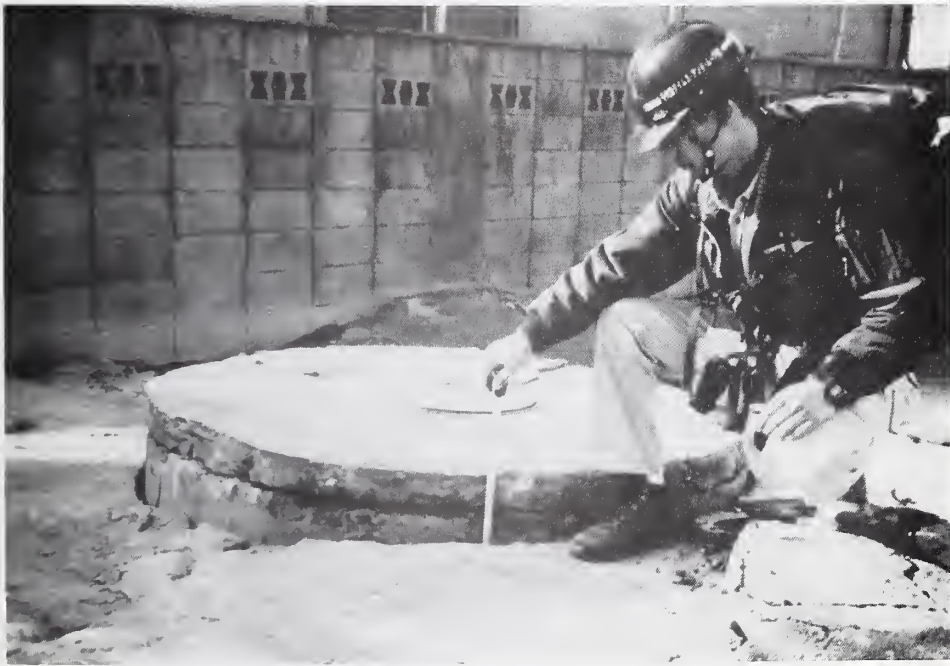
Photo 26 Same as Photo 25.

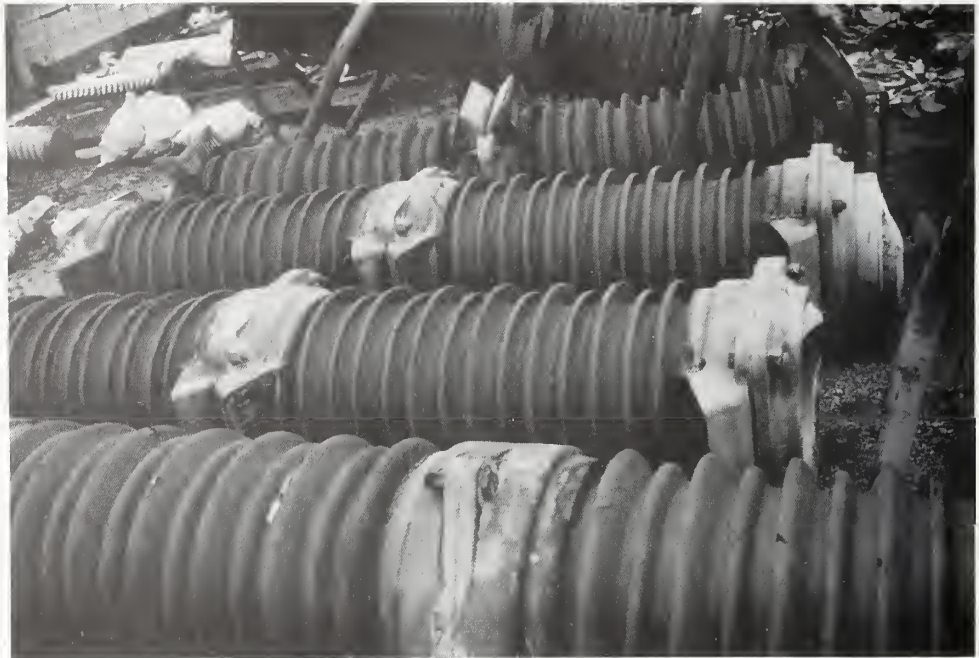
Figure 5.4.31 Damaged 275 kV lightning arrester in the grave yard.

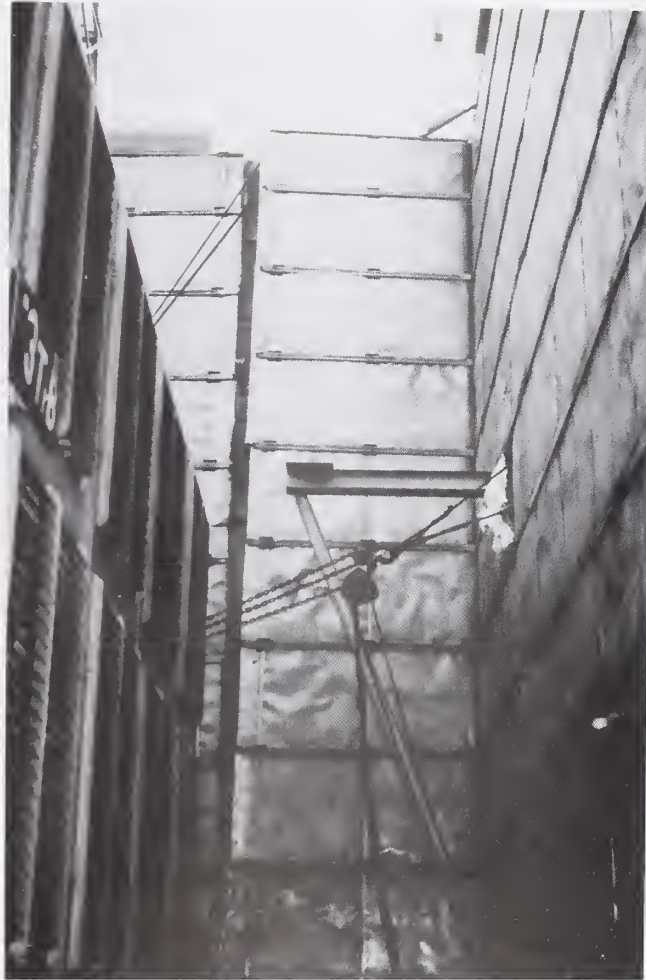
Figure 5.4.37

Transformer acoustical enclosure support was damaged and the enclosure shifted.

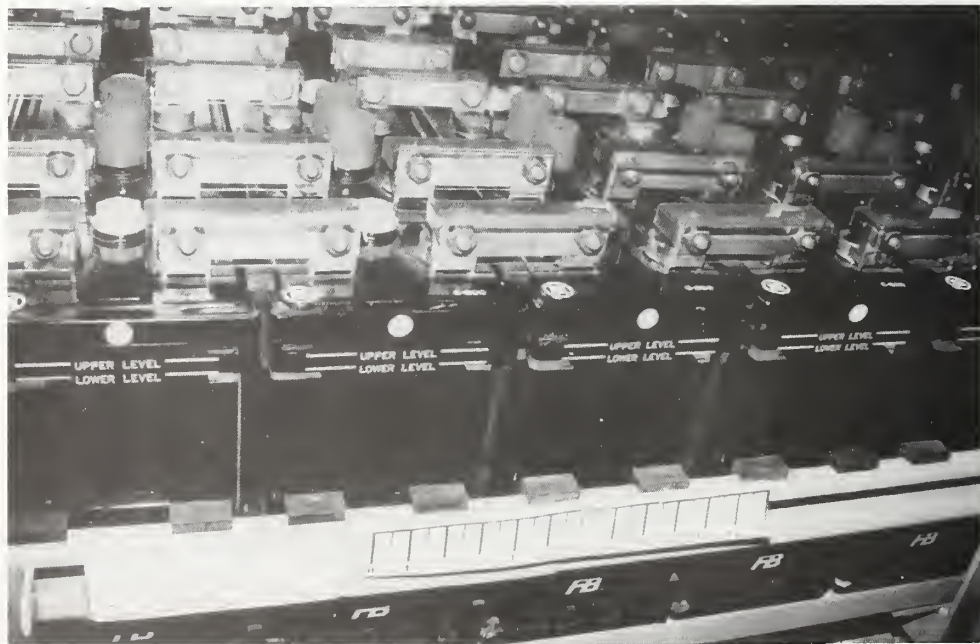
Figure 5.4.40 A low slung battery rack configuration not found in the U.S. reduces bracing requirements of the rack.

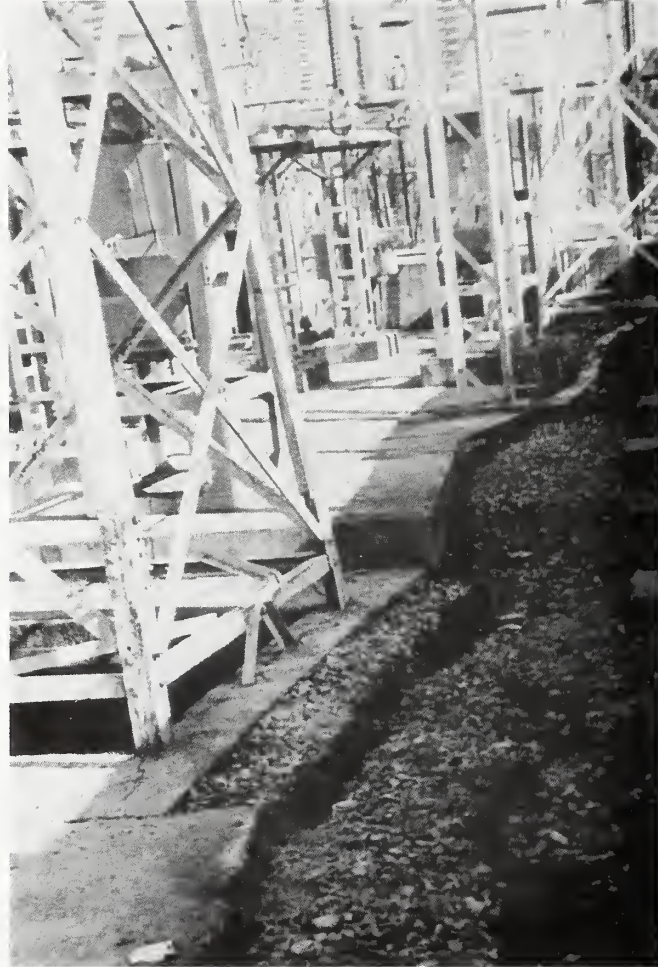
Figure 5.4.42

Cable tray sections are bolted together and cables restrained with ties to the tray.

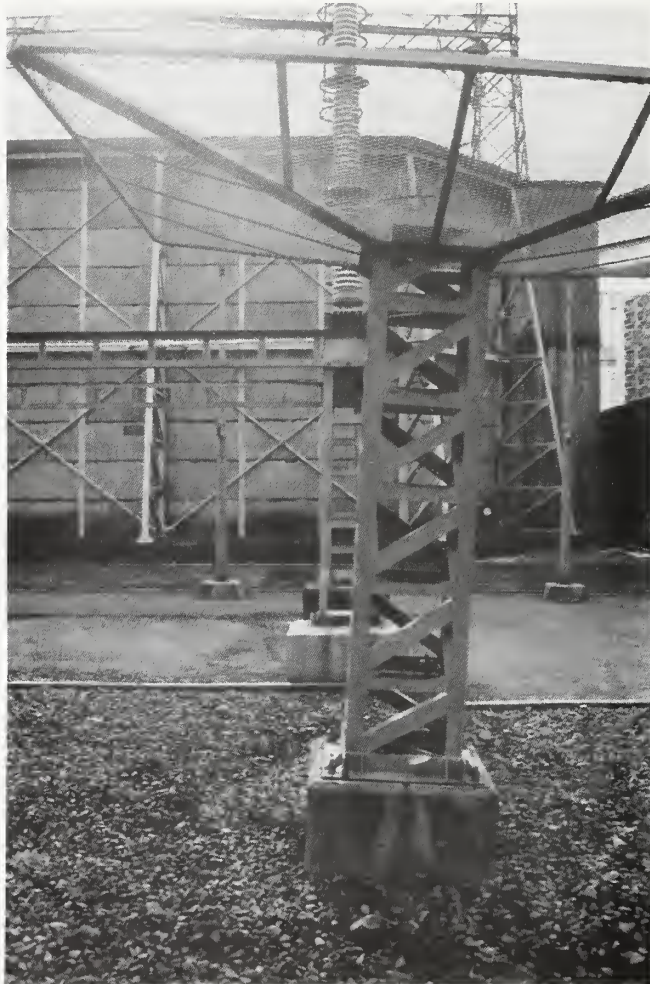
Figure 5.4.46

Foundations of conductor support structures were disturbed and individual footings rotated as much as 25 degrees.

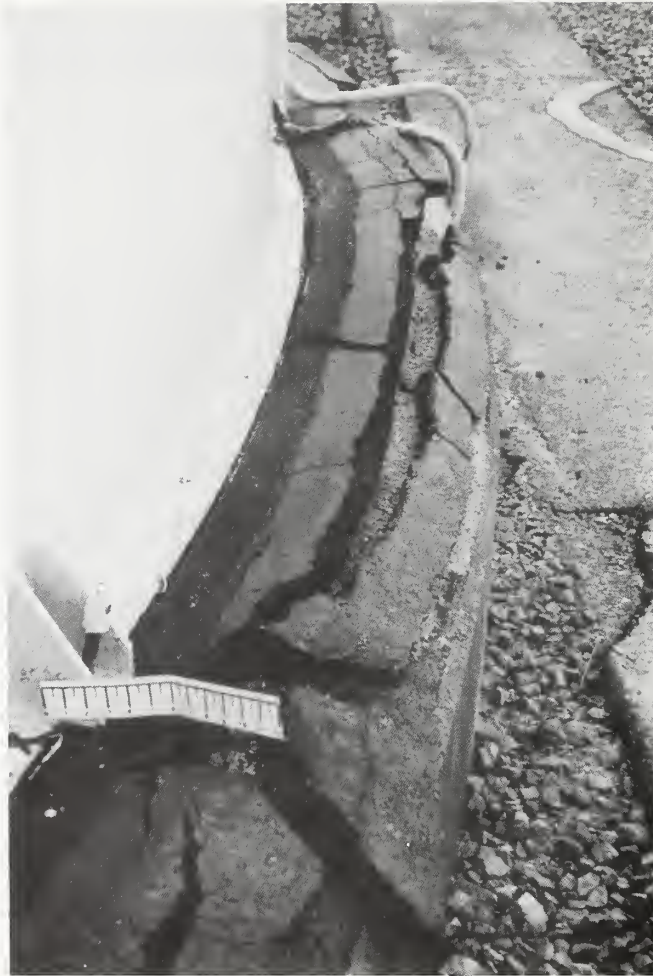
Figure 5.4.48

A new monolithic disconnect switch pad replaced individual footings that were disturbed by a surface crack in the soil.

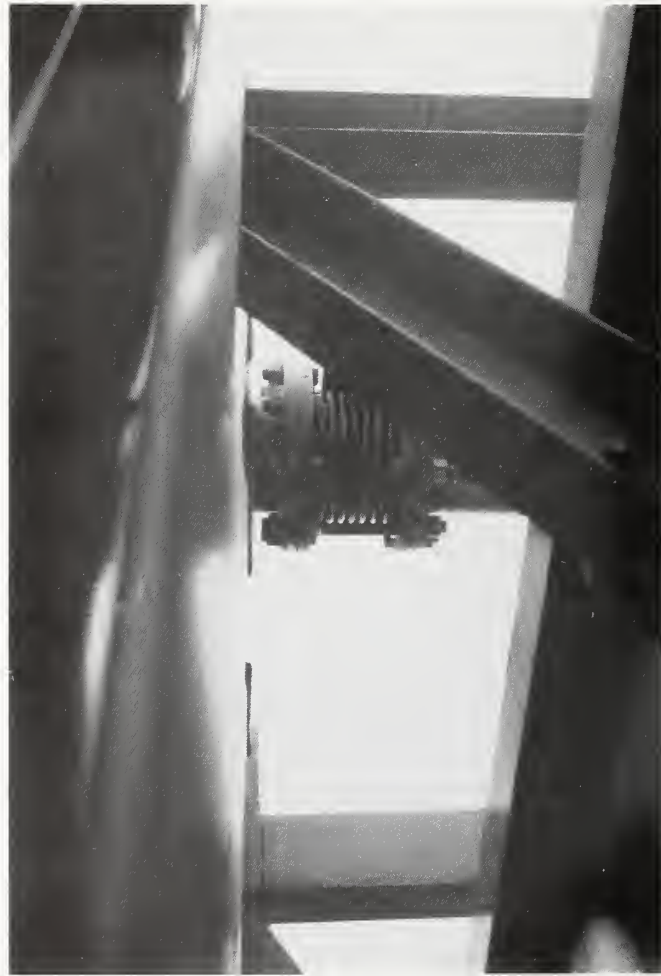
Figure 5.4.62

A pot head connected to the bushing failed, probably when it was hit by the bushing.

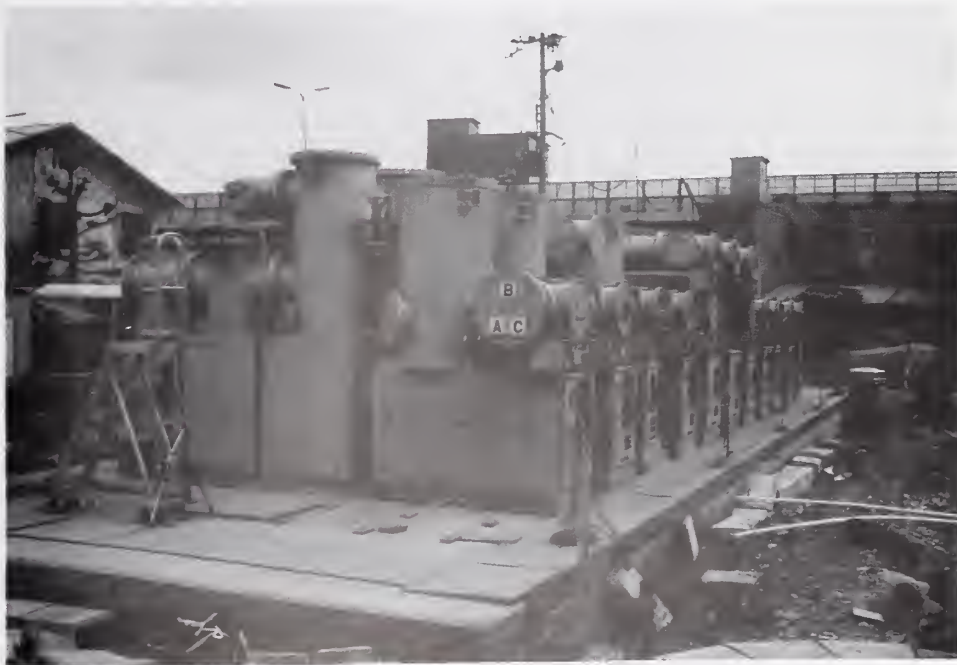
Figure 5.4.64 Movement of the transformer after its anchorage failed allowed the radiators to hit a nearby structural support causing a leak.
