NIST Special Publication 901

The January 17, 1995 Hyogoken-Nanbu (Kobe) Earthquake

*Performance of Structures, Lifelines, and Fire
Protection Systems*

Riley Chung, Team Leader and Editor

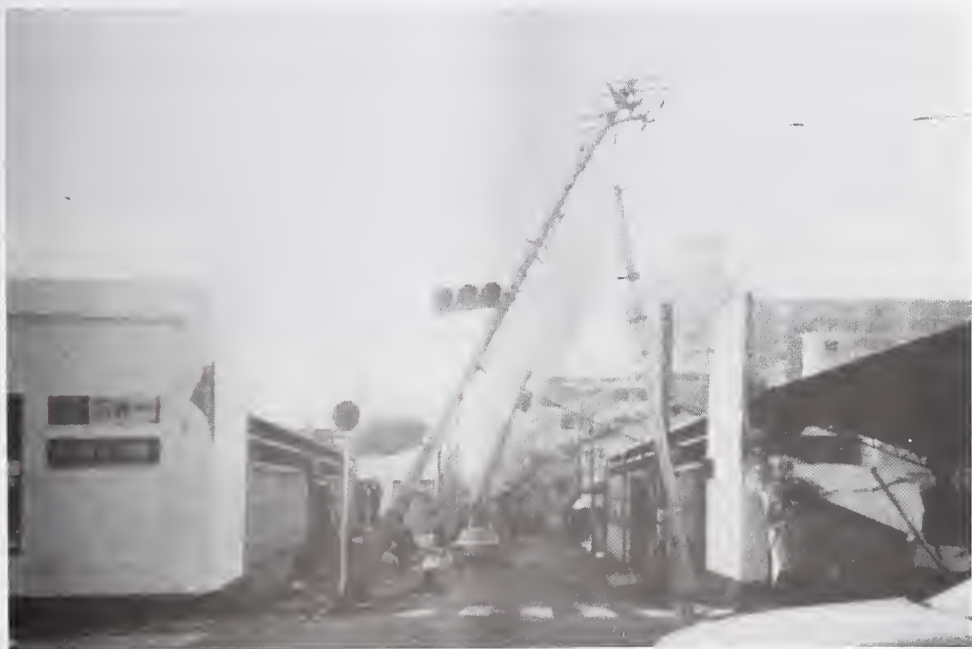
Figure 5.4.68 Fallen housed pushed over some distribution poles.

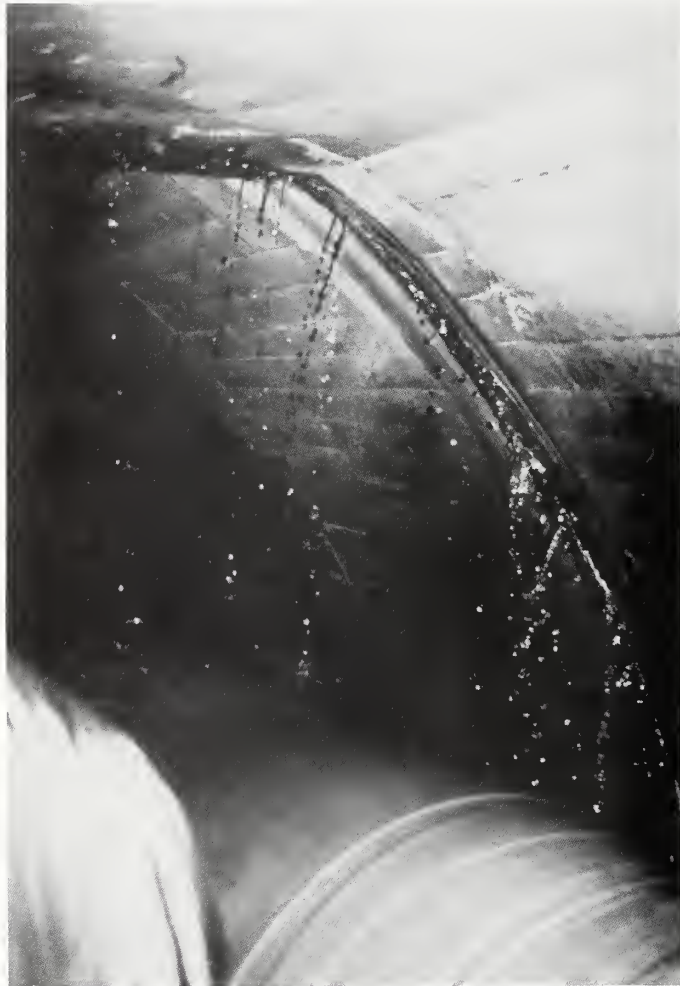
the tunnel settled about 7 cm relative to the building and shifted about 7 cm laterally; however, there was no damage to trunk lines. Figure 5.5.2 shows a schematic diagram of the tunnel-building connection and a post-earthquake repair used to stop water leaks. This detail was used throughout Japan. There was minor damage to the Joint Utility Tunnels, primarily slight movement at construction joints resulting in leaks (Figure 5.5.3). Communication cables in the Joint Utility Tunnel had fire resistant covers near entrances and staircases, but were generally unprotected (Figure 5.5.4).

Figure 5.5.2 Schematic diagram of tunnel-building connection detail and post-earthquake repair.

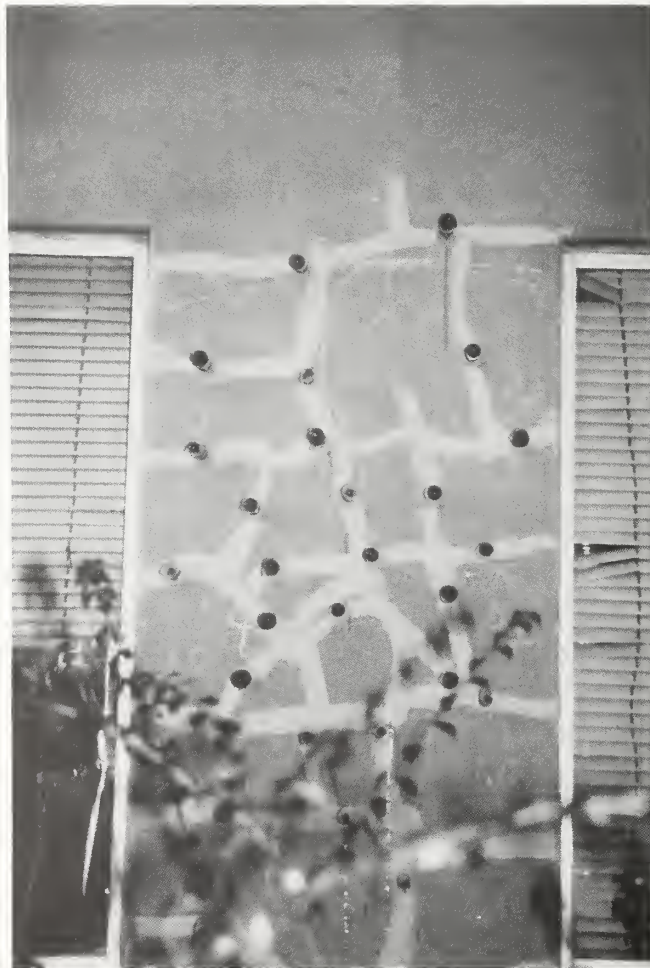
Figure 5.6.1

Column on the first floor of the old hospital being repaired with epoxy injection.

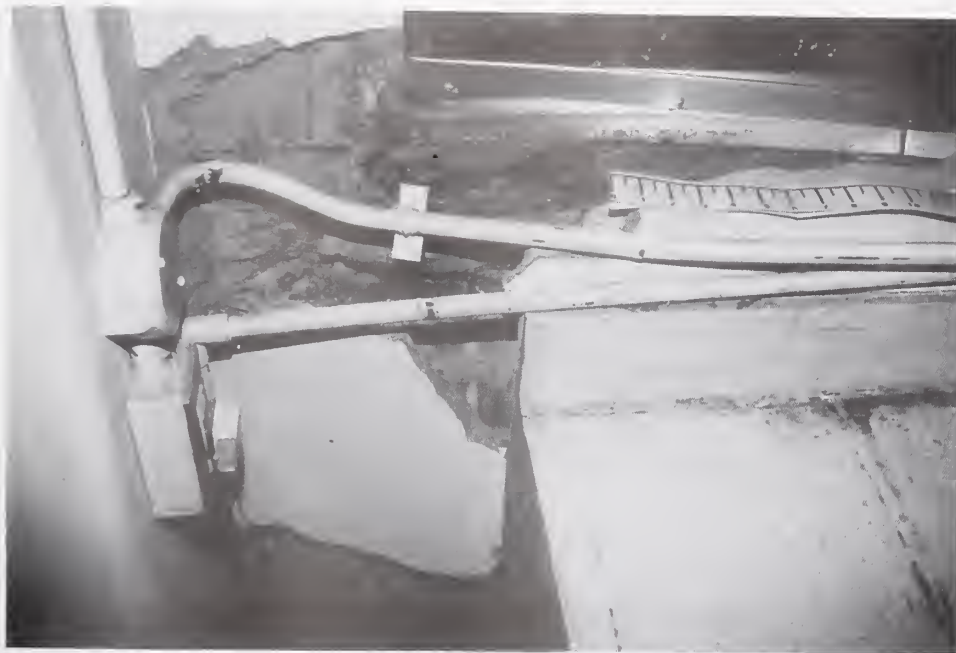
Figure 5.6.2

There appeared to be relatively little structural damage to the hospital, except as noted above. In the new wing of the hospital a section of a wall that joins the new and old wings had severe local damage due to interaction of the two buildings where the corridor connects the two buildings (Figure 5.6.2). There was some spalling of concrete adjacent to at least one seismic joint observed during the short visit to the hospital.

Beam shattered due to interaction between the two wings of the hospital at cross walks connecting the buildings.

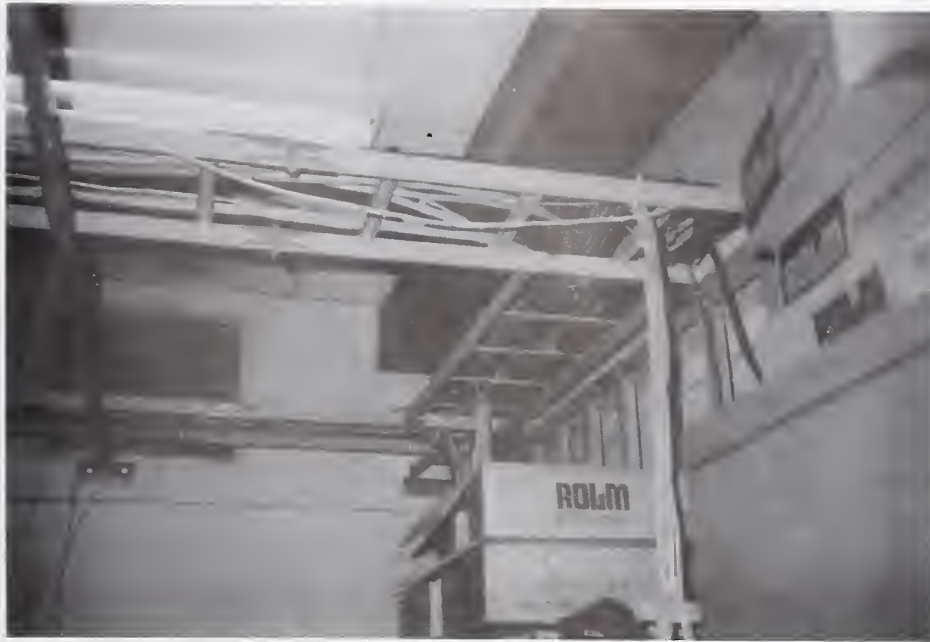
Figure 5.6.13

Typical, low tensile strength, friction-clip type communication cable tray hardware used to join tray sections in the U.S.

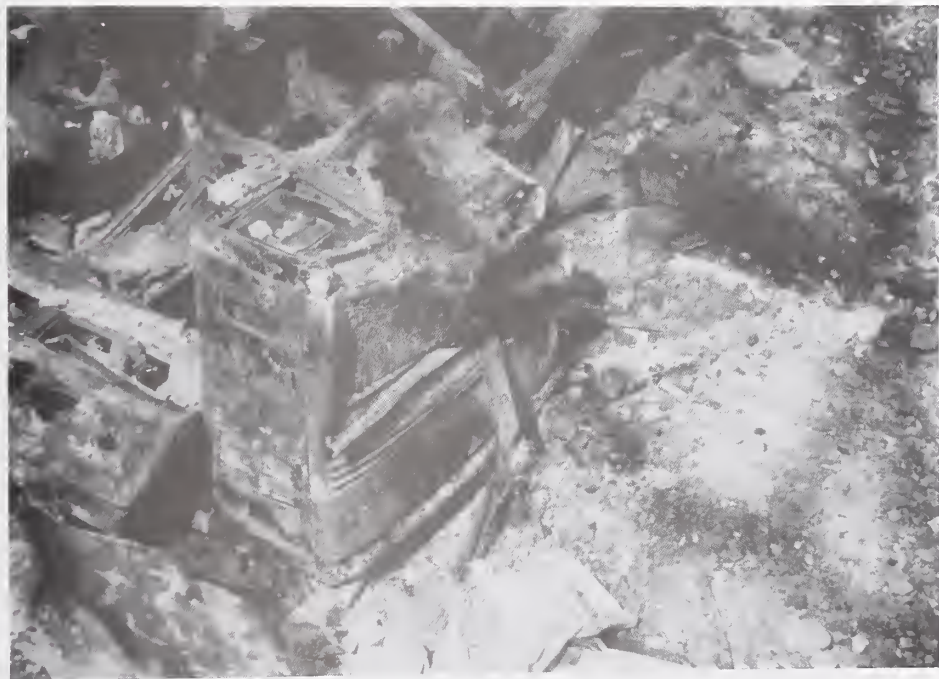
knocked down by the earthquake or torn from collapsed buildings creating potential arcing situations. Some electric lines were still connected to partially collapsed buildings (Figure 6.2.7). These lines may have stretched, creating a reduced cross sectional area of the wire, which could cause

ignition of a fire due to overheating. Insulation may have pulled away from the wires making short circuits or ground faults more likely. The majority of the fire damage occurred in areas of predominantly wooden construction which provided fuels to sustain and spread fires which ignited.

Figure 6.2.7 Example of electric power lines connected to a damaged house.

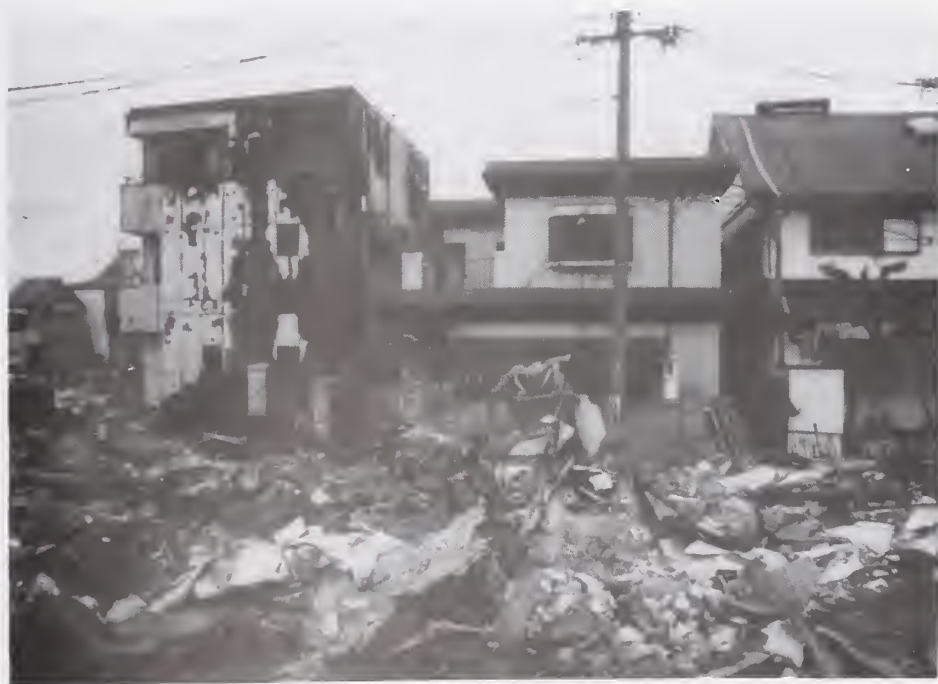
Figure 6.2.18 Burned out structure constructed from fire resistive materials.

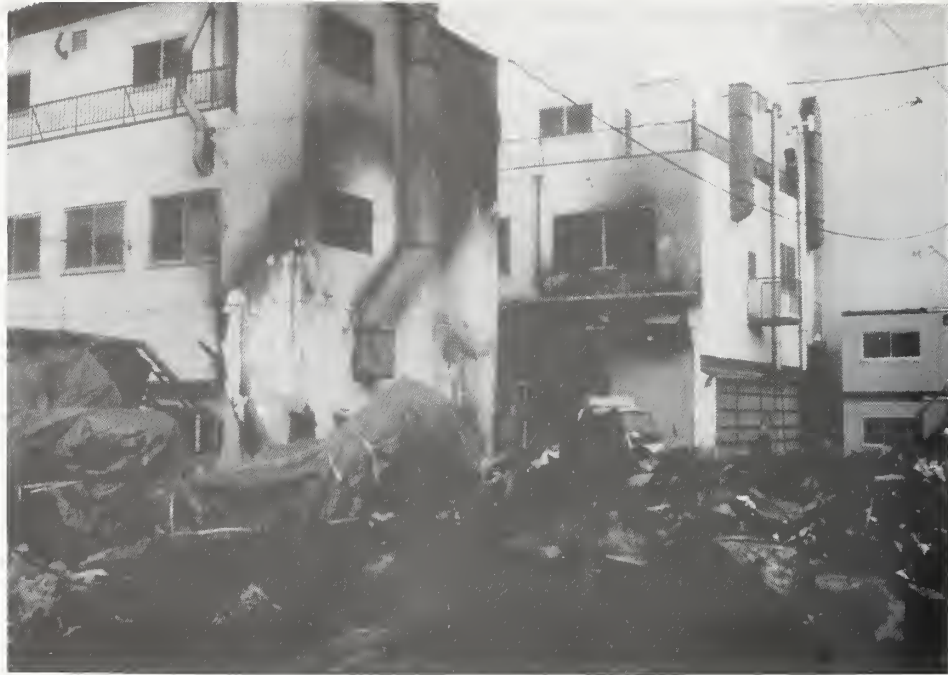
Figure 6.2.19 Buildings with fire resistive exteriors and wired glass windows.

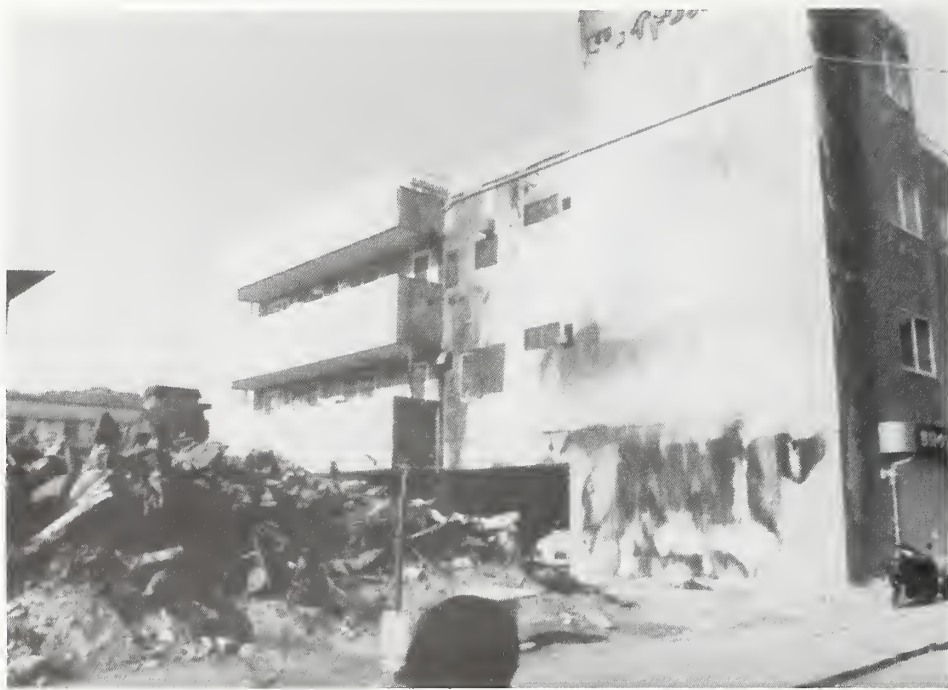
Figure 6.2.20 A building with a fire resistive exterior and wired glass windows.
